Inspection Report

Re: Indian River Landfill – Annual CCR Unit Inspection Report No. 2

Inspection Date: December 5, 2016

Memo Date: January 18, 2017

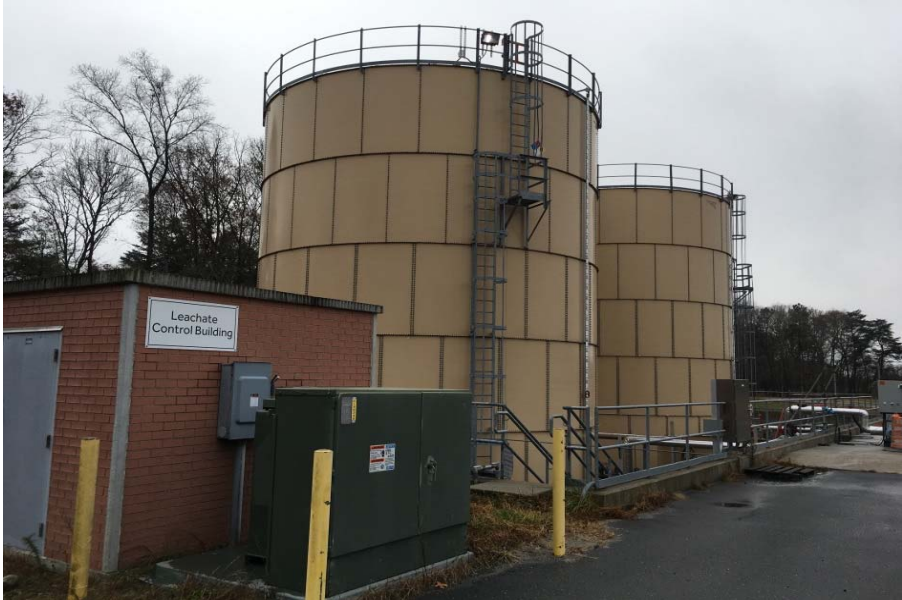
<p>Photograph No. 1</p> <p>Date: Dec. 5, 2016</p> <p>Direction: Southeast</p>

<p>A photograph showing a brick building labeled 'Leachate Control Building' next to two large, tan, cylindrical storage vaults. The vaults have metal ladders and railings. The scene is outdoors with trees in the background.</p>
<p>Leachate Control Building and leachate storage vaults in secondary containment. Secondary containment was dry with no evidence of staining.</p>

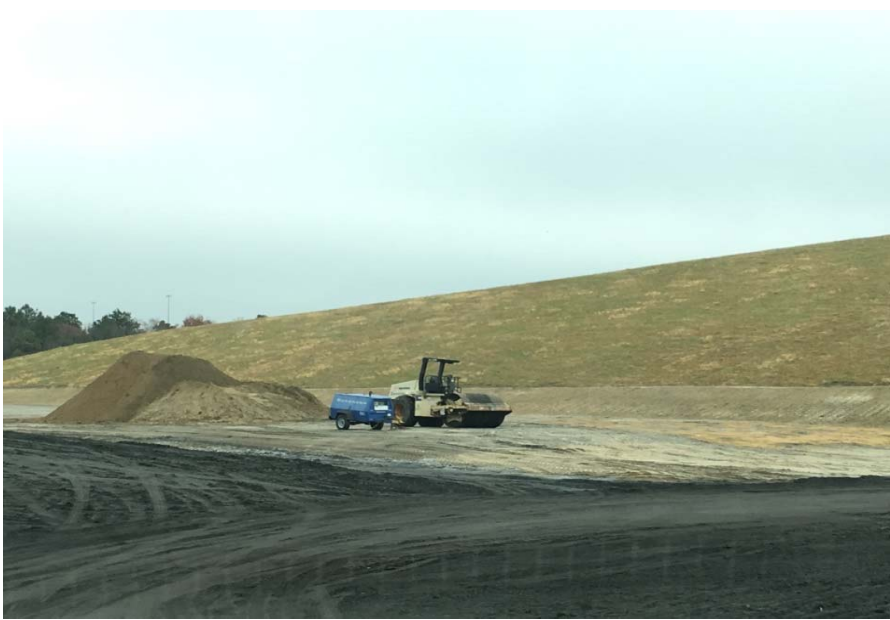
<p>Photograph No. 2</p> <p>Date: Dec. 5, 2016</p> <p>Direction: Northeast</p>

<p>A wide-angle photograph of a landfill site. In the center, there is a large pile of lime. A blue truck and a yellow compactor are visible on the ground. The background shows a large, grassy hill under a clear sky.</p>
<p>Description: Active Phase II Cell II area. Lime pile in center of photograph. Active area is well maintained with no ponding areas and no dust being generated.</p>

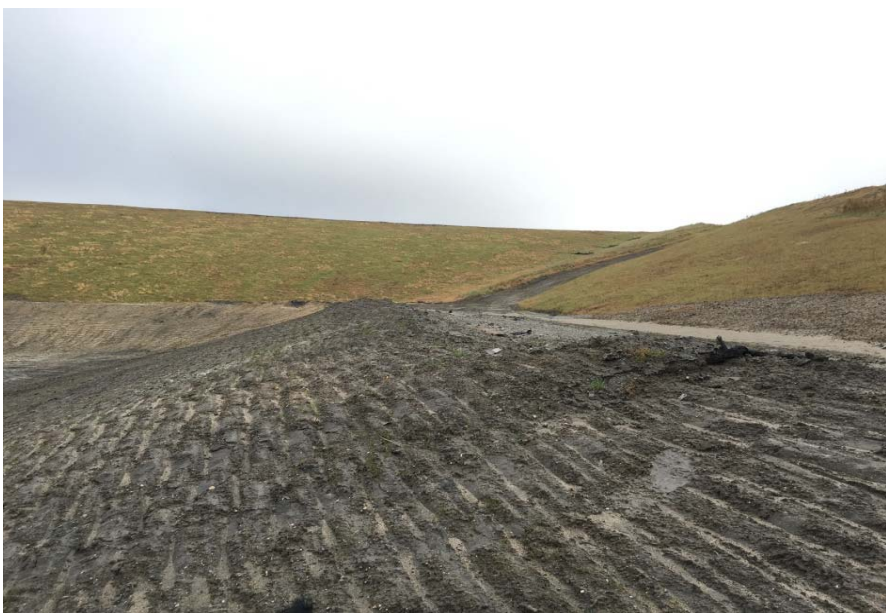
<p>Photograph No. 3</p> <p>Date: Dec. 5, 2016</p> <p>Direction: East</p>

<p>Description: Phase II Cell 1/Cell 2 boundary looking toward Phase II separation berm. No erosion or dust observed.</p>

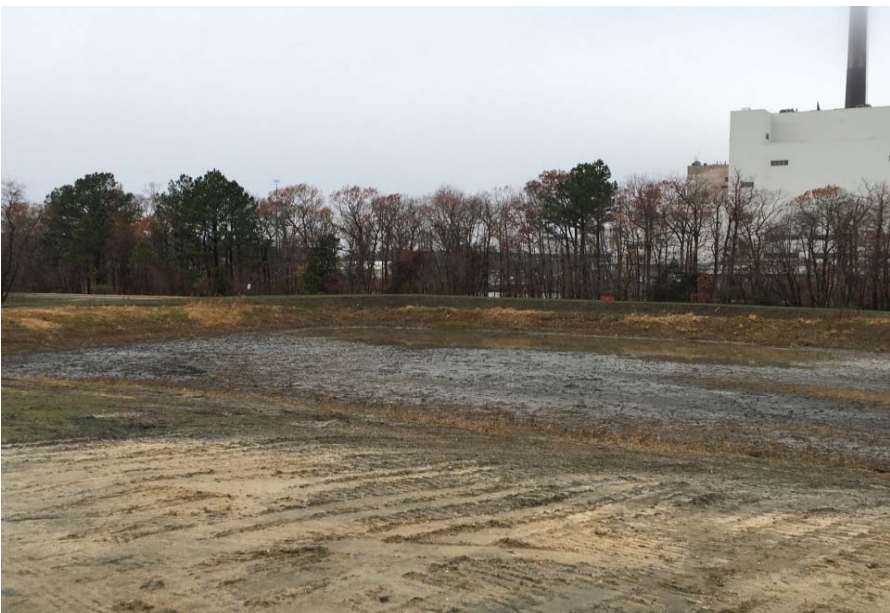
<p>Photograph No. 6</p> <p>Date: Dec. 5, 2016</p> <p>Direction: Northwest</p>

<p>Description: Sump area of Cell II Phase II. Leachate from significant recent rain is present, but has been effectively contained.</p>

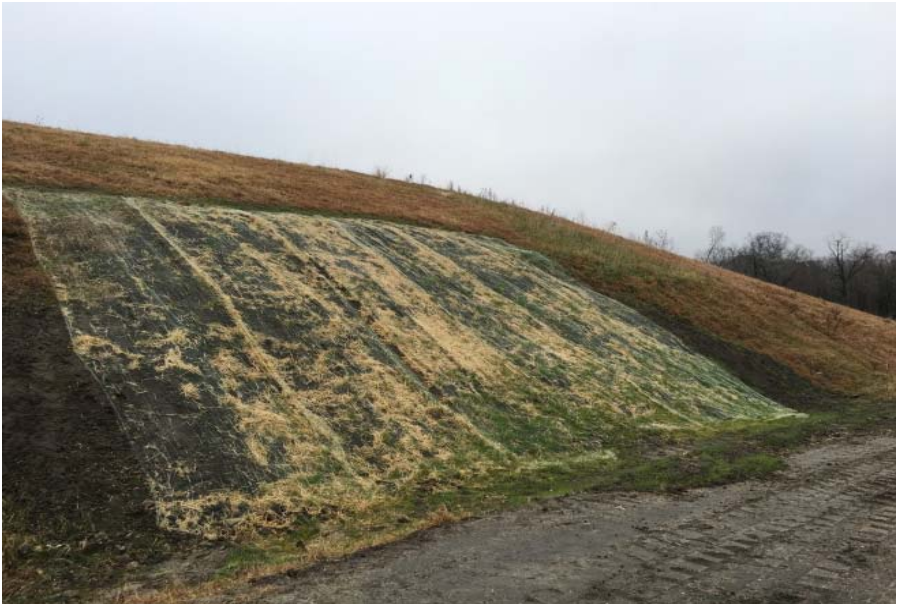
<p>Photograph No. 8</p> <p>Date: Dec. 5, 2016</p> <p>Direction: southeast</p>

No visual signs of distress or malfunction were observed during the inspection. Stormwater drainage features, slope appearance and stability, leachate conveyance mechanisms, and overall site conditions were assessed. Closed portions of Phase I and stabilized intermediate cover areas of Phase II exhibited well established vegetative cover. A small area of the cover showed evidence of regrading, seeding, and stabilization. Upon discussion with the Landfill Manager, it was determined that this area was a corrective action area to address an erosion gully that formed in 2016. The repairs appeared to be appropriate. Please see Photograph 8 in Attachment 2 and the attached figure in Attachment 1 for the corresponding location.

<p>Description: Cover repair area on Cell 1. Cover material was regraded, seeded, and covered with erosion control blanket.</p>

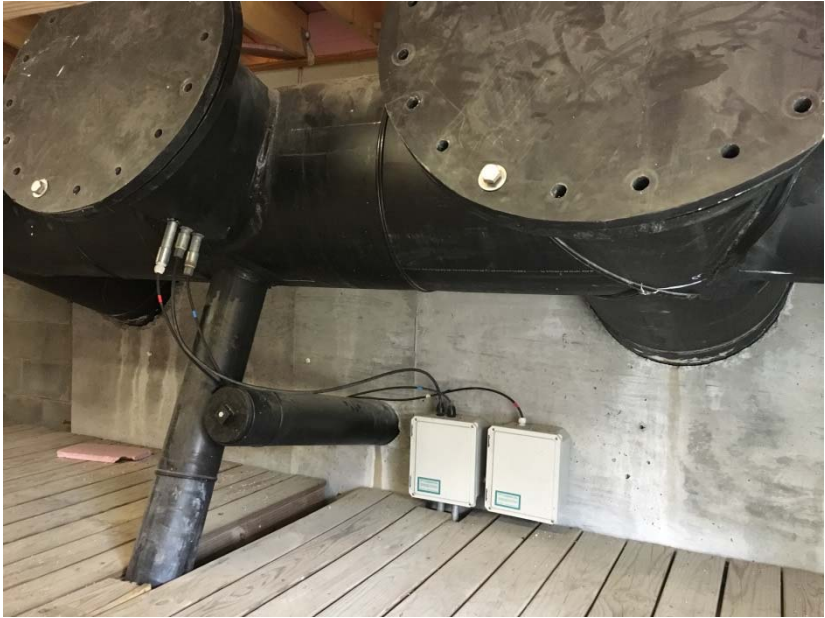
<p>Photograph No. 11</p> <p>Date: November 17, 2016</p> <p>Direction: east</p>

<p>Description: Inside Cell 1 Leachate Pump House. Cleanout riser (bottom pipe), leachate pump risers, and T connection to forcemain shown.</p>

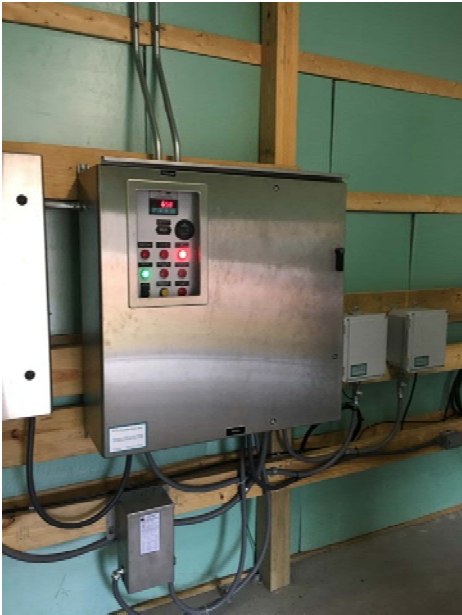
<p>Photograph No. 12</p> <p>Date: November 17, 2016</p> <p>Direction: East</p>

<p>Description: Leachate liquid level indicator and controls of Cell II Phase II leachate pumphouse. Red Light is indicating high leachate level due to recent rain.</p>

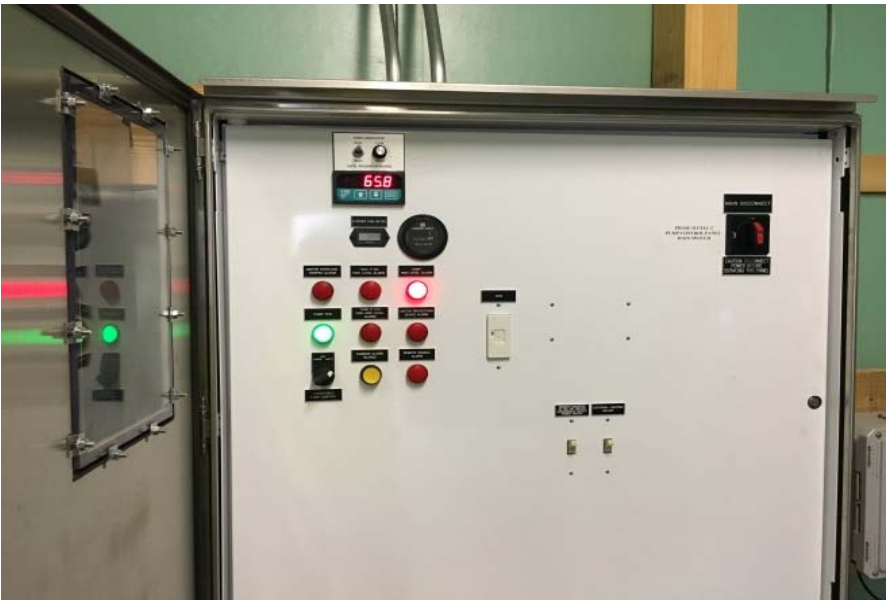
<p>Photograph No. 14</p> <p>Date: Dec 5, 2016</p> <p>Direction: East</p>

<p>Description: Leachate liquid level indicator and controls of Cell II Phase II leachate pumphouse. Red Light is indicating high leachate level due to recent rain.</p>

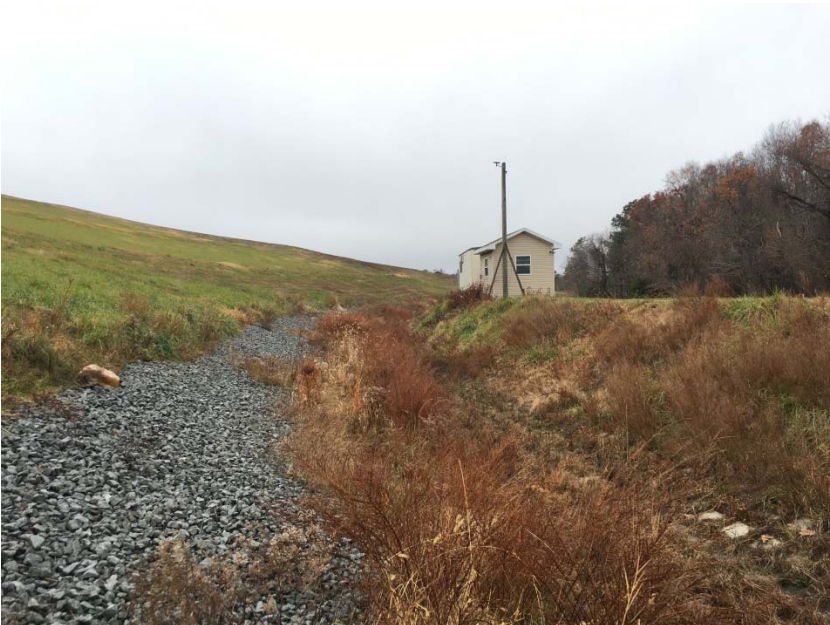
<p>Photograph No. 16</p> <p>Date: Dec 5, 2016</p> <p>Direction: West</p>

<p>Description: Perimeter stormwater channel with temporary storage trailer shown.</p>
