Inspection Report

From: Richard Southorn, P.E., P.G., CPSWQ

Re: Indian River Landfill – Annual CCR Unit Inspection Report No. 3

Inspection Date: October 5, 2017

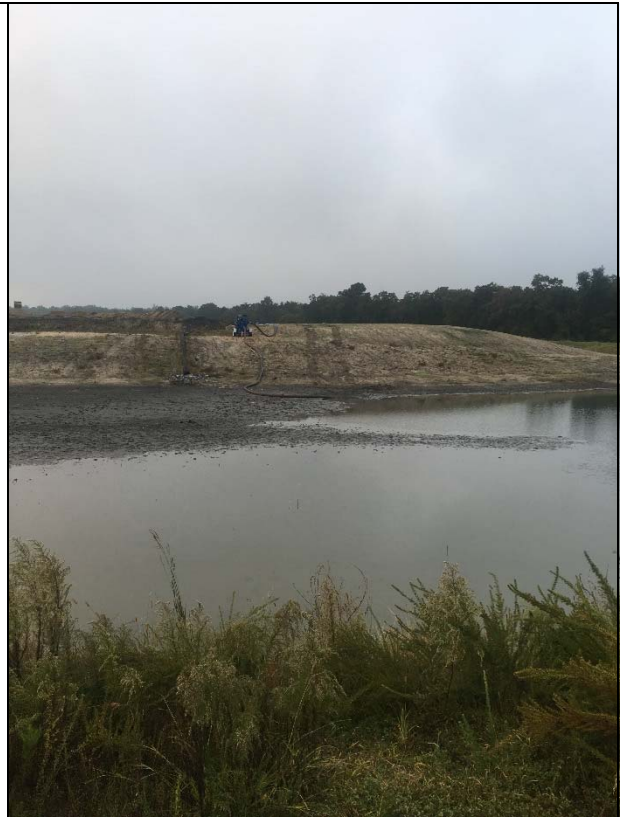
Photograph No. 1

Standing water within cell due to recent rains. The stormwater water percolates through the ash into the leachate collection layer, where it is pumped out and removed as leachate.

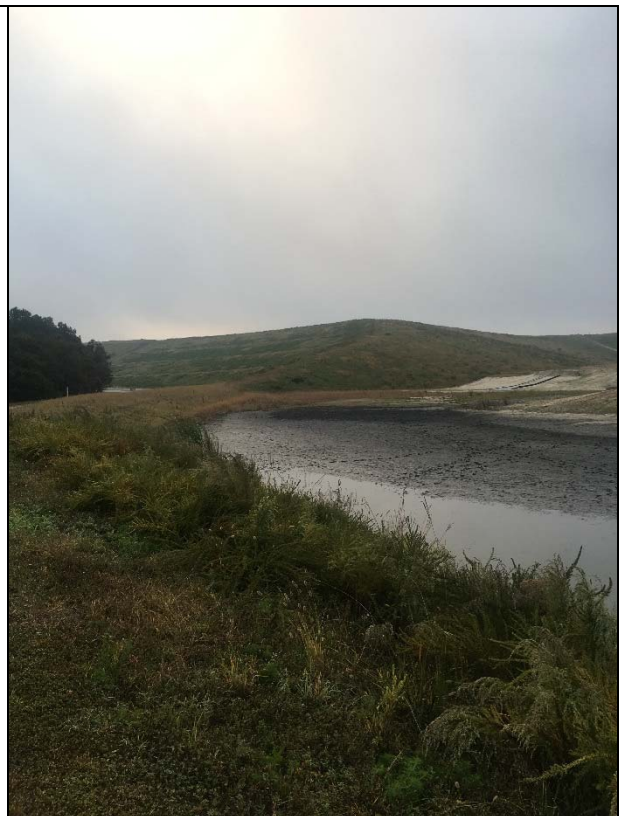
Photograph No. 2

View of berm containing standing water within cell due to recent rains. The berms are in good condition and are effective in containing the water.

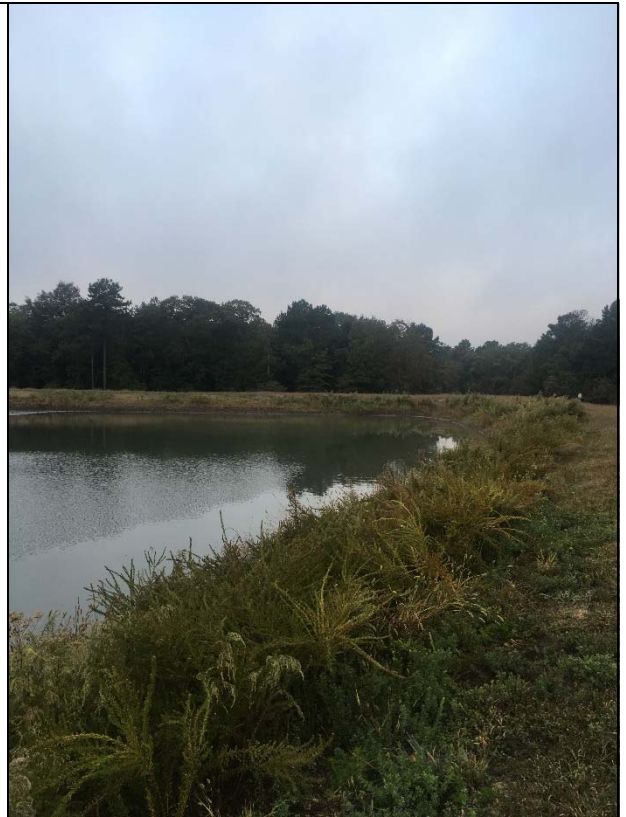
Photograph No. 3

Second view of berm containing standing water within cell due to recent rains. The berms are in good condition and are effective in containing the water.

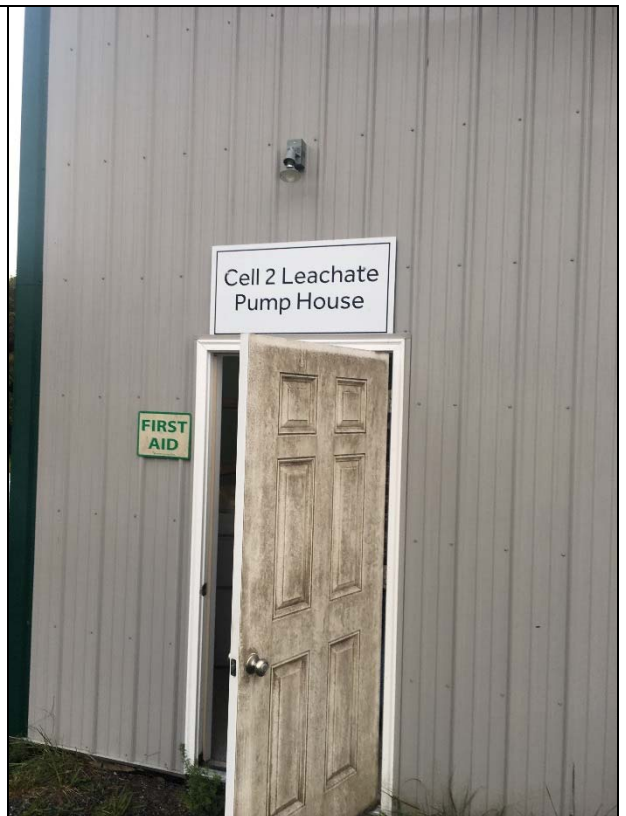
Photograph No. 4

Phase 2, Cell 2 leachate pump house. Building exterior is in good condition and appropriately signed.

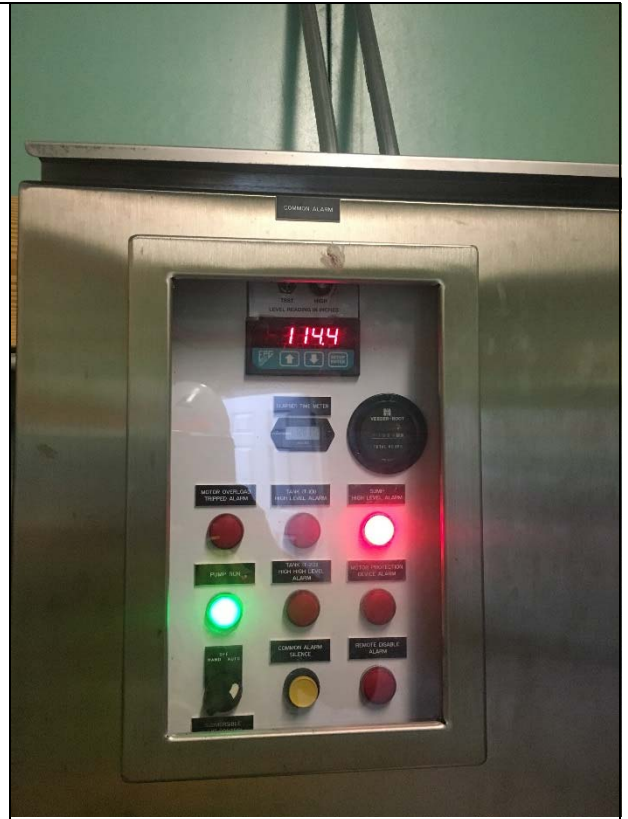
Photograph No. 5

Leachate liquid level indicator and controls in the Phase 2, Cell 2 leachate pump house. Red light is indicating a high leachate level associated with standing water.

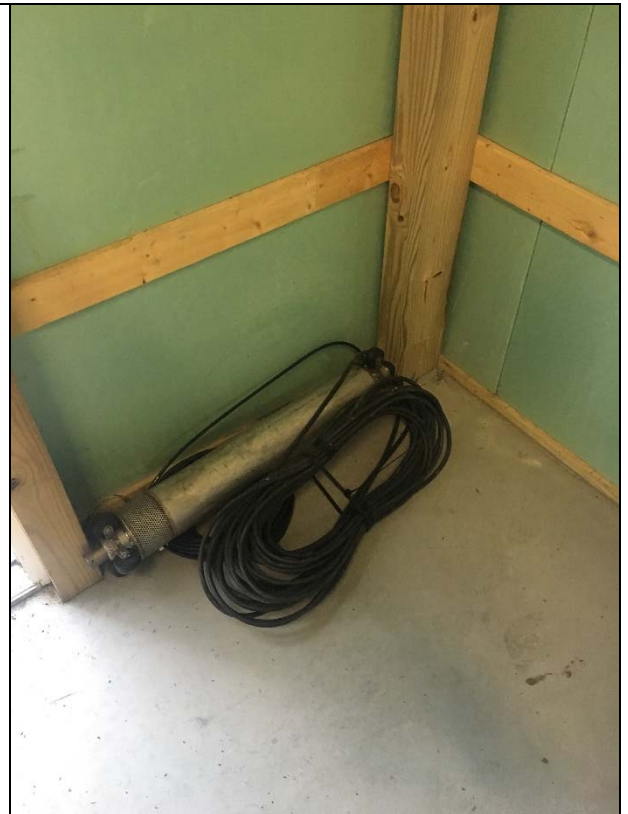
Photograph No. 6

Phase 2, Cell 2 spare leachate pump.

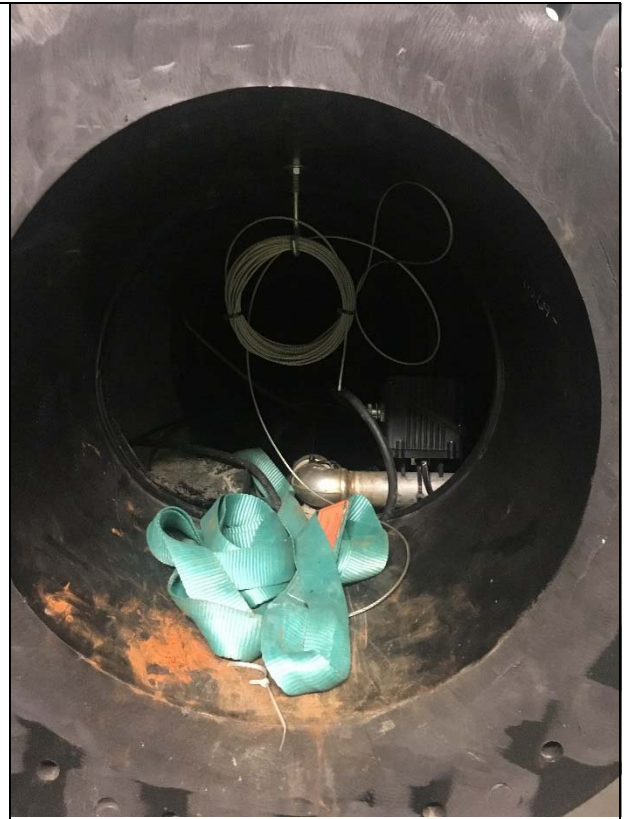
Photograph No. 7

Inside Phase, Cell 2 leachate pump riser.

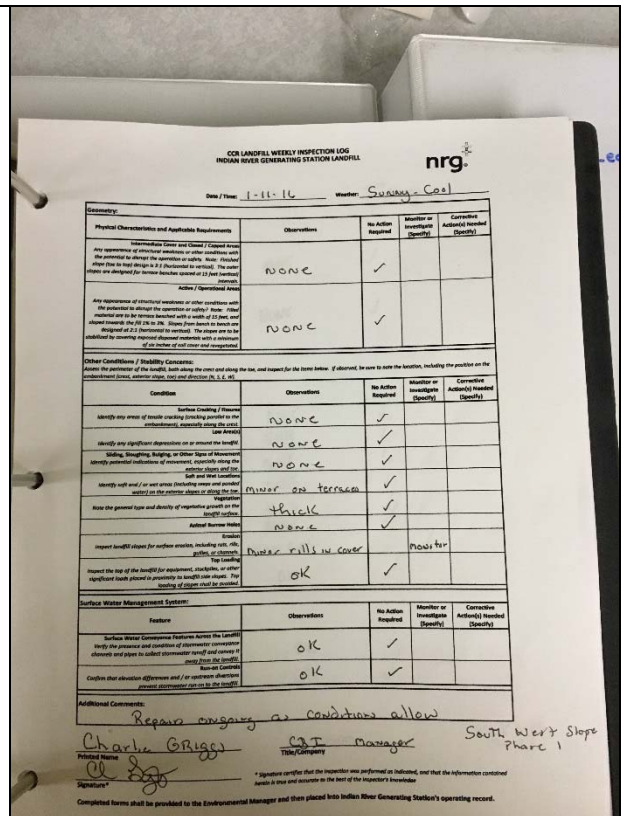
Photograph No. 8

Typical weekly inspection report. Logs appear to be correctly used and up to date.

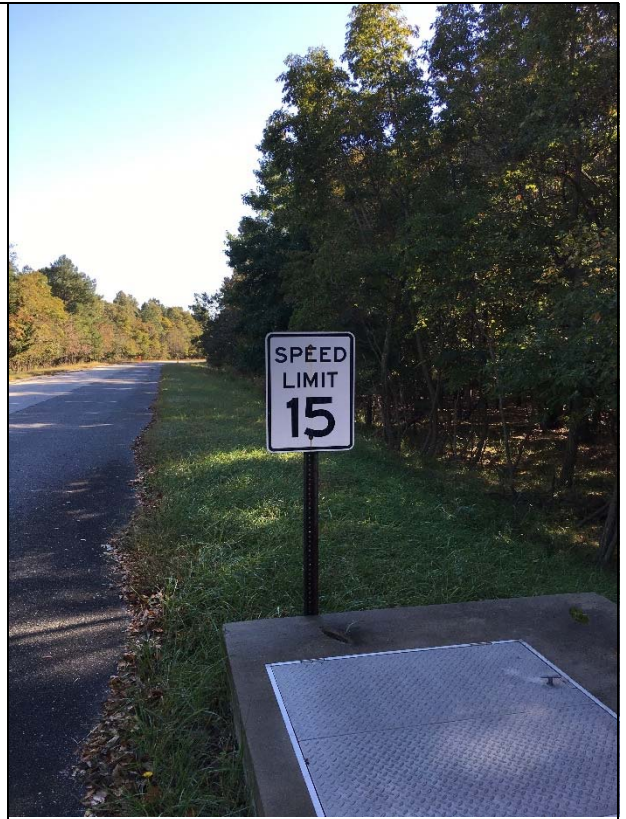
Photograph No. 9

15 mph speed limit sign.

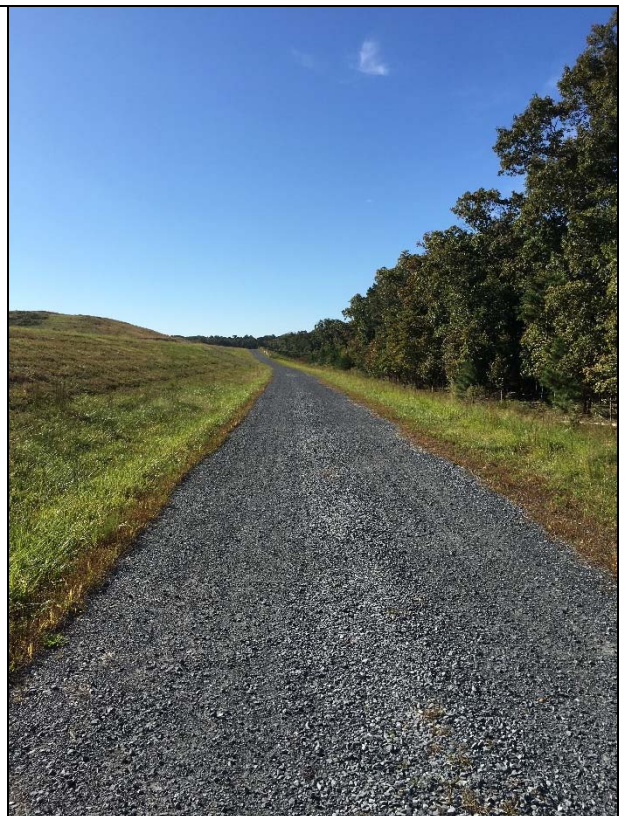
Photograph No. 10

Access roads are well maintained.

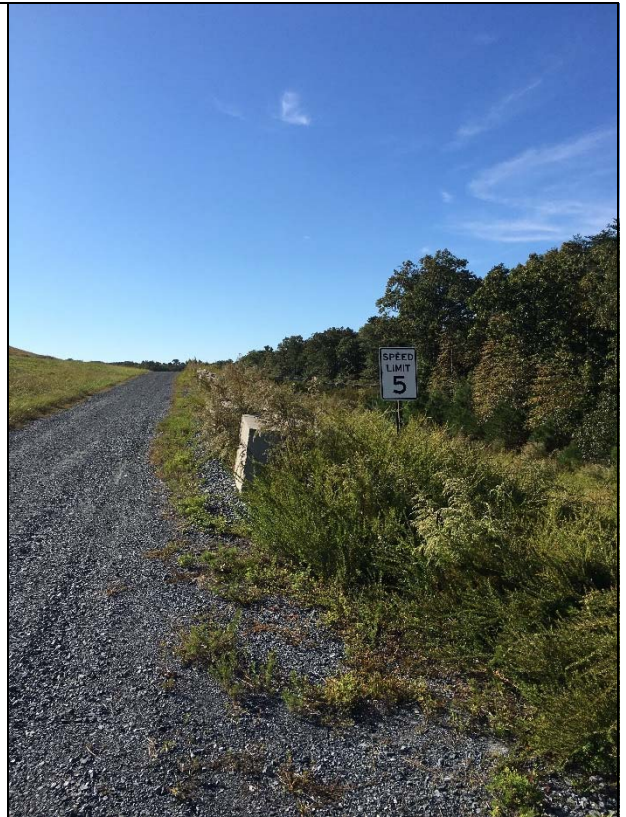
Photograph No. 11

5 mph speed limit near active area.

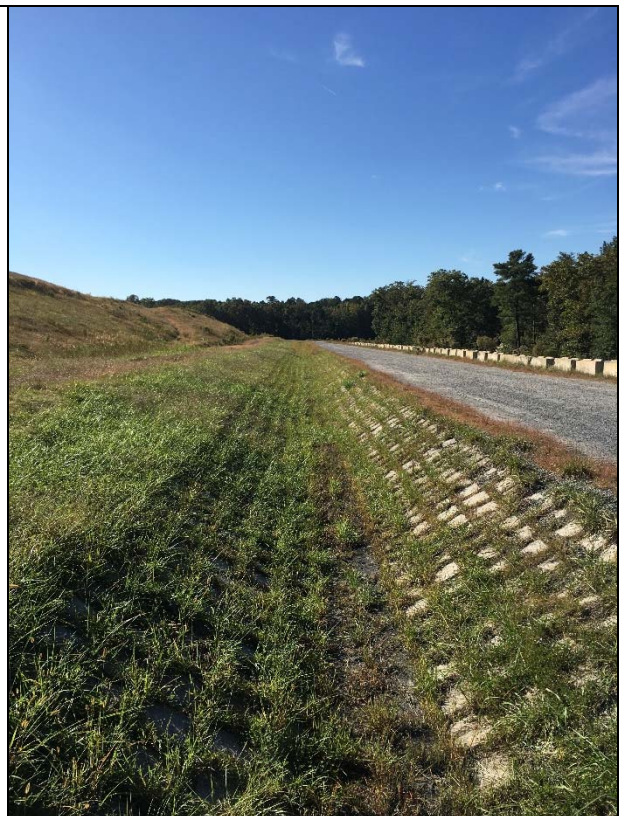
Photograph No. 12

Armored perimeter stormwater channel.

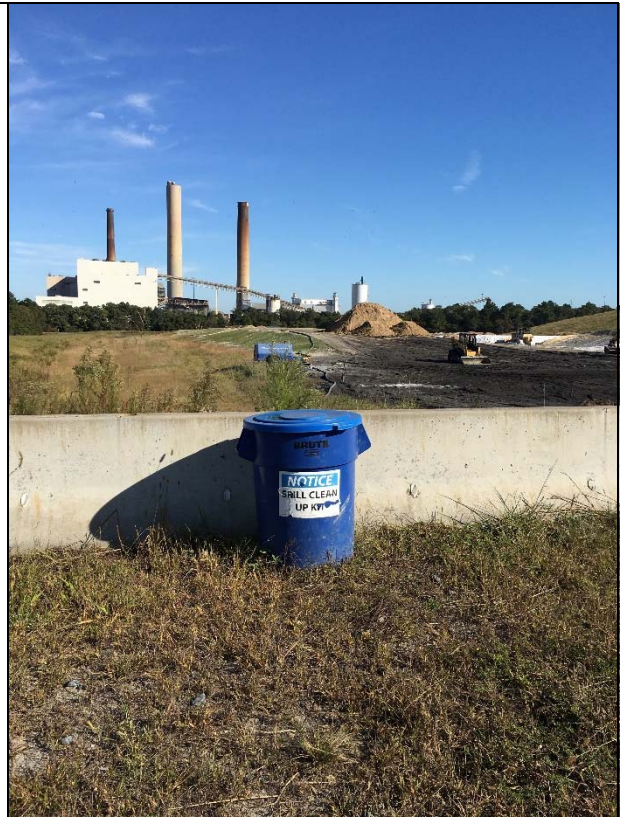
Photograph No. 13

Spill cleanup kit near active face of Phase 2, Cell 2.

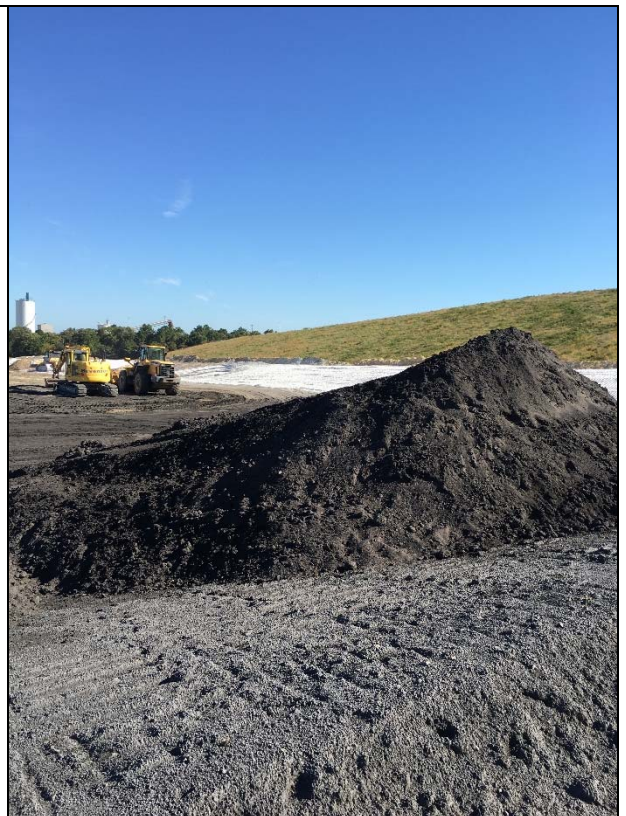
Photograph No. 14

Bottom ash for disposal in Cell 2, Phase 2. The material is segregated for use as an interior driving surface.

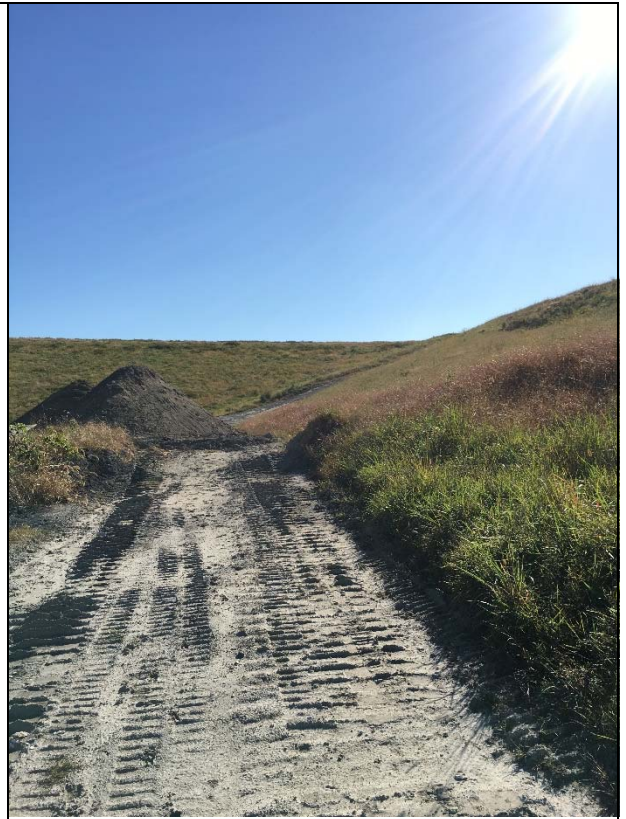
Photograph No. 15

Phase 2 Cell 1/Cell 2 boundary looking towards the separation berm. No erosion or dust observed.

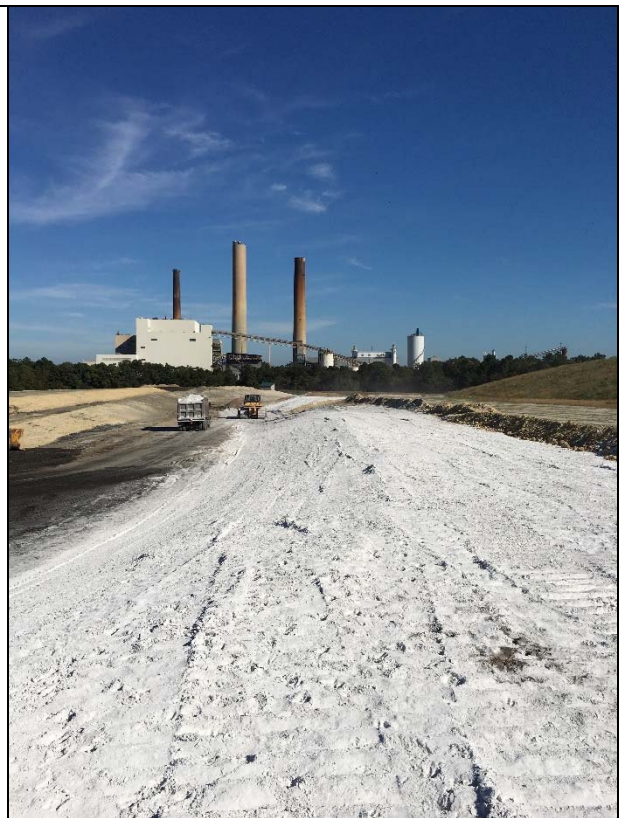
Photograph No. 16

Lime being placed in Phase 2, Cell 2.

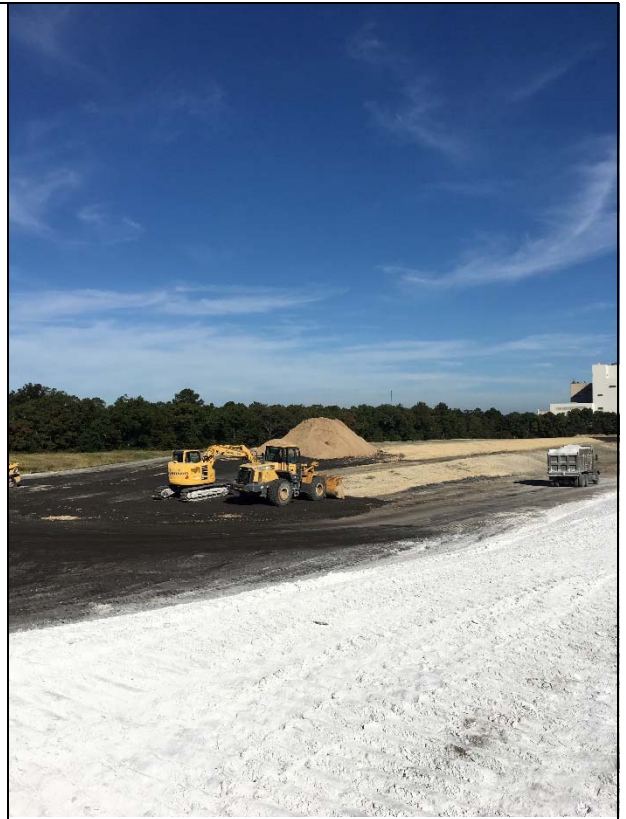
Photograph No. 17

Daily cover soil stockpile in active area of Phase 2, Cell 2. Area is well maintained.

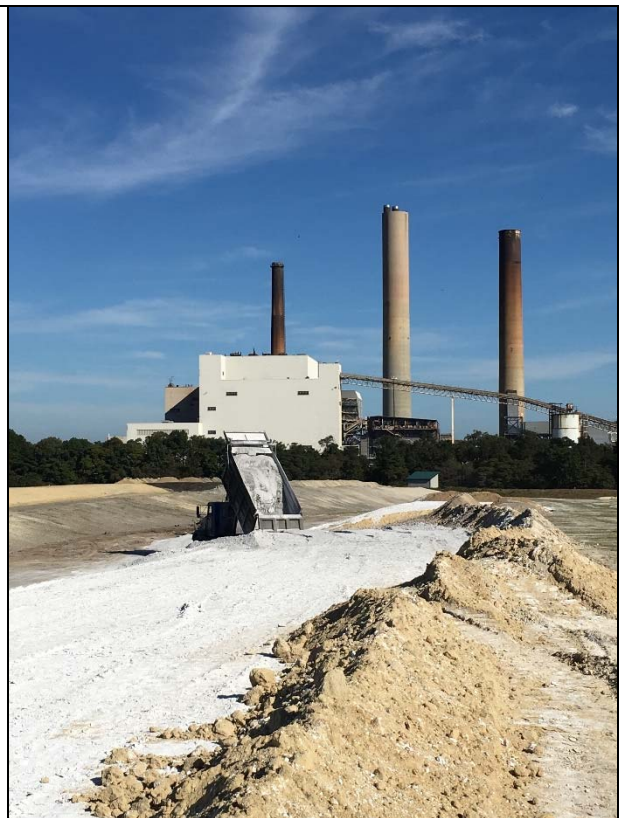
Photograph No. 18

Haul truck unloading CCR material (lime) for placement in active area of Phase 2, Cell 2. Area is well maintained and graded.

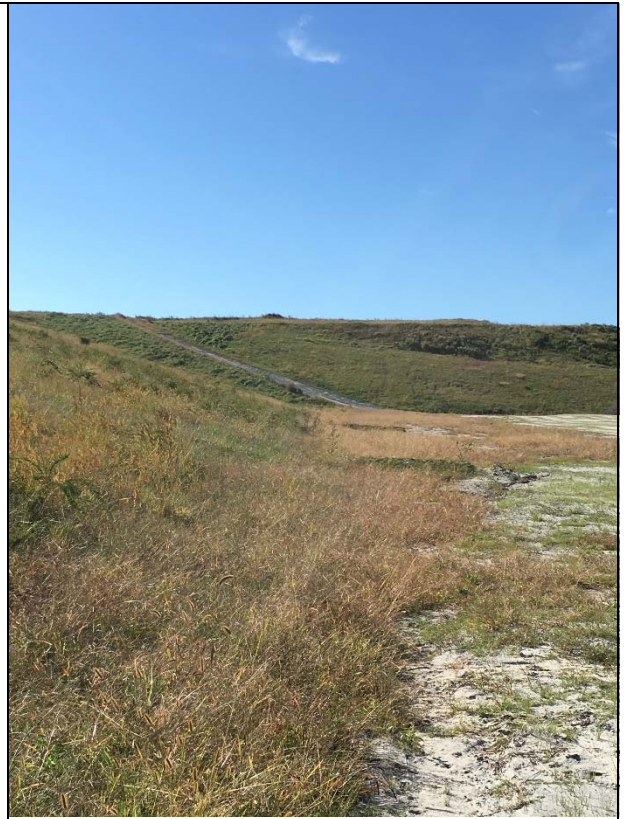
Photograph No. 19

Phase 1 and Phase 2, Cell 2 boundary.

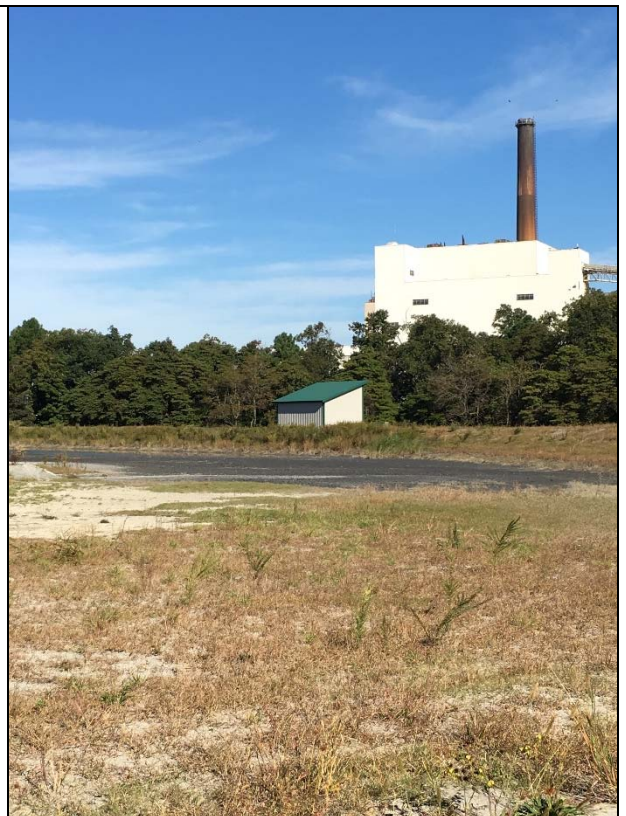
Photograph No. 20

Phase 2 Cell 2 sump area and pump house in background.

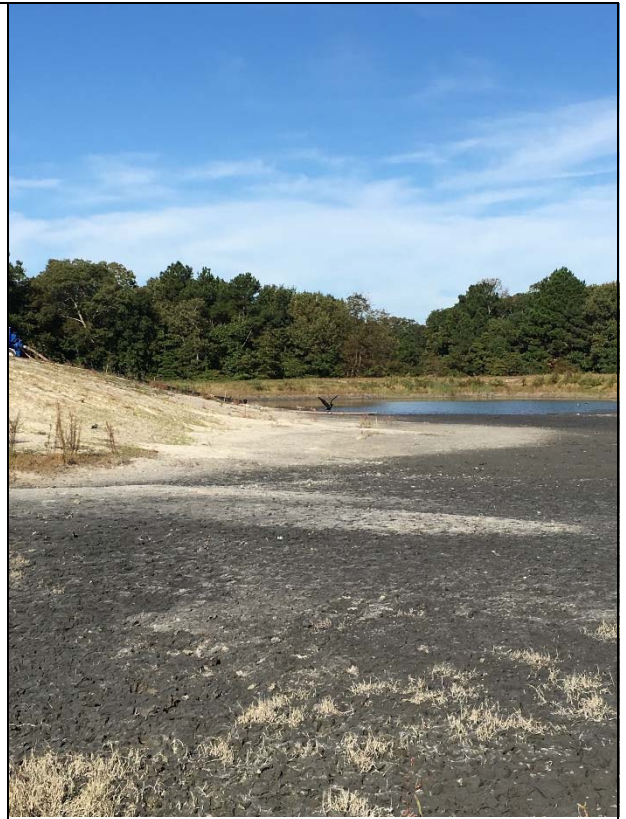
Photograph No. 21

Sump area of Phase 2, Cell 2.

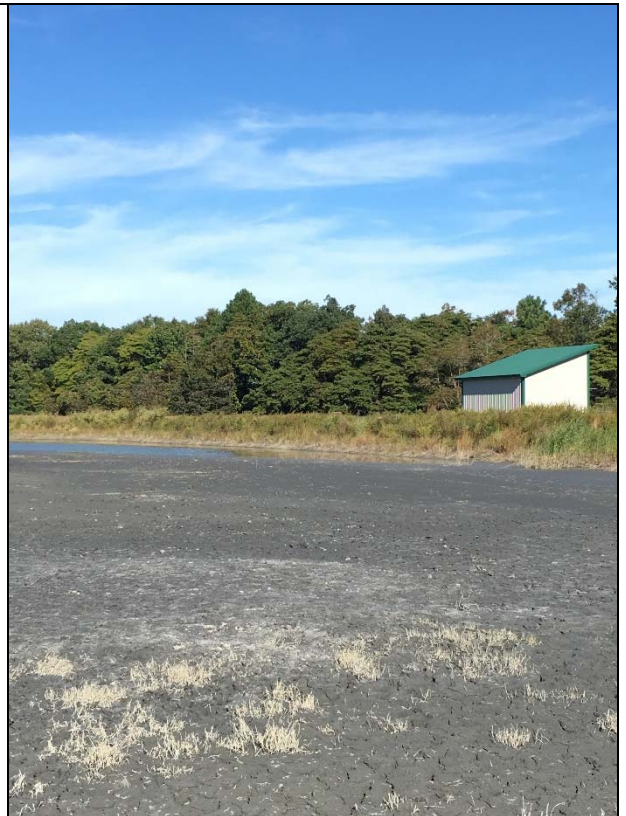
Photograph No. 22

Sump area of Phase 2, Cell 2. Phase 2, Cell 2 leachate pump house in the background.

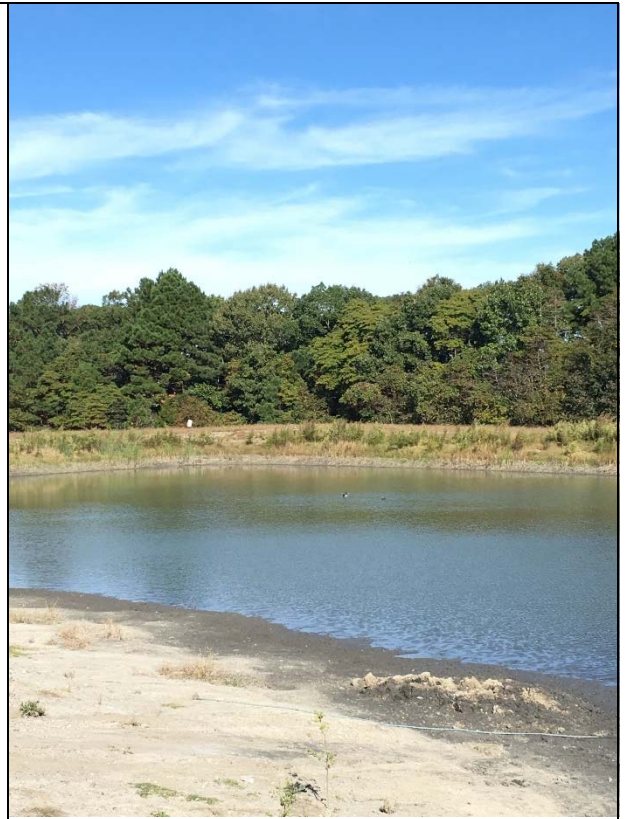
Photograph No. 23

Phase 2, Cell 2 sump area. Leachate from significant rain events is present as standing water, but is effectively contained.

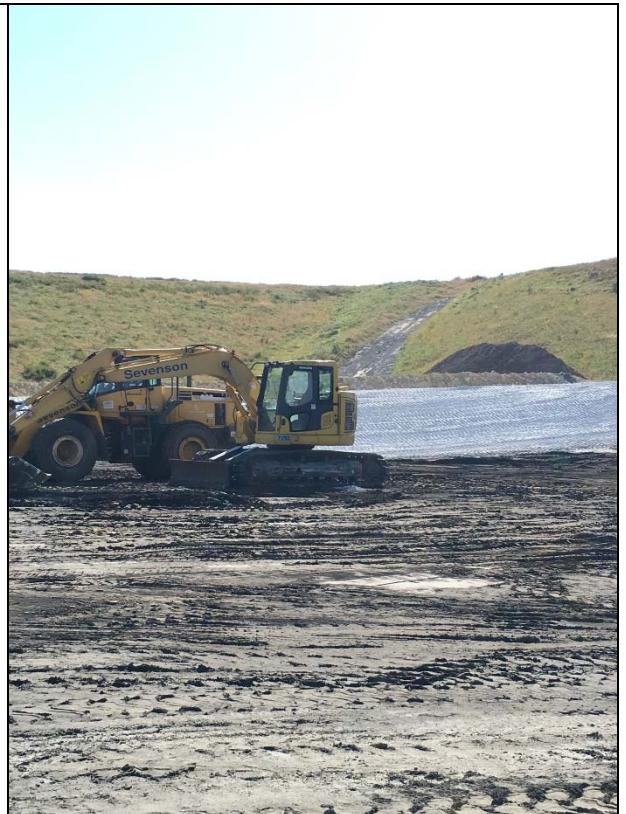
Photograph No. 24

Active Phase 2, Cell 2 area. Active area is well maintained with no ponding areas or dust generation.

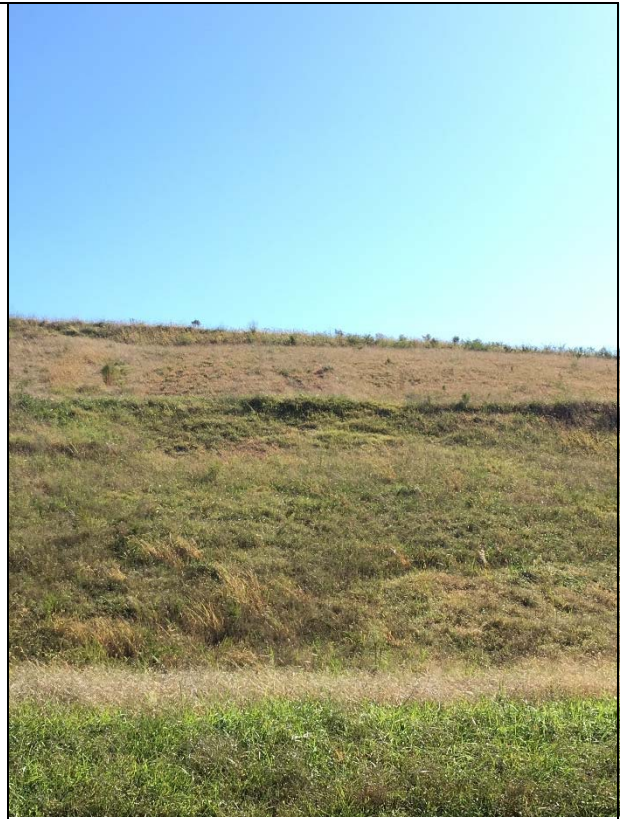
Photograph No. 25

Phase 2, Cell 1 final cover has established vegetation which is well maintained. No signs of stability issues on slope or at toe.

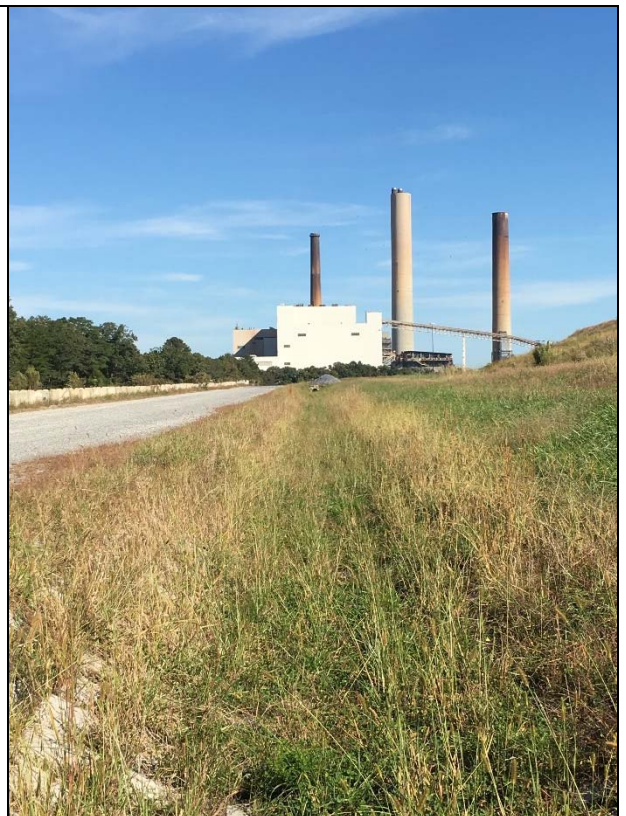
Photograph No. 26

Phase 2, Cell 1 stormwater ditch. Well maintained with armor present.

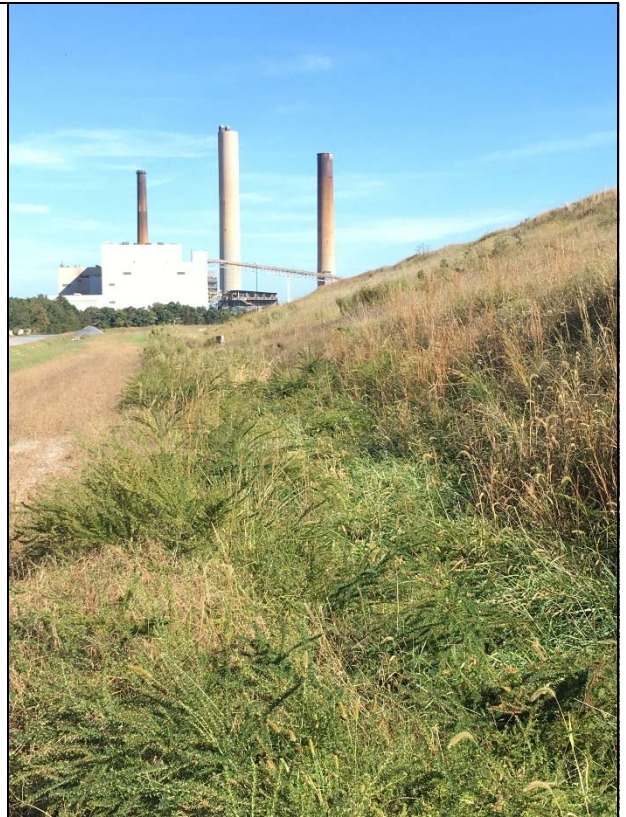
Photograph No. 27

Phase 2, Cell 1 interior ditch.

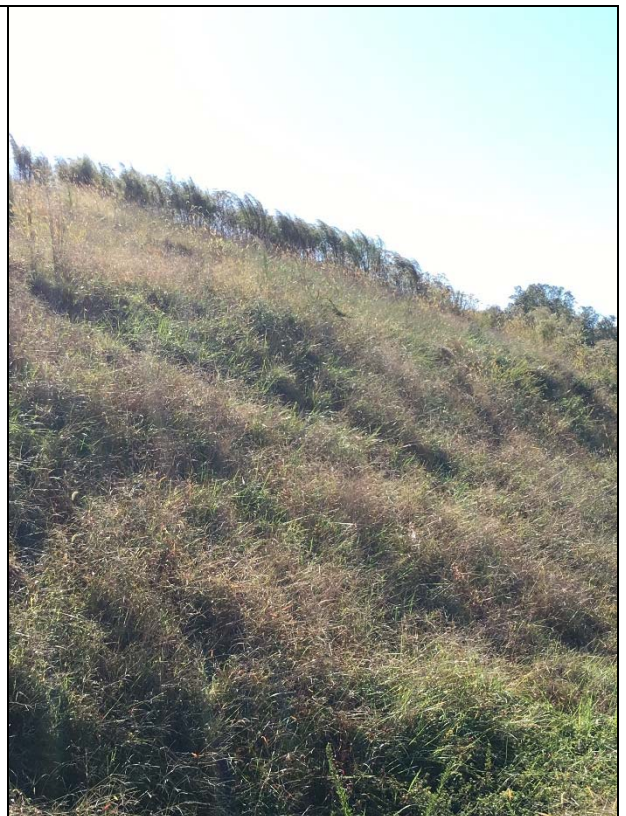
Photograph No. 28

Cell 1 final cover rill area repaired in 2016 (see 2016 annual report). Vegetation is lush and no evidence of previous rill is present.

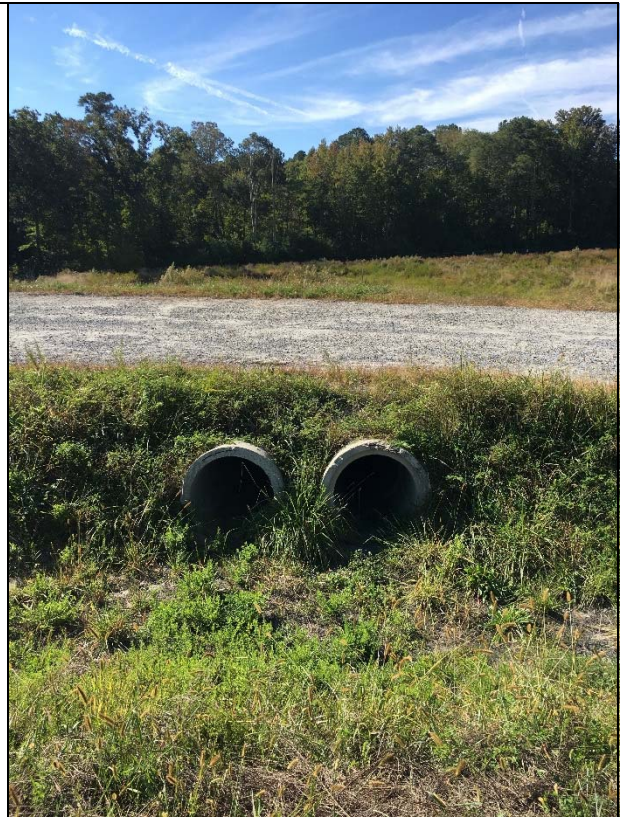
Photograph No. 29

Inlets to stormwater basin. Clear of obstruction at inlets and outlets.

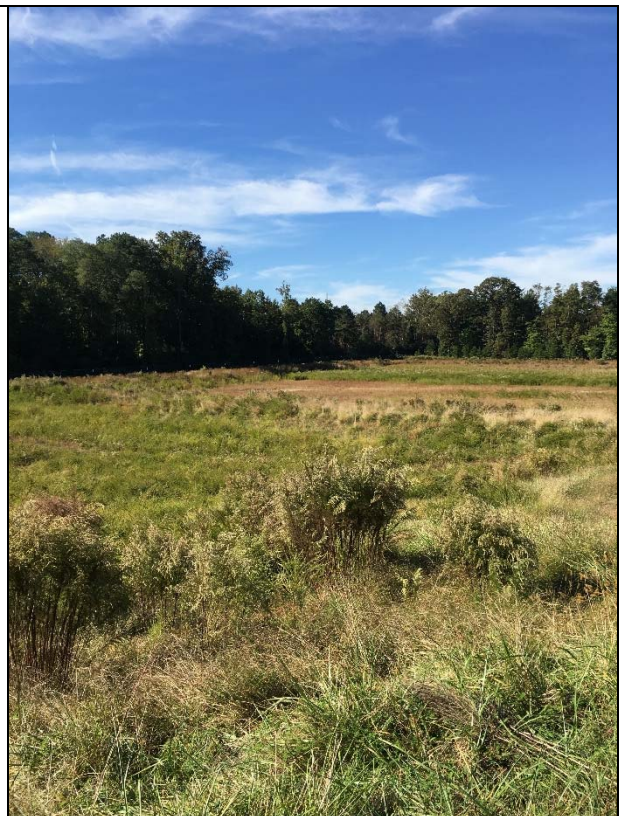
Photograph No. 30

Stormwater basin forebay. In good condition.

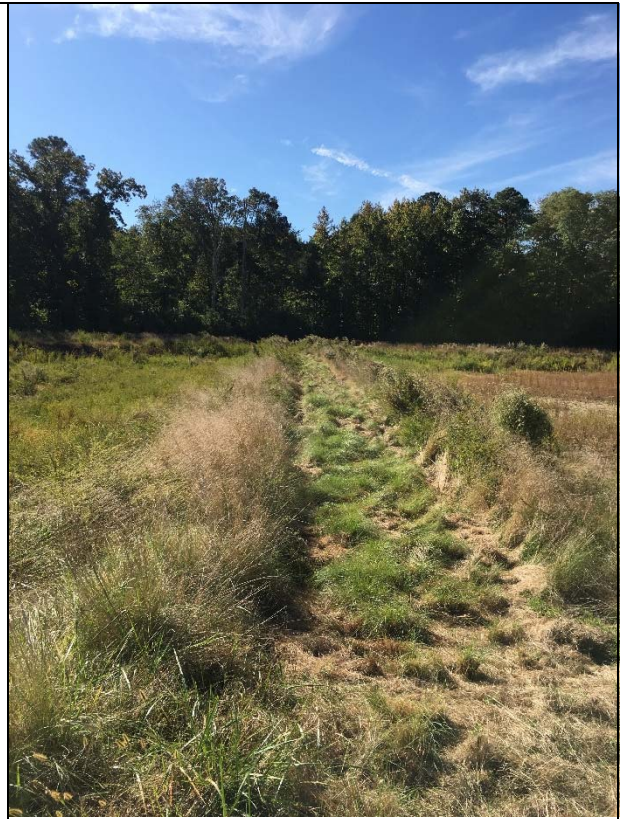
Photograph No. 31

Stormwater basin forebay berm.

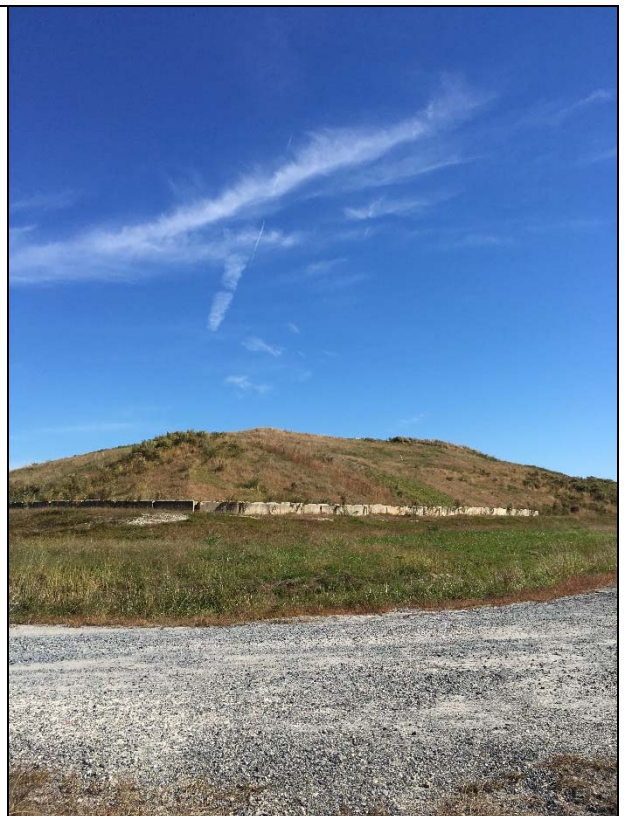
Photograph No. 32

Phase 1, Cell 1 final cover on sideslopes. Vegetation is established.

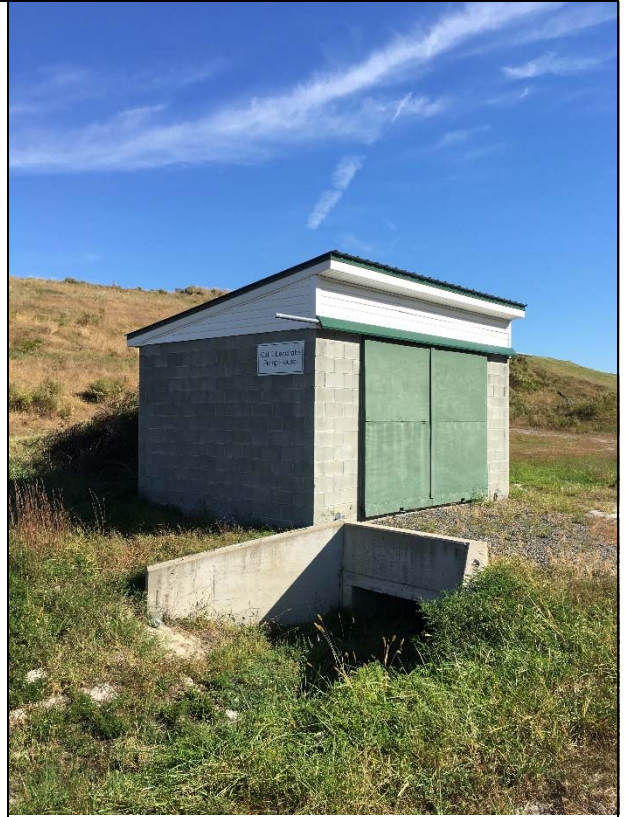
Photograph No. 33

Phase 1, Cell 1 leachate pump house and stormwater culvert. Building is appropriately signed. Culvert is free of obstructions.

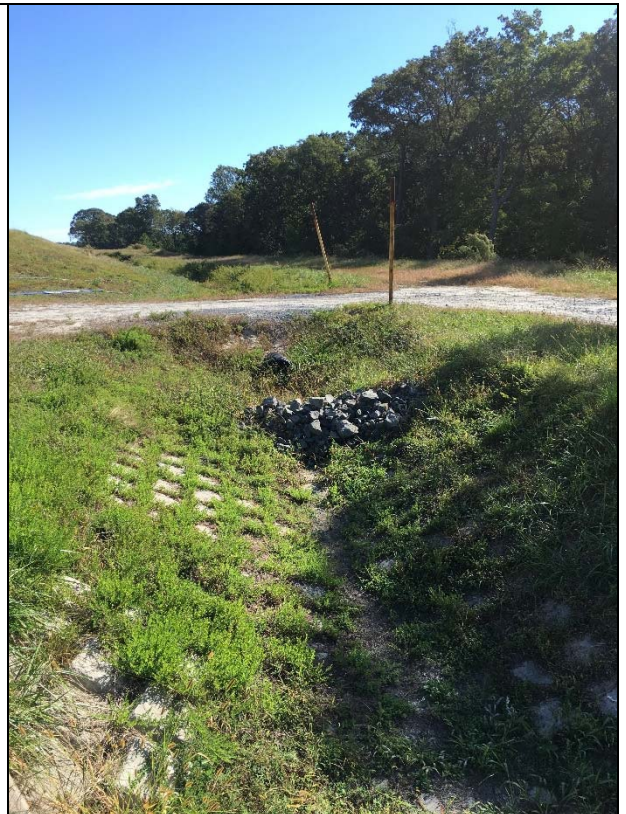
Photograph No. 34

Stormwater rock check dams in an armored perimeter stormwater ditch. Stormwater rock check dams in an armored perimeter stormwater ditch.

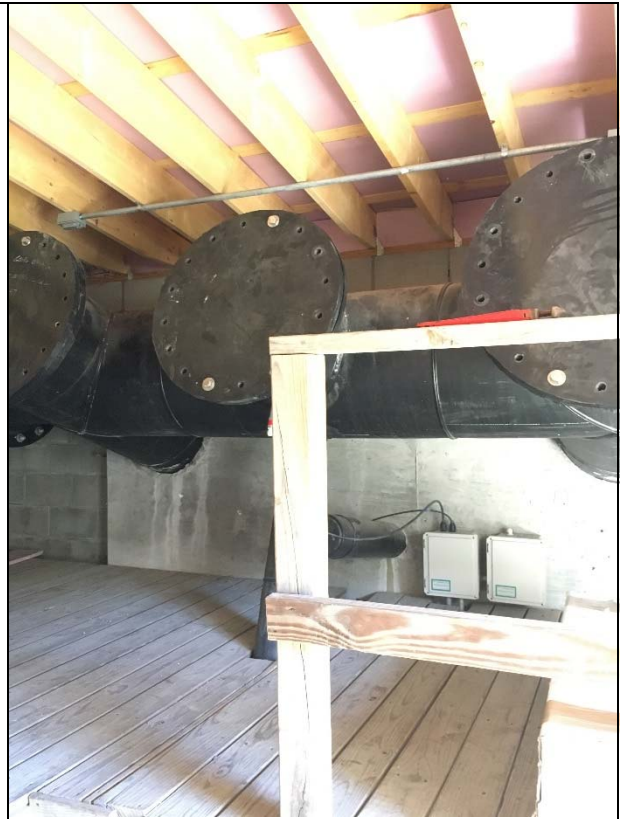
Photograph No. 35

Inside Phase 1, Cell 1 Leachate Pump House. Cleanout riser and pump risers with T connection to forcemain shown. Building is well maintained.

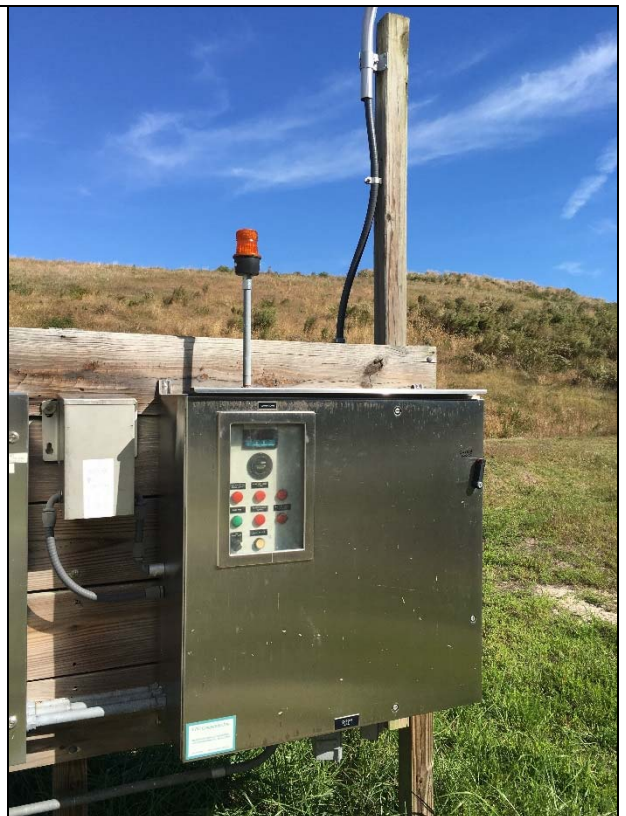
Photograph No. 36

Phase 1, Cell 1 leachate instrument panel. Good working order.

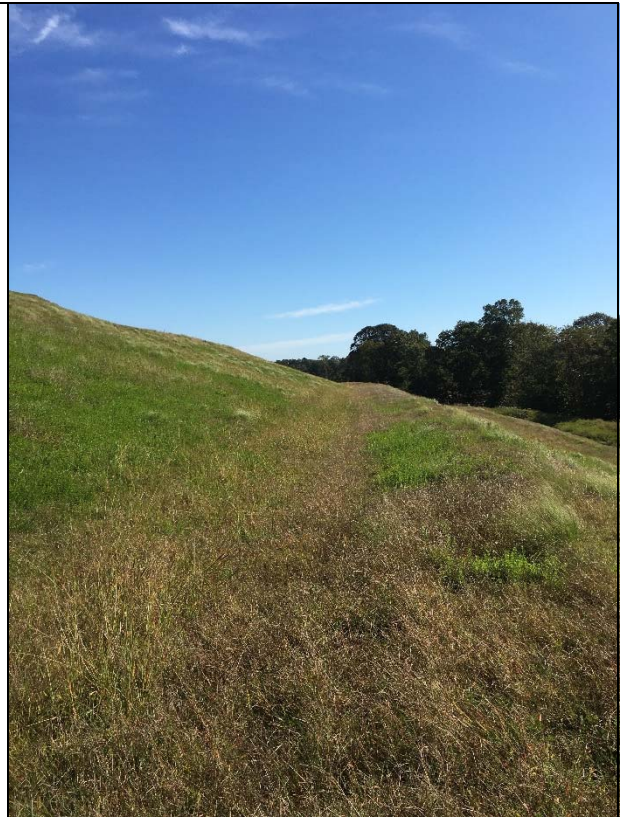
Photograph No. 37

Terrace berm. Clear of obstructions and functioning as intended. Vegetative cover is dense and healthy.

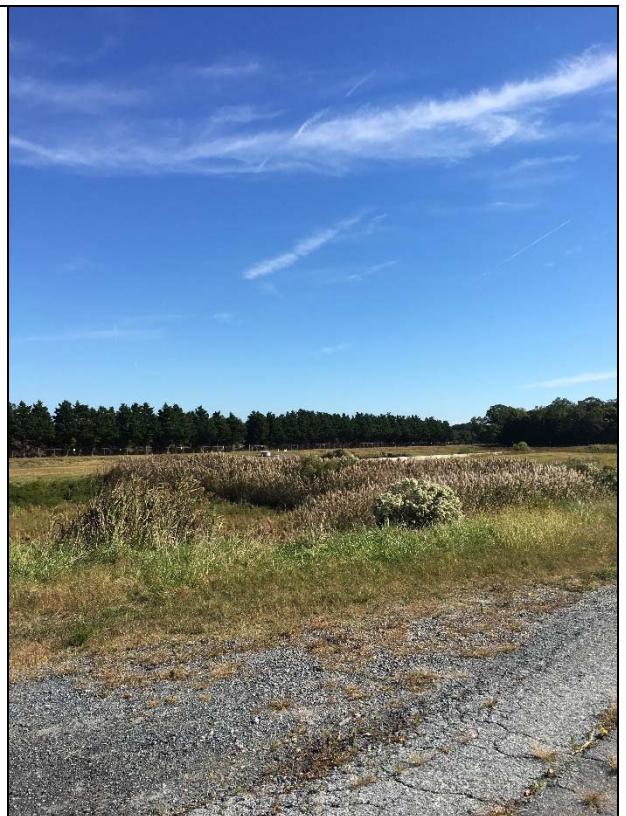
Photograph No. 38

Northwest basin west forebay.

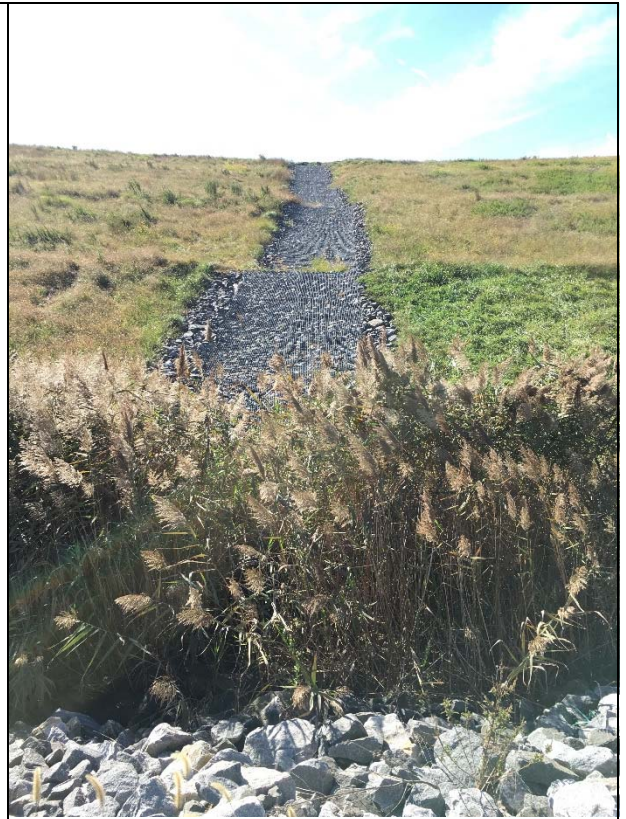
Photograph No. 39

Downchute near northwest basin west forebay.

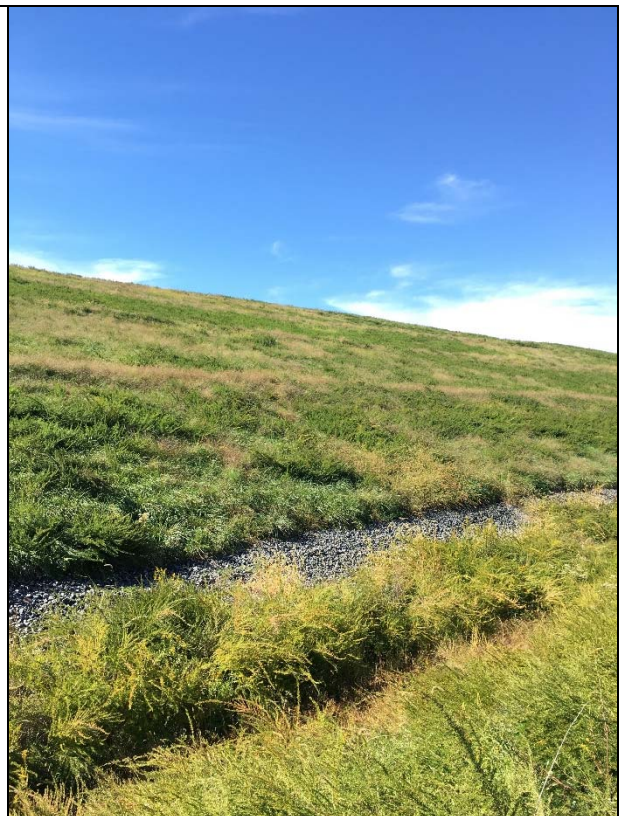
Photograph No. 40

Phase 1 final cover. Vegetation is healthy and well maintained.

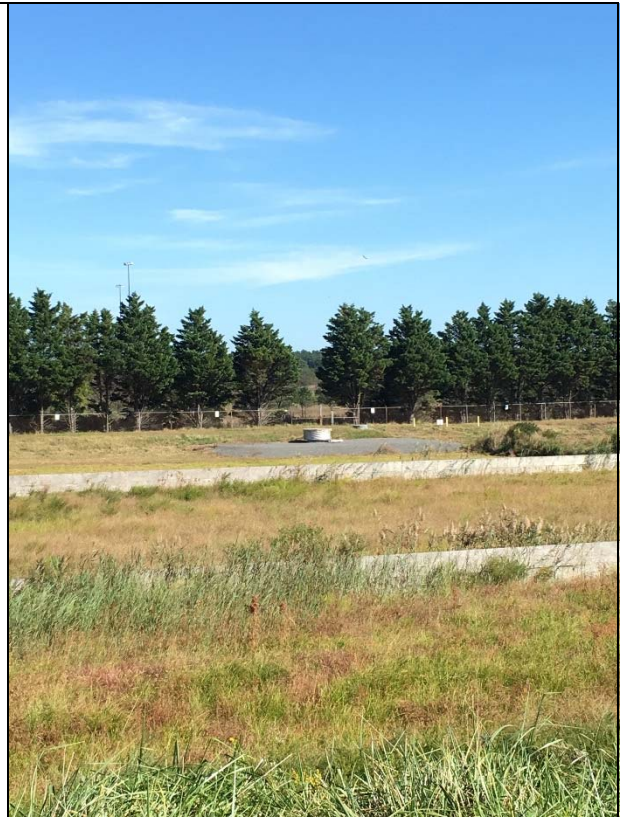
Photograph No. 41

Northwest basin with outlet in background.

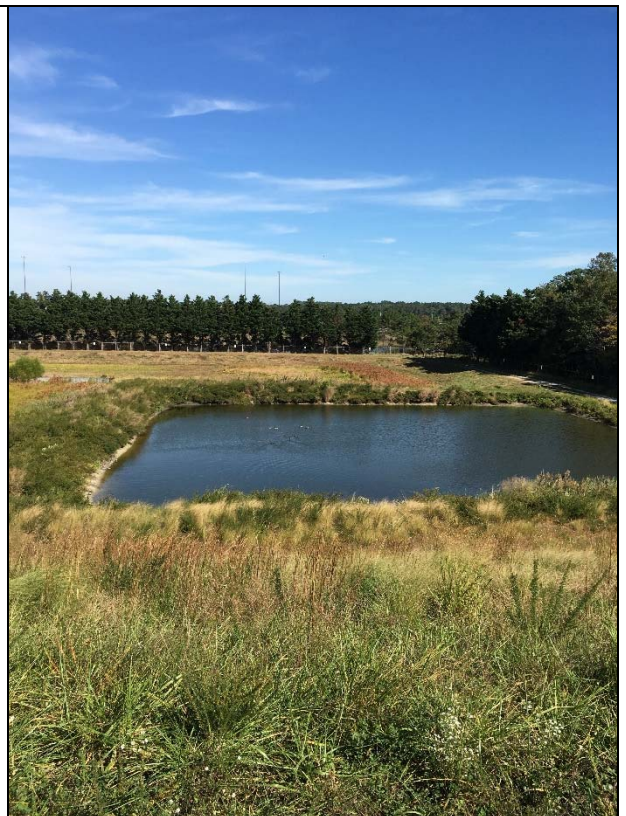
Photograph No. 42

East forebay of northwest basin.

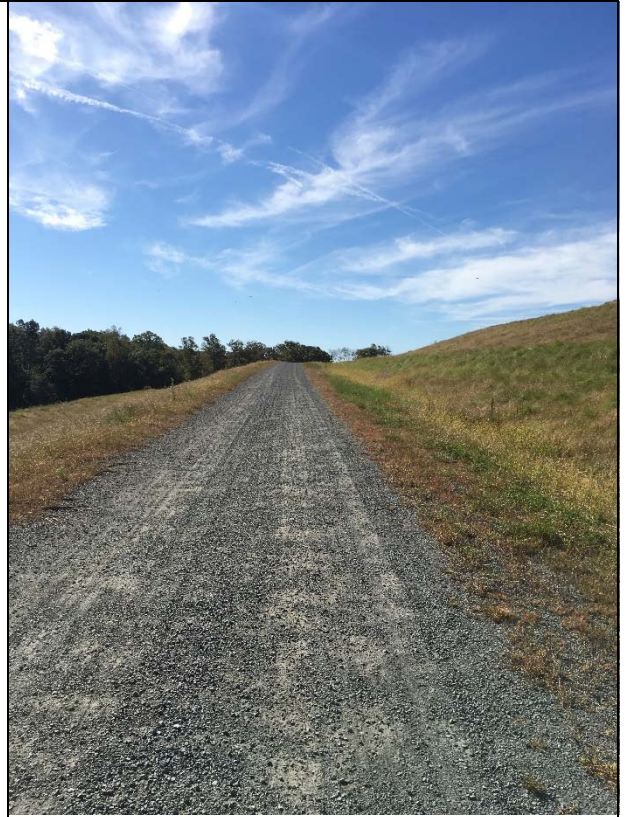
Photograph No. 43

Phase 1 plateau access road. Well maintained. No rutting or potholes. Final cover on either side of road is well maintained with no evidence of stability issues or erosion.
