Inspection Report

From: Richard Southorn, P.E., P.G., CPSWQ

Re: Indian River Landfill – Annual CCR Unit Inspection Report No. 3

Inspection Date: October 5, 2017

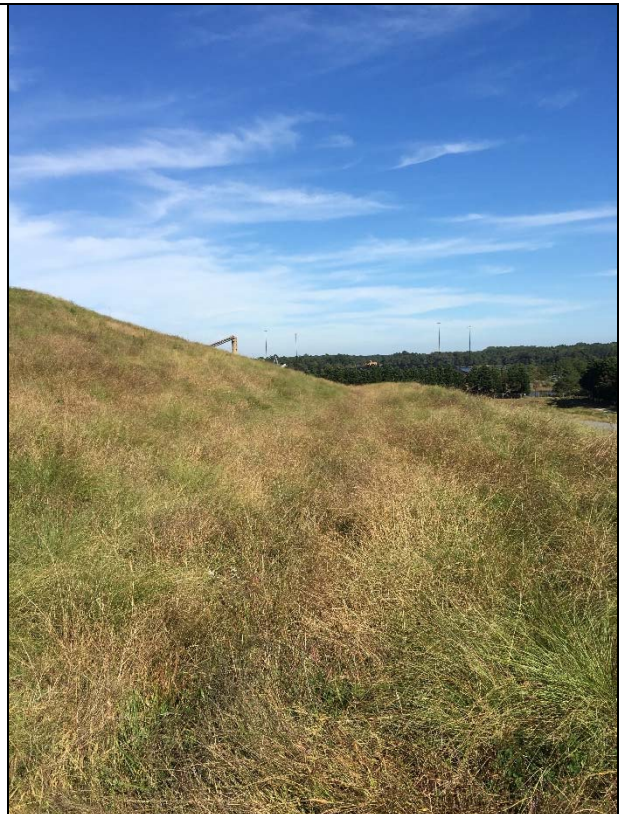
Photograph No. 44

Phase 1 terrace berm. Clear of obstructions and functioning as intended. Vegetative cover is dense and healthy.

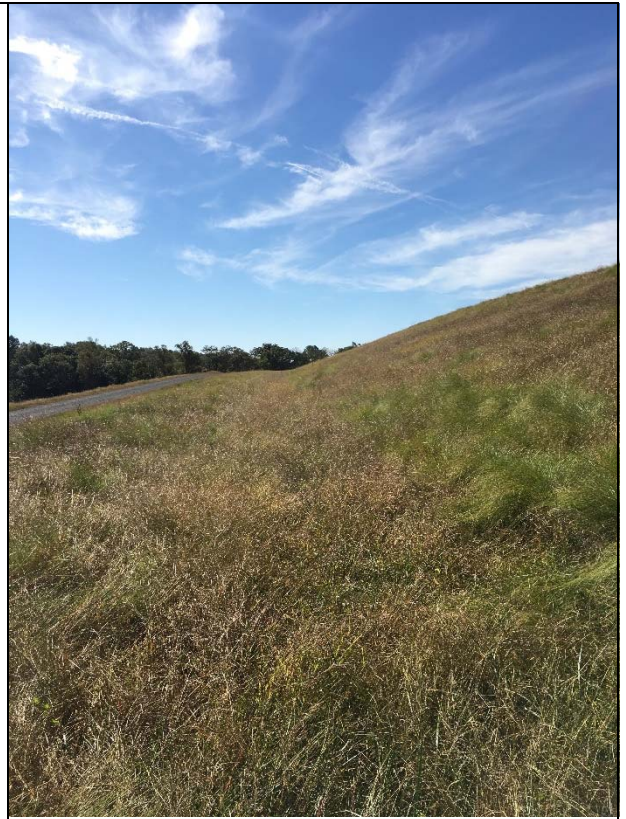
Photograph No. 45

Phase 1 terrace berm. Clear of obstructions and functioning as intended. Vegetative cover is dense and healthy.

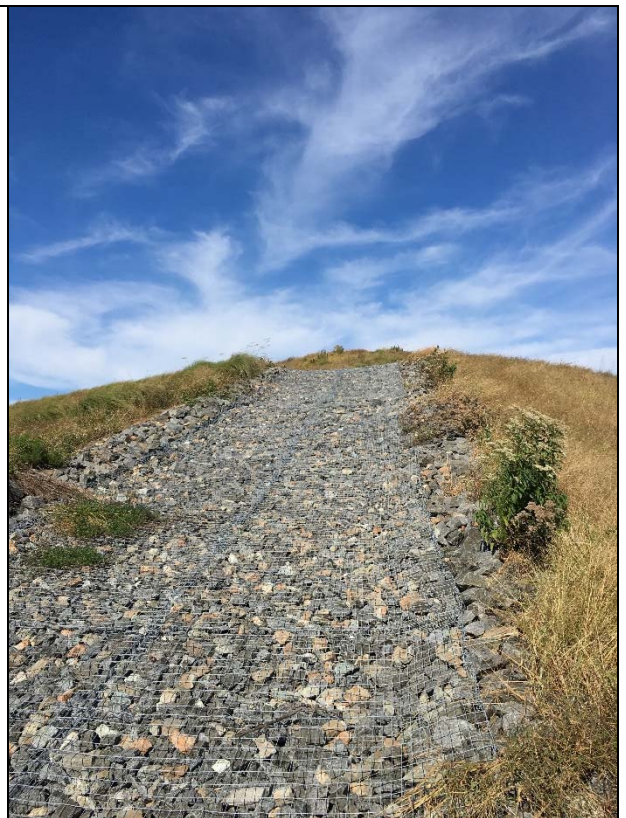
Photograph No. 46

Phase 1 corner downchute. Rock is in-place and not migrating. No evidence of washouts.

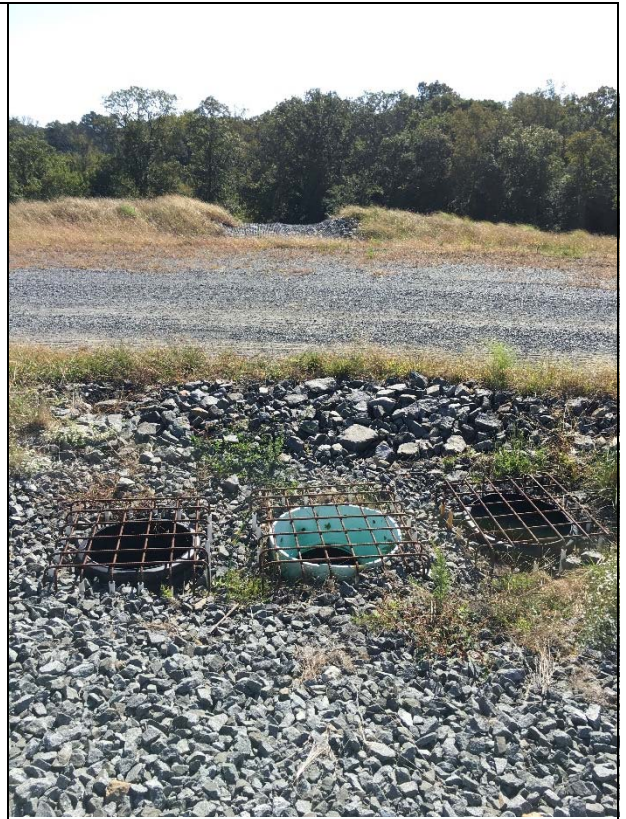
Photograph No. 47

Phase 1 corner downchute road crossing equalizing pipes. Free of obstructions.

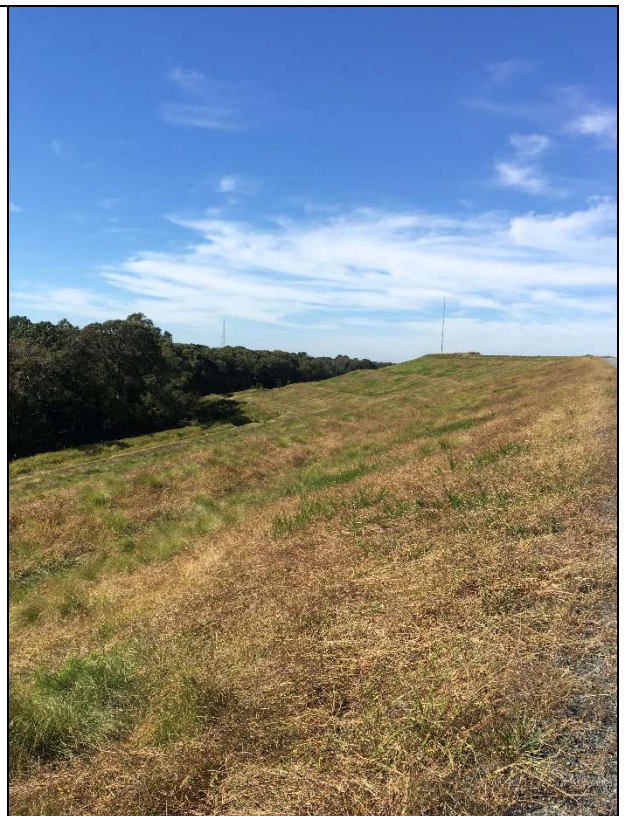
Photograph No. 48

Phase 1 final cover and stormwater terraces. Well maintained and functioning as intended.

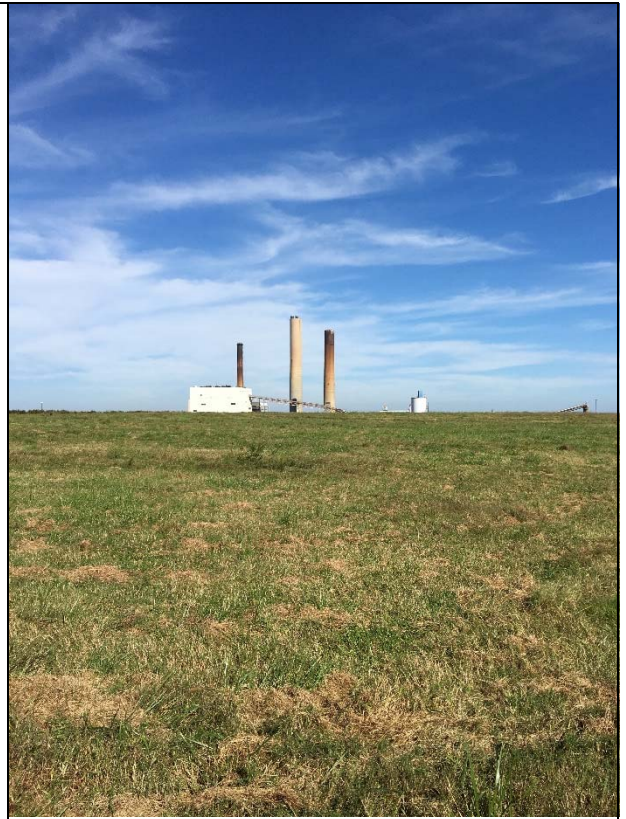
Photograph No. 49

Final cover on plateau. Vegetation is well established. No signs of animal burrows or erosion.

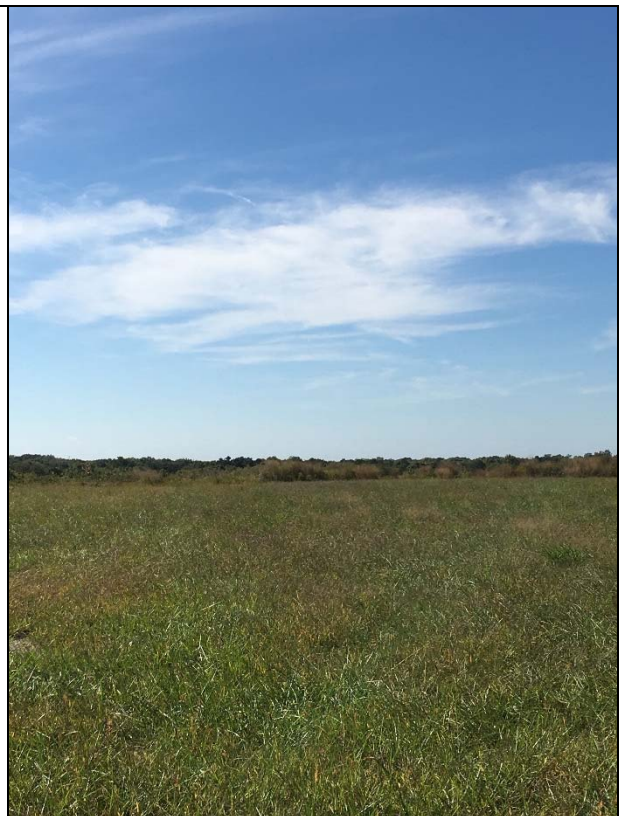
Photograph No. 50

Final cover on plateau. Vegetation is well established. No signs of animal burrows or erosion.

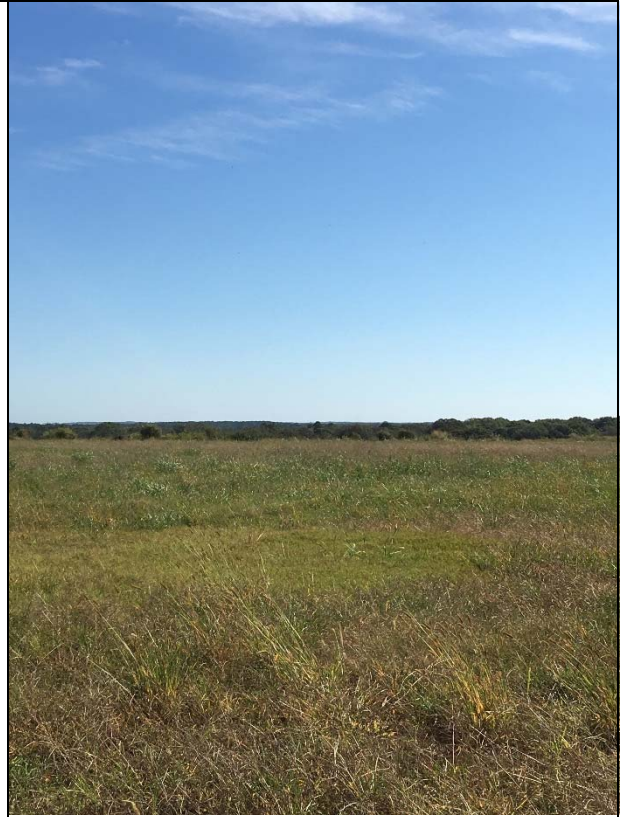
Photograph No. 51

Final cover on plateau. Vegetation is well established. No signs of animal burrows or erosion.

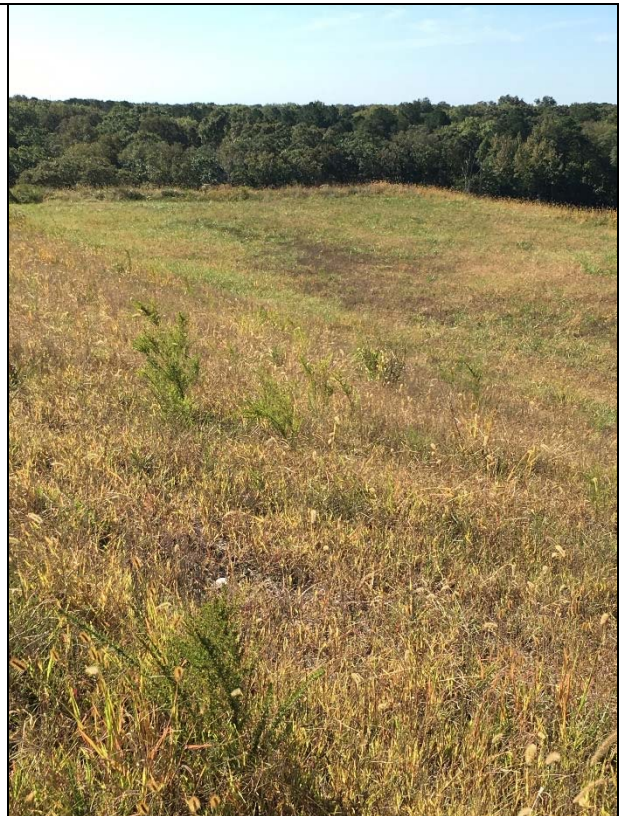
Photograph No. 52

Final cover on plateau. Vegetation is well established. No signs of animal burrows or erosion.

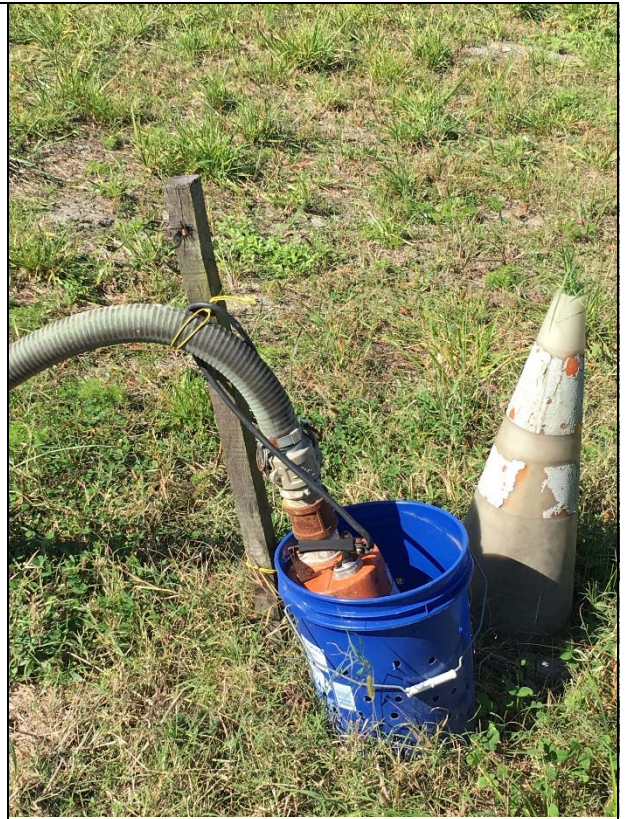
Photograph No. 53

Pump used to remove collected stormwater.

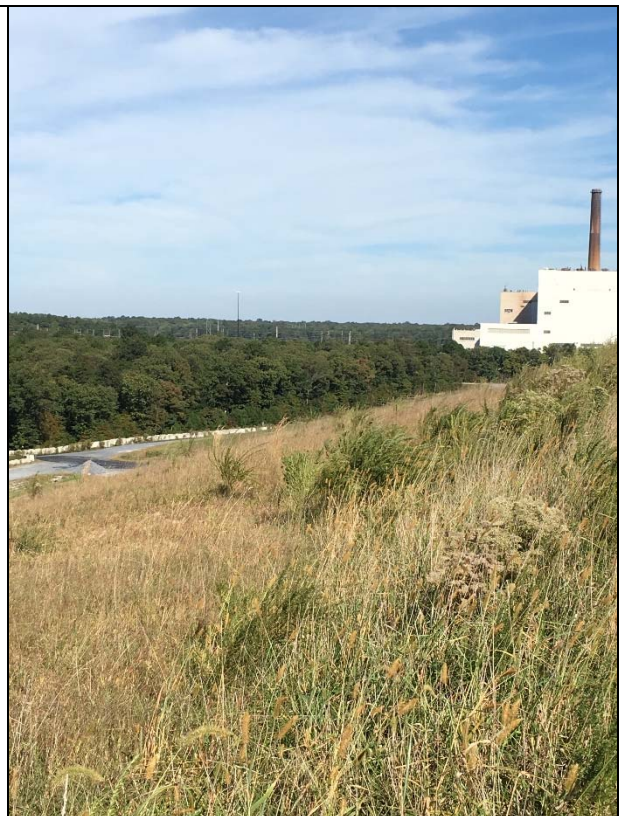
Photograph No. 54

Final cover sideslopes. Vegetation is well established. No signs of animal burrows or erosion.

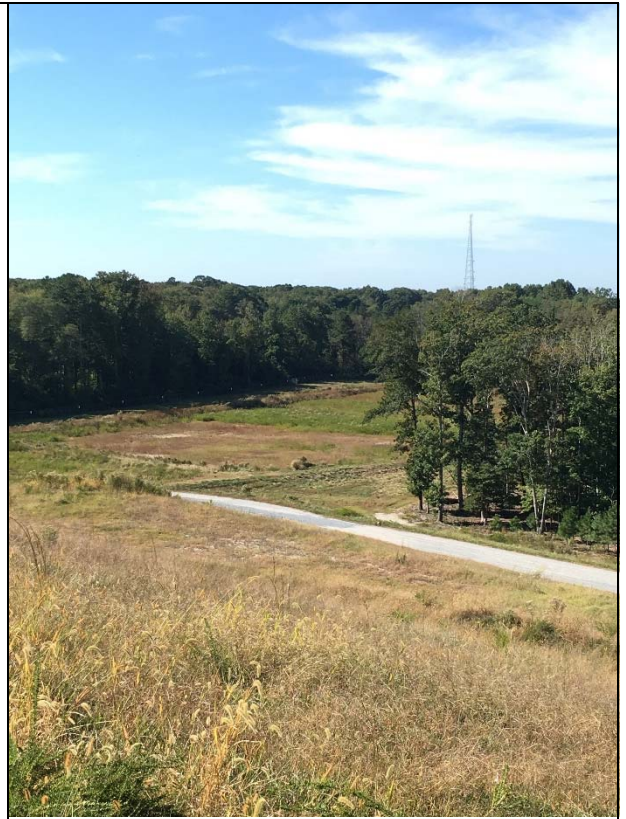
Photograph No. 55

View of Southeast Basin from top of landfill.

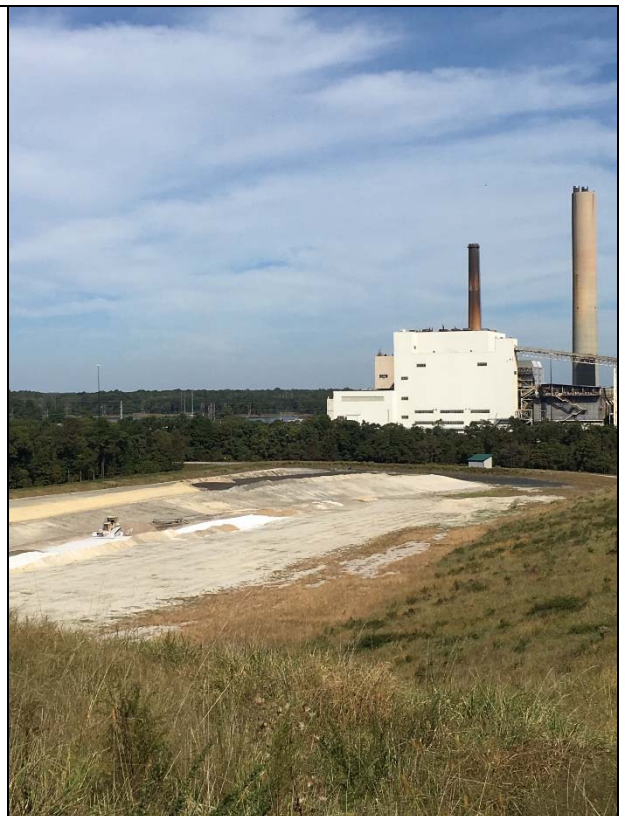
Photograph No. 56

Phase 2, Cell 2 active area.

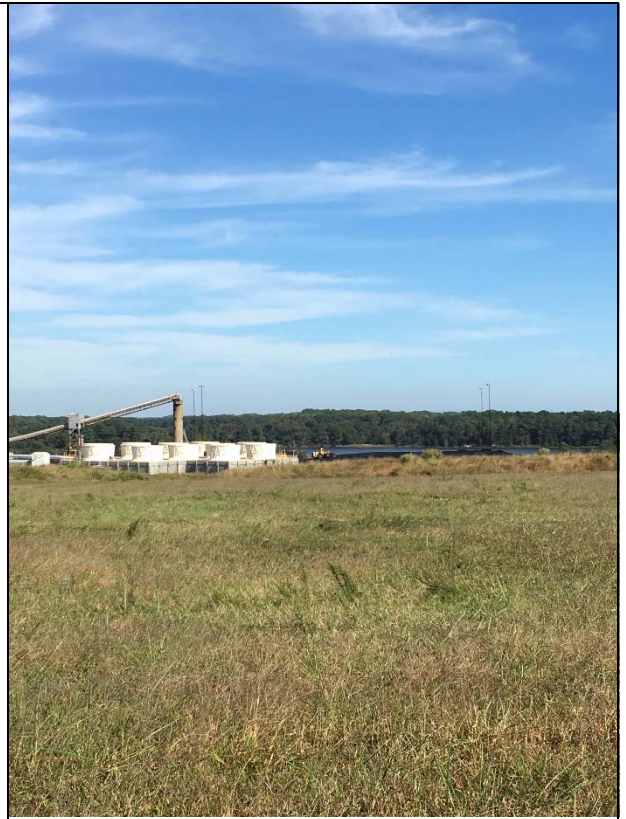
Photograph No. 57

Final cover on plateau. Vegetation is well established. No signs of animal burrows or erosion.

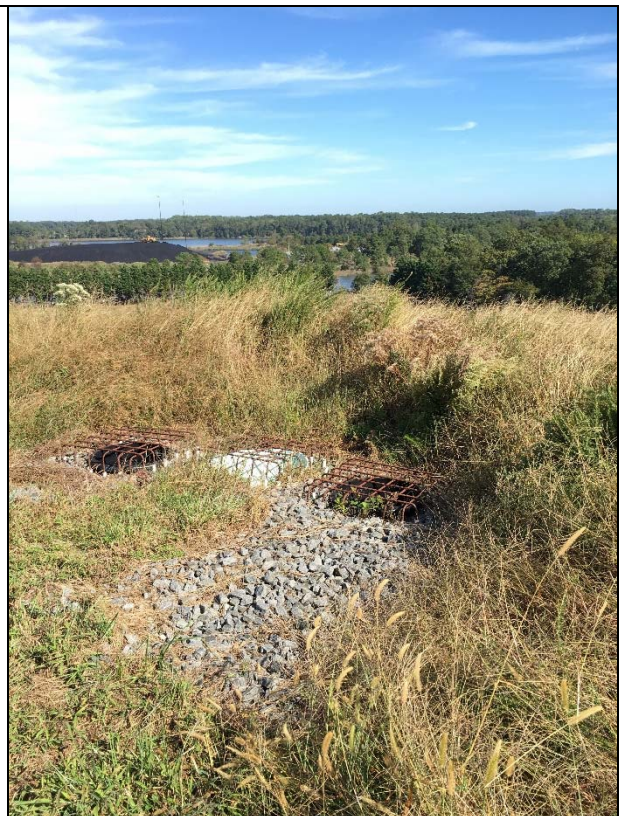
Photograph No. 58

Downchute inlet from plateau. Free of obstruction. Berms show no evidence of erosion.

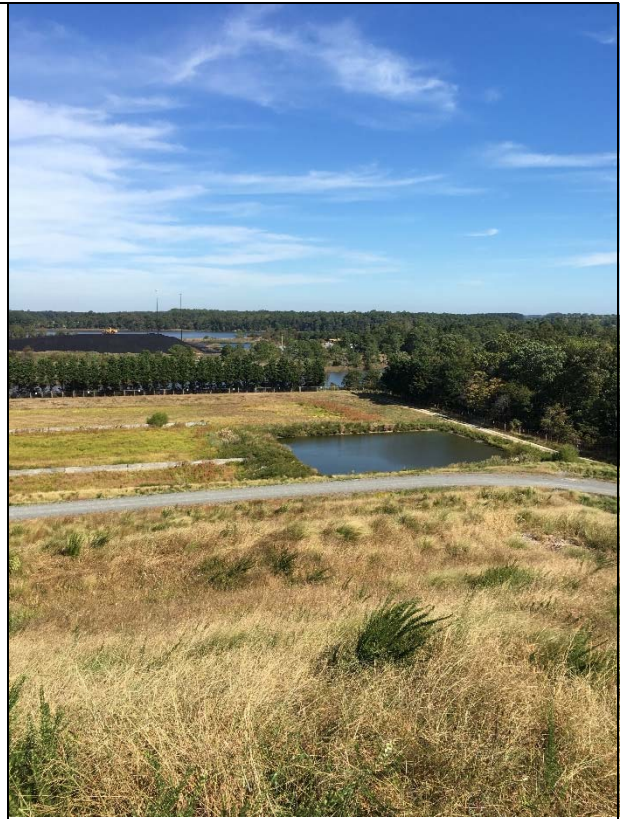
Photograph No. 59

East forebay of surface water sediment control basin.

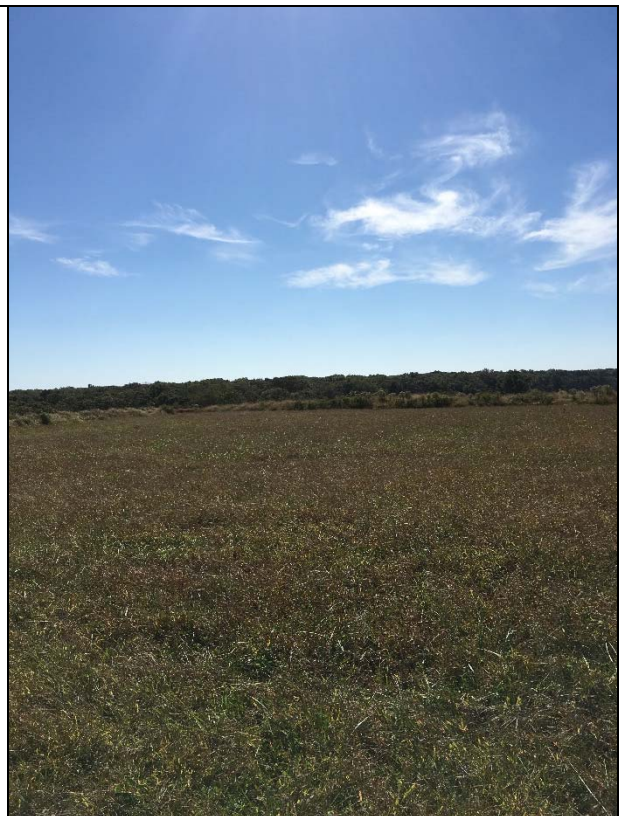
Photograph No. 60

Final cover on plateau. Vegetation is well established. No signs of animal burrows or erosion.

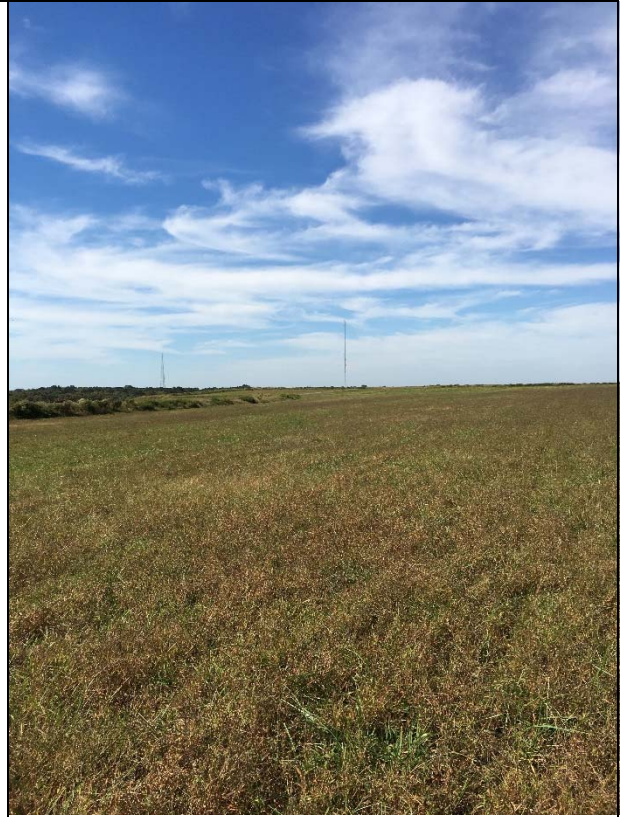
Photograph No. 61

Final cover on plateau. Vegetation is well established. No signs of animal burrows or erosion.

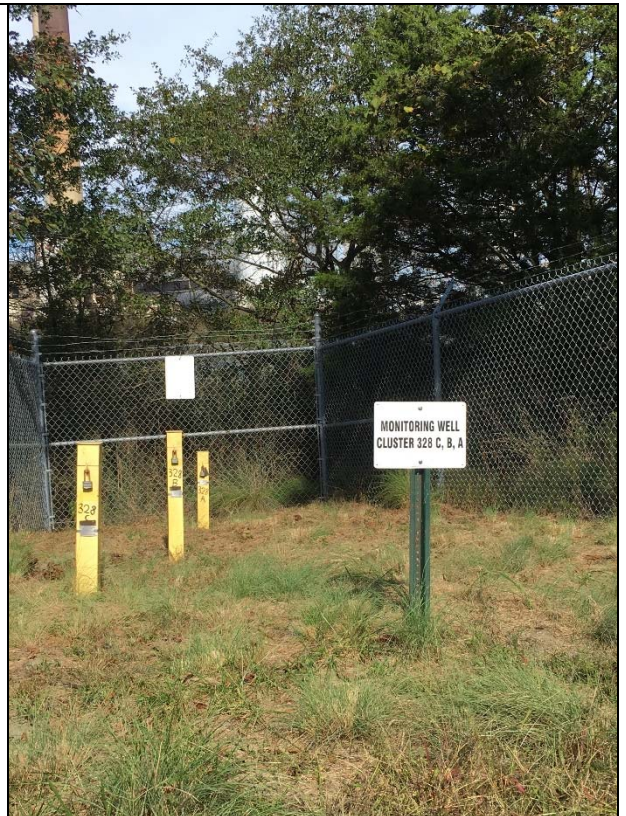
Photograph No. 62

Monitoring well cluster.

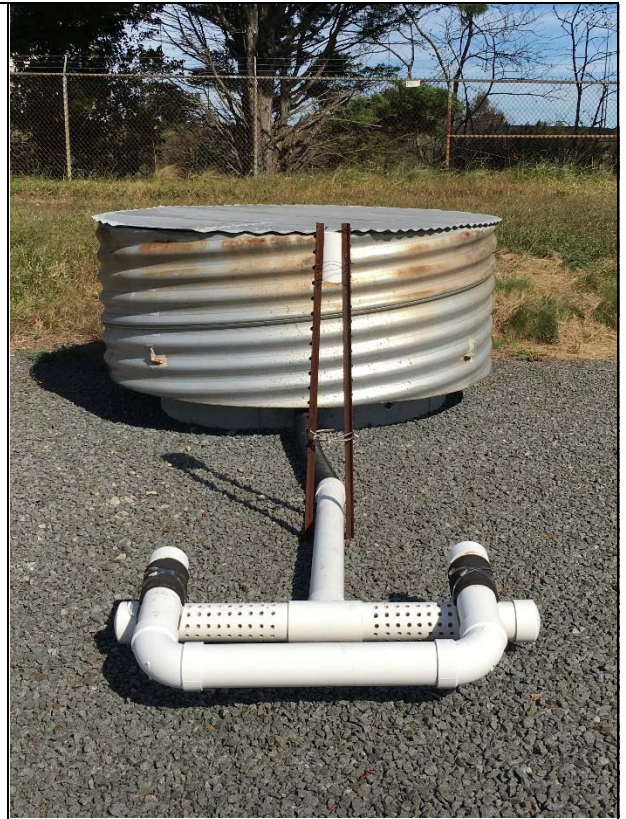
Photograph No. 63

Northeast basin outlet skimmer.

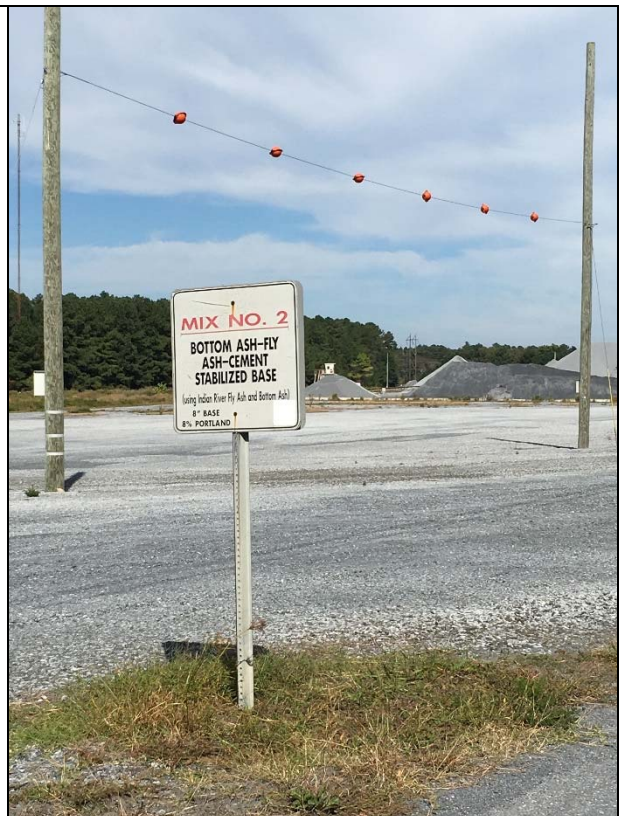
Photograph No. 64

Beneficial use product area.

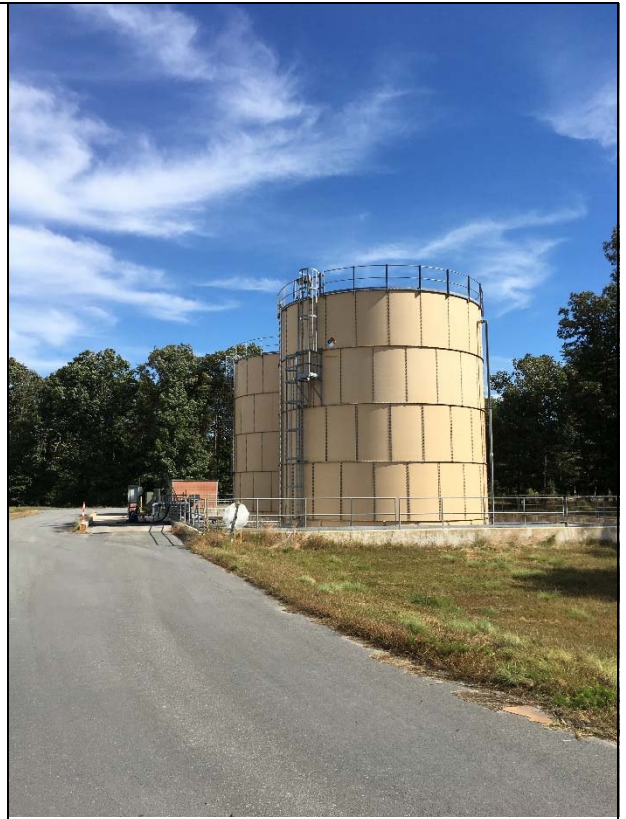
Photograph No. 65

Leachate storage tanks and the leachate control building.

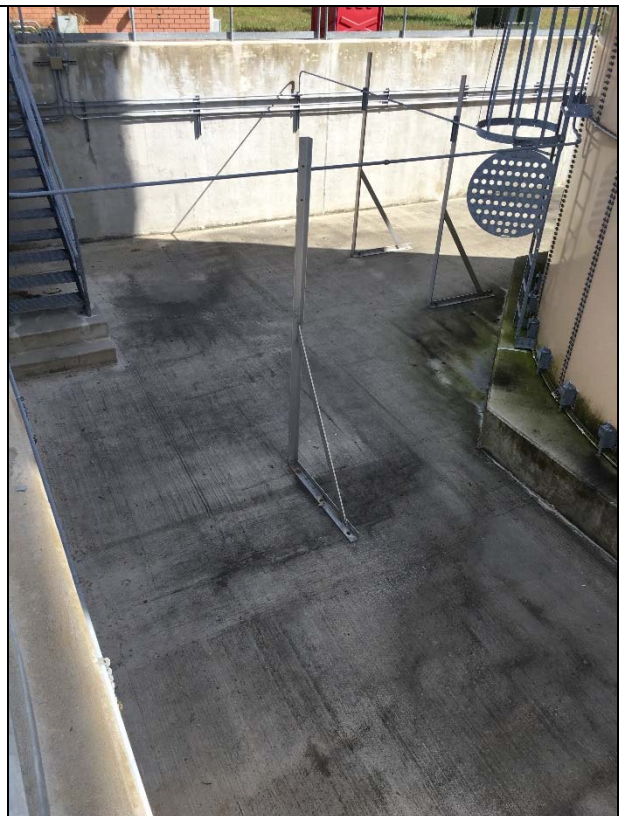
Photograph No. 66

Leachate storage tanks secondary containment. Secondary containment was dry with no evidence of staining.

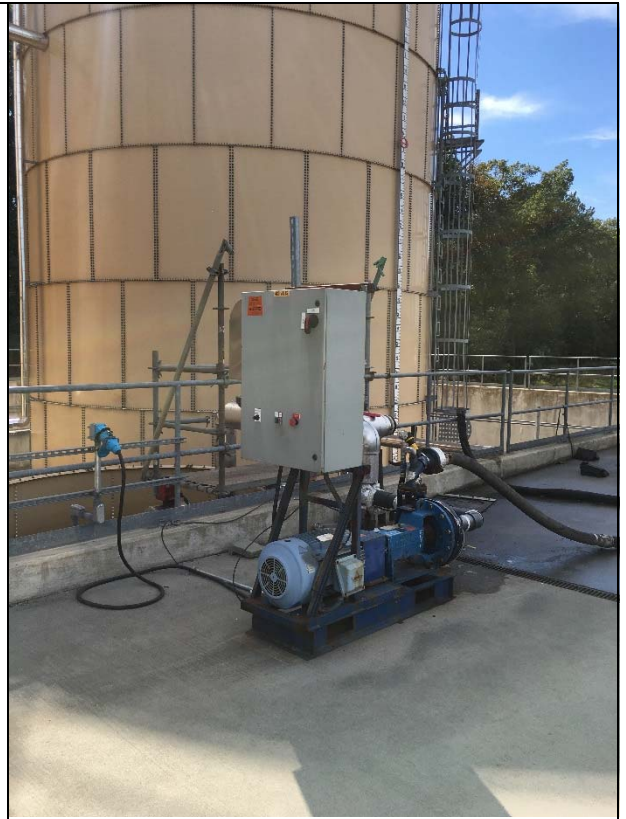
Photograph No. 67

Leachate storage vault and secondary containment controls.
