Inspection Report

To: David Bacher, NRG
From: Richard Southorn, P.E., P.G.
Re: Indian River Landfill – Annual CCR Unit Inspection Report
Inspection Date: October 16, 2018
Memo Date: January 18, 2019

Project: Indian River Landfill 2018 CCR Annual Inspection

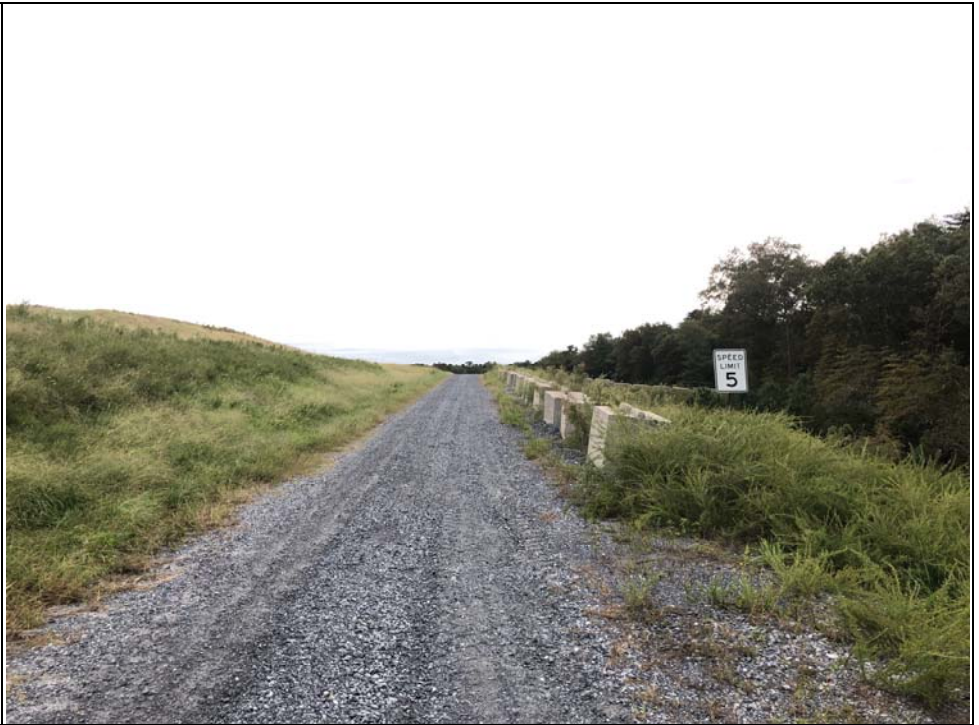
Image: 2087
Date: 10/16/2018
Time: 7:11 AM
Direction: South

5 mph speed limit near active face.

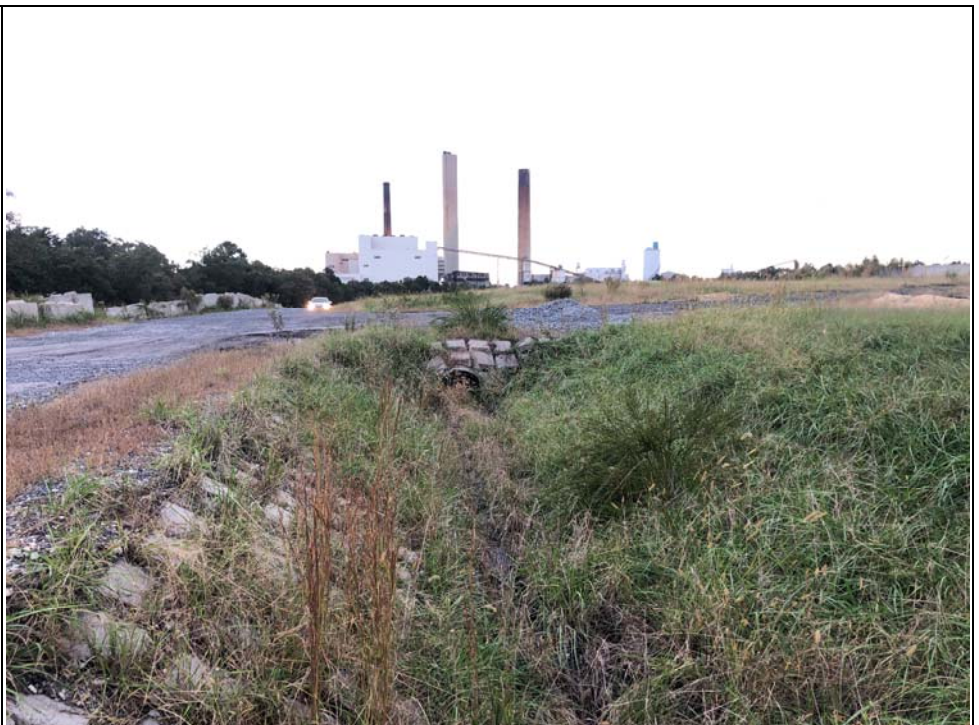
Image: 2089
Date: 10/16/2018
Time: 7:13 AM
Direction: North

Armored perimeter stormwater channel.

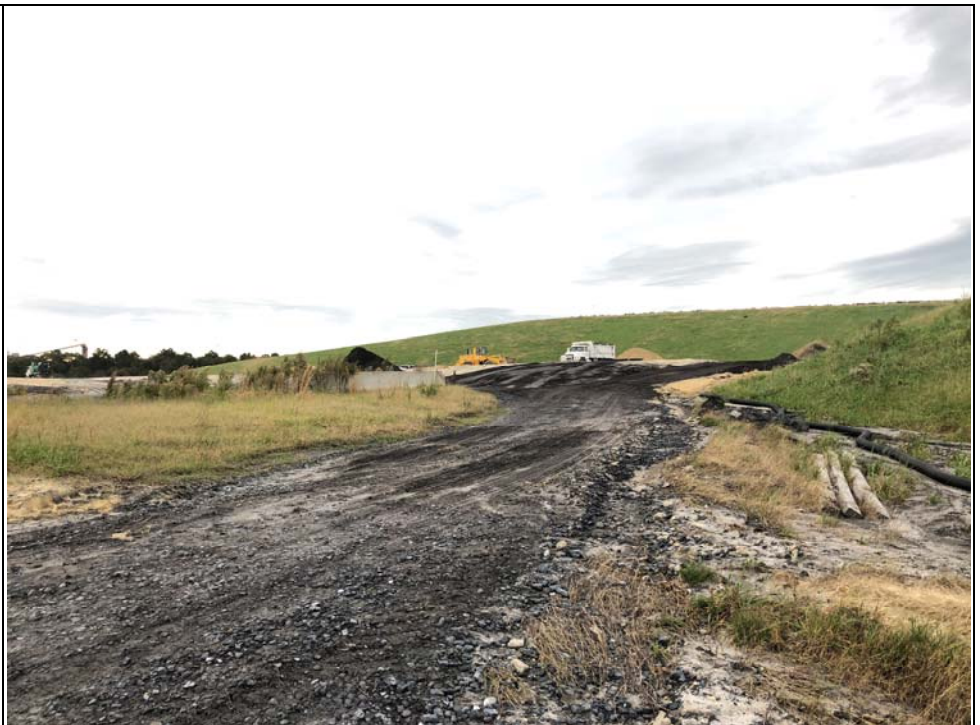
Image: 2091
Date: 10/16/2018
Time: 7:16 AM
Direction: Northeast

Description:
Entrance to active face.

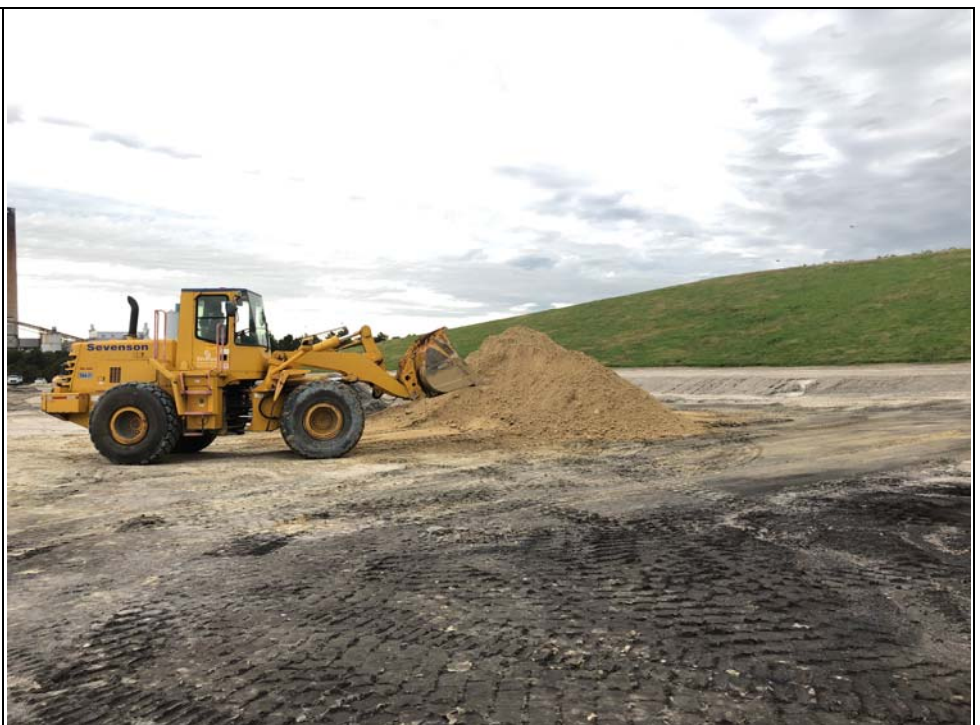
Image: 2099
Date: 10/16/2018
Time: 7:20 AM
Direction: Northeast

Description:
Gypsum stockpile.

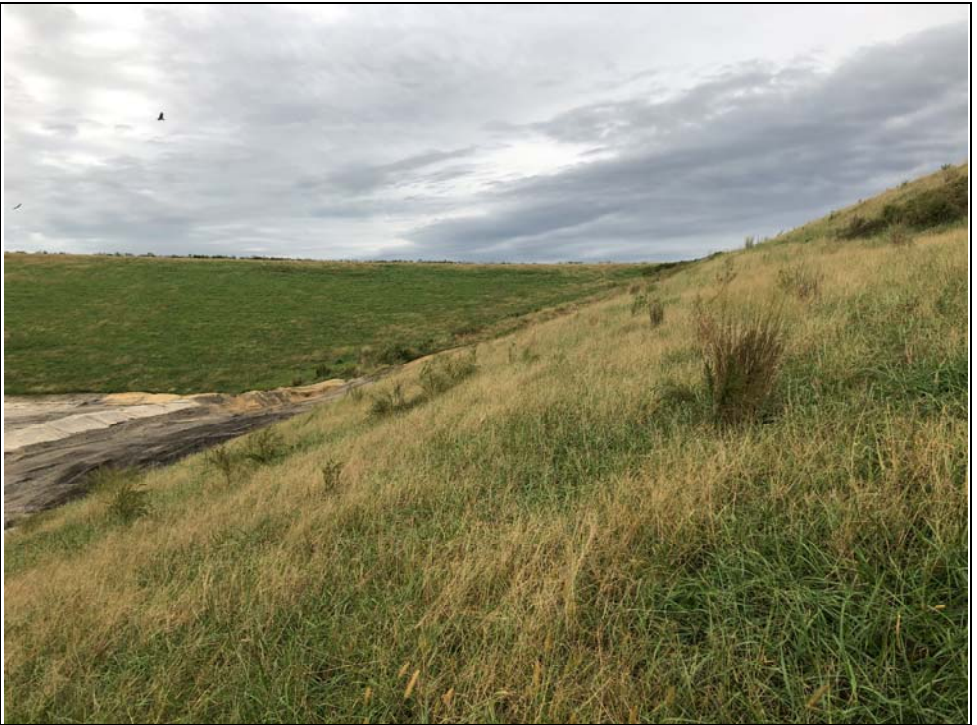
Image: 2101
Date: 10/16/2018
Time: 7:21 AM
Direction: East

Phase 2 Cell 1/Cell 2 boundary looking towards the separation berm. Slopes are well vegetated with no sign of erosion, sloughing, or animal borrows.

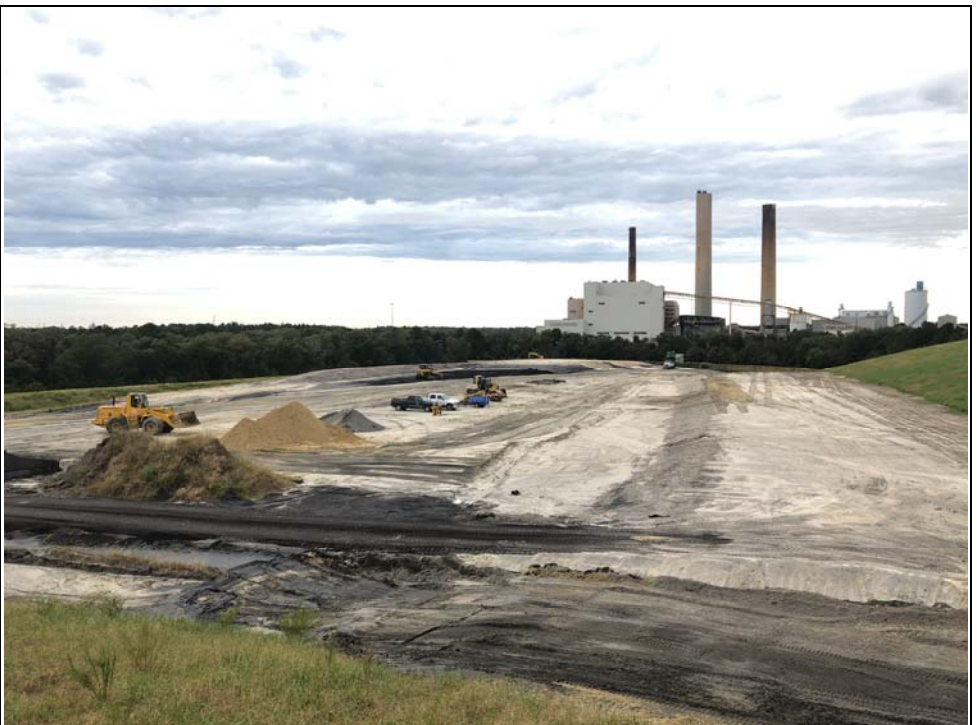
Image: 2103
Date: 10/16/2018
Time: 7:22 AM
Direction: North

Overview of active face

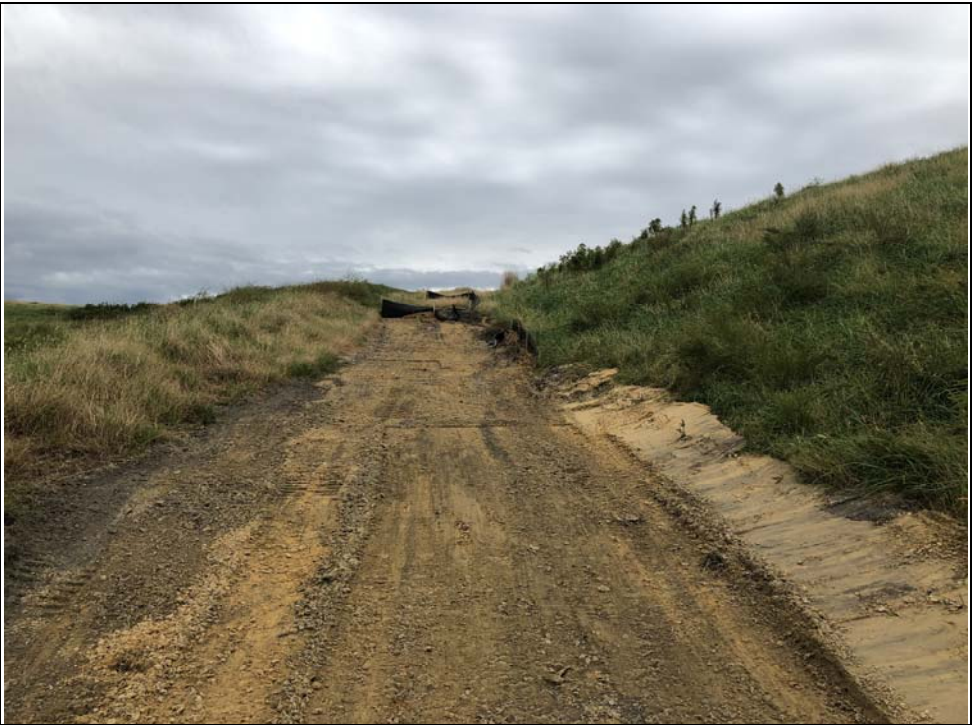
Image: 2105
 Date: 10/16/2018
 Time: 7:22 AM
 Direction: Southeast

Elbow of Phase 1/Phase 2 Cell 1 confluence. Erosion was experienced following a significant recent rain event. Repairs to an erosion channel that had formed are shown, looking upslope.

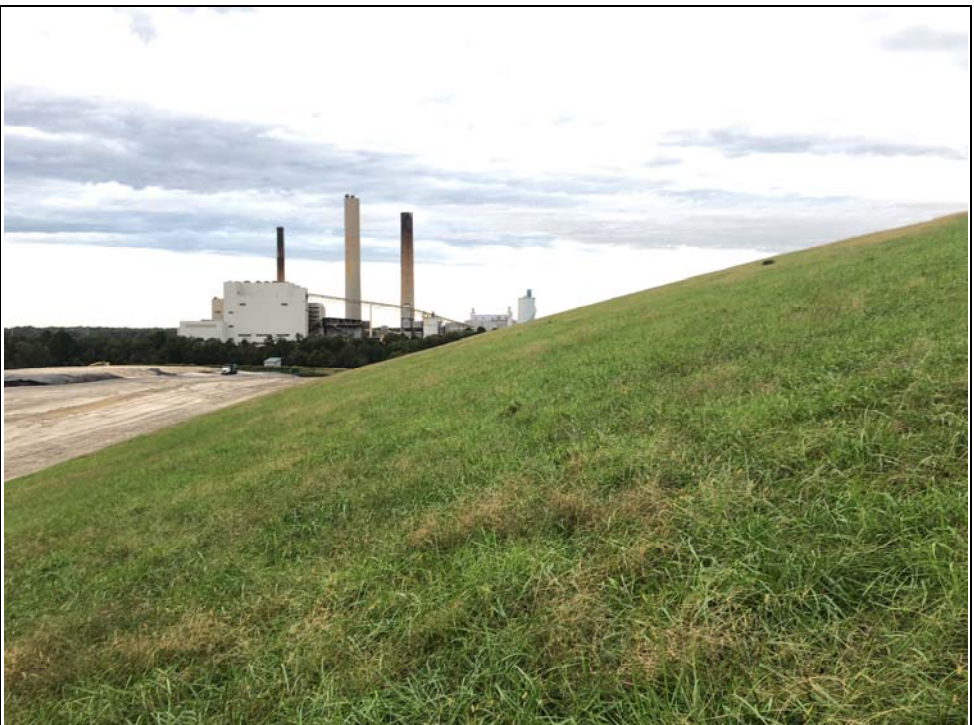
Image: 2107
 Date: 10/16/2018
 Time: 7:23 AM
 Direction: North

Description: Phase I intermediate cover slopes are well vegetated with no sign of erosion or sloughing.

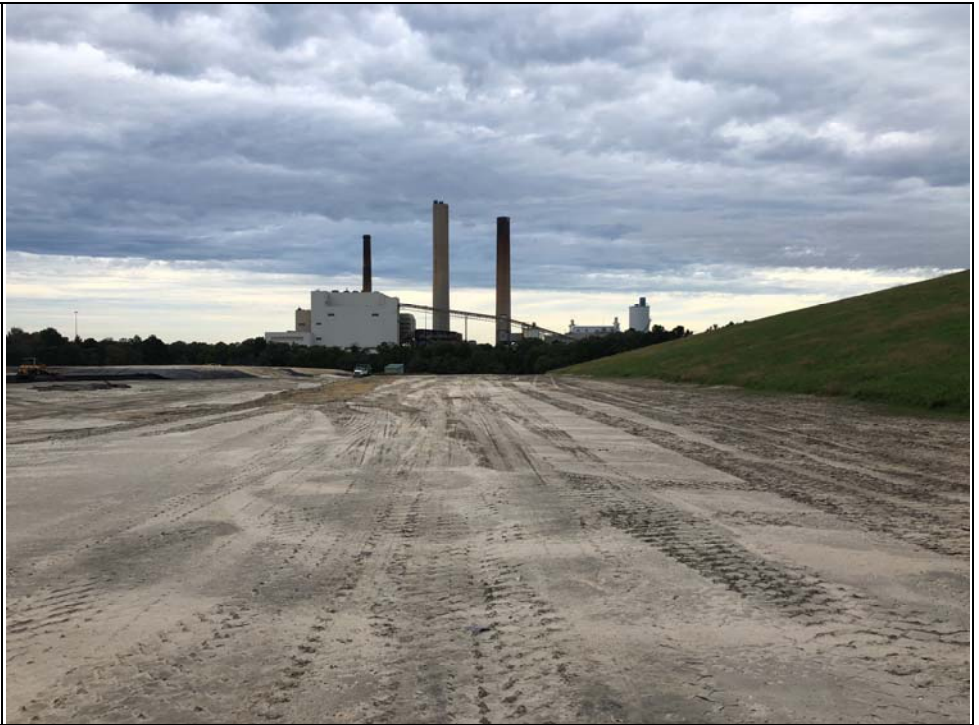
Image: 2111
Date: 10/16/2018
Time: 7:25 AM
Direction: North

Active face is well maintained. Material is graded and compacted. No ponding water.

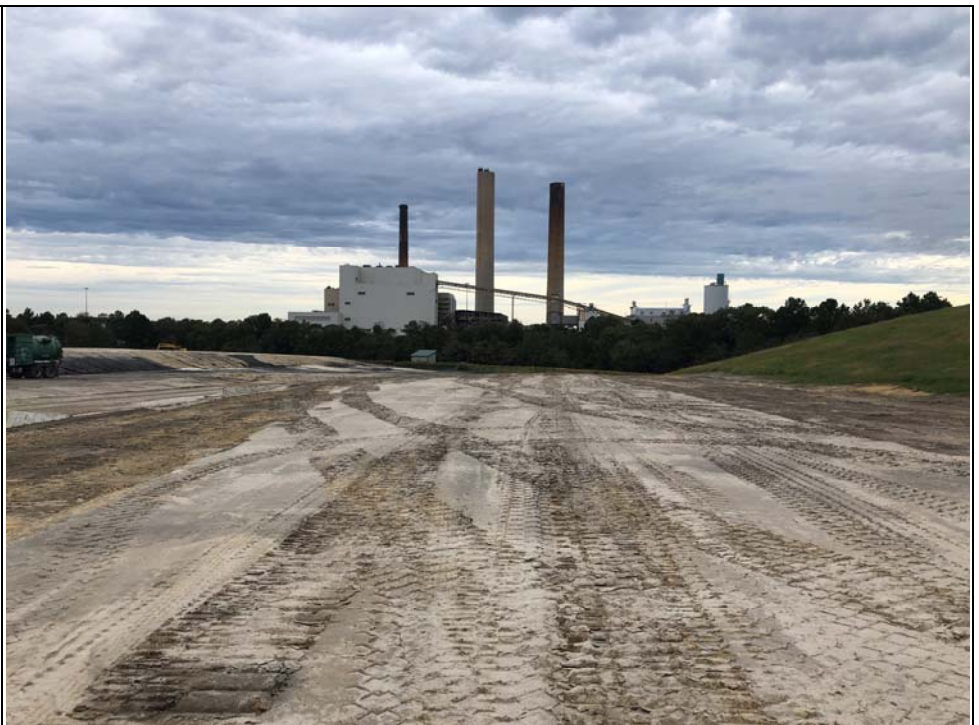
Image: 2115
Date: 10/16/2018
Time: 7:27 AM
Direction: North

Active face is well maintained. Material is graded and compacted. No ponding water.

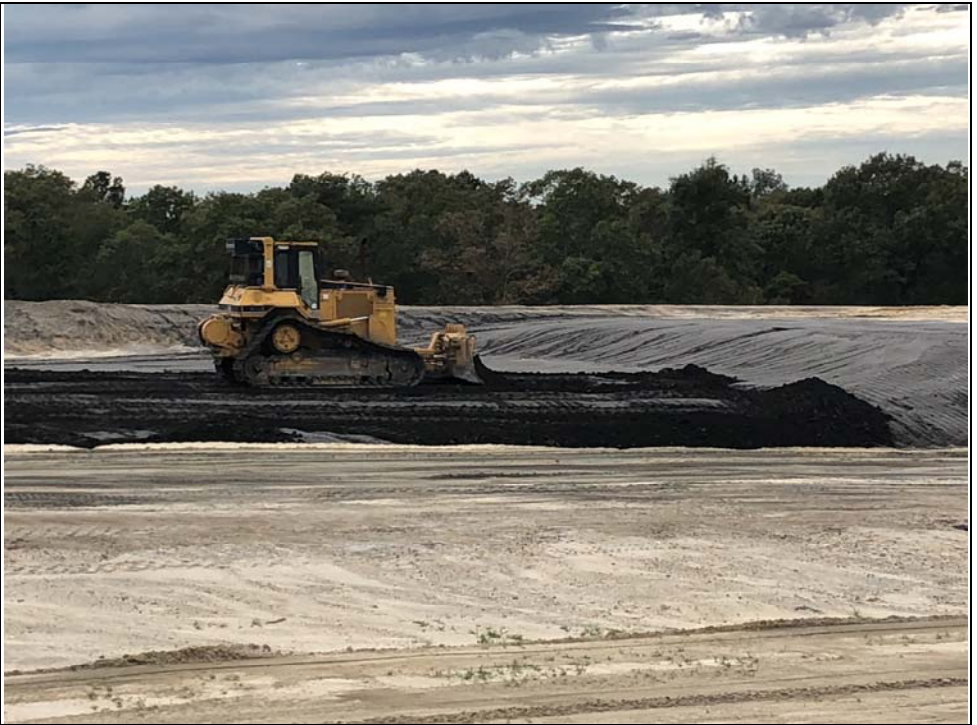
Image: 2117
Date: 10/16/2018
Time: 7:28 AM
Direction: Northwest

Spreading bottom ash in active face.

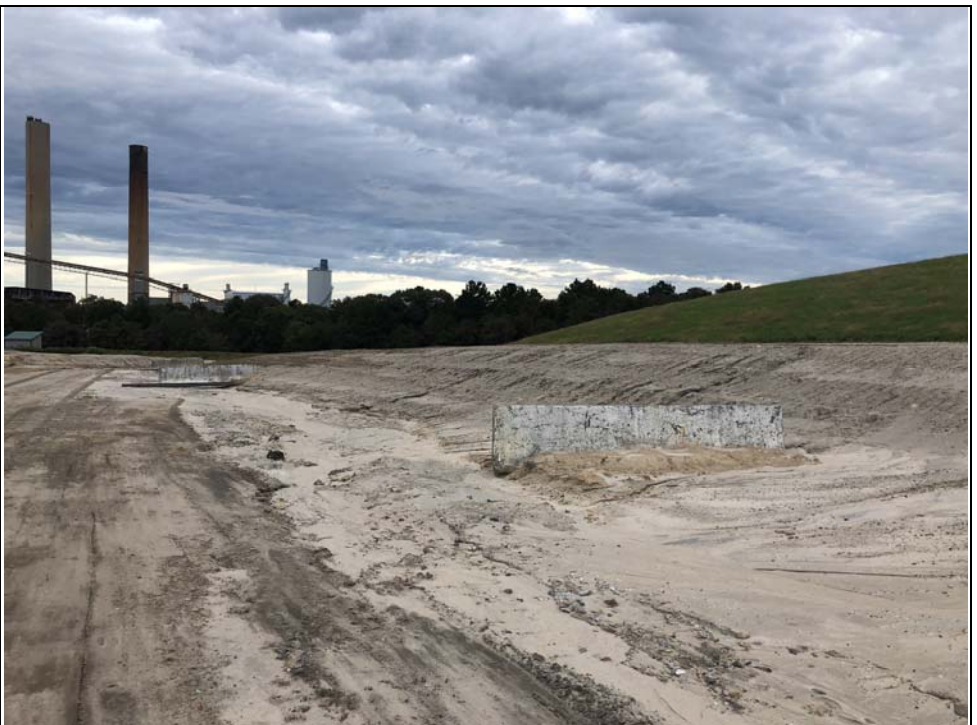
Image: 2119
Date: 10/16/2018
Time: 7:28 AM
Direction: Northeast

Description: Jersey barriers that are used in concentrated flow areas of the active face to prevent erosion rills from forming.

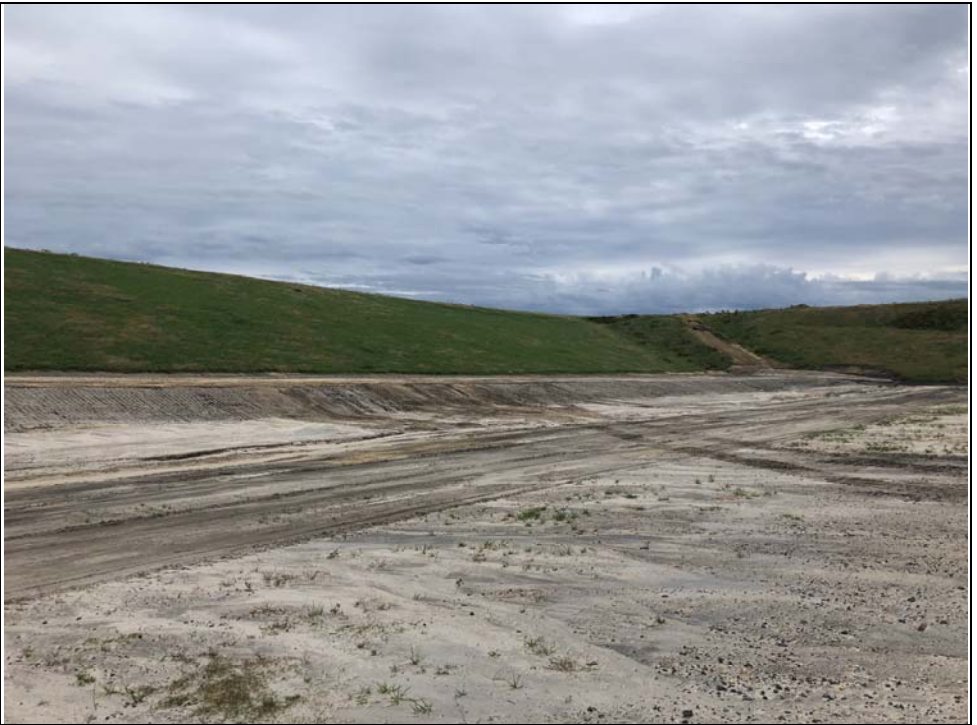
Image: 2121
Date: 10/16/2018
Time: 7:29 AM
Direction: Southeast

Active face is well maintained. Material is graded and compacted. No ponding water.

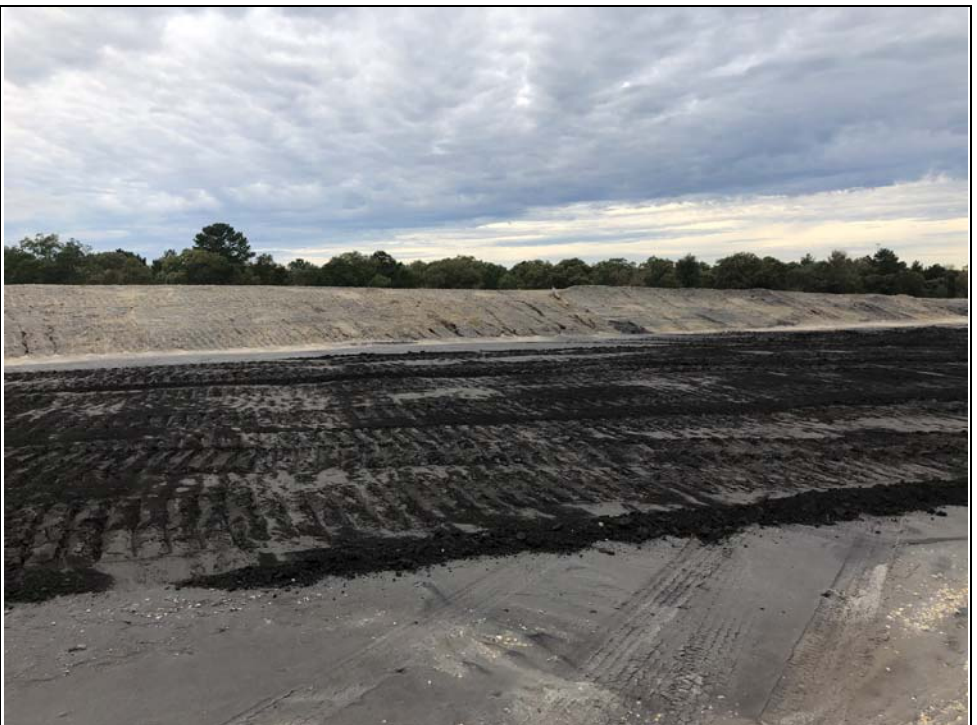
Image: 2123
Date: 10/16/2018
Time: 7:30 AM
Direction: Northwest

Recently spread bottom ash in active face.

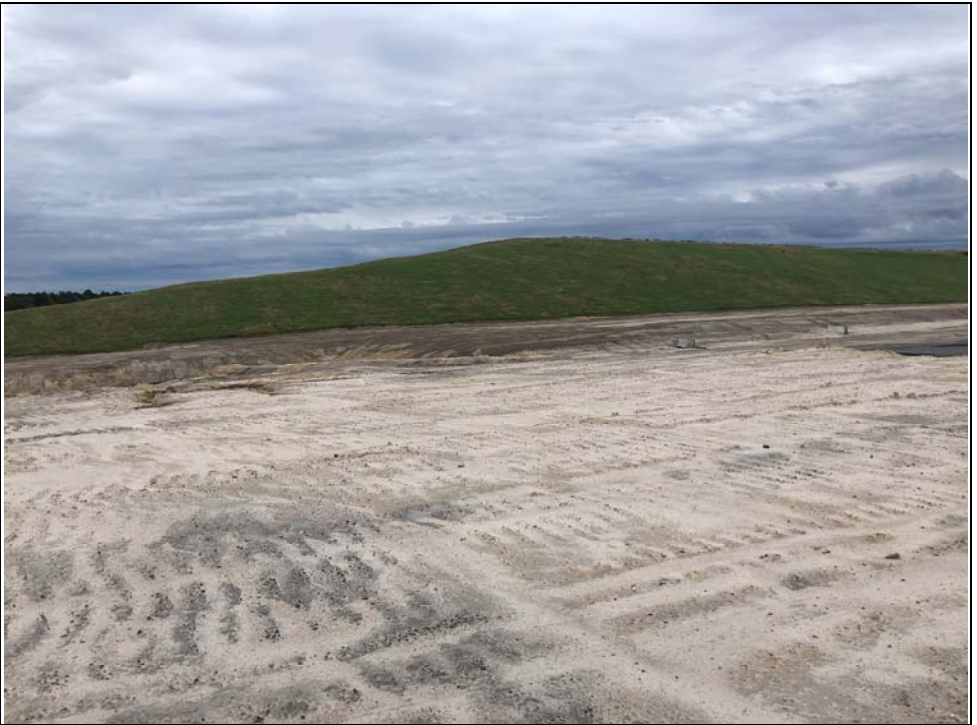
Image: 2125
Date: 10/16/2018
Time: 7:32 AM
Direction: Southeast

Active face is well maintained. Material is graded and compacted. No ponding water.

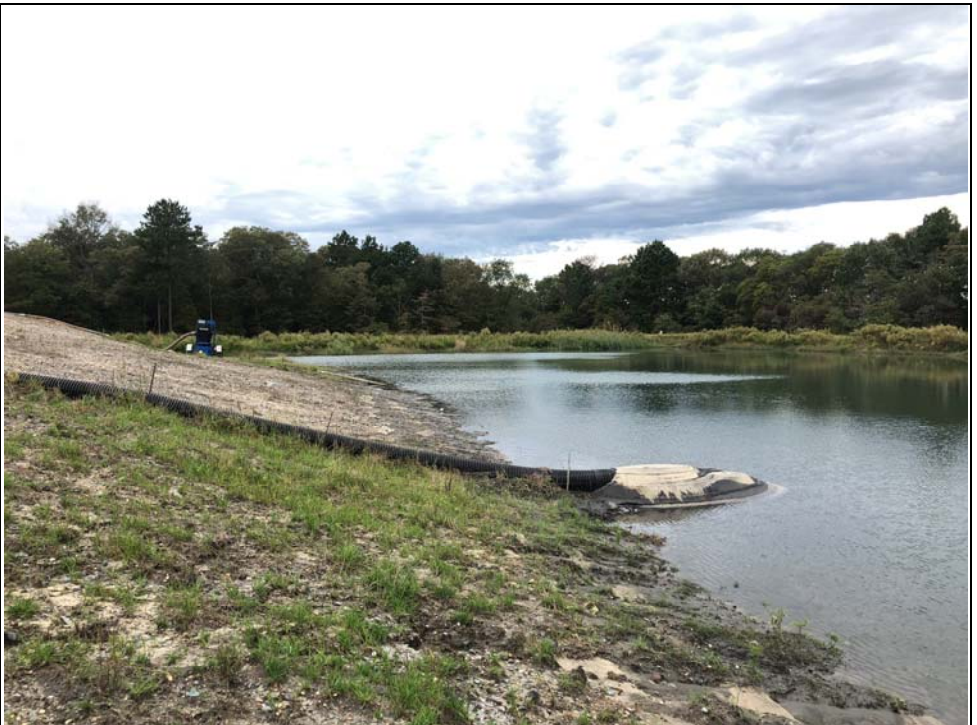
Image: 2127
Date: 10/16/2018
Time: 7:33 AM
Direction: Northwest

Standing water within cell due to recent rains. The stormwater water percolates through the ash into the leachate collection layer, where it is pumped out and removed as leachate.

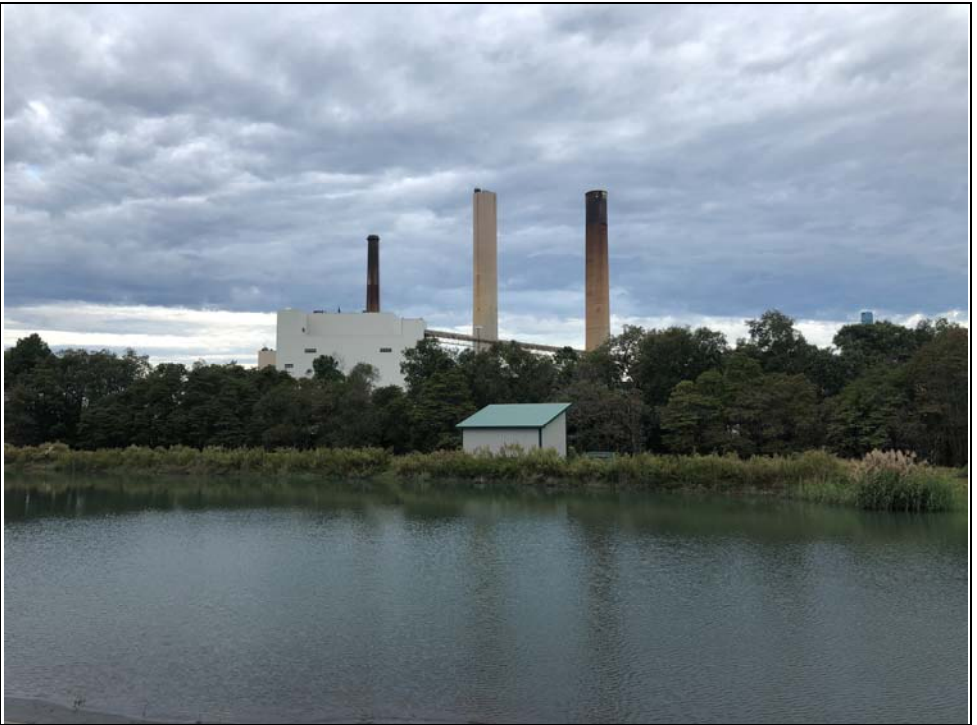
Image: 2131
Date: 10/16/2018
Time: 7:36 AM
Direction: North

Standing water within cell due to recent rains. The stormwater water percolates through the ash into the leachate collection layer, where it is pumped out and removed as leachate.

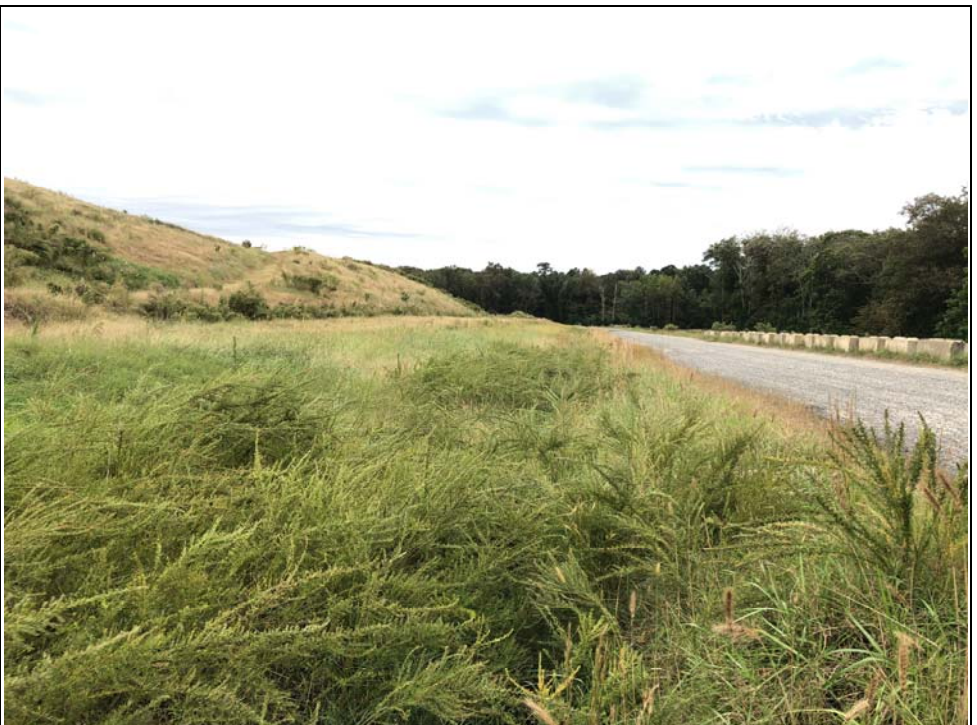
Image: 2133
Date: 10/16/2018
Time: 7:42 AM
Direction: South

Vegetation in perimeter channel. No signs of erosion.

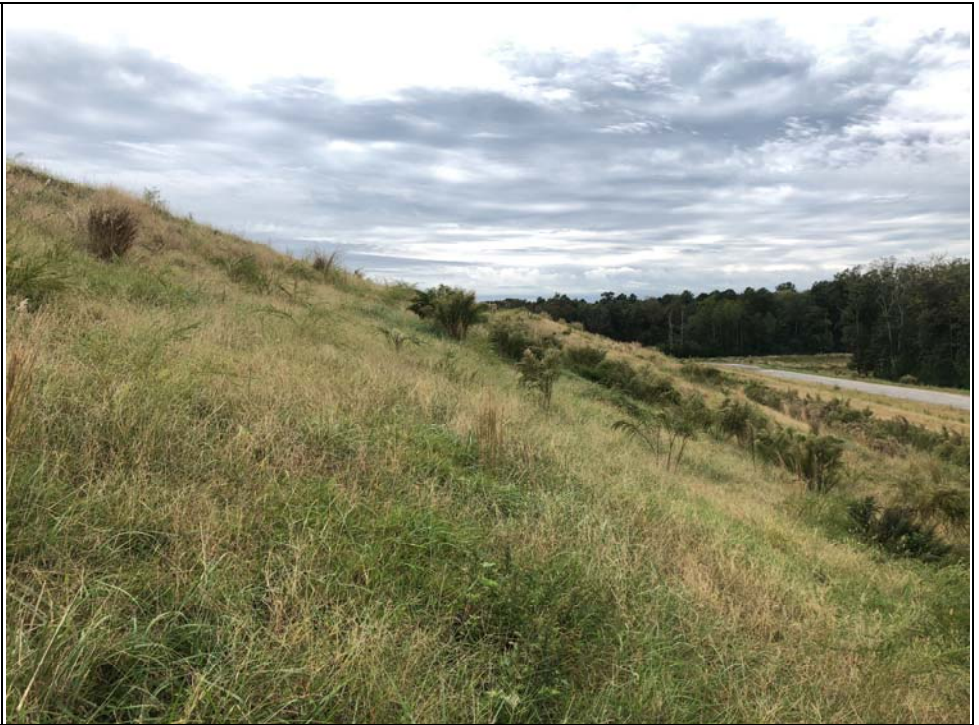
Image: 2135
Date: 10/16/2018
Time: 7:43 AM
Direction: South

Final cover on sideslopes of Phase II Cell 1. Vegetation is healthy with full coverage. No signs of erosion stability issues observed on sideslope.

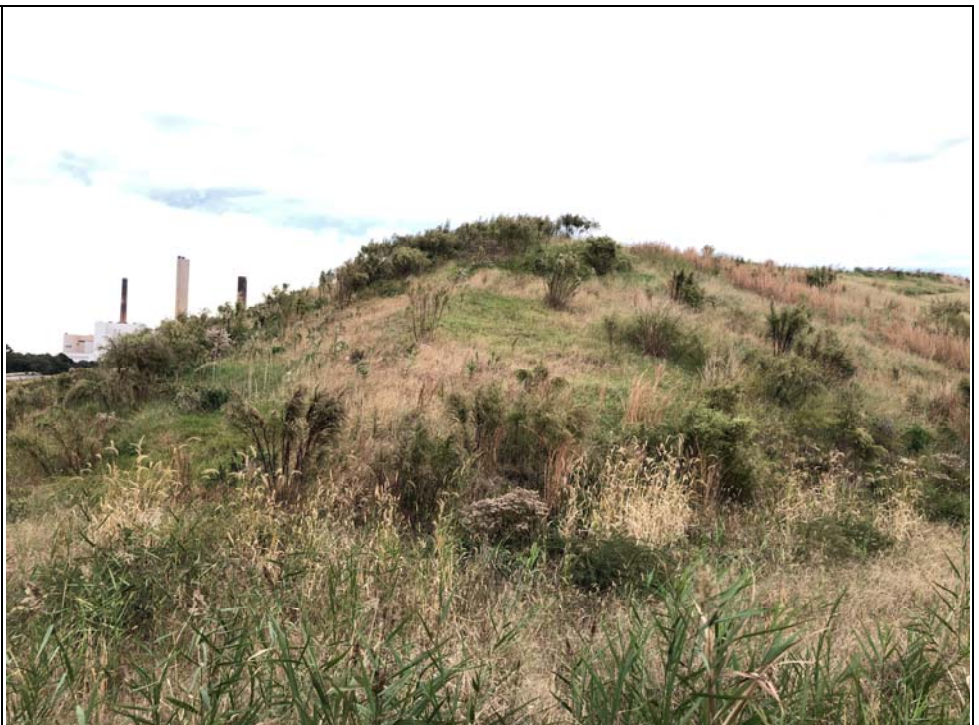
Image: 2137
Date: 10/16/2018
Time: 7:47 AM
Direction: Northeast

Final cover on sideslopes of Phase II Cell 1. Vegetation is healthy with full coverage. No signs of erosion stability issues observed on sideslope.

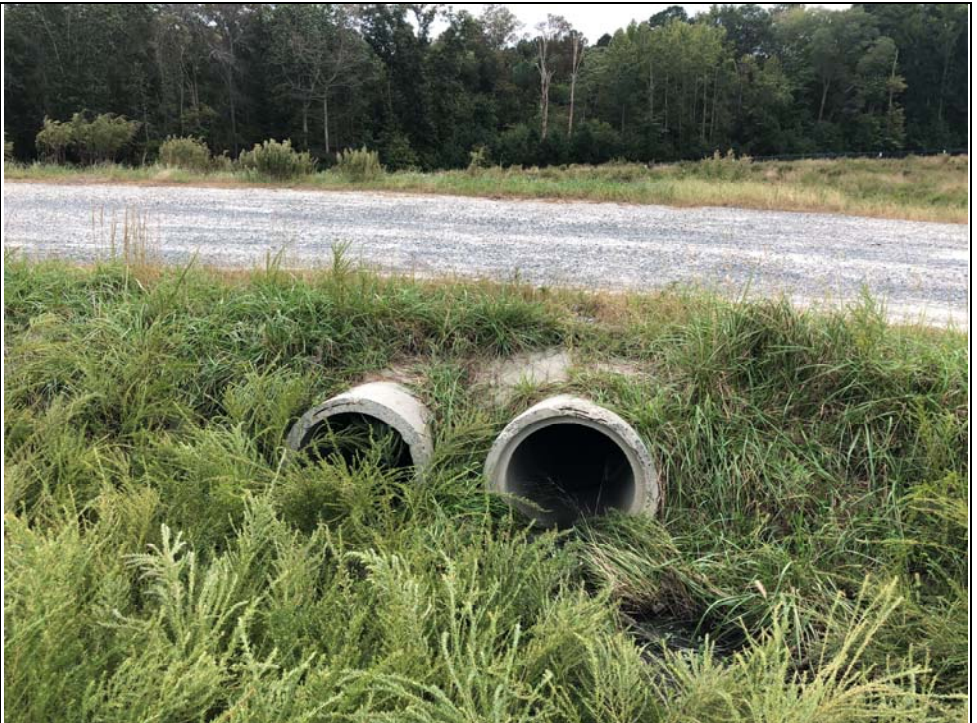
Image: 2139
Date: 10/16/2018
Time: 7:48 AM
Direction: South

Pipes conveying water from perimeter ditch to stormwater basin. Clear of obstruction at inlets and outlets.

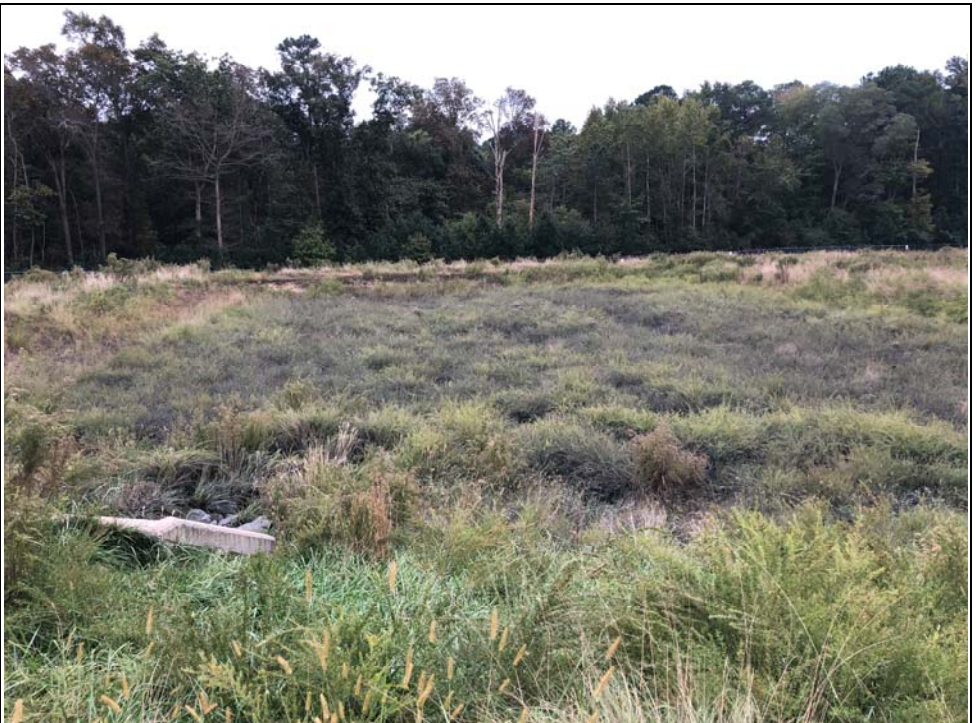
Image: 2141
Date: 10/16/2018
Time: 7:49 AM
Direction: South

Stormwater basin forebay. In good condition.

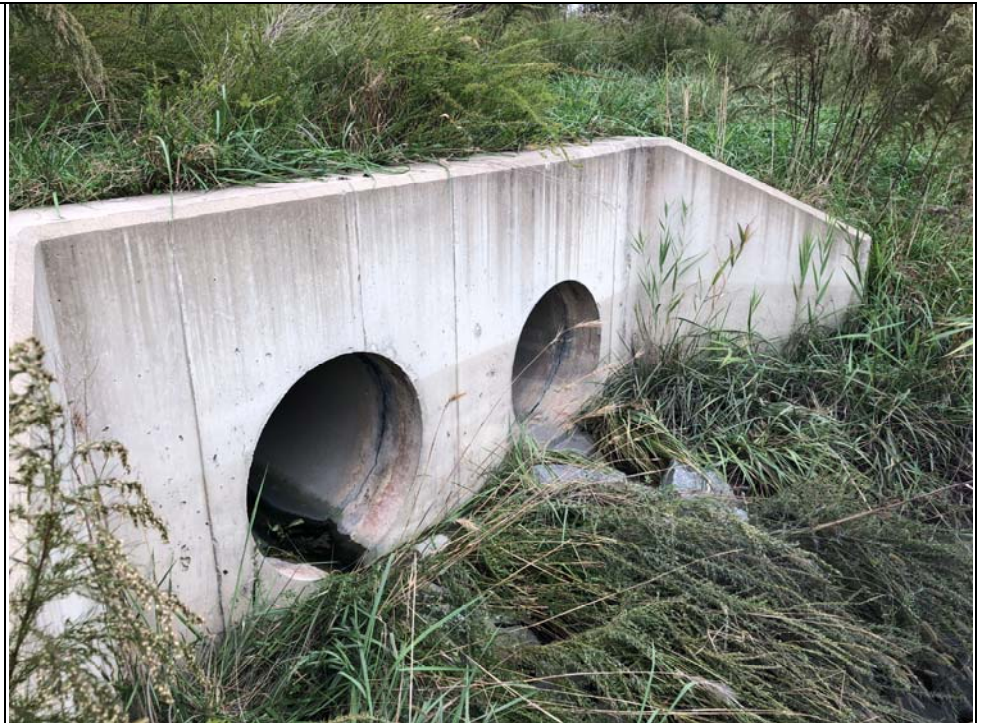
Image: 2143
Date: 10/16/2018
Time: 7:49 AM
Direction: Northeast

Inlets to stormwater basin.
Clear of obstruction at
inlets and outlets.

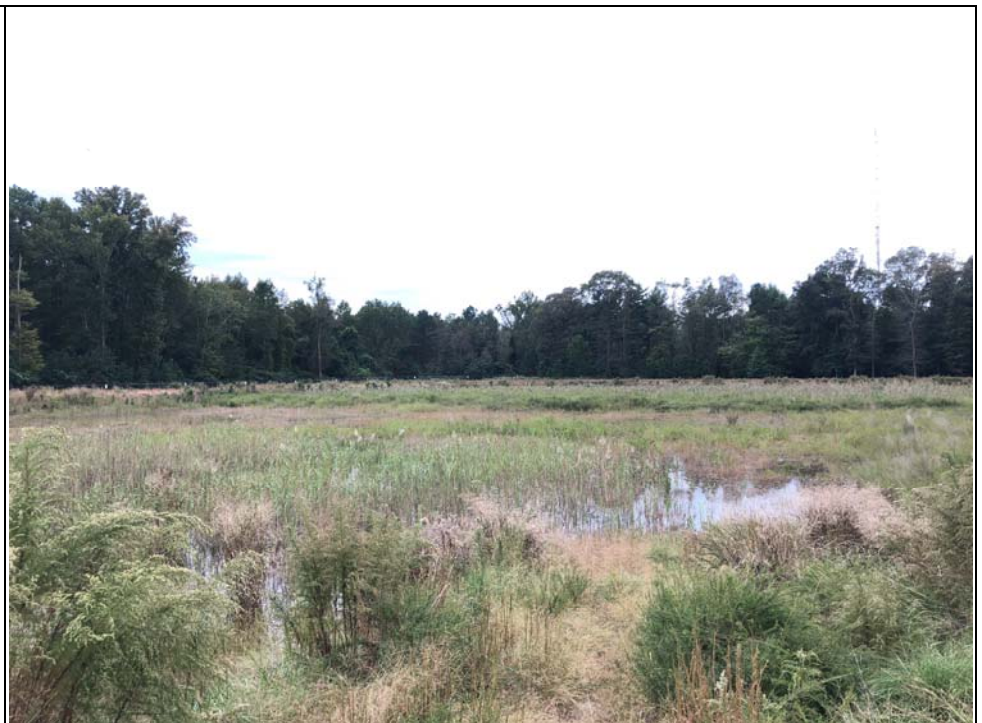
Image: 2147
Date: 10/16/2018
Time: 7:51 AM
Direction: Southwest

Stormwater basin forebay.
In good condition.

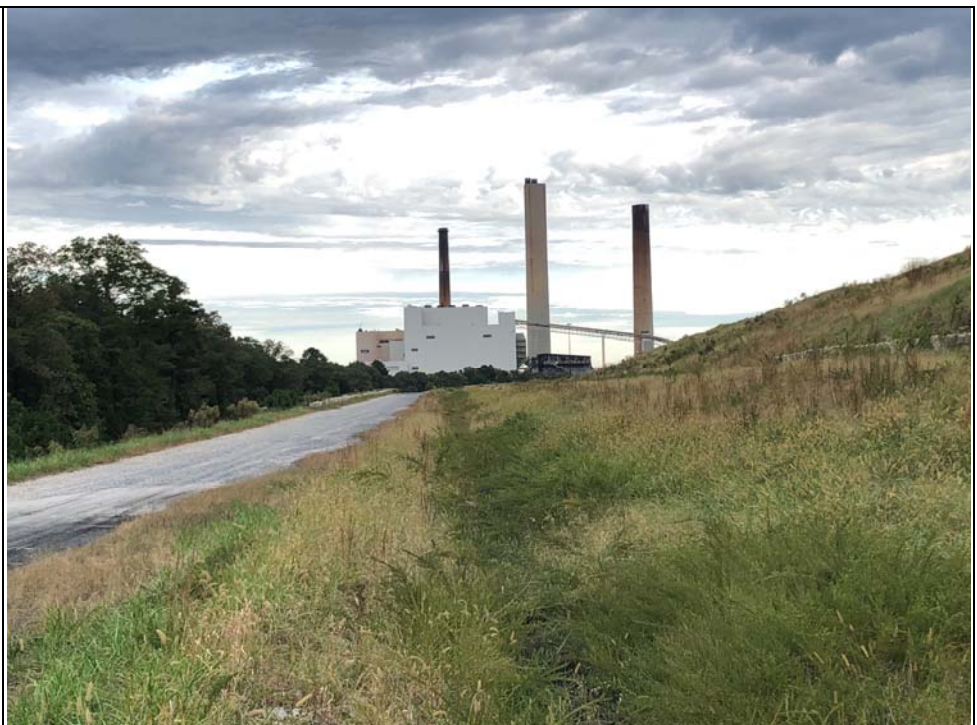
Image: 2149
Date: 10/16/2018
Time: 7:52 AM
Direction: North

Perimeter stormwater ditch is well maintained and in good condition.

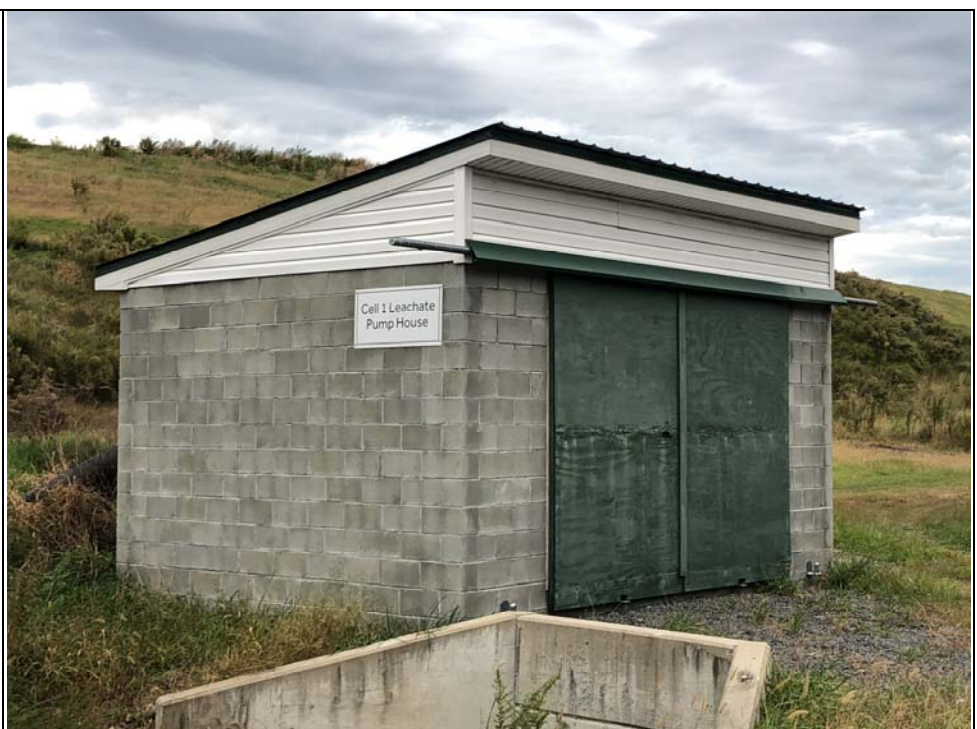
Image: 2151
Date: 10/16/2018
Time: 7:53 AM
Direction: East

Phase 1, Cell 1 leachate pump house and stormwater culvert. Building is appropriately signed. Culvert is free of obstructions.

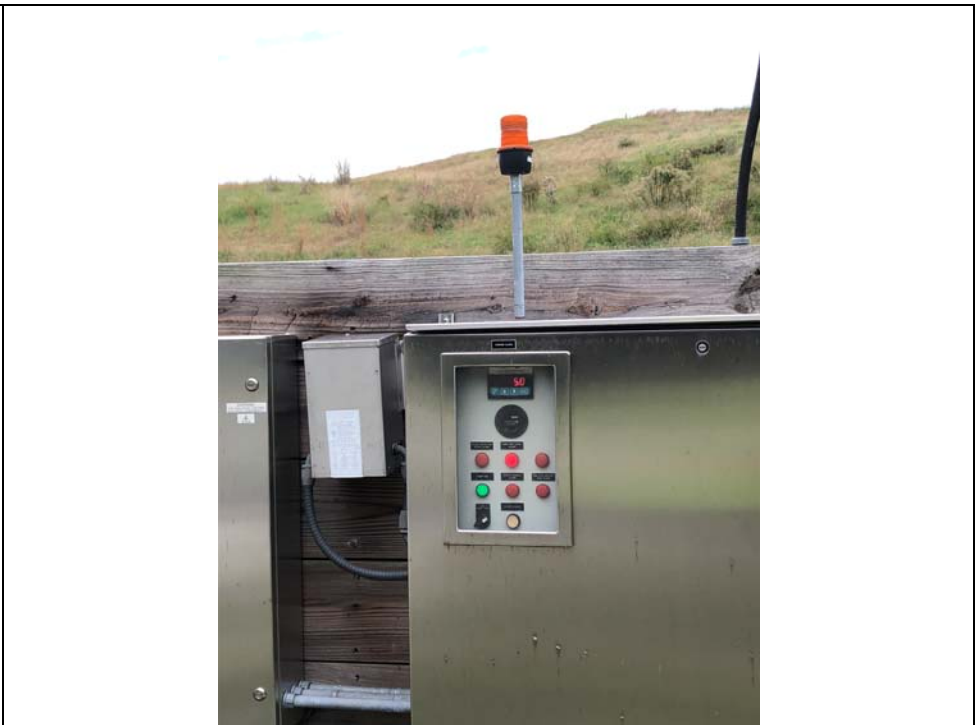
Image: 2153
Date: 10/16/2018
Time: 7:53 AM
Direction: North

Phase 1, Cell 1 leachate instrument panel. Good working order.

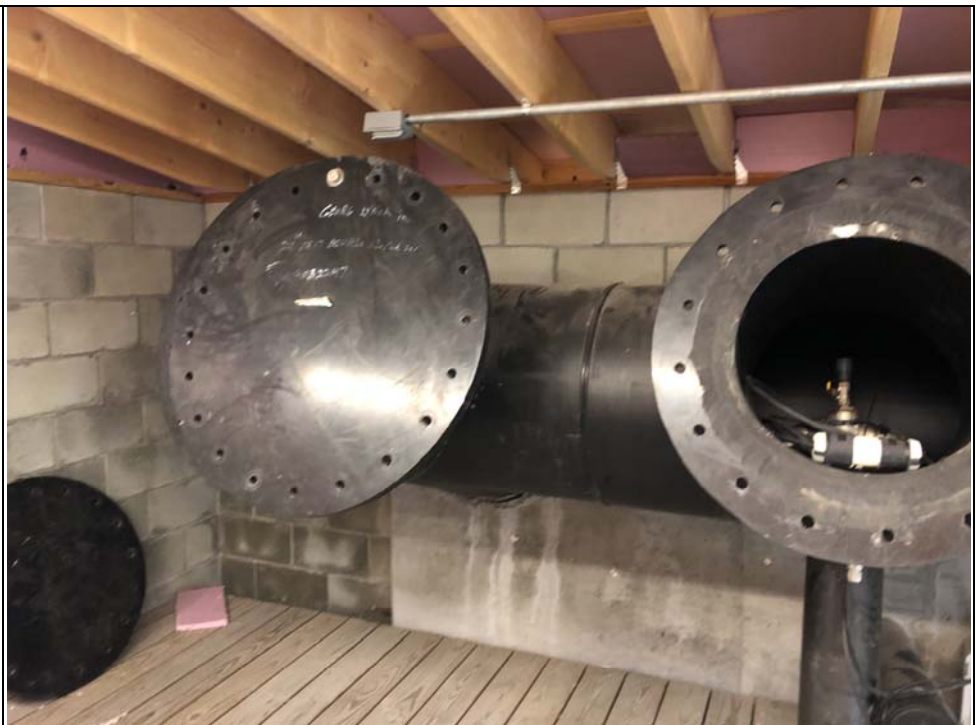
Image: 2155
Date: 10/16/2018
Time: 7:54 AM
Direction: Northwest

Inside Phase 1, Cell 1 Leachate Pump House. Cleanout riser and pump risers with T connection to forcemain shown. Building is well maintained.

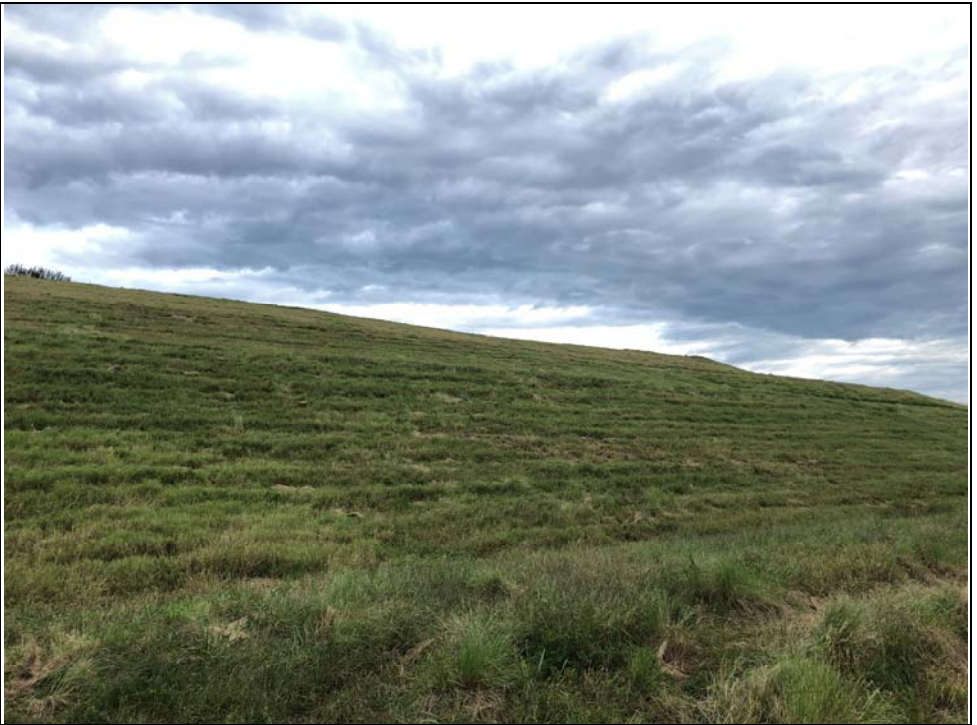
Image: 2159
Date: 10/16/2018
Time: 7:58 AM
Direction: Northeast

Terrace berm. Clear of obstructions and functioning as intended. Vegetative cover is dense and healthy.

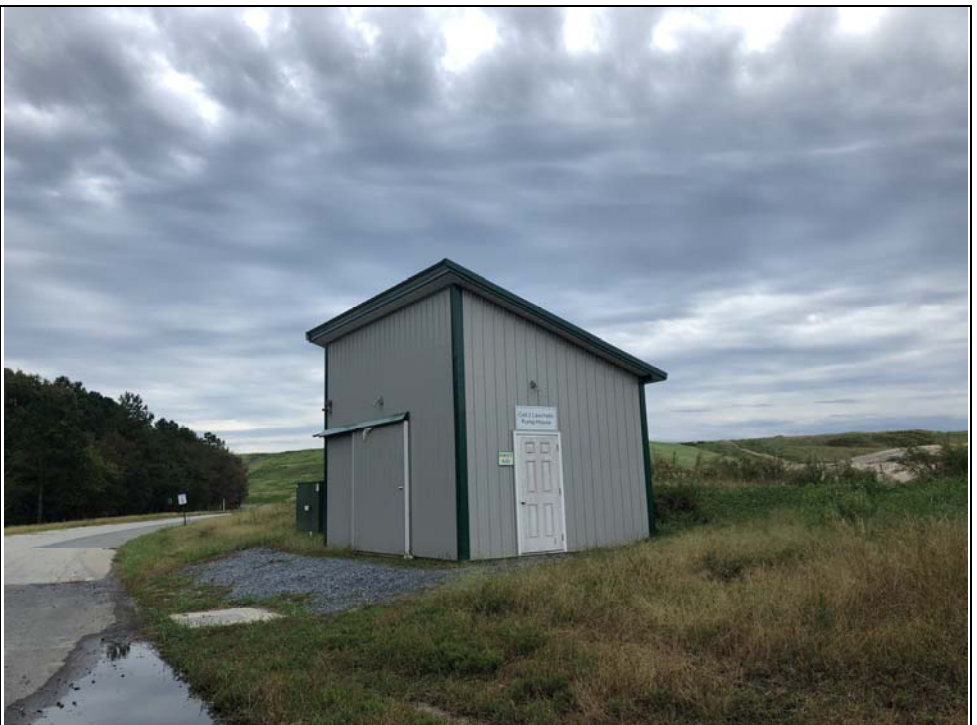
Image: 2161
Date: 10/16/2018
Time: 8:03 AM
Direction: Southeast

Phase 2, Cell 2 leachate pump house. Building exterior is in good condition and appropriately signed.
