Inspection Report

To: David Bacher, NRG
From: Richard Southorn, P.E., P.G.
Re: Indian River Landfill – Annual CCR Unit Inspection Report
Inspection Date: October 16, 2018
Memo Date: January 18, 2019

Project: Indian River Landfill 2018 CCR Annual Inspection

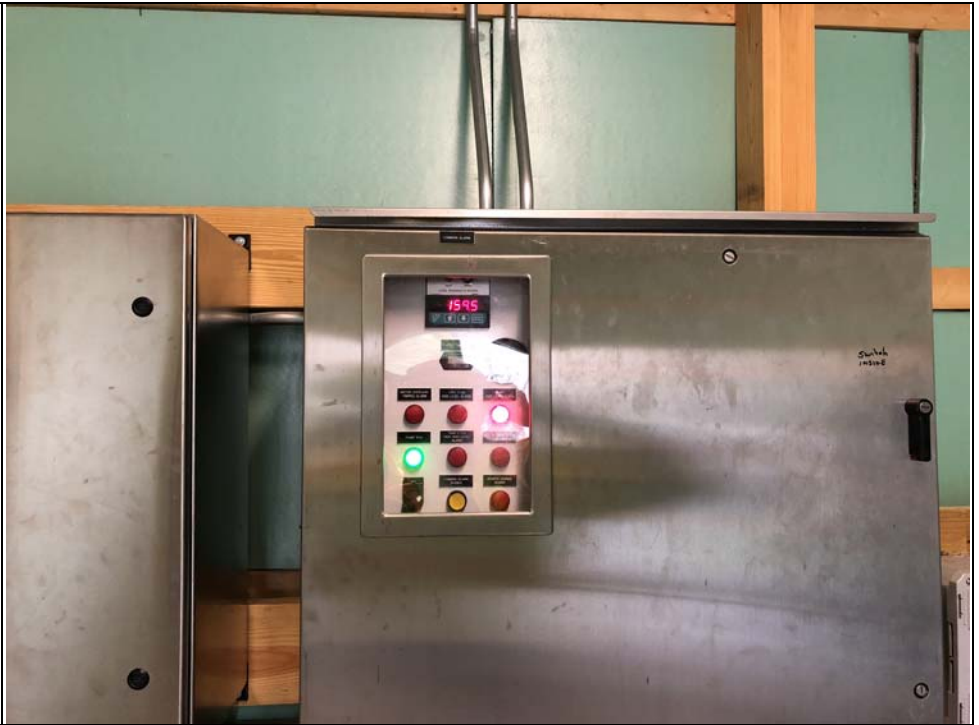
Image: 2165
Date: 10/16/2018
Time: 8:05 AM
Direction: Southeast

Leachate liquid level indicator and controls in the Phase 2, Cell 2 leachate pump house. Red light is indicating a high leachate level associated with standing water.

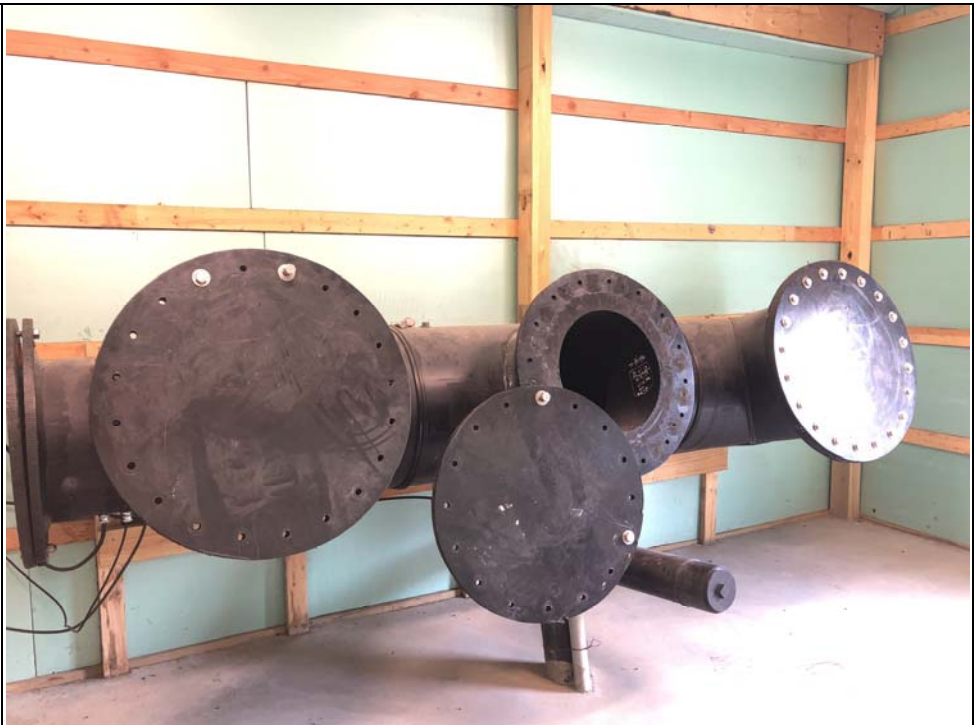
Image: 2167
Date: 10/16/2018
Time: 8:05 AM
Direction: Southwest

Phase 1, Cell 2 leachate sump risers.

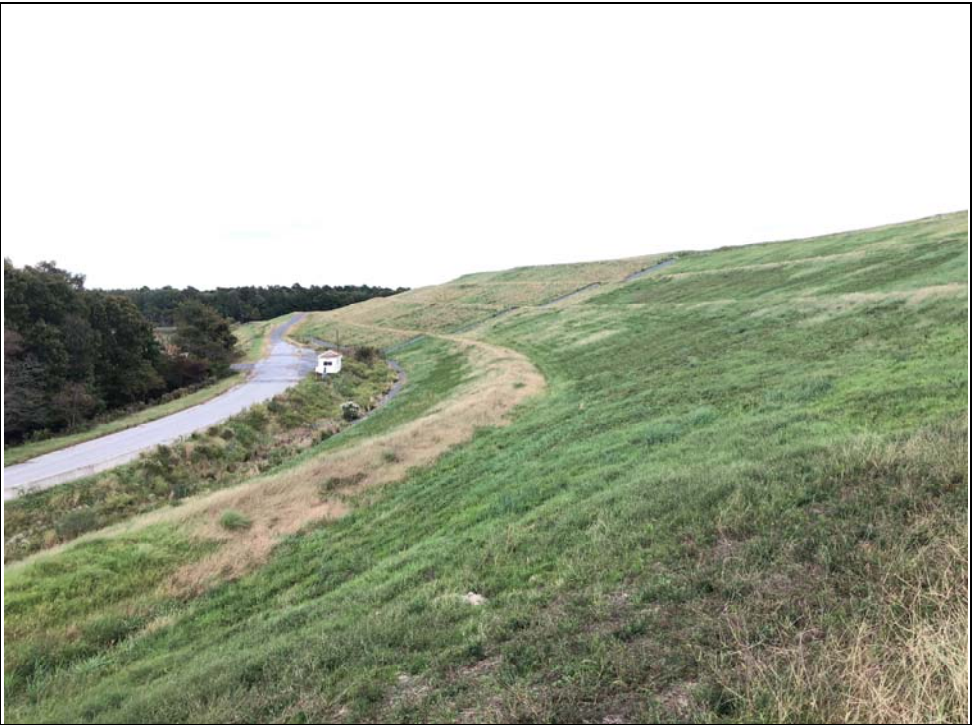
Image: 2173
Date: 10/16/2018
Time: 8:09 AM
Direction: East

Landfilll sideslopes and terraces are well maintained. No evidence of slope stability issues.

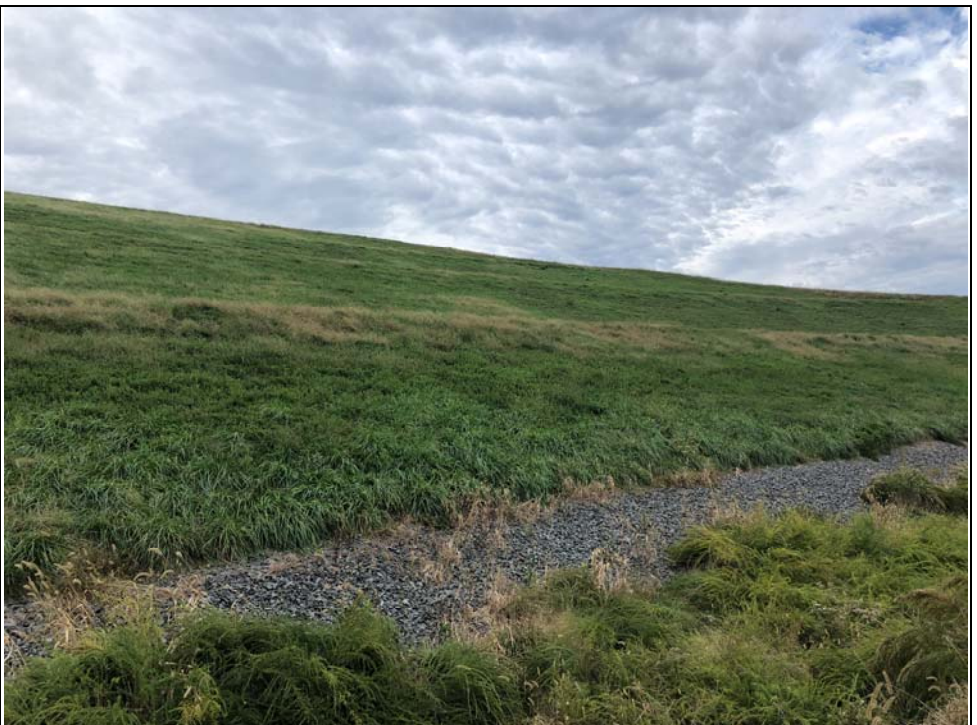
Image: 2176
Date: 10/16/2018
Time: 8:12 AM
Direction: Southwest

Final cover on sideslopes with stormwater ditch in foreground.

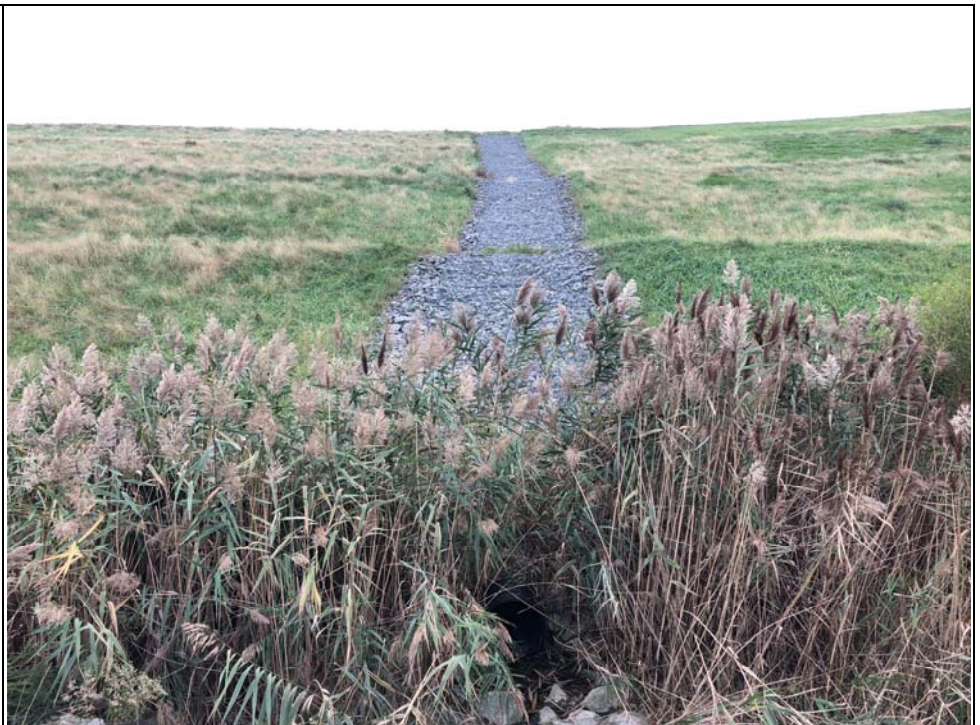
Image: 2178
Date: 10/16/2018
Time: 8:13 AM
Direction: South

Downchute near northwest basin west forebay.

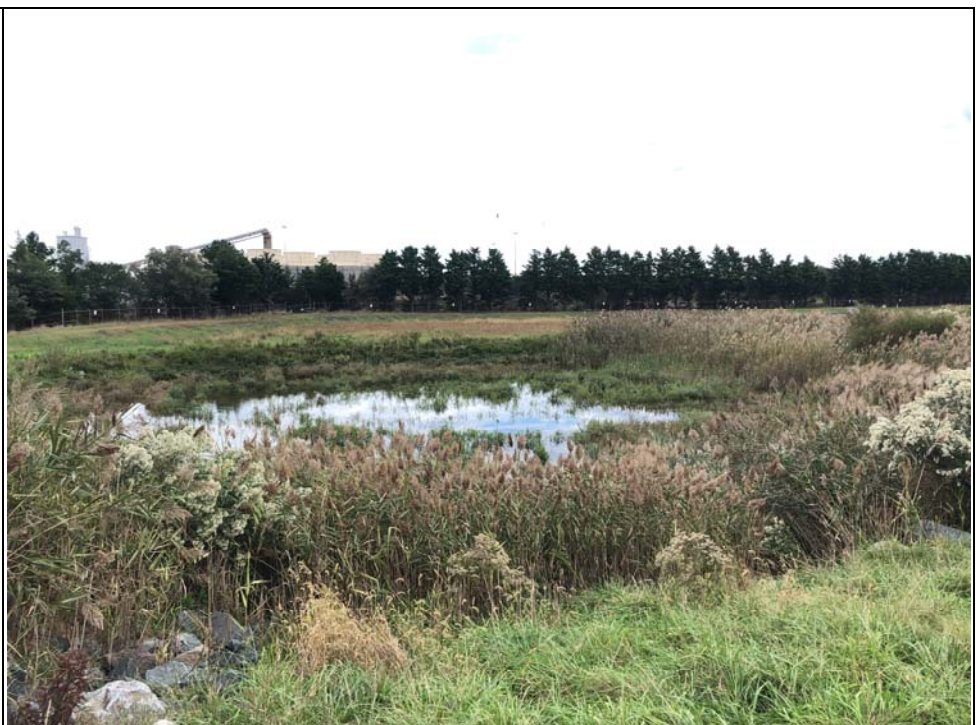
Image: 2180
Date: 10/16/2018
Time: 8:14 AM
Direction: North

Northwest basin forebay.

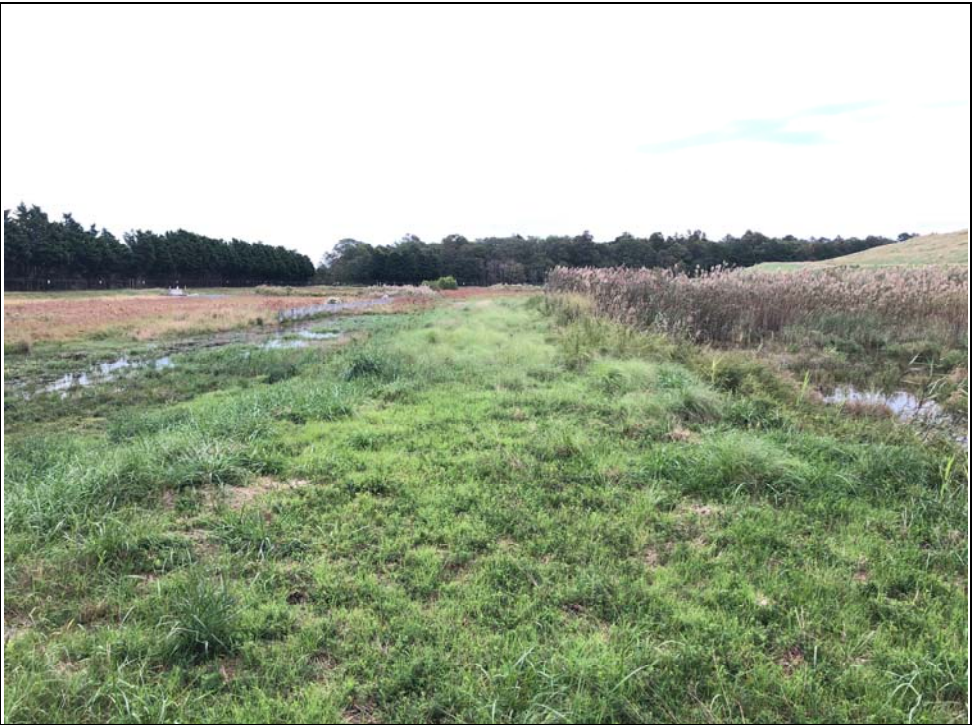
Image: 2182
Date: 10/16/2018
Time: 8:16 AM
Direction: East

Description:
Northwest basin.

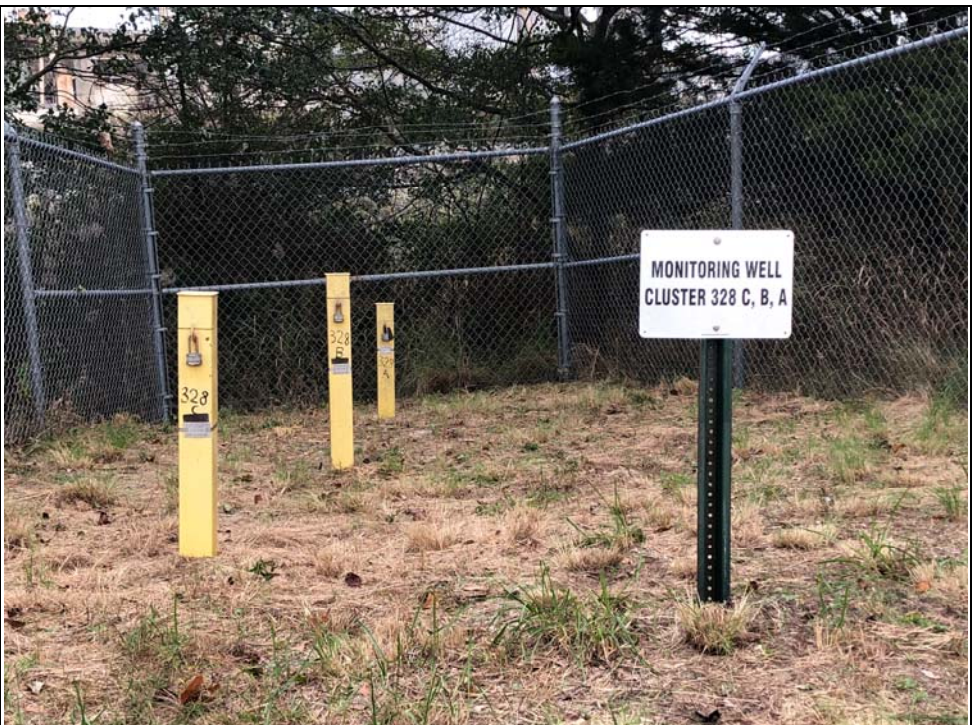
Image: 2184
Date: 10/16/2018
Time: 8:17 AM
Direction: West

Description:
Monitoring well cluster.

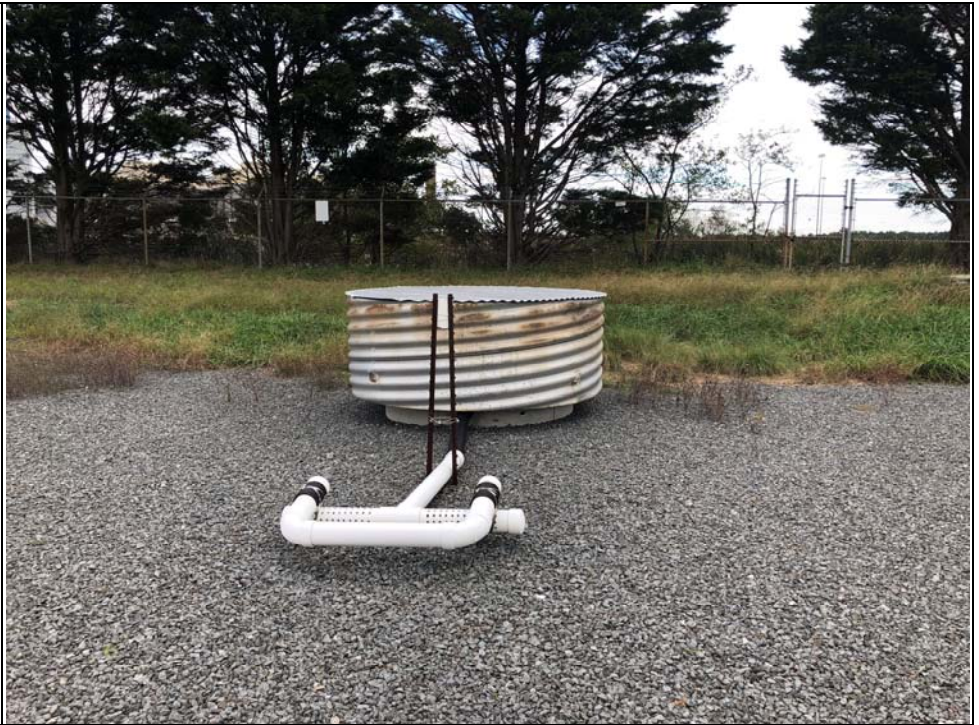
Image: 2186
Date: 10/16/2018
Time: 8:18 AM
Direction: North

Northeast basin outlet skimmer.

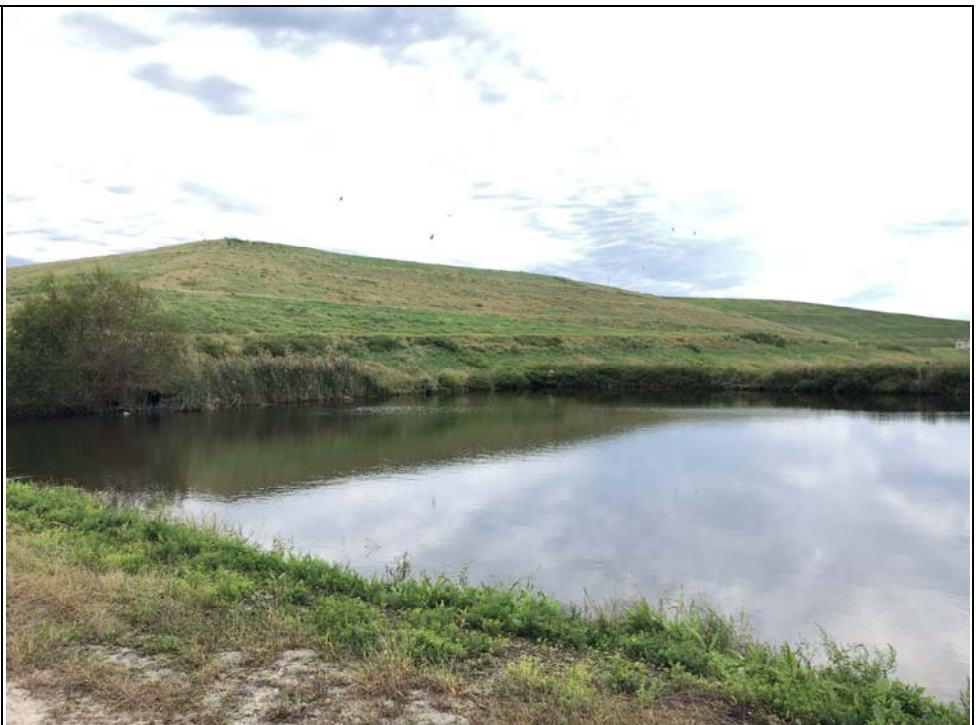
Image: 2190
Date: 10/16/2018
Time: 8:21 AM
Direction: Southwest

East forebay of northwest basin.

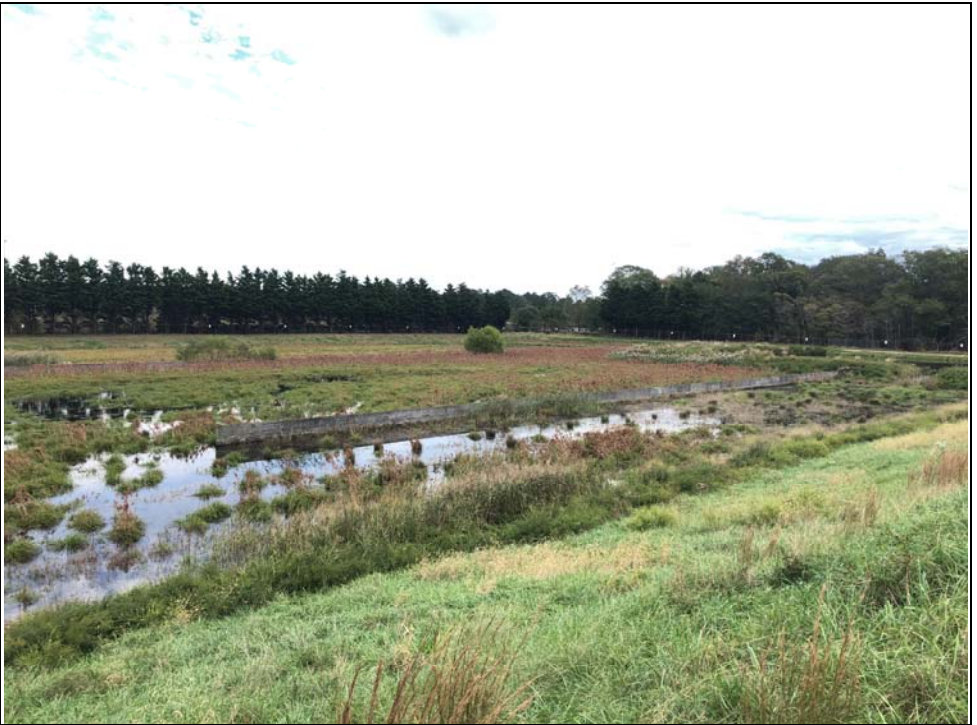
Image: 2192
Date: 10/16/2018
Time: 8:25 AM
Direction: Northeast

Northwest basin.

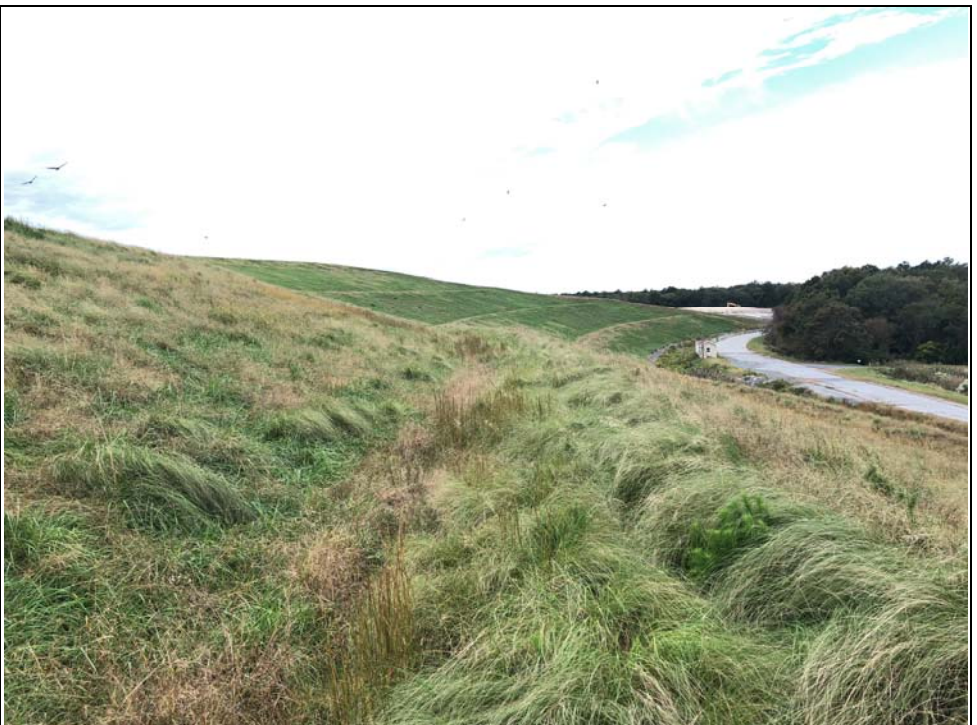
Image: 2194
Date: 10/16/2018
Time: 8:26 AM
Direction: West

Phase 1 terrace berm.
Clear of obstructions and
functioning as intended.
Vegetative cover is dense
and healthy.

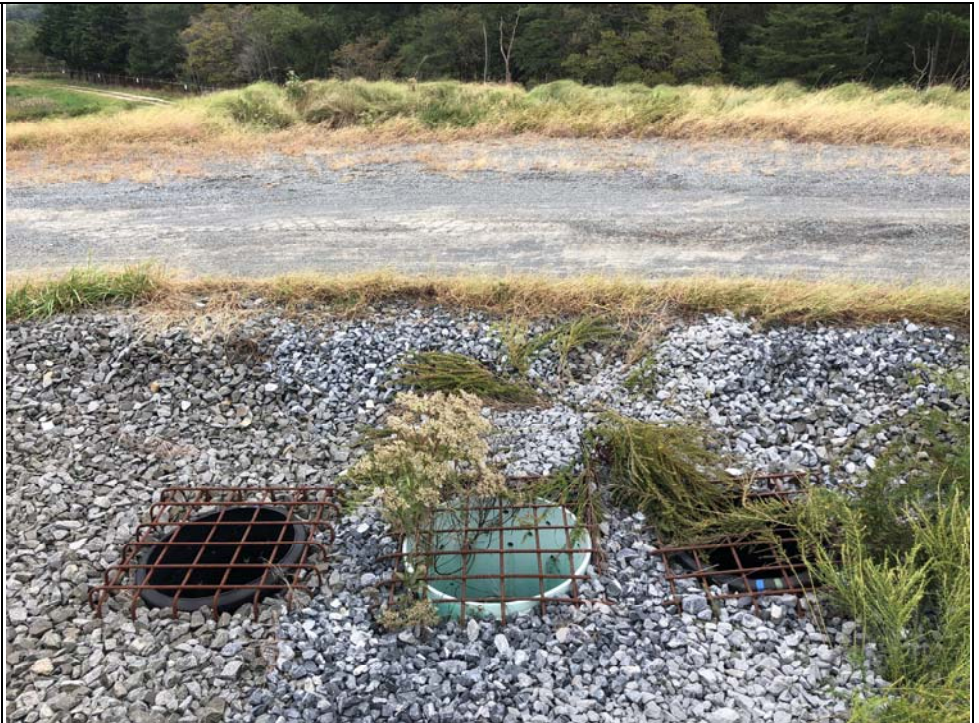
Image: 2196
Date: 10/16/2018
Time: 8:29 AM
Direction: Northeast

Phase 1 corner downchute road crossing equalizing pipes. Free of obstructions.

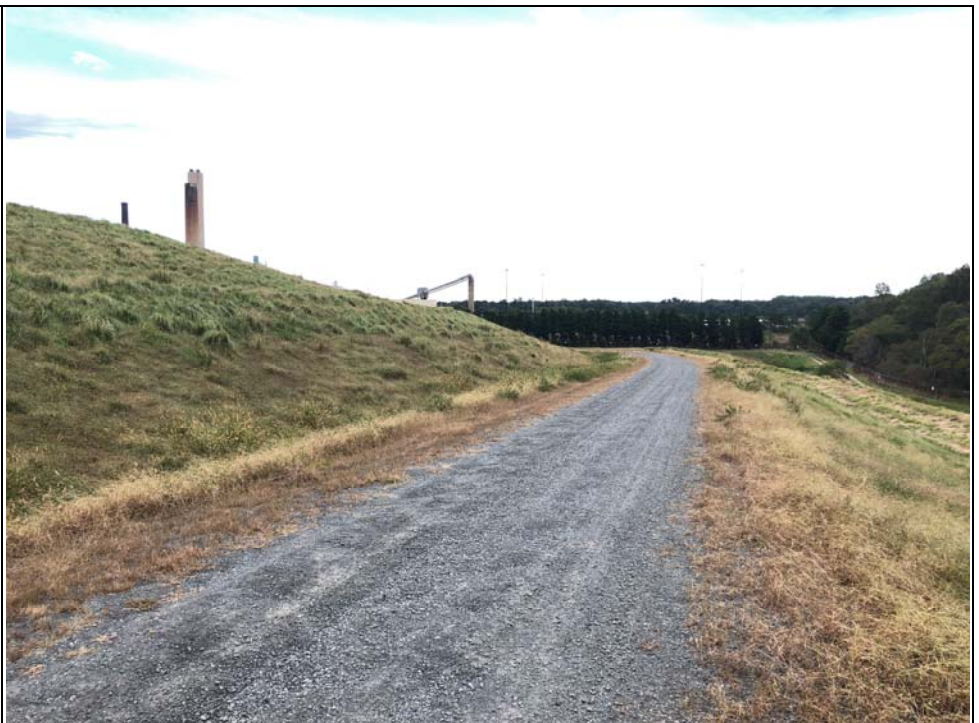
Image: 2198
Date: 10/16/2018
Time: 8:30 AM
Direction: North

Phase 1 plateau access road. Well maintained. No rutting or potholes. Final cover on either side of road is well maintained with no evidence of stability issues or erosion.

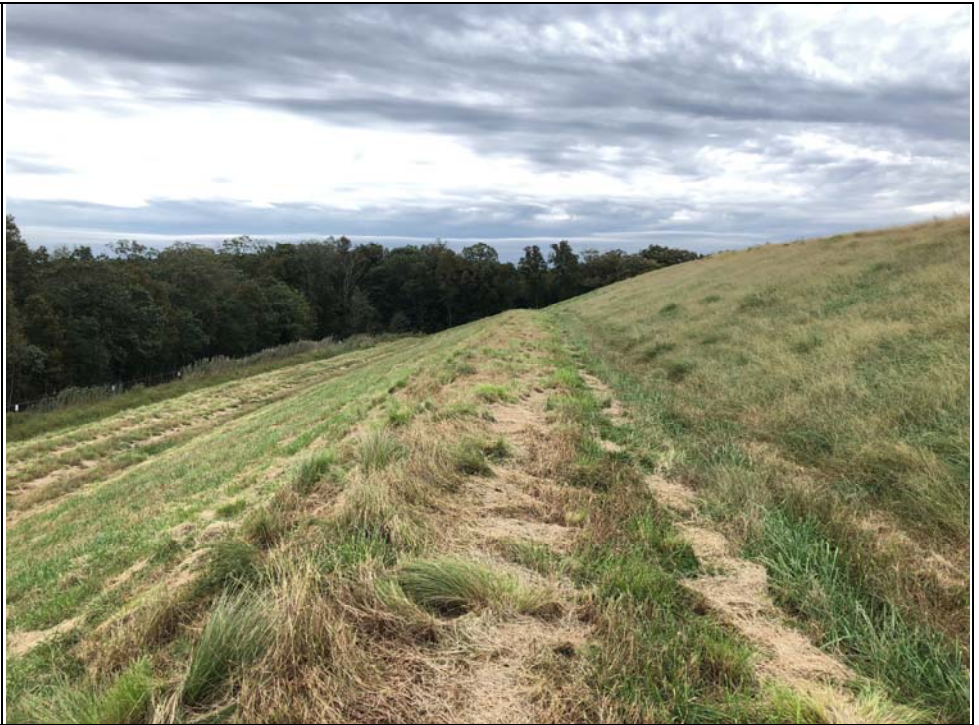
Image: 2200
Date: 10/16/2018
Time: 8:31 AM
Direction: South

Phase 1 terrace berm.
Clear of obstructions and
functioning as intended.
Vegetative cover is dense
and healthy.

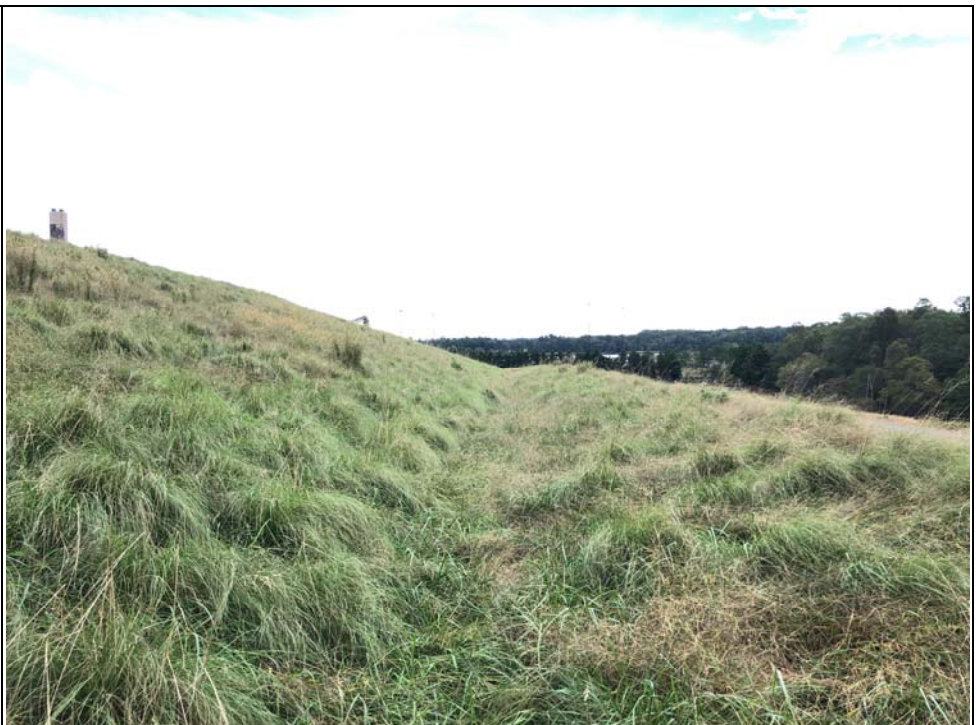
Image: 2202
Date: 10/16/2018
Time: 8:32 AM
Direction: North

Phase 1 terrace berm.
Clear of obstructions and
functioning as intended.
Vegetative cover is dense
and healthy.

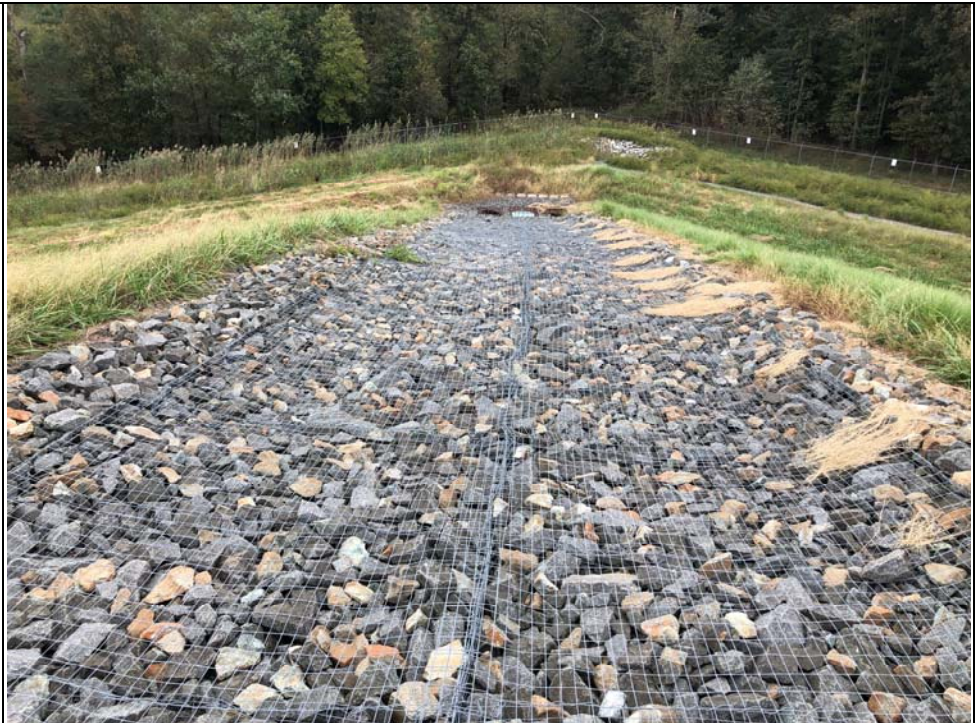
Image: 2204
Date: 10/16/2018
Time: 8:33 AM
Direction: Southeast

Phase 1 corner downchute. Rock is in-place and not migrating. No evidence of washouts.

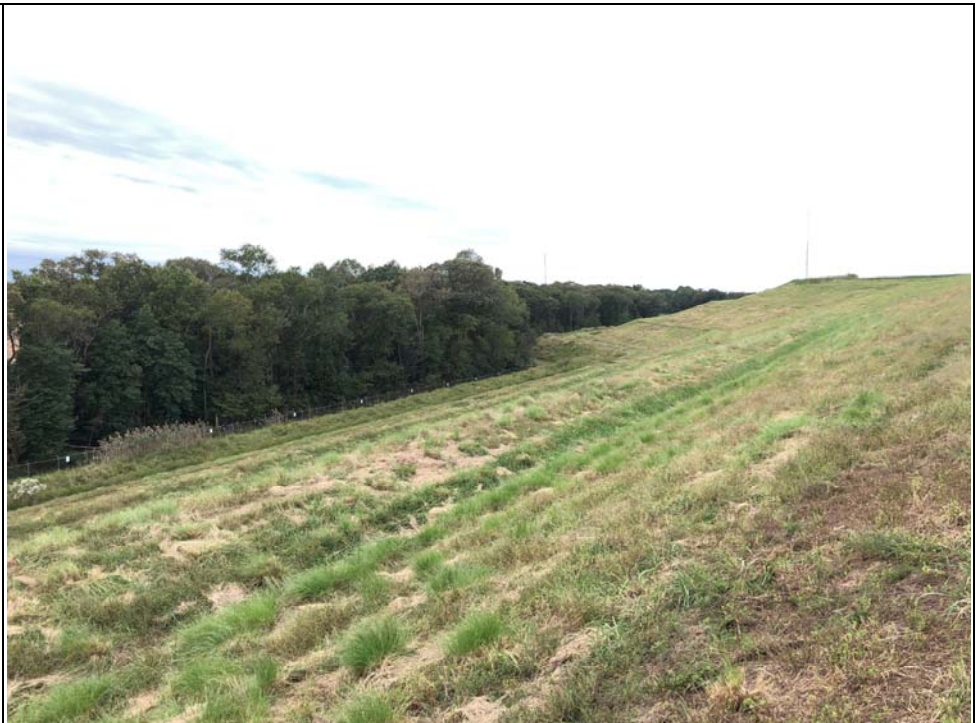
Image: 2206
Date: 10/16/2018
Time: 8:35 AM
Direction: Southwest

Phase 1 final cover and stormwater terraces. Well maintained and functioning as intended.

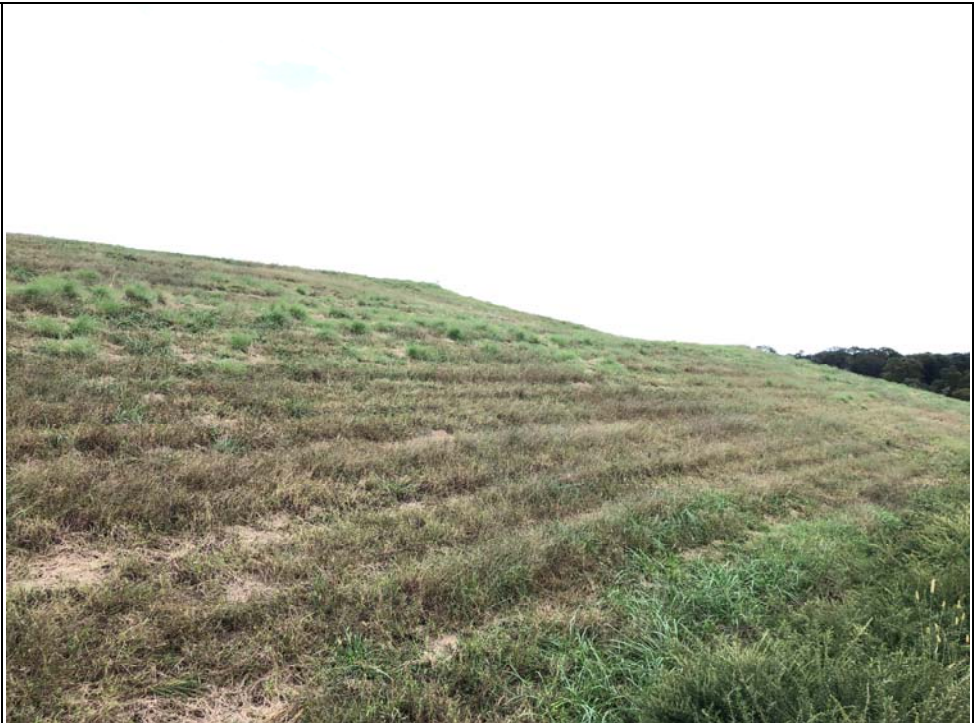
Image: 2208
Date: 10/16/2018
Time: 8:35 AM
Direction: Northeast

Phase 1 final cover and stormwater terraces. Well maintained and functioning as intended.

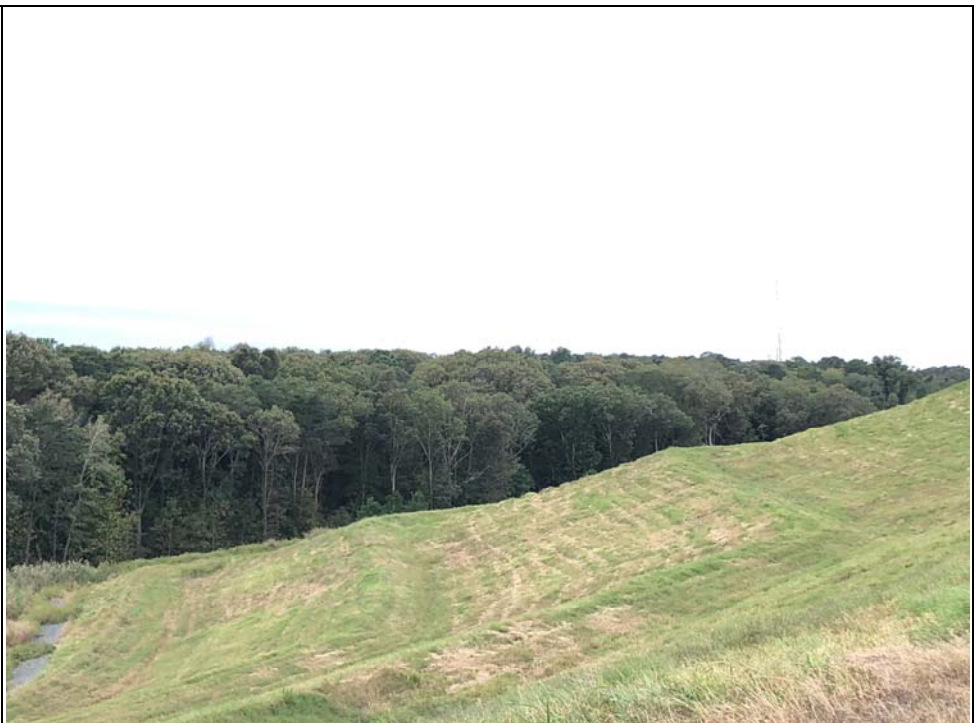
Image: 2210
Date: 10/16/2018
Time: 8:36 AM
Direction: Southwest

Phase 1 final cover and stormwater terraces. Well maintained and functioning as intended.

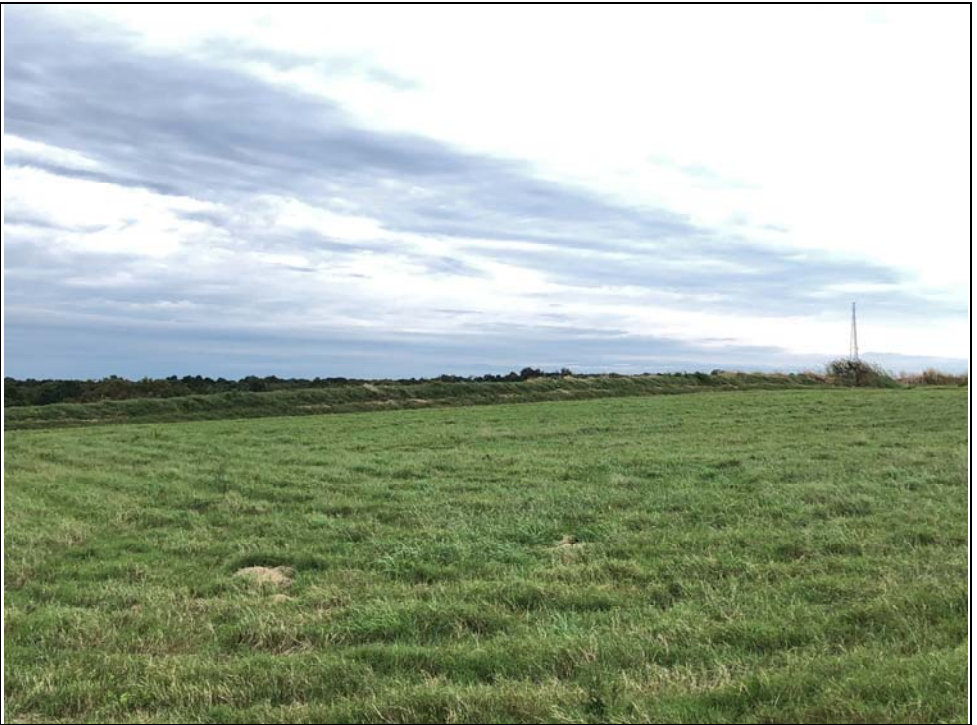
Image: 2212
Date: 10/16/2018
Time: 8:37 AM
Direction: West

Final cover on plateau.
Vegetation is well established. No signs of animal burrows or erosion.

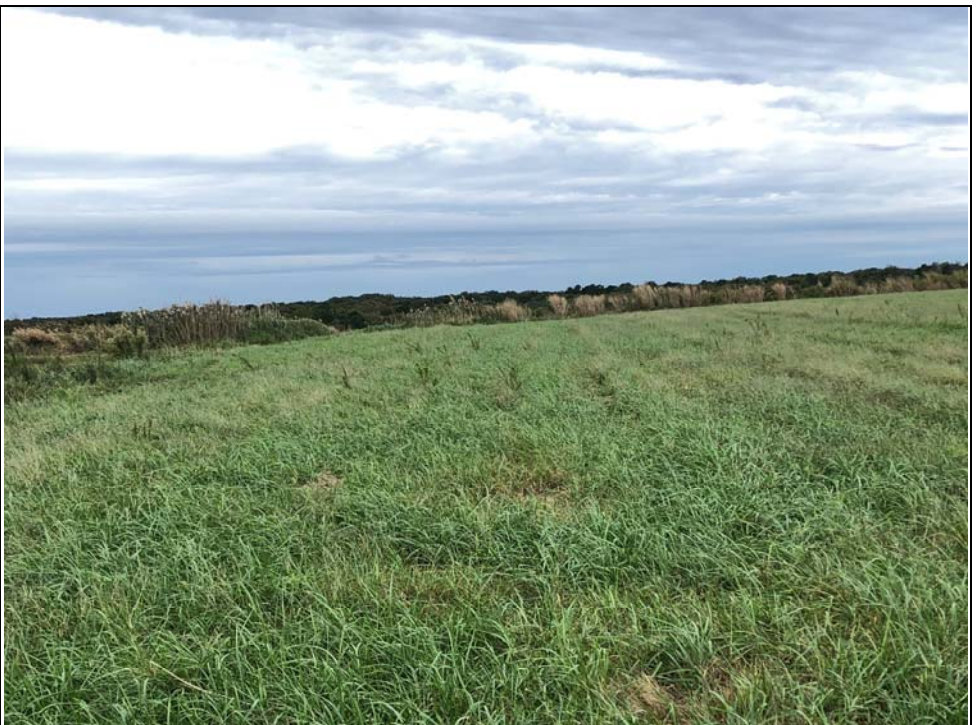
Image: 2214
Date: 10/16/2018
Time: 8:37 AM
Direction: West

Final cover on plateau.
Vegetation is well established. No signs of animal burrows or erosion.

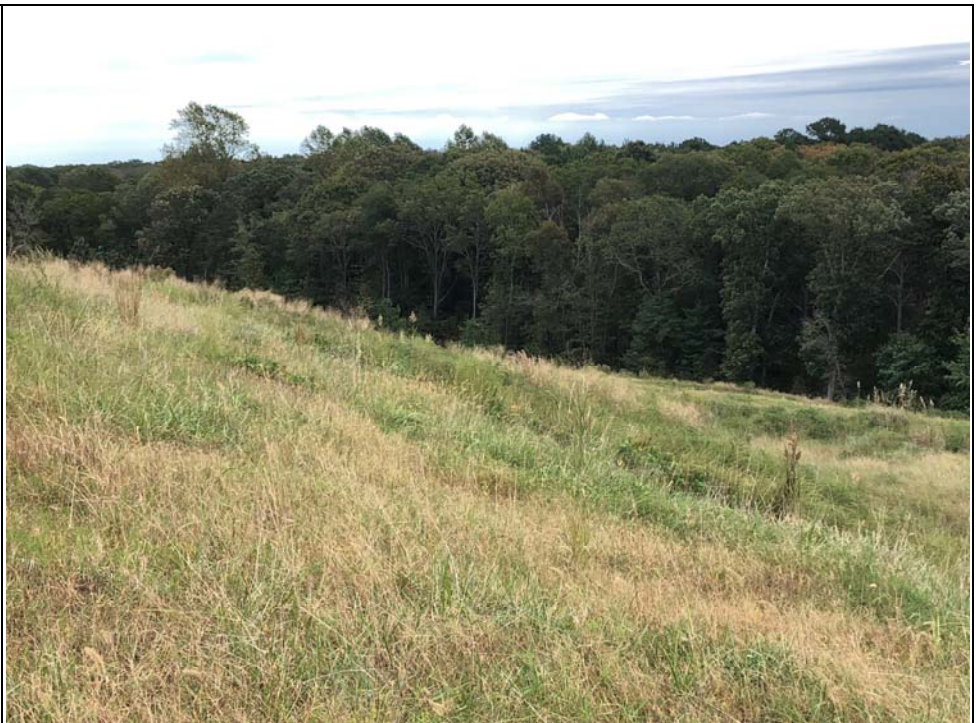
Image: 2216
Date: 10/16/2018
Time: 8:39 AM
Direction: East

Final cover on plateau.
Vegetation is well established. No signs of animal burrows or erosion.

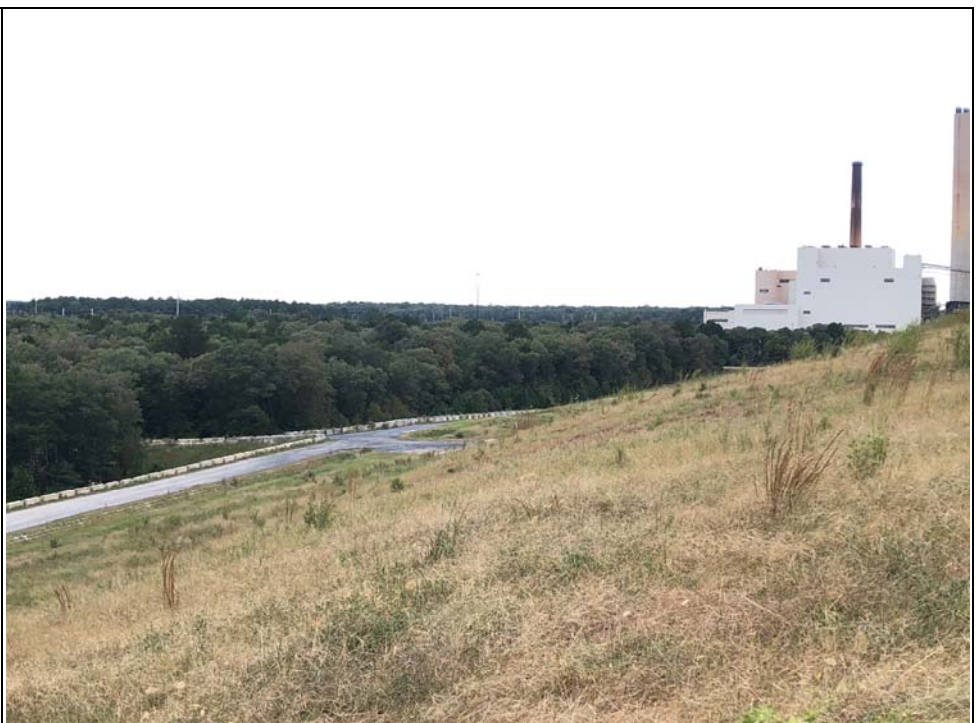
Image: 2218
Date: 10/16/2018
Time: 8:40 AM
Direction: North

Final cover on sideslopes.
Vegetation is well established. No signs of animal burrows or erosion.

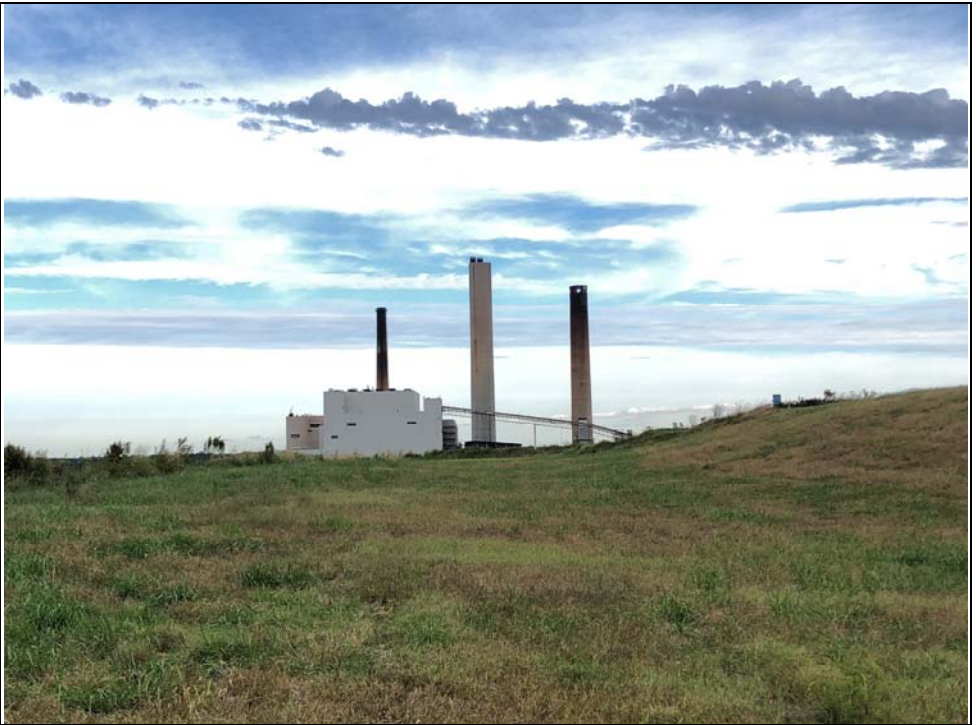
Image: 2220
Date: 10/16/2018
Time: 8:41 AM
Direction: North

Final cover on plateau.
Vegetation is well established. No signs of animal burrows or erosion.

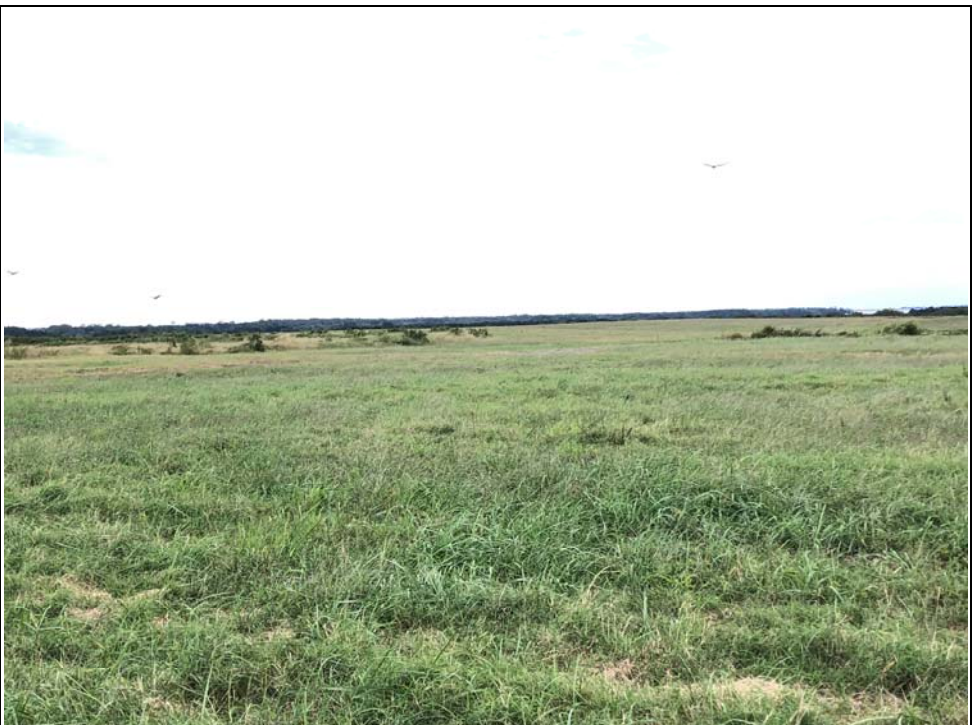
Image: 2222
Date: 10/16/2018
Time: 8:42 AM
Direction: East

Final cover on plateau.
Vegetation is well established. No signs of animal burrows or erosion.

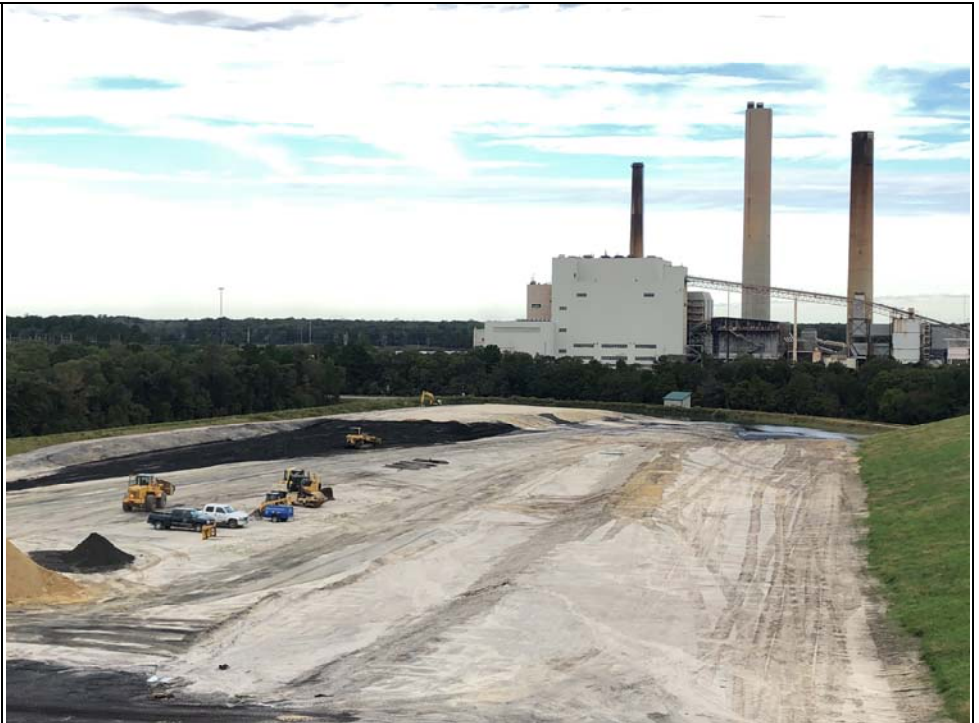
Description:
Phase 2, Cell 2 active area.

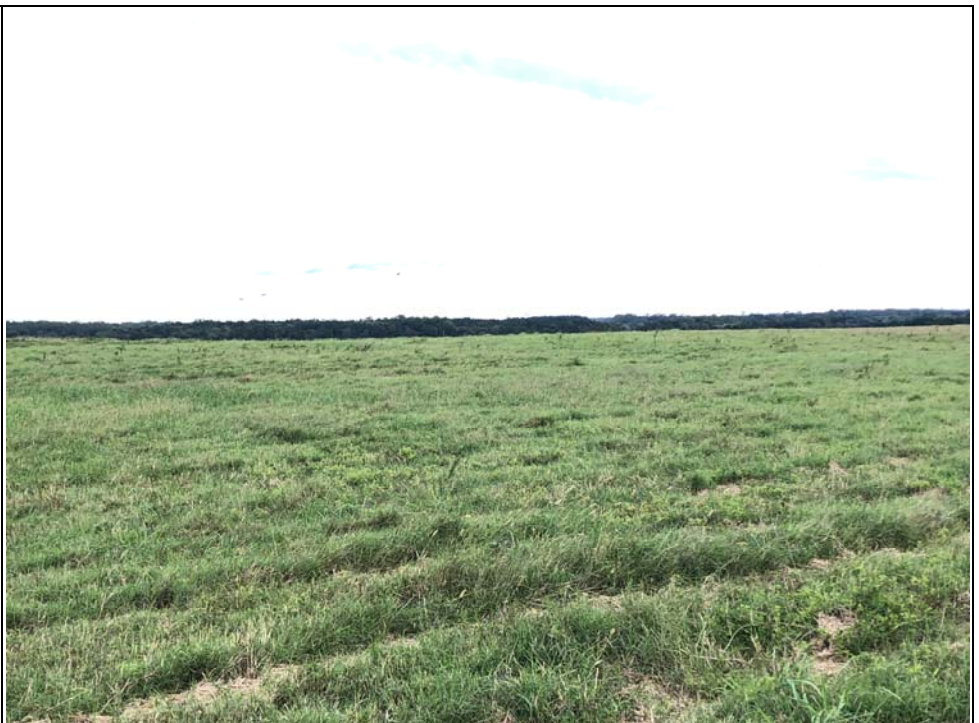
Image: 2228
Date: 10/16/2018
Time: 8:45 AM
Direction: East

Description:
Final cover on plateau.
Vegetation is well established. No signs of animal burrows or erosion.

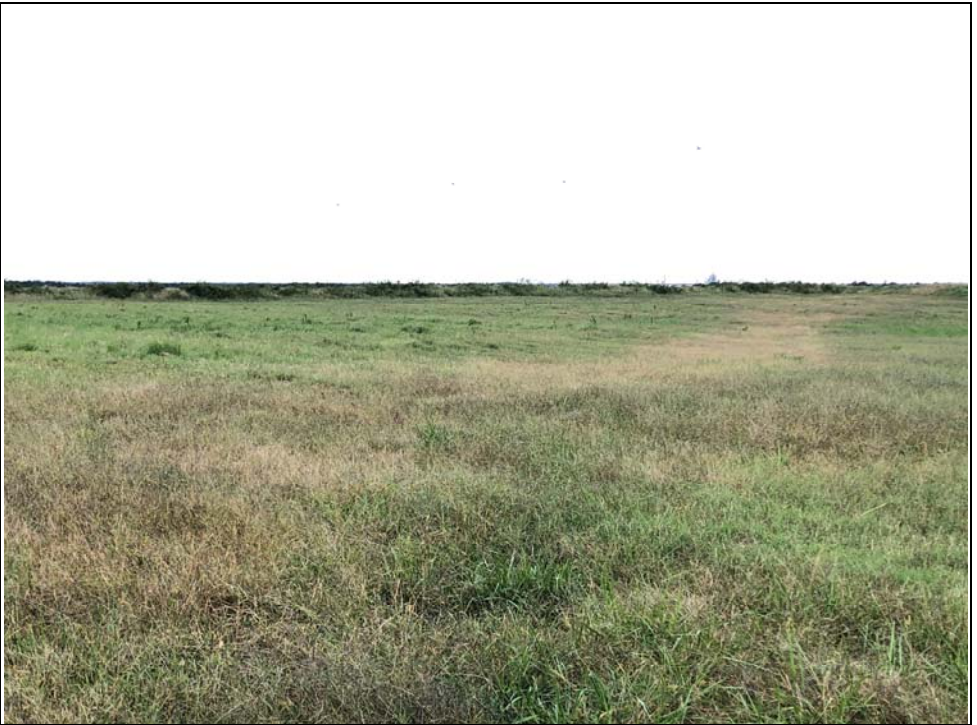
Final cover on plateau.
Vegetation is well established. No signs of animal burrows or erosion.

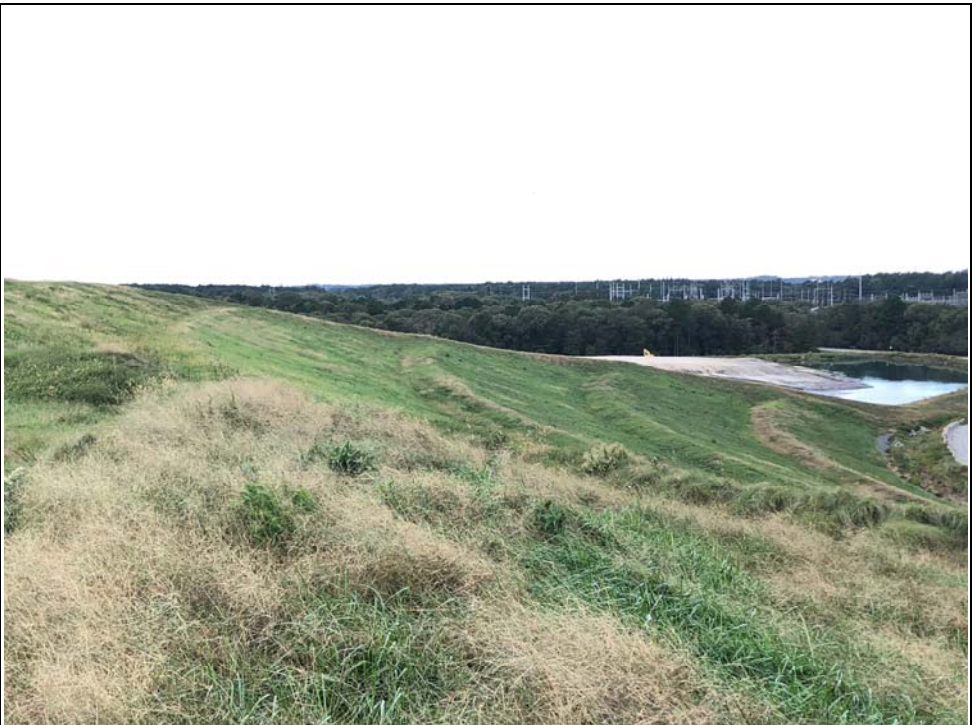
Image: 2234
Date: 10/16/2018
Time: 8:47 AM
Direction: West

Terraces are well maintained and drain as intended.

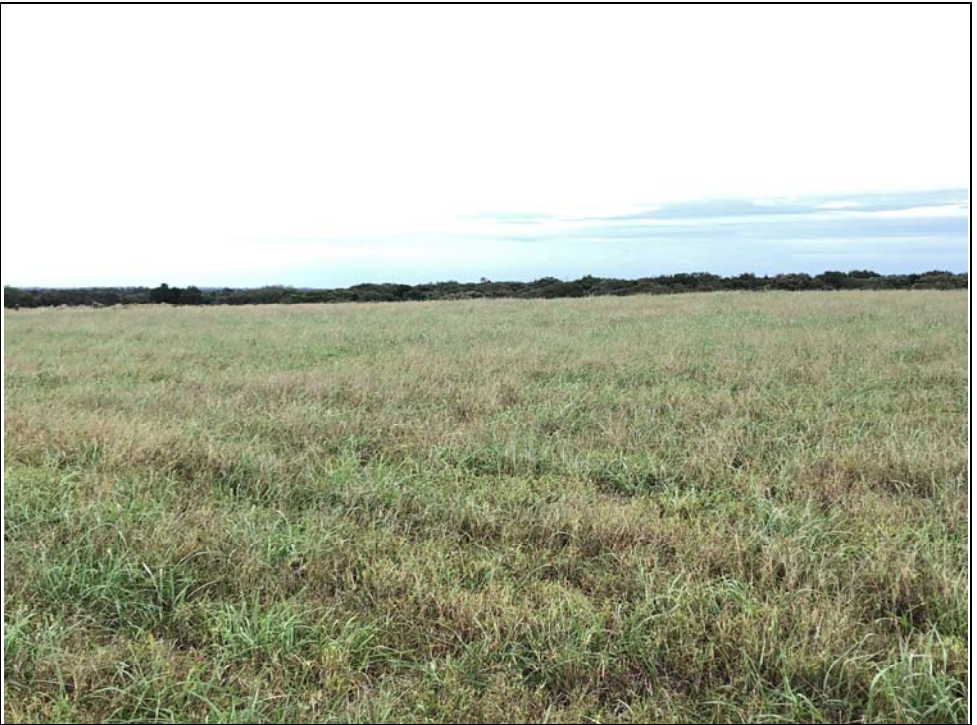
Final cover on plateau.
Vegetation is well established. No signs of animal burrows or erosion.
