Inspection Report

To: David Bacher, NRG
From: Richard Southorn, P.E., P.G.
Re: Indian River Landfill – Annual CCR Unit Inspection Report
Inspection Date: October 16, 2018
Memo Date: January 18, 2019

Project: Indian River Landfill 2018 CCR Annual Inspection

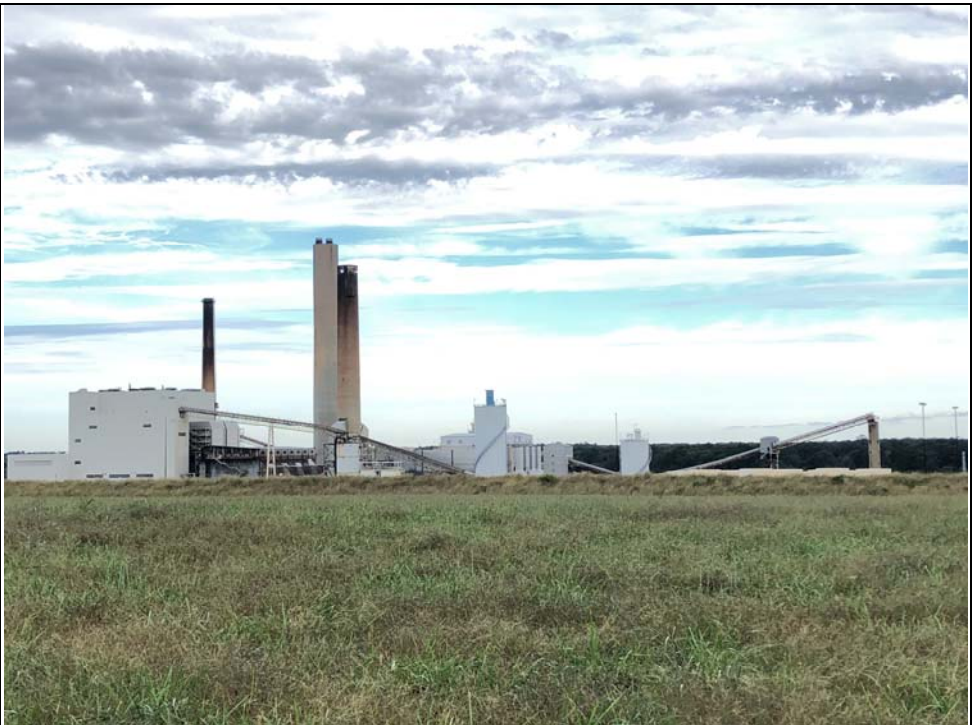
Image: 2238
Date: 10/16/2018
Time: 8:49 AM
Direction: Southeast

Final cover on plateau.
Vegetation is well established. No signs of animal burrows or erosion.

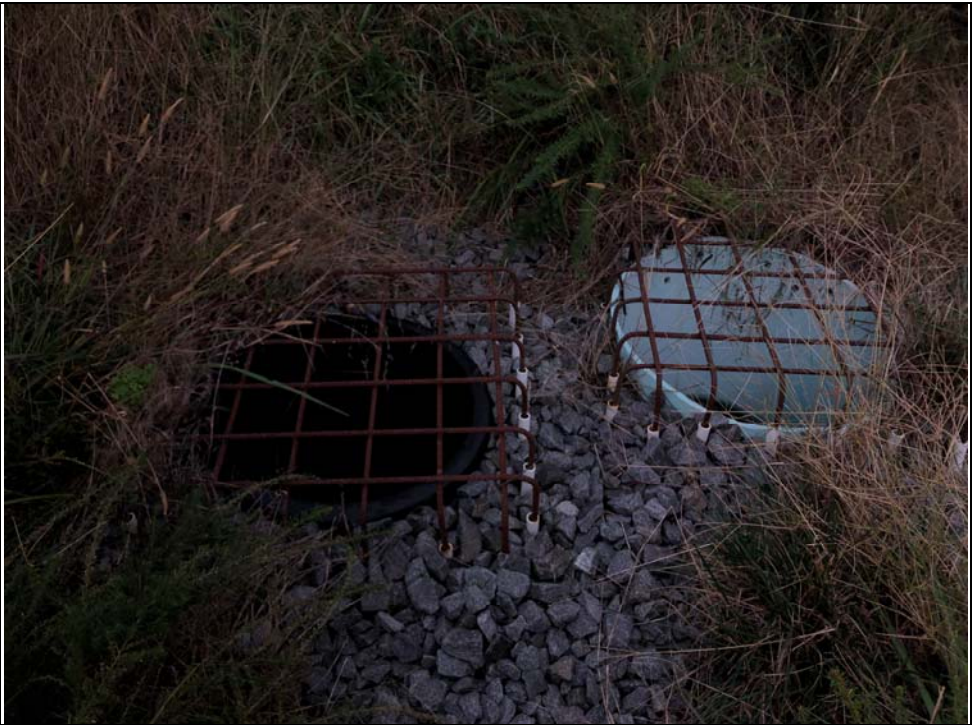
Inlet pipes on inside plateau berm to letdown channel.

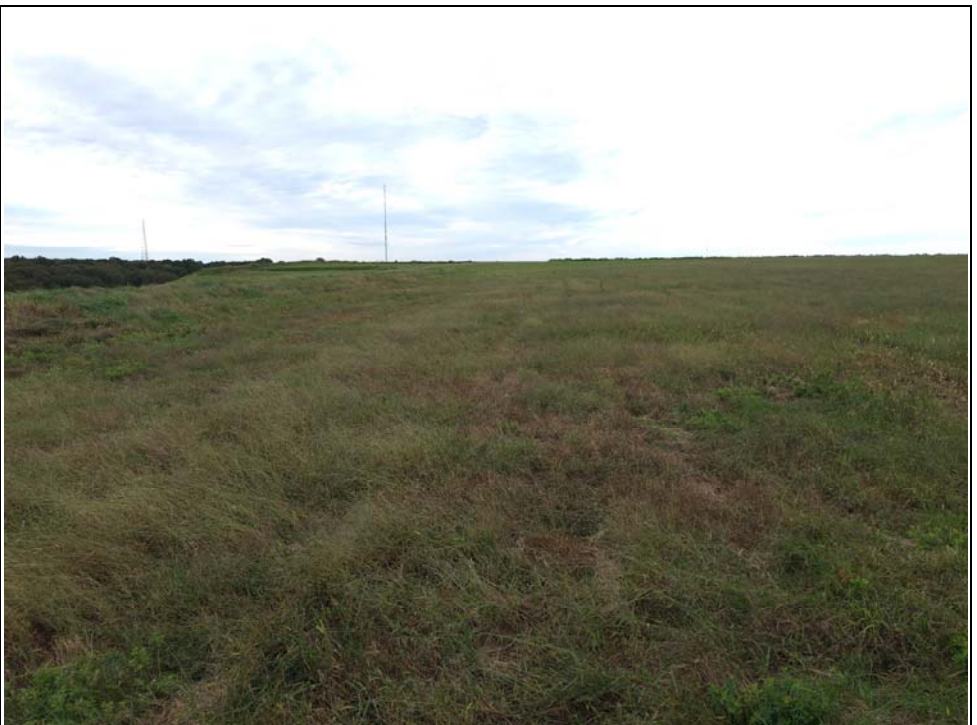
Image: 2244
Date: 10/16/2018
Time: 8:51 AM
Direction: Southeast

Final cover on plateau. Vegetation is well established. No signs of animal burrows or erosion.

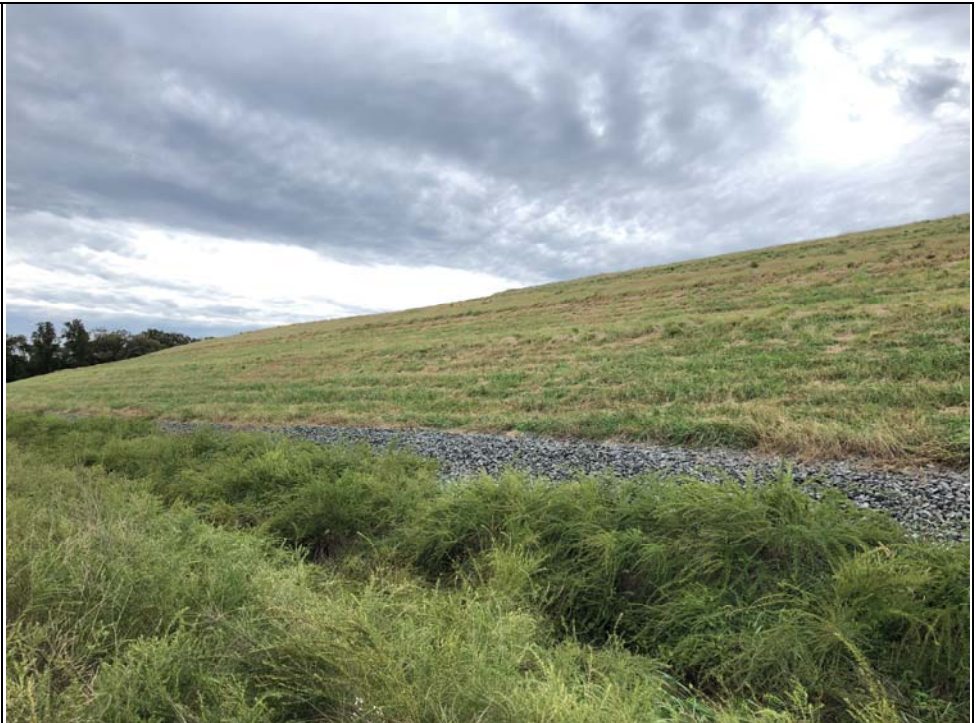
Overview of sideslopes from toe of slope. Recently mowed and in good condition.
