To: David Bacher, NRG
From: Richard Southorn, P.E., P.G.
Re: Indian River Landfill – Annual CCR Unit Inspection Report
Inspection Date: October 16, 2019
Memo Date: January 18, 2020

Project: Indian River 2019 Annual Inspection

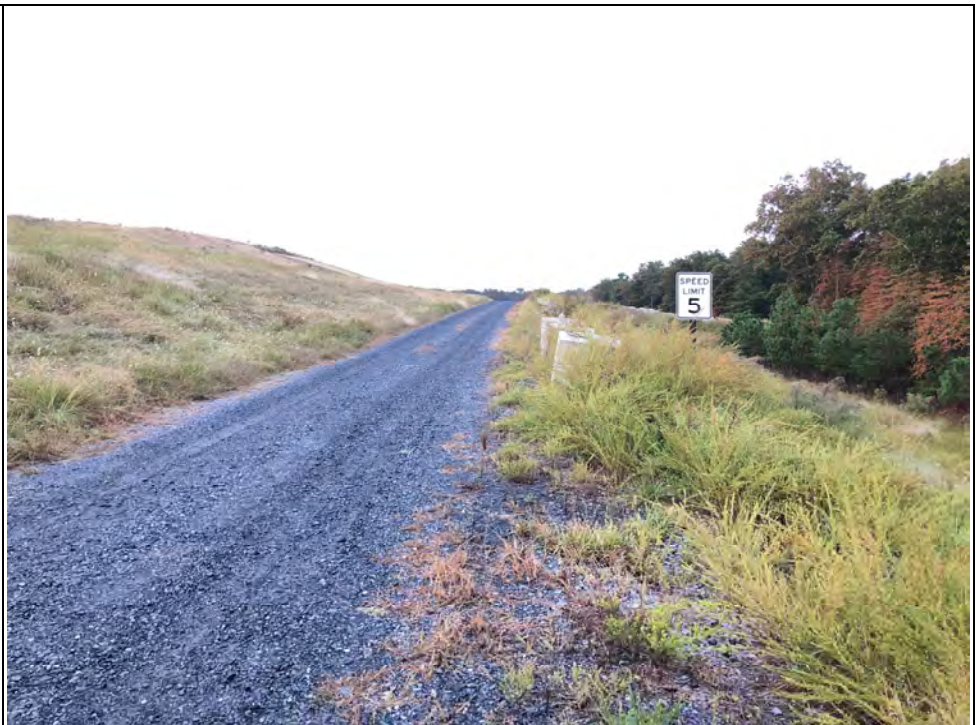
Image: 3213
 Date: 10/16/2019
 Time: 6:25:00 AM
 Direction: South

5 mph speed limit near active face.

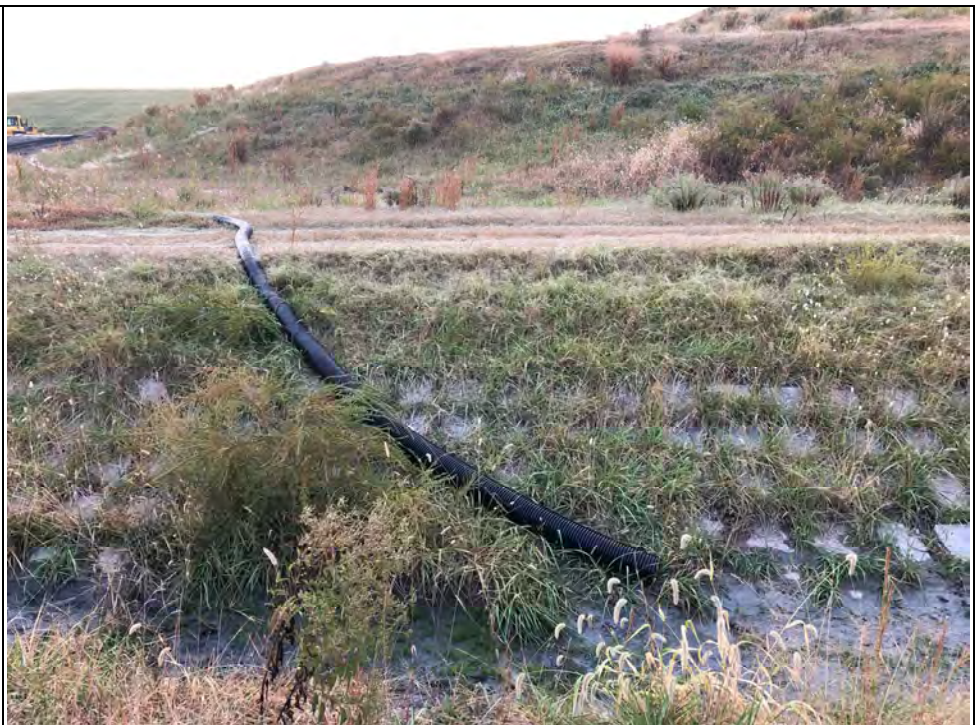
Image: 3217
 Date: 10/16/2019
 Time: 6:27:00 AM
 Direction: East

Non-contact stormwater that falls on final cover is collected at the toe of Phase II Cell 1 North slope, which then gravity drains into the perimeter stormwater ditch. These efforts reduce contact water by diverting the water before it enters the active face. Discharge location shown in photograph.

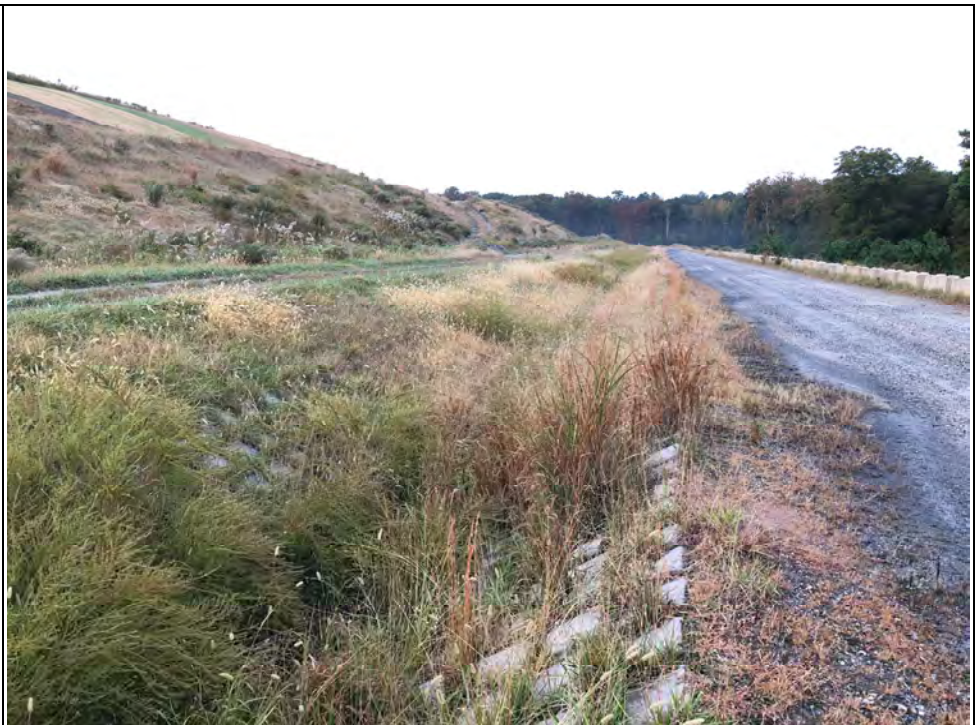
Image: 3219
Date: 10/16/2019
Time: 6:28:00 AM
Direction: South

Armored perimeter stormwater channel.

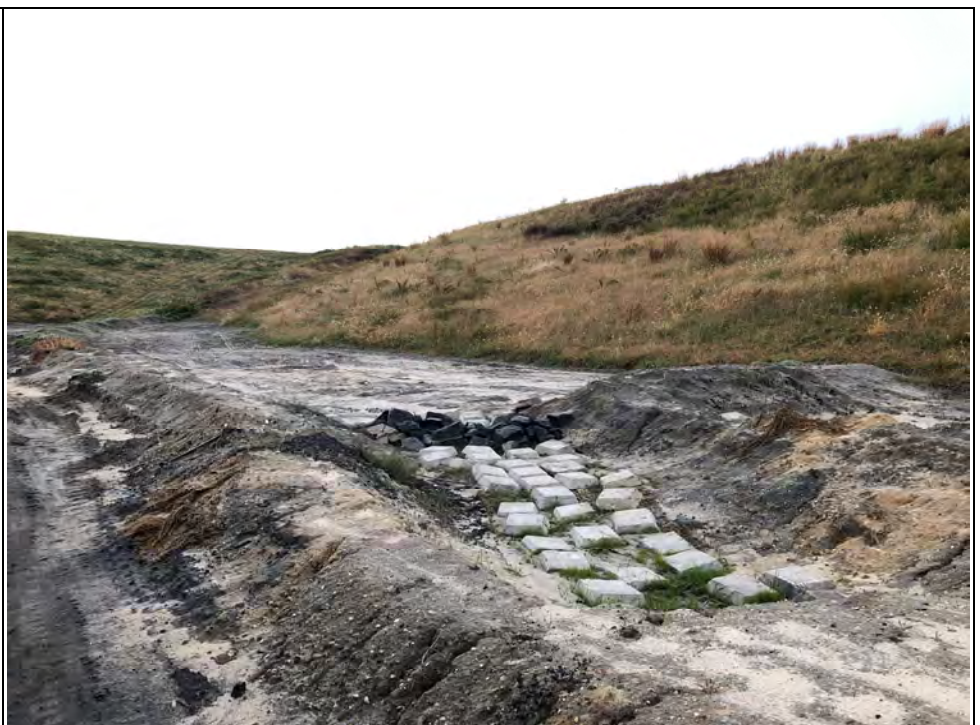
Image: 3221
Date: 10/16/2019
Time: 6:30:00 AM
Direction: Southeast

Non-contact stormwater that falls on final cover is collected at the toe of Phase II Cell 1 North slope, which then gravity drains into the perimeter stormwater ditch. Bermed stormwater collection area at toe of slope shown in photograph. Concrete blocks dissipate energy before entering pipe.

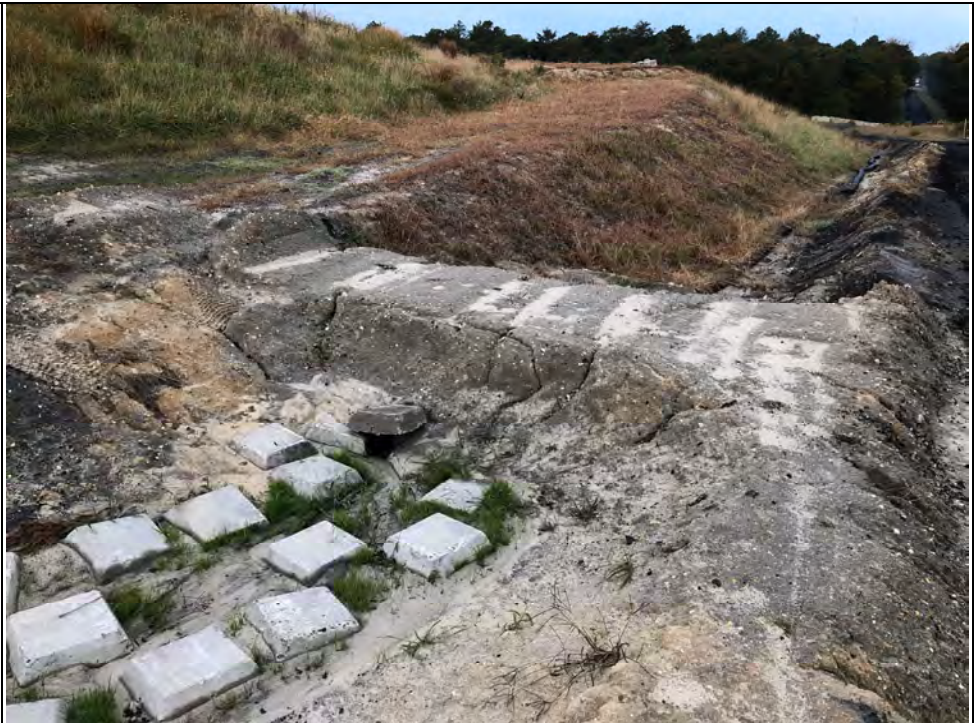
Image: 3223
 Date: 10/16/2019
 Time: 6:31:00 AM
 Direction: Southwest

Non-contact stormwater that falls on final cover is collected at the toe of Phase II Cell 1 North slope and pumped into the perimeter stormwater ditch. Bermed stormwater collection area and pipe inlet shown in photograph. Concrete blocks dissipate energy before entering pipe.

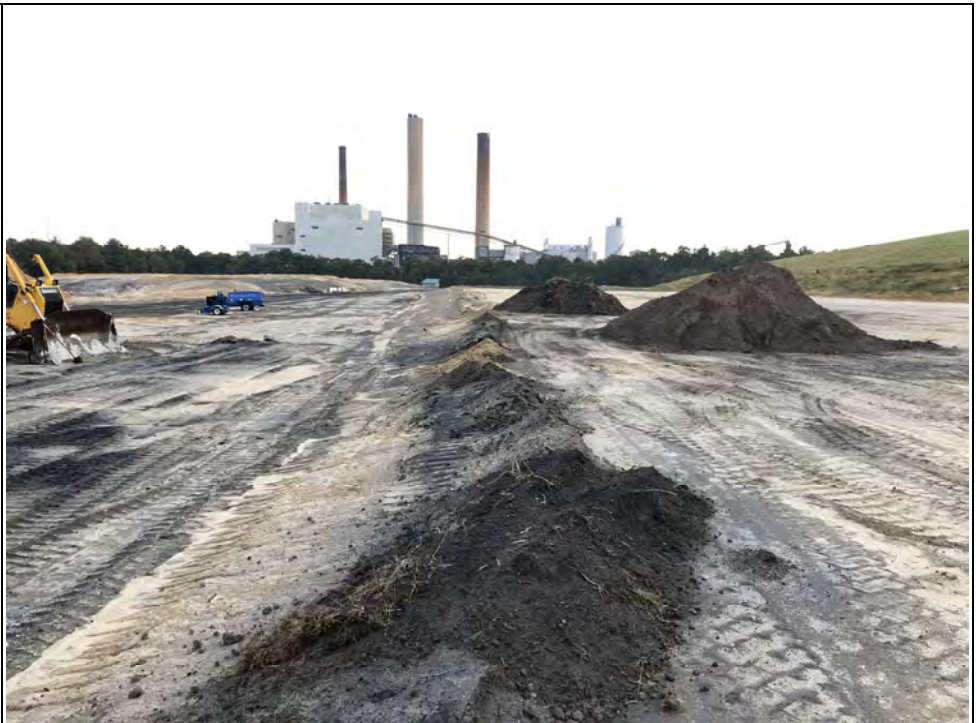
Image: 3225
 Date: 10/16/2019
 Time: 6:31:00 AM
 Direction: North

Overview of active area where CCR is placed in controlled lifts.

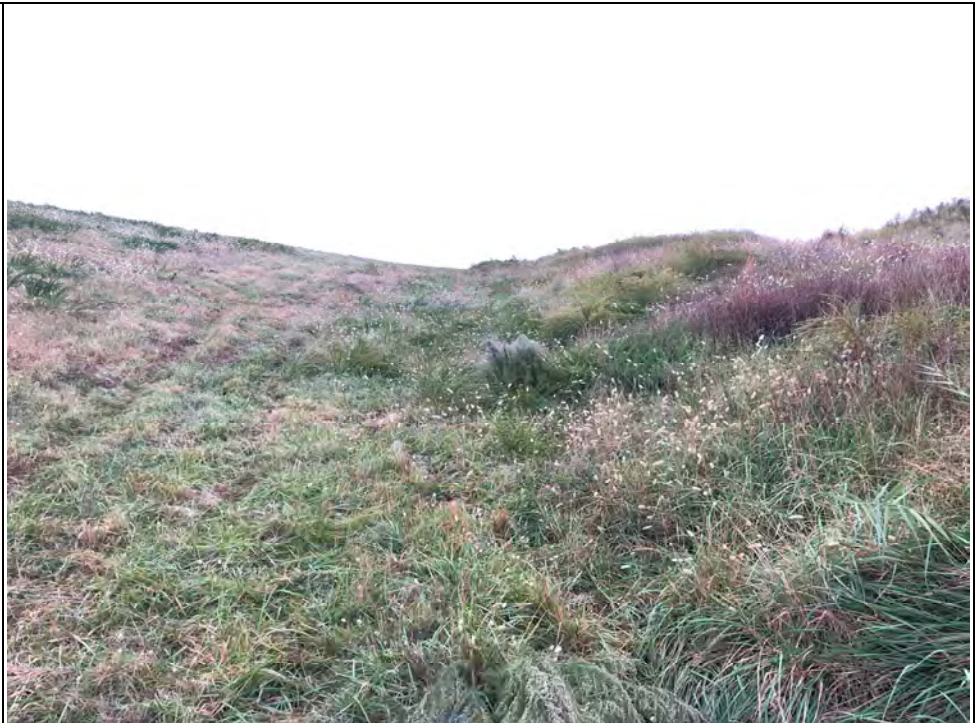
Image: 3227
Date: 10/16/2019
Time: 6:33:00 AM
Direction: Southeast

Elbow of Phase 1/Phase 2 Cell 1 confluence, looking upslope. Erosion was observed following a significant recent rain event in 2018. The elbow was repaired in 2018 but vegetation had not been established by the 2018 Annual Inspection. One year later, vegetation is thick and healthy.

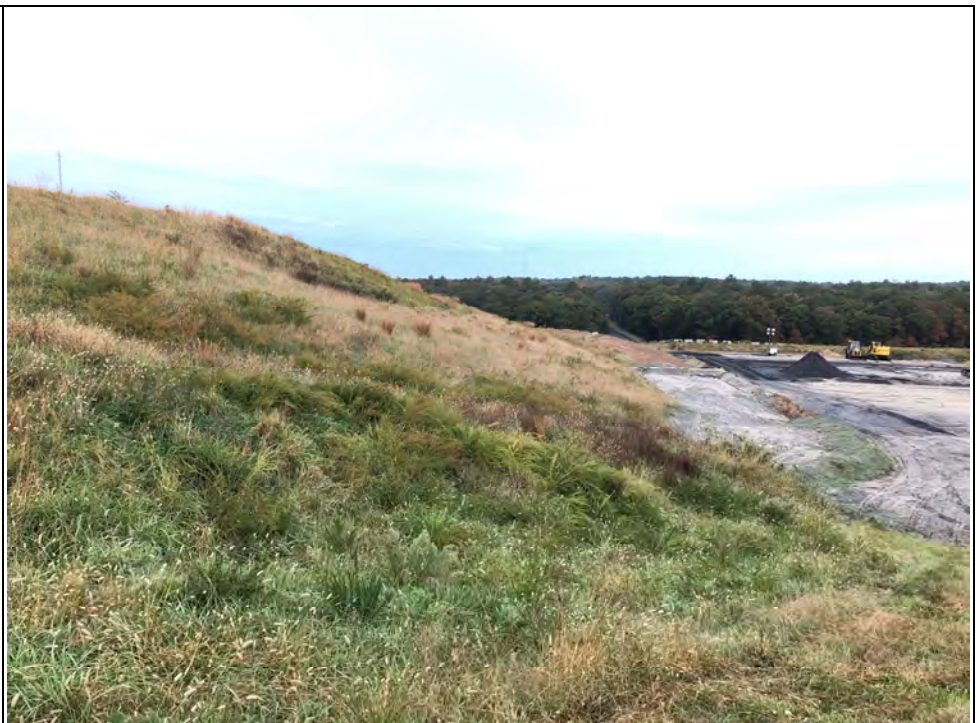
Image: 3229
Date: 10/16/2019
Time: 6:34:00 AM
Direction: West

Phase 2 Cell 1/Cell 2 boundary. Slopes are well vegetated with no sign of erosion, sloughing, or animal borrows.

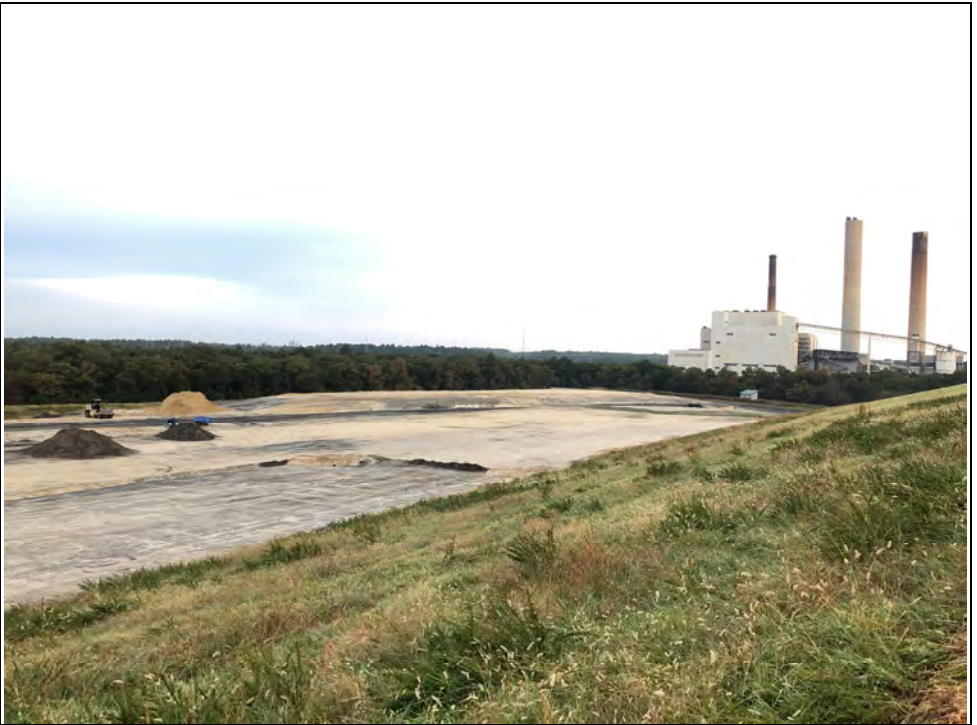
Image: 3231
Date: 10/16/2019
Time: 6:35:00 AM
Direction: Northwest

Overview of active face and Phase I intermediate cover slopes. Slopes are well vegetated with no sign of erosion or sloughing. Active area is well maintained and orderly.

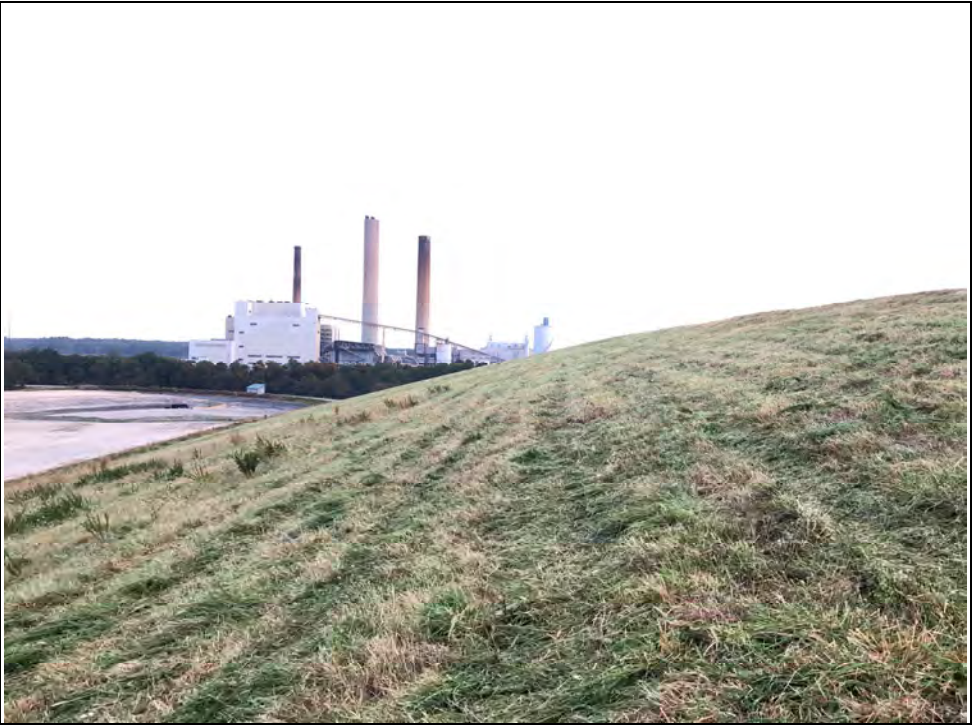
Image: 3233
Date: 10/16/2019
Time: 6:35:00 AM
Direction: North

Phase I intermediate cover slopes are well vegetated with no sign of erosion or sloughing.

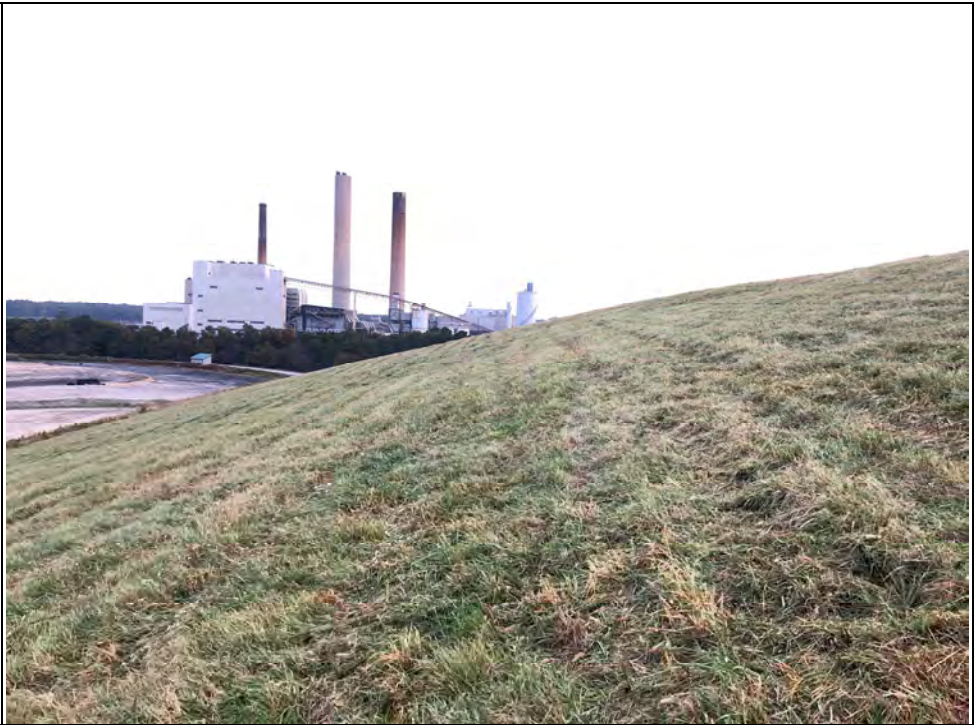
Image: 3235
 Date: 10/16/2019
 Time: 6:36:00 AM
 Direction: North

Phase I intermediate cover slopes are well vegetated with no sign of erosion or sloughing. Vegetation shown was mowed shortly before inspection.

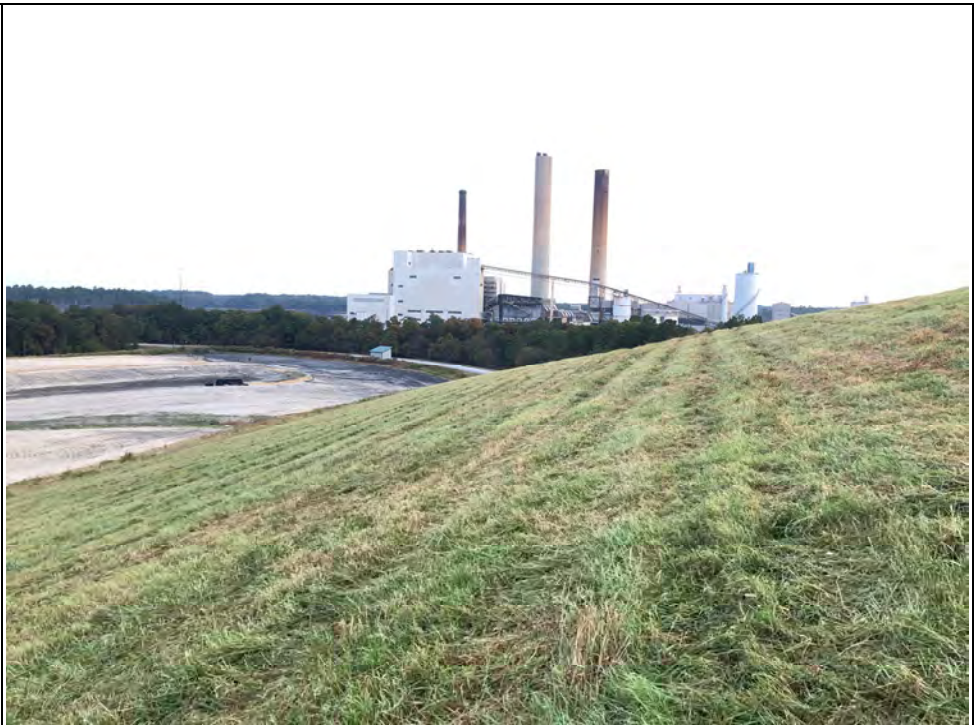
Image: 3237
 Date: 10/16/2019
 Time: 6:37:00 AM
 Direction: North

Phase I intermediate cover slopes are well vegetated with no sign of erosion or sloughing. Vegetation shown was mowed shortly before inspection.

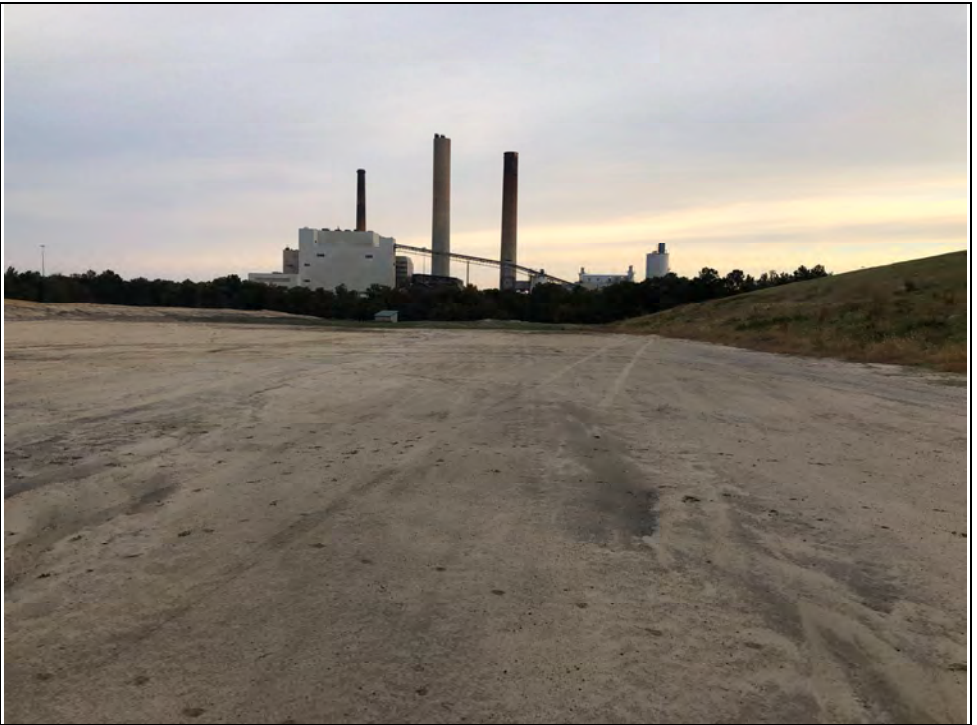
Image: 3239
 Date: 10/16/2019
 Time: 6:39:00 AM
 Direction: North

Active face is well maintained. Material is graded and compacted. No ponding water.

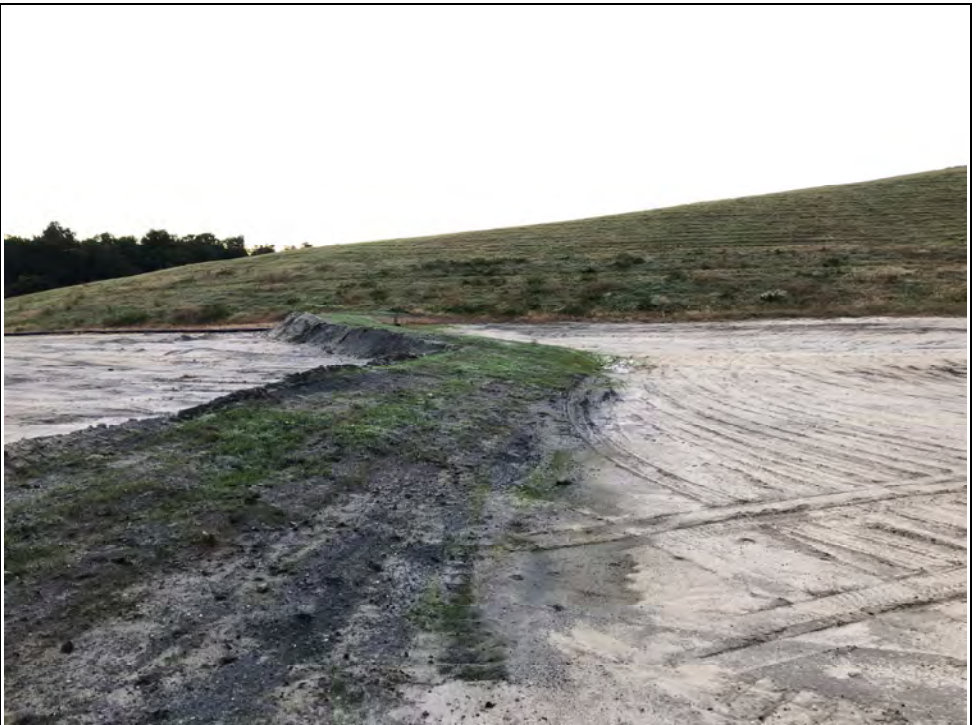
Image: 3241
 Date: 10/16/2019
 Time: 6:40:00 AM
 Direction: Northeast

Erosion control berm that has been established on active face. This berm slows contact water travelling over the active face during rain events, which in turn minimizes erosion. Pipes at the toe of the berm collect contact water and convey it to the leachate sump.

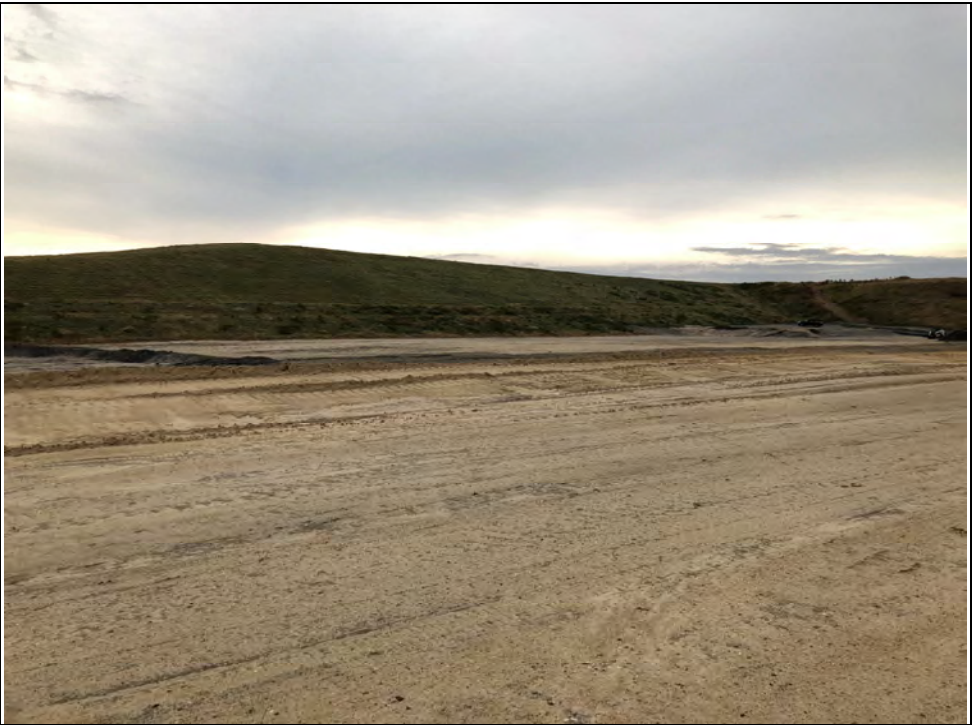
Lift of fly ash in active face. Well placed, graded, and maintained.

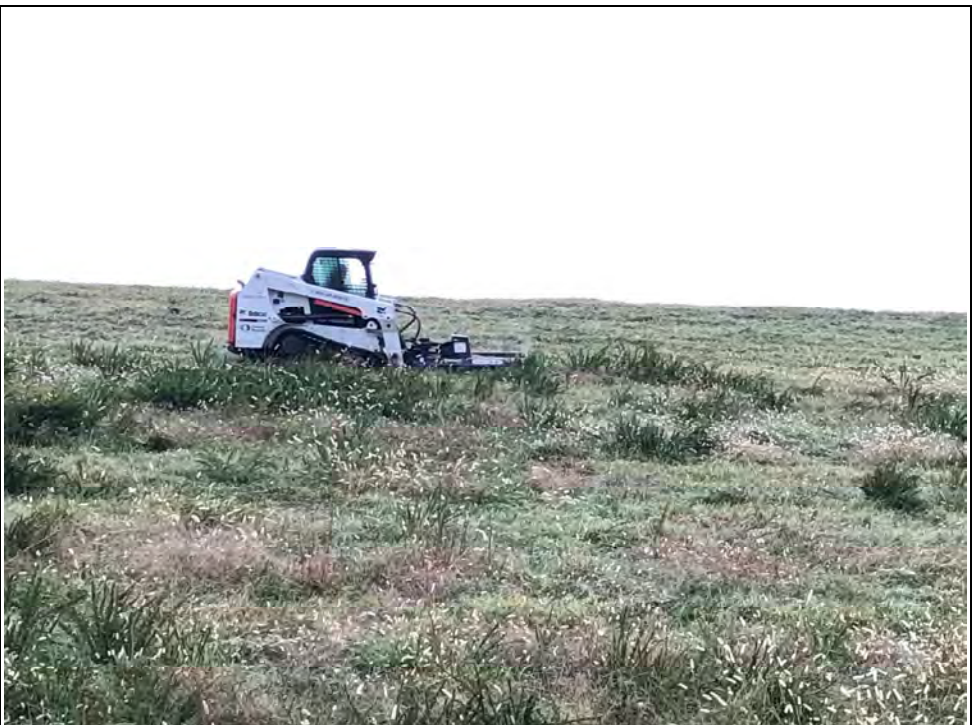
Image: 3253
Date: 10/16/2019
Time: 6:51:00 AM
Direction: East

Mowing being completed on the Phase I intermediate cover slopes. Slopes are well vegetated with no sign of erosion or sloughing.

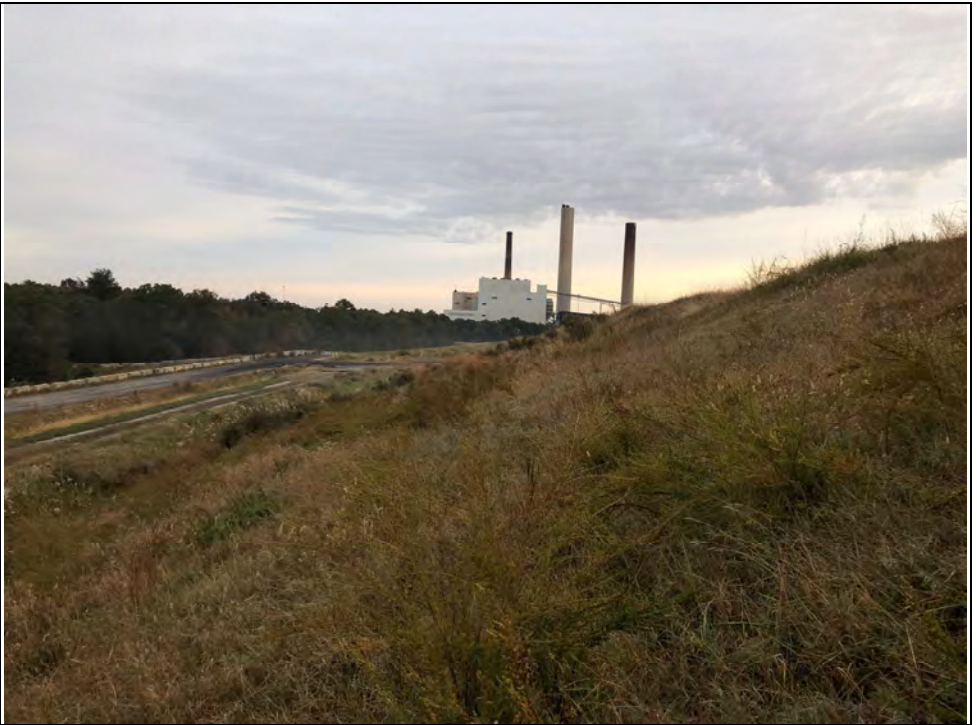
Final cover on sideslopes of Phase II Cell 1. Vegetation is healthy with full coverage. No signs of erosion stability issues observed on sideslope.

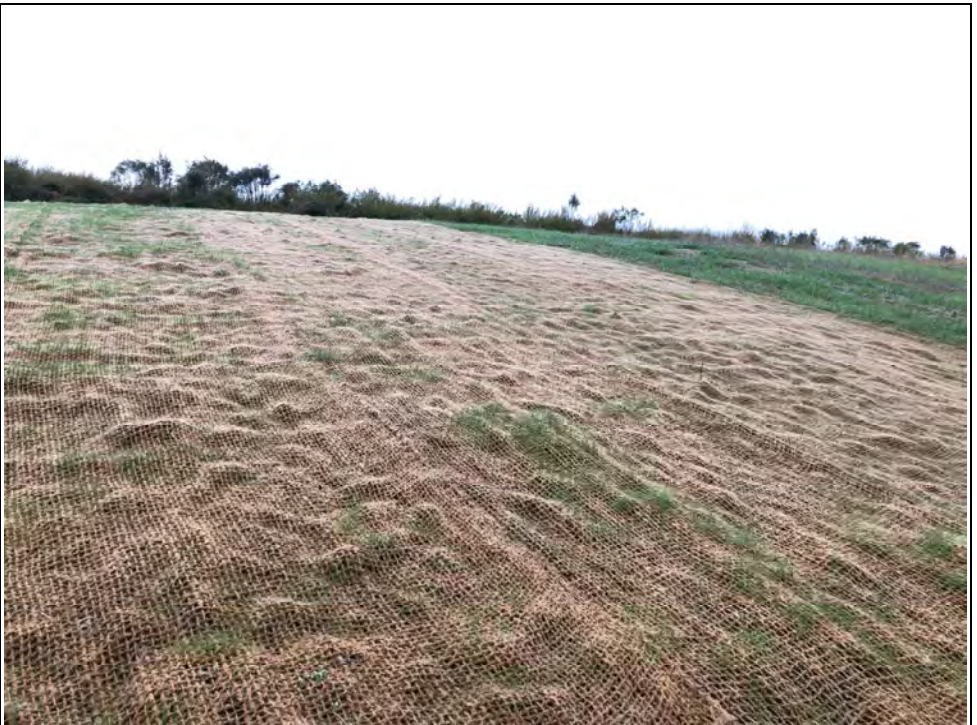
Image: 3257
Date: 10/16/2019
Time: 6:55:00 AM
Direction: East

Minor erosion rills formed after large storm events in 2019. These rills were identified as part of routine weekly landfill inspections and remediated. Areas with identified erosion features were regraded, and seeded with matting stabilization. The vegetation has become established,

although it is has not yet received full coverage. The remedy was deemed appropriate and successful.

An area of Phase II Cell 1 experienced erosion rills, which were identified as part of routine inspections and documented in operating record. New protective soil was placed, graded, and vegetated. Erosion control netting was utilized. Vegetation is beginning to grow in.

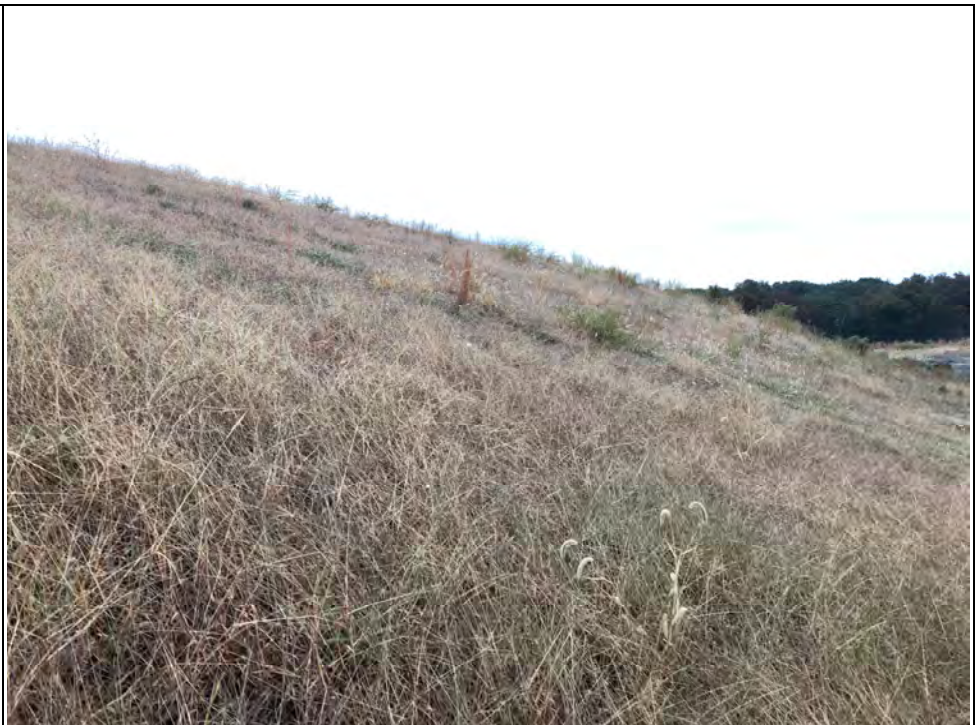
Final cover on sideslopes of Phase II Cell 1. Vegetation is healthy with full coverage. No signs of erosion stability issues observed on sideslope.

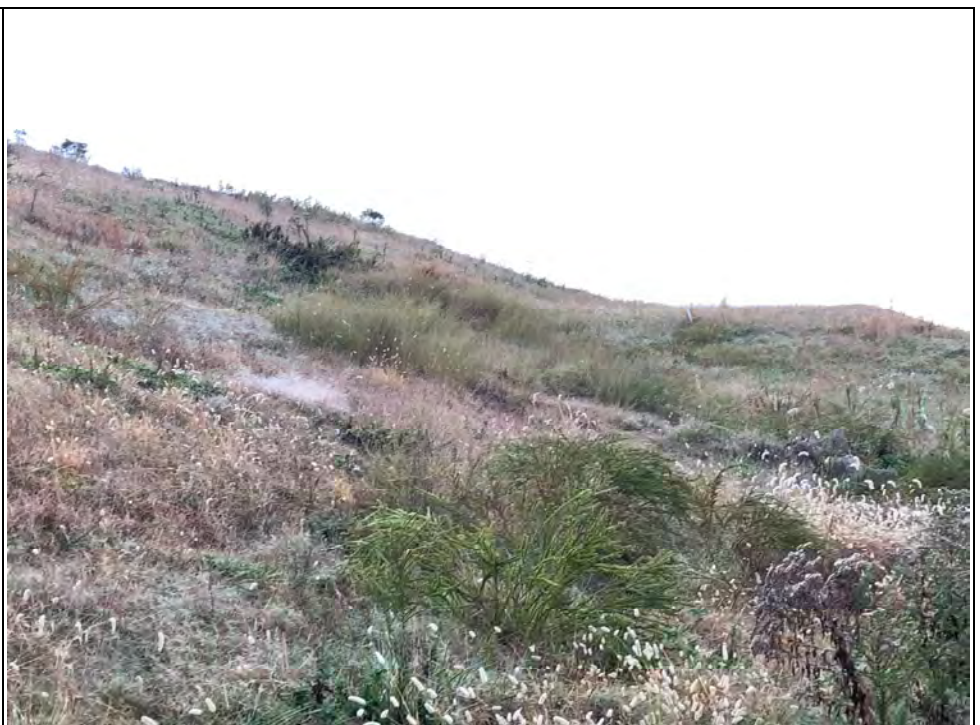
Image: 3261
Date: 10/16/2019
Time: 6:58:00 AM
Direction: Northeast

Final cover on sideslopes of Phase II Cell 1. Vegetation is healthy with full coverage. No signs of erosion stability issues observed on sideslope.

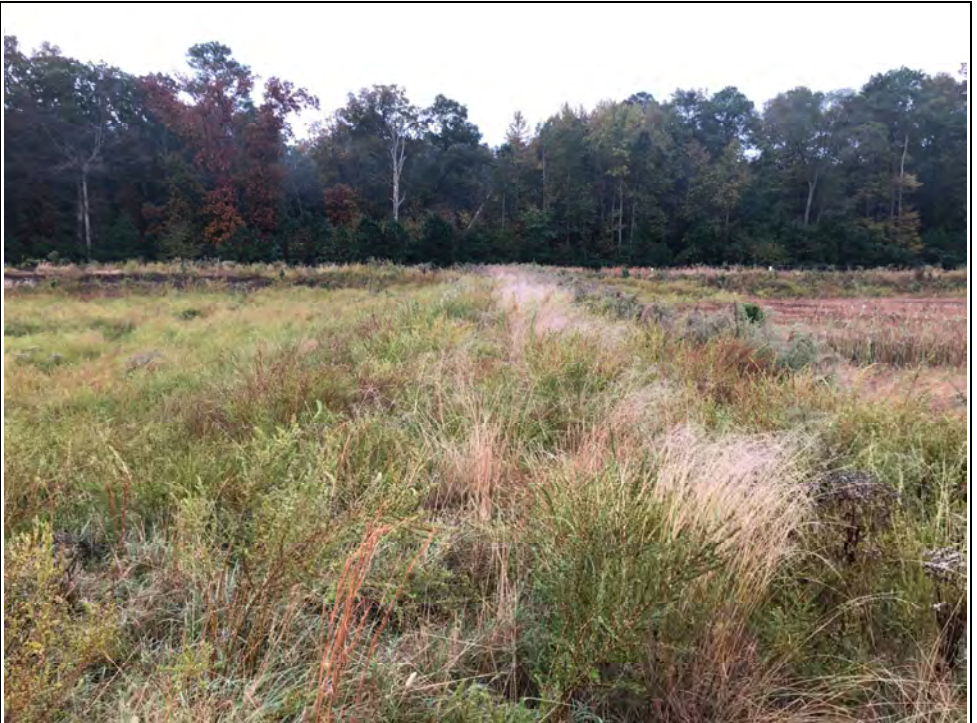
Stormwater basin forebay.
In good condition.

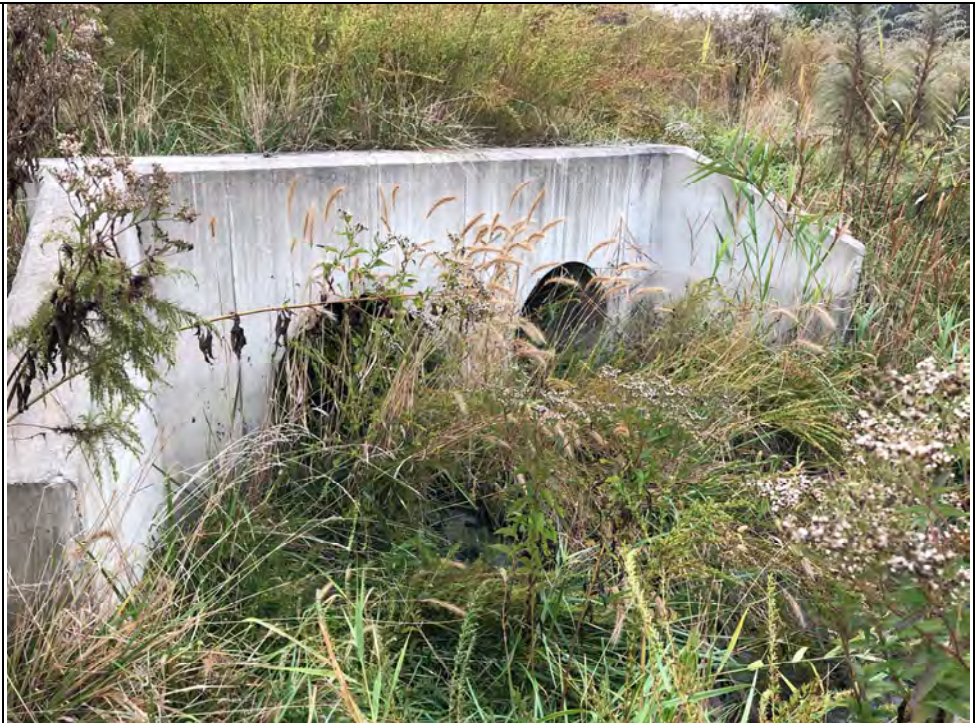
Inlets to stormwater basin.
Clear of obstruction at
inlets and outlets.

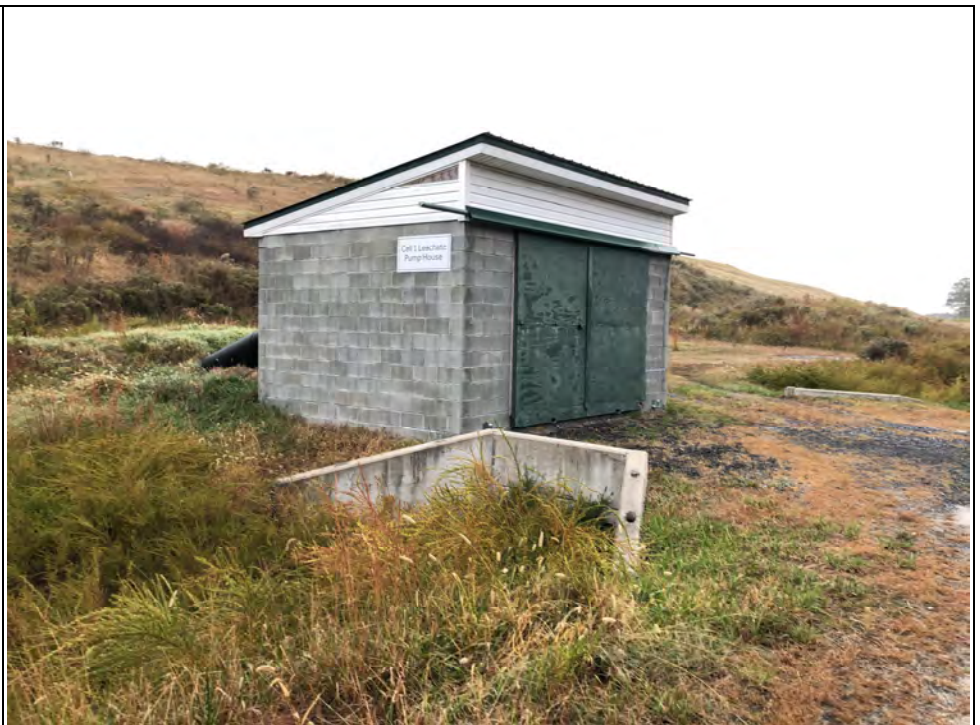
Image: 3269
Date: 10/16/2019
Time: 7:04:00 AM
Direction: Northeast

Phase 1, Cell 1 leachate
pump house and
stormwater culvert.
Building is appropriately
signed. Culvert is free of
obstructions.

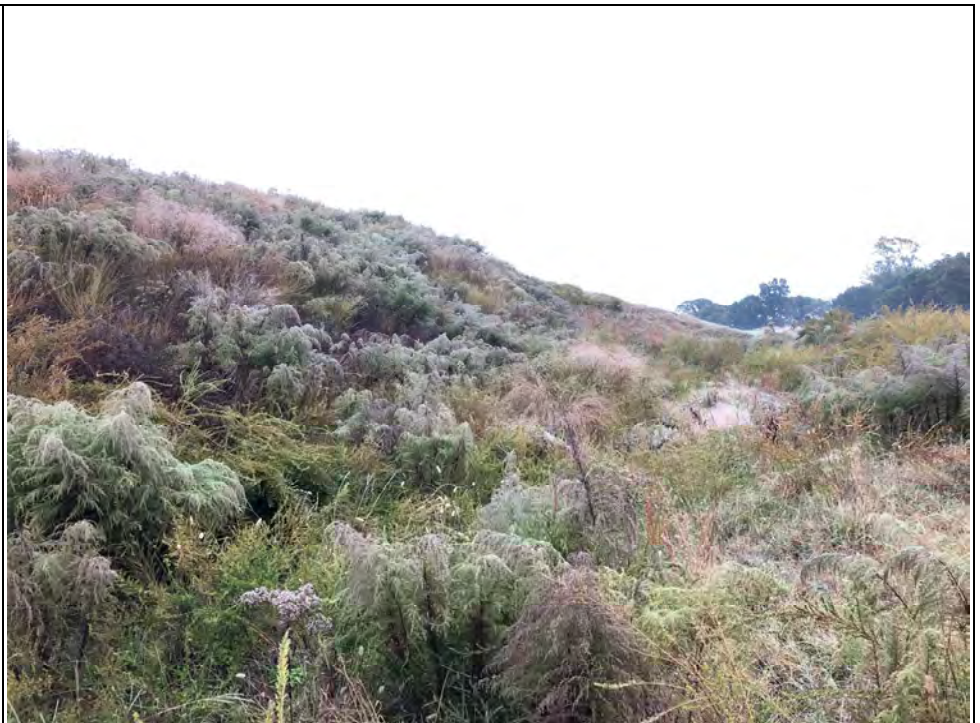
Final cover vegetative cover is dense and healthy.

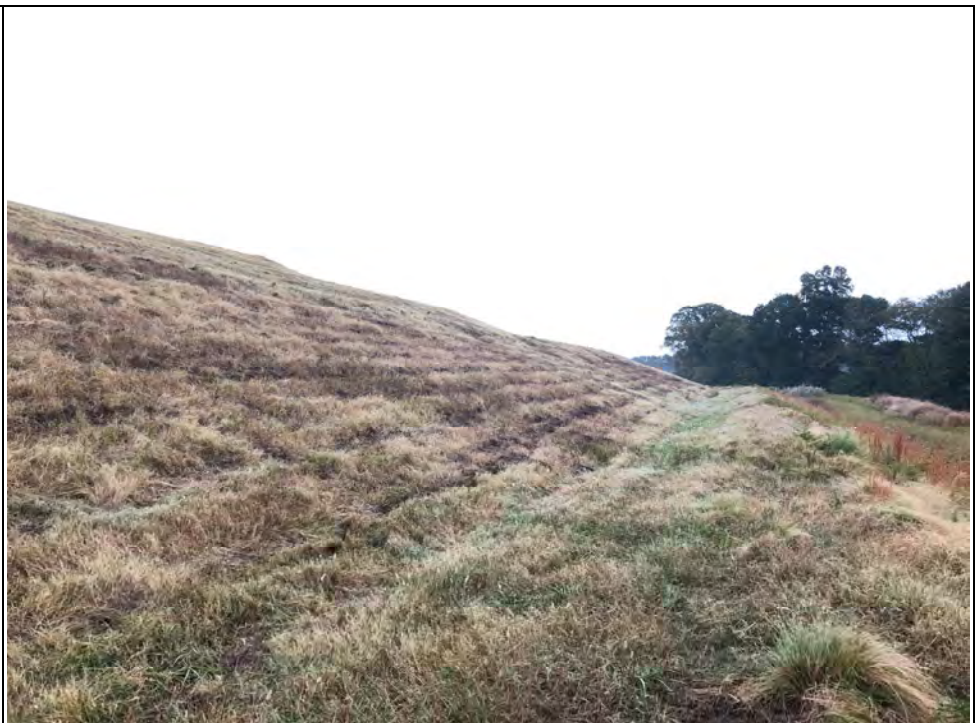
Image: 3277
Date: 10/16/2019
Time: 7:09:00 AM
Direction: Northeast

Terrace berm. Clear of obstructions and functioning as intended. Vegetative cover is dense and healthy.

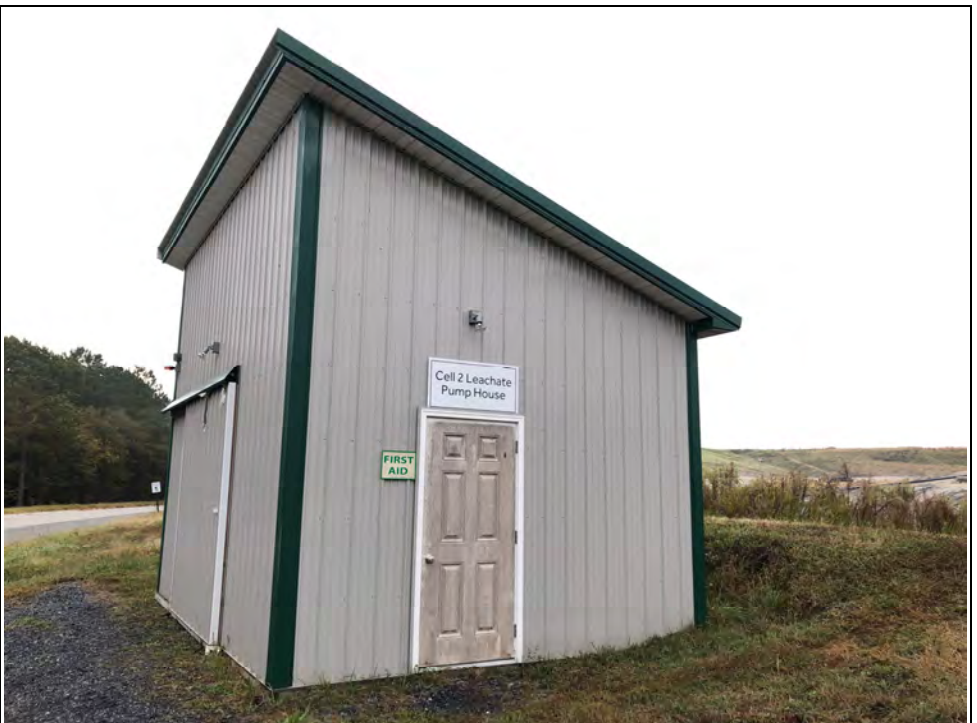
Phase 2, Cell 2 leachate pump house. Building exterior is in good condition and appropriately signed.

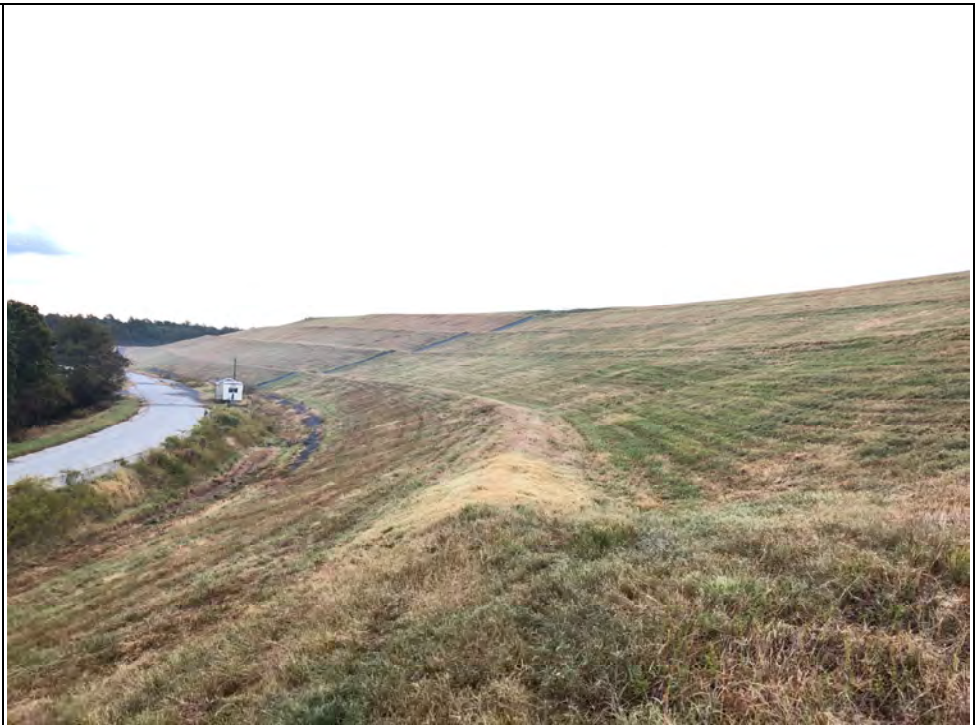
Image: 3285
 Date: 10/16/2019
 Time: 7:16:00 AM
 Direction: Southeast

Landfill sideslopes and terraces are well maintained. No evidence of slope stability issues.

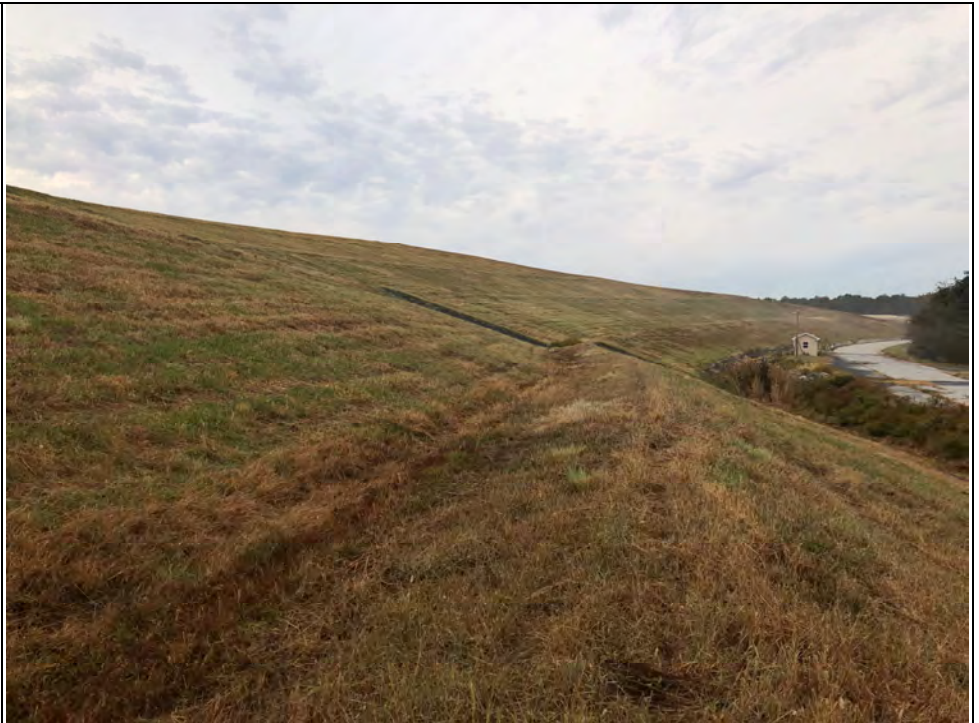
Phase 1 terrace berm.
Clear of obstructions and
functioning as intended.
Vegetative cover is dense
and healthy.

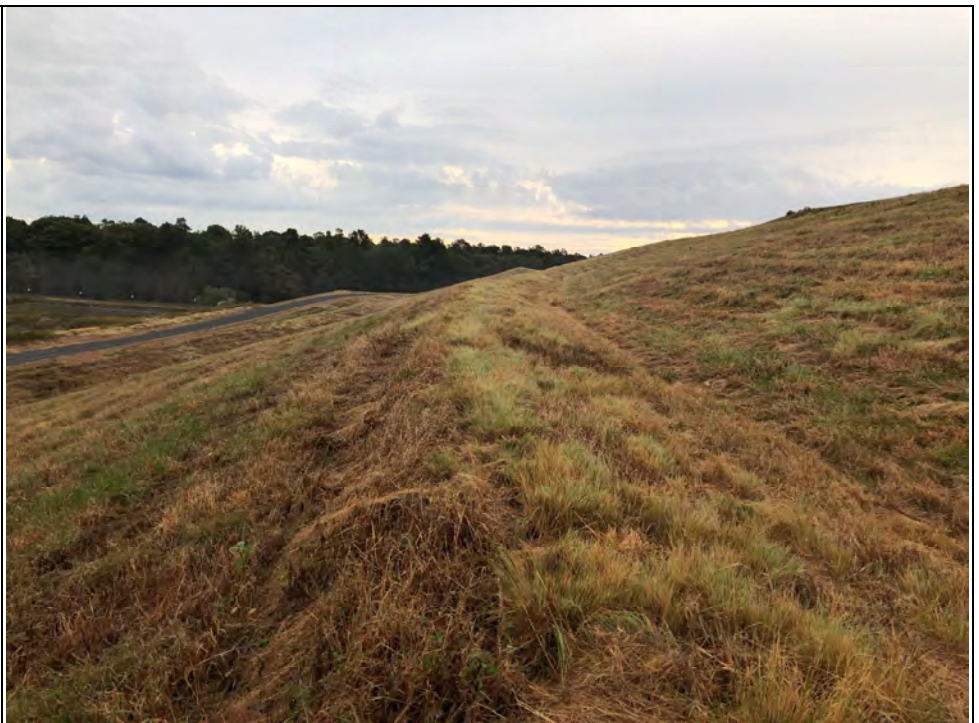
Image: 3293
Date: 10/16/2019
Time: 7:21:00 AM
Direction: East

Phase 1 terrace berm.
Clear of obstructions and
functioning as intended.
Vegetative cover is dense
and healthy.

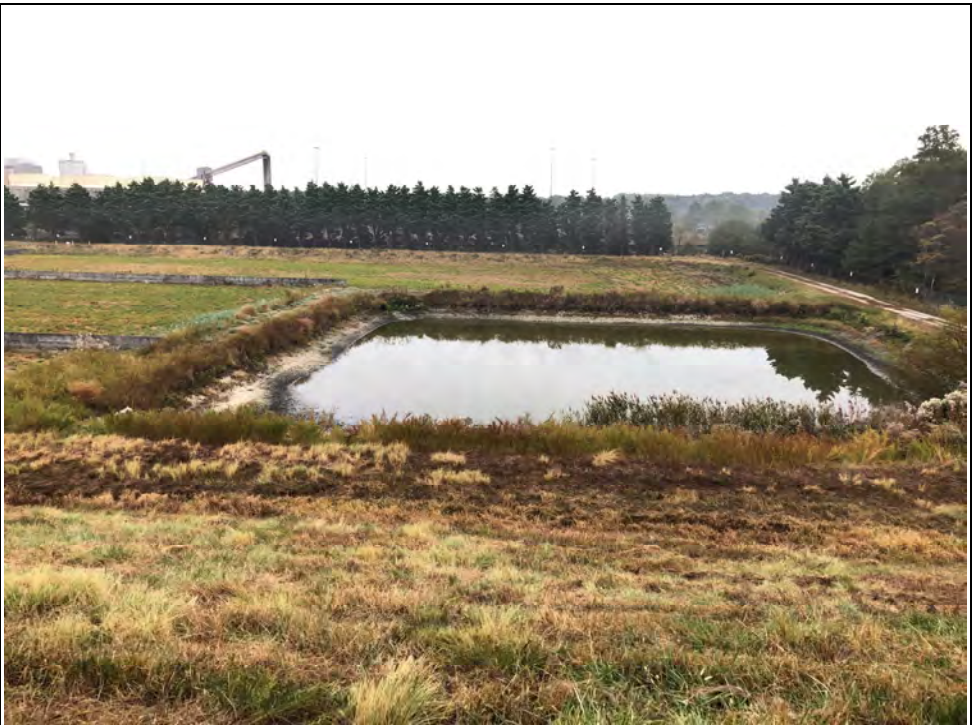
Image: 3297
Date: 10/16/2019
Time: 7:23:00 AM
Direction: North

Southeast forebay of
Northeast Detention
Basin. Functioning as
intended.
