To: David Bacher, NRG
From: Richard Southorn, P.E., P.G.
Re: Indian River Landfill – Annual CCR Unit Inspection Report
Inspection Date: October 16, 2019
Memo Date: January 18, 2020

Project: Indian River 2019 Annual Inspection

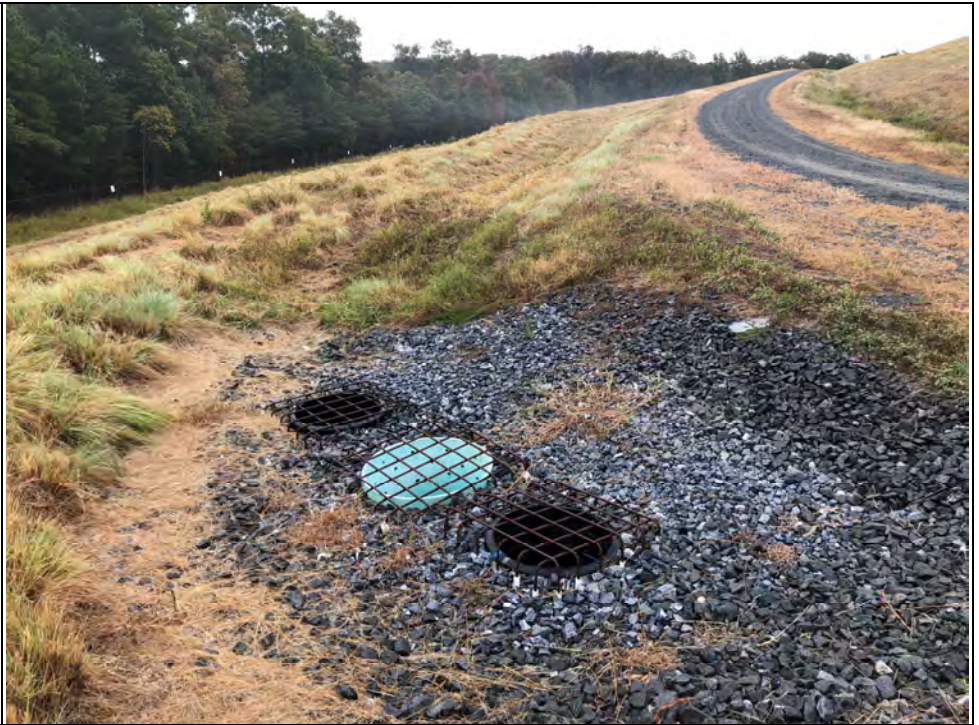
Phase 1 corner downchute road crossing equalizing pipes. Free of obstructions.

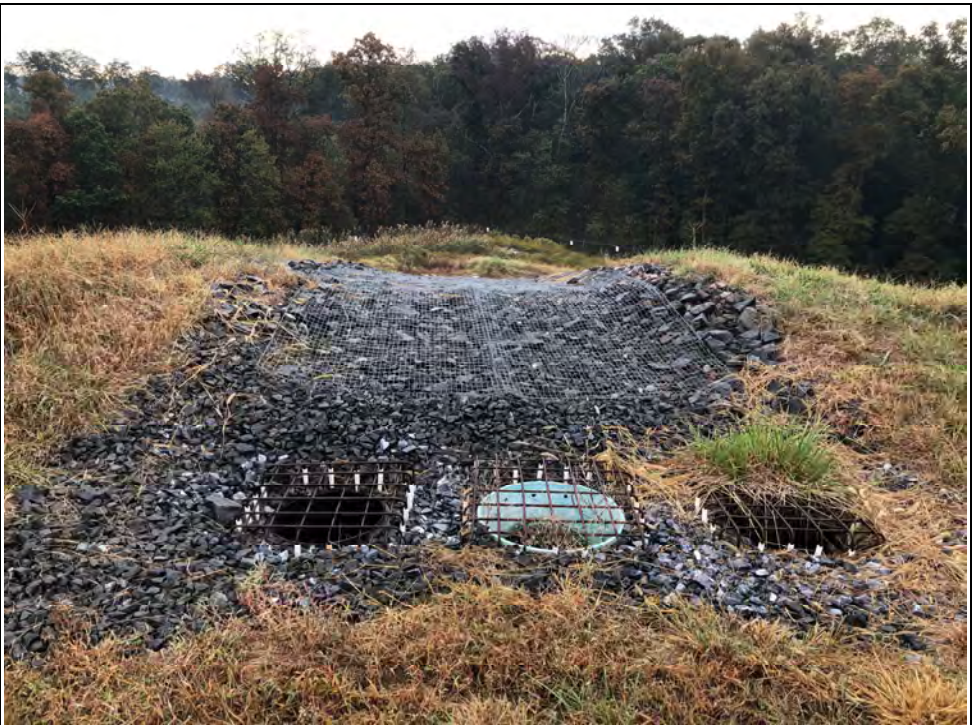
Image: 3305
Date: 10/16/2019
Time: 7:28:00 AM
Direction: Southeast

Phase 1 corner downchute.
Rock is in-place and not
migrating. No evidence of
washouts.

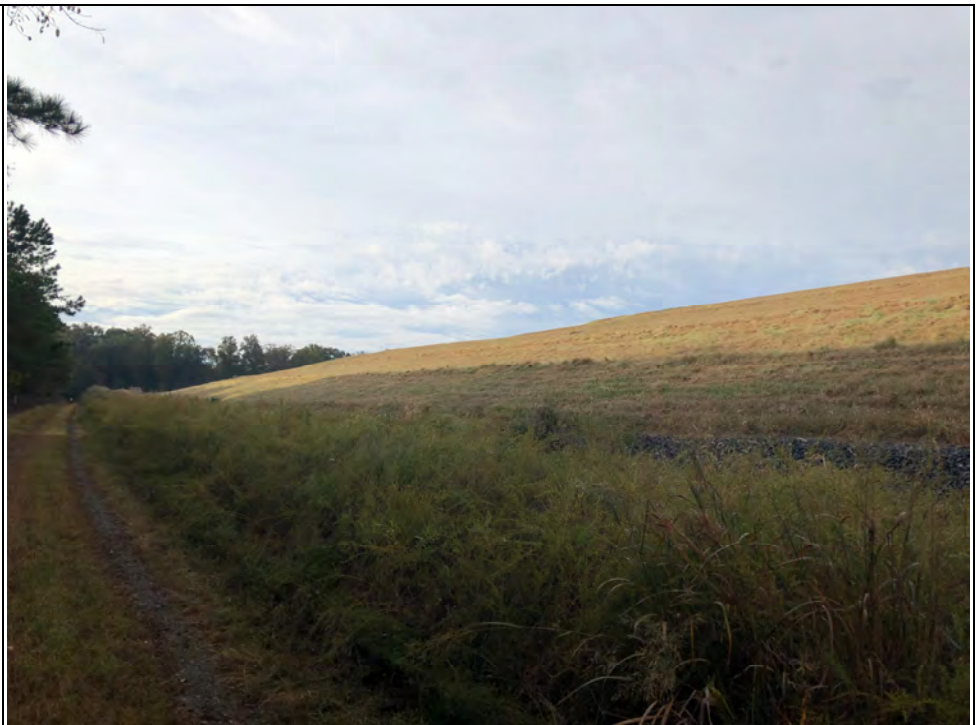
Toe of slope. No sign of erosion or slope stability issues.

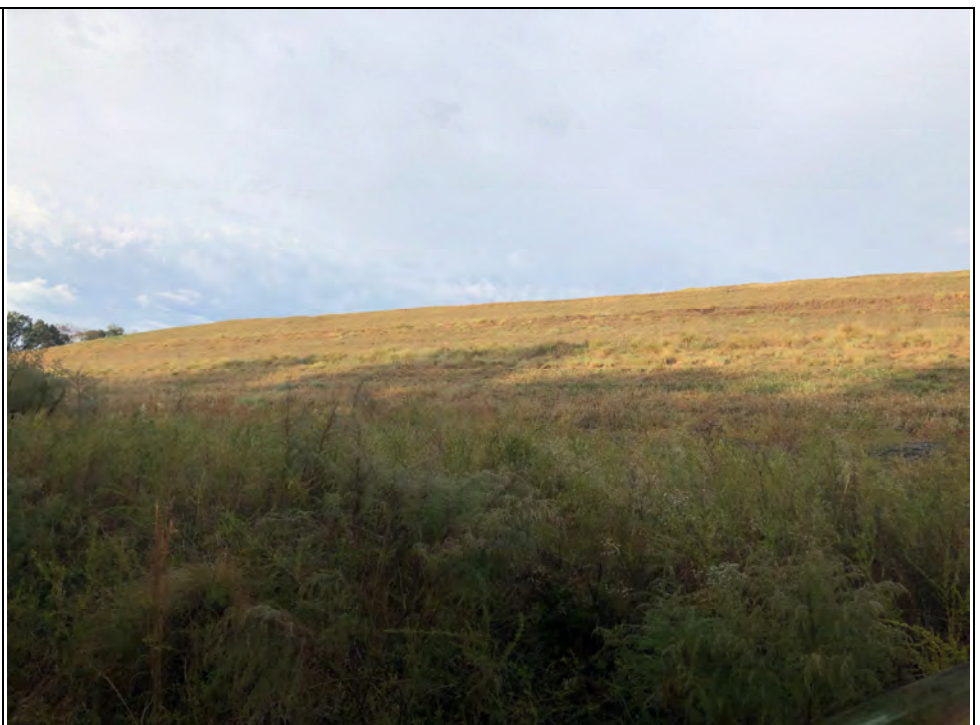
Image: 3373
Date: 10/16/2019
Time: 7:56:00 AM
Direction: Northwest

Toe of slope. No sign of erosion or slope stability issues.
