## Inspection Report

**To:** David Bacher, NRG  
**From:** Richard Southorn, P.E., P.G.  
**Re:** Indian River Landfill – Annual CCR Unit Inspection Report  
**Inspection Date:** October 29, 2020  
**Memo Date:** January 18, 2021

**Project: Indian River Landfill 2020 Annual Inspection**

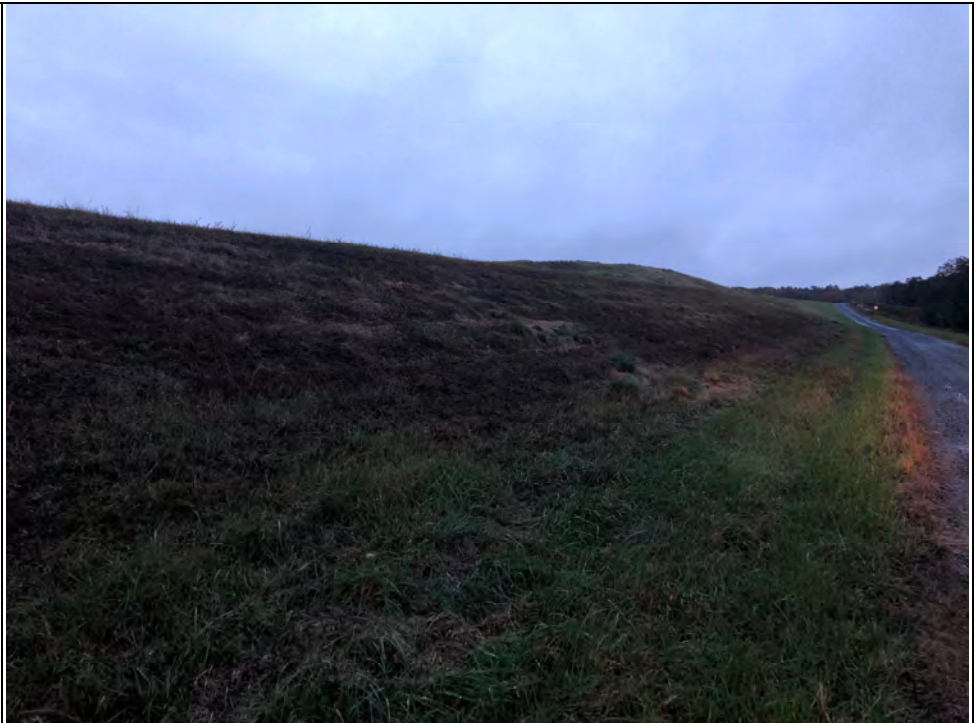
Image: 7374  
Date: 10/29/2020  
Time: 6:29 AM  
Direction: South-Southeast

Outer sideslope of Phase II Cell 1. Sideslope is well vegetated and maintained. No signs of vegetative stress or geotechnical instability.

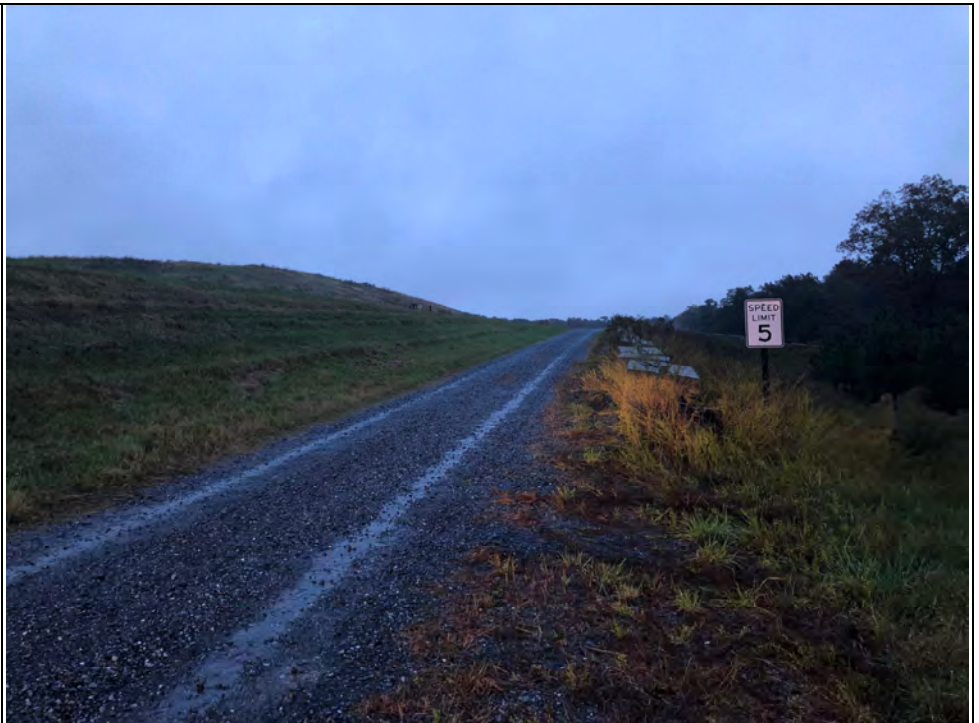
Image: 7376  
Date: 10/29/2020  
Time: 6:30 AM  
Direction: Southeast

5 mph speed limit near active face.

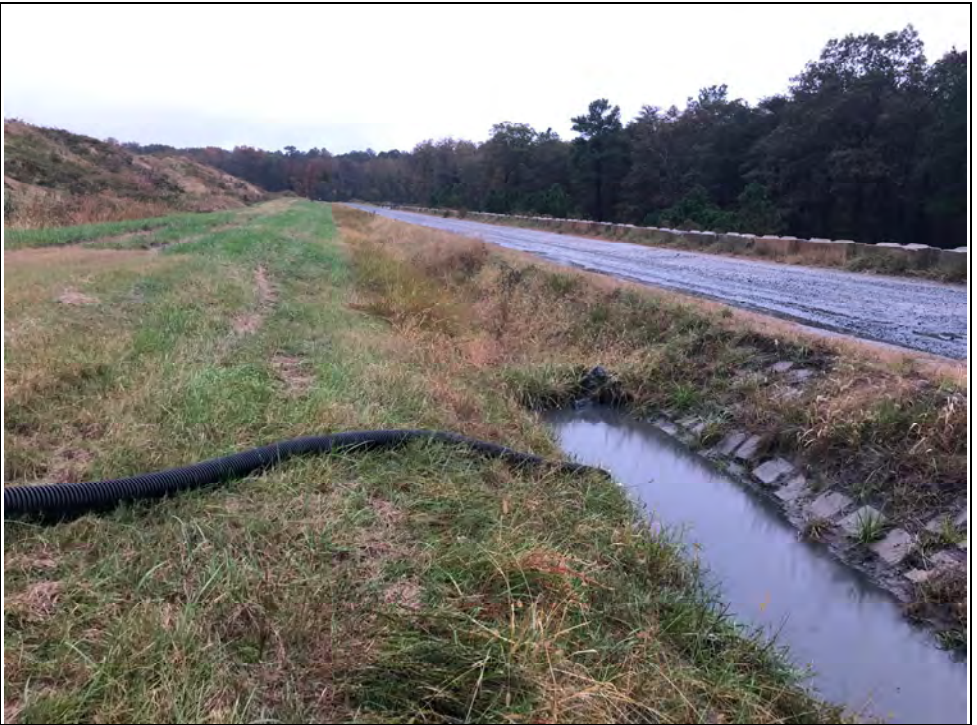
Image: 7378  
Date: 10/29/2020  
Time: 6:32 AM  
Direction: South

Non-contact stormwater that falls on final cover is collected at the toe of Phase II Cell 1 North slope, which then gravity drains into the perimeter stormwater ditch. These efforts reduce contact water by diverting the water before it enters the active face. Discharge location shown in photograph.

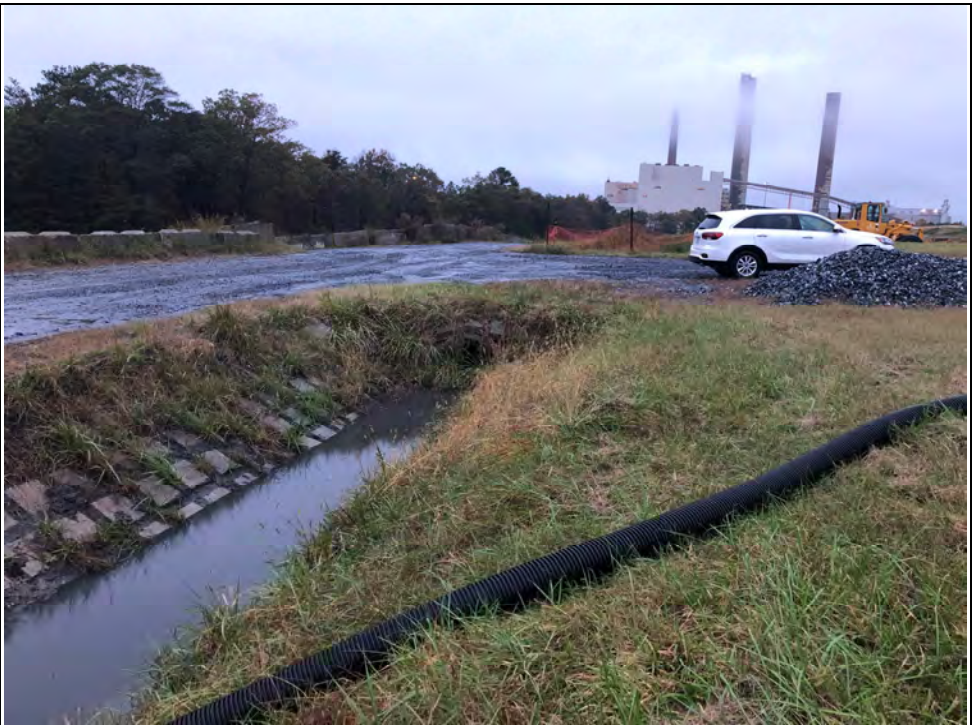
Image: 7380  
Date: 10/29/2020  
Time: 6:32 AM  
Direction: North

Armored perimeter stormwater channel.

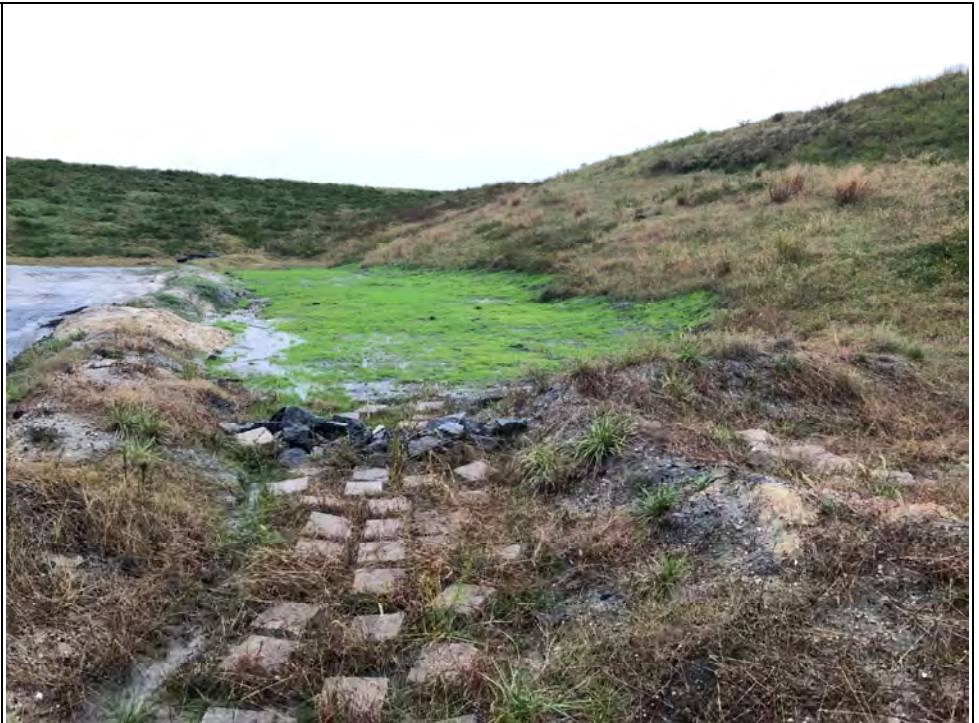
Image: 7382  
 Date: 10/29/2020  
 Time: 6:34 AM  
 Direction: East-Southeast

Non-contact stormwater that falls on final cover is collected at the toe of Phase II Cell 1 North slope, which then gravity drains into the perimeter stormwater ditch. Bermed stormwater collection area at toe of slope shown in photograph. Concrete blocks dissipate energy before entering pipe.

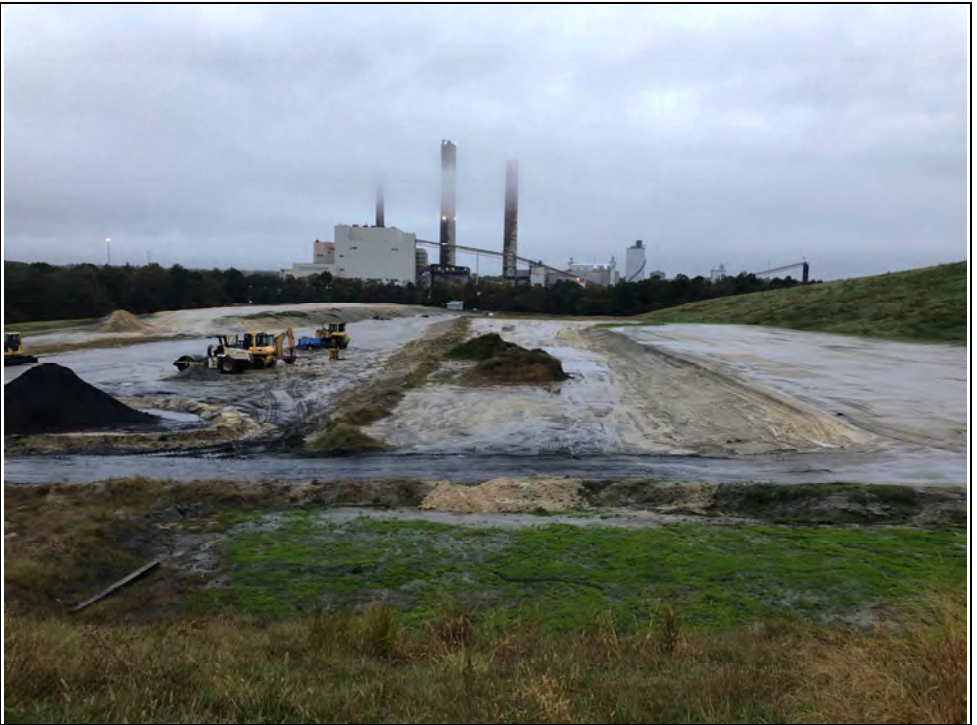
Image: 7386  
Date: 10/29/2020  
Time: 6:36 AM  
Direction: North

Active face is well maintained. Material is graded and compacted. Photograph was taken during significant rainfall. Water is draining appropriately.

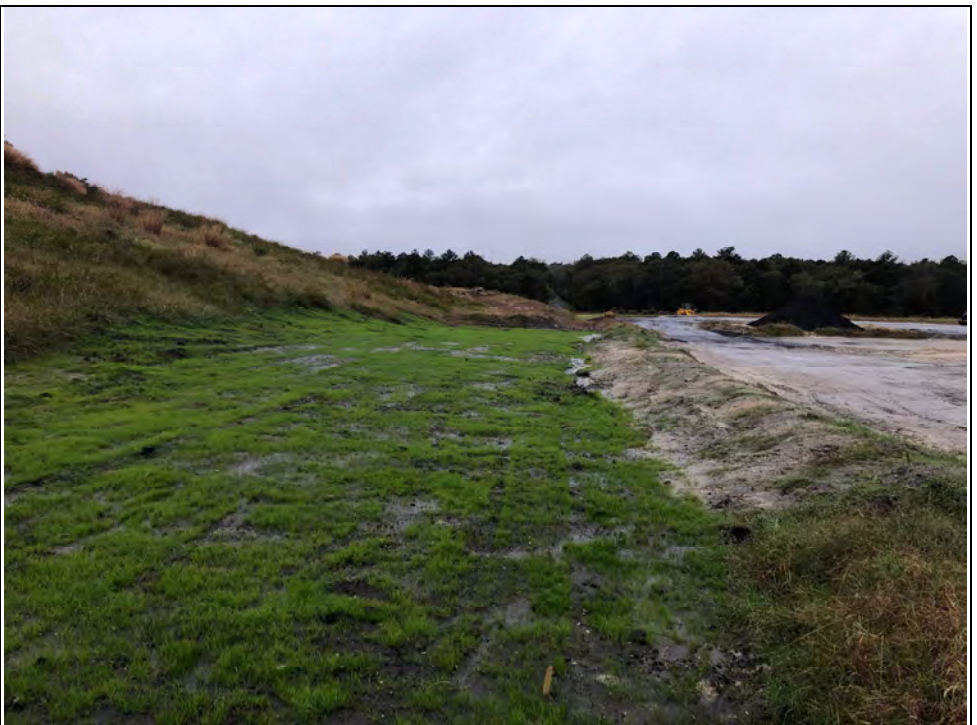
Image: 7388  
Date: 10/29/2020  
Time: 6:37 AM  
Direction: West

Area at toe of Phase II Cell 1 North slope. Non-contact stormwater that falls on final cover is collected in this area and drains into the perimeter stormwater ditch.

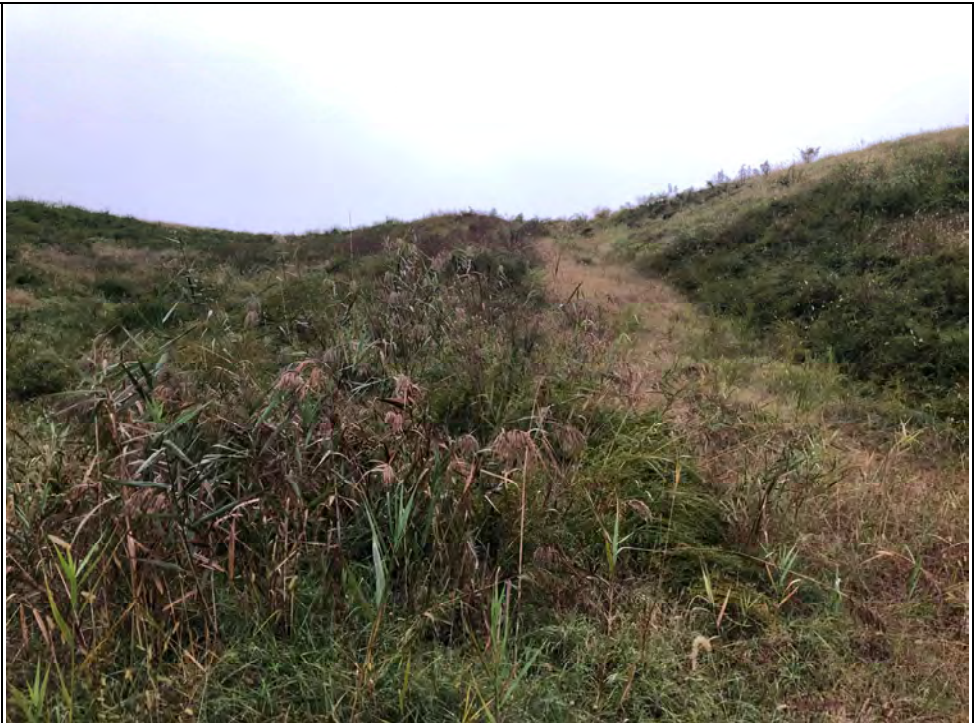
Image: 7390  
Date: 10/29/2020  
Time: 6:37 AM  
Direction: Southeast

Elbow of Phase 1/Phase 2 Cell 1 confluence, looking upslope. Erosion was observed following a significant recent rain event in 2018. The elbow was repaired in 2018 but vegetation had not been established by the 2018 Annual Inspection. One year later, vegetation is thick and healthy.

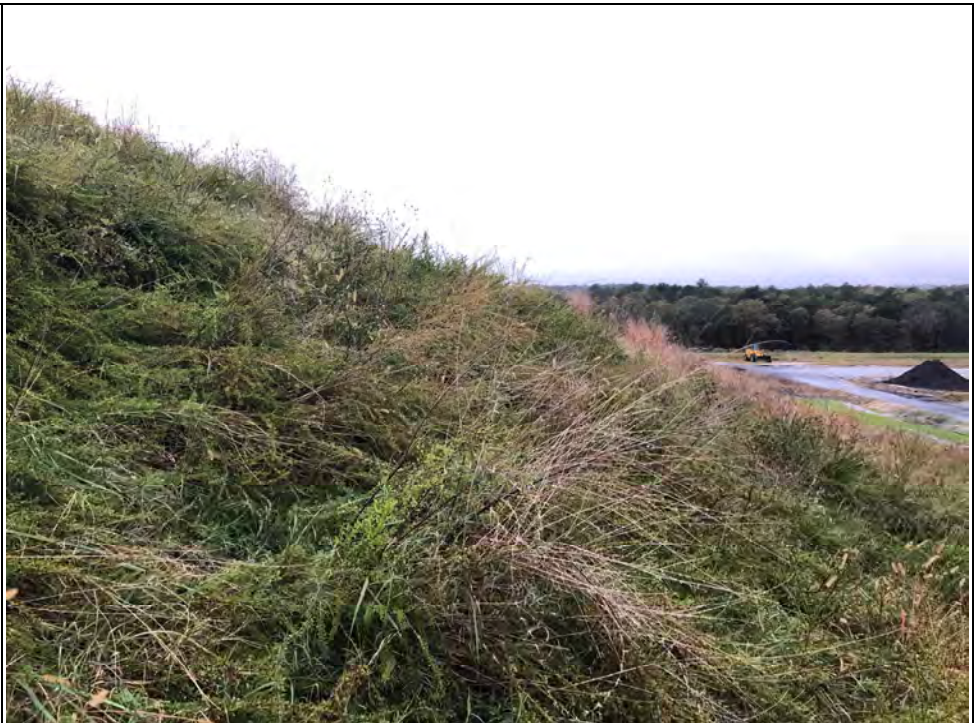
Image: 7392  
Date: 10/29/2020  
Time: 6:38 AM  
Direction: West

Phase 2 Cell 1/Cell 2 boundary. Slopes are well vegetated with no sign of erosion, sloughing, or animal borrows.

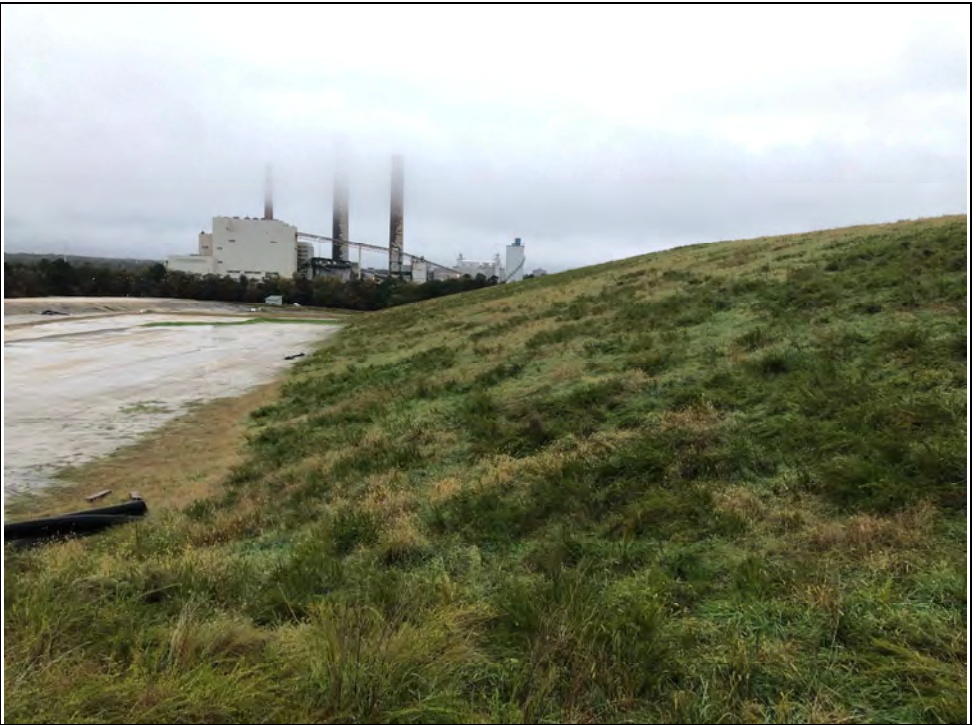
Image: 7394  
Date: 10/29/2020  
Time: 6:39 AM  
Direction: North

Overview of active face and Phase I intermediate cover slopes. Slopes are well vegetated with no sign of erosion or sloughing. Active area is well maintained and orderly.

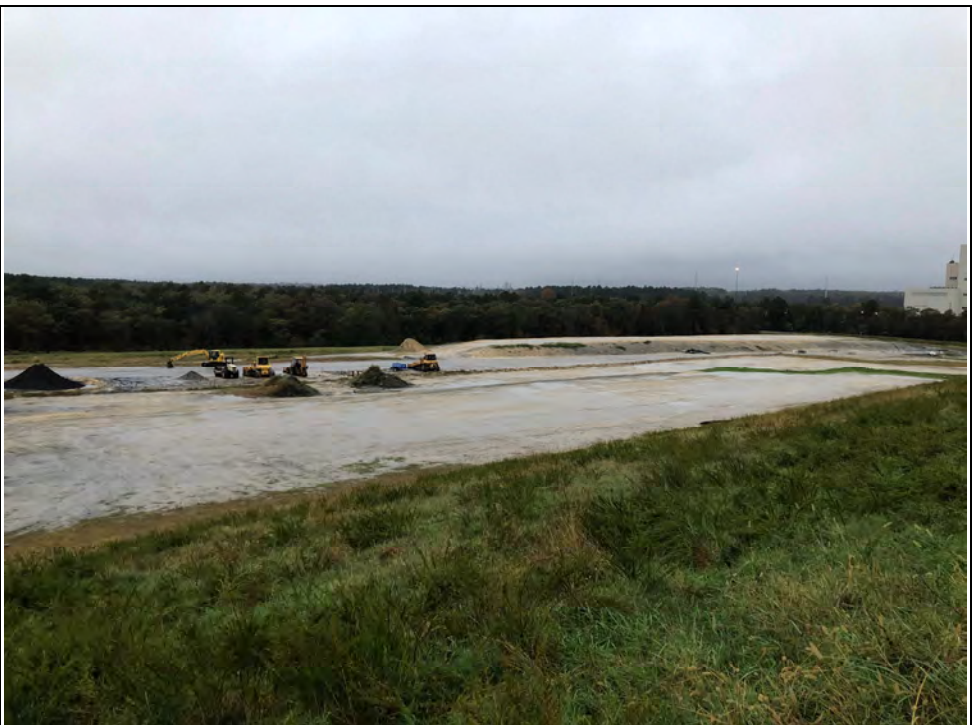
Image: 7396  
Date: 10/29/2020  
Time: 6:40 AM  
Direction: Northwest

Active face is well maintained. Material is graded and compacted. No ponding water, despite significant rainfall occurring at the time of inspection.

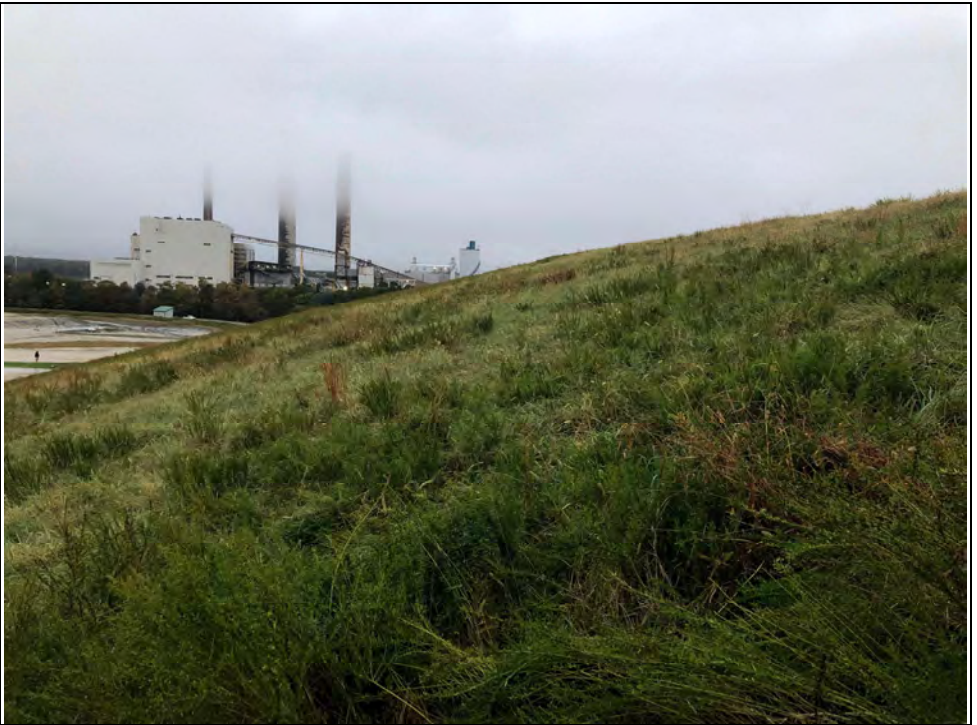
Image: 7398  
Date: 10/29/2020  
Time: 6:40 AM  
Direction: North

Phase I intermediate cover slopes are well vegetated with no sign of erosion or sloughing.

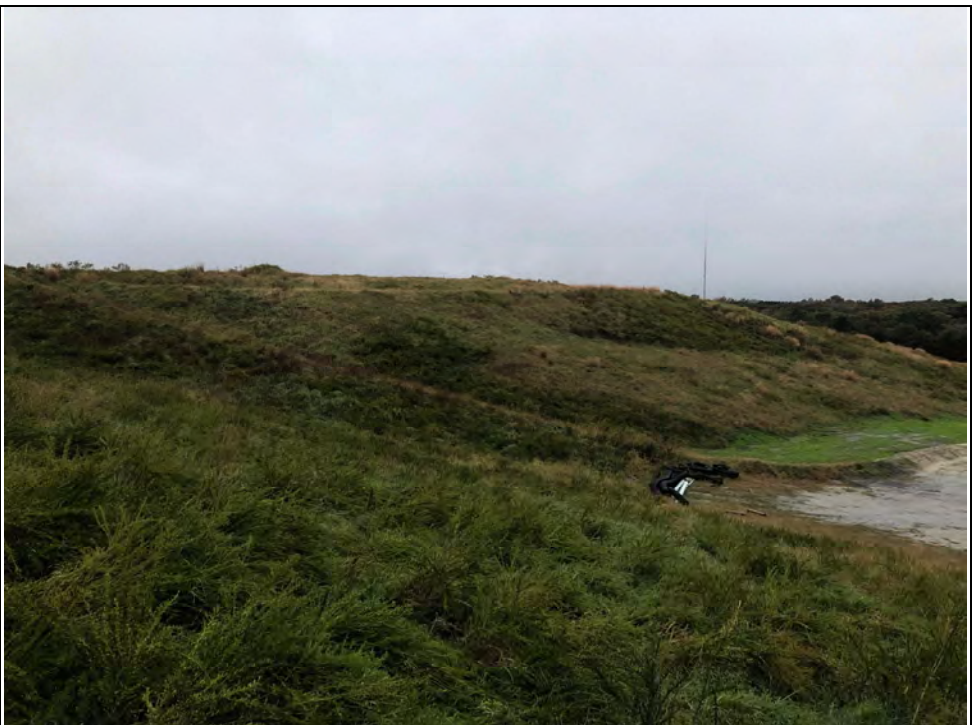
Image: 7400  
Date: 10/29/2020  
Time: 6:40 AM  
Direction: Southwest

Phase 2 Cell 1/Cell 2 boundary. Slopes are well vegetated with no sign of erosion, sloughing, or animal borrows

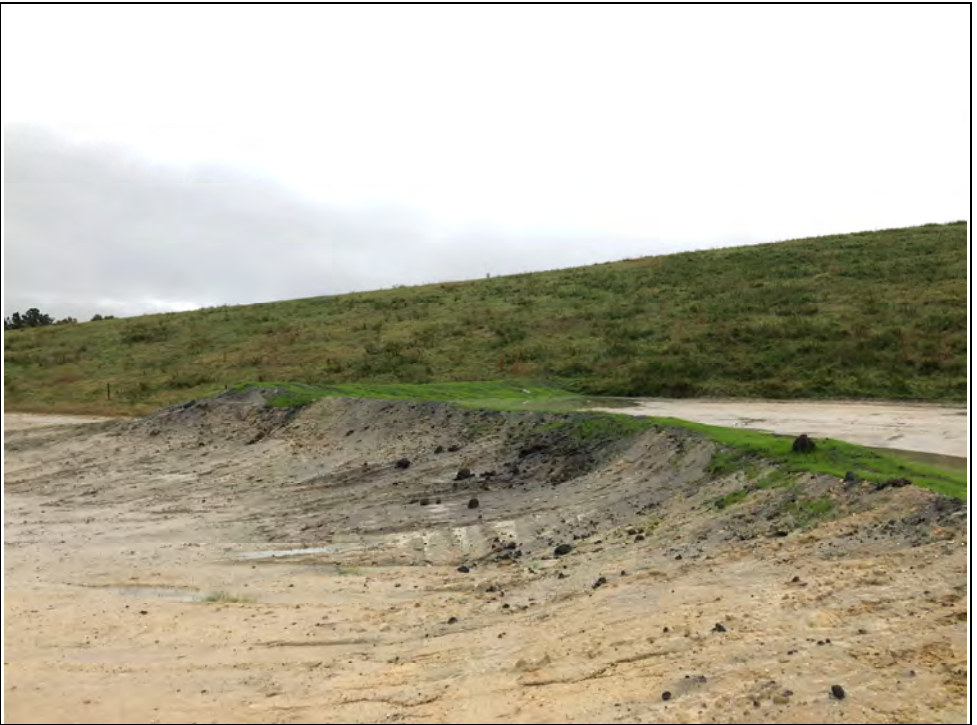
Erosion control berm that has been established on active face. This berm slows contact water travelling over the active face during rain events, which in turn minimizes erosion. Pipes at the toe of the berm collect contact water and convey it to the leachate sump.

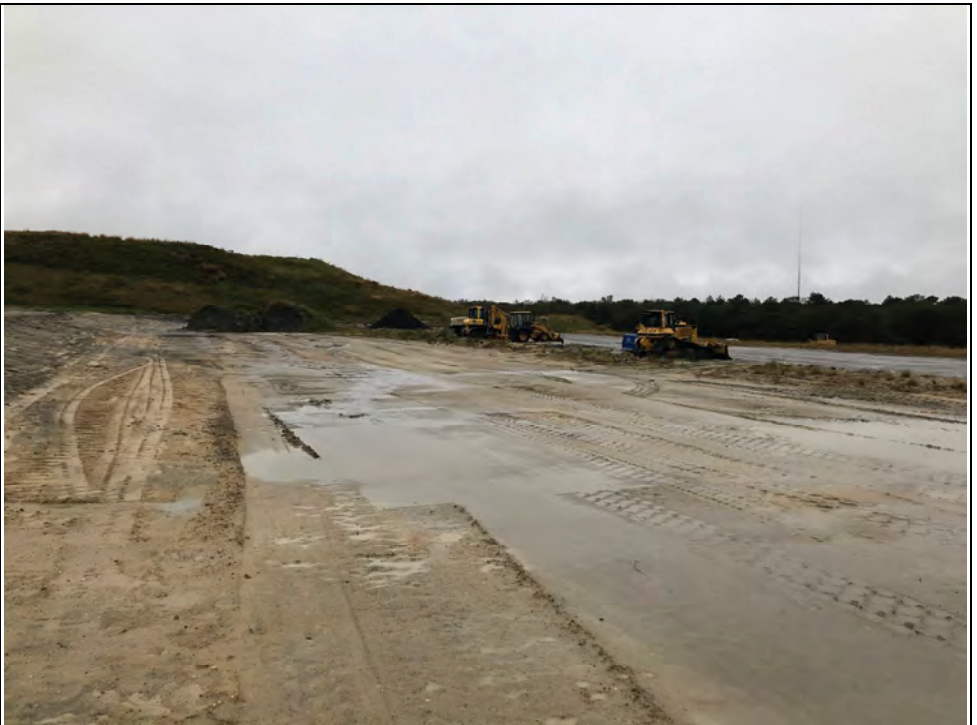
Image: 7412  
 Date: 10/29/2020  
 Time: 6:45 AM  
 Direction: South-Southwest

Active face is well maintained. Material is graded and compacted. Water is draining to the north toward the leachate sump.

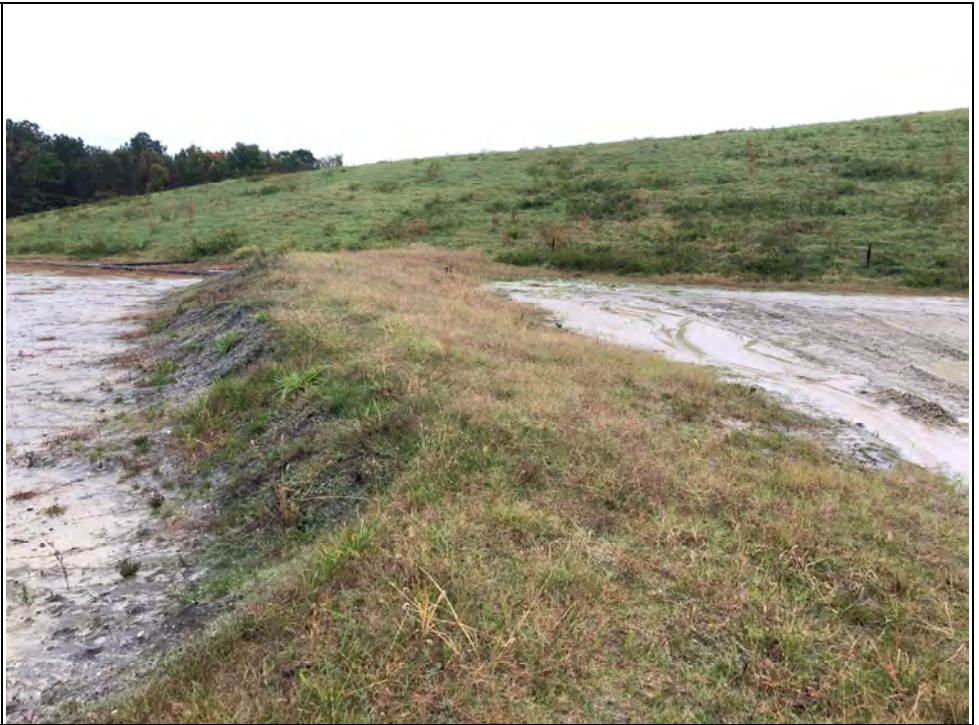
Erosion control berm that has been established on active face. This berm slows contact water travelling over the active face during rain events, which in turn minimizes erosion. Pipes at the toe of the berm collect contact water and convey it to the leachate sump.

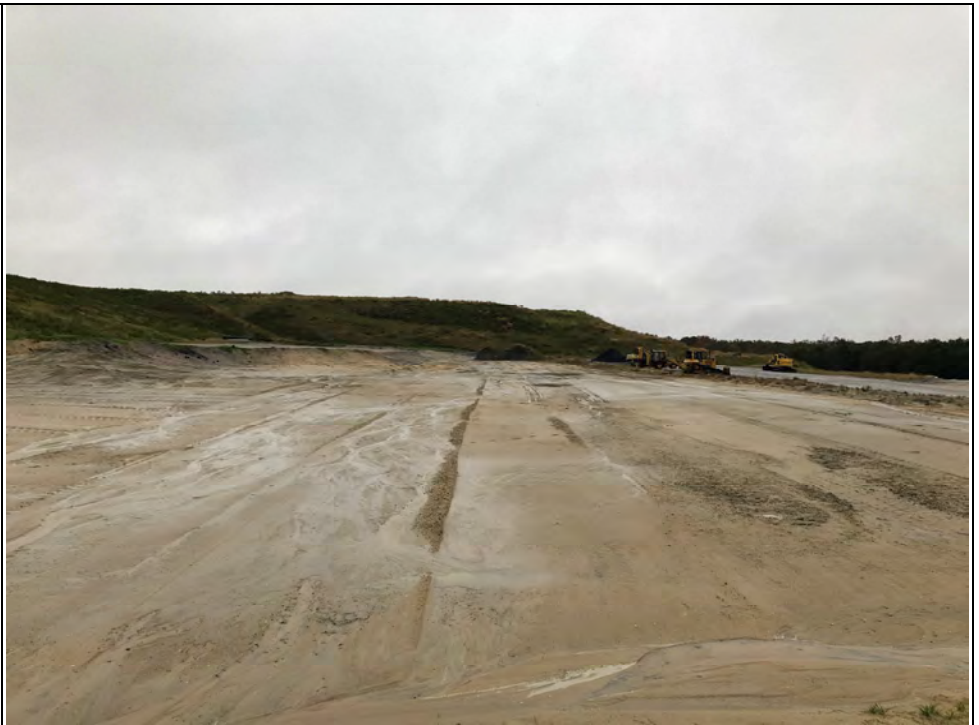
Image: 7420  
Date: 10/29/2020  
Time: 6:48 AM  
Direction: South

Active face is well maintained. Material is graded and compacted. No ponding water.

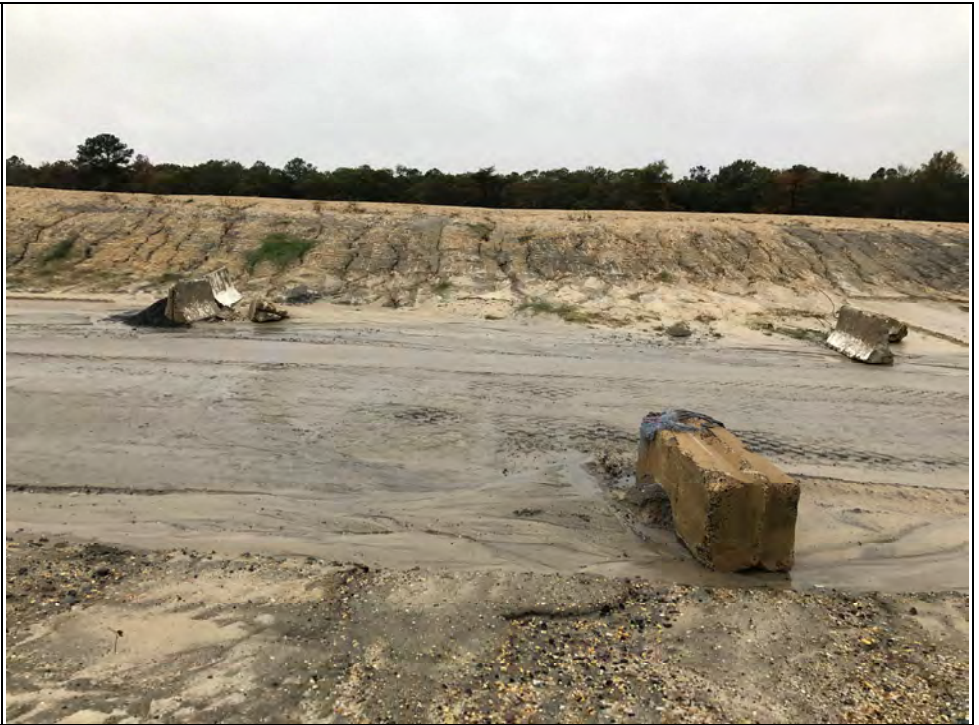
Jersey barriers are strategically placed within active area to slow contact water and minimize sedimentation.

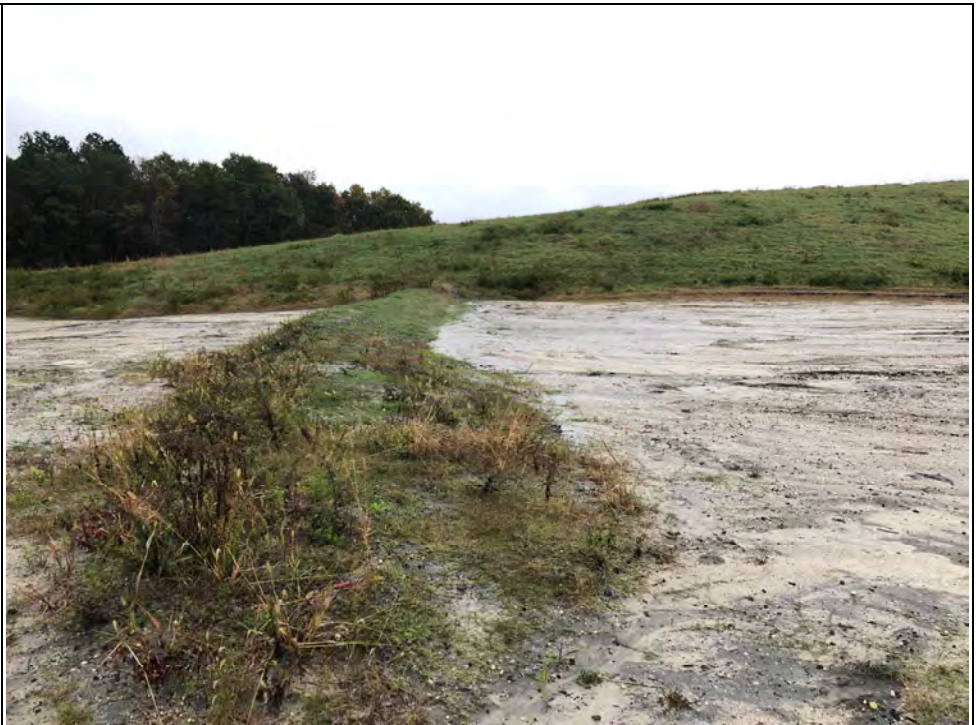
Image: 7424  
 Date: 10/29/2020  
 Time: 6:50 AM  
 Direction: East

Erosion control berm that has been established on active face. This berm slows contact water travelling over the active face during rain events, which in turn minimizes erosion. Pipes at the toe of the berm collect contact water and convey it to the leachate sump.

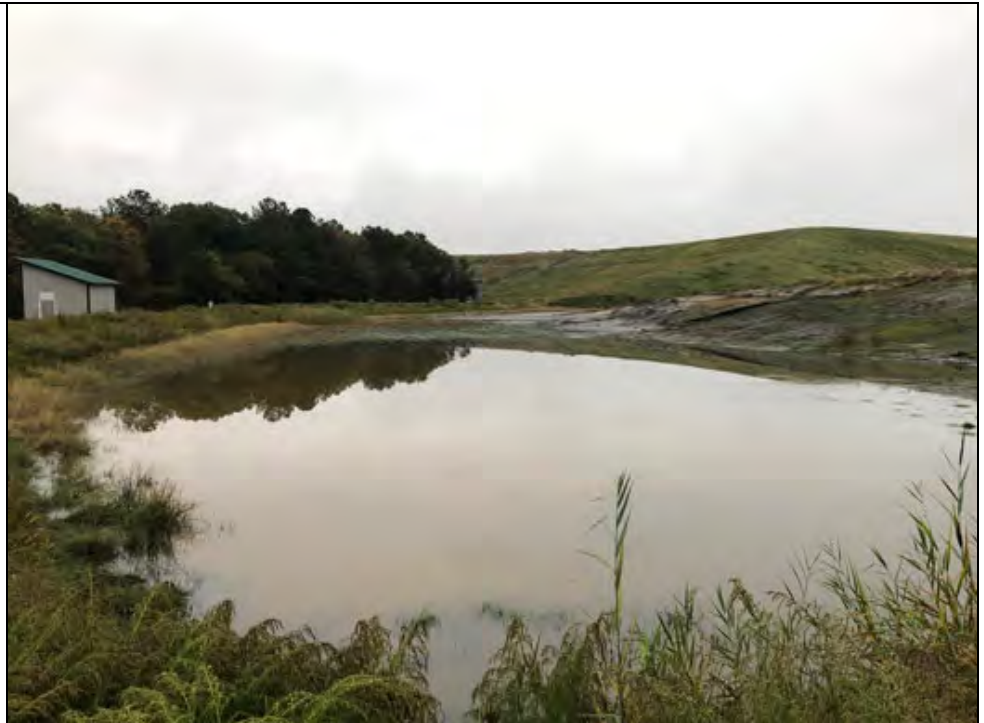
Sump area of active face. Standing water is present in this location due to large rains. Significant efforts have been made to remove standing water, which was treated as leachate.

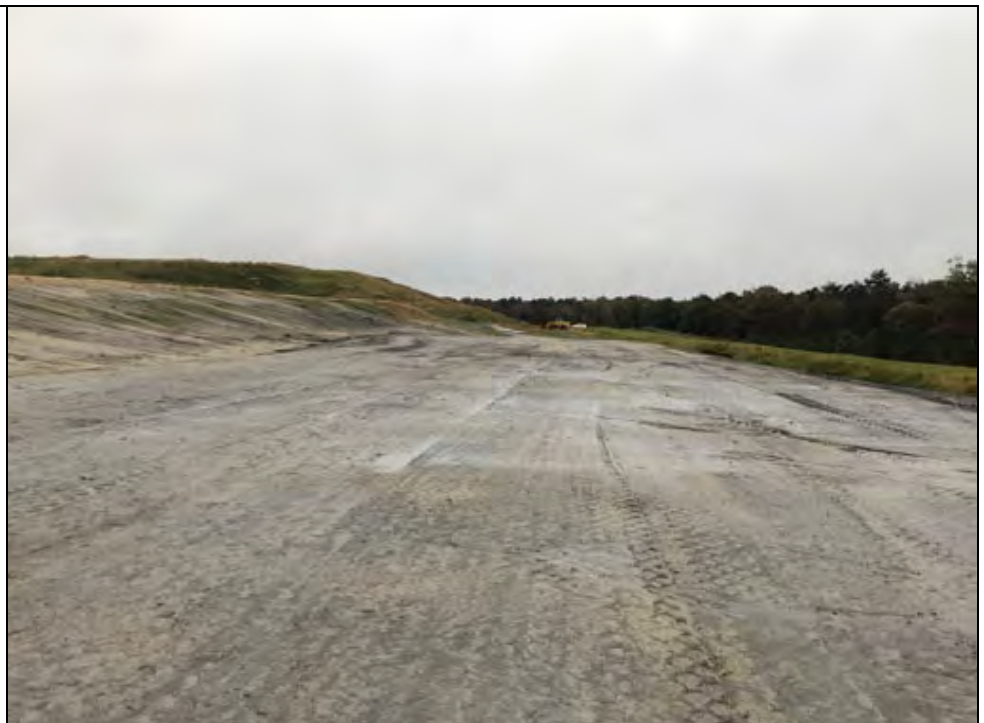
Image: 7442  
Date: 10/29/2020  
Time: 7:01 AM  
Direction: South

Lift of fly ash in active face. Well placed, graded, and maintained.

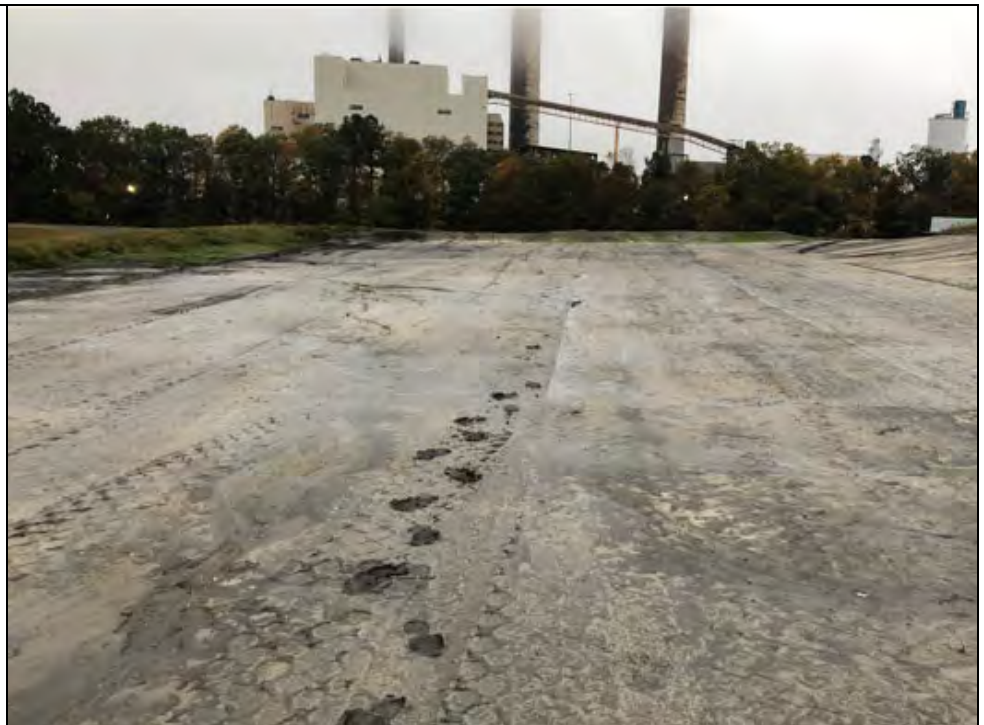
Lift of fly ash in active face. Well placed, graded, and maintained.

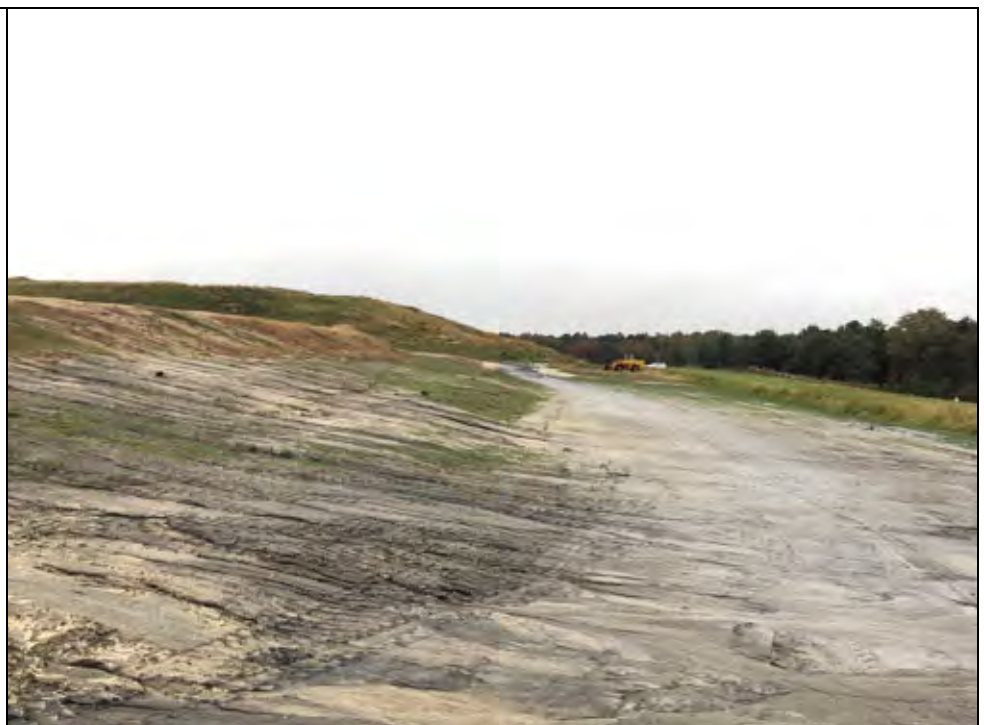
Image: 7444  
Date: 10/29/2020  
Time: 7:03 AM  
Direction: South

Active face is well maintained. Material is graded and compacted. No ponding water.

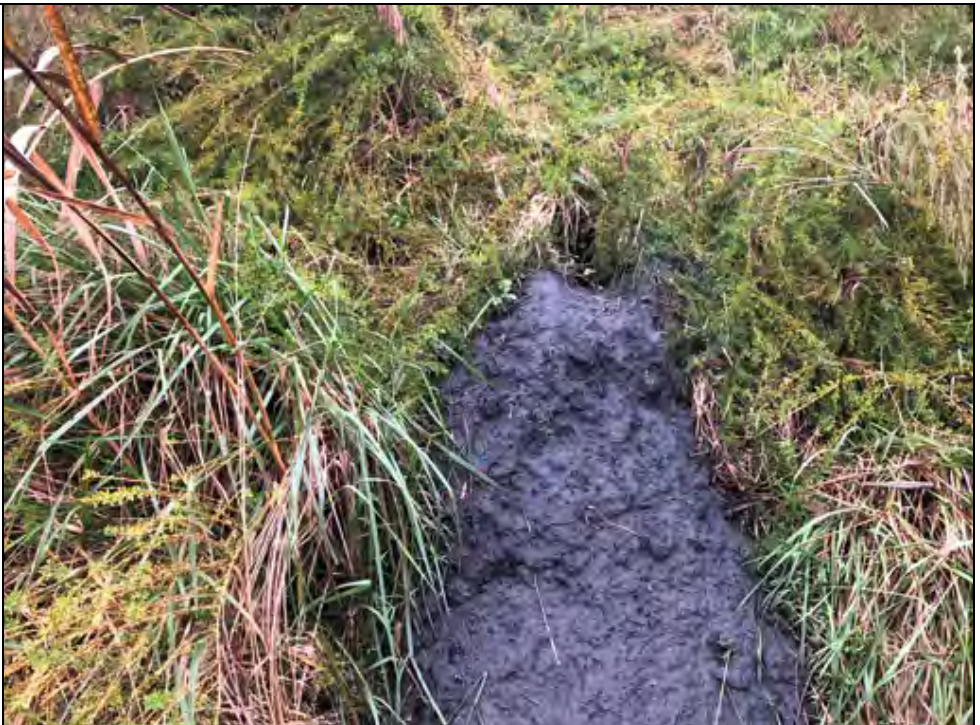
Image: 7446  
Date: 10/29/2020  
Time: 7:10 AM  
Direction: East

A fox den is shown. Review of routine inspection reports indicate that animal burrows are routinely identified and filled once found.

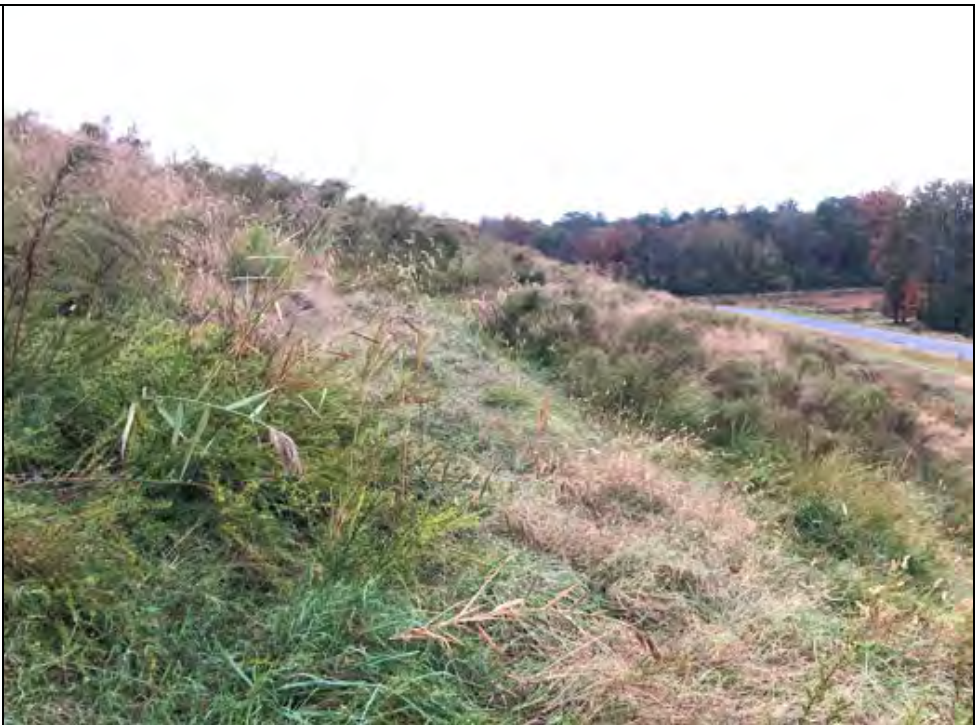
Final cover on sideslopes of Phase II Cell 1. Vegetation is healthy with full coverage. No signs of erosion stability issues observed on sideslope.

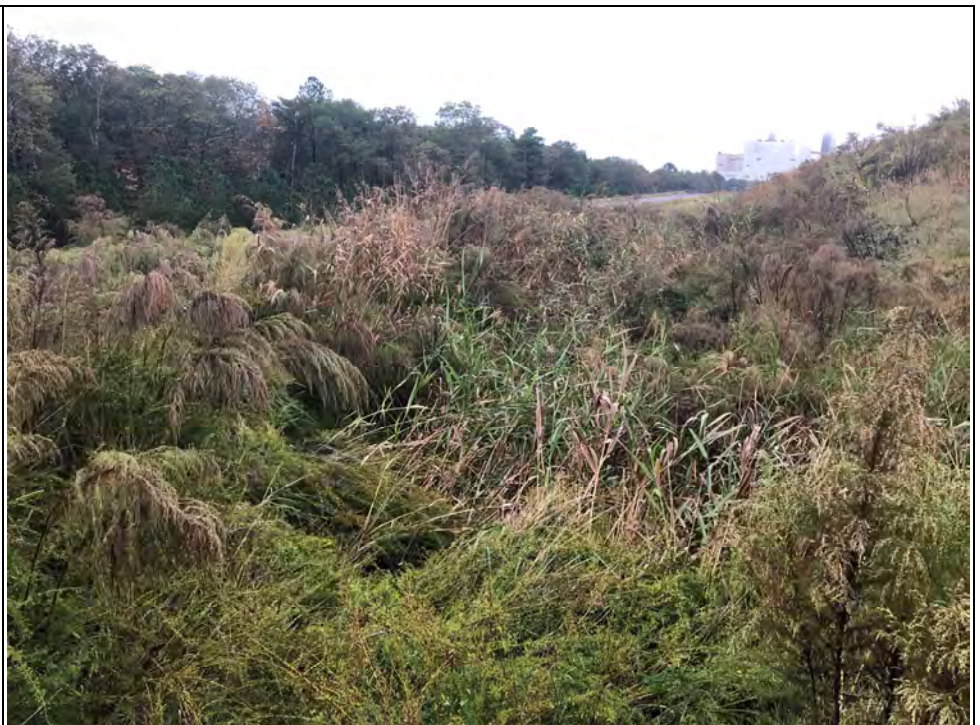
Image: 7450  
Date: 10/29/2020  
Time: 7:11 AM  
Direction: North

Final cover on sideslopes of Phase II Cell 1. Vegetation is healthy with full coverage. No signs of erosion stability issues observed on sideslope.

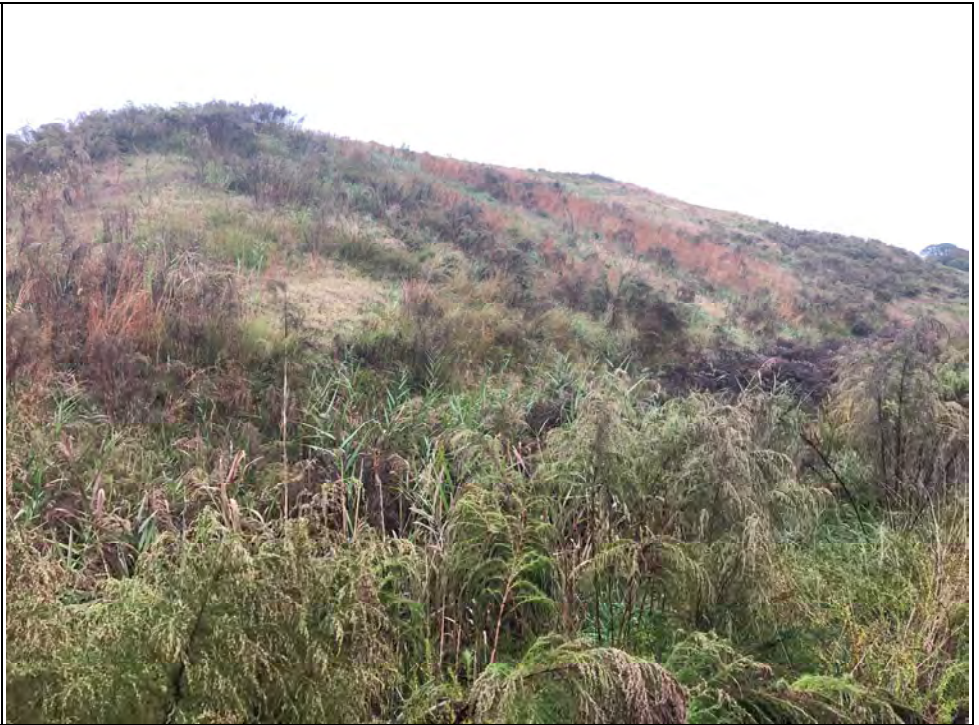
Final cover on sideslopes of Phase II Cell 1. Vegetation is healthy with full coverage. No signs of erosion stability issues observed on sideslope.

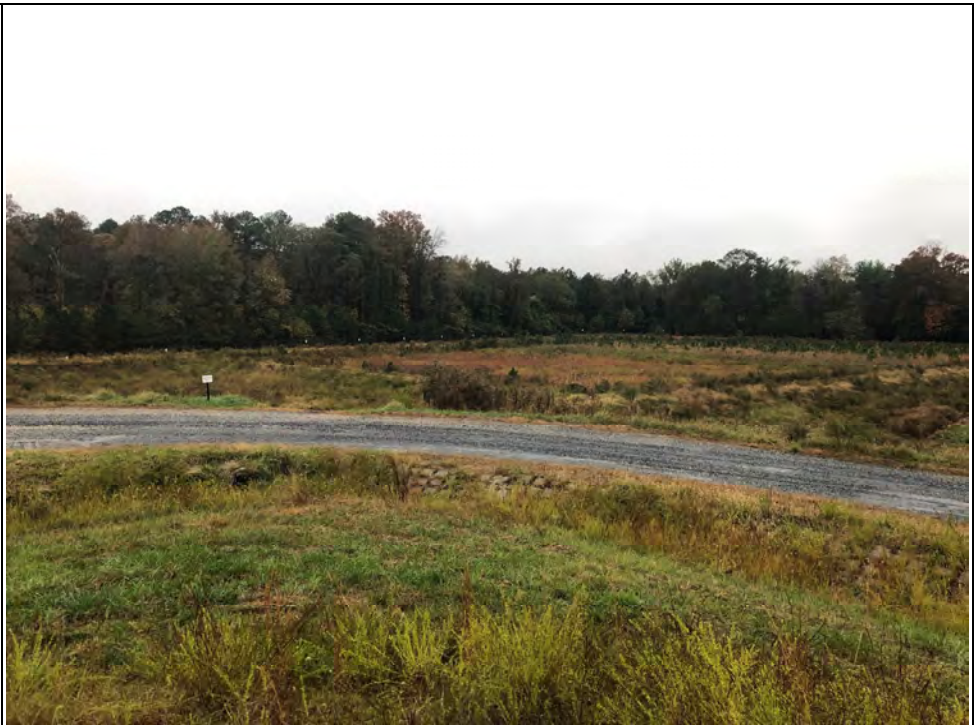
Image: 7454  
Date: 10/29/2020  
Time: 7:16 AM  
Direction: North-Northwest

Overview of stormwater basin.

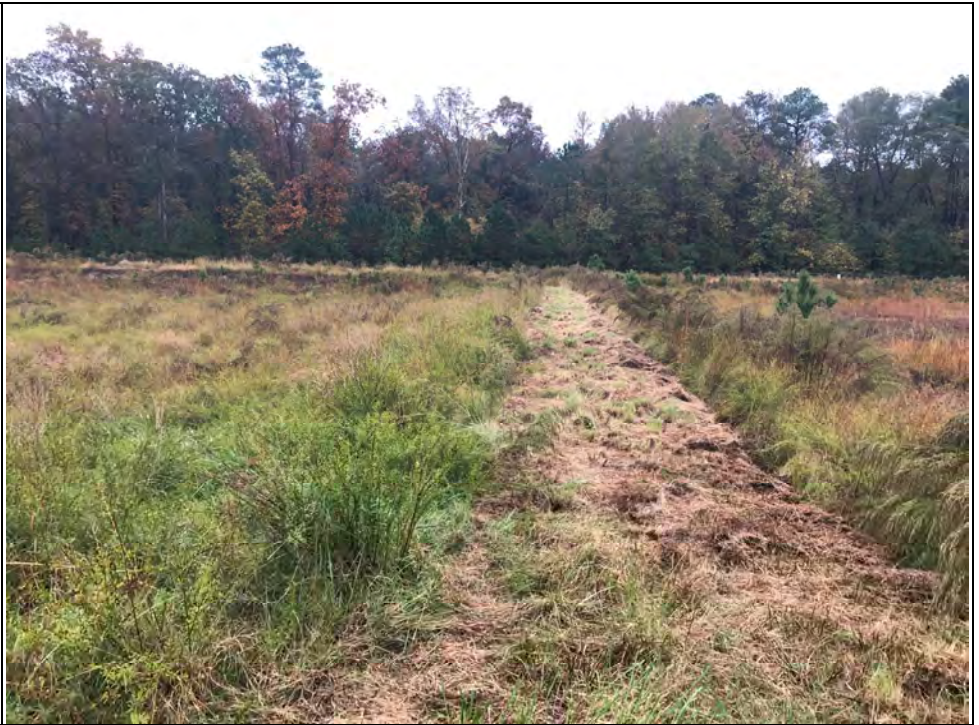
Stormwater basin forebay.  
In good condition.

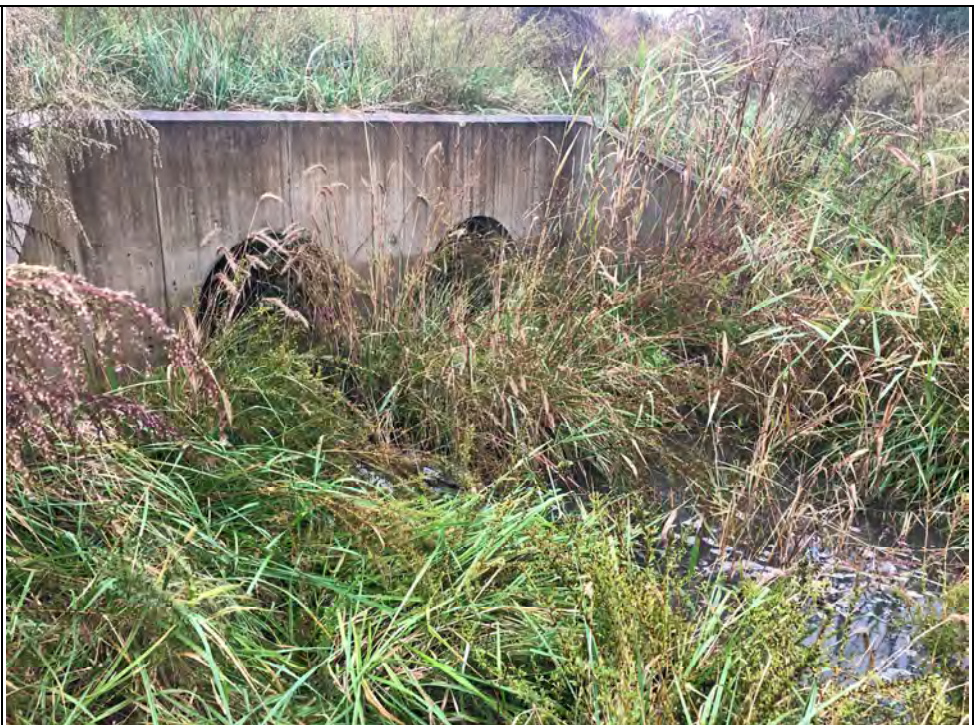
Image: 7458  
Date: 10/29/2020  
Time: 7:17 AM  
Direction: Southwest

Inlets to stormwater basin.  
Clear of obstruction at  
inlets and outlets.
