## Inspection Report

**To:** David Bacher, NRG  
**From:** Richard Southorn, P.E., P.G.  
**Re:** Indian River Landfill – Annual CCR Unit Inspection Report  
**Inspection Date:** October 29, 2020  
**Memo Date:** January 18, 2021

**Project: Indian River Landfill 2020 Annual Inspection**

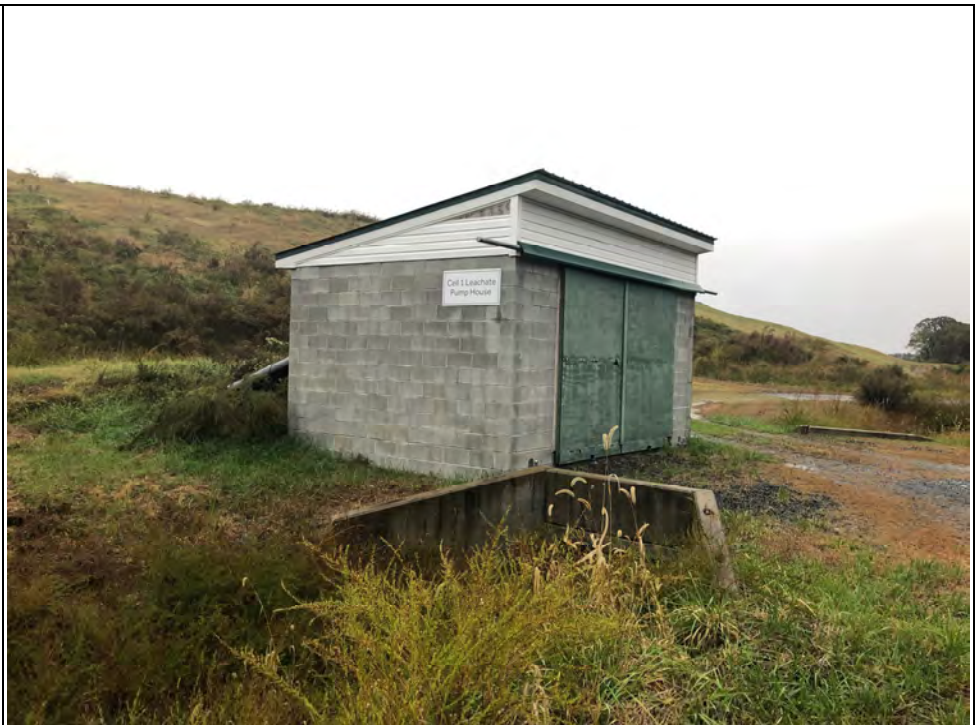
Phase 1, Cell 1 leachate pump house and stormwater culvert. Building is appropriately signed. Culvert is free of obstructions.

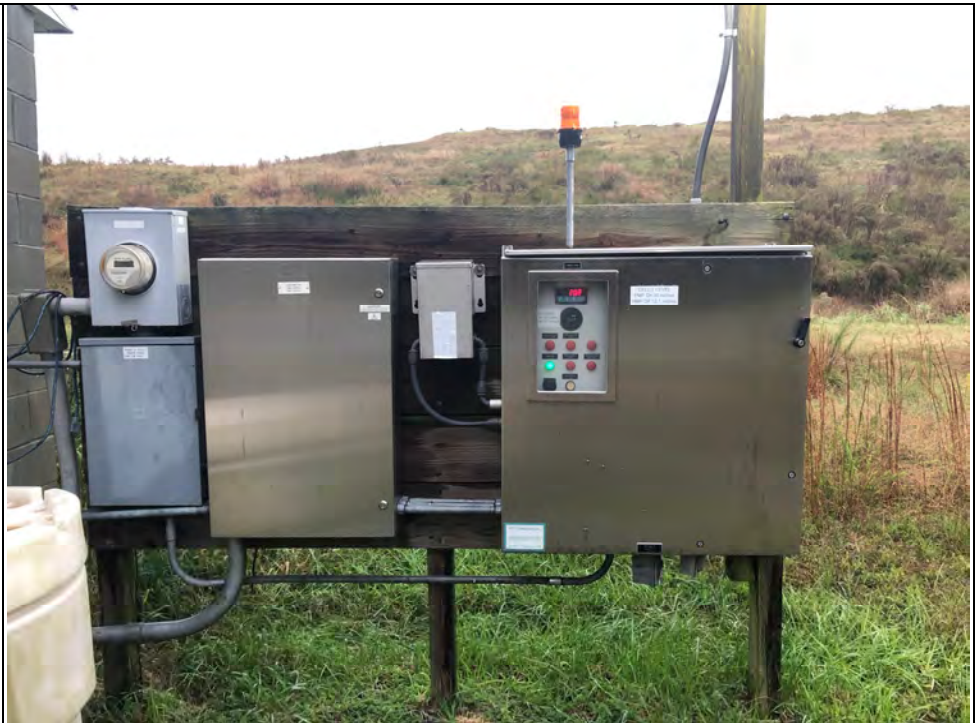
Image: 7462  
Date: 10/29/2020  
Time: 7:19 AM  
Direction: East-Northeast

Phase 1, Cell 1 leachate instrument panel. Good working order.

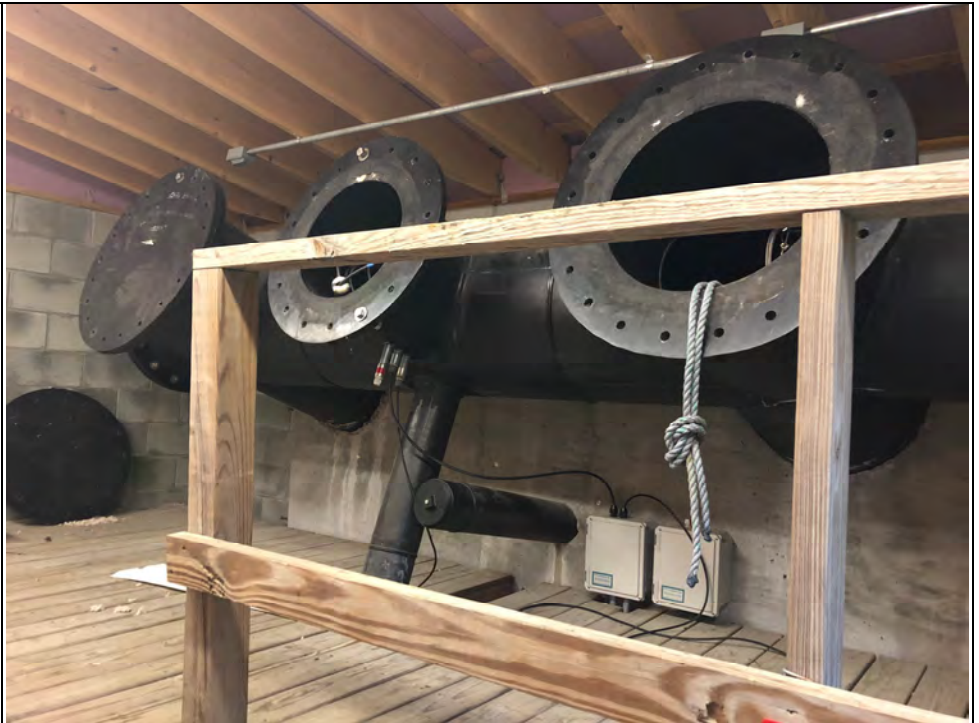
Inside Phase 1, Cell 1 Leachate Pump House. Cleanout riser and pump risers with T connection to forcemain shown. Building is well maintained.

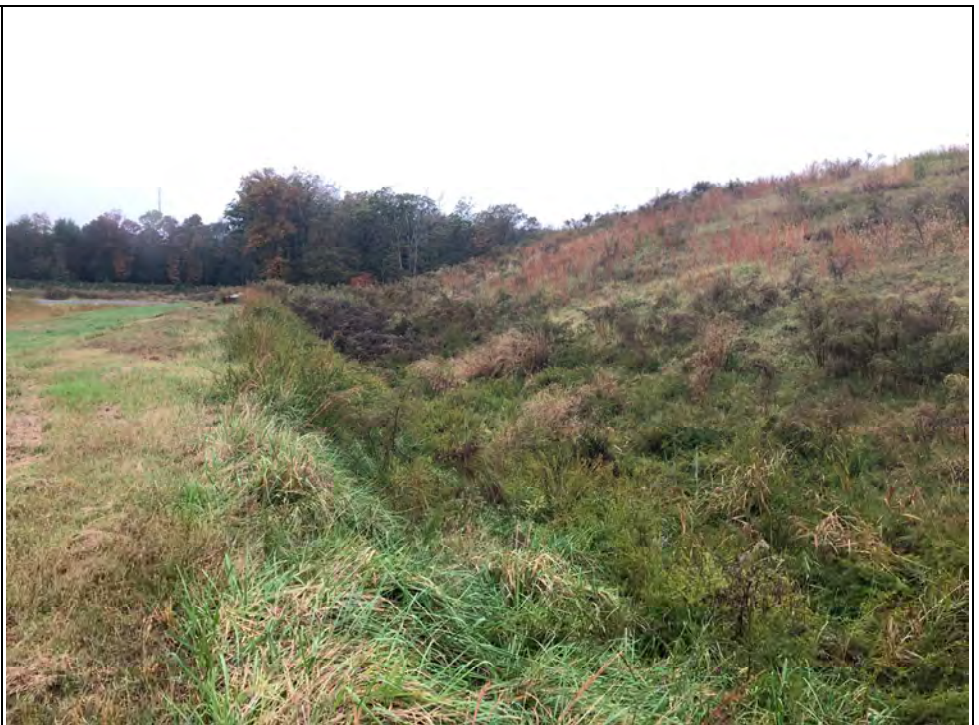
Image: 7466  
Date: 10/29/2020  
Time: 7:21 AM  
Direction: North

Final cover vegetative cover is dense and healthy.

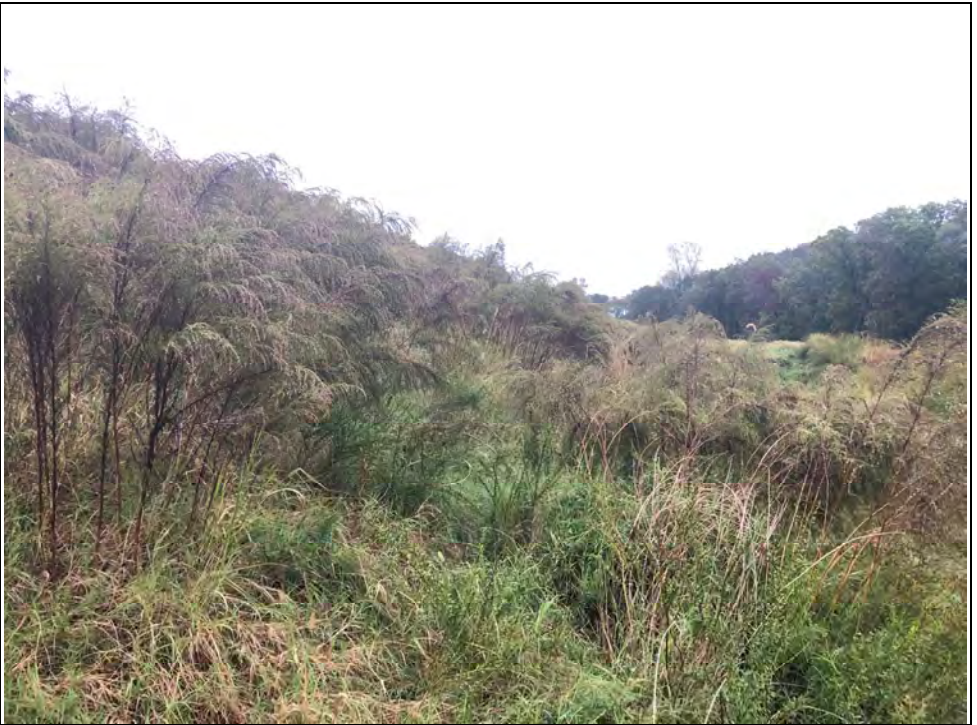
Final cover vegetative cover is dense and healthy.

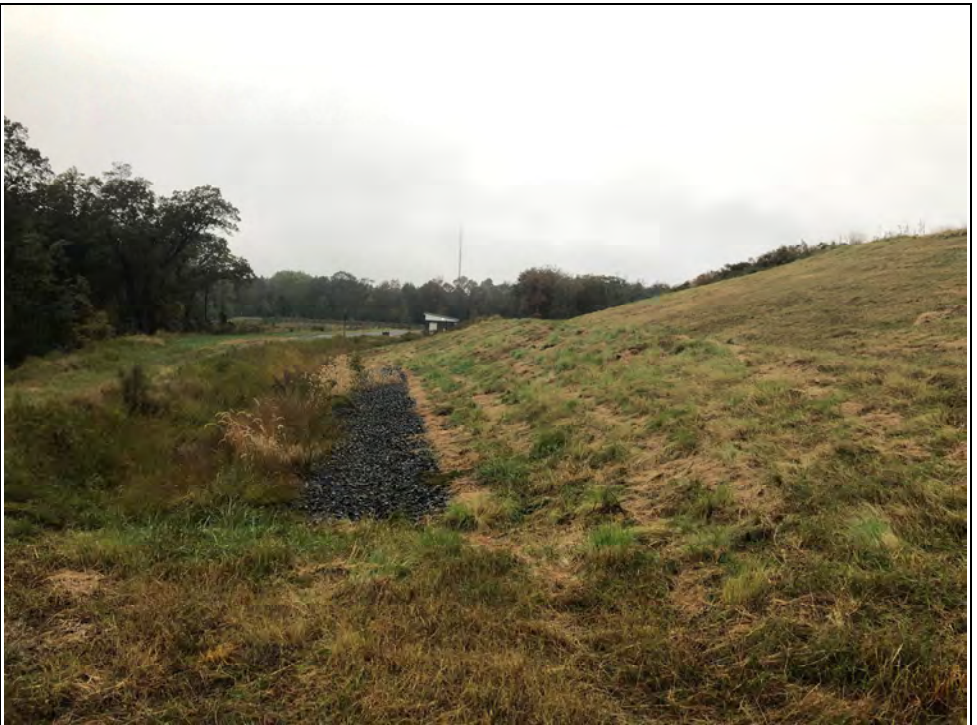
Image: 7470  
Date: 10/29/2020  
Time: 7:22 AM  
Direction: West

Vegetative cover is dense and healthy.

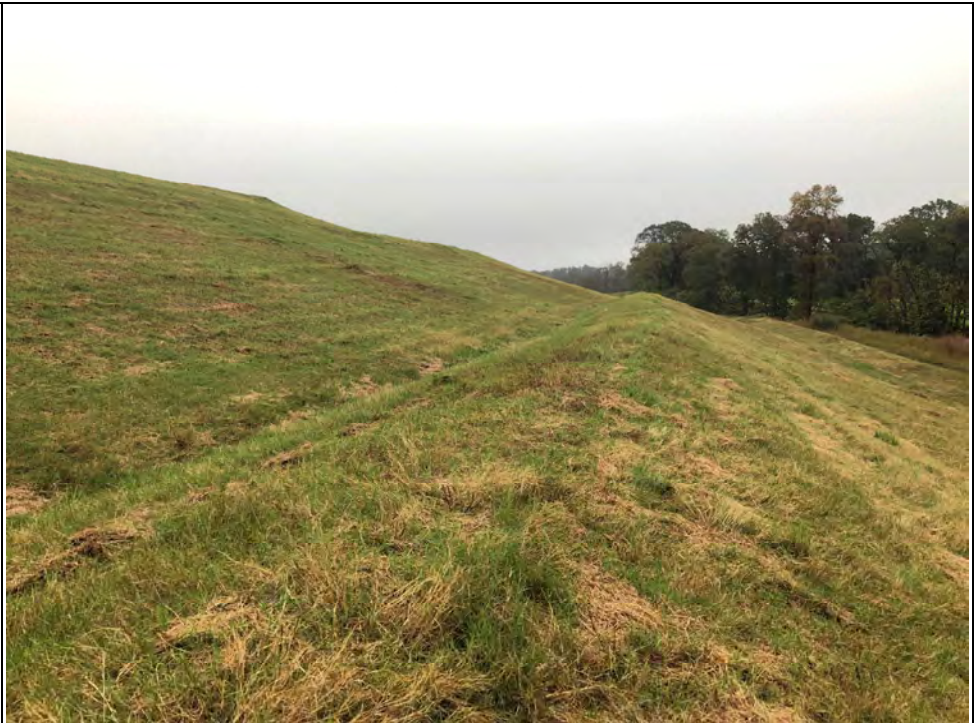
Terrace berm. Clear of obstructions and functioning as intended. Vegetative cover is dense and healthy.

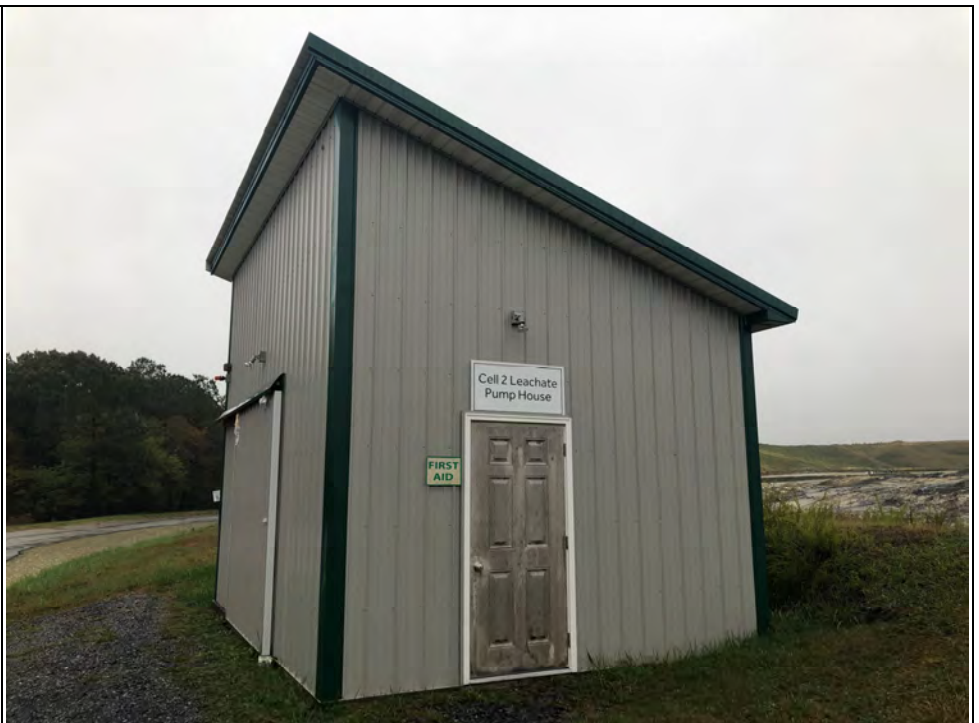
Image: 7474  
Date: 10/29/2020  
Time: 7:25 AM  
Direction: West

Phase 2, Cell 2 leachate pump house. Building exterior is in good condition and appropriately signed.

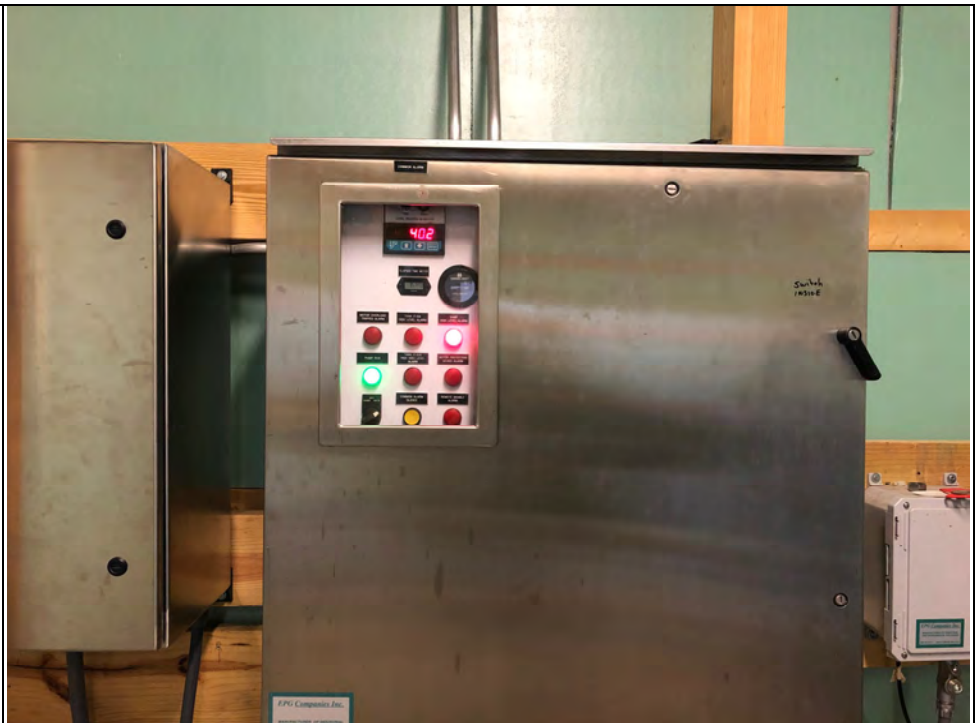
Leachate liquid level indicator and controls in the Phase 2, Cell 2 leachate pump house.

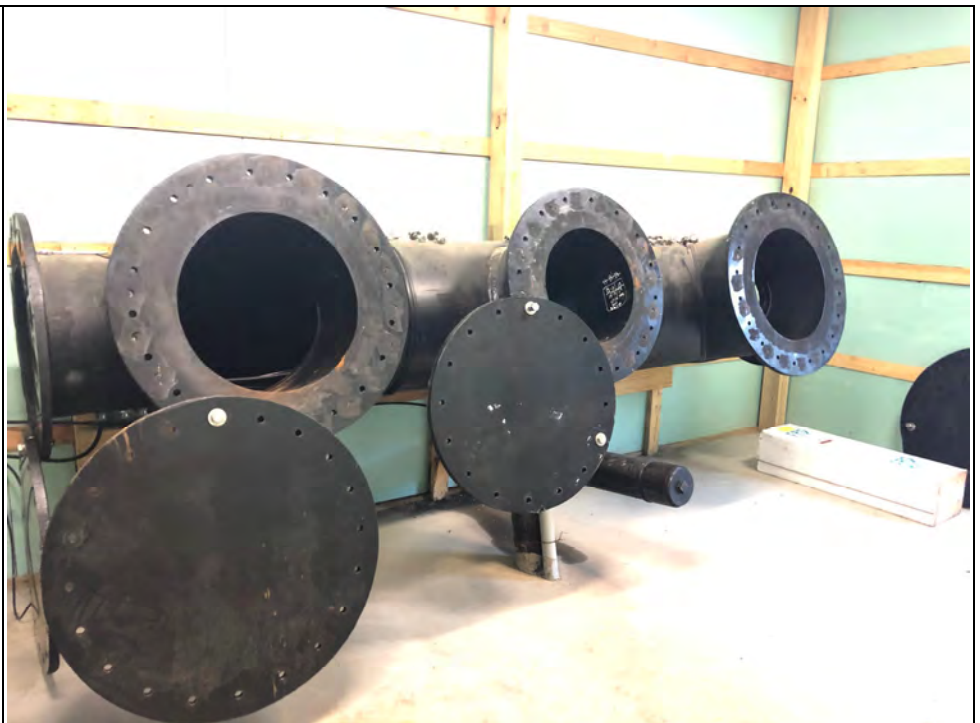
Image: 7478  
Date: 10/29/2020  
Time: 7:30 AM  
Direction: In Building

Inside Phase 2, Cell 2 Leachate Pump House. Cleanout riser and pump risers with T connection to forcemain shown. Building is well maintained.

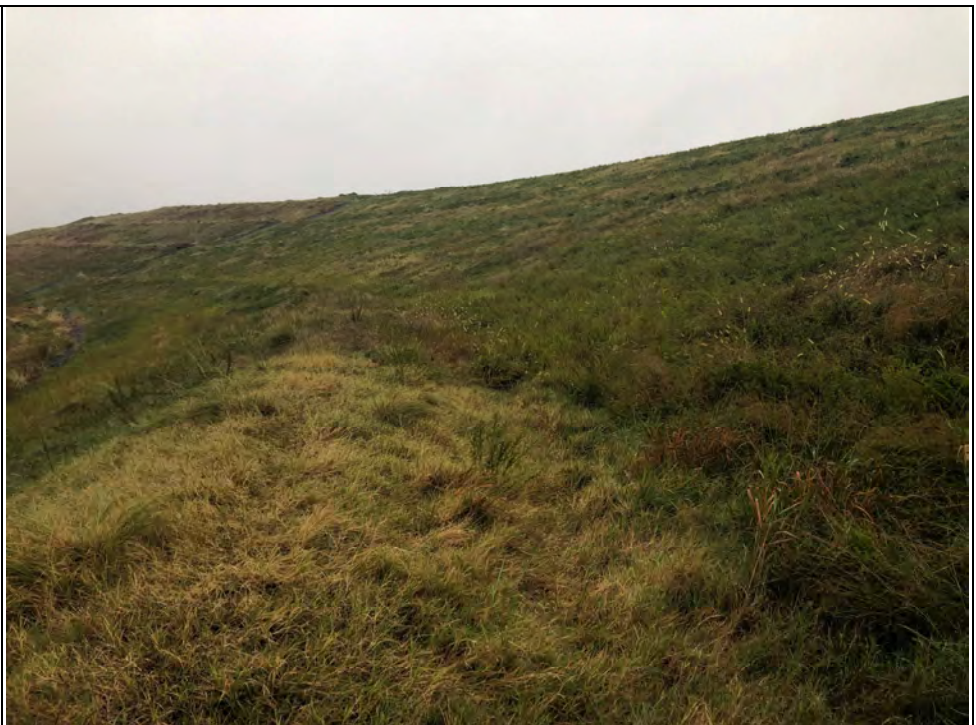
Terrace bench is in good condition, no evidence of scour or erosion.

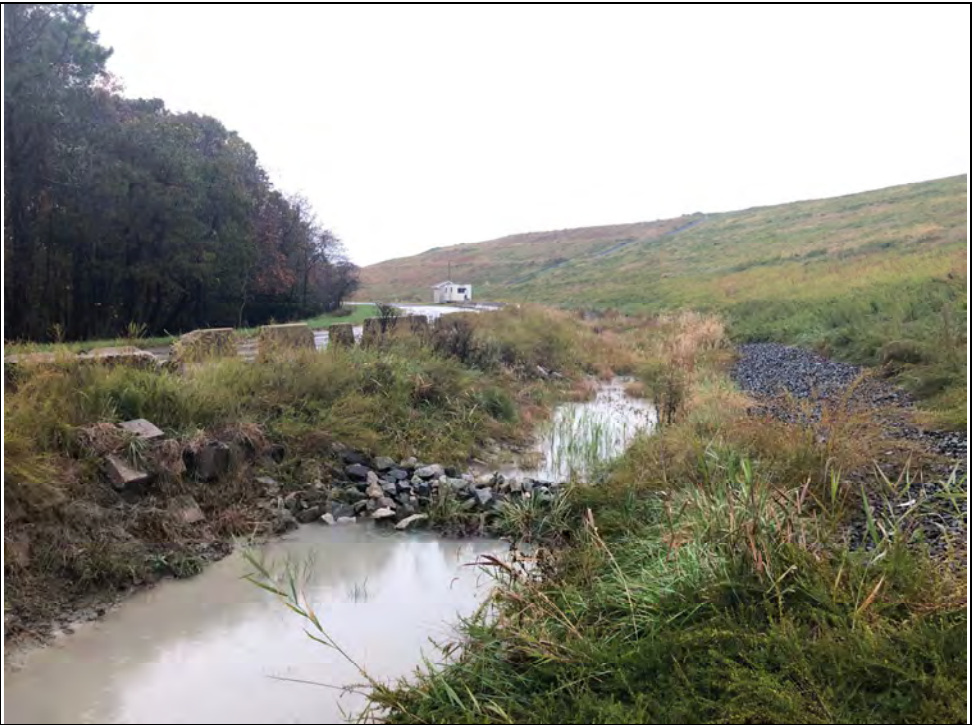
Rock check dams are used in the perimeter non-contact (stormwater) ditches to knock out sediment and provide water quality benefits.

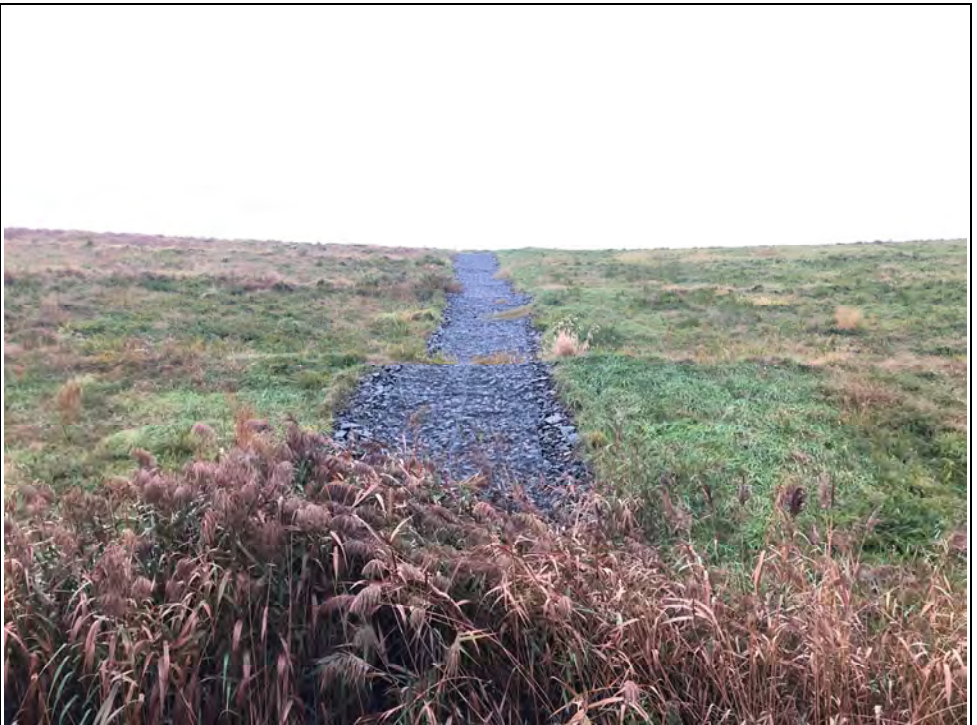
Image: 7490  
Date: 10/29/2020  
Time: 7:58 AM  
Direction: South

Downchute near southwest forebay of Northeast Detention Basin.

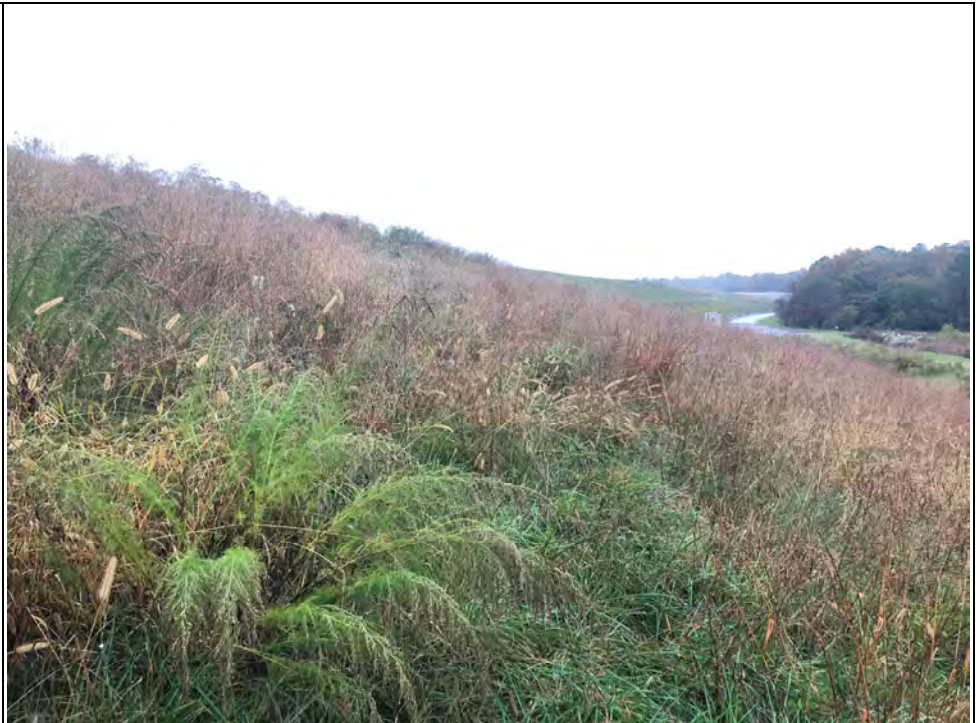
Phase 1 final cover.  
Vegetative cover is dense  
and healthy.

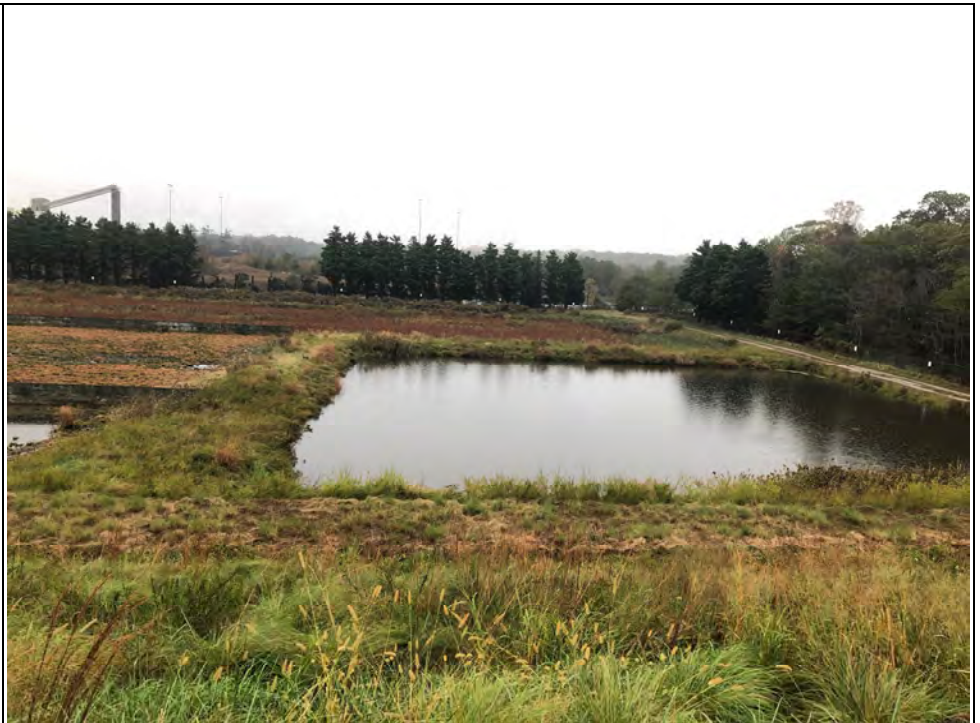
Image: 7500  
Date: 10/29/2020  
Time: 8:01 AM  
Direction:

Southeast forebay of  
Northeast Detention  
Basin. Functioning as  
intended.

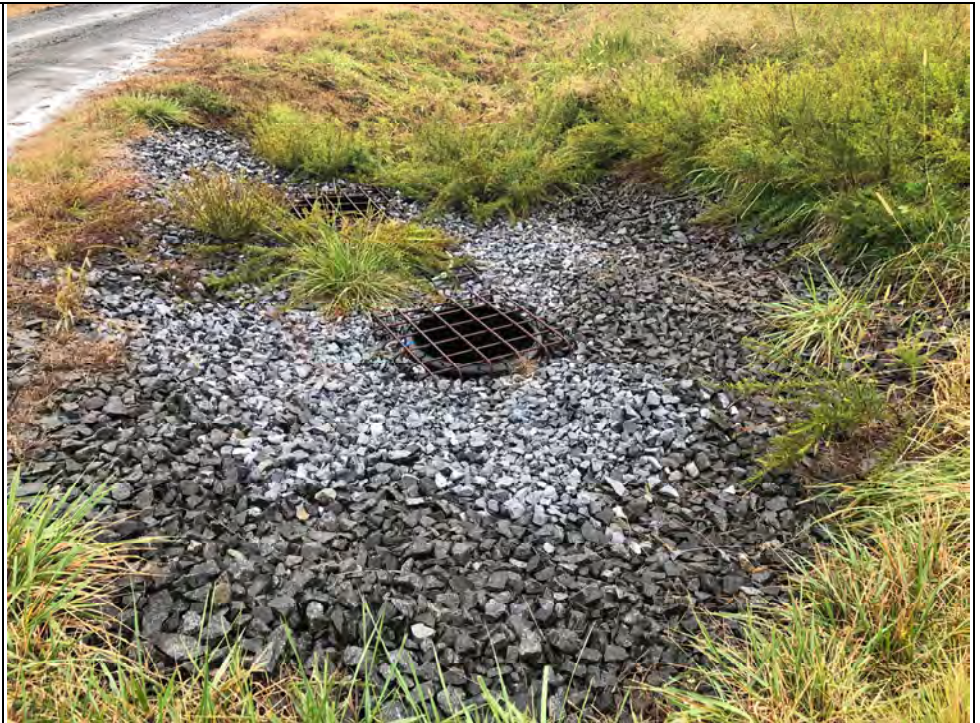
Phase 1 corner downchute road crossing equalizing pipes. Free of obstructions.

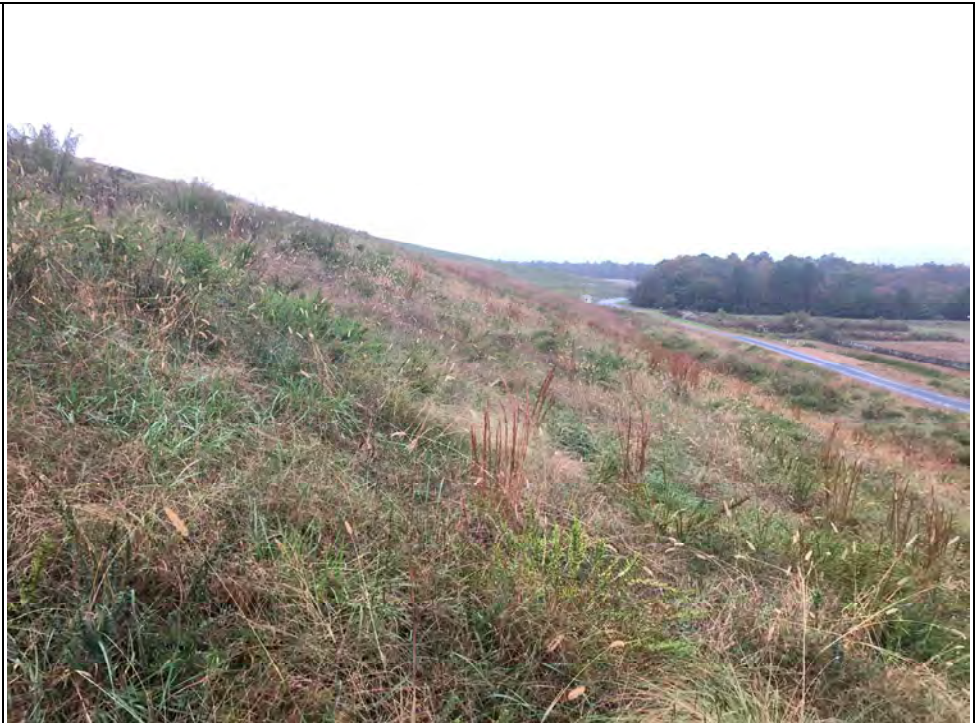
Phase 1 final cover.  
Vegetative cover is dense  
and healthy.

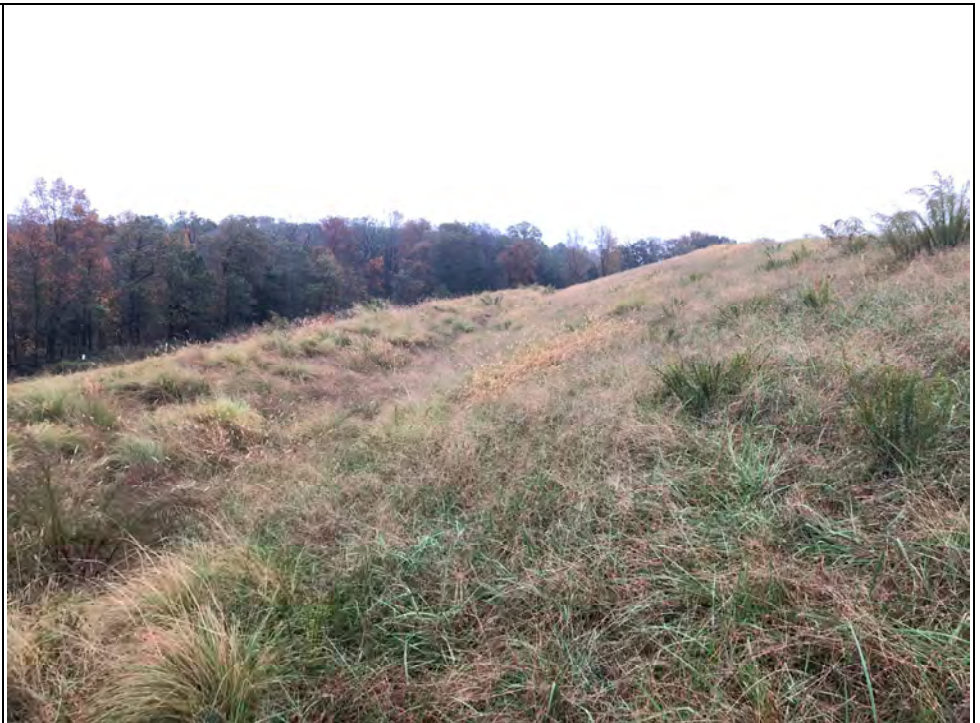
Image: 7508  
Date: 10/29/2020  
Time: 8:04 AM  
Direction: South Southwest

Phase 1 terrace berm.  
Clear of obstructions and  
functioning as intended.  
Vegetative cover is dense  
and healthy.

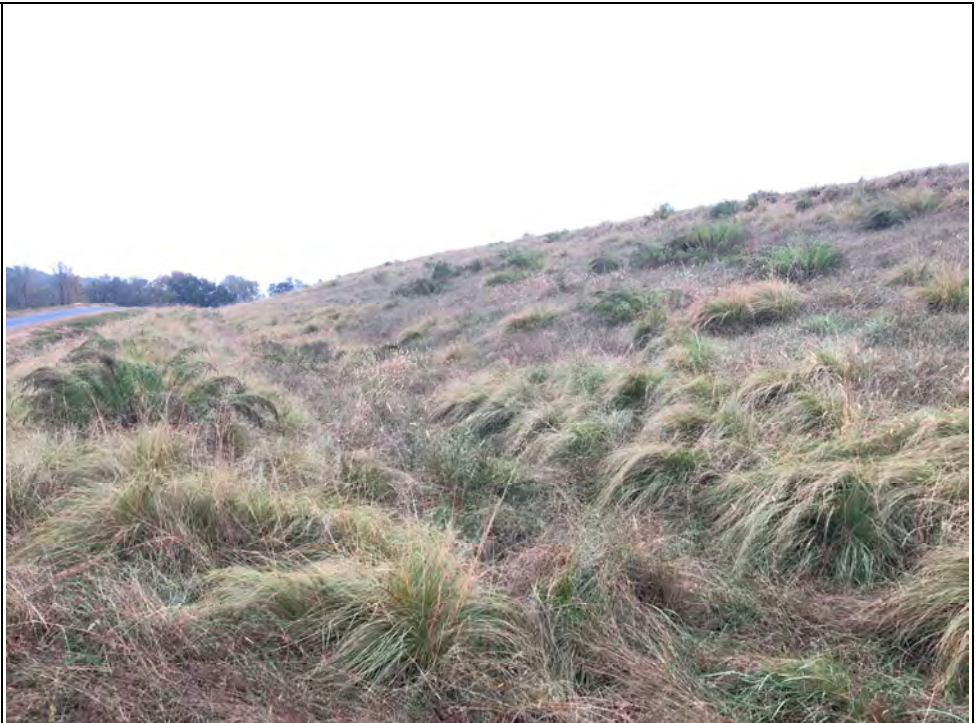
Phase 1 terrace berm.  
Clear of obstructions and  
functioning as intended.  
Vegetative cover is dense  
and healthy.

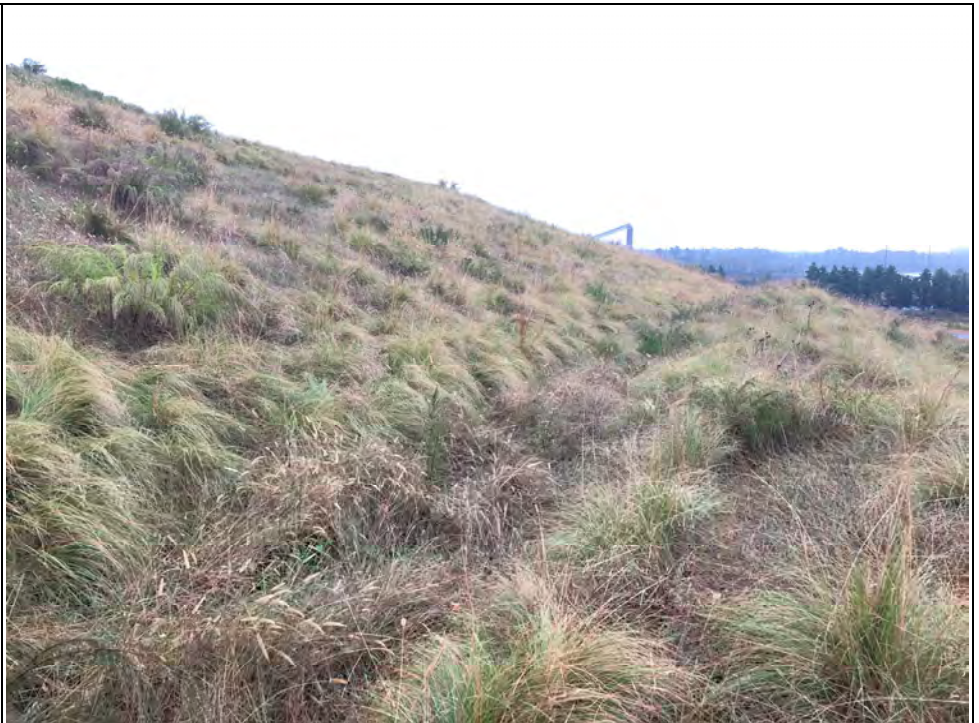
Image: 7512  
Date: 10/29/2020  
Time: 8:07 AM  
Direction: Northwest

Phase 1 terrace berm.  
Clear of obstructions and  
functioning as intended.  
Vegetative cover is dense  
and healthy.

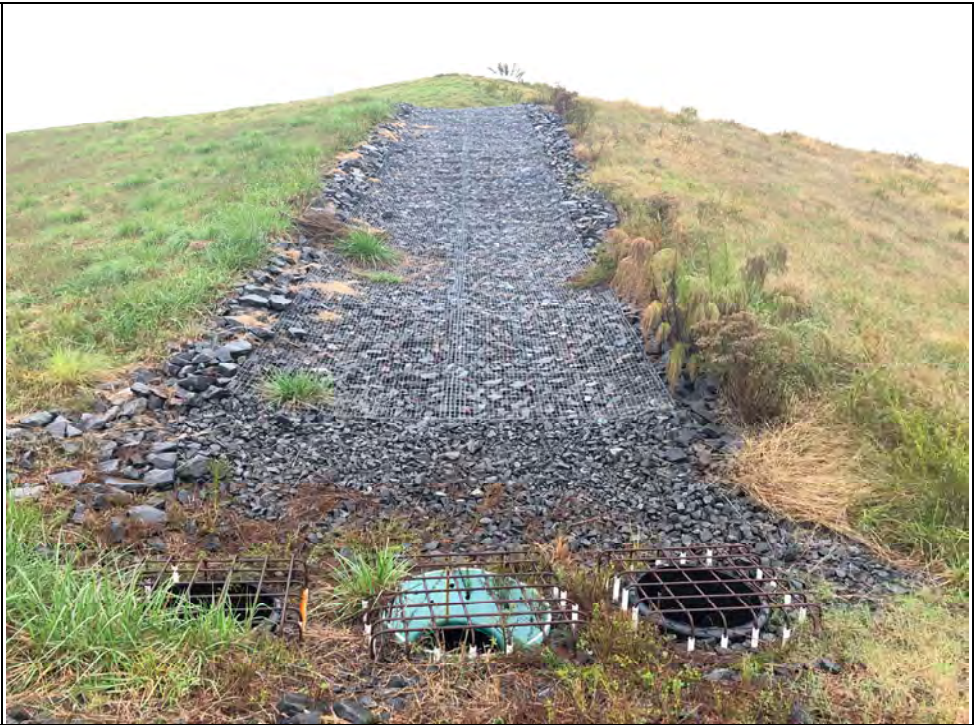
Phase 1 corner downchute. Rock is in-place and not migrating. No evidence of washouts.

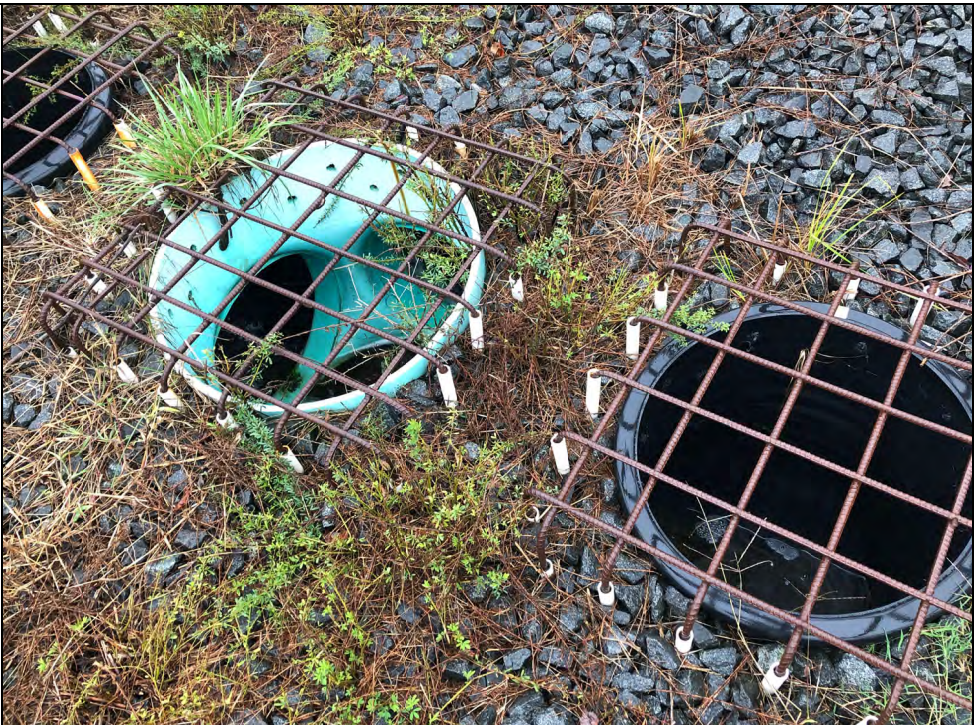
Image: 7516  
Date: 10/29/2020  
Time: 8:09 AM  
Direction: West Northwest

Phase 1 corner downchute. Rock is in-place and not migrating. No evidence of washouts.

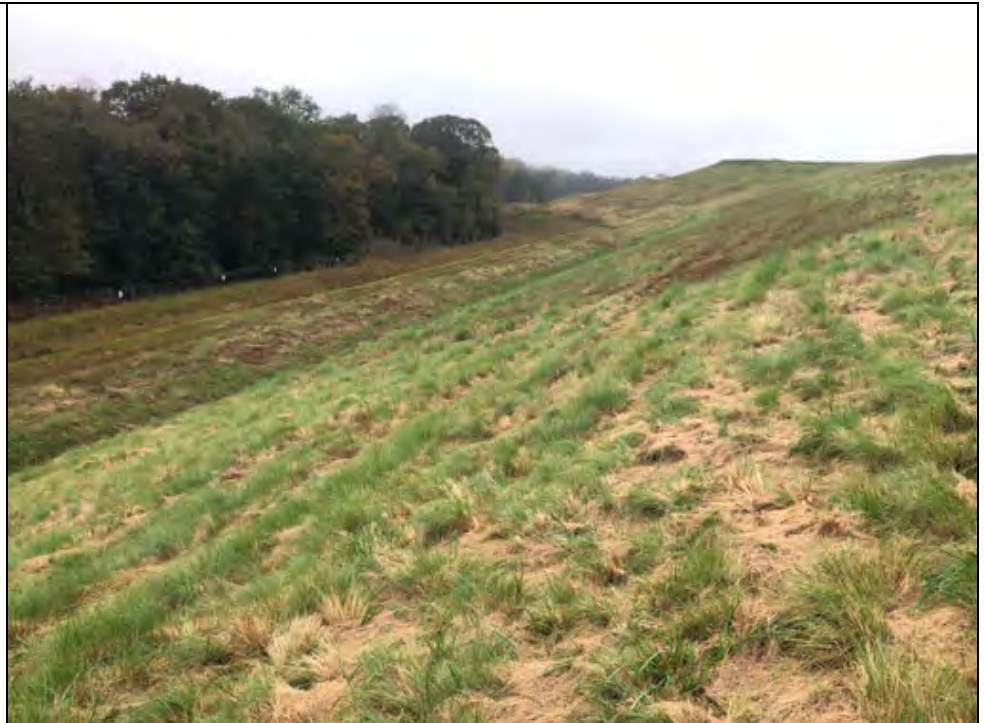
Phase 1 final cover and stormwater terraces. Well maintained and functioning as intended.

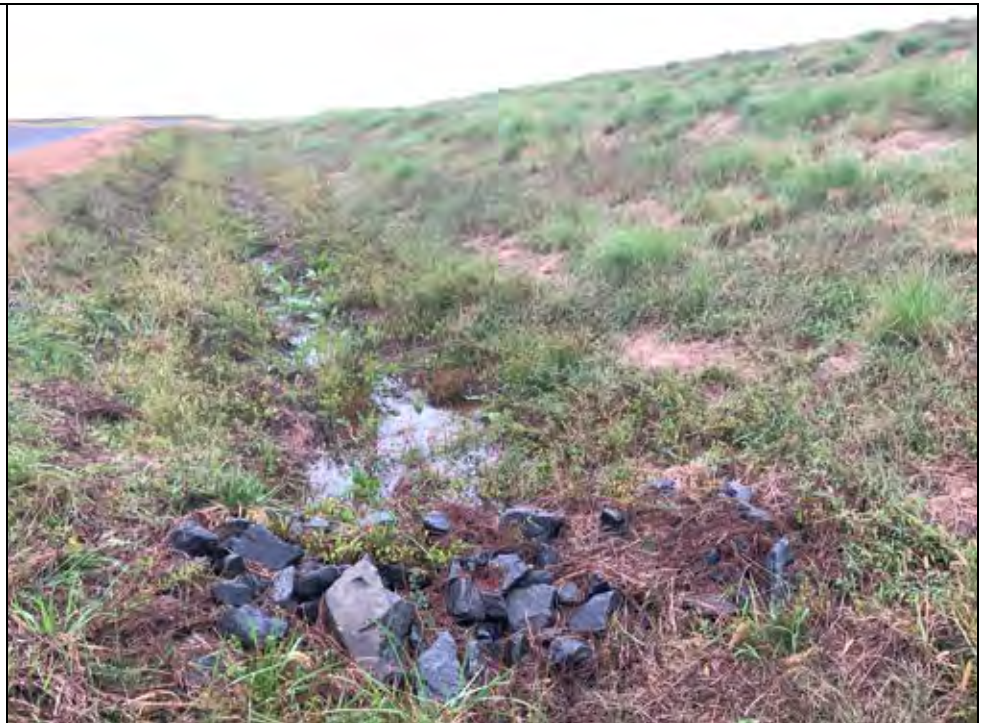
Image: 7519  
Date: 10/29/2020  
Time: 8:11 AM  
Direction: West Northwest

Rock check dam along access road ditch. Functioning as intended.

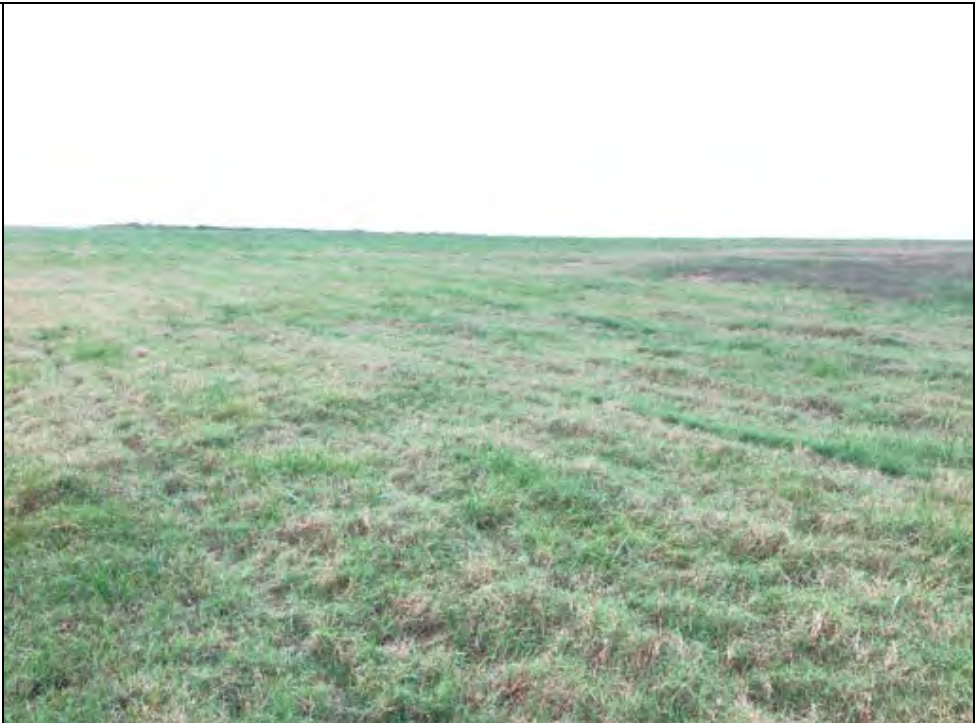
Final cover on plateau.  
Vegetation is well established. No signs of animal burrows or erosion.

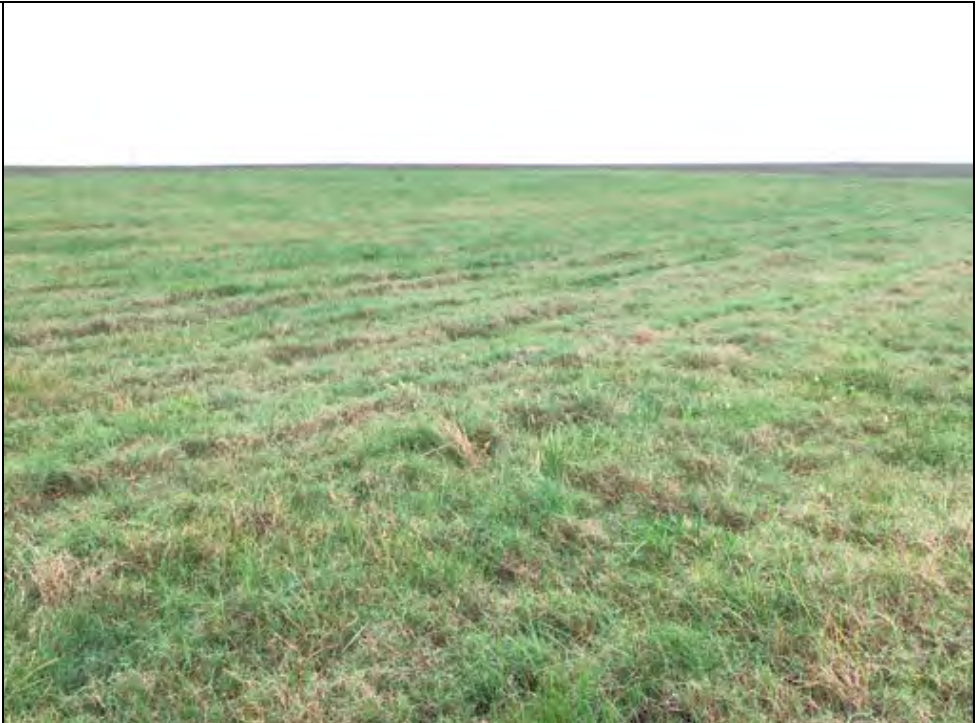
Image: 7525  
Date: 10/29/2020  
Time: 8:16 AM  
Direction: West Northwest

Final cover on plateau.  
Vegetation is well established. No signs of animal burrows or erosion.
