2022 ANNUAL CCR UNIT INSPECTION
INDIAN RIVER LANDFILL
NRG INDIAN RIVER STATION
DAGSBORO, DELAWARE

SCS ENGINEERS

25221158.00 | January 18, 2023

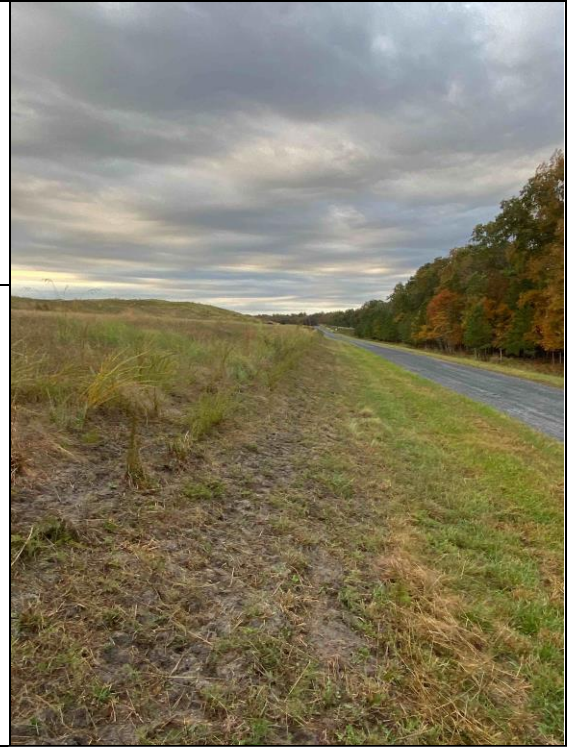
Image Number: 1057
Date: October 18, 2022
Time: 6:55 AM
Direction: South

Description: Outer side slope of Phase II, Cell 2. The side slope is well vegetated and maintained. No signs of vegetative stress, erosion, or geotechnical instability.

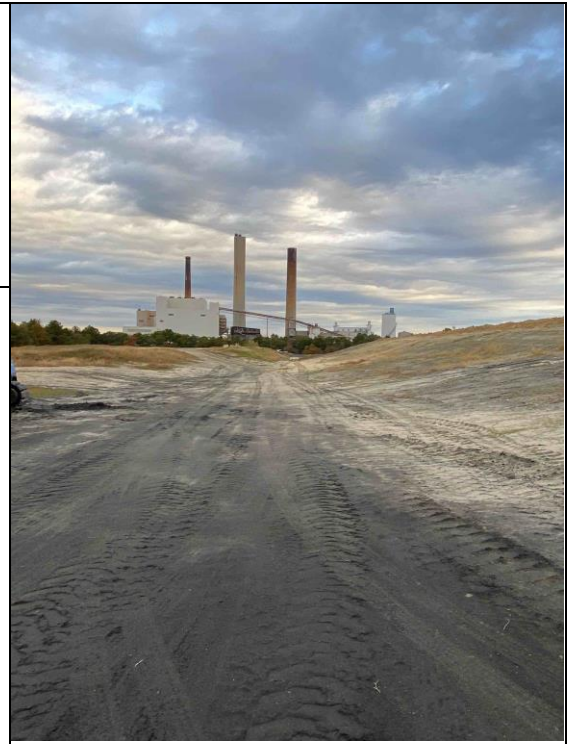
Image Number: 1061
Date: October 18, 2022
Time: 7:01 AM
Direction: North

Description: Intermediate cover has been placed over Phase II, Cell 2 during periods of inactivity. Material is well graded and compacted.

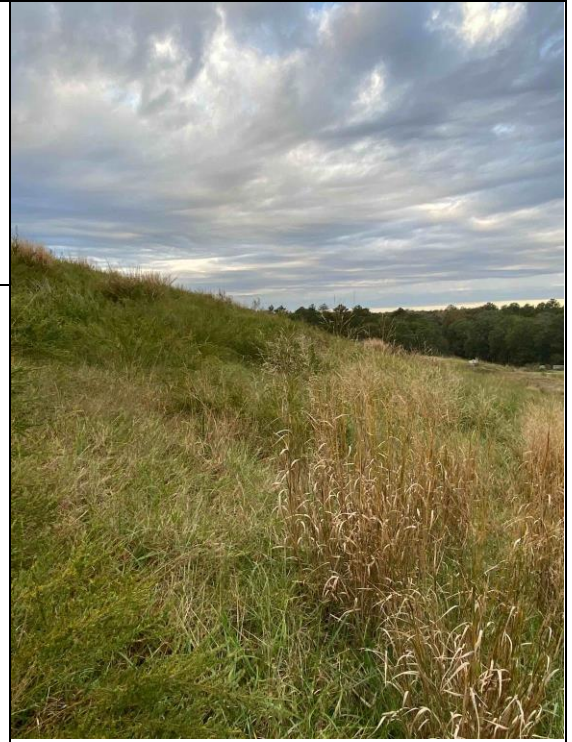
Image Number: 1063
Date: October 18, 2022
Time: 7:03 AM
Direction: West

Description: Phase II, Cell 1 / Cell 2 boundary. Slopes are well vegetated with no sign of erosion, sloughing, or animal borrows.

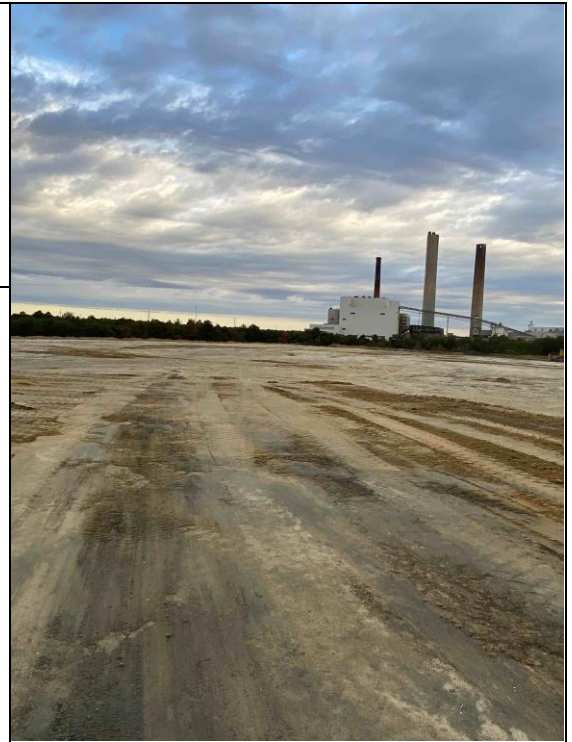
Image Number: 1065
Date: October 18, 2022
Time: 7:04 AM
Direction: North-Northwest

Description: Active face is well maintained. Material is graded and compacted.

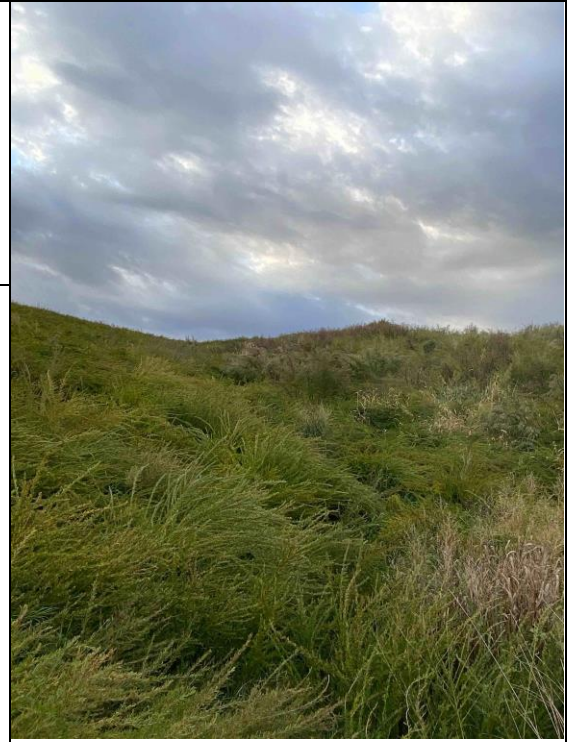
Image Number: 1067
Date: October 18, 2022
Time: 7:04 AM
Direction: Southeast

Description: Elbow of Phase I/Phase II Cell 1 confluence, looking upslope. Vegetation is thick and healthy.

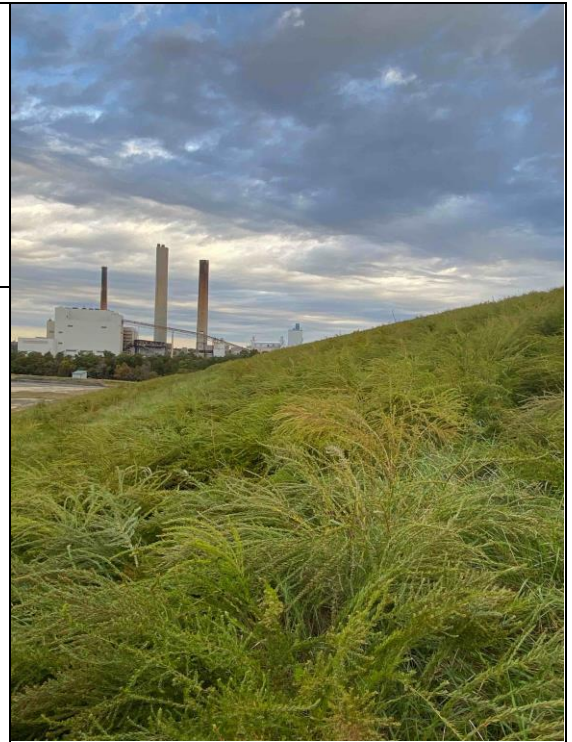
Image Number: 1071
Date: October 18, 2022
Time: 7:06 AM
Direction: North

Description: Overview of the active face and Phase I intermediate cover slopes. Slopes are well vegetated with no signs of erosion, sloughing, or animal borrows.

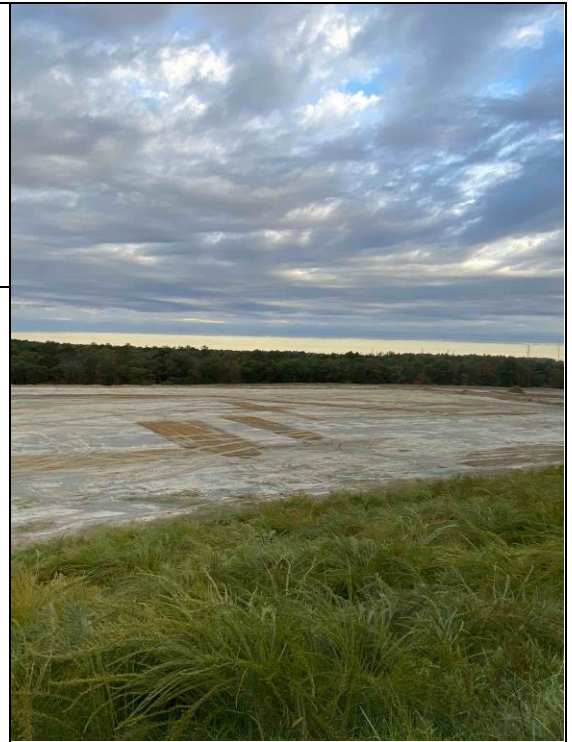
Image Number: 1073
Date: October 18, 2022
Time: 7:06 AM
Direction: Northwest

Description: Active face in the background is well maintained and orderly. Material is graded and compacted.

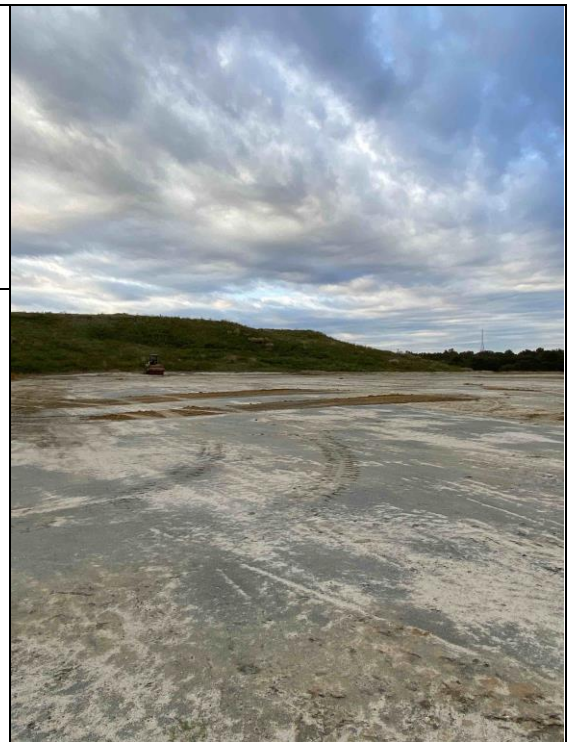
Image Number: 1075
Date: October 18, 2022
Time: 7:08 AM
Direction: South-Southwest

Description: Intermediate cover soils in foreground have been installed at the toe of slope within Phase I to collect and transfer non-contact water to the north and away from the active face.

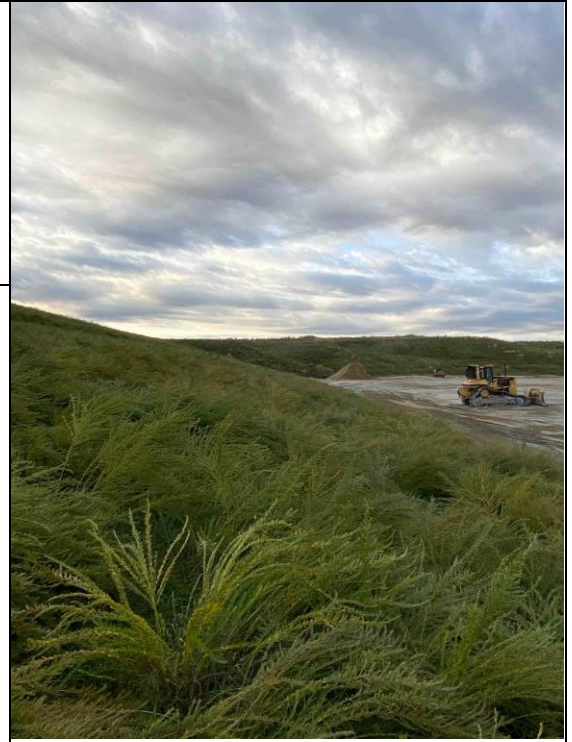
Image Number: 1079
Date: October 18, 2022
Time: 7:11 AM
Direction: South

Description: Vegetation on side slopes is well established. No signs of erosion, sloughing, or animal borrows.

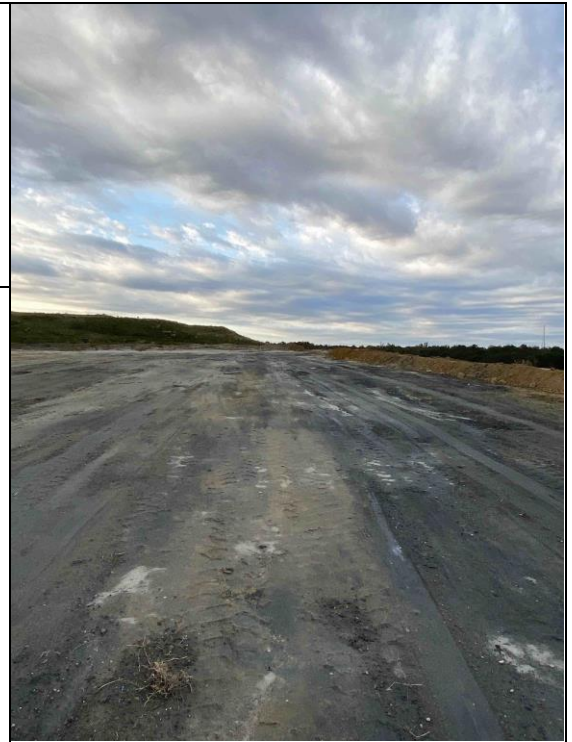
Image Number: 1081
Date: October 18, 2022
Time: 7:12 AM
Direction: South-Southwest

Description: Active face is well graded and maintained

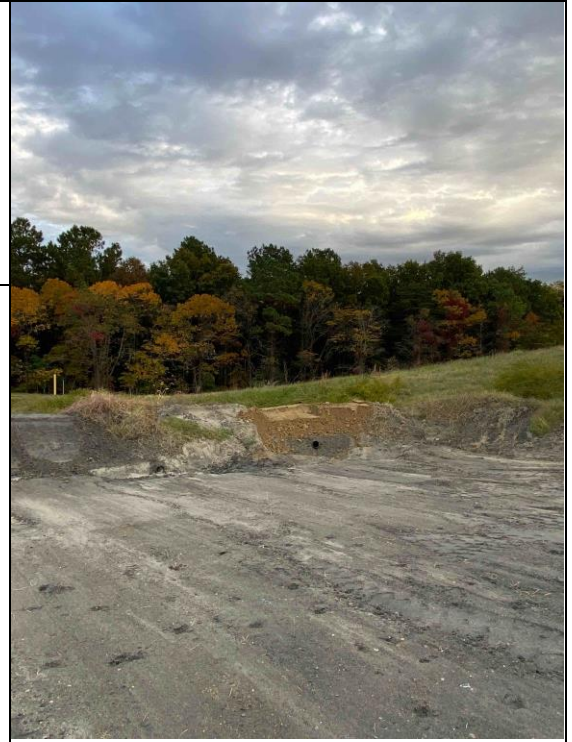
Image Number: 1083
Date: October 18, 2022
Time: 7:13 AM
Direction: East-Northeast

Description: Intermediate cover soils at the toe of slope within Phase I drain north to this location. Non-contact water enters into this pipe shown in the middle of the photograph and is conveyed to the adjacent landfill perimeter (non-contact water) ditch.

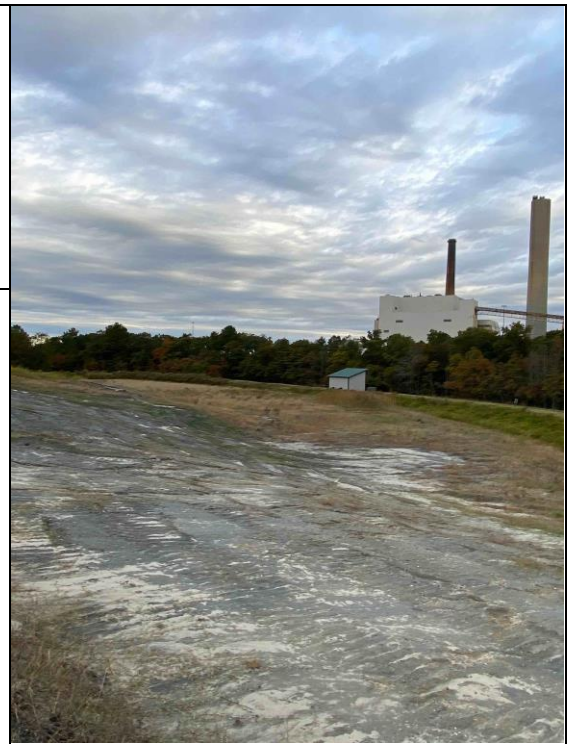
Image Number: 1085
Date: October 18, 2022
Time: 7:13 AM
Direction: North-Northwest

Description: Overview of sump area of Phase II, Cell 2. No standing water/leachate. Intermediate cover soils are in foreground. Water that lands on top of intermediate cover soils are managed as non-contact water.

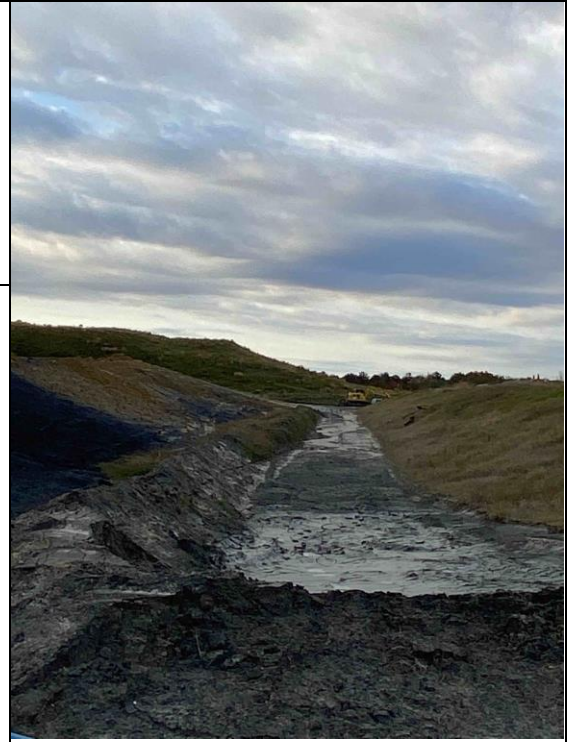
Image Number: 1089
Date: October 18, 2022
Time: 7:15 AM
Direction: South

Description: Interior drainage ditch for contact water collection and diversion to the Phase II, Cell 2 sump.

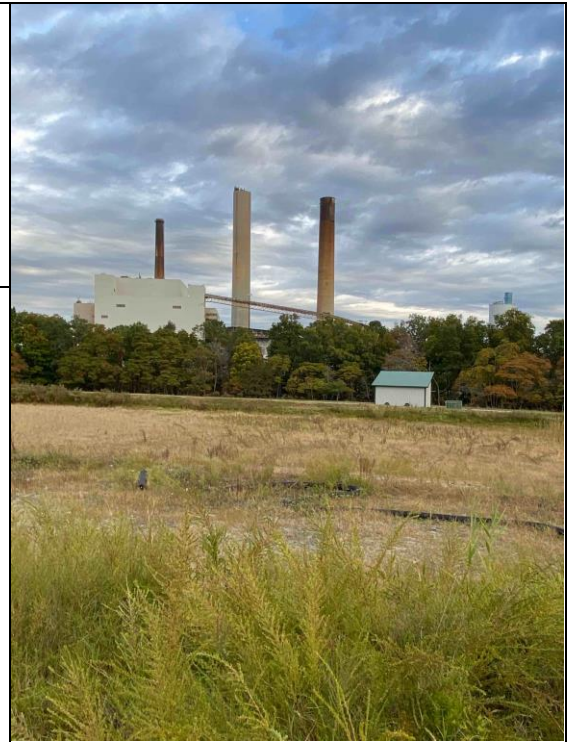
Image Number: 1091
Date: October 18, 2022
Time: 7:17 AM
Direction: North

Description: Sump area within the Phase II, Cell 2 area that collects contact water. No standing water was observed.

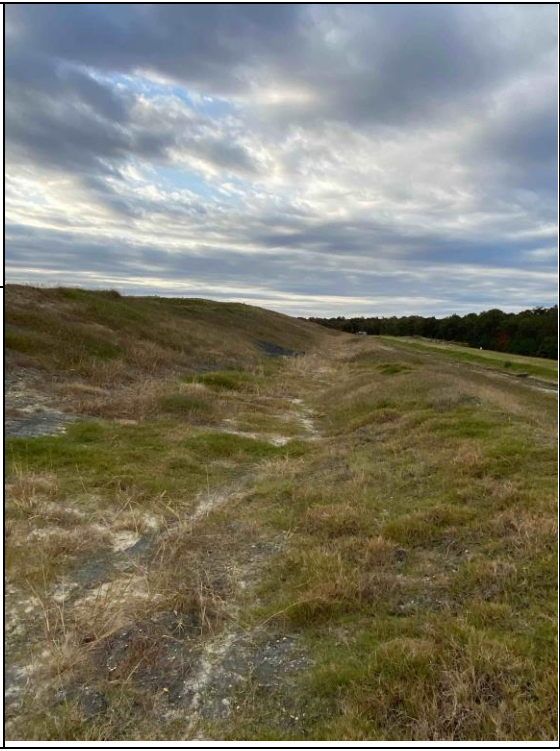
<p>Image Number: 1093 Date: October 18, 2022 Time: 7:31 AM Direction: South</p>

<p>Description: Diversion berm and ditch with intermediate cover soils to collect and transfer non-contact water from the western, exterior side slope of the active area. Diversion ditch conveys non-contact water to the south and away from the active face.</p>

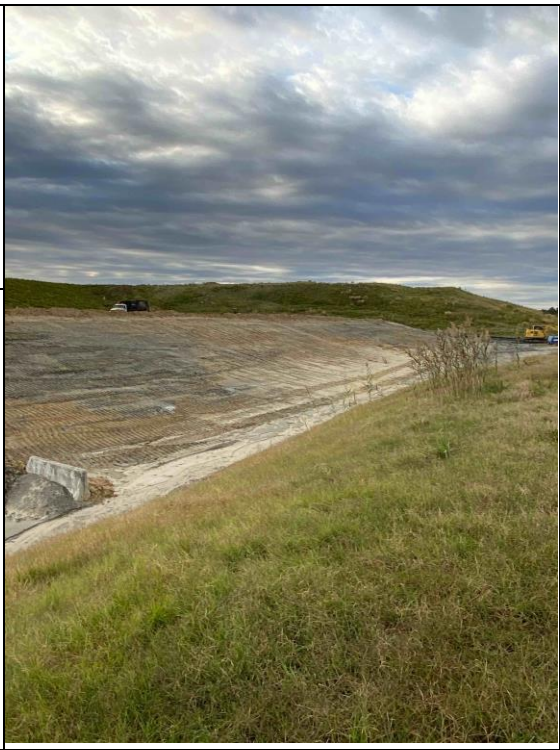
<p>Image Number: 1099 Date: October 18, 2022 Time: 7:36 AM Direction: South-Southeast</p>

<p>Description: Interior drainage ditch for contact water collection. Jersey barriers and rock checks are used to slow water and minimize erosion.</p>

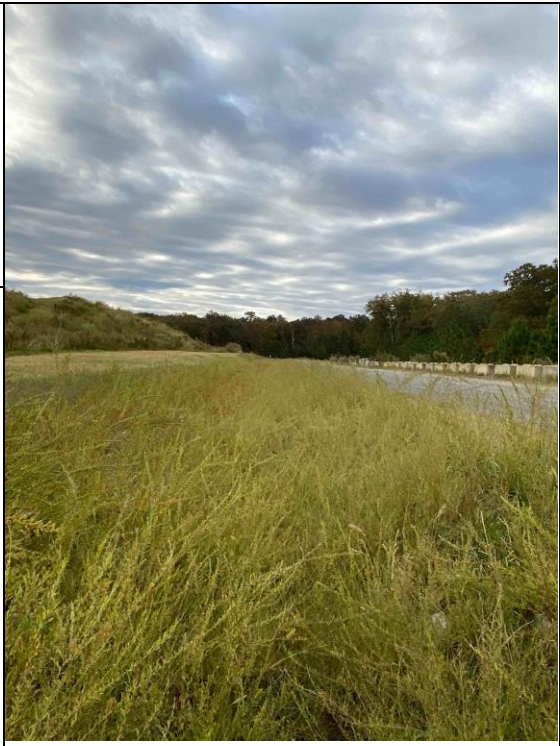
<p>Image Number: 1101 Date: October 18, 2022 Time: 7:49 AM Direction: South</p>

<p>Description: Drainage ditch of Phase II, Cell 1. Vegetation is well established and is periodically mowed.</p>

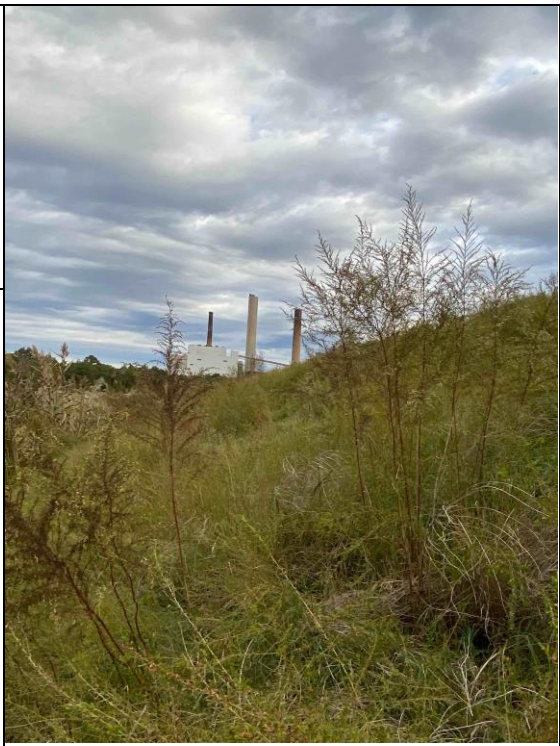
<p>Image Number: 1103 Date: October 18, 2022 Time: 7:50 AM Direction: North</p>

<p>Description: Outer side slope of Phase II, Cell 2. The side slope is well vegetated and maintained. No signs of vegetative stress, erosion, or geotechnical instability.</p>

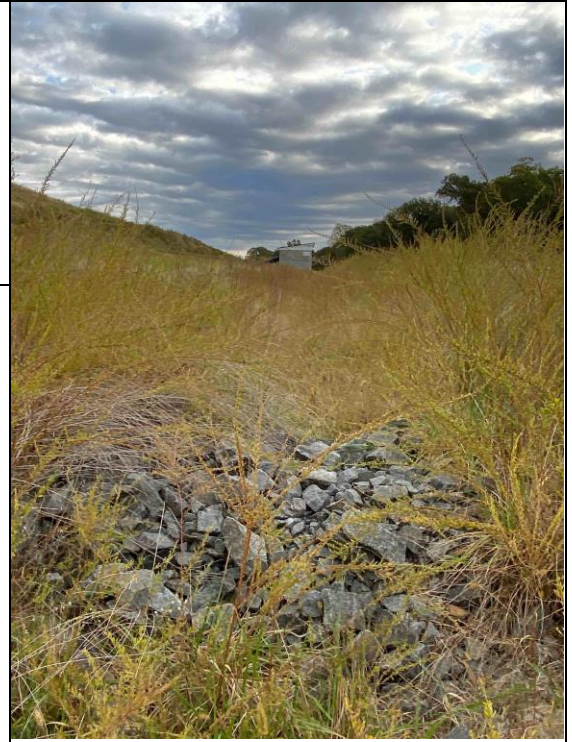
Image Number: 1105
 Date: October 18, 2022
 Time: 7:53 AM
 Direction: East-Northeast

Description: Perimeter ditch segment with dense, healthy vegetation. Erosion control functioning and in good condition. No signs of vegetative stress or erosion. Rock checks are used to slow water and minimize erosion.

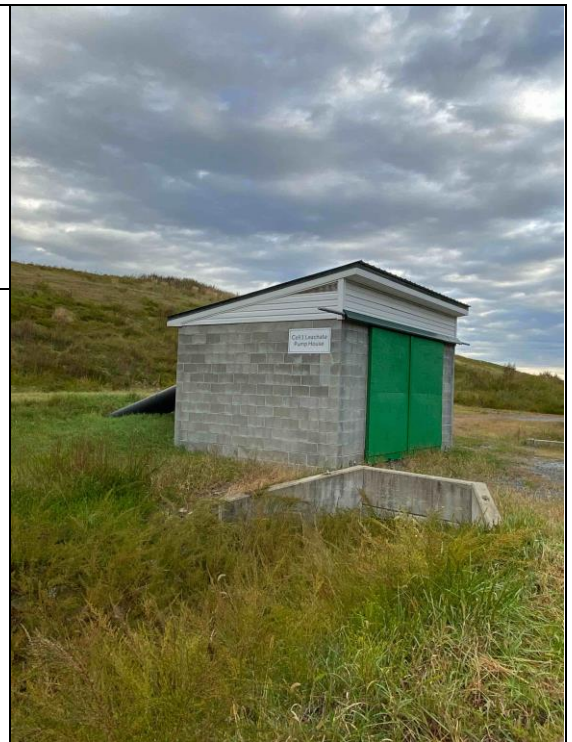
Image Number: 1111
 Date: October 18, 2022
 Time: 7:56 AM
 Direction: Northeast

Description: Phase I, Cell 1 leachate pump house and storm water culvert. Building is appropriately marked (signage). Culvert is free of obstruction.

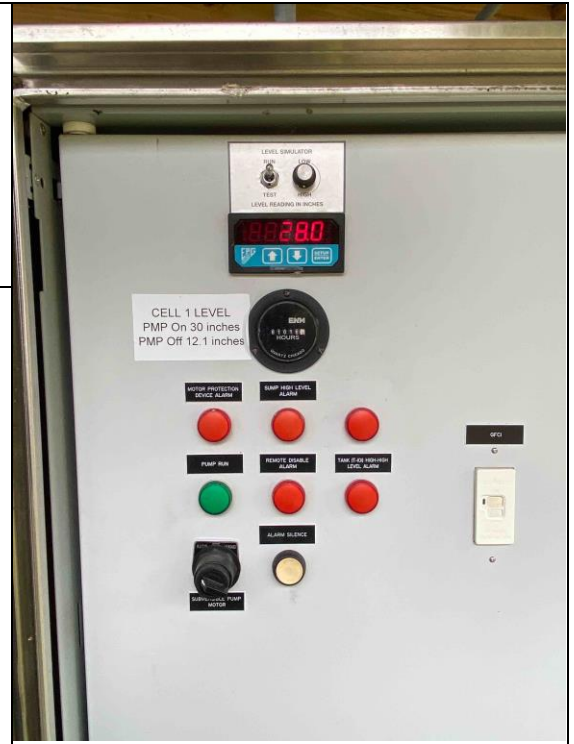
Image Number: 1113
 Date: October 18, 2022
 Time: 7:57 AM
 Direction: North

Description: Phase I, Cell 1 leachate liquid level indicator and controls in good working condition.

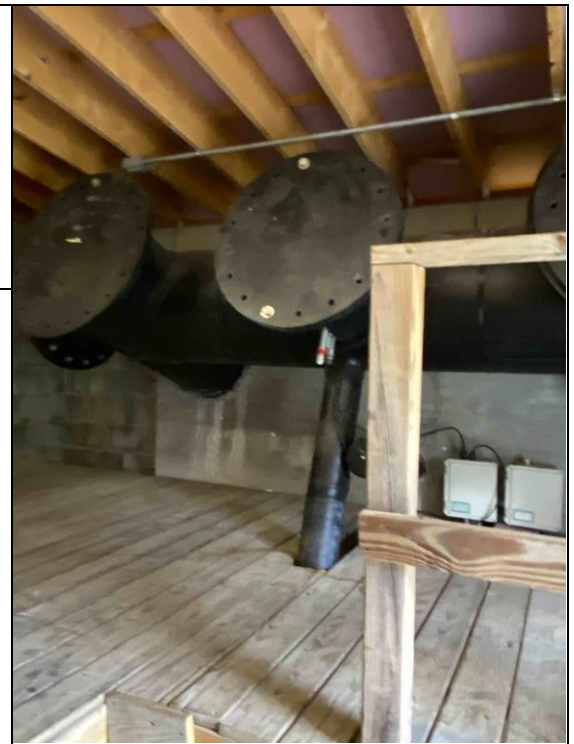
Image Number: 1115
 Date: October 18, 2022
 Time: 7:58 AM
 Direction: Northwest

Description: Inside the Phase I, Cell 1 leachate pump house. Cleanout riser and pump risers with T-connections to forcemain are shown in this photograph. Building is well maintained.

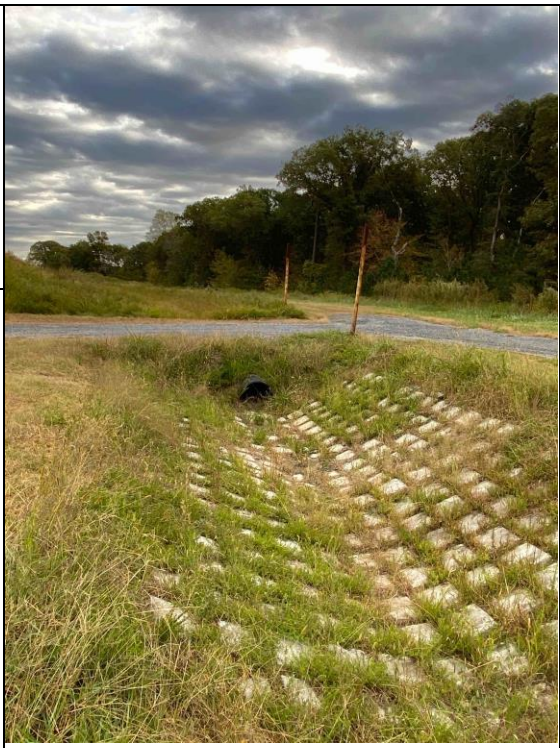
<p>Image Number: 1117 Date: October 18, 2022 Time: 7:58 AM Direction: East</p>

<p>Description: Perimeter landfill ditch segment and culvert underneath access roadway. Culvert and ditch segment are in good working condition with no obstructions. Vegetation density and growth is healthy.</p>

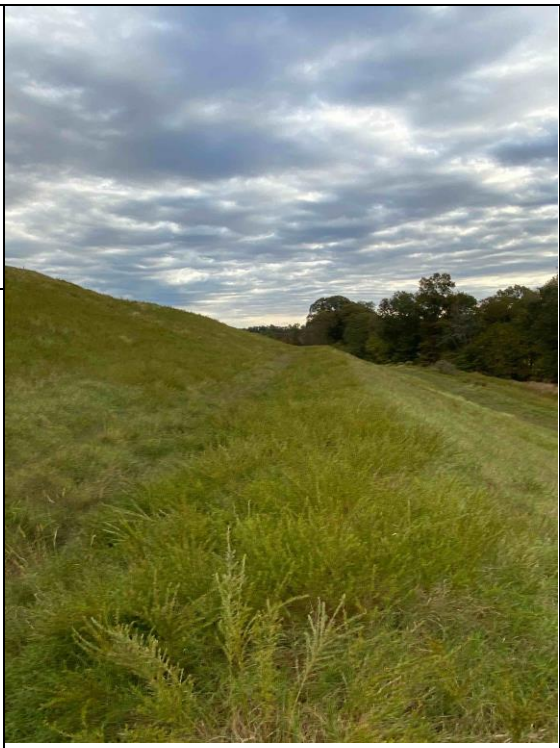
<p>Image Number: 1119 Date: October 18, 2022 Time: 8:03 AM Direction: East-Northeast</p>

<p>Description: Terrace berm segment on the Phase I landfill side slope. Clear of obstructions and functioning as intended. Vegetative cover is dense and healthy.</p>

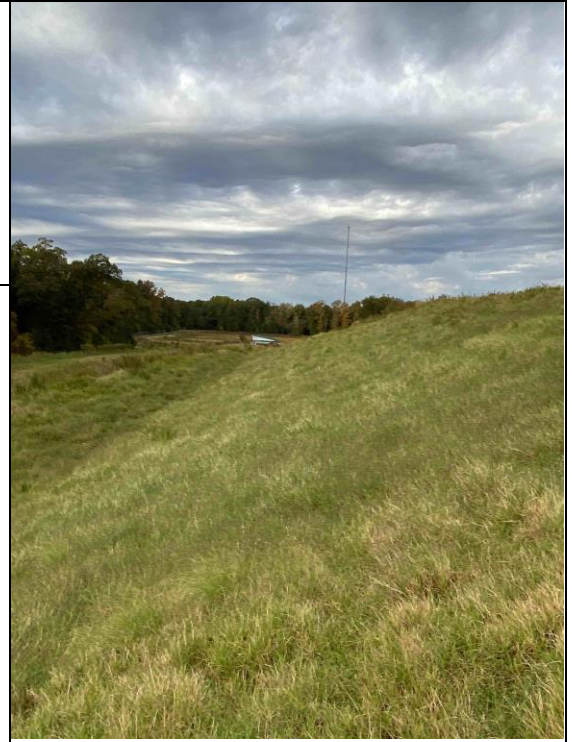
Description: Final cover on side slopes of Phase II, Cell 1. Vegetation is healthy with full coverage. No signs of erosion or stability issues were observed.

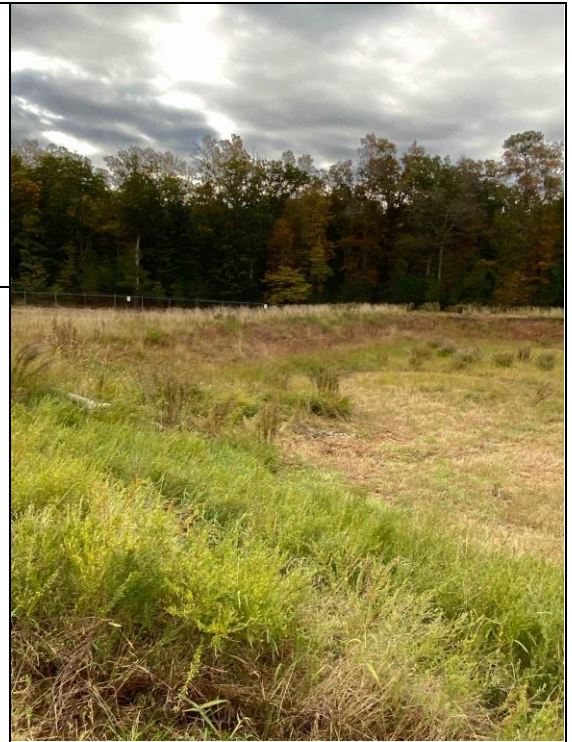
Image Number: 1125
Date: October 18, 2022
Time: 8:06 AM
Direction: Southeast

Description: Southeast Detention Basin forebay in good condition. Vegetation coverage is dense and healthy. No standing water was observed.

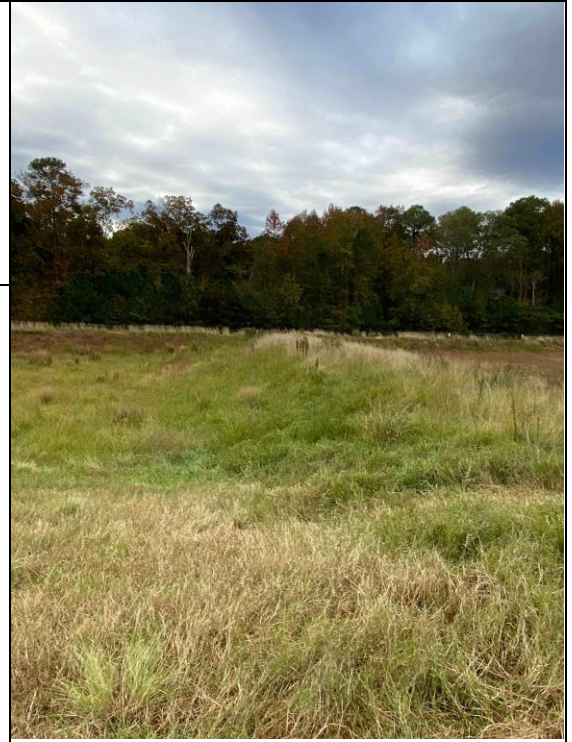
Description: Forebay berm within the Southeast Detention Basin in good condition. Vegetation coverage is dense and healthy.

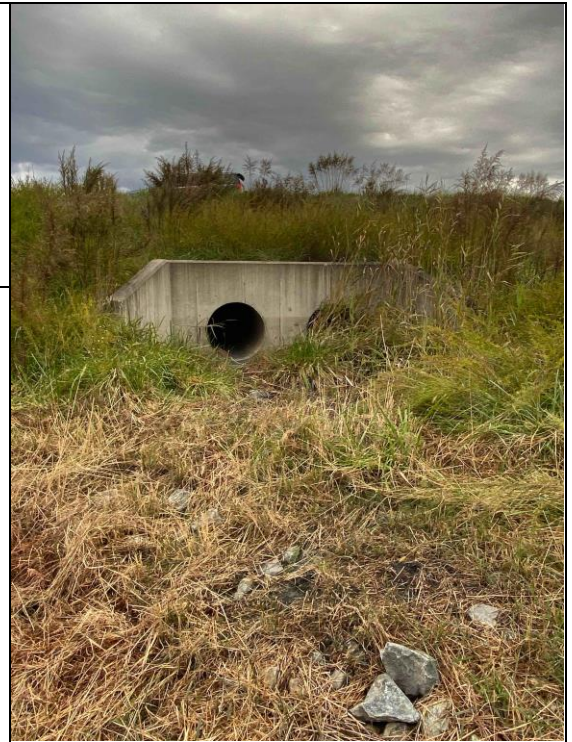
Image Number: 1129
Date: October 18, 2022
Time: 8:07 AM
Direction: North-Northeast

Description: Inlet to Southeast Detention Basin forebay in good condition. Clear of obstruction at inlets and outlets.

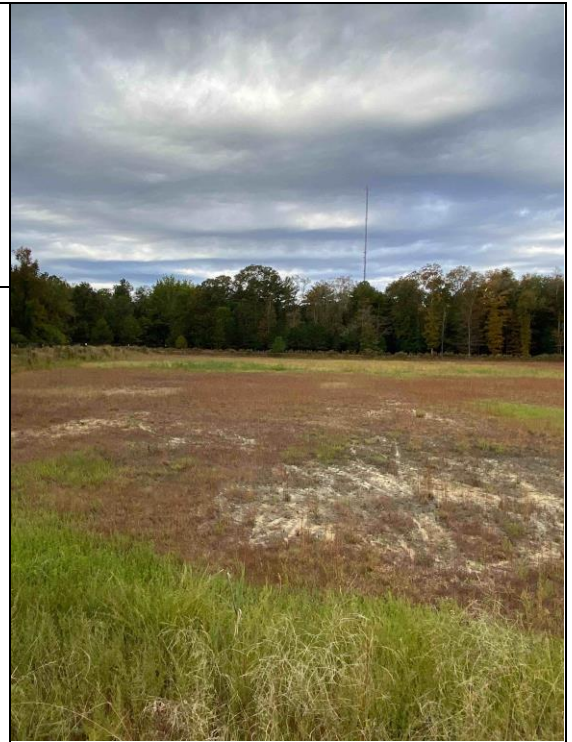
Description: Southeast Detention Basin in good condition. Vegetation coverage is dense and healthy. No standing water was observed.

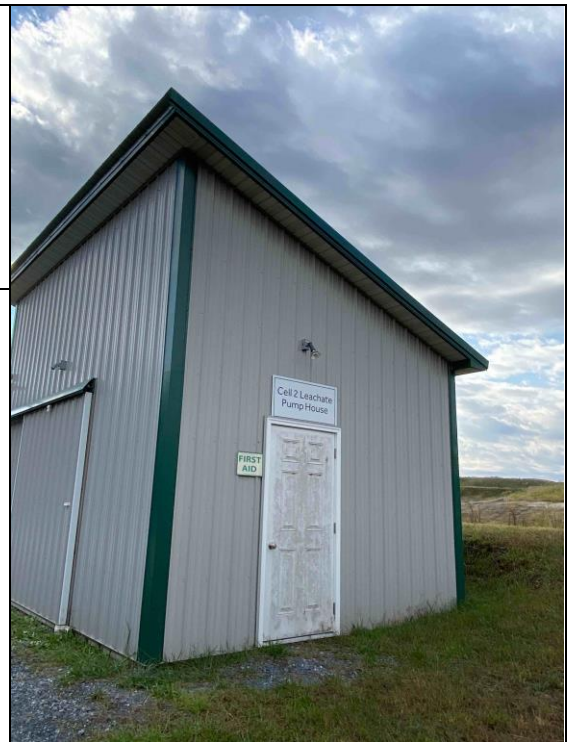
Image Number: 1193
Date: October 18, 2022
Time: 8:34 AM
Direction: South-Southeast

Description: Phase II, Cell 2 leachate pump house. Building exterior is in good condition. Building is appropriately marked (signage).

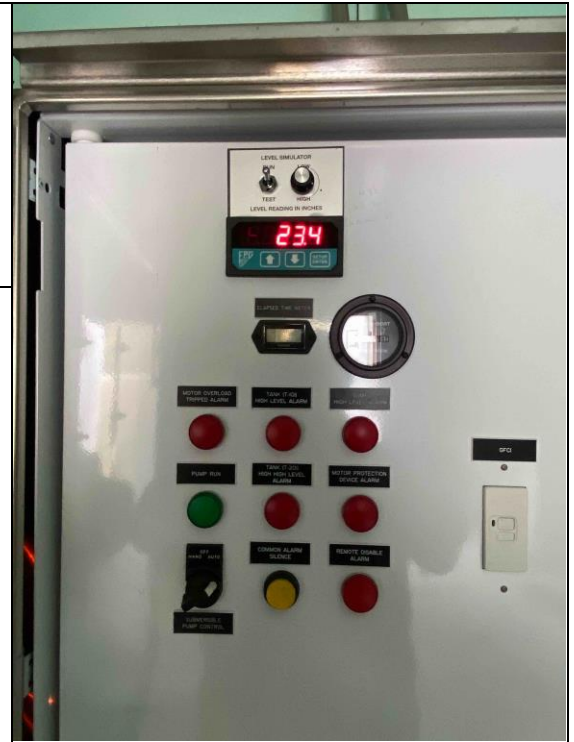
Description: Phase II, Cell 2 leachate liquid level indicator and controls in good working condition.

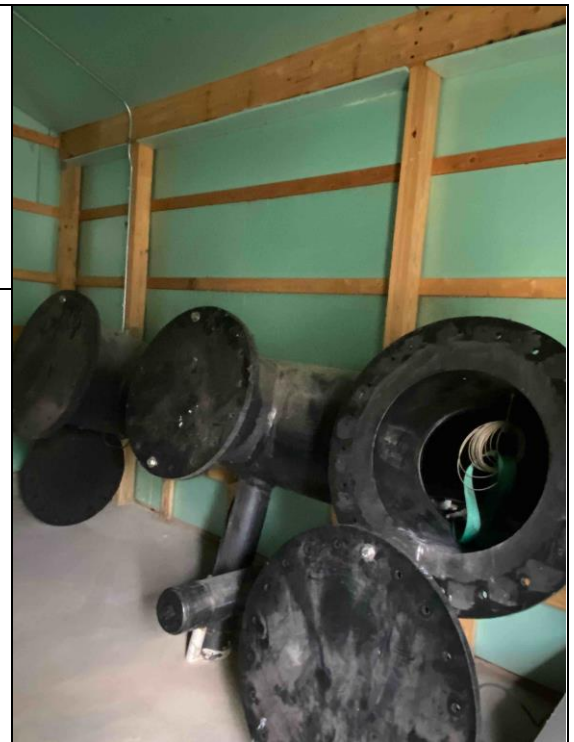
Image Number: 1197
Date: October 18, 2022
Time: 8:35 AM
Direction: South-Southeast

Description: Inside the Phase II, Cell 2 leachate pump house. Cleanout riser and pump risers with T-connections to forcemain are shown in this photograph. Building is well maintained.

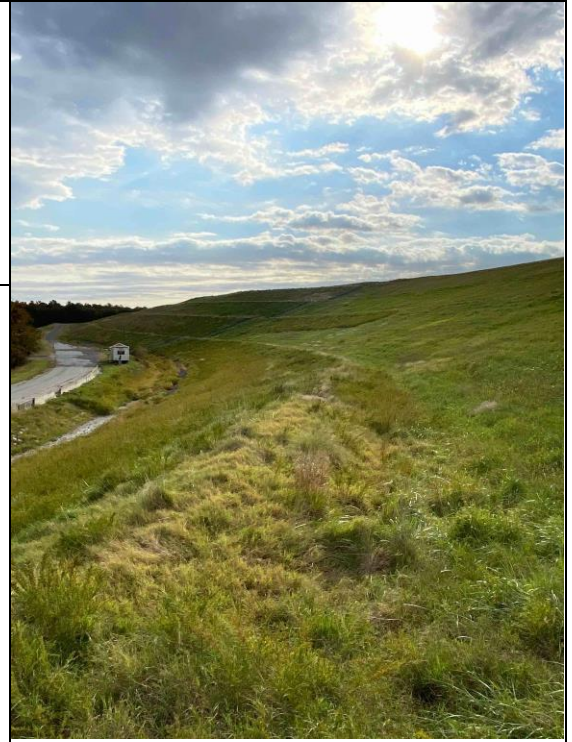
Description: Landfill side slopes and terrace are well maintained. No evidence of slope stability issues or erosion.

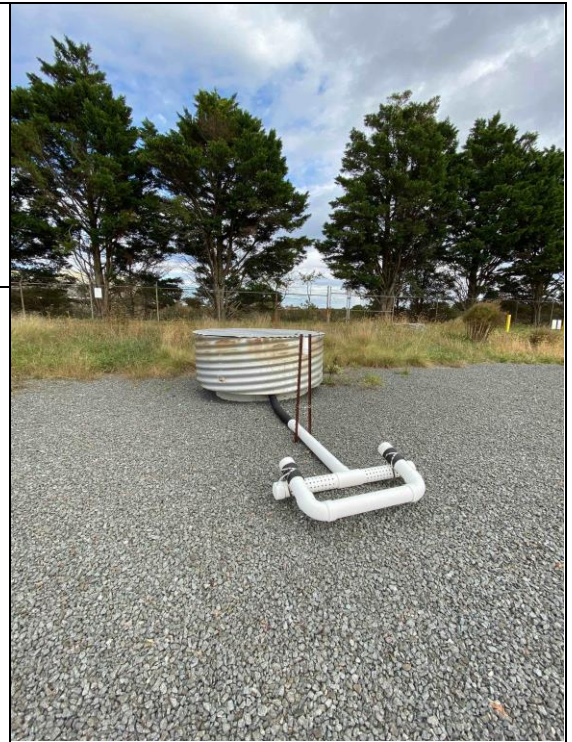
Image Number: 1271
Date: October 18, 2022
Time: 9:10 AM
Direction: North-Northeast

Description: Northeast Detention Basin outlet floating skimmer in good condition. No standing water in main basin area.

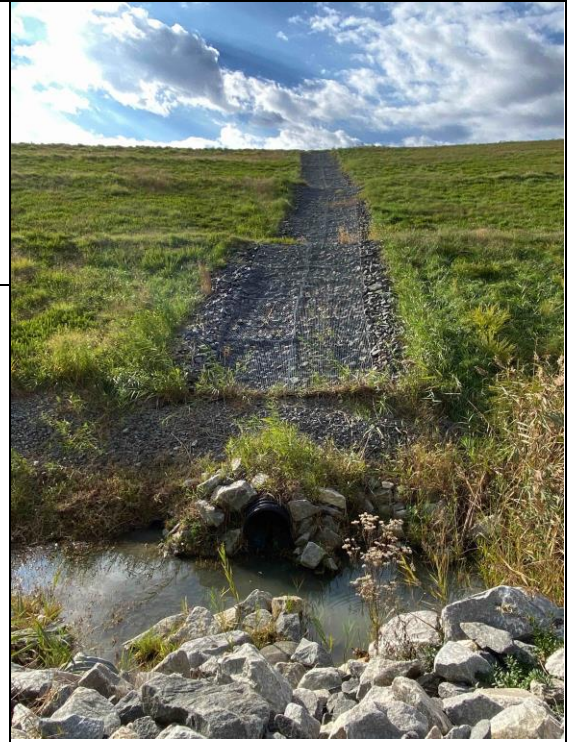
Description: Downchute near southwest forebay of the Northeast Detention Basin. Pipe and downchute are functioning appropriately, as intended.

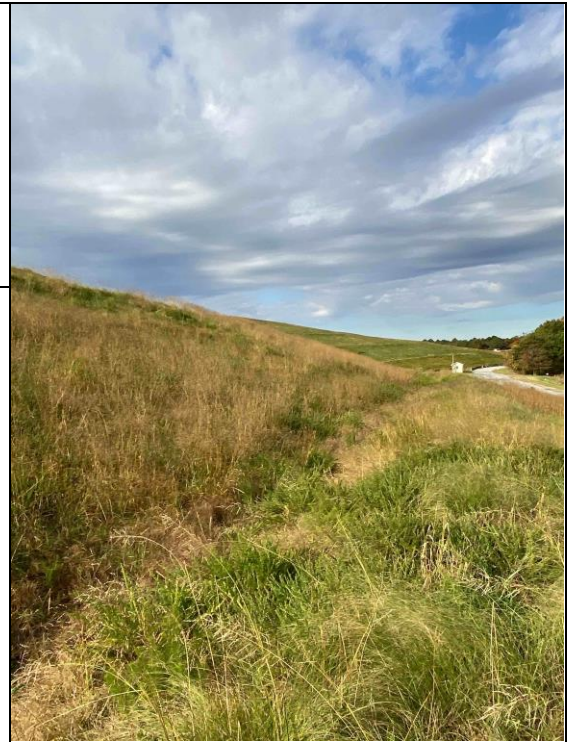
Image Number: 1207
Date: October 18, 2022
Time: 8:43 AM
Direction: West

Description: Phase I final cover and terrace berm. Vegetation coverage is dense and healthy.

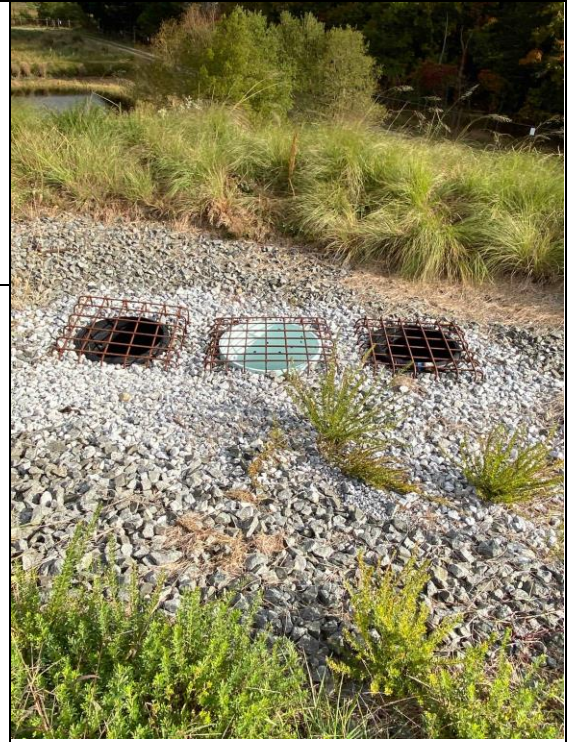
Description: Phase I corner downchute road crossing pipes inlets with grated covers. Free of obstructions and functioning.

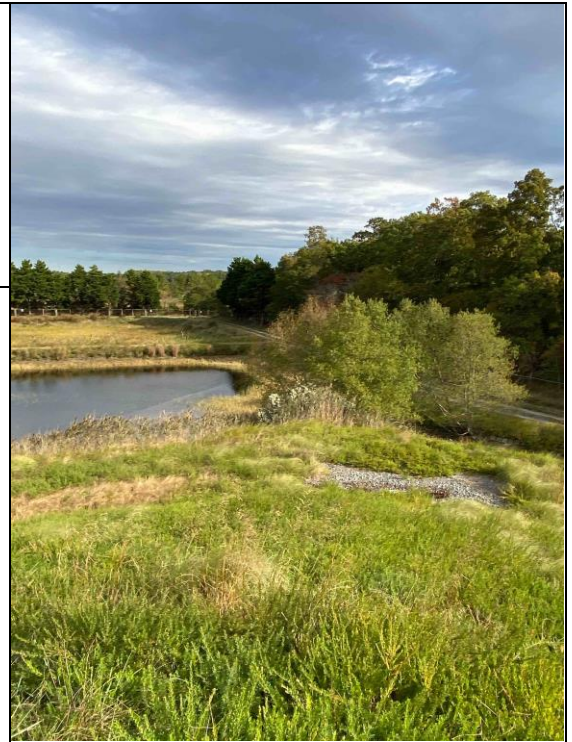
Image Number: 1213
Date: October 18, 2022
Time: 8:45 AM
Direction: North-Northeast

Description: Phase I corner downchute road crossing pipe outlets into southeast forebay of the Northeast Detention Basin. No erosion was observed.

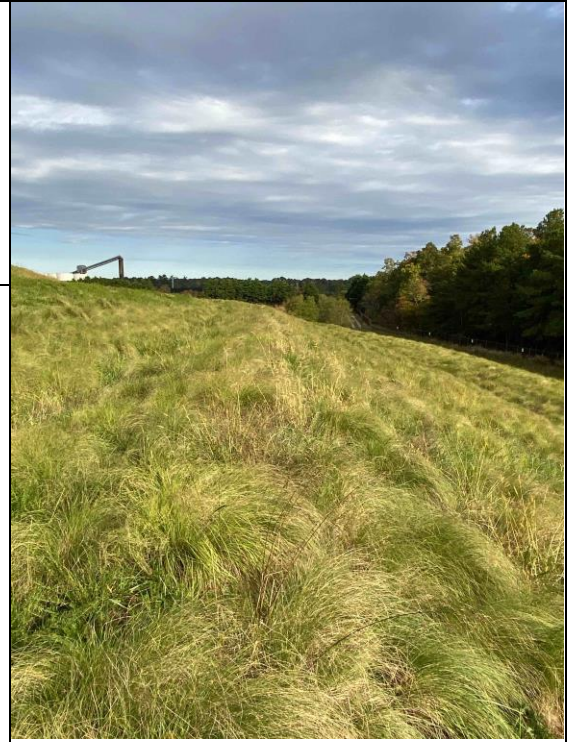
Description: Phase I final cover. Vegetation coverage is dense and healthy.

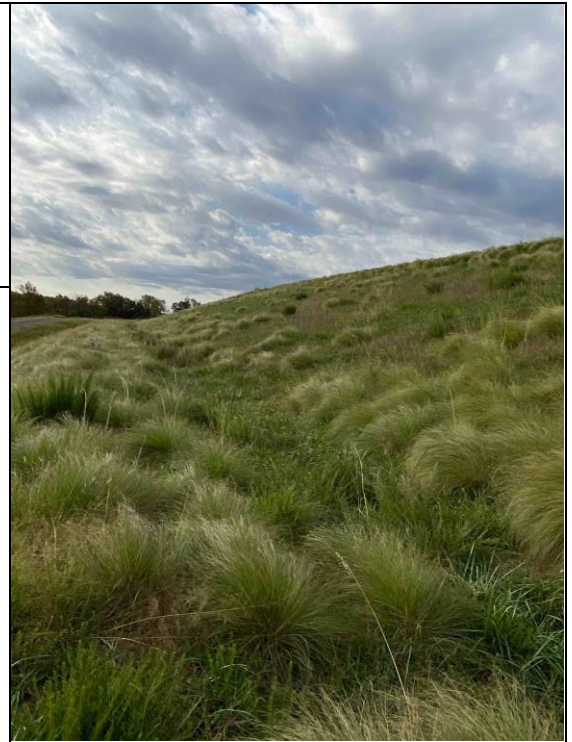
Image Number: 1217
Date: October 18, 2022
Time: 8:48 AM
Direction: South

Description: Phase I side slopes and terrace berm are well maintained. No evidence of slope stability issues or erosion.

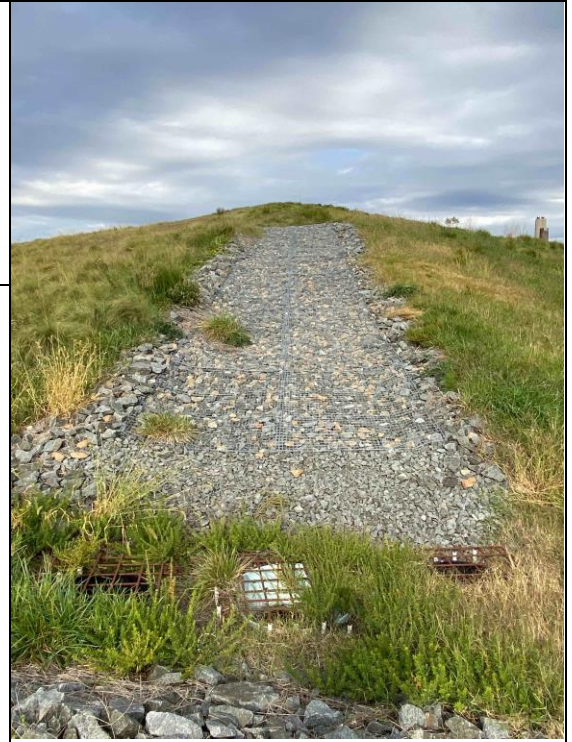
Description: Phase I downchute (background) sloped to downchute road crossing pipe inlets (foreground). Both features are in good working order.

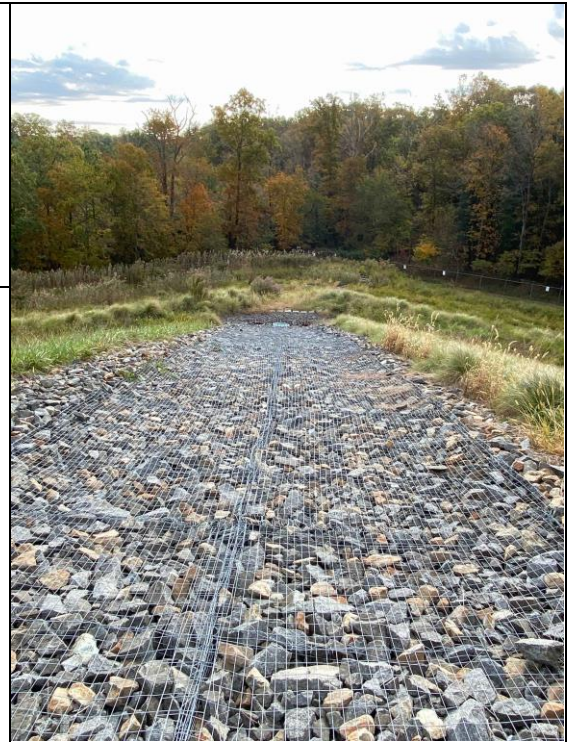
Image Number: 1221
Date: October 18, 2022
Time: 8:50 AM
Direction: East-Southeast

Description: Phase I downchute appears to be functioning as intended. No signs of washout, erosion, or stability issues.

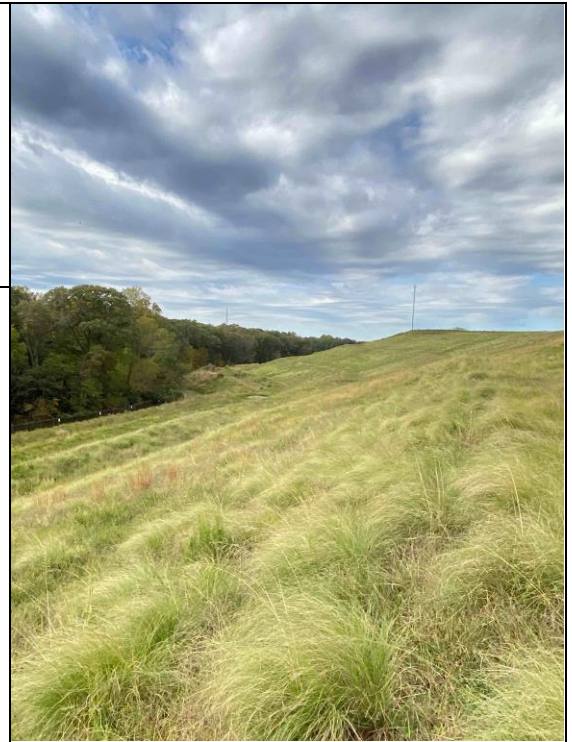
Description: Phase I final cover. Vegetation coverage is dense and healthy.

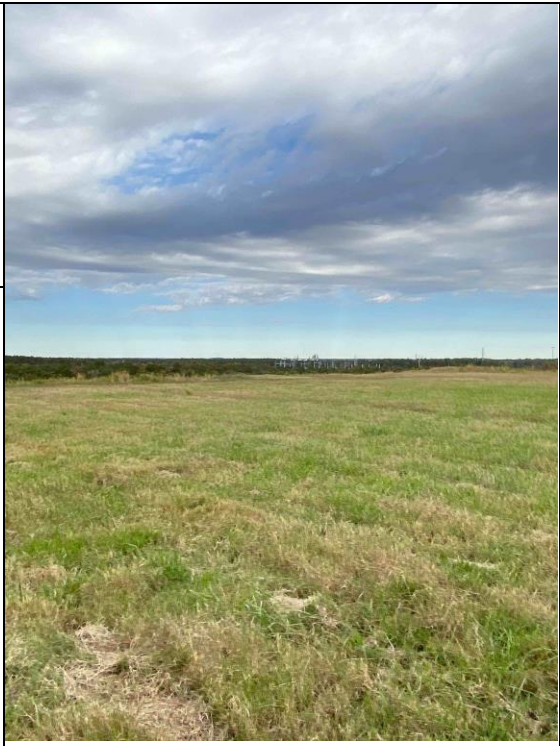
<p>Image Number: 1237 Date: October 18, 2022 Time: 8:55 AM Direction: West-Northwest</p>

<p>Description: Phase II final cover plateau area. Vegetation coverage is dense and healthy.</p>

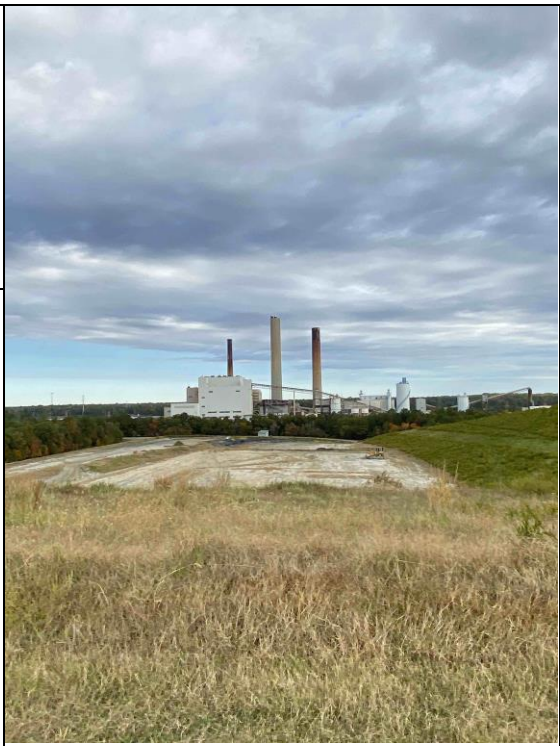
<p>Description: Overlooking Phase II, Cell 2 active area from Phase II, Cell 1 plateau. Phase II final cover plateau. Vegetation is well established with no signs of erosion, sloughing, or animal burrows.</p>
