2023 ANNUAL CCR UNIT INSPECTION
INDIAN RIVER LANDFILL
NRG INDIAN RIVER STATION
DAGSBORO, DELAWARE

SCS ENGINEERS

25221158.00 | January 18, 2024

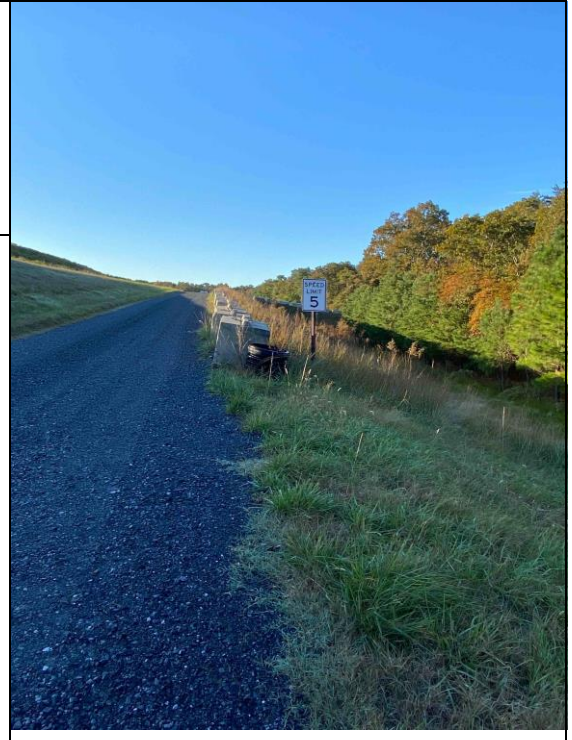
Image Number: 3296
Date: 10/17/2023
Time: 7:13 AM
Direction: South-Southwest

Description:
Speed limit sign and outer side slope of Phase II, Cell 2. The side slope is well vegetated and maintained. No signs of vegetative stress, erosion, or geotechnical instability. Road is well maintained.

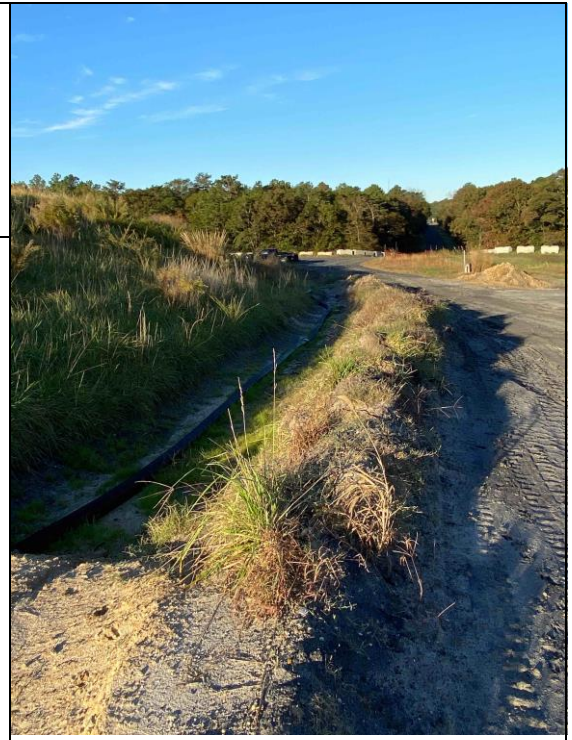
Image Number: 3298
Date: 10/17/2023
Time: 7:16 AM
Direction: West

Description:
Phase II, Cell 1/Cell 2 boundary. Non-contact water that drains from the Cell 1 boundary is intercepted by a constructed berm and ditch and is directed to the stormwater perimeter channel.

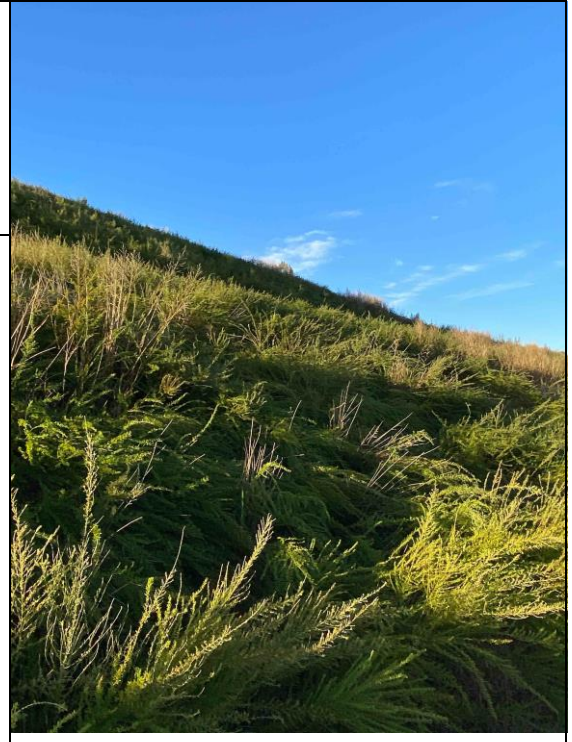
Image Number: 3302
Date: 10/17/2023
Time: 7:18 AM
Direction: Southwest

Description:
Phase II, Cell 1 / Cell 2 boundary. Slopes are well vegetated with no sign of erosion, sloughing, or animal borrows.

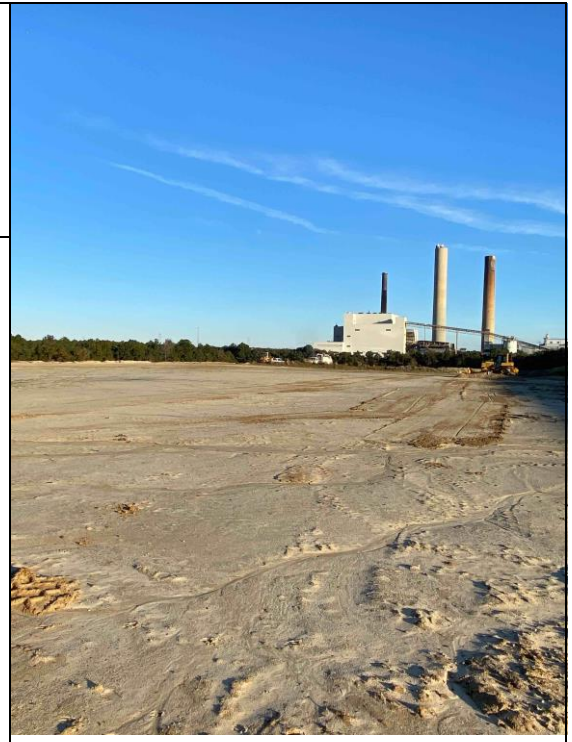
Image Number: 3304
Date: 10/17/2023
Time: 7:19 AM
Direction: North-Northwest

Description:
Phase II Cell 2 intermediate cover. Material is graded to drain to the north. The intermediate cover is well maintained.

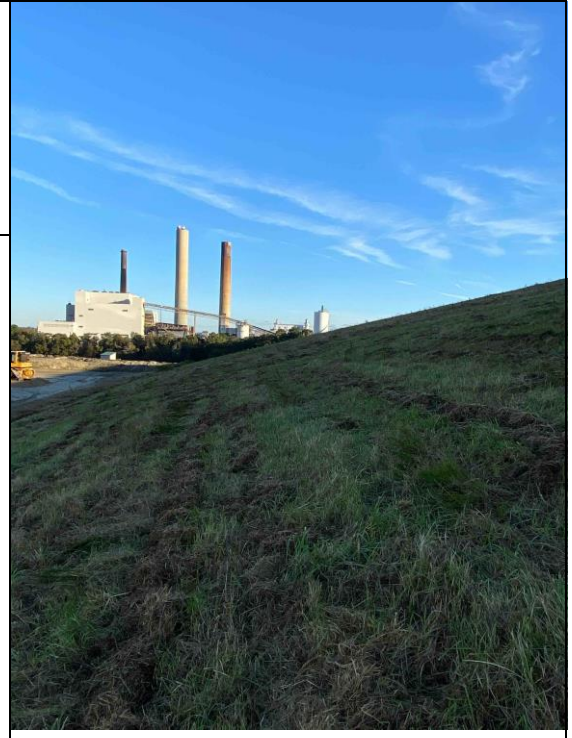
Image Number: 3306
Date: 10/17/2023
Time: 7:20 AM
Direction: North

Description:
Overview of the vegetated Phase I intermediate cover slopes.
No signs of erosion, sloughing, or animal borrows.

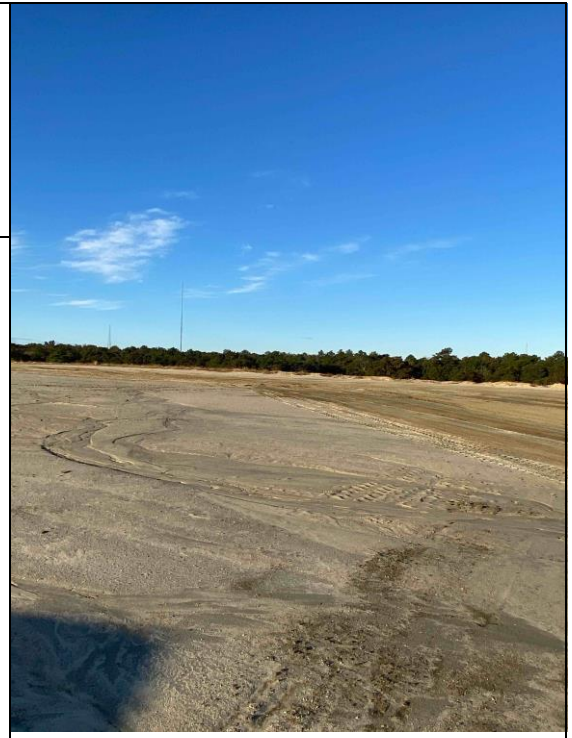
Image Number: 3308
Date: 10/17/2023
Time: 7:21 AM
Direction: West-Southwest

Description:
Phase II Cell 2 intermediate cover. Material is graded to drain to north and is well maintained.

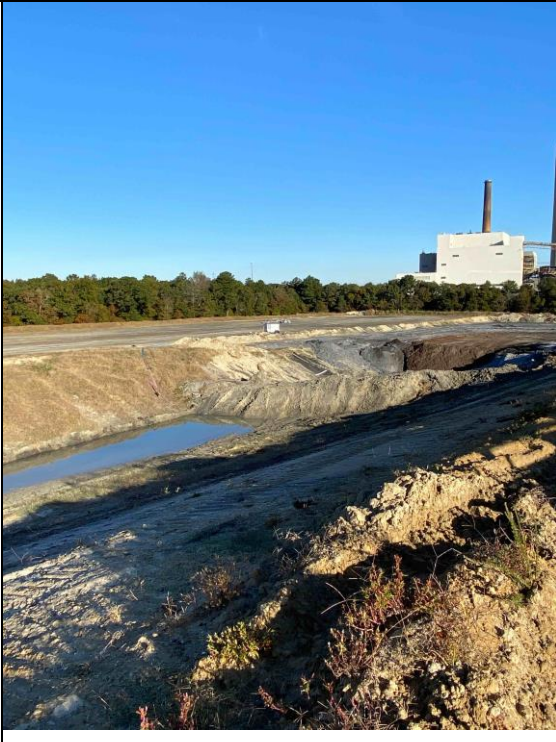
Image Number: 3310
Date: 10/17/2023
Time: 7:54 AM
Direction: North-Northwest

Description:
Non-contact water flowing over intermediate cover. The water is slowed through berms to minimize erosion. Water flows through pipes located at the toe of the berm.

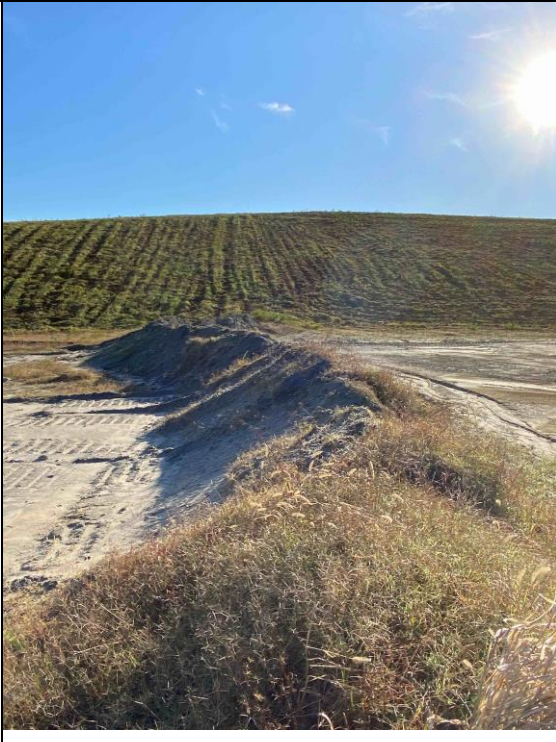
Image Number: 3312
Date: 10/17/2023
Time: 7:54 AM
Direction: East

Description:
Erosion control berm installed on top of the intermediate cover to slow sheet flow and direct non-contact water. Non-contact water intercepted by the berm is discharged through pipes located at the toe of the berm. These pipes discharge to the perimeter non-contact water channel.

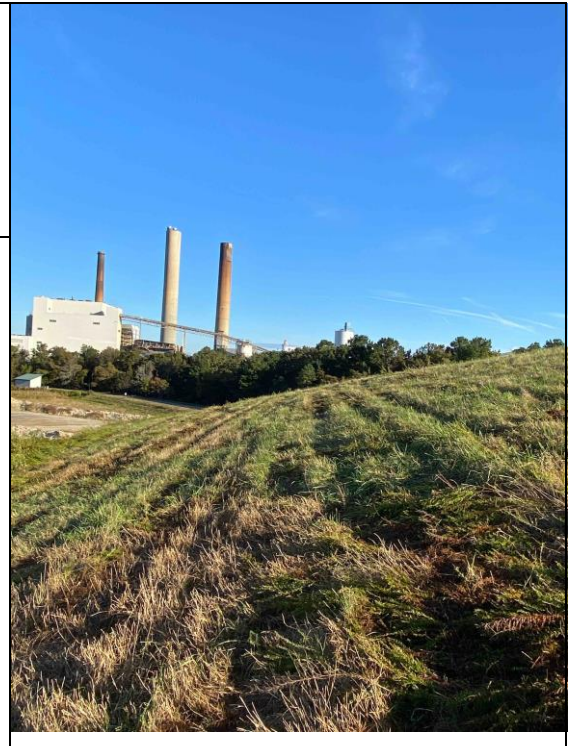
Image Number: 3314
 Date: 10/17/2023
 Time: 7:55 AM
 Direction: North

Description:
 Overview of the vegetated Phase I intermediate cover slopes. No signs of erosion, sloughing, or animal borrows. Well maintained.

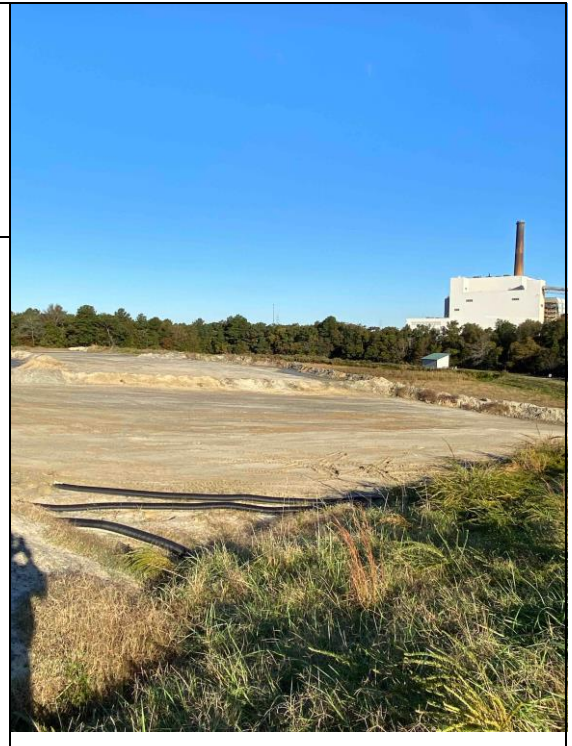
Image Number: 3316
 Date: 10/17/2023
 Time: 7:56 AM
 Direction: Northwest

Description:
 Phase II Cell 2 intermediate cover. Material is graded and compacted. View downstream from an erosion control berm. The black pipes convey water from the upstream side of the berm (left side) to the perimeter non-contact water ditch (out of picture on right).

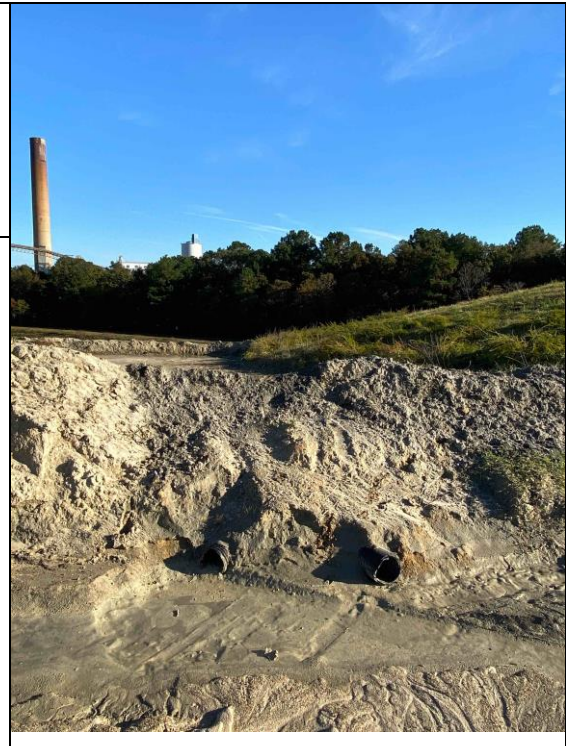
Image Number: 3318
 Date: 10/17/2023
 Time: 7:56 AM
 Direction: North-Northeast

Description:
 Upstream side of erosion control berm photographed in Image Number 3316. The black pipes convey water from the upstream side of the berm to the perimeter non-contact water ditch.

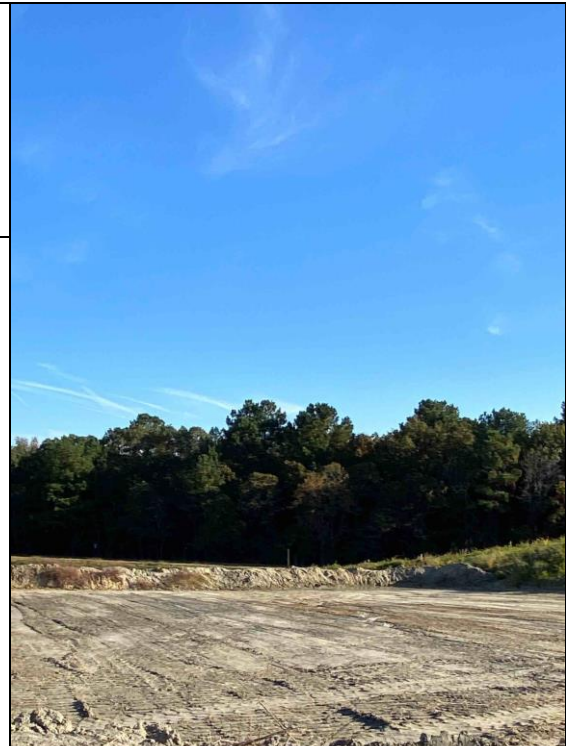
Image Number: 3320
 Date: 10/17/2023
 Time: 7:56 AM
 Direction: North-Northeast

Description:
 Active disposal area (approximately 1/4 acre) to north of erosion control berm shown in Image Number 3318. The active area is well graded and maintained.

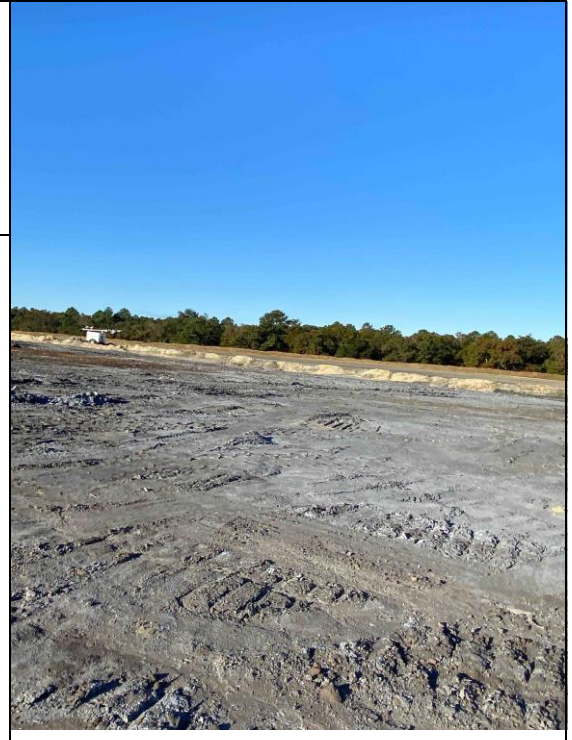
Image Number: 3322
Date: 10/17/2023
Time: 7:57 AM
Direction: West-Southwest

Description:
Phase II Cell 2 intermediate cover. Material is graded and well maintained.

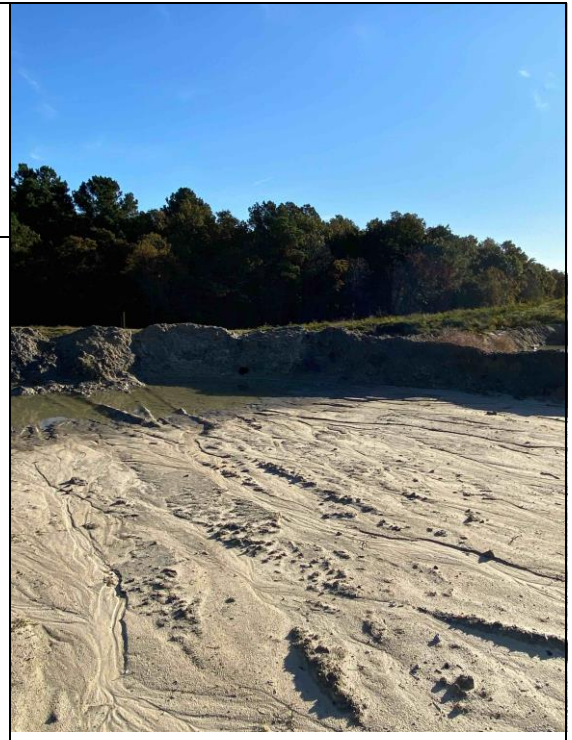
Image Number: 3324
Date: 10/17/2023
Time: 7:57 AM
Direction: East-Northeast

Description:
Active disposal area (approximately 1/4 acre) with some ponded contact water after overnight rain. The active area is well graded and maintained.

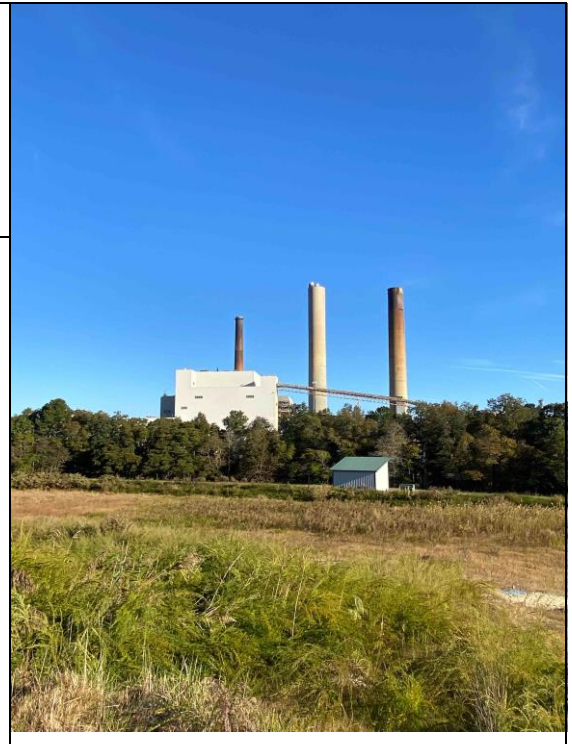
Image Number: 3326
Date: 10/17/2023
Time: 7:58 AM
Direction: North

Description:
Vegetated intermediate cover on northern area of Phase II Cell II. Vegetated intermediate cover is present to north of photo location. Intermediate cover without vegetation is present to the south of the photo location. Well maintained. No ponding water.

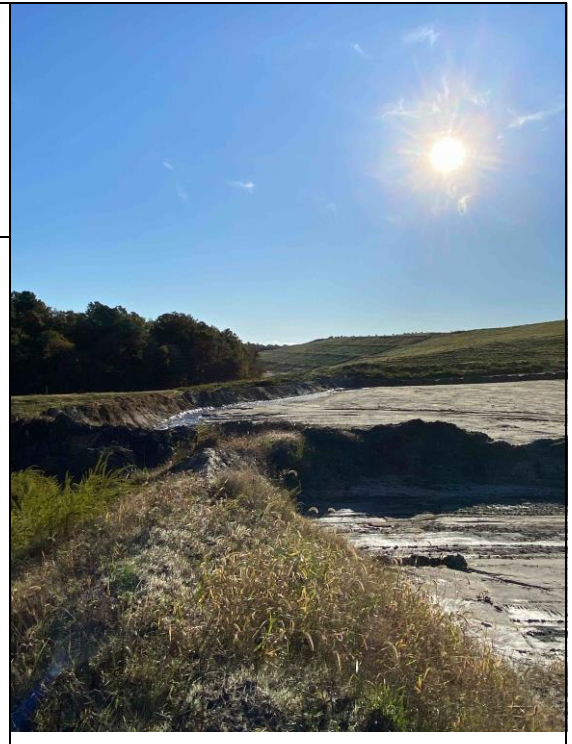
Image Number: 3328
Date: 10/17/2023
Time: 7:59 AM
Direction: East

Description:
Limits of vegetated intermediate cover on erosion control berm. Intermediate cover is soil to the south (right on picture) and vegetated soils to the north (left on picture).

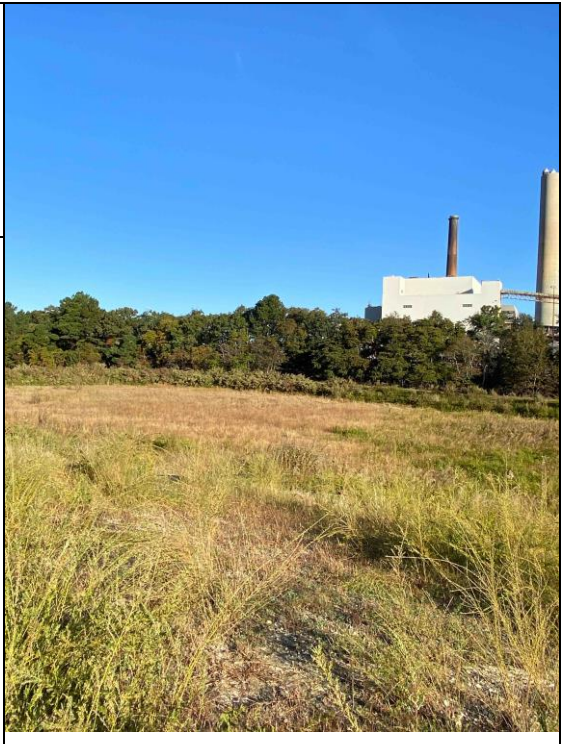
<p>Image Number: 3330 Date: 10/17/2023 Time: 8 AM Direction: North-Northwest</p>

<p>Description: Vegetated intermediate cover is well maintained. No ponding non-contact water observed. No erosion observed.</p>

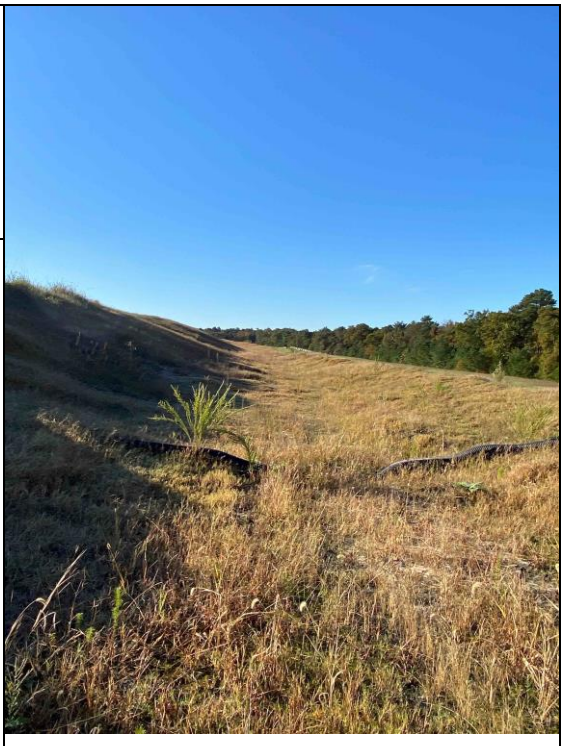
<p>Image Number: 3332 Date: 10/17/2023 Time: 8:02 AM Direction: South-Southwest</p>

<p>Description: Vegetated intermediate cover on terrace near exterior of Phase II, Cell II. Well maintained. No observed ponding or significant erosion.</p>

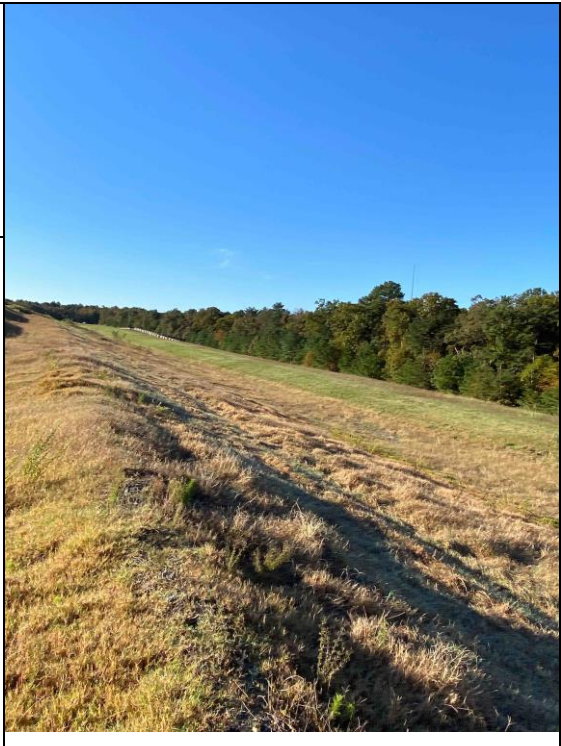
<p>Image Number: 3334 Date: 10/17/2023 Time: 8:02 AM Direction: Southwest</p>

<p>Description: Vegetated intermediate cover on terrace near exterior of Phase II, Cell II. Well maintained. No observed ponding or significant erosion.</p>

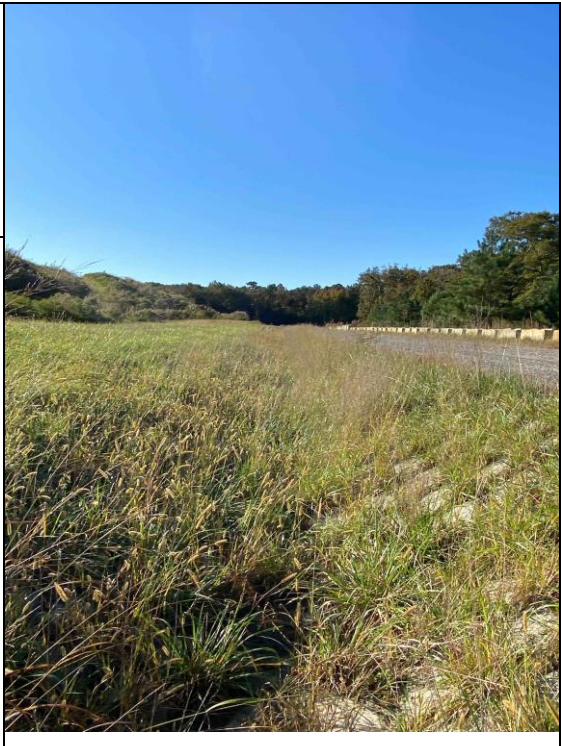
<p>Description: Perimeter non-contact water (stormwater) ditch with erosion control revetment concrete blocks. Well maintained.</p>

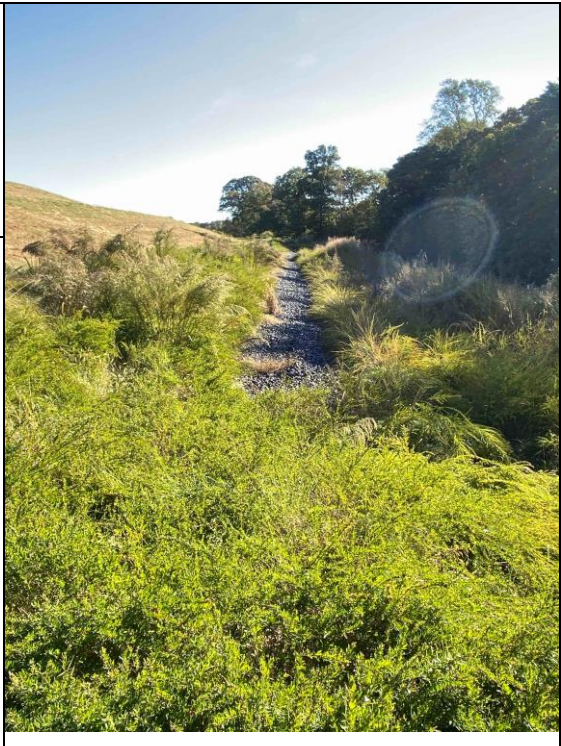
<p>Description: Aggregate lined ditch recently cleaned and free of obstructions.</p>

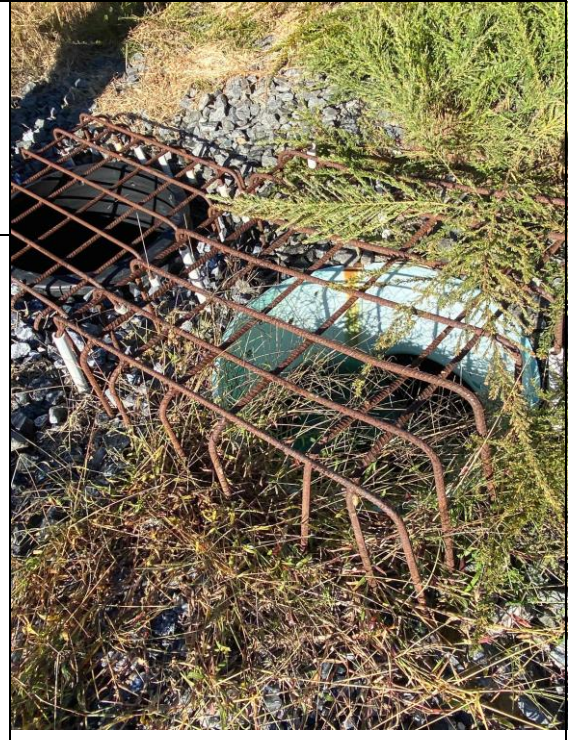
Image Number: 3358
Date: 10/17/2023
Time: 8:39 AM
Direction: West

Description:
Inlet to downslope pipe is well maintained and free of obstructions.

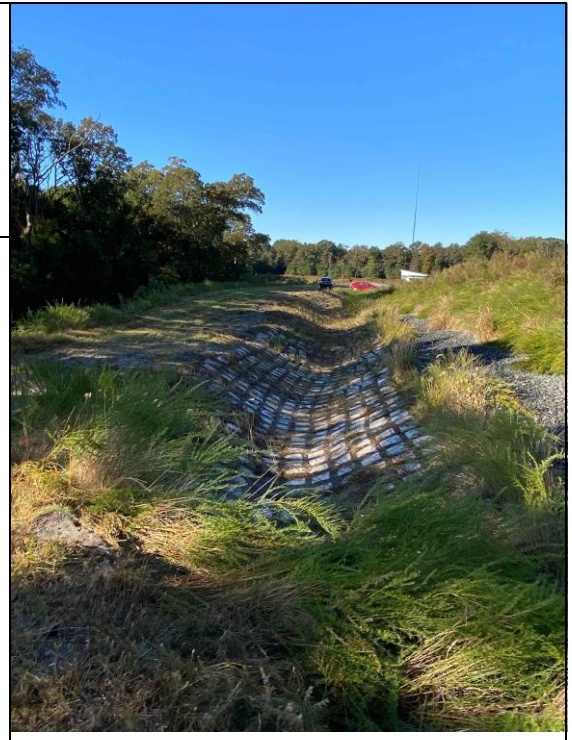
Image Number: 3364
Date: 10/17/2023
Time: 8:42 AM
Direction: West-Southwest

Description:
Perimeter landfill ditch segment is in good working condition with no obstructions.

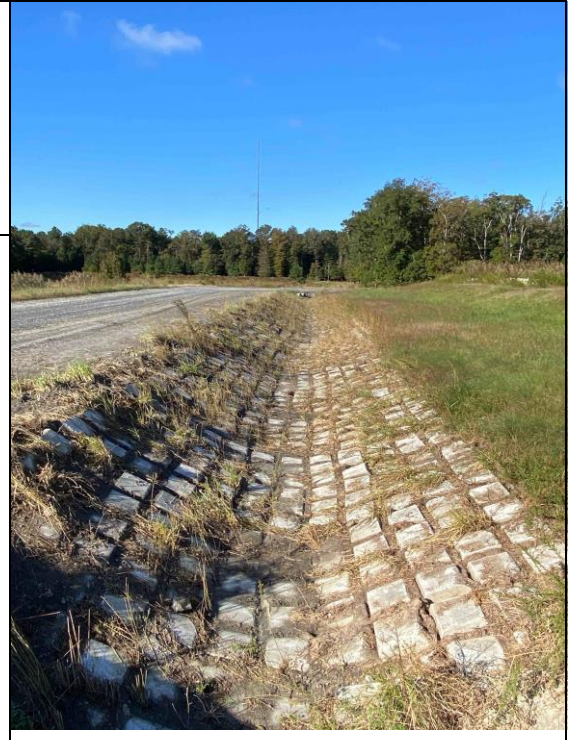
Image Number: 3370
Date: 10/17/2023
Time: 8:56 AM
Direction: West

Description:
Perimeter landfill ditch segment is in good working condition with no obstructions.

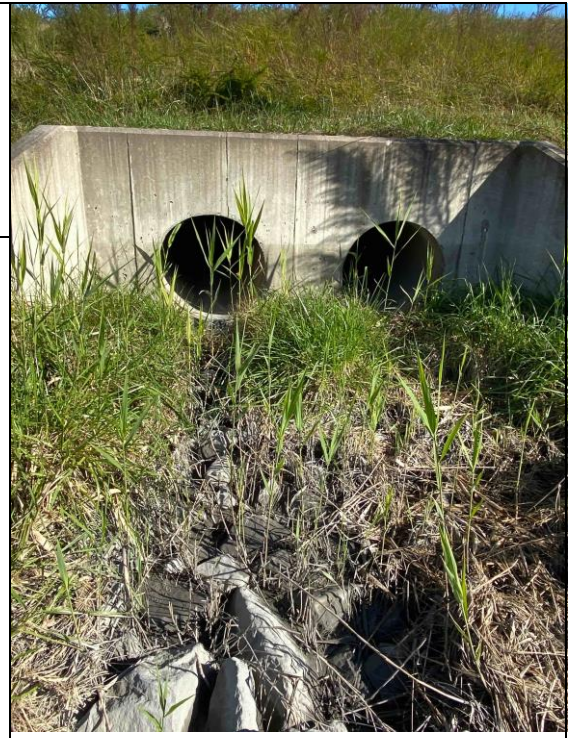
Image Number: 3372
Date: 10/17/2023
Time: 9 AM
Direction: North-Northeast

Description:
Inlet to Southeast Detention Basin forebay in good condition. Free of obstruction at inlets and outlets.

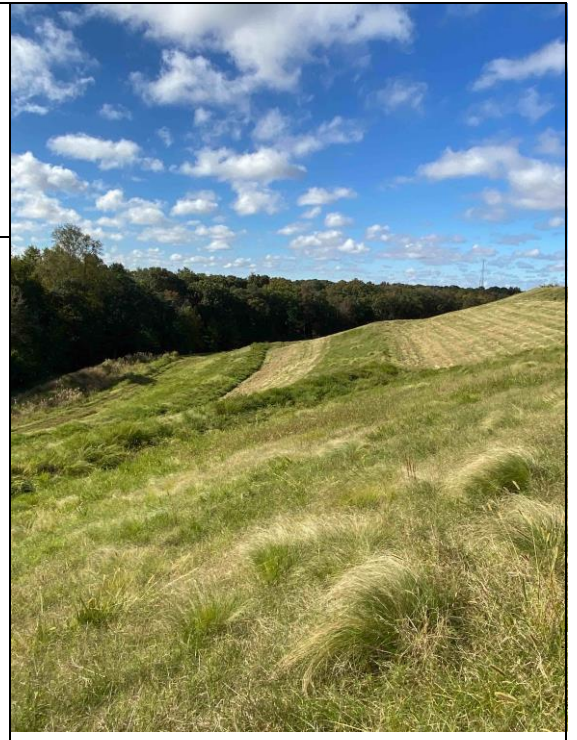
Image Number: 3406
Date: 10/17/2023
Time: 9:24 AM
Direction: South-Southwest

Description:
Phase I final cover. Vegetation coverage is dense and healthy. No animal burrows, erosion, or sloughing were observed.

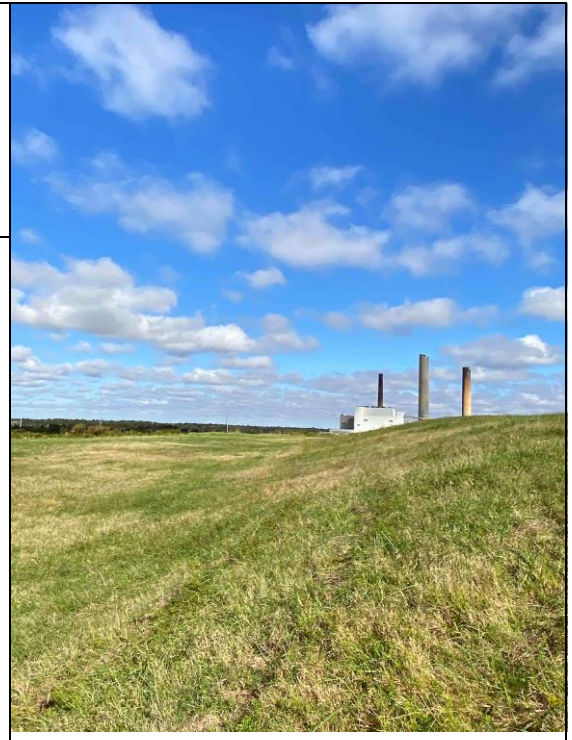
Image Number: 3418
Date: 10/17/2023
Time: 9:28 AM
Direction: North

Description:
Phase II final cover plateau. Vegetation is well established with no signs of erosion, sloughing, or animal burrows. No animal burrows, erosion, or sloughing were observed.

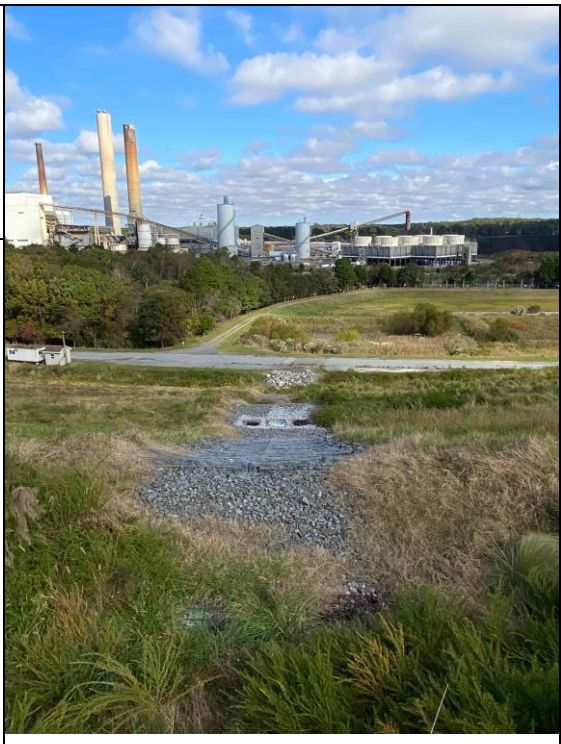
<p>Description: Phase I downchute downchute riprap. Free of obstructions and functioning. No signs of wash out or erosion.</p>

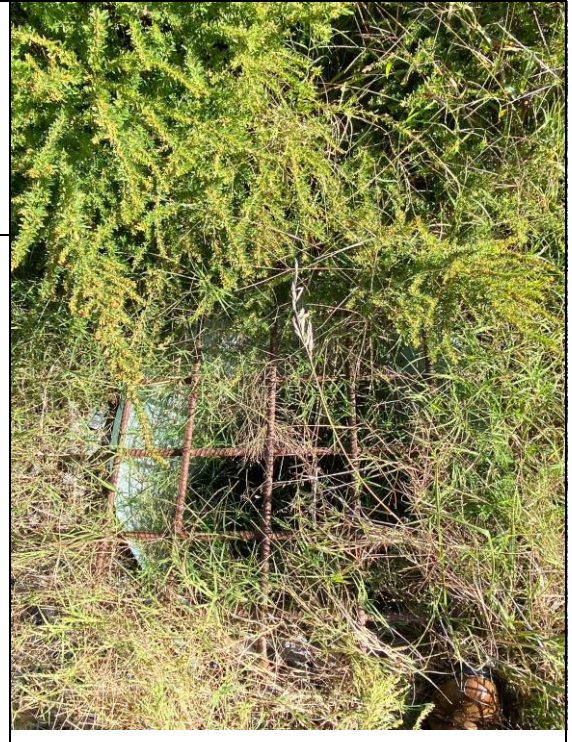
Description:
Phase I downchute pipe inlets with grated covers. Some vegetation should be cleared to eliminate obstructions for non-contact water to enter the pipe.
