## Annual PE Inspection Report

**Re:** Indian River Landfill – Annual CCR Unit Inspection Report

**Inspection Date:** December 15, 2015

**Memo Date:** January 14, 2016

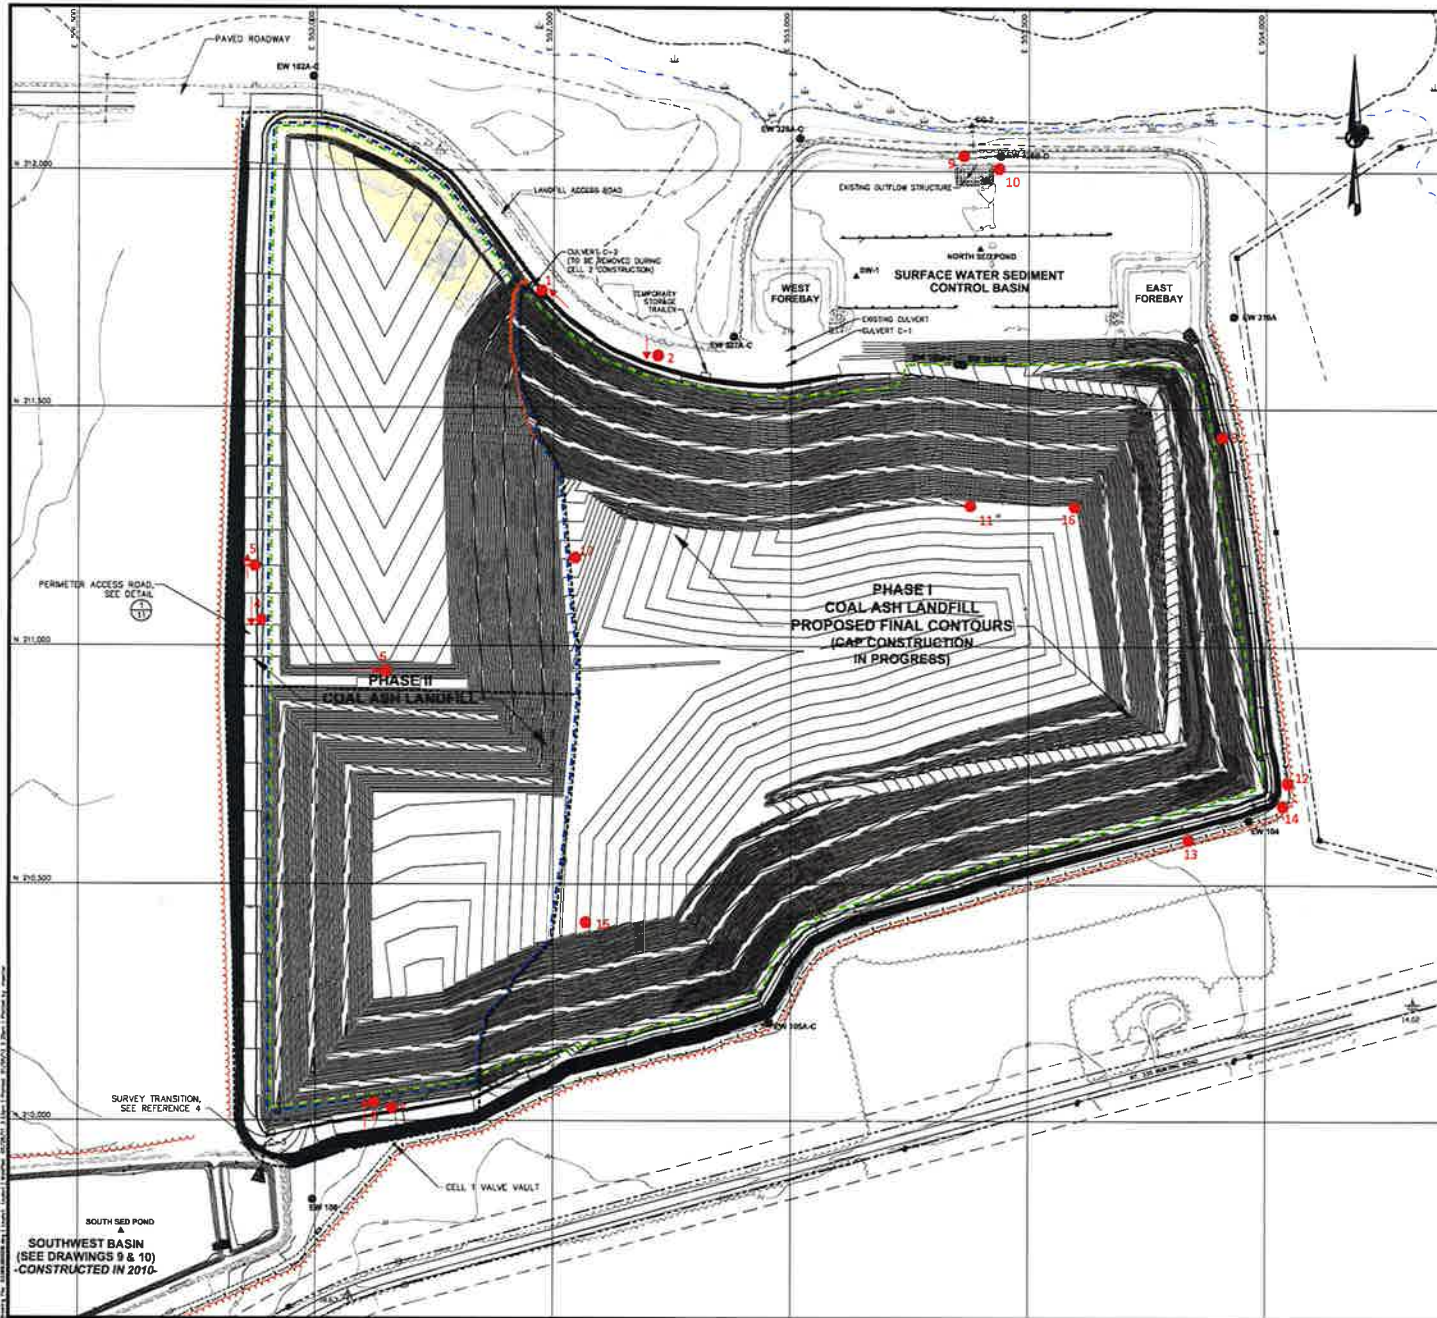
**DRAWING 6**

As of the date of this inspection, the IRLF had two active disposal areas (1) plateau of Cell 1, Phase II and bottom of Cell 2, Phase II. The peak fill elevations for Cell 1 was approximately 98 feet MSL and for Cell 2 was approximately 20 feet MSL to 30 feet MSL (refer to figure in Attachment 1). Since this is the first annual inspection, comparative changes in geometry were not directly relevant.

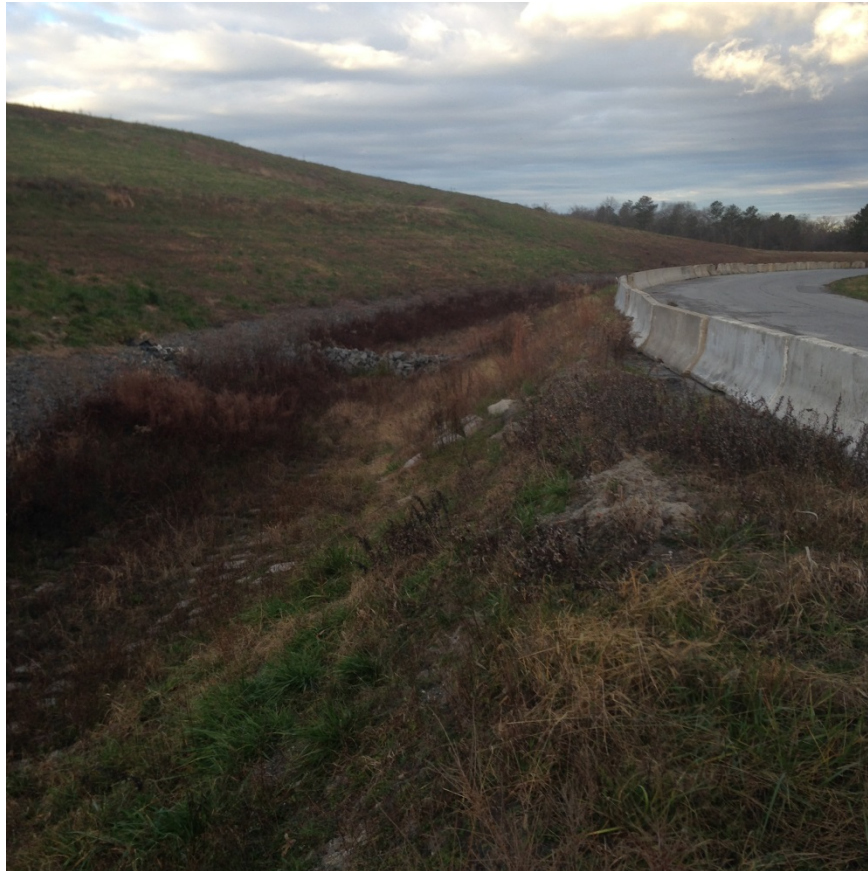
Photograph No. 1

North perimeter of landfill, transition between Phases I and II, looking west

Observing toe of slope for sloughing or mass movement; inspecting perimeter stormwater drainage ditch for adequate flow capacity.

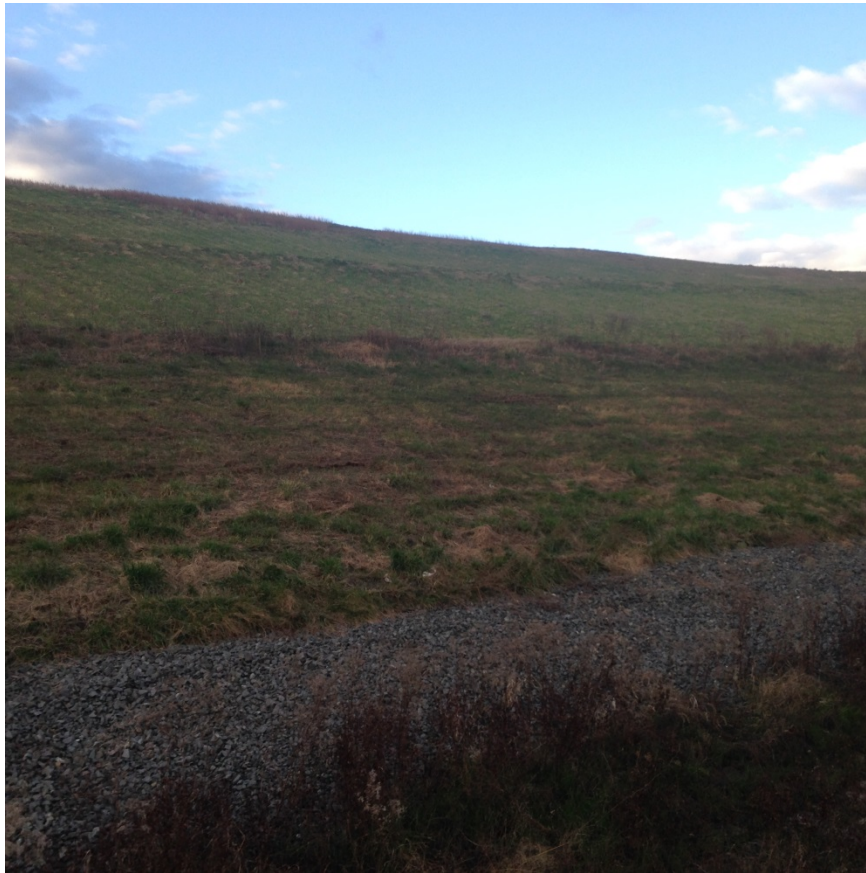
Photograph No. 2

North perimeter of landfill, looking south at closed Phase I Unit

Observing final cover over the closed Phase I Unit

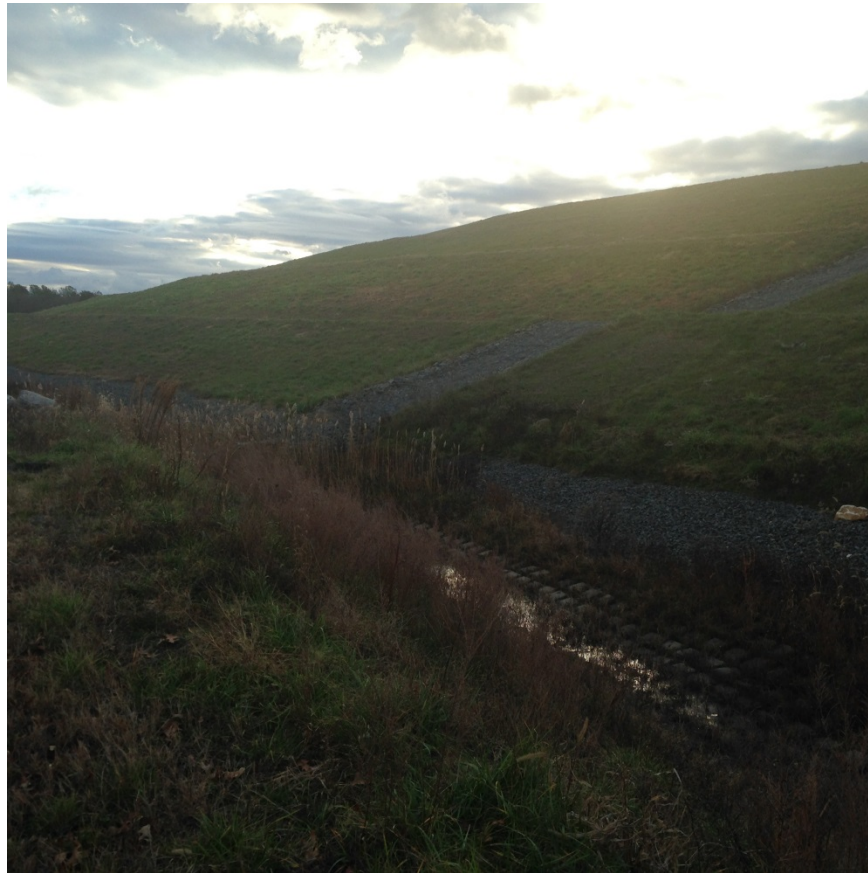
**Photograph No. 3**

**Location of Photograph:**  
East perimeter of Phase I, looking south

**Description of Photograph:**  
Observing closed Phase I with stormwater downchutes

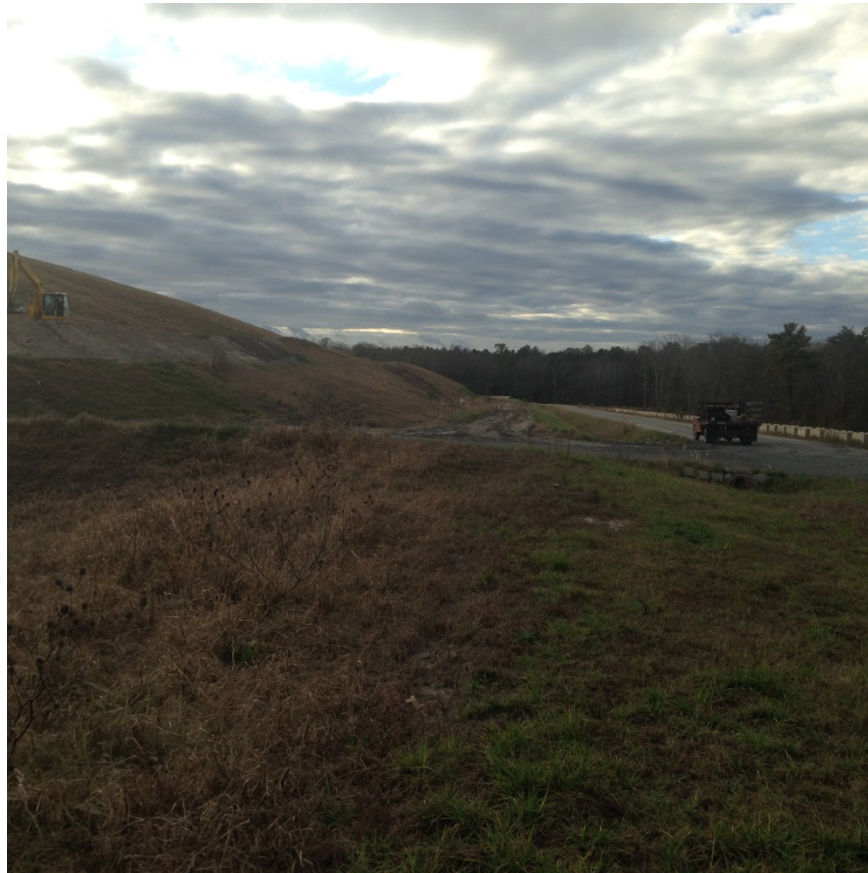
Photograph No. 4

West perimeter haul road, looking south

Observing the intermediate fill slopes of Cell 1 of Phase II

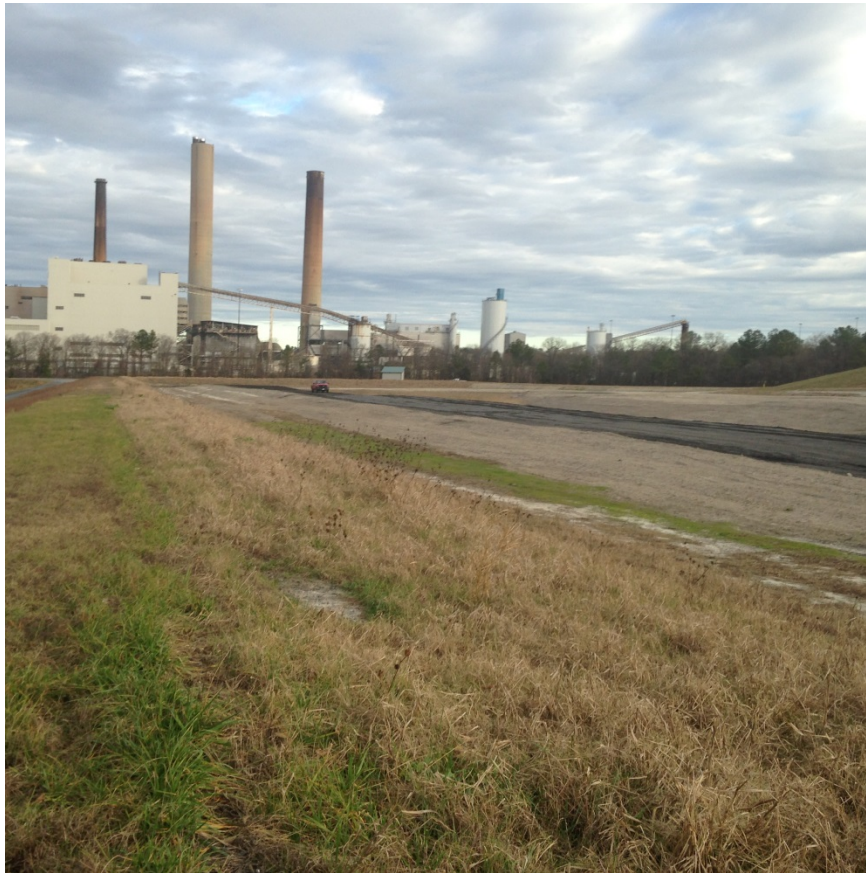
Photograph No. 5

West perimeter haul road, looking north

Observing CCR protective cover within Cell 2 of Phase II

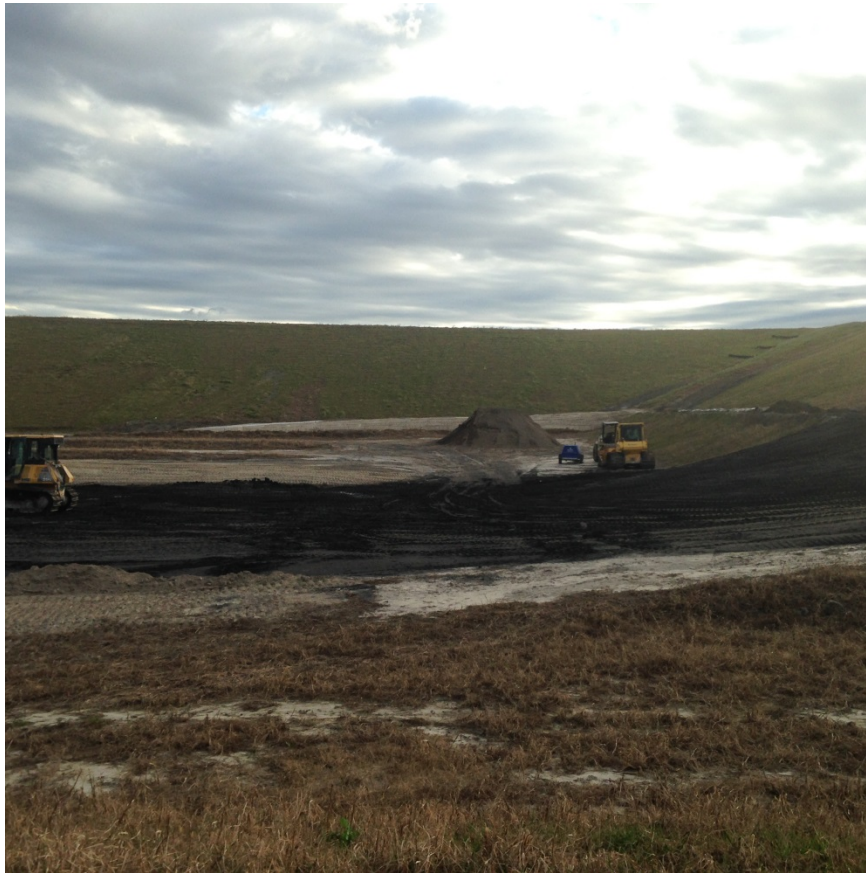
**Photograph No. 6**

Cell 1/Cell 2 of Phase II separation berm, looking east

CCR placement within active area of the landfill

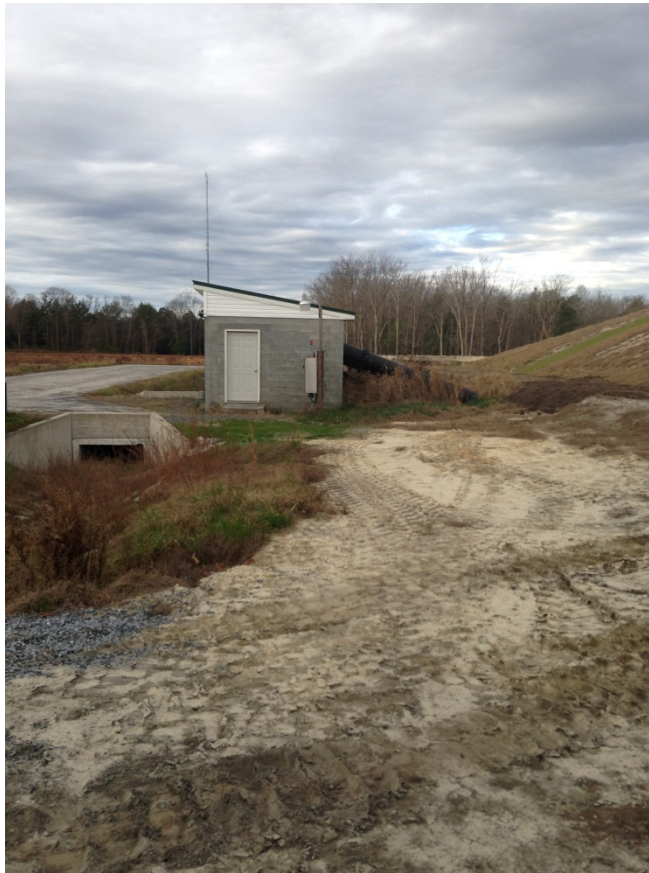
**Photograph No. 7**

**Location of Photograph:**  
Cell 1 Leachate loadout sump structure, looking west

**Description of Photograph:**  
Cell 1 Leachate loadout sump structure and stormwater culvert

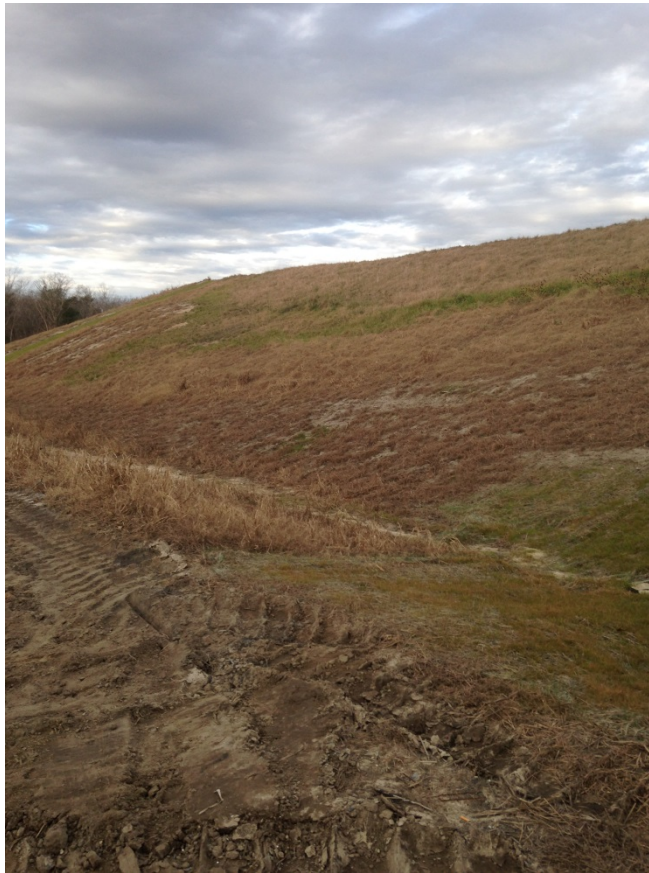
Photograph No. 8

South perimeter of Cell 1, looking northwest

Final slopes with intermediate cover at Cell 1, Phase II

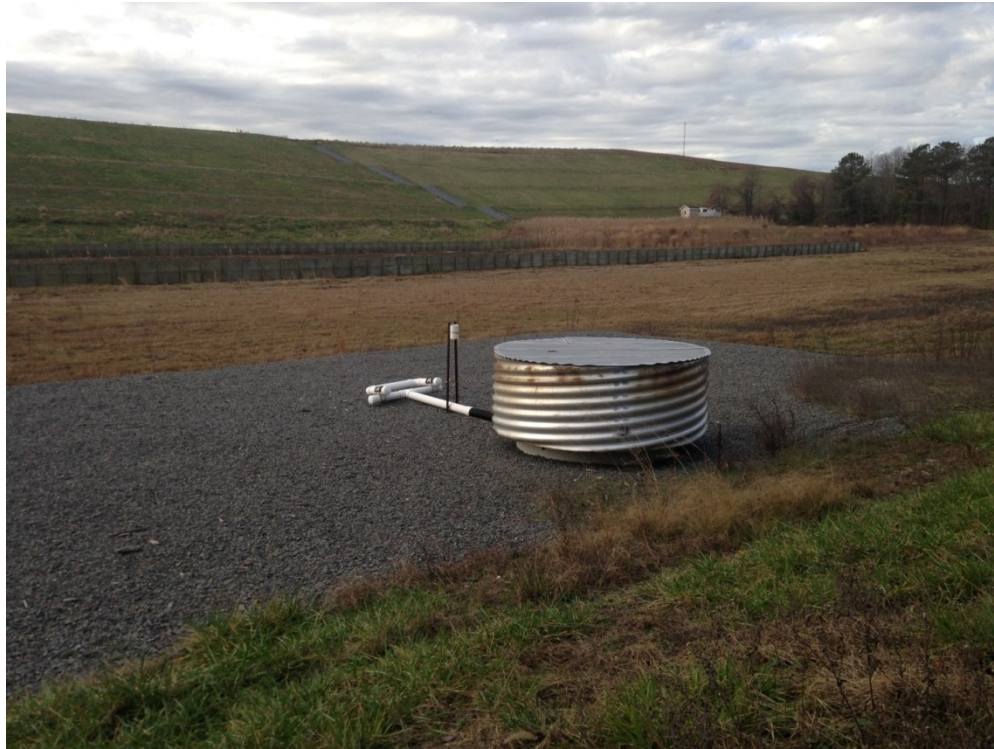
**Photograph No. 9**

North perimeter of surface waste sediment control basin, looking south

Observing outlet structure for north stormwater basin

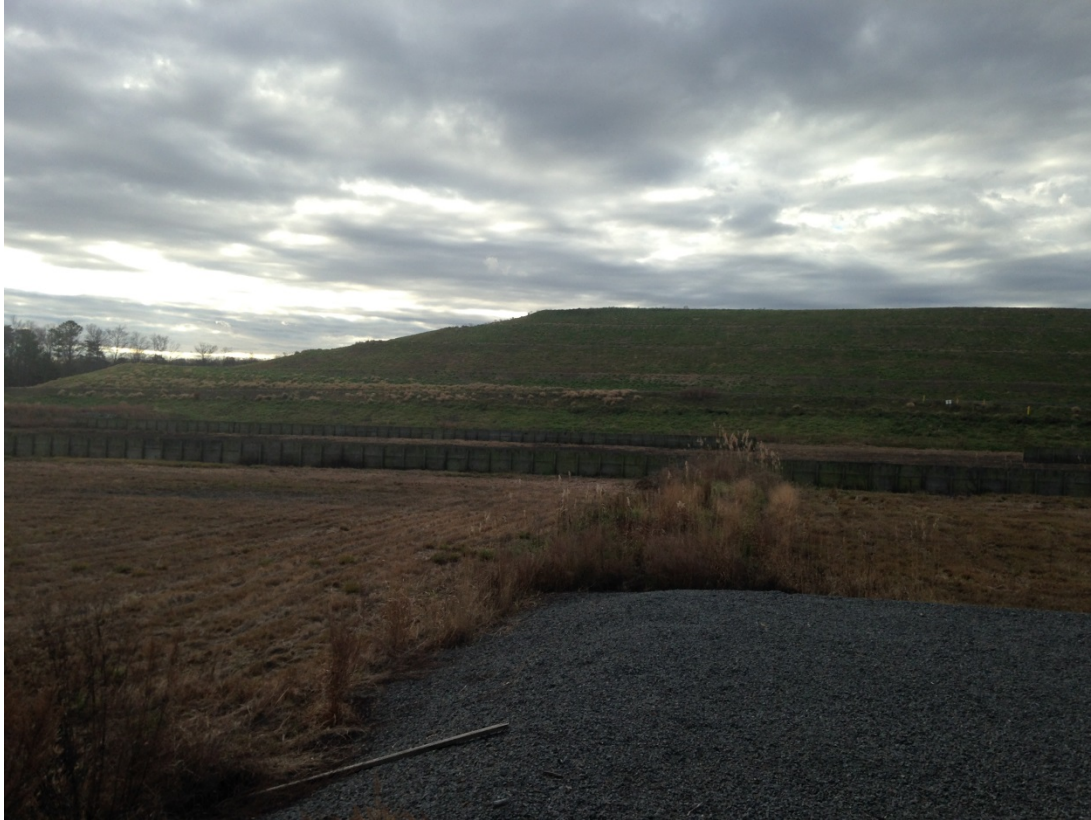
**Photograph No. 10**

North perimeter of landfill, looking south

Observing final cover slopes along Phase I

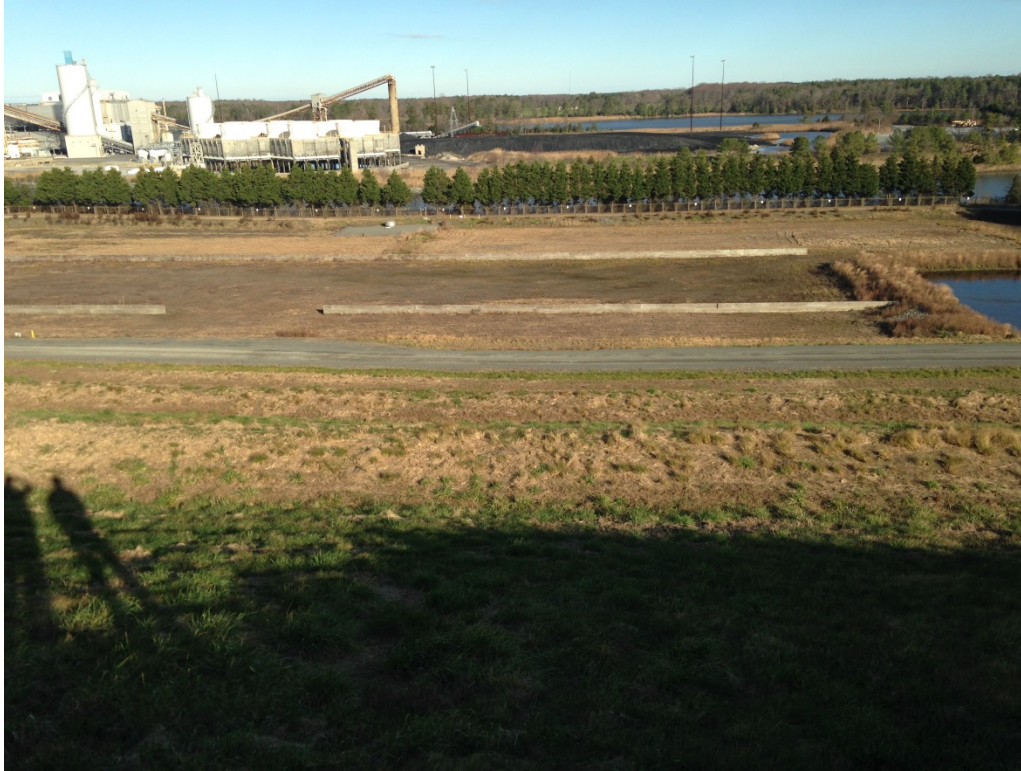
**Photograph No. 11**

Plateau area of Phase I, looking north

Overview of north stormwater detention pond

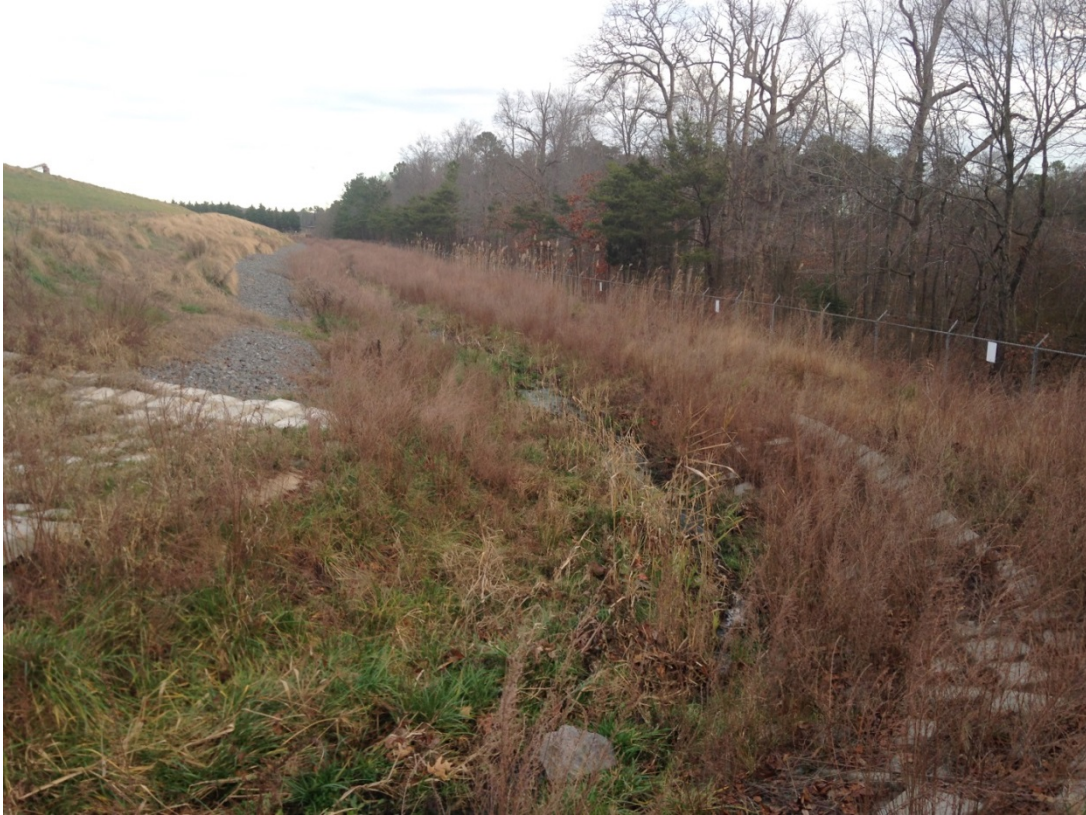
**Photograph No. 12**

Southeast corner of Phase I, looking north

Toe of slope and eastern stormwater ditch at Phase I

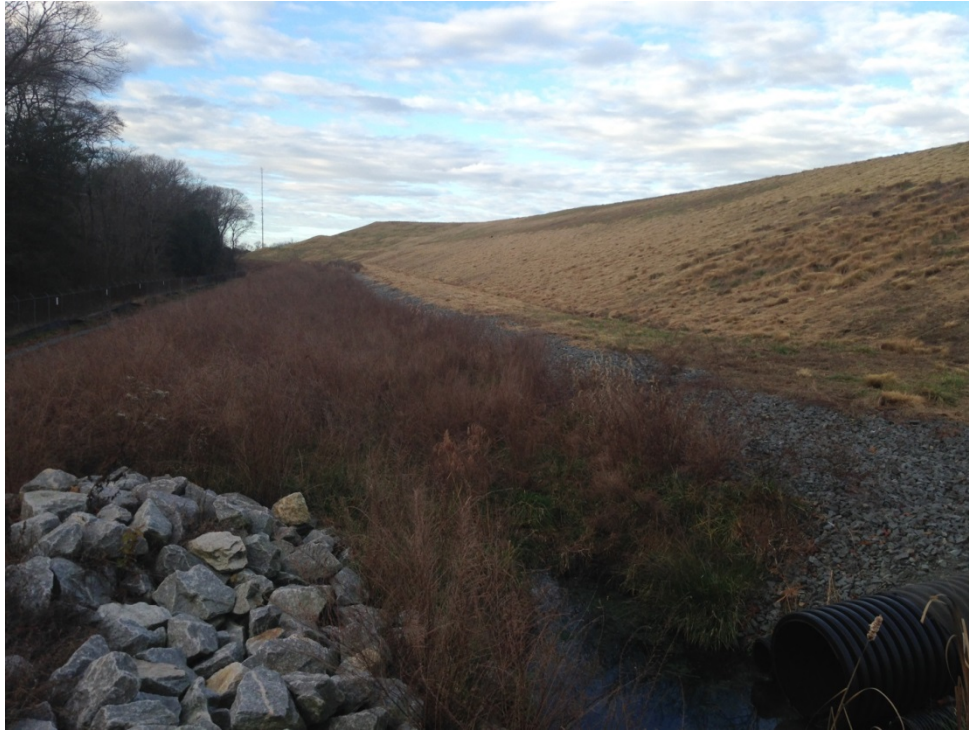
**Photograph No. 13**

South perimeter of Phase I, looking west

South perimeter stormwater ditch

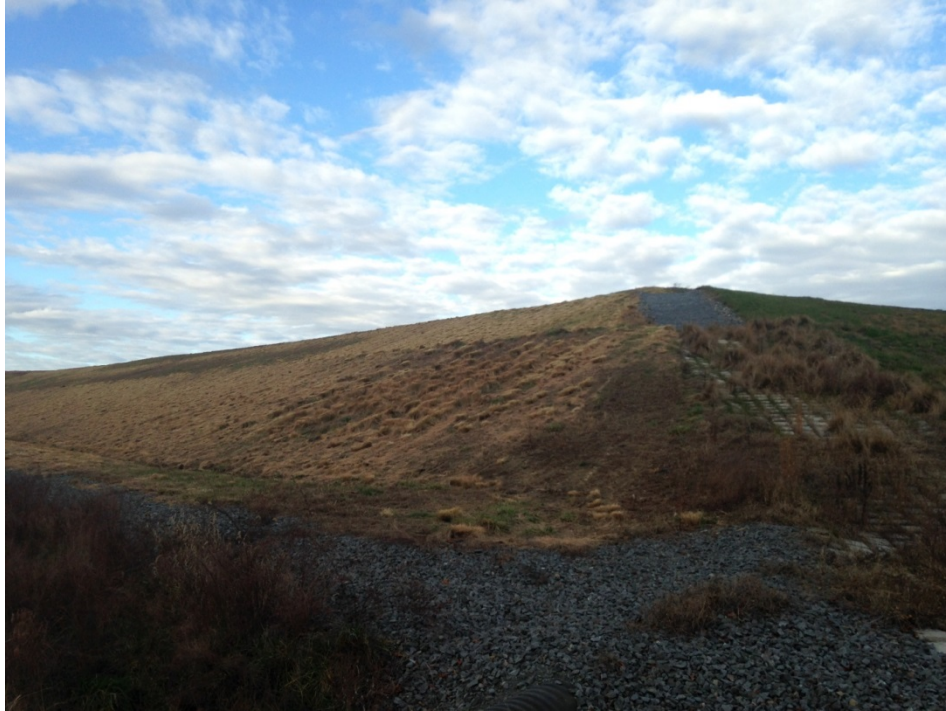
**Photograph No. 14**

Southeast corner of Phase I, looking northwest

Stormwater downchute and final cover slopes of Phase I

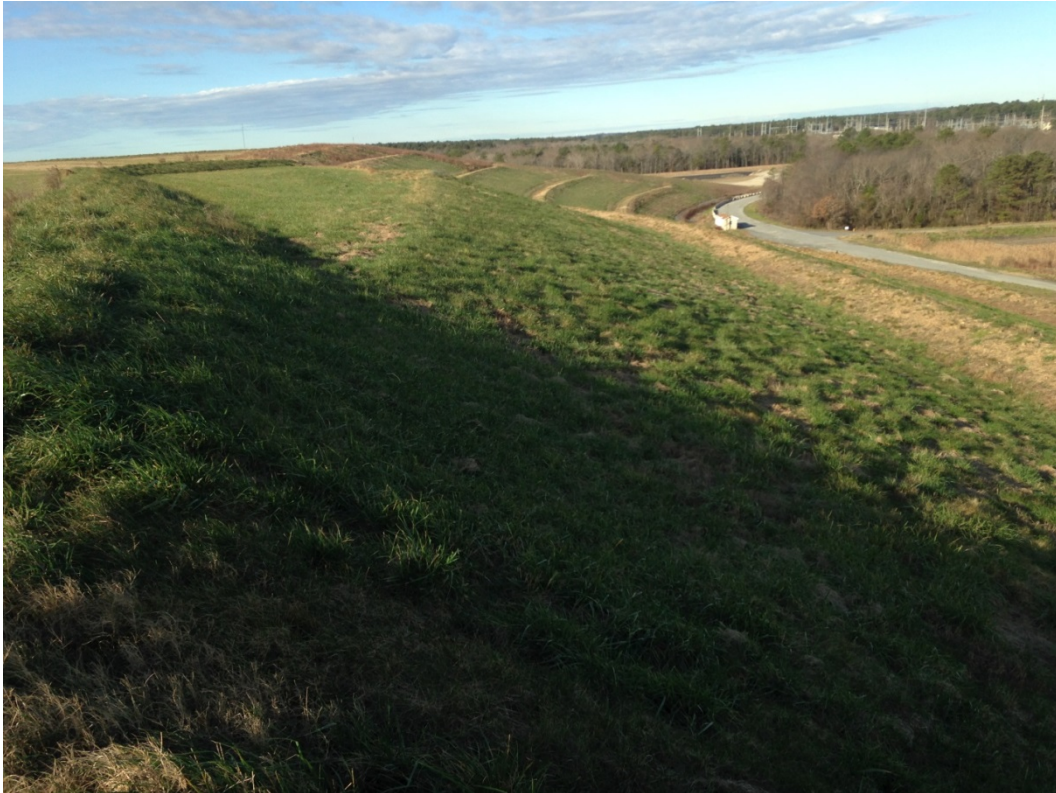
**Photograph No. 15**

South side of Phase I plateau area, looking east

Observing final cover slopes on south side of landfill, no evidence of tensile cracking

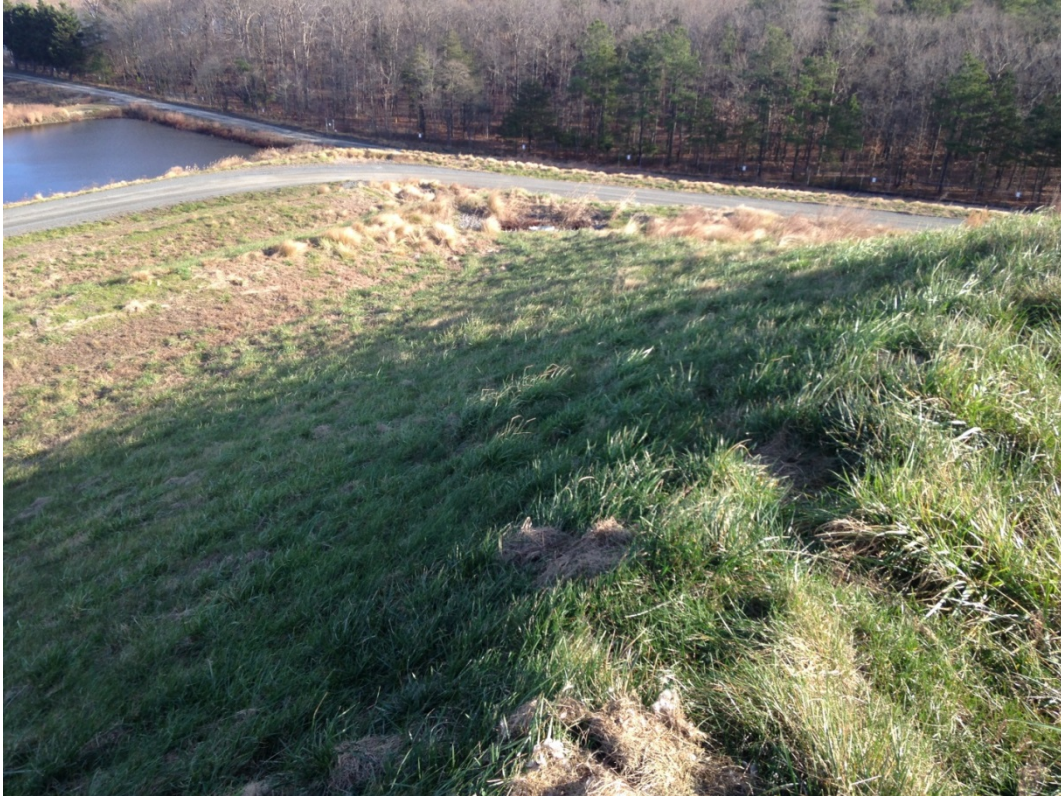
Photograph No. 16

Northeast corner of Phase I plateau area, looking north

Looking for any tensile cracking at crest of slope, no tensile cracking was observed

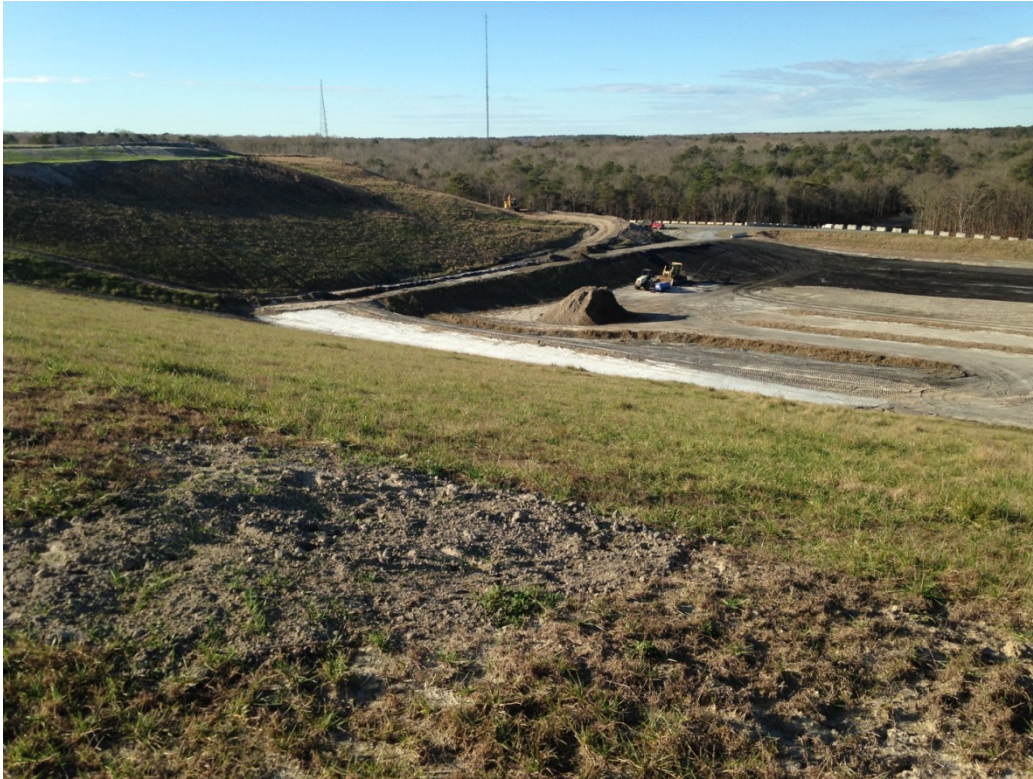
**Photograph No. 17**

Phase II piggyback, looking west

Observing active filling operations, intermediate slopes of Cell 1, Phase II
