2021 ANNUAL CCR UNIT INSPECTION
INDIAN RIVER LANDFILL
NRG INDIAN RIVER STATION
DAGSBORO, DELAWARE

25221158.00 | January 18, 2022

**Indian River Landfill – 2021 Annual Inspection
Dagsboro, DE
SCS Engineers Project #25221158.00**

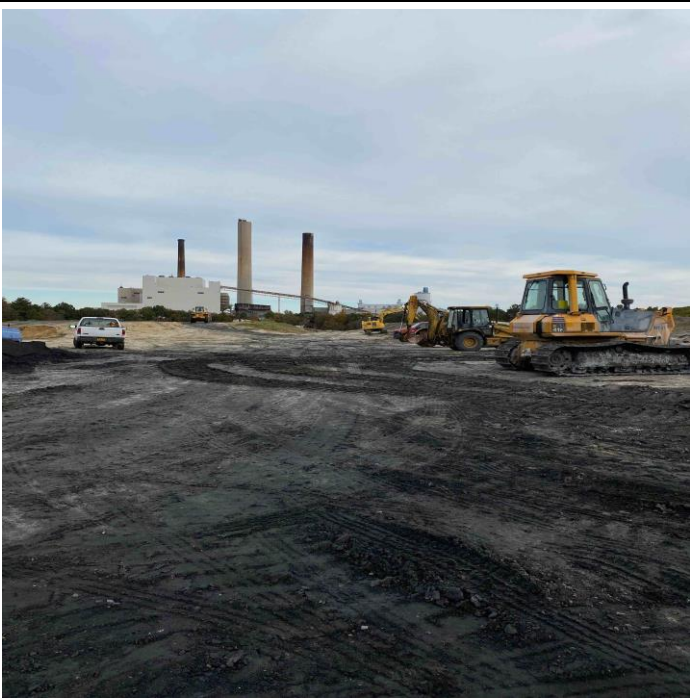
<p>Image Number: 243 Date: 11/4/2021 Time: 8:17 AM Direction: North</p>

<p>Description: Active face is well maintained. Material is graded and compacted.</p>

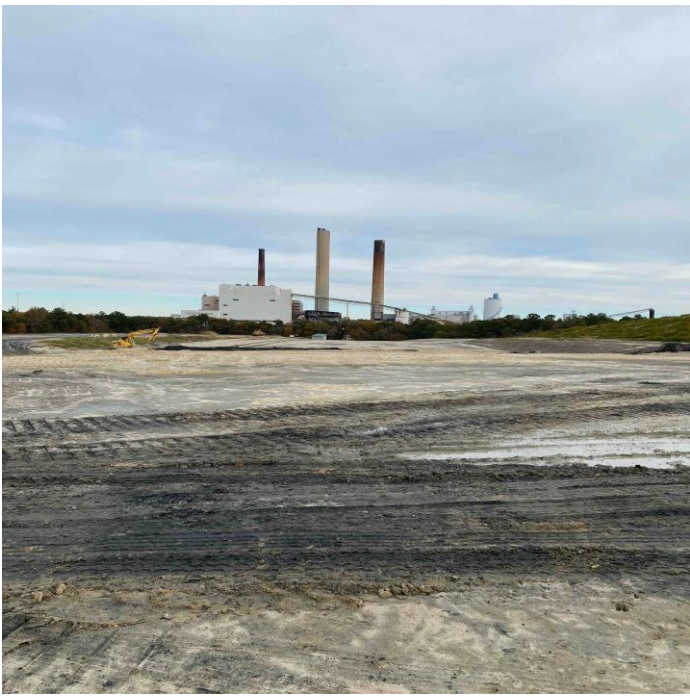
<p>Image Number: 245 Date: 11/4/2021 Time: 8:18 AM Direction: North</p>

<p>Description: Active face is well maintained. Material is graded and compacted.</p>

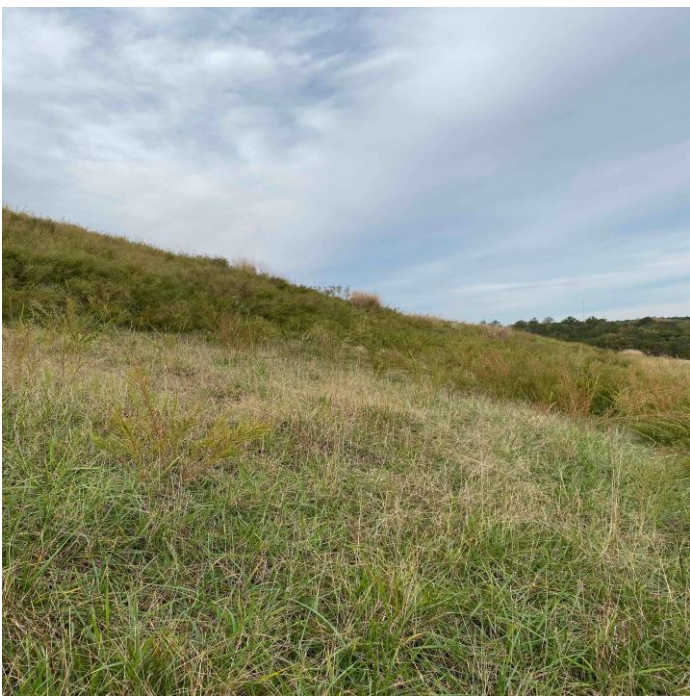
<p>Image Number: 247 Date: 11/4/2021 Time: 8:19 AM Direction: West</p>

<p>Description: Phase II Cell 1/Cell 2 boundary. Slopes are well vegetated with no sign of erosion, sloughing, or animal borrows.</p>

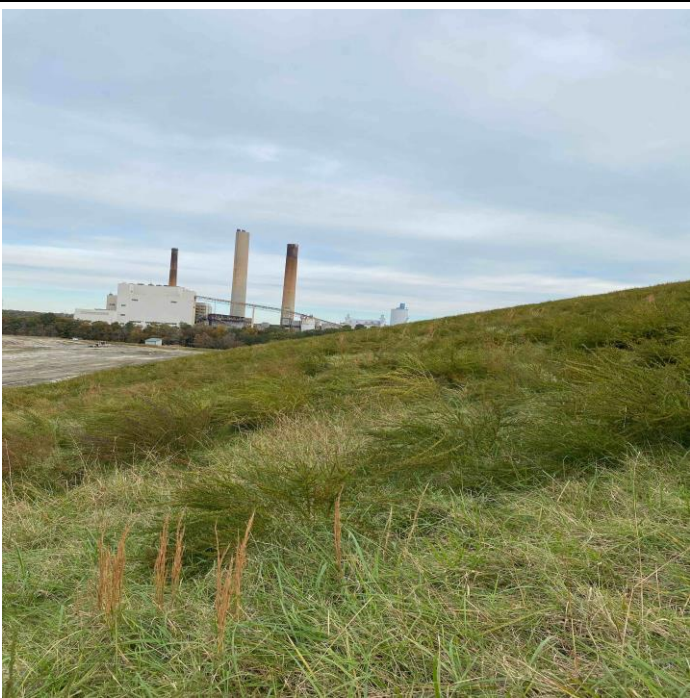
<p>Image Number: 251 Date: 11/4/2021 Time: 8:21 AM Direction: North</p>

<p>Description: Overview of active face and Phase I intermediate cover slopes. Slopes are well vegetated with no sign of erosion or sloughing.</p>

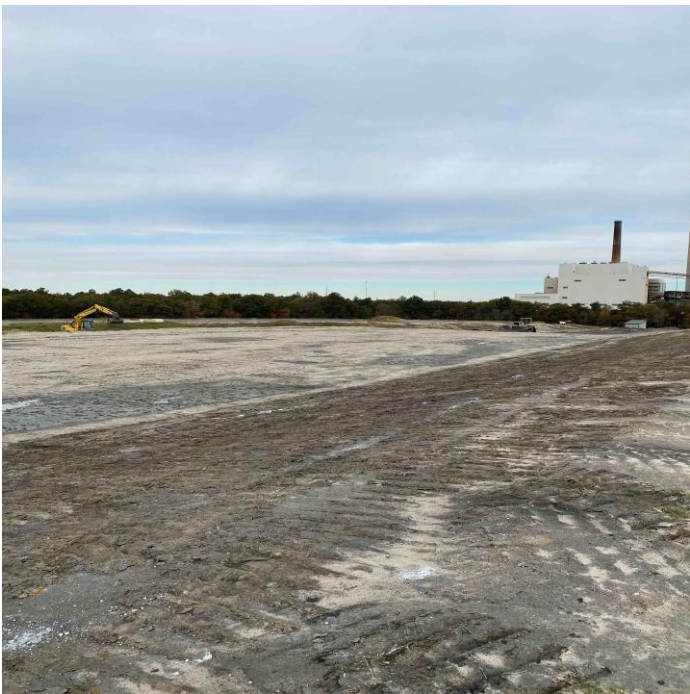
<p>Image Number: 253 Date: 11/4/2021 Time: 8:22 AM Direction: North-Northwest</p> <hr/> <p>Description: Active face is background well maintained and orderly. Material is graded and compacted. Intermediate cover soils in foreground have been installed at the toe of the Phase I slope to collect and transfer non-contact water to the north and away from the active area.</p>

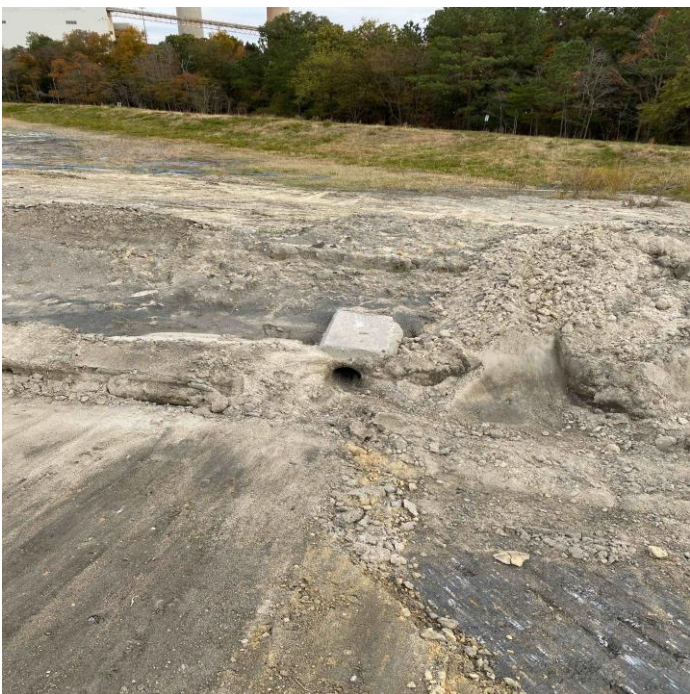
<p>Image Number: 257 Date: 11/4/2021 Time: 8:26 AM Direction: North</p> <hr/> <p>Description: Intermediate cover soils at the toe of the Phase I slope drain to the north to this location. Non-contact water enters into the pipe shown in the middle of the photograph and are conveyed to the adjacent landfill perimeter (non-contact water) ditch.</p>

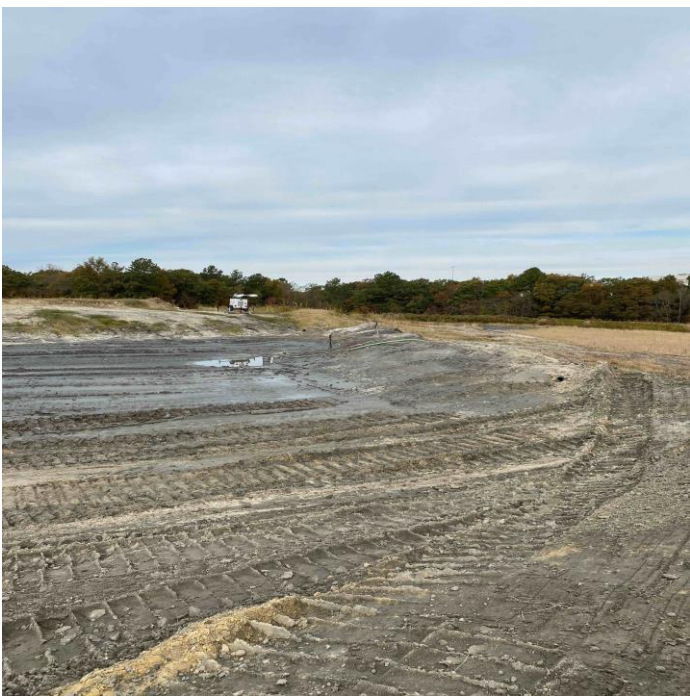
<p>Image Number: 259 Date: 11/4/2021 Time: 8:36 AM Direction: Northwest</p>

<p>Description: Looking across active area toward sump, with intermediate cover soils in foreground. Well maintained. No erosion or scour.</p>

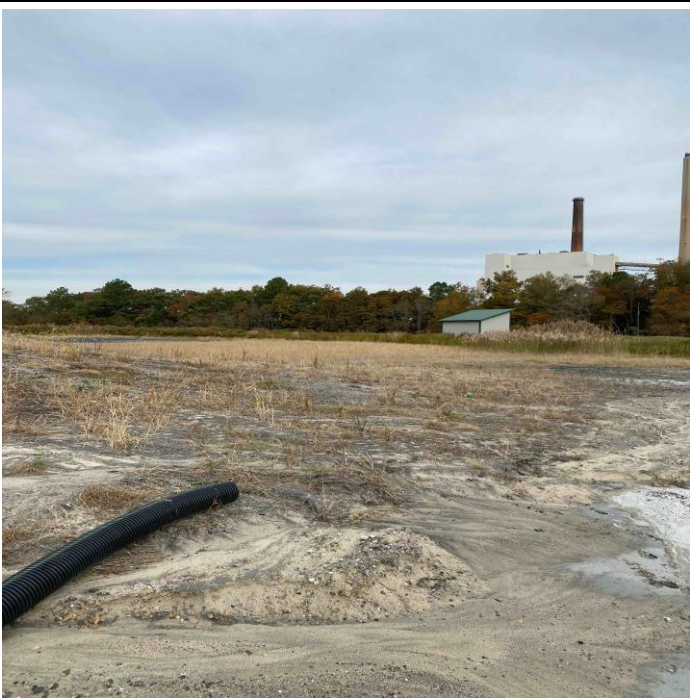
<p>Image Number: 261 Date: 11/4/2021 Time: 8:40 AM Direction: Northwest</p>

<p>Description: The slope of the active face slopes to the north toward a sump area. Shallow berms are placed perpendicular to the slope to slow contact water and prevent erosion. At the toe of the berms, contact water enters pipes, which direct contact water toward the sump. Pipe discharge location is shown.</p>

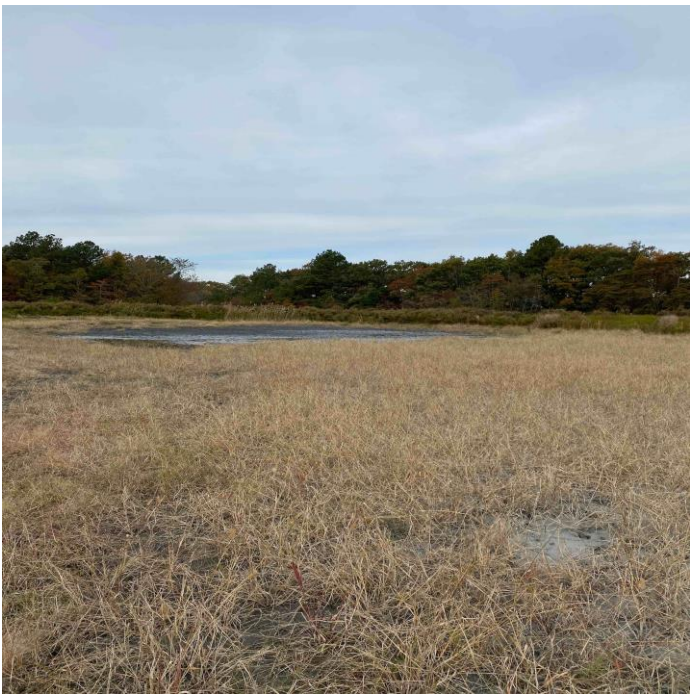
Image Number: 263 Date: 11/4/2021 Time: 8:42 AM Direction: Northwest

Description: Sump area of Phase II Cell 2. No standing water.

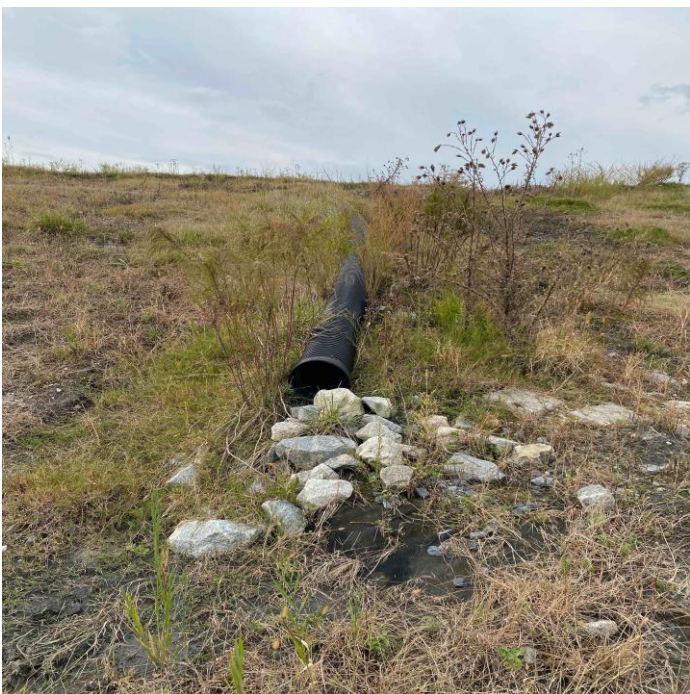
Image Number: 265 Date: 11/4/2021 Time: 8:42 AM Direction: South-Southwest

Description: The slope of the active face is slopes to the north toward the active face. Shallow berms are placed perpendicular to the slope to slow contact water and prevent erosion. At the toe of the berms, contact water enters pipes, which direct contact water toward the sump. Pipe discharge location is shown.

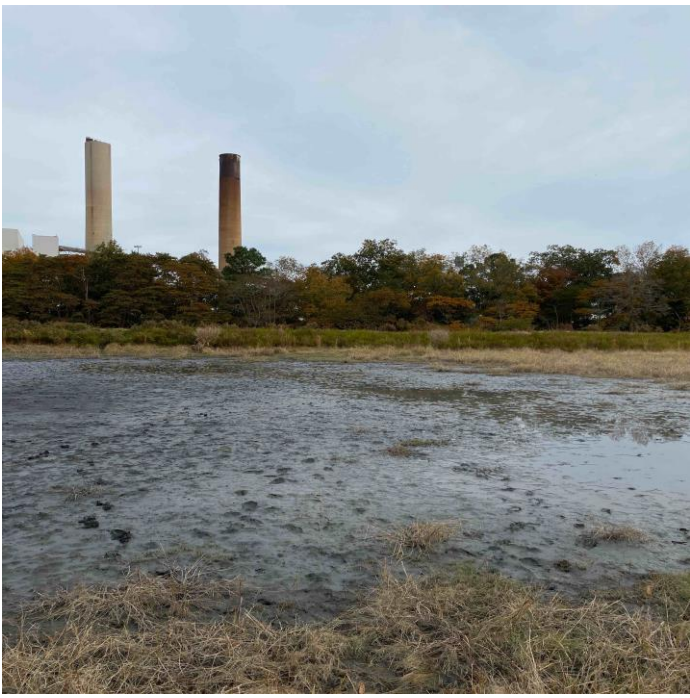
<p>Image Number: 267 Date: 11/4/2021 Time: 8:43 AM Direction: North-Northeast</p>

<p>Description: Sump area of Phase II Cell 2. No standing water.</p>

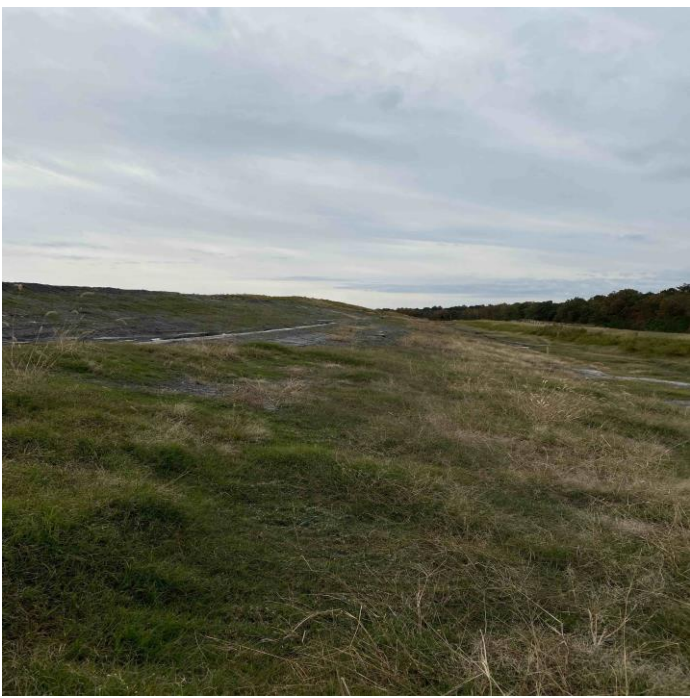
<p>Image Number: 269 Date: 11/4/2021 Time: 8:45 AM Direction: South-Southwest</p>

<p>Description: Outer berm of Phase II Cell 2. Berm is in good condition with healthy vegetation. No signs of erosion, sloughing, geotechnical distress, or animal burrows.</p>

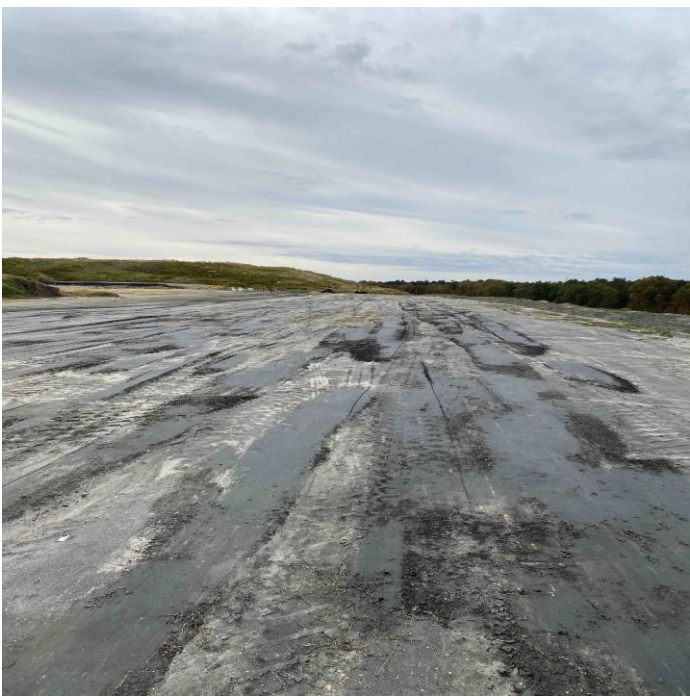
<p>Image Number: 271 Date: 11/4/2021 Time: 8:46 AM Direction: South</p>

<p>Description: Active face is well maintained.</p>

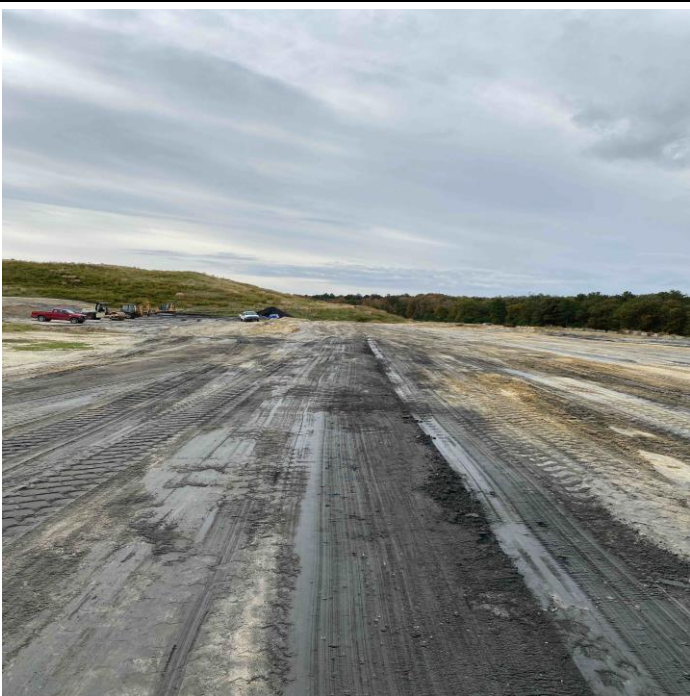
<p>Image Number: 277 Date: 11/4/2021 Time: 8:49 AM Direction: South</p>

<p>Description: Active face is well maintained.</p>

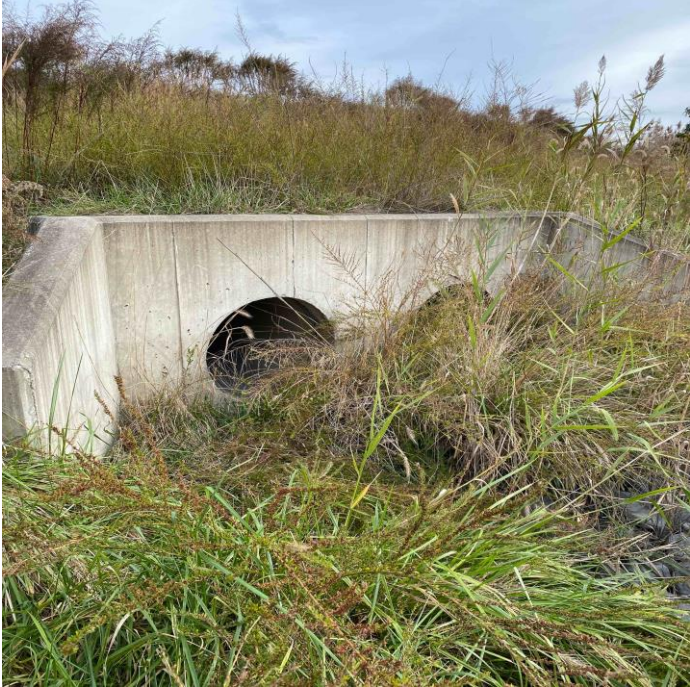
<p>Image Number: 279 Date: 11/4/2021 Time: 9:03 AM Direction: Northeast</p>

<p>Description: Inlets to stormwater basin. Clear of obstruction at inlets and outlets.</p>

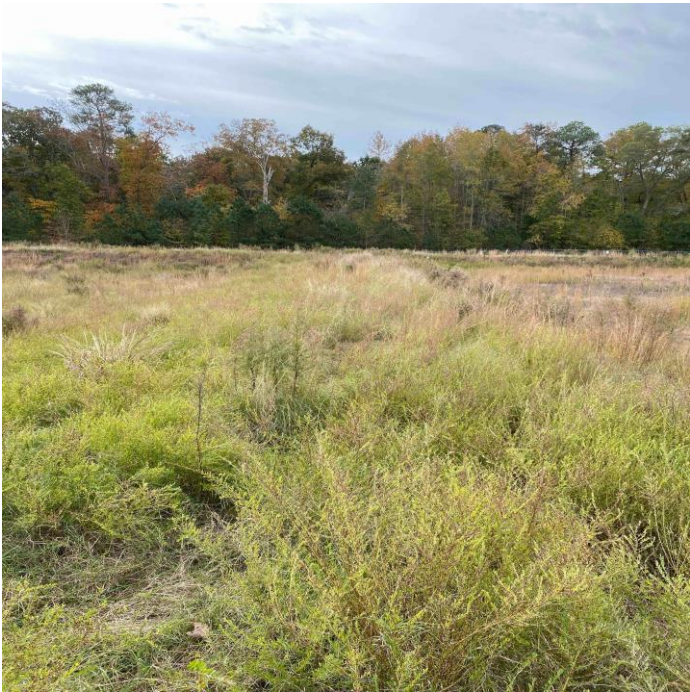
<p>Image Number: 283 Date: 11/4/2021 Time: 9:04 AM Direction: South</p>

<p>Description: Stormwater basin forebay. In good condition.</p>

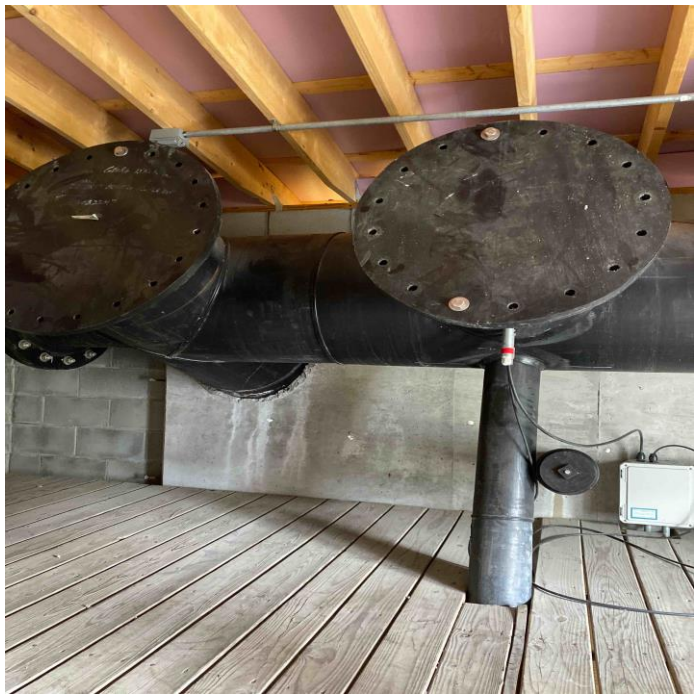
Image Number: 311
Date: 11/4/2021
Time: 9:17 AM
Direction: North

Description:
Inside Phase I, Cell 1 Leachate Pump House. Cleanout riser and pump risers with T connection to forcemain shown. Building is well maintained.

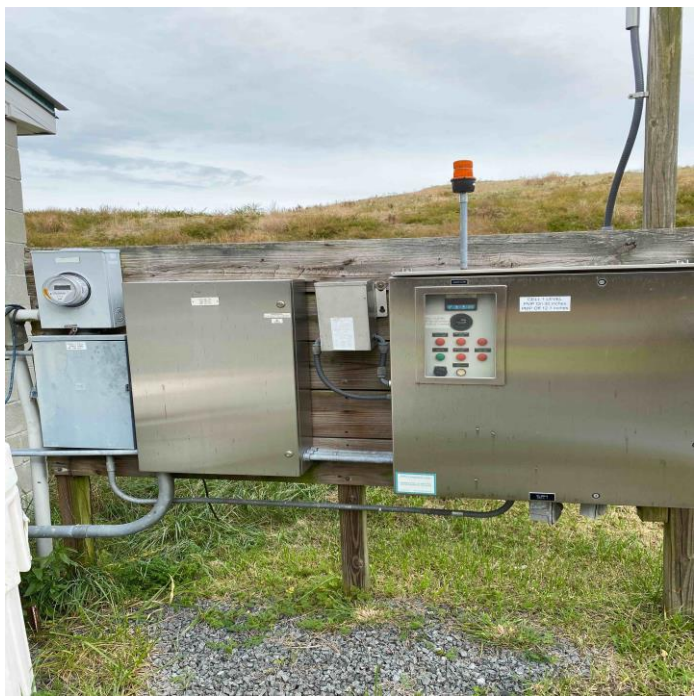
Image Number: 315
Date: 11/4/2021
Time: 9:18 AM
Direction: North-Northwest

Description:
Phase I, Cell 1 leachate instrument panel. Good working order.

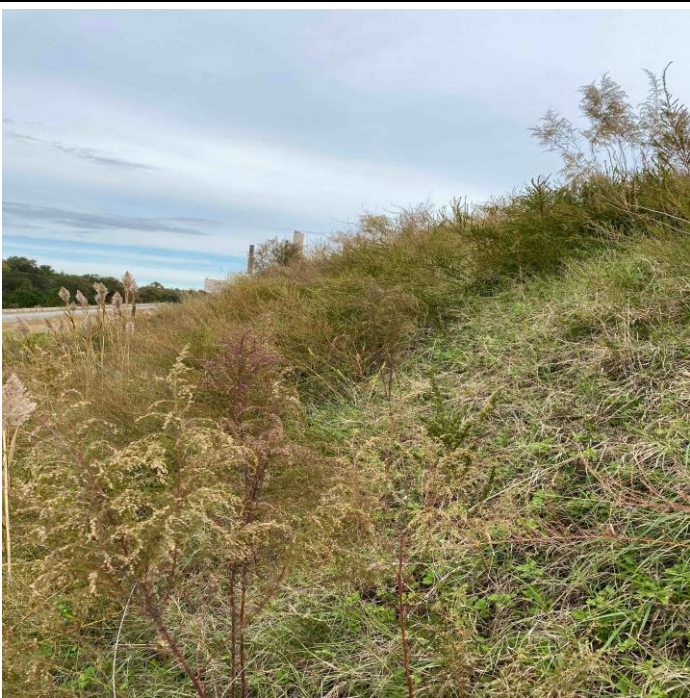
<p>Image Number: 327 Date: 11/4/2021 Time: 9:43 AM Direction: North-Northeast</p>

<p>Description: Final cover on sideslopes of Phase II Cell 1. Vegetation is healthy with full coverage. No signs of erosion stability issues observed on sideslope.</p>

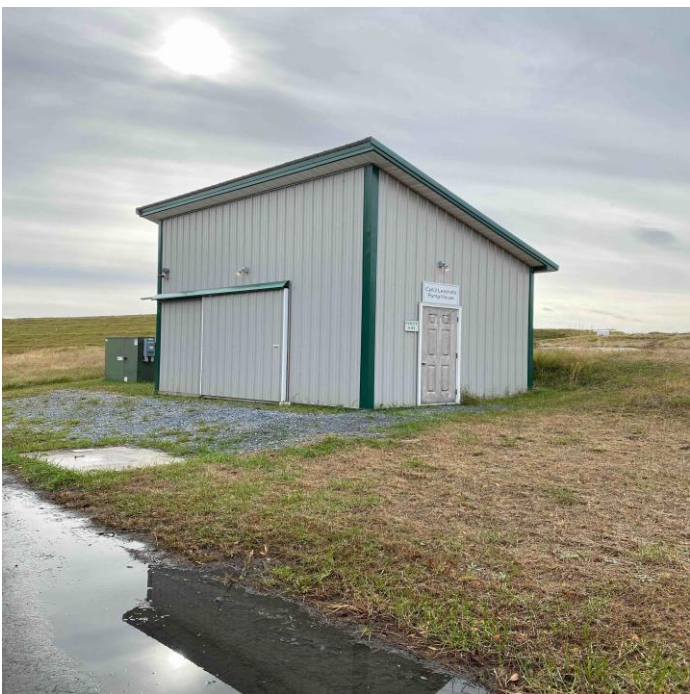
Image Number: 331 Date: 11/4/2021 Time: 9:47 AM Direction: South-Southeast

Description: Phase II, Cell 2 leachate pump house. Building exterior is in good condition and appropriately signed.

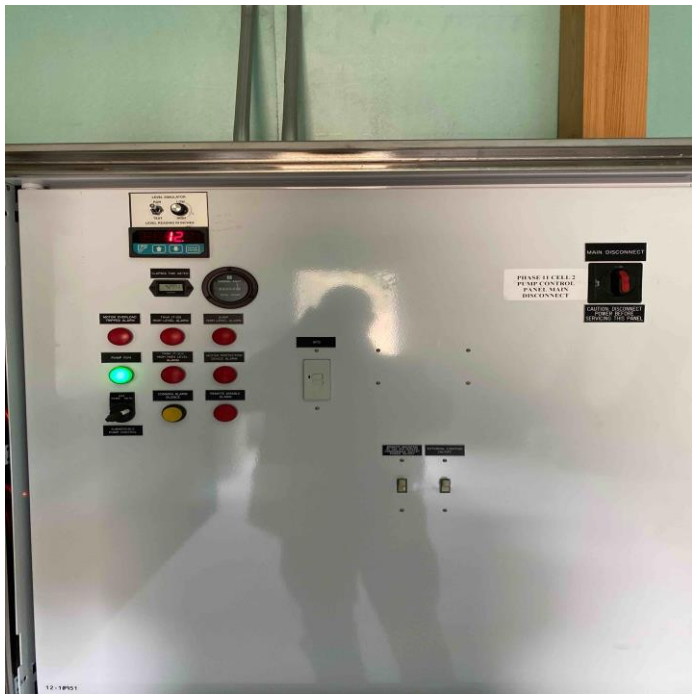
Description:
Leachate liquid level indicator and controls in the Phase II, Cell 2 leachate pump house.

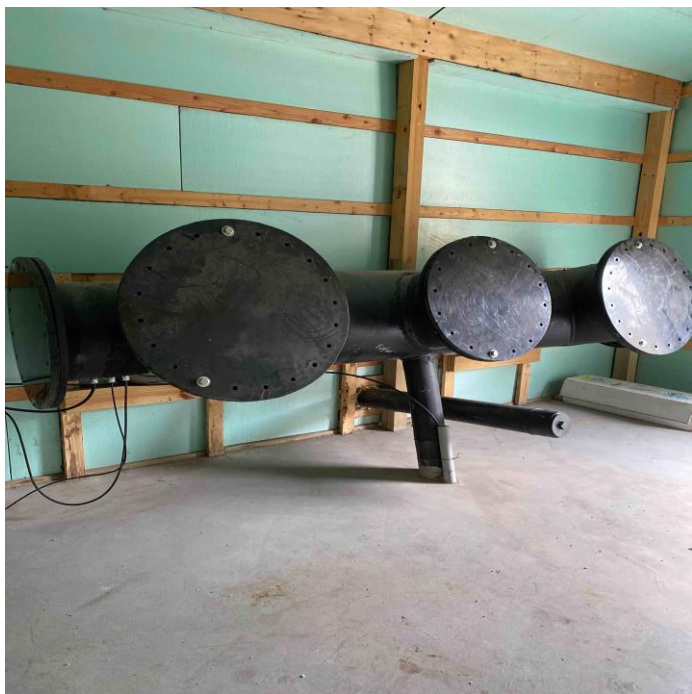
Image Number: 341
Date: 11/4/2021
Time: 9:49 AM
Direction: West-Southwest

Description:
Inside Phase II, Cell 2 Leachate Pump House. Cleanout riser and pump risers with T connection to forcemain shown. Building is well maintained.

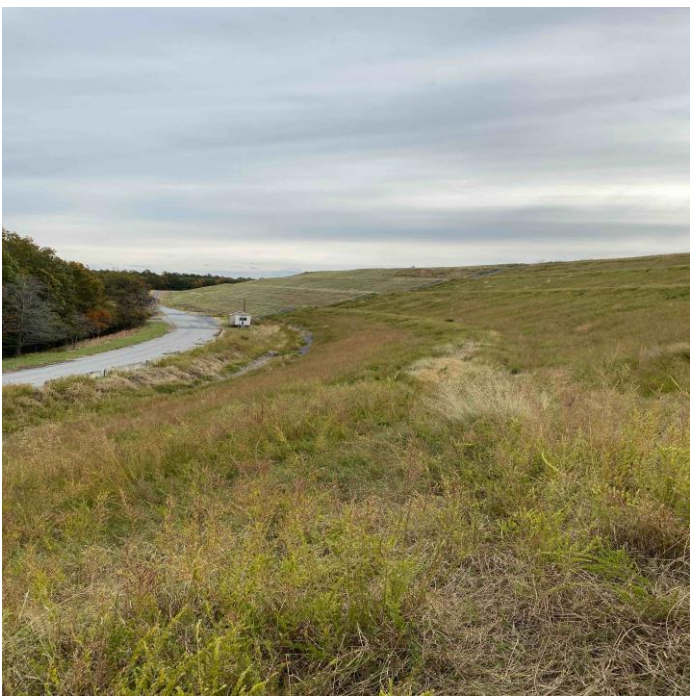
<p>Image Number: 343 Date: 11/4/2021 Time: 9:53 AM Direction: East-Southeast</p>

<p>Description: Landfilll sideslopes and terraces are well maintained. No evidence of slope stability issues.</p>

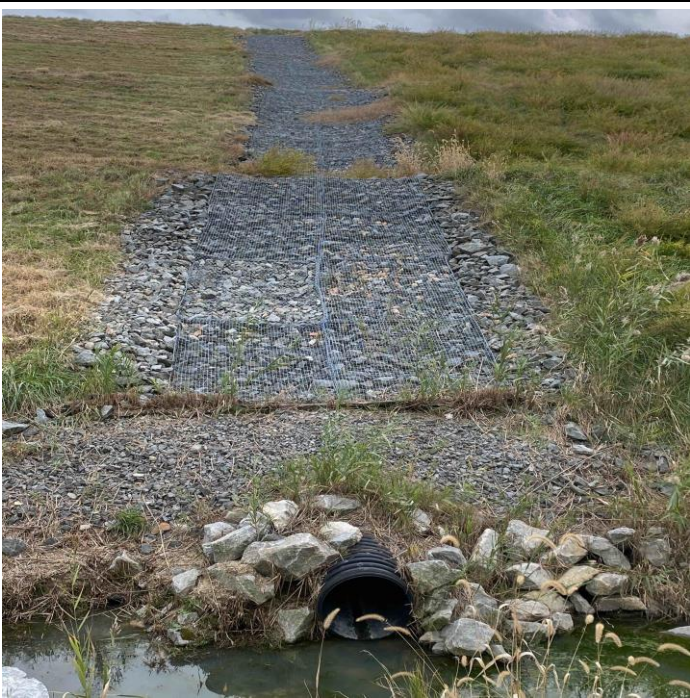
<p>Image Number: 345 Date: 11/5/2021 Time: 1:22 PM Direction: South-Southeast</p>

<p>Description: Downchute near southwest forebay of Northeast Detention Basin. The side outlet pipe detached in 2021 and was repaired, as documented in the operating record and communicated to DNREC. Pipe and downchute appear to be functioning appropriately as intended.</p>

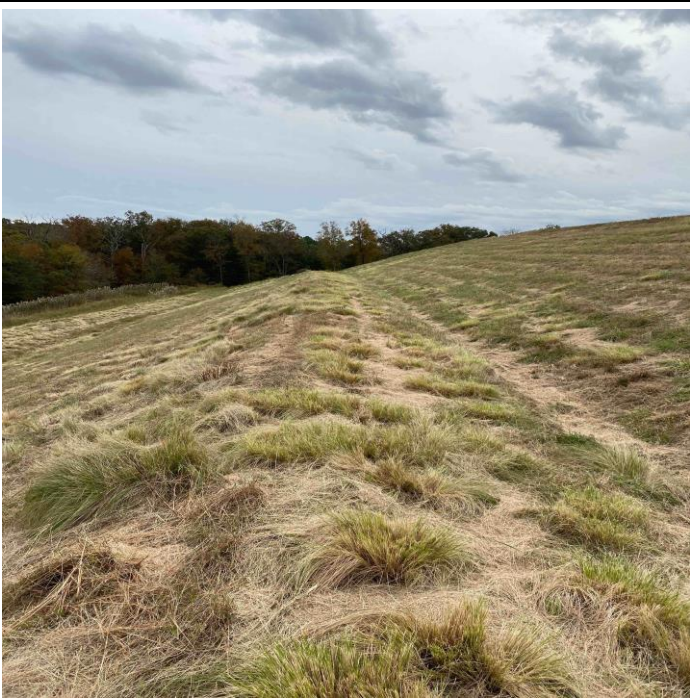
<p>Image Number: 349 Date: 11/7/2021 Time: 1:26 PM Direction: South</p>

<p>Description: Phase I terrace berm and sideslopes. Clear of obstructions and functioning as intended. Vegetative cover is dense and healthy.</p>

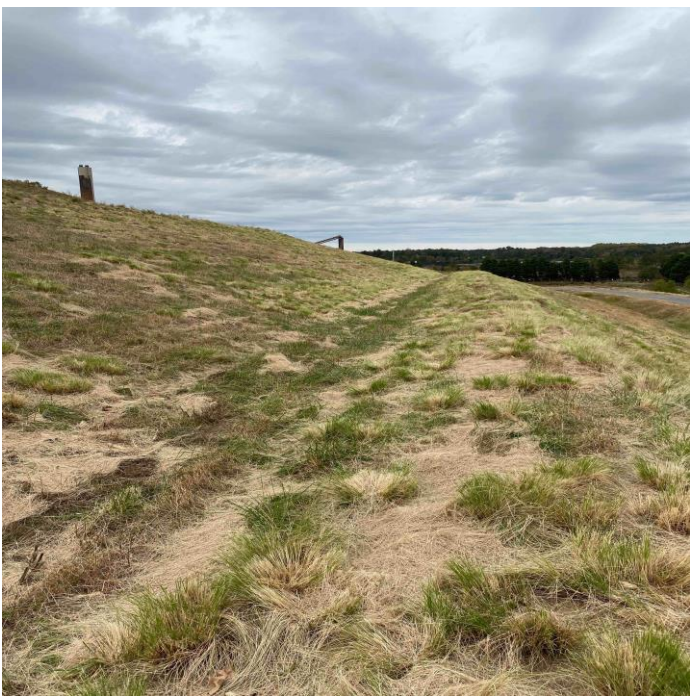
<p>Image Number: 351 Date: 11/8/2021 Time: 1:27 PM Direction: North-Northwest</p>

<p>Description: Phase I terrace berm and sideslopes. Clear of obstructions and functioning as intended. Vegetative cover is dense and healthy.</p>

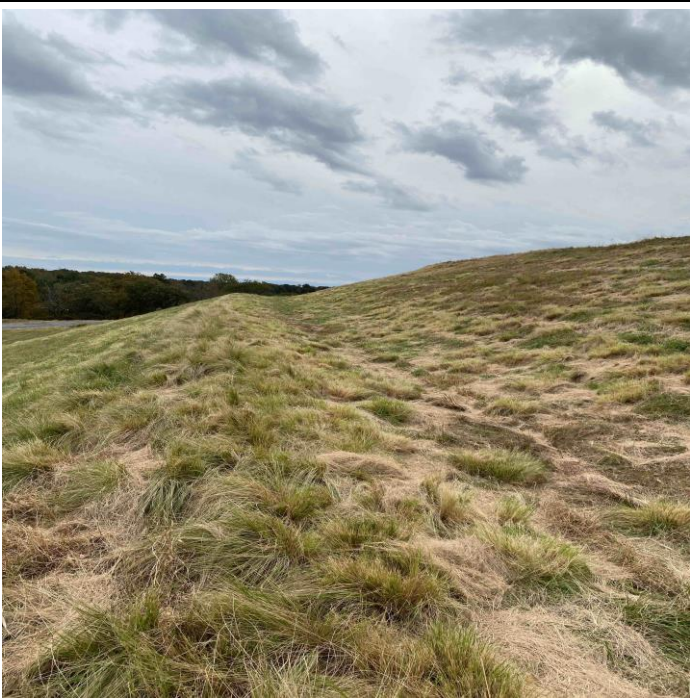
<p>Image Number: 353 Date: 11/9/2021 Time: 1:27 PM Direction: South</p>

<p>Description: Phase I terrace berm and sideslopes. Clear of obstructions and functioning as intended. Vegetative cover is dense and healthy.</p>

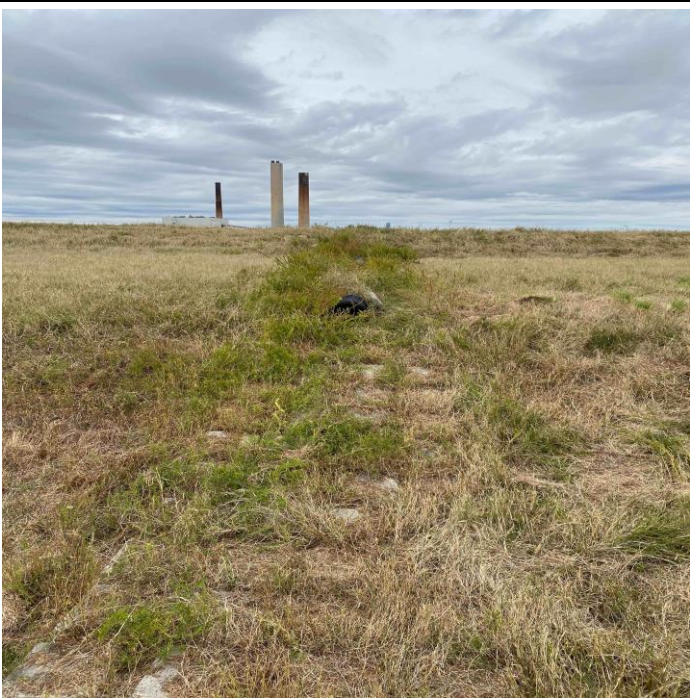
<p>Image Number: 361 Date: 11/13/2021 Time: 1:34 PM Direction: North-Northwest</p>

<p>Description: Letdown pipe location from plateau terrace into access road ditch. Free draining. No evidence of erosion.</p>

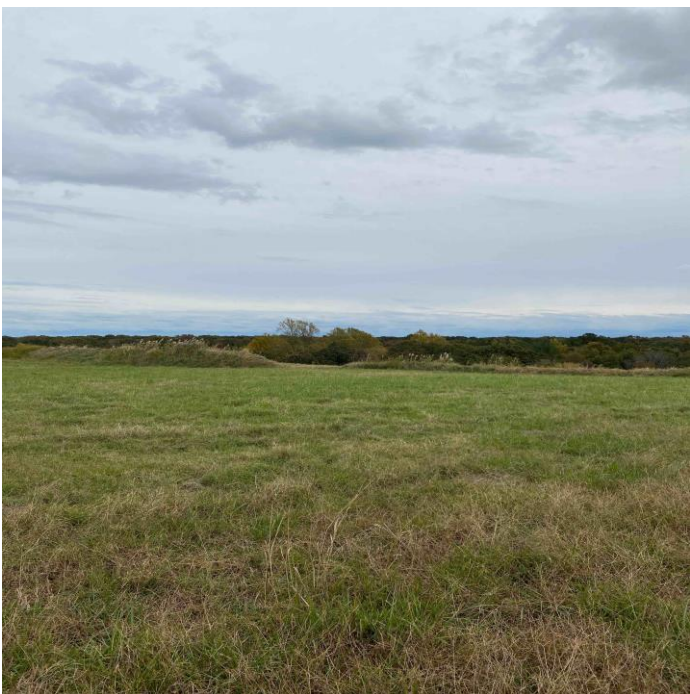
Image Number: 365 Date: 11/15/2021 Time: 1:36 PM Direction: East

Description: Final cover on plateau. Vegetation is well established. No signs of animal burrows or erosion.

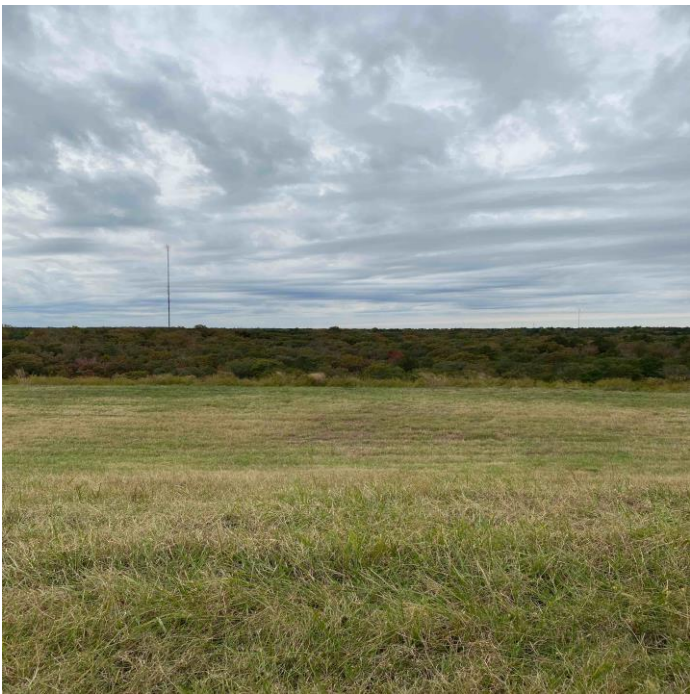
<p>Image Number: 367 Date: 11/16/2021 Time: 1:37 PM Direction: Southwest</p>

<p>Description: Final cover on plateau. Vegetation is well established. No signs of animal burrows or erosion.</p>

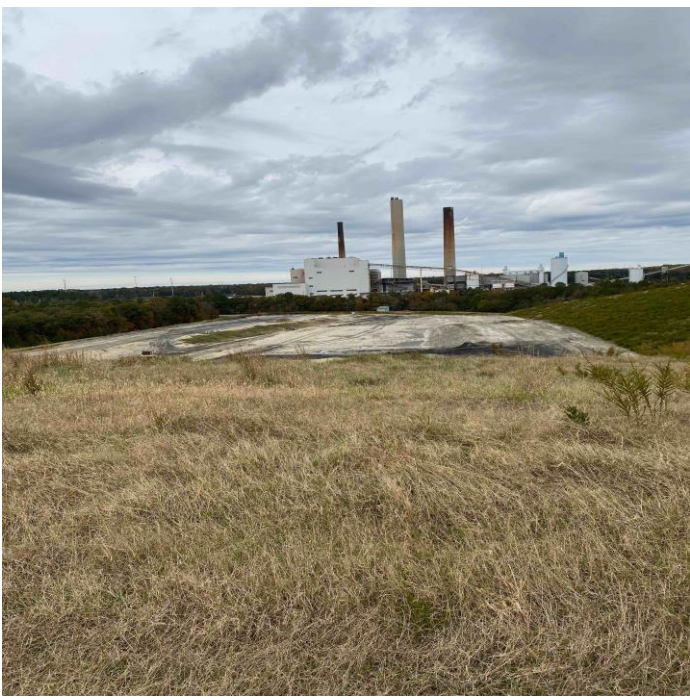
<p>Image Number: 369 Date: 11/17/2021 Time: 1:38 PM Direction: North</p>

<p>Description: Final cover on plateau. Vegetation is well established. No signs of animal burrows or erosion. Overlooking Phase II, Cell 2 active area from Phase II Cell 1 plateau.</p>

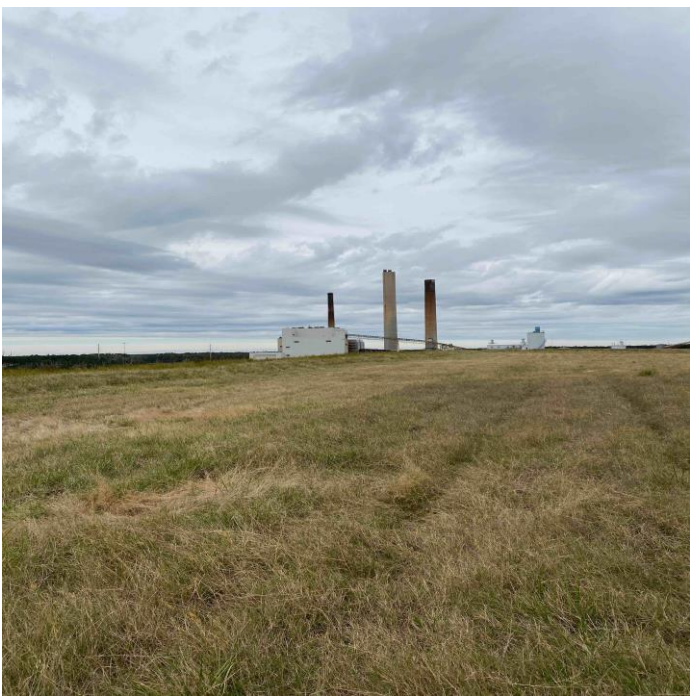
<p>Image Number: 371 Date: 11/18/2021 Time: 1:39 PM Direction: North-Northwest</p>

<p>Description: Final cover on plateau. Vegetation is well established. No signs of animal burrows or erosion.</p>

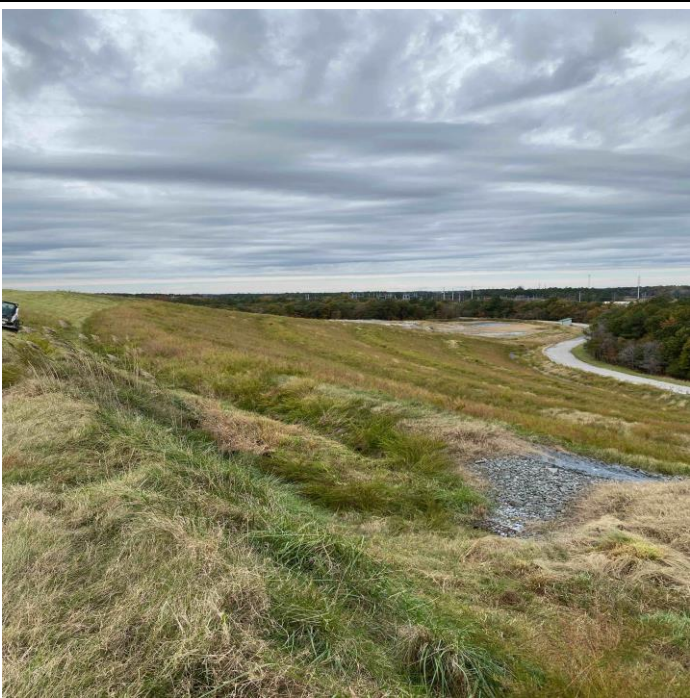
<p>Image Number: 373 Date: 11/19/2021 Time: 1:40 PM Direction: West-Northwest</p>

<p>Description: Sideslope overview from plateau. Well maintained.</p>

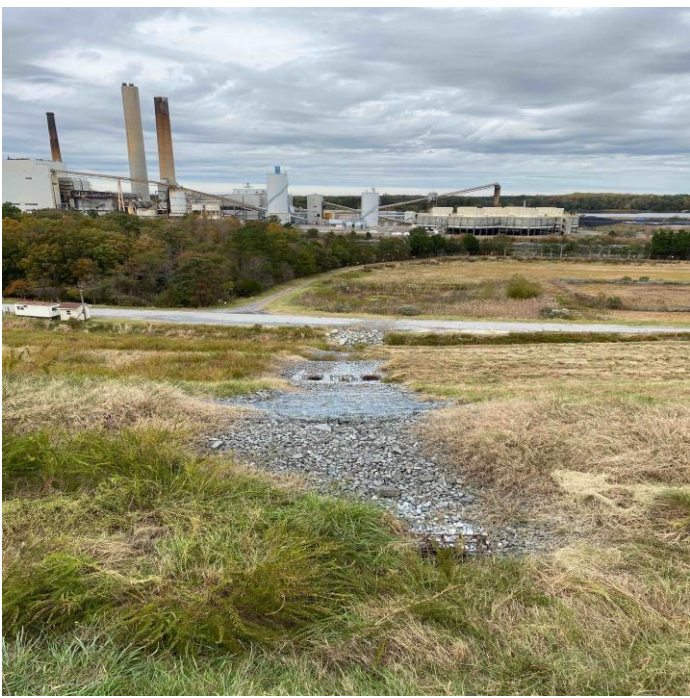
<p>Image Number: 377 Date: 11/21/2021 Time: 1:41 PM Direction: North</p>

<p>Description: Downchute from plateau area. Functioning as intended.</p>

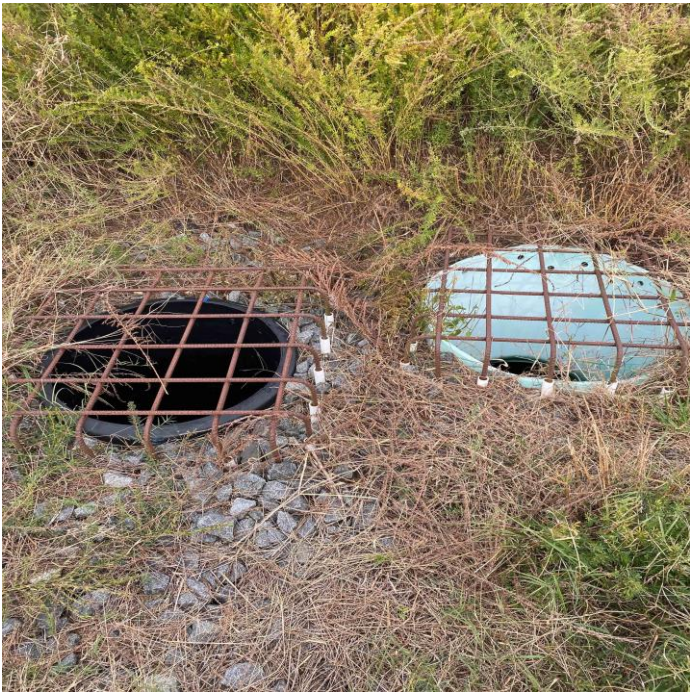
<p>Image Number: 379 Date: 11/22/2021 Time: 1:42 PM Direction: Northeast</p>

<p>Description: Downchute inlet, free of obstructions.</p>

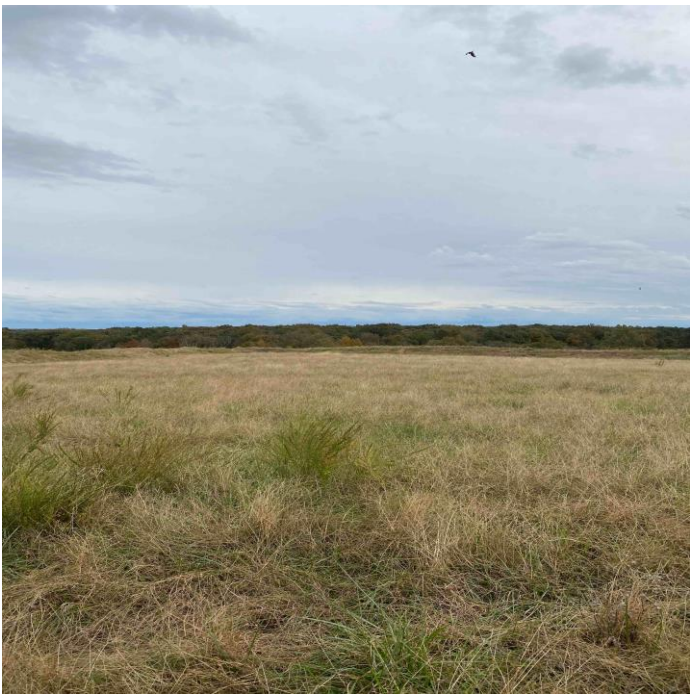
<p>Image Number: 385 Date: 11/25/2021 Time: 1:44 PM Direction: Southeast</p>

<p>Description: Final cover on plateau. Vegetation is well established. No signs of animal burrows or erosion.</p>

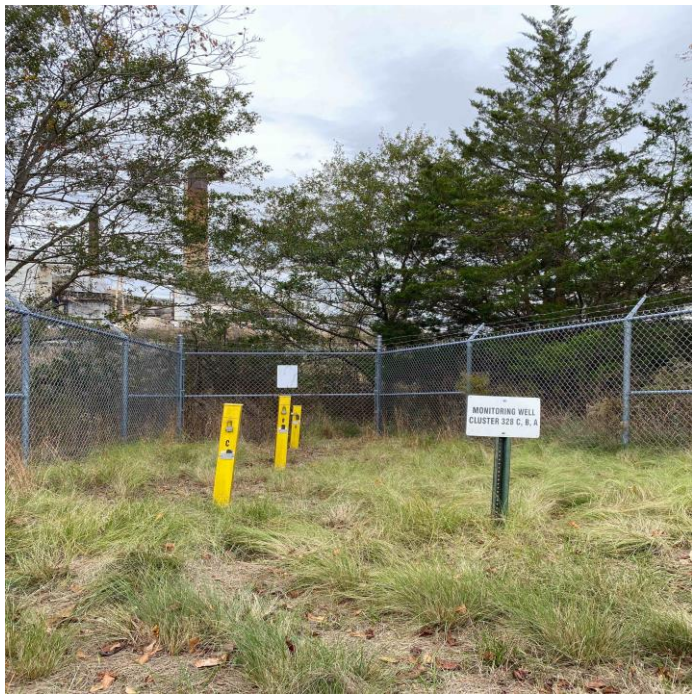
Description:
Monitoring well cluster.

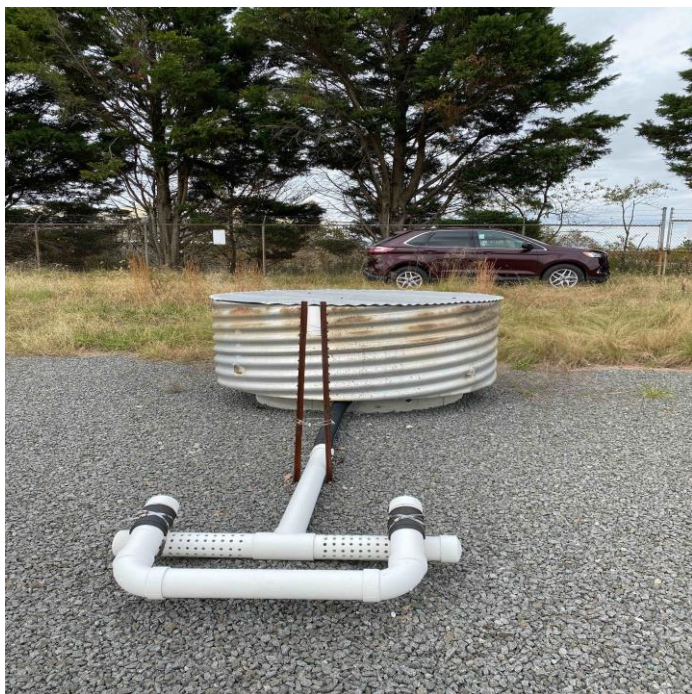
Image Number: 389
Date: 11/27/2021
Time: 1:48 PM
Direction: North

Description:
Northeast Detention Basin outlet skimmer.
