2024 ANNUAL CCR UNIT INSPECTION
INDIAN RIVER LANDFILL
NRG INDIAN RIVER STATION
DAGSBORO, DELAWARE

SCS ENGINEERS

25221158.00 | January 18, 2025

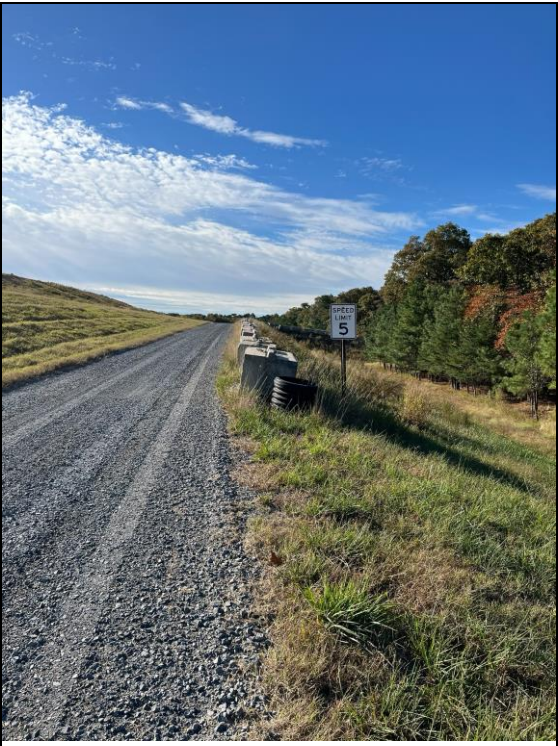
Image Number: 1
Date: 10/15/2024
Time: 8:26 AM
Direction: South-Southeast

Description:
Speed limit sign and outer side slope of Phase II, Cell 2. The side slope is well vegetated and maintained. No signs of vegetative stress, erosion, or geotechnical instability. Road is well maintained.

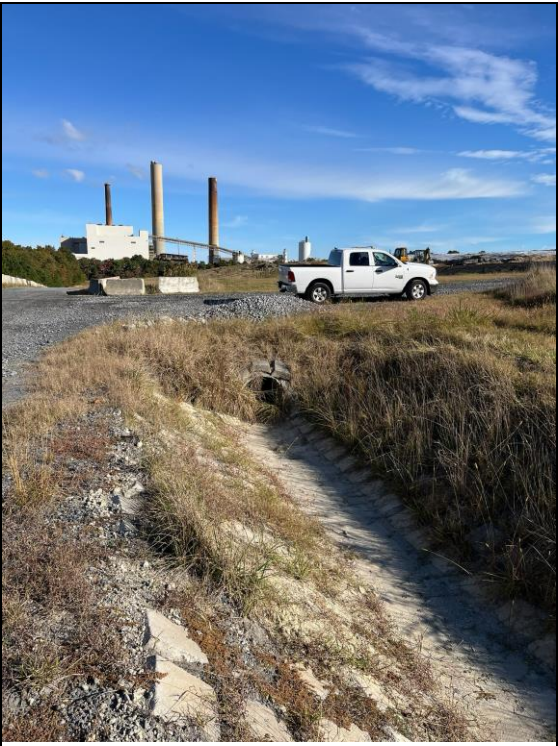
Image Number: 2
Date: 10/15/2024
Time: 8:29 AM
Direction: North-Northeast

Description:
Perimeter landfill ditch segment is in good working condition with no obstructions.

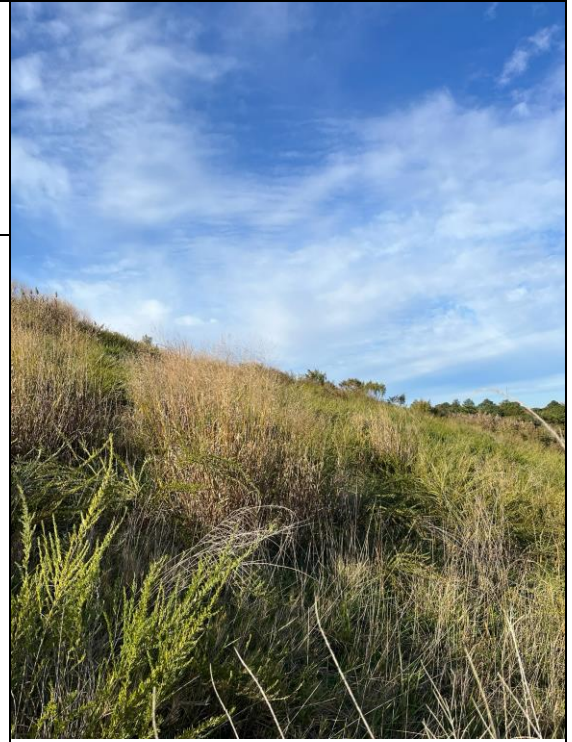
Image Number: 3
Date: 10/15/2024
Time: 8:32 AM
Direction: West-Southwest

Description:
Phase II, Cell 1 / Cell 2 boundary. Slopes are well vegetated with no sign of erosion, sloughing, or animal borrows.

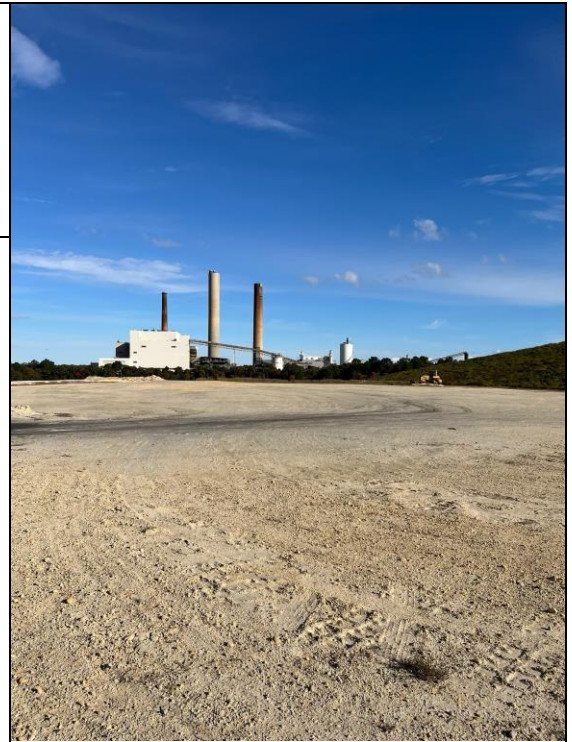
Image Number: 4
Date: 10/15/2024
Time: 8:32 AM
Direction: North

Description:
Phase II Cell 2 intermediate cover. Material is graded to drain to the north. The intermediate cover is well maintained.

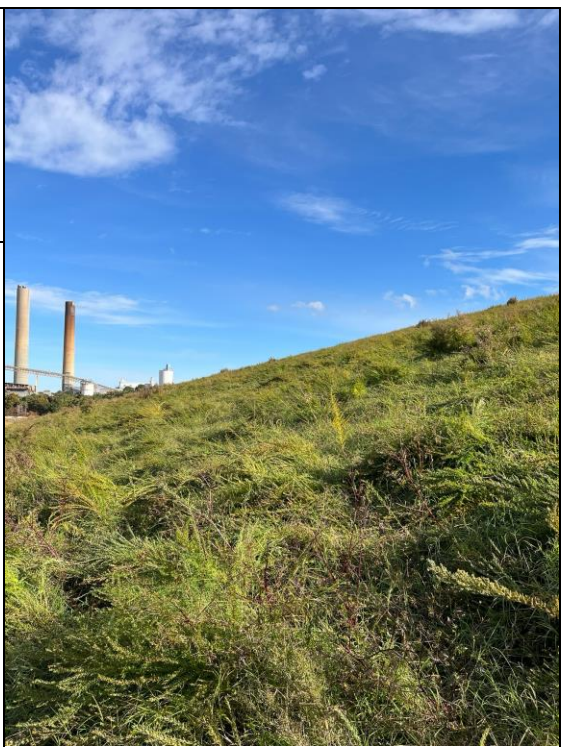
<p>Image Number: 6 Date: 10/15/2024 Time: 8:35 AM Direction: North-Northeast</p>

<p>Description: Overview of the vegetated Phase I intermediate cover slopes. No signs of erosion, sloughing, or animal borrows.</p>

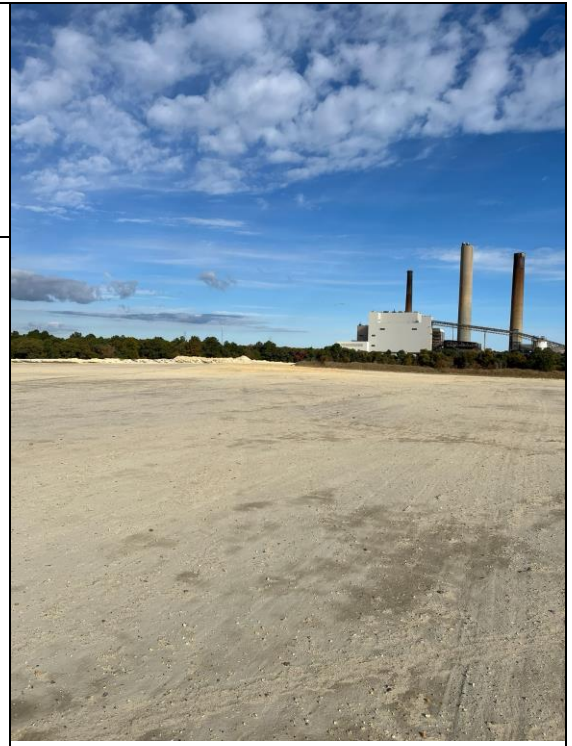
Image Number: 7
Date: 10/15/2024
Time: 8:35 AM
Direction: North-Northwest

Description:
Phase II Cell 2 intermediate cover. Material is graded to drain to the north. The intermediate cover is well maintained.

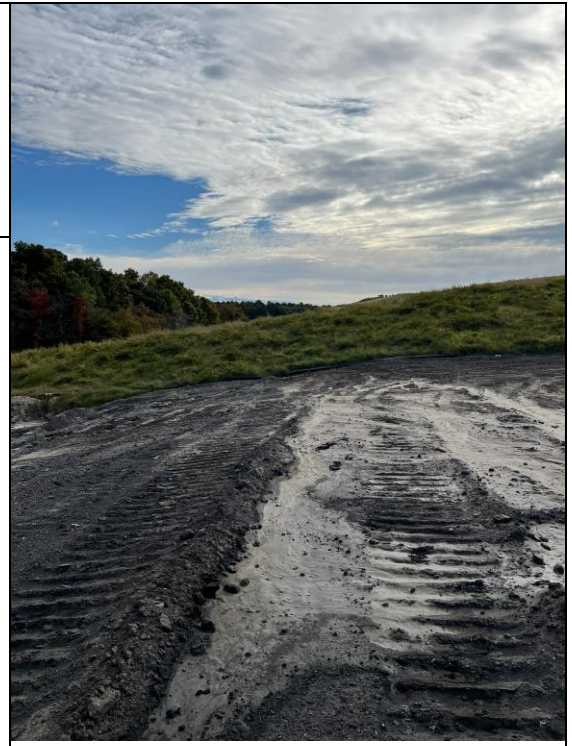
Image Number: 8
Date: 10/15/2024
Time: 8:42 AM
Direction: East

Description:
Active disposal area is small and well maintained.

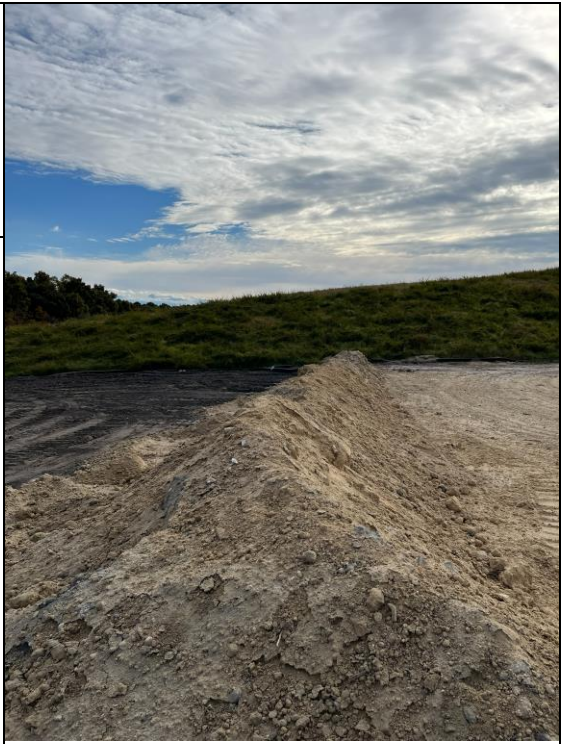
<p>Image Number: 9 Date: 10/15/2024 Time: 8:43 AM Direction: East</p>

<p>Description: Perimeter berm defines the limits of the active disposal area (left) and the intermediate cover area (right). Stormwater that lands on the intermediate cover area is routed to a pipe that conveys the water around the active disposal area to its discharge location within the perimeter stormwater channel.</p>

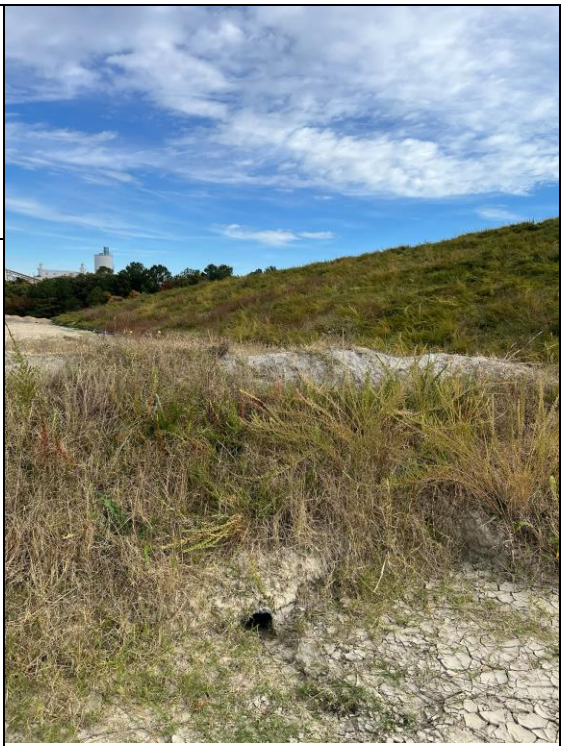
<p>Image Number: 10 Date: 10/15/2024 Time: 8:45 AM Direction: North-Northeast</p>

<p>Description: Upstream side of erosion control berm photographed in Image 9. The black pipes convey water from the upstream side of the berm to the perimeter non-contact water ditch.</p>

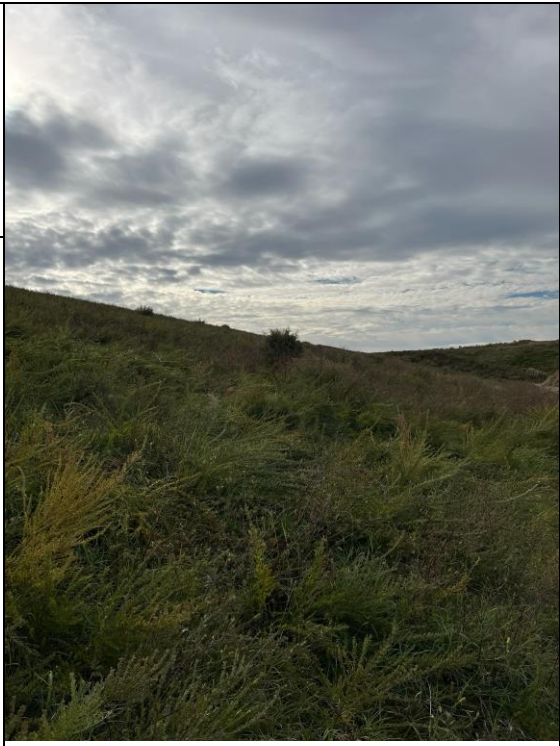
<p>Image Number: 11 Date: 10/15/2024 Time: 8:45 AM Direction: South-Southeast</p>

<p>Description: Overview of the vegetated Phase I intermediate cover slopes. No signs of erosion, sloughing, or animal borrows.</p>

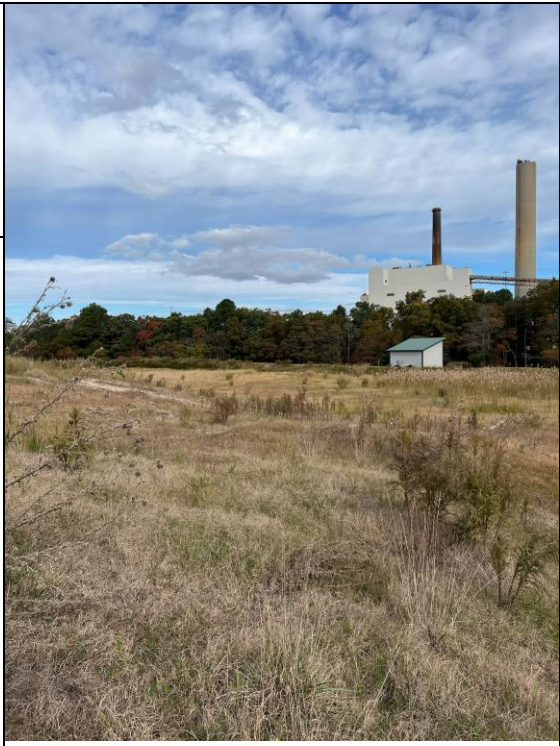
<p>Image Number: 12 Date: 10/15/2024 Time: 8:48 AM Direction: Northwest</p>

<p>Description: Vegetated intermediate cover on northern area of Phase II Cell II. Vegetated intermediate cover is present to north of photo location. Intermediate cover without vegetation is present to the south of the photo location. Well maintained. No ponding water.</p>

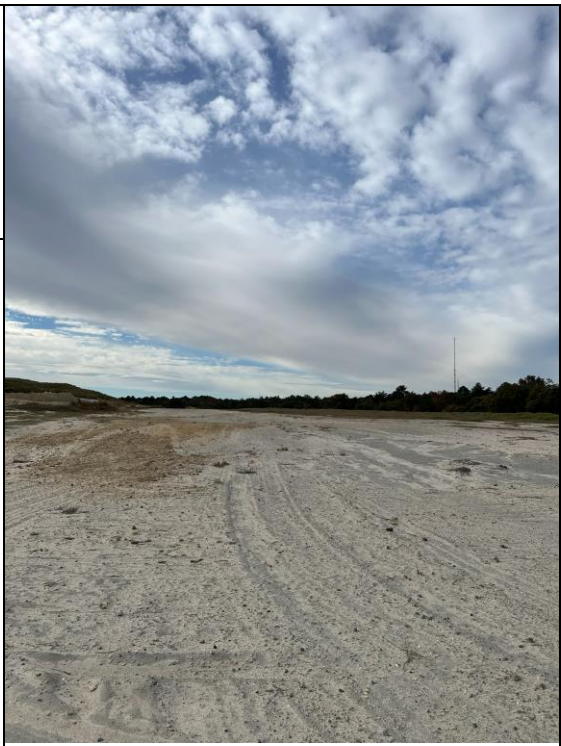
<p>Image Number: 13 Date: 10/15/2024 Time: 8:49 AM Direction: South-Southwest</p>

<p>Description: Phase II Cell 2 intermediate cover. Material is graded and well maintained.</p>

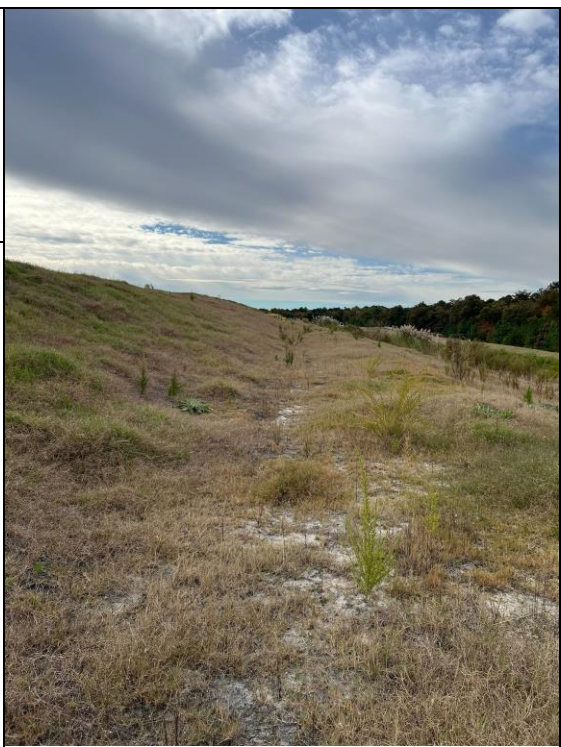
<p>Image Number: 14 Date: 10/15/2024 Time: 8:50 AM Direction: South</p>

<p>Description: Vegetated intermediate cover on terrace near exterior of Phase II, Cell II. Well maintained. No observed ponding or significant erosion.</p>

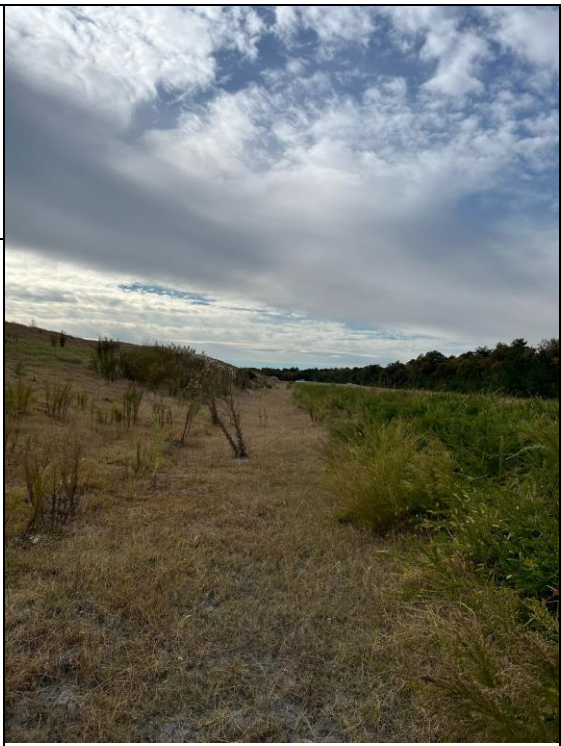
<p>Image Number: 15 Date: 10/15/2024 Time: 8:51 AM Direction: South</p>

<p>Description: Vegetated intermediate cover on terrace near exterior of Phase II, Cell II. Well maintained. No observed ponding or significant erosion.</p>

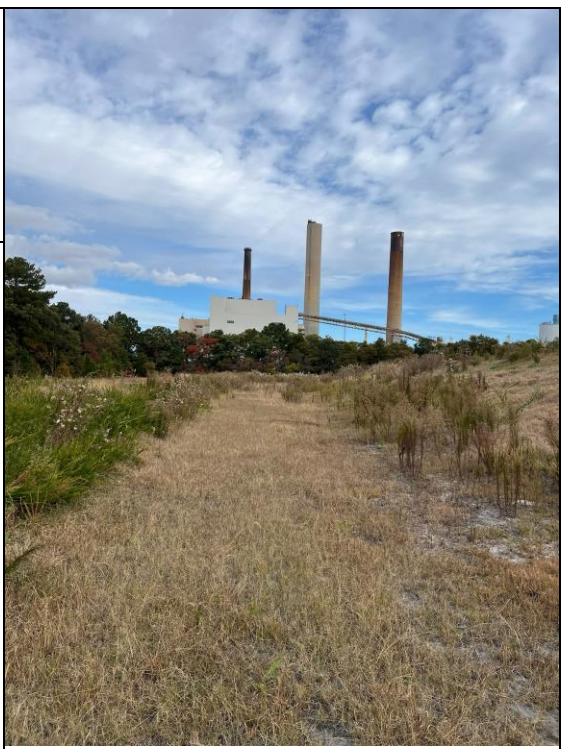
<p>Image Number: 16 Date: 10/15/2024 Time: 8:51 AM Direction: North</p>

<p>Description: Vegetated intermediate cover on terrace near exterior of Phase II, Cell II. Well maintained. No observed ponding or significant erosion.</p>

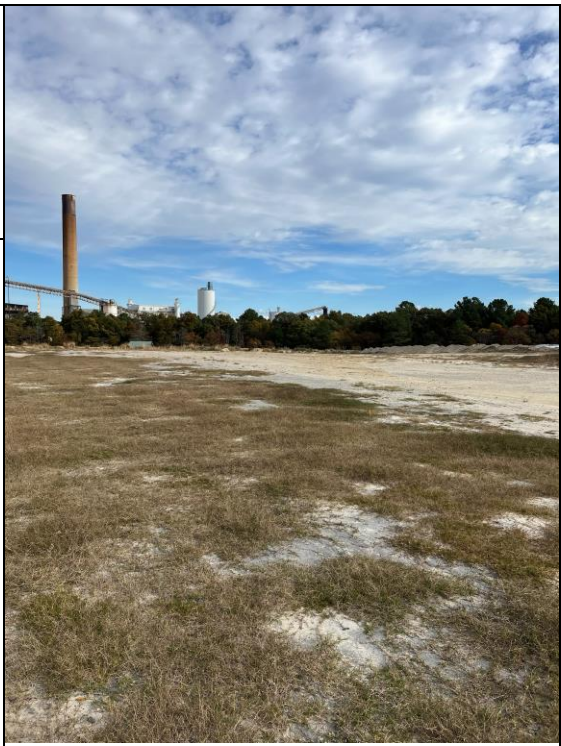
<p>Image Number: 18 Date: 10/15/2024 Time: 8:53 AM Direction: North-Northeast</p>

<p>Description: Vegetation establishing on Phase II Cell 2 intermediate cover. Material is graded and well maintained.</p>

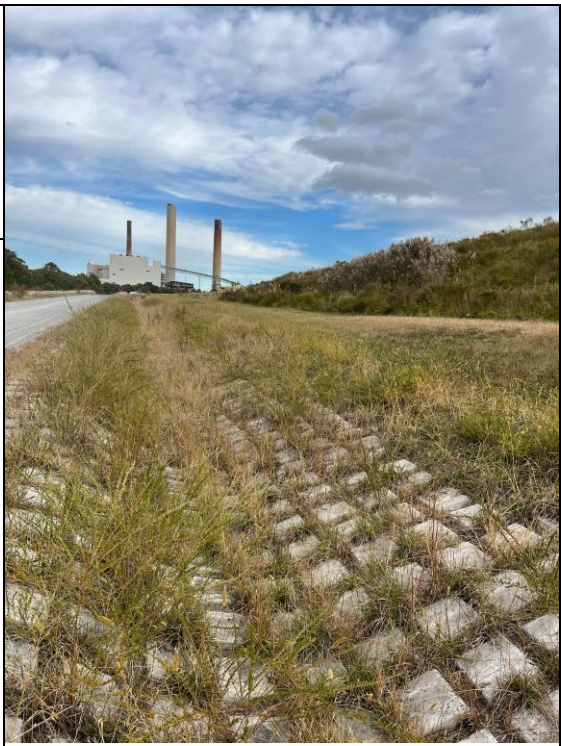
<p>Image Number: 21 Date: 10/15/2024 Time: 9:05 AM Direction: North-Northeast</p>

<p>Description: Perimeter landfill ditch segment is in good working condition with no obstructions.</p>

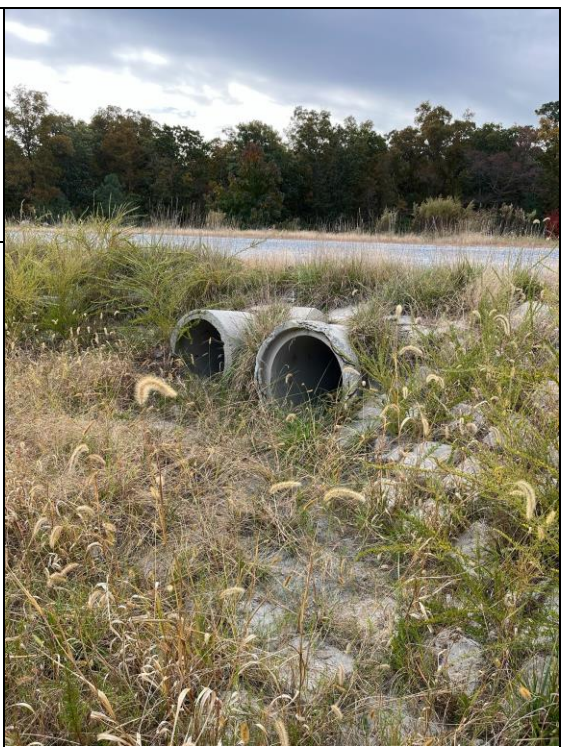
<p>Image Number: 22 Date: 10/15/2024 Time: 9:06 AM Direction: South-Southeast</p>

<p>Description: Culvert inlets that convey water from landfill final cover to the Southeast Detention Basin.</p>

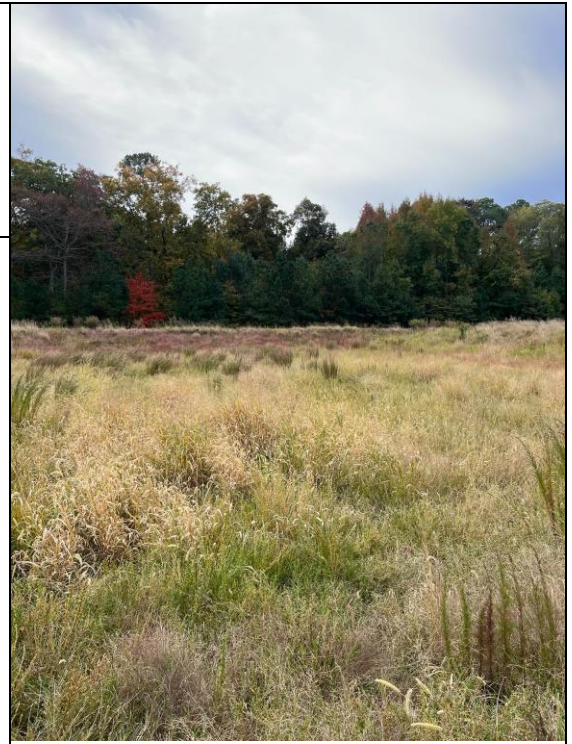
Description:
Forebay berm within the Southeast Detention Basin in good condition. Vegetation coverage is dense and healthy.

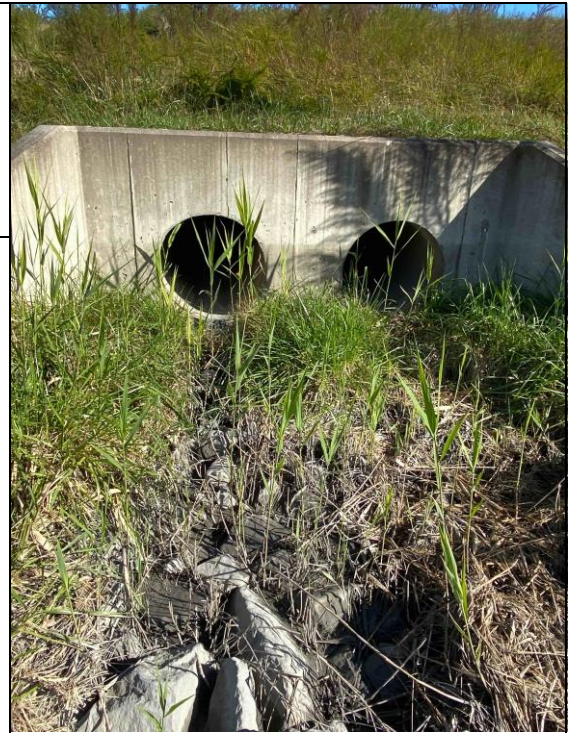
Image Number: 24
Date: 10/15/2024
Time: 9:07 AM
Direction: Northeast

Description:
Inlet to Southeast Detention Basin forebay in good condition. Free of obstruction at inlets and outlets.

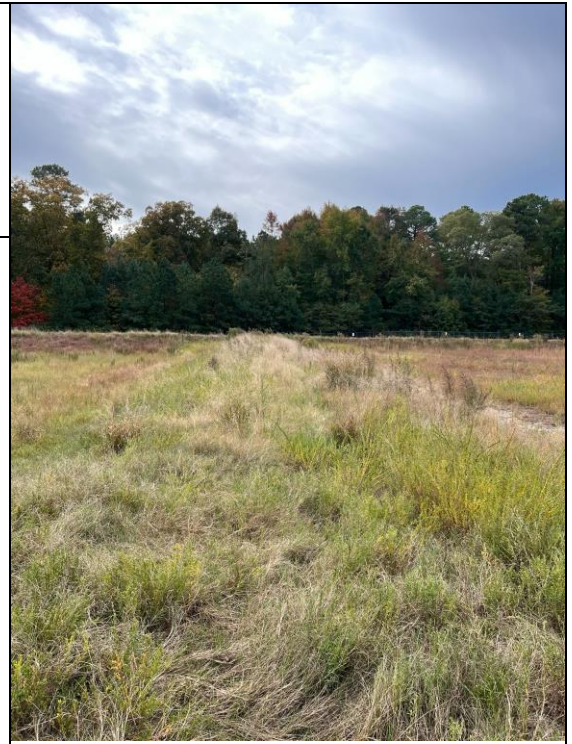
Image Number: 25
Date: 10/15/2024
Time: 9:07 AM
Direction: South

Description:
Southeast Detention Basin berm that divides the forebay and main basin storage area is well maintained.

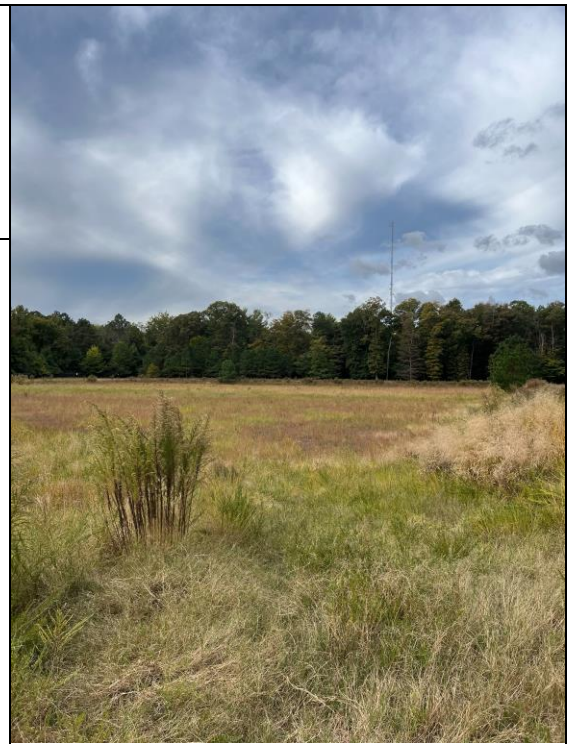
Image Number: 26
Date: 10/15/2024
Time: 9:07 AM
Direction: West-Southwest

Description:
Southeast Detention Basin in good condition. Vegetation coverage is dense and healthy.

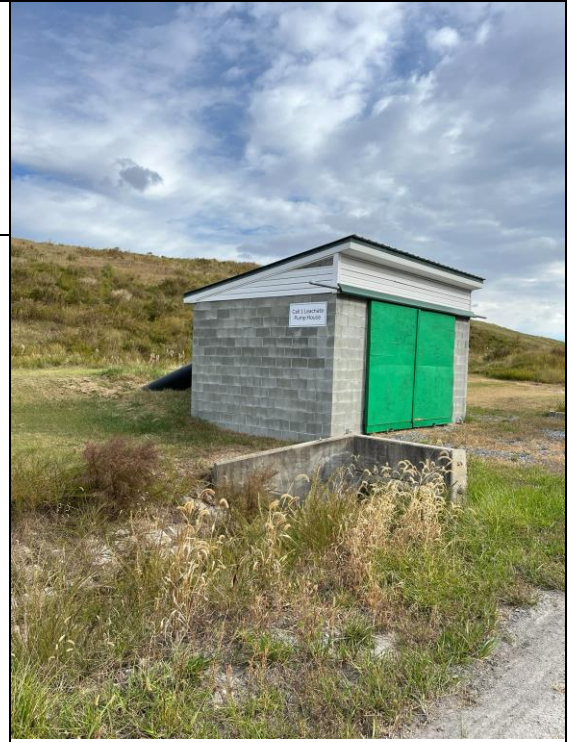
Description:
Phase II, Cell 1 leachate pump house. Building exterior is in good condition. Building is appropriately marked (signage).

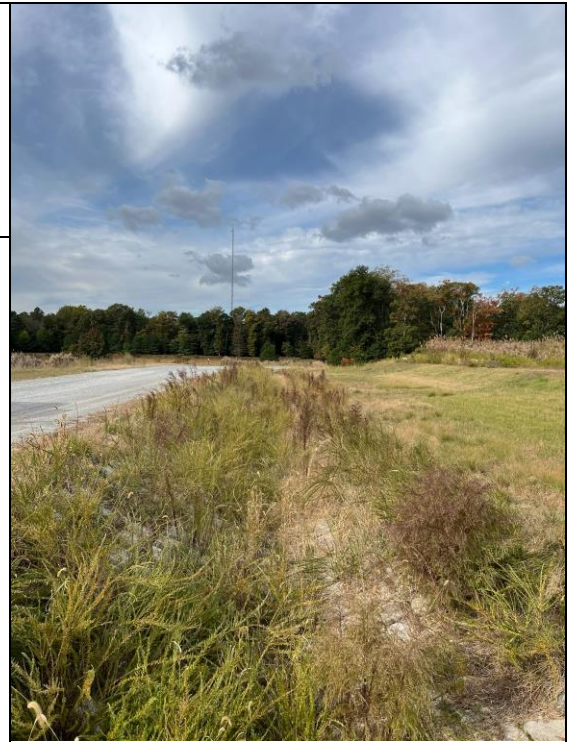
Image Number: 28
Date: 10/15/2024
Time: 9:09 AM
Direction: West

Description:
Perimeter landfill ditch segment is in good working condition.

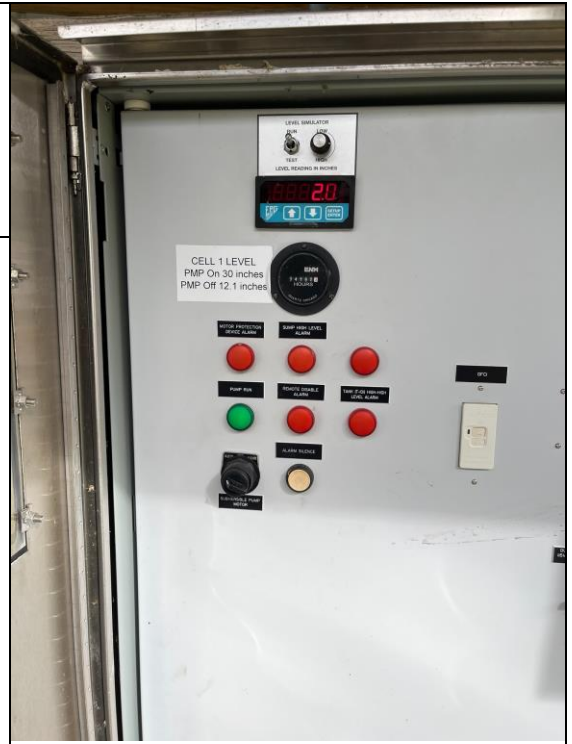
Description:
Phase I, Cell 1 leachate liquid level indicator and controls in working condition.

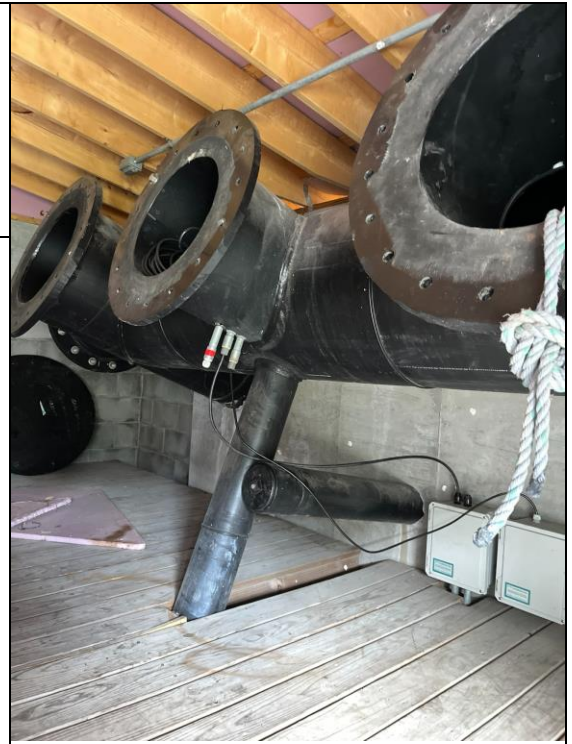
Image Number: 30
Date: 10/15/2024
Time: 9:11 AM
Direction: West-Northwest

Description:
Inside the Phase I, Cell 1 leachate pump house. Cleanout riser and pump risers with T-connections to forcemain are shown in this photograph. Building is well maintained.

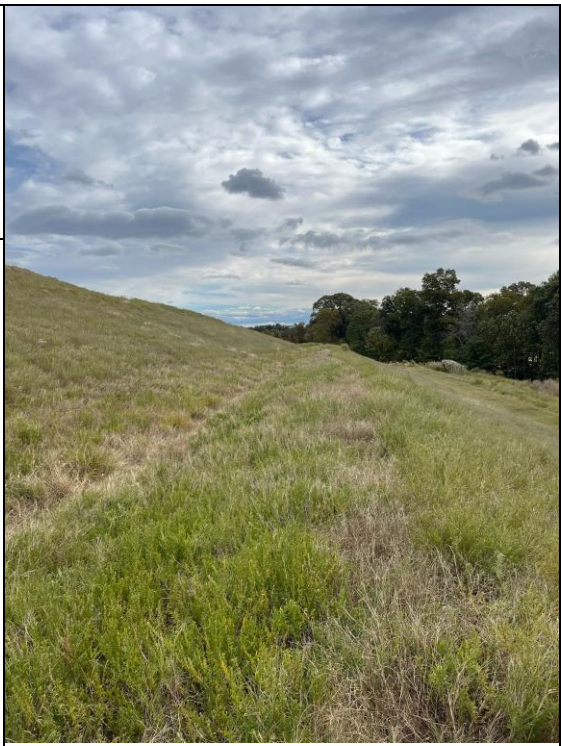
<p>Image Number: 31 Date: 10/15/2024 Time: 9:14 AM Direction: East-Northeast</p>

<p>Description: Landfill side slopes and terrace are well maintained. No evidence of slope stability issues or erosion.</p>

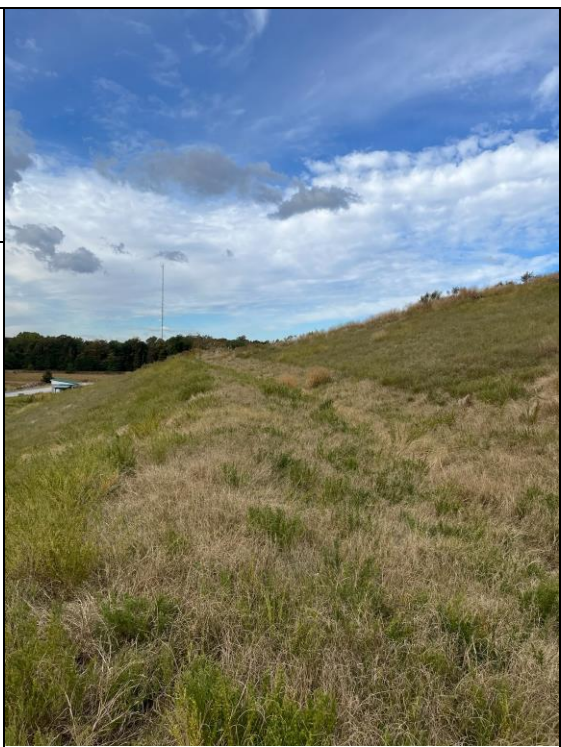
<p>Description: Landfill side slopes and terrace are well maintained. No evidence of slope stability issues or erosion.</p>

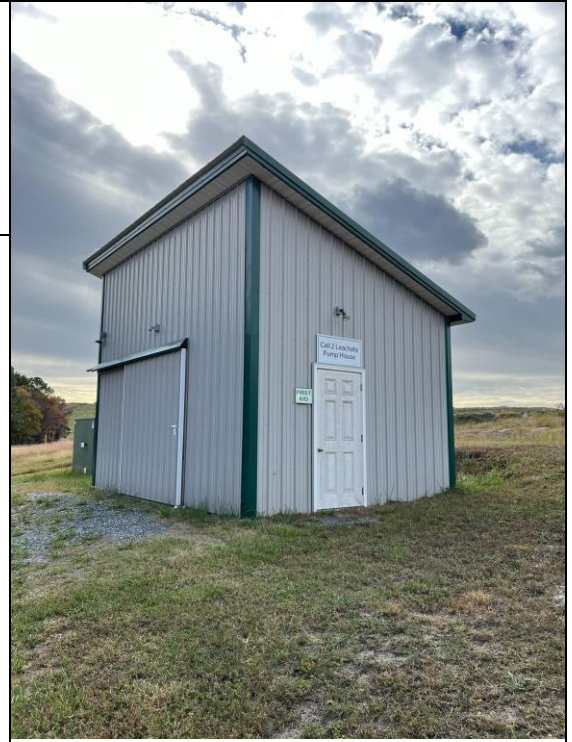
Description:
Phase II, Cell 2 leachate pump house. Building exterior is in good condition. Building is appropriately marked (signage).

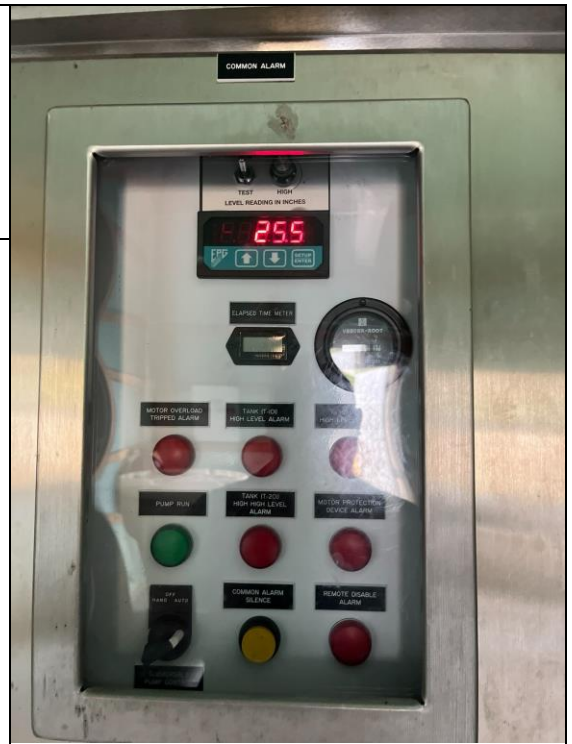
Image Number: 36
Date: 10/15/2024
Time: 9:22 AM
Direction: East

Description:
Phase II, Cell 2 leachate liquid level indicator and controls in working condition.

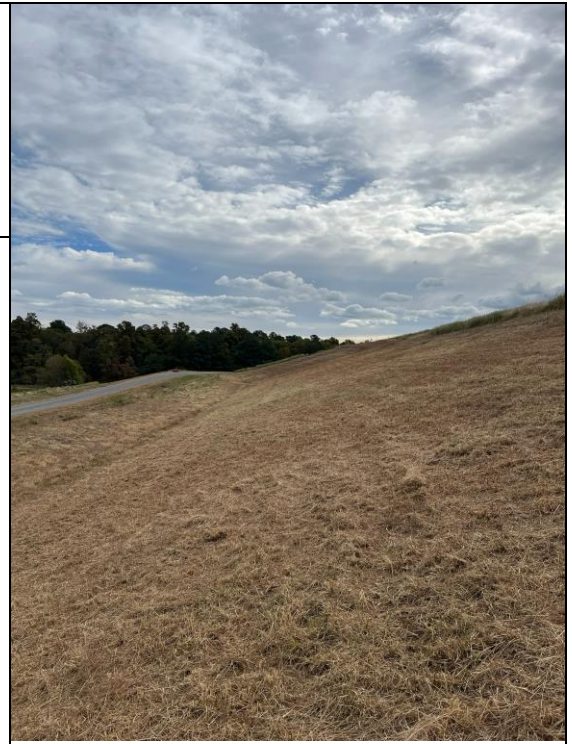
Description:
Phase I final cover. Vegetation has recently been mowed. Coverage is dense and healthy. No animal burrows, erosion, or sloughing were observed.

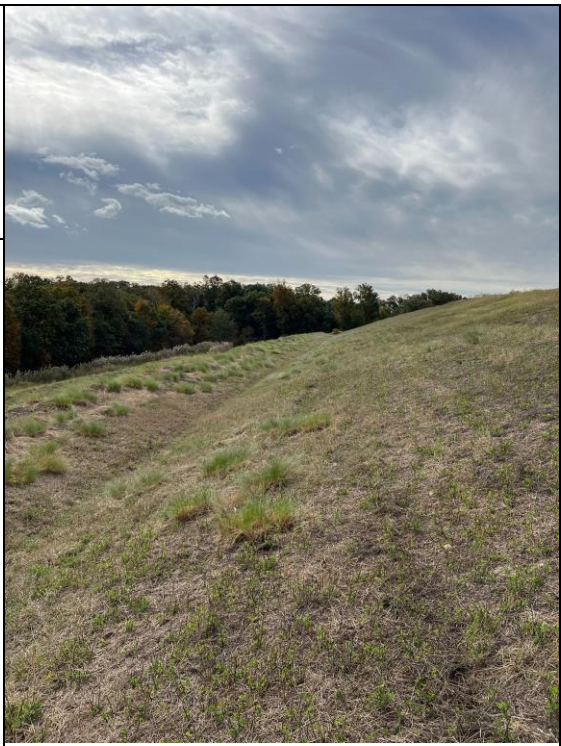
<p>Description: Phase I final cover. Vegetation coverage is dense and healthy. No animal burrows, erosion, or sloughing were observed.</p>

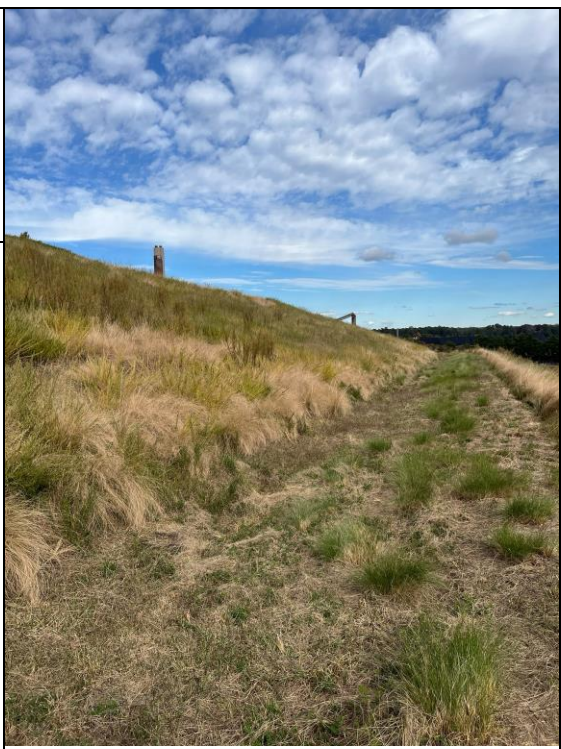
<p>Description: Phase I side slopes and terrace berm are well maintained. No evidence of slope stability issues or erosion.</p>

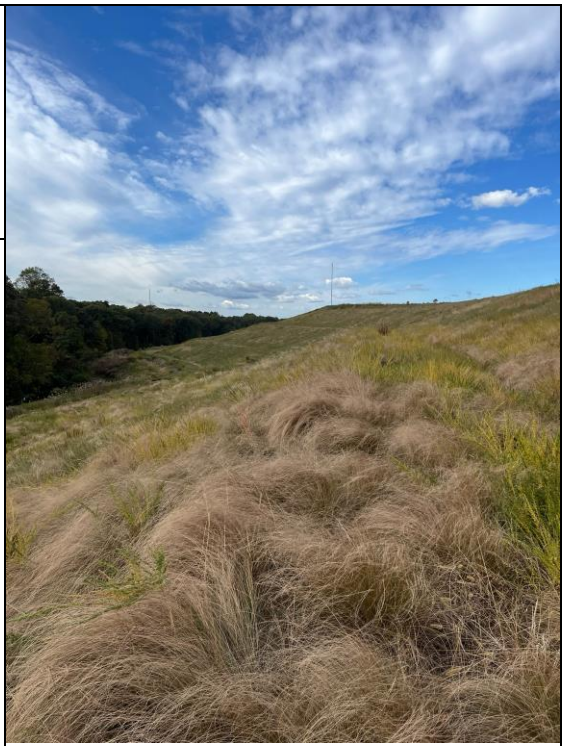
<p>Description: Phase I final cover. Vegetation coverage is dense and healthy. No animal burrows, erosion, or sloughing were observed.</p>

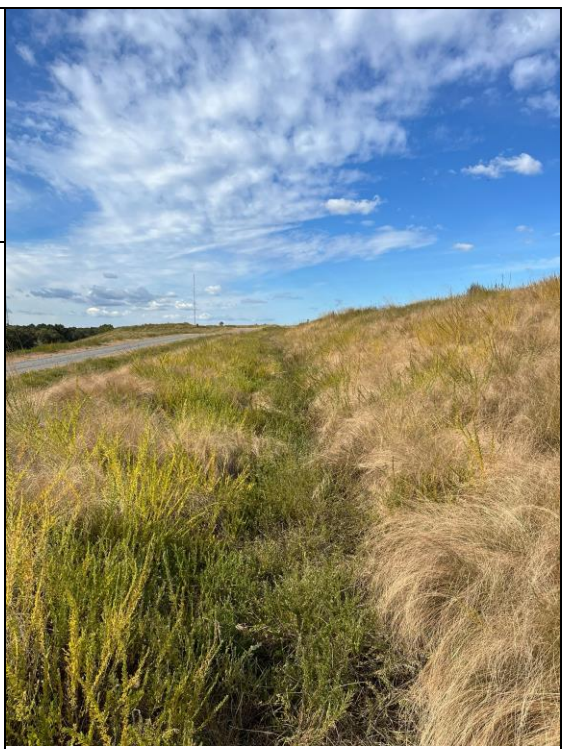
<p>Description: Phase I side slopes and terrace berm are well maintained. No evidence of slope stability issues or erosion.</p>

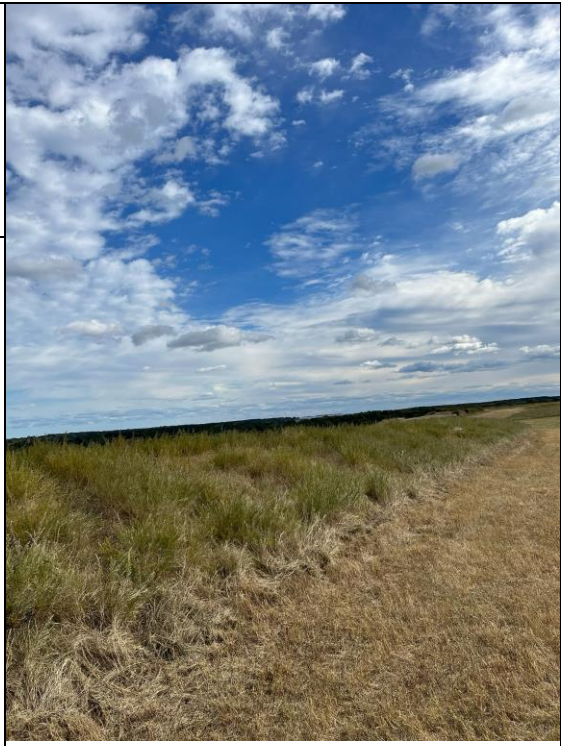
Image Number: 62
Date: 10/15/2024
Time: 9:48 AM
Direction: East-Northeast

Description:
Final cover plateau area. Vegetation coverage is dense and healthy. No animal burrows, erosion, or sloughing were observed.

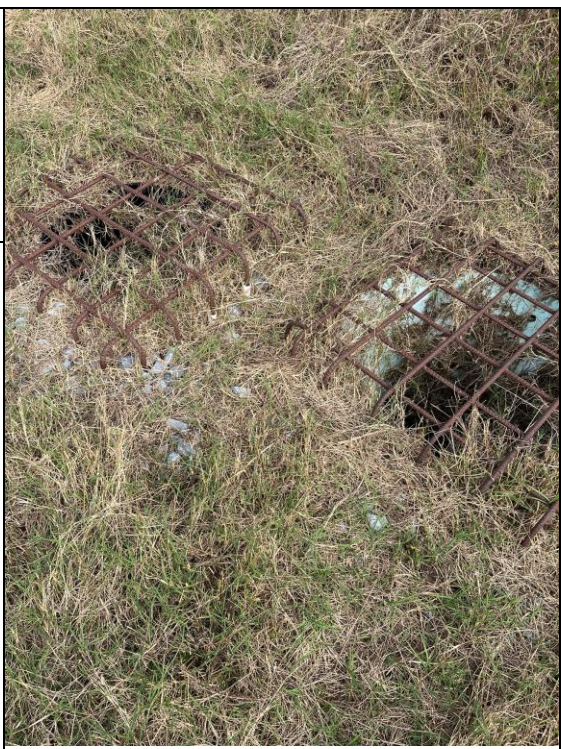
<p>Description: Phase I downchute pipe inlets with grated covers are well maintained and free of obstructions.</p>

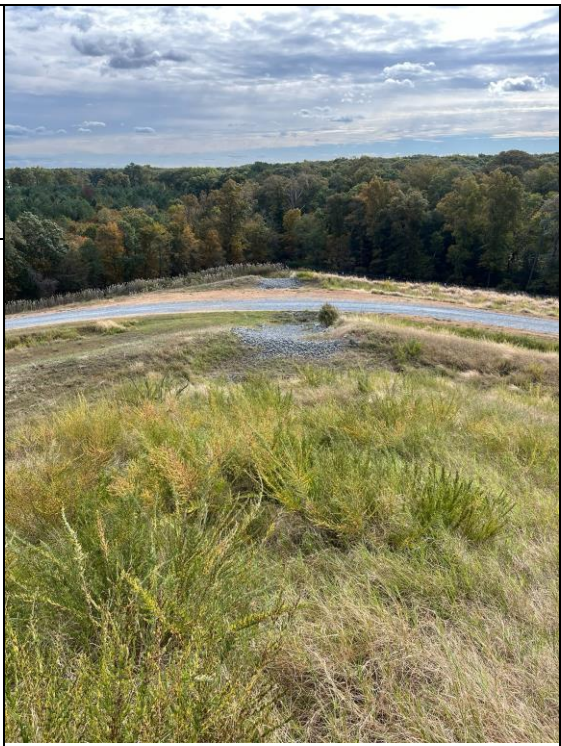
<p>Description: Phase I downchute riprap. Free of obstructions and functioning. No signs of wash out or erosion.</p>

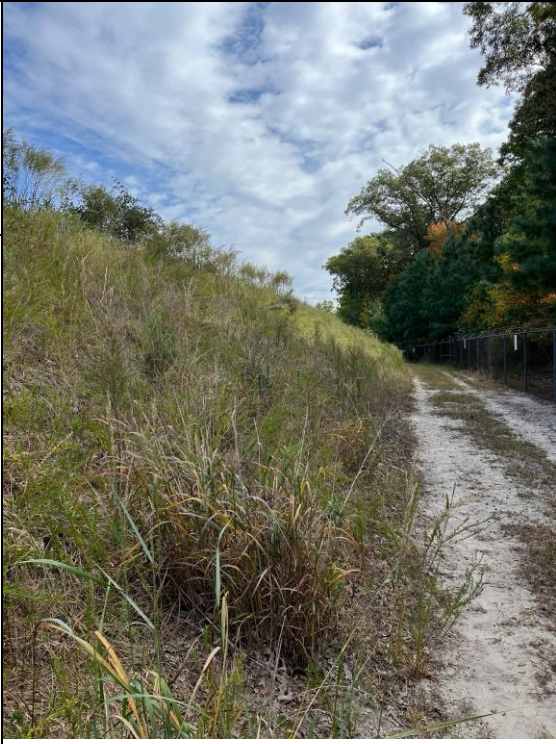
Description:
Vegetation on final cover is dense and healthy. No animal burrows, erosion, or sloughing were observed.

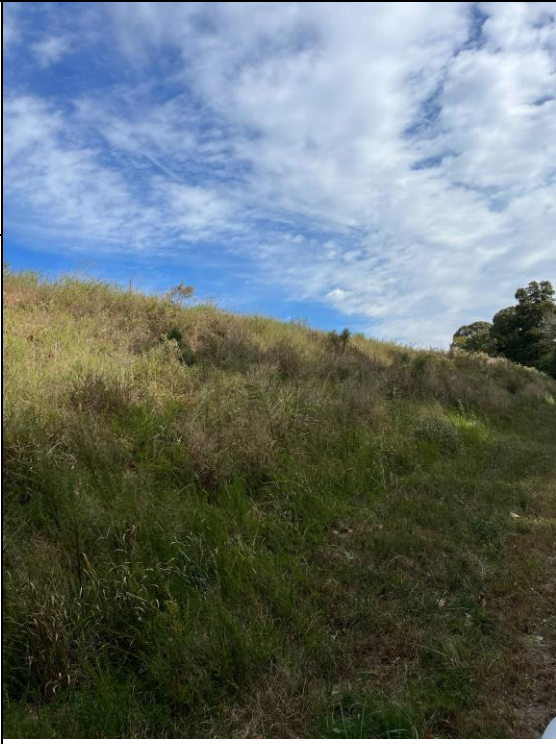
Image Number: 76
Date: 10/15/2024
Time: 10:17 AM
Direction: East-Northeast

Description:
Vegetation on final cover is dense and healthy. No animal burrows, erosion, or sloughing were observed.

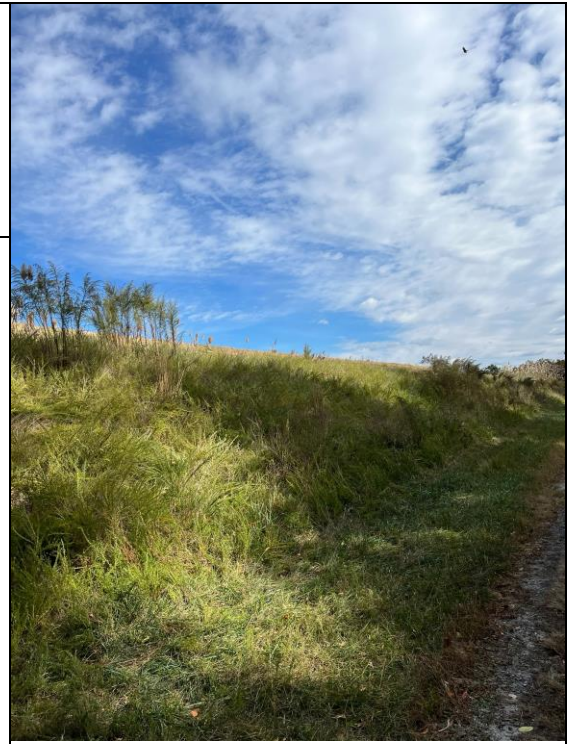
Description:
Vegetation on final cover is dense and healthy. No animal burrows, erosion, or sloughing were observed.
