2025 ANNUAL CCR UNIT INSPECTION
INDIAN RIVER LANDFILL
NRG INDIAN RIVER STATION
DAGSBORO, DELAWARE

SCS ENGINEERS

25221158.00 | January 18, 2026

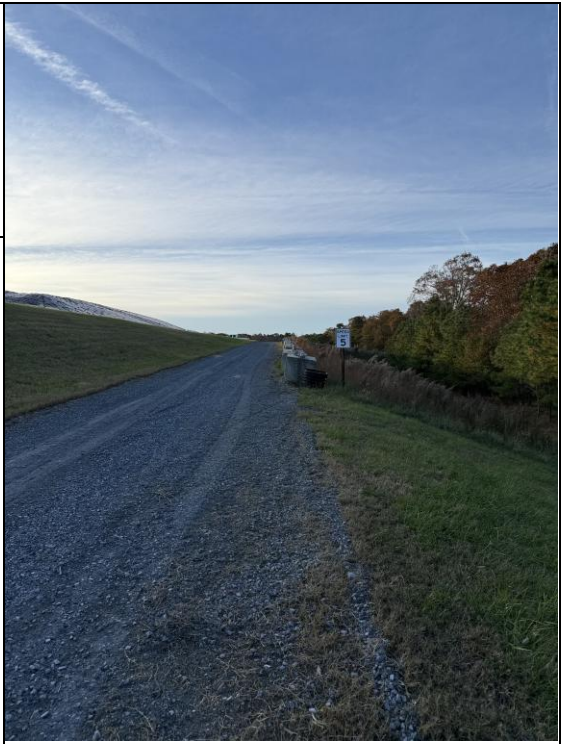
<p>Image Number: 1 Date: 11/13/2025 Time: 7:30 AM Direction: South-Southwest</p>

<p>Description: Speed limit sign and outer side slope of Phase II, Cell 2. The side slope is well vegetated and maintained. No signs of vegetative stress, erosion, or geotechnical instability. Road is well maintained.</p>

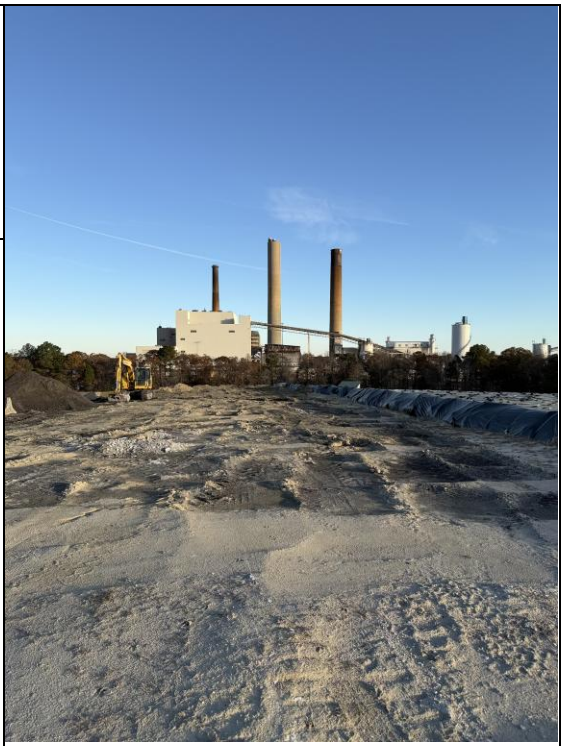
<p>Image Number: 2 Date: 11/13/2025 Time: 7:35 AM Direction: North</p>

<p>Description: Active face of Phase II, Cell 2. Significant portions of the active face have been covered with tarps or intermediate cover over the past year.</p>

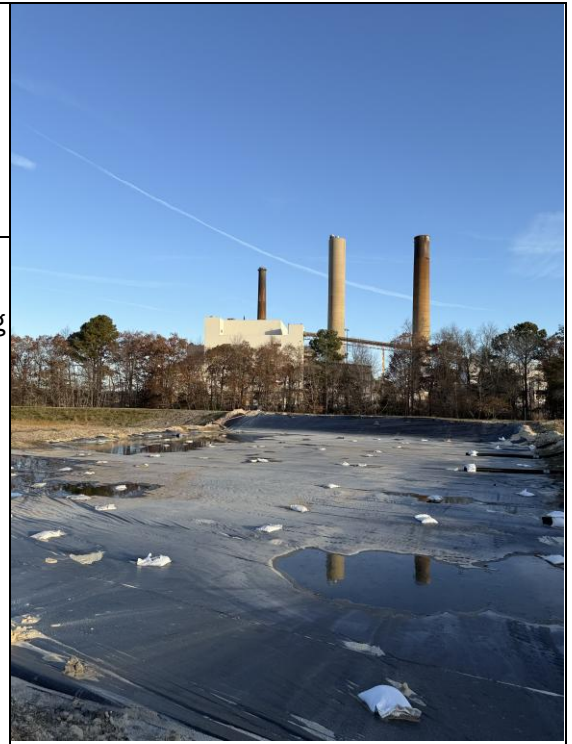
Image Number: 3
Date: 11/13/2025
Time: 7:39 AM
Direction: North

Description:
A tarp has been installed over Phase II to prevent rainwater from coming into contact with coal combustion residuals (CCR). The tarp is well maintained with no observed tears, punctures, or identified damage. The ground feels firm and level beneath the tarp.

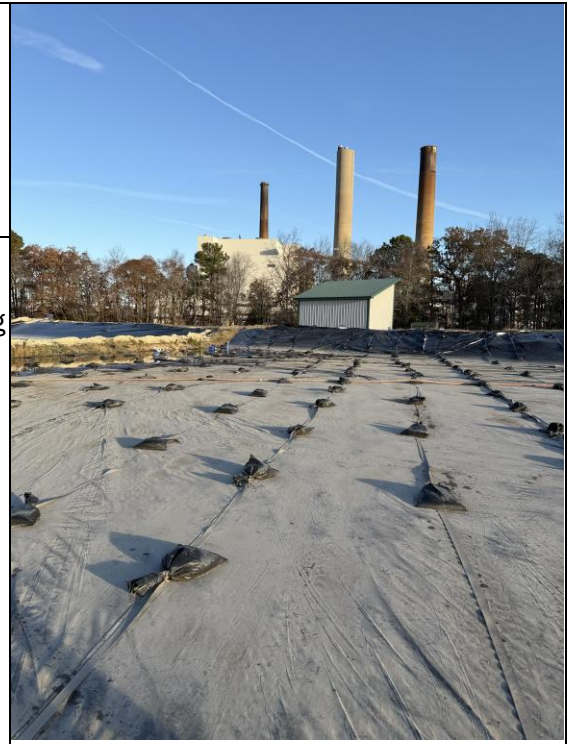
Image Number: 4
Date: 11/13/2025
Time: 7:40 AM
Direction: North

Description:
A tarp has been installed over Phase II to prevent rainwater from coming into contact with coal combustion residuals (CCR). The tarp is well maintained with no observed tears, punctures, or identified damage. The ground feels firm and level beneath the tarp.

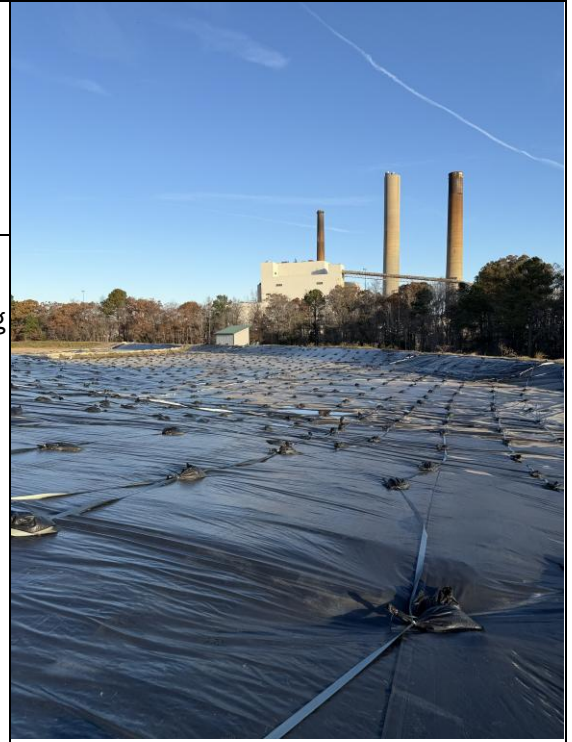
Image Number: 5
Date: 11/13/2025
Time: 7:42 AM
Direction: North-Northwest

Description:
A tarp has been installed over Phase II to prevent rainwater from coming into contact with coal combustion residuals (CCR). The tarp is well maintained with no observed tears, punctures, or identified damage. The ground feels firm and level beneath the tarp.

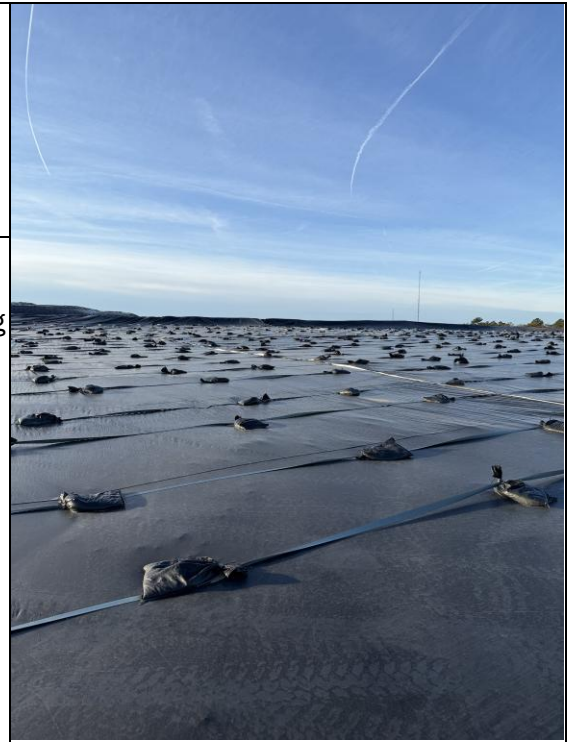
Image Number: 6
Date: 11/13/2025
Time: 7:43 AM
Direction: South-Southwest

Description:
A tarp has been installed over Phase II to prevent rainwater from coming into contact with coal combustion residuals (CCR). The tarp is well maintained with no observed tears, punctures, or identified damage. The ground feels firm and level beneath the tarp.

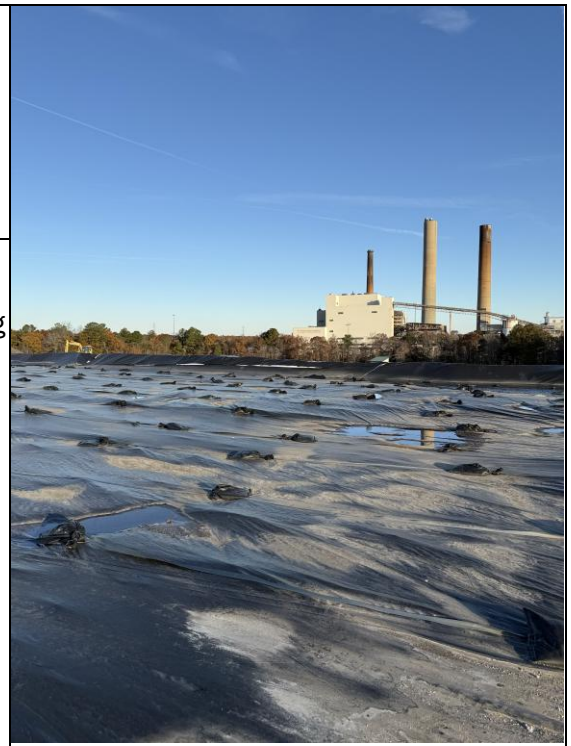
<p>Image Number: 7 Date: 11/13/2025 Time: 7:44 AM Direction: North-Northwest</p>

<p>Description: A tarp has been installed over Phase II to prevent rainwater from coming into contact with coal combustion residuals (CCR). The tarp is well maintained with no observed tears, punctures, or identified damage. The ground feels firm and level beneath the tarp.</p>

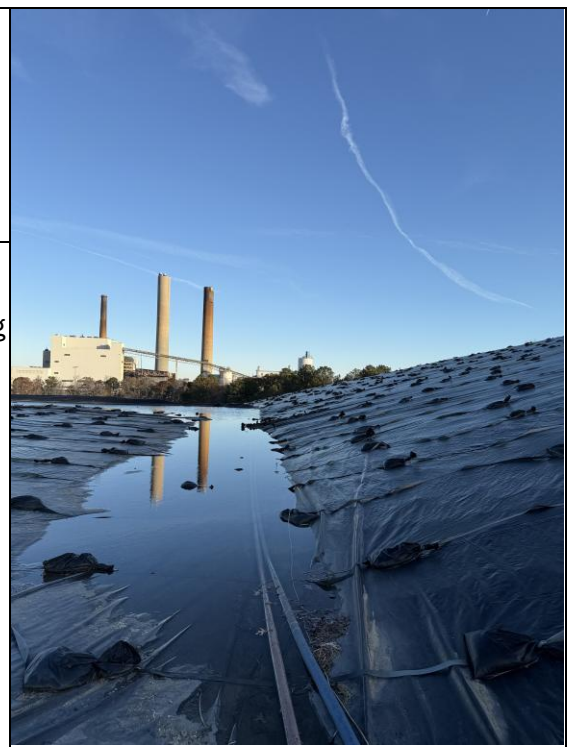
<p>Image Number: 8 Date: 11/13/2025 Time: 7:45 AM Direction: North</p>

<p>Description: A tarp has been installed over Phase II to prevent rainwater from coming into contact with coal combustion residuals (CCR). The tarp is well maintained with no observed tears, punctures, or identified damage. Water ponds in localized areas at the toe of slope as shown in this image after rainfalls; this water is pumped to the perimeter ditch (pump hose lines shown).</p>

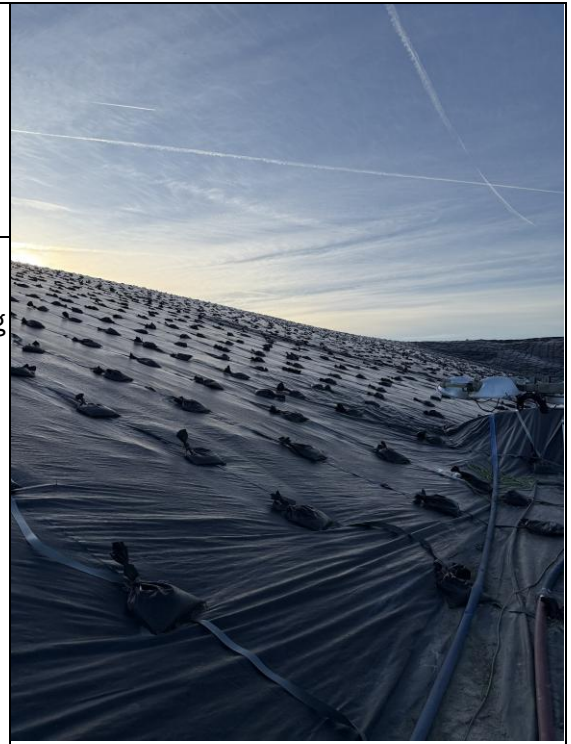
<p>Image Number: 9 Date: 11/13/2025 Time: 7:45 AM Direction: South-Southeast</p>

<p>Description: A tarp has been installed over Phase II to prevent rainwater from coming into contact with coal combustion residuals (CCR). The tarp is well maintained with no observed tears, punctures, or identified damage. Water ponds in localized areas after rainfalls; this water is pumped to the perimeter ditch (pump hose lines shown).</p>

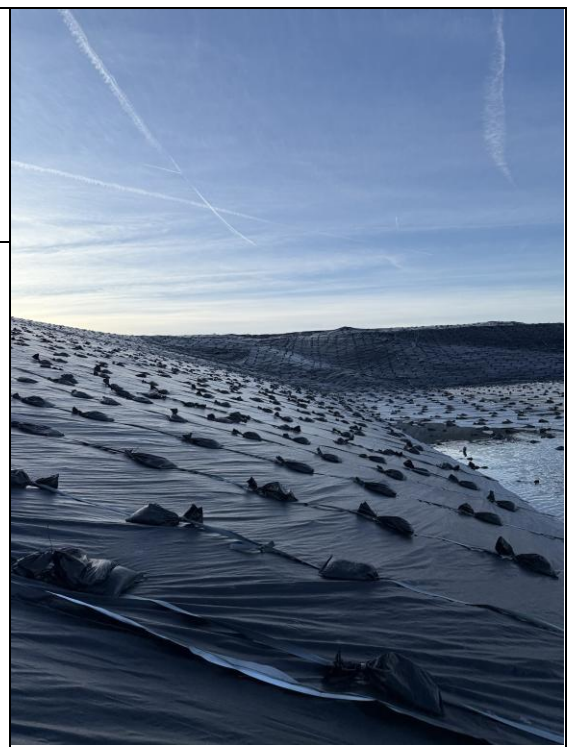
<p>Image Number: 10 Date: 11/13/2025 Time: 7:46 AM Direction: South</p>

<p>Description: Sideslopes of Phase II Cell 2 looking south toward Cell 1. A tarp has been installed over Phase II to prevent rainwater from coming into contact with coal combustion residuals (CCR). The tarp is well maintained with no observed tears, punctures, or identified damage. The ground feels firm and level beneath the tarp.</p>

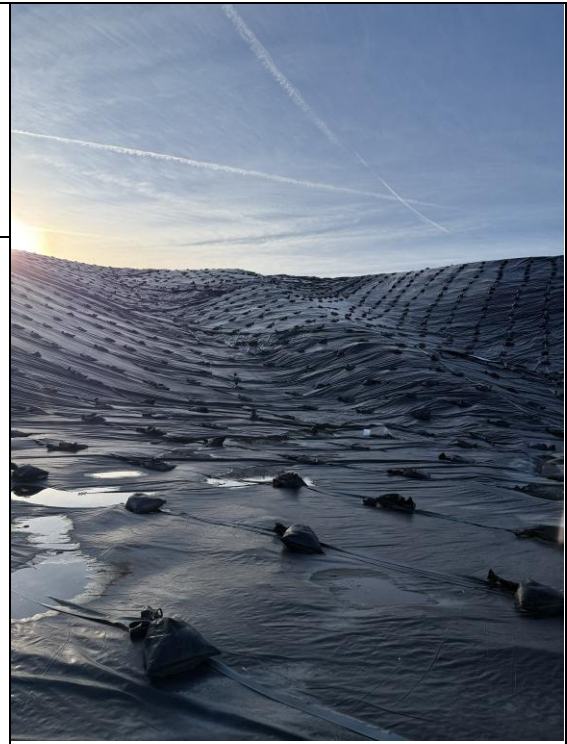
<p>Image Number: 11 Date: 11/13/2025 Time: 7:47 AM Direction: South-Southeast</p>

<p>Description: Elbow where Cells 1 and 2 sideslopes of Phase II meet. A tarp has been installed over Phase II to prevent rainwater from coming into contact with coal combustion residuals (CCR). The tarp is well maintained with no observed tears, punctures, or identified damage. The ground feels firm and level beneath the tarp.</p>

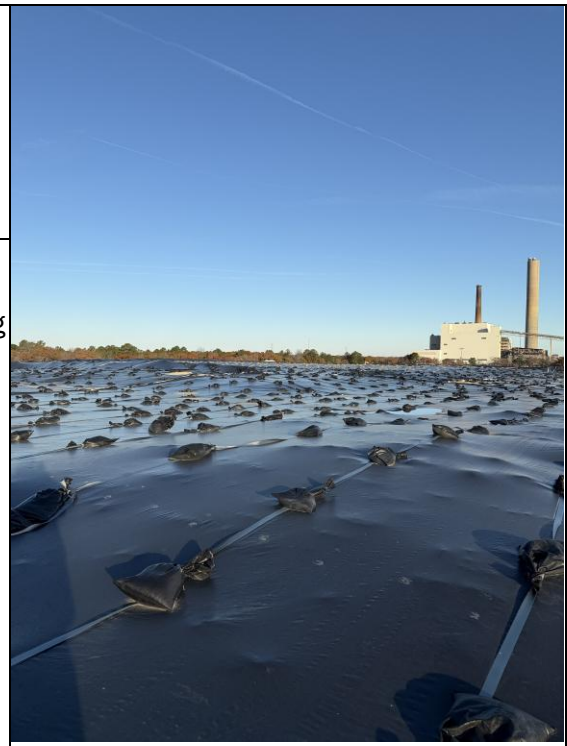
<p>Image Number: 12 Date: 11/13/2025 Time: 7:48 AM Direction: North-Northwest</p>

<p>Description: A tarp has been installed over Phase II to prevent rainwater from coming into contact with coal combustion residuals (CCR). The tarp is well maintained with no observed tears, punctures, or identified damage. The ground feels firm and level beneath the tarp.</p>

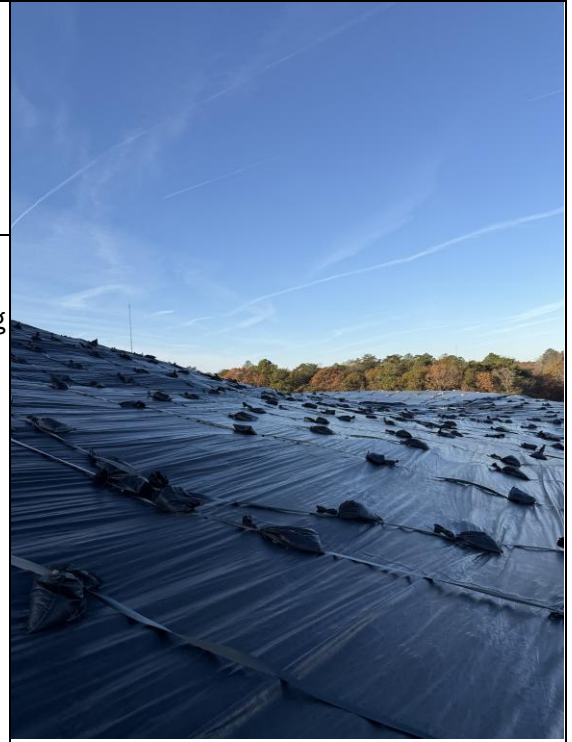
Image Number: 13
Date: 11/13/2025
Time: 7:49 AM
Direction: West

Description:
A tarp has been installed over Phase II to prevent rainwater from coming into contact with coal combustion residuals (CCR). The tarp is well maintained with no observed tears, punctures, or identified damage. The ground feels firm and level beneath the tarp.

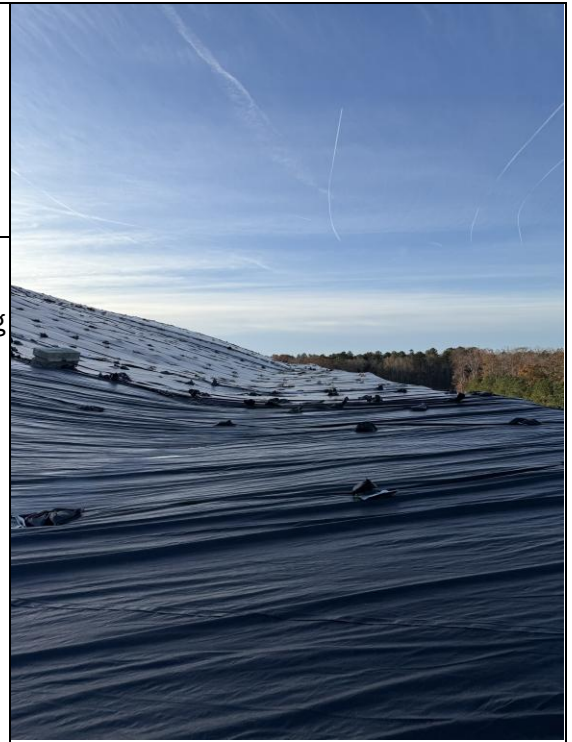
Image Number: 14
Date: 11/13/2025
Time: 7:50 AM
Direction: South

Description:
A tarp has been installed over Phase II to prevent rainwater from coming into contact with coal combustion residuals (CCR). The tarp is well maintained with no observed tears, punctures, or identified damage. The ground feels firm and level beneath the tarp.

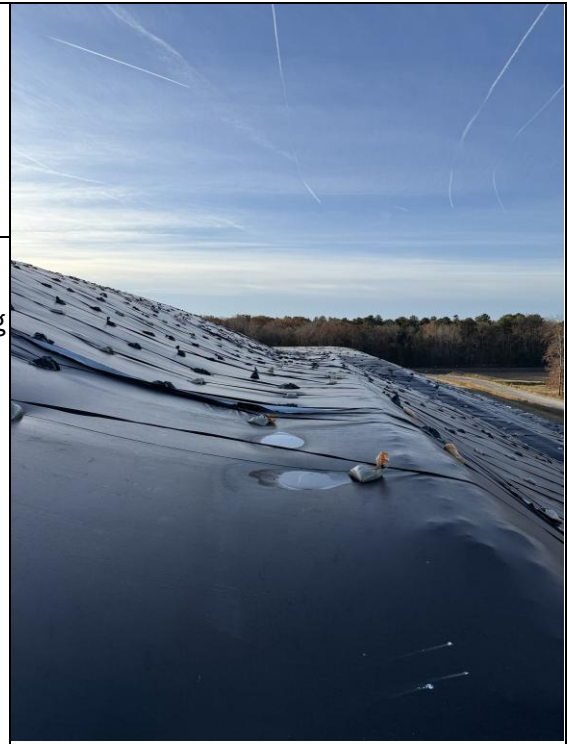
<p>Image Number: 15 Date: 11/13/2025 Time: 7:51 AM Direction: South</p>

<p>Description: A tarp has been installed over Phase II to prevent rainwater from coming into contact with coal combustion residuals (CCR). The tarp is well maintained with no observed tears, punctures, or identified damage. The ground feels firm and level beneath the tarp.</p>

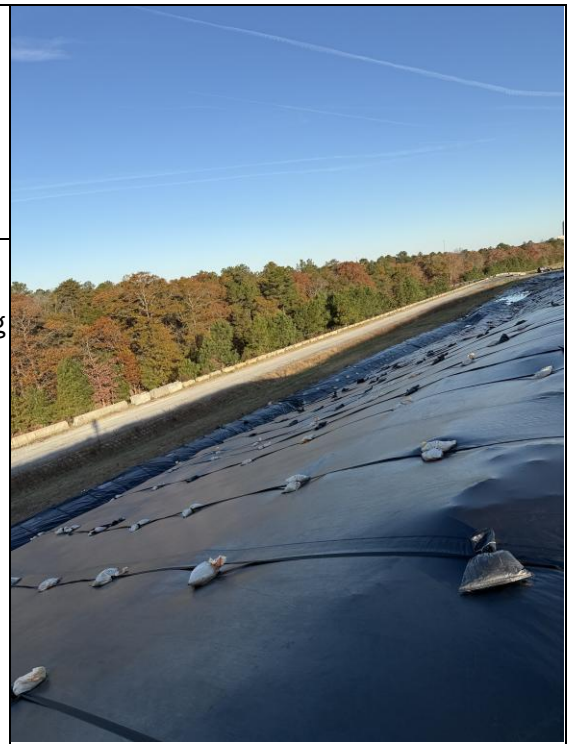
<p>Image Number: 16 Date: 11/13/2025 Time: 7:53 AM Direction: North-Northwest</p>

<p>Description: A tarp has been installed over Phase II to prevent rainwater from coming into contact with coal combustion residuals (CCR). The tarp is well maintained with no observed tears, punctures, or identified damage. The ground feels firm and level beneath the tarp. No slumping at the toe of slope or other signs of geotechnical distress were observed.</p>

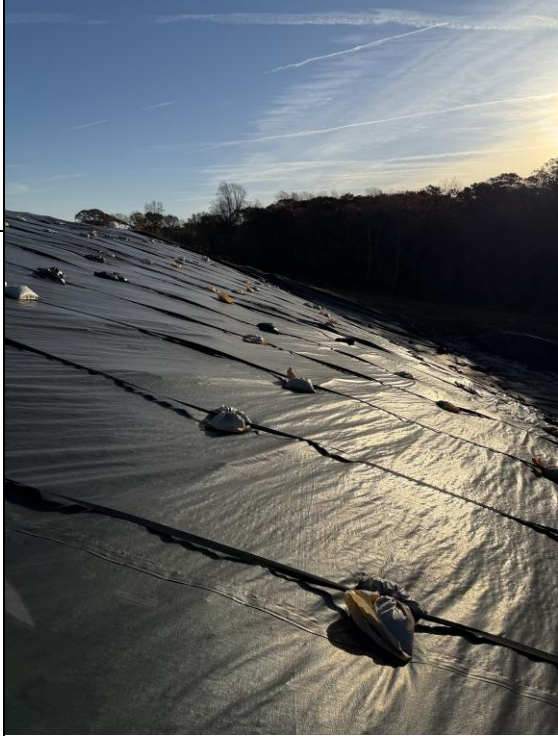
<p>Image Number: 17 Date: 11/13/2025 Time: 7:55 AM Direction: East</p>

<p>Description: A tarp has been installed over Phase II to prevent rainwater from coming into contact with coal combustion residuals (CCR). The tarp is well maintained with no observed tears, punctures, or identified damage. The ground feels firm and level beneath the tarp.</p>

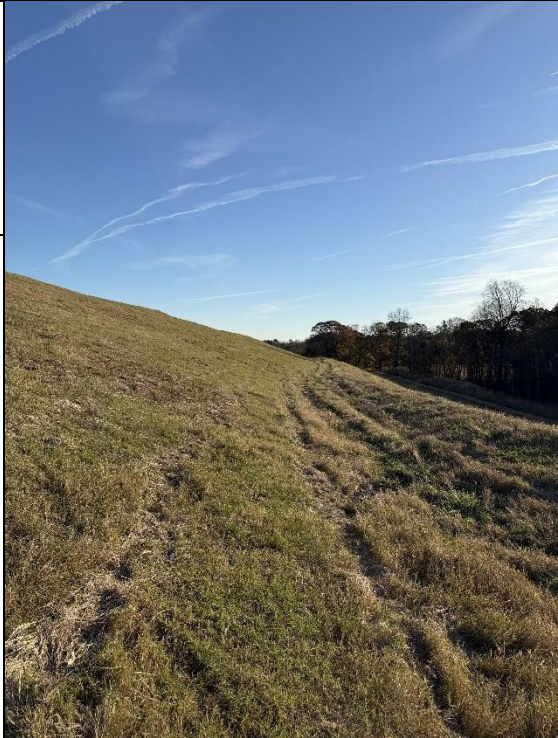
<p>Image Number: 18 Date: 11/13/2025 Time: 7:56 AM Direction: North-Northeast</p>

<p>Description: Landfill side slopes and terrace are well maintained. No evidence of slope stability issues or erosion.</p>

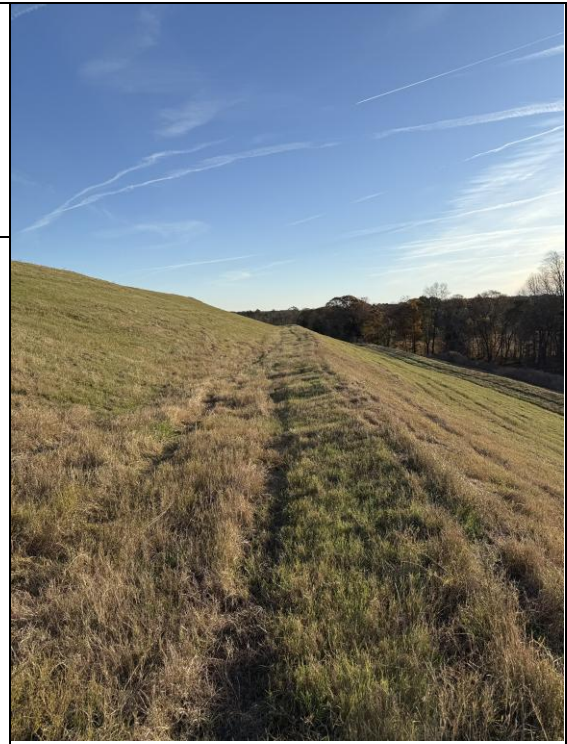
<p>Image Number: 19 Date: 11/13/2025 Time: 7:57 AM Direction: East-Northeast</p>

<p>Description: Landfill side slopes and terrace are well maintained. No evidence of slope stability issues or erosion.</p>

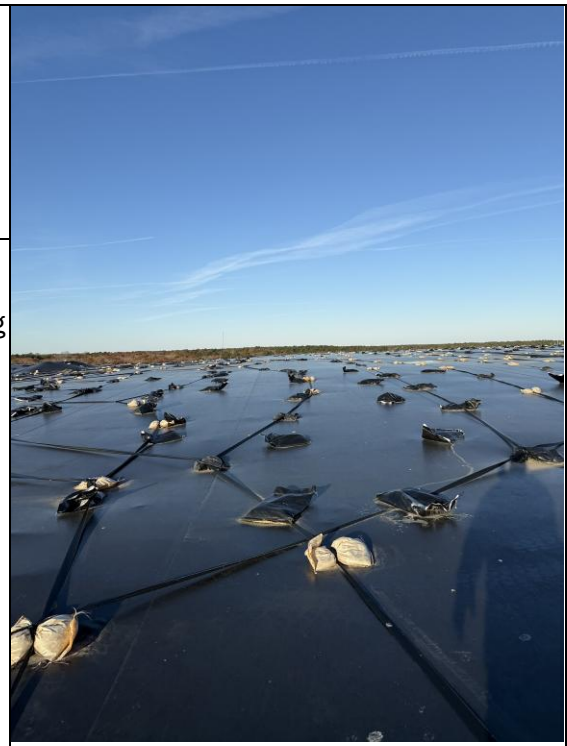
<p>Image Number: 20 Date: 11/13/2025 Time: 7:58 AM Direction: West-Northwest</p>

<p>Description: A tarp has been installed over Phase II to prevent rainwater from coming into contact with coal combustion residuals (CCR). The tarp is well maintained with no observed tears, punctures, or identified damage. The ground feels firm and level beneath the tarp.</p>

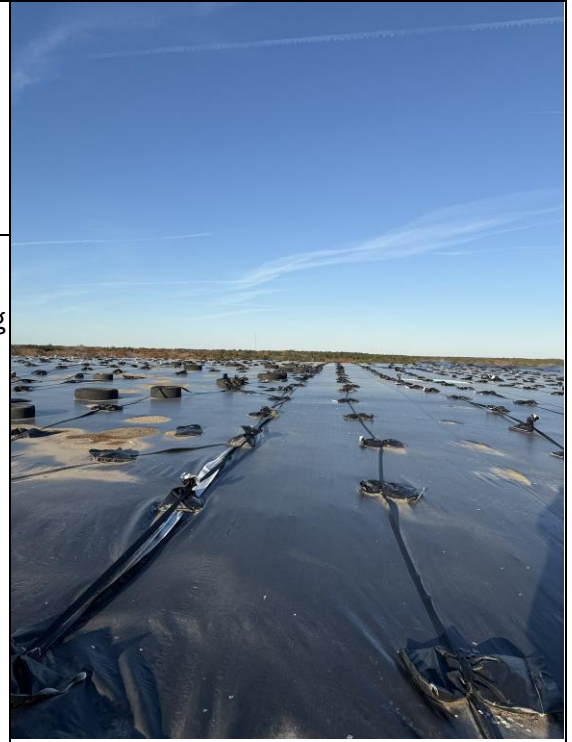
Image Number: 21
Date: 11/13/2025
Time: 7:59 AM
Direction: West-Northwest

Description:
A tarp has been installed over Phase II to prevent rainwater from coming into contact with coal combustion residuals (CCR). The tarp is well maintained with no observed tears, punctures, or identified damage. The ground feels firm and level beneath the tarp.

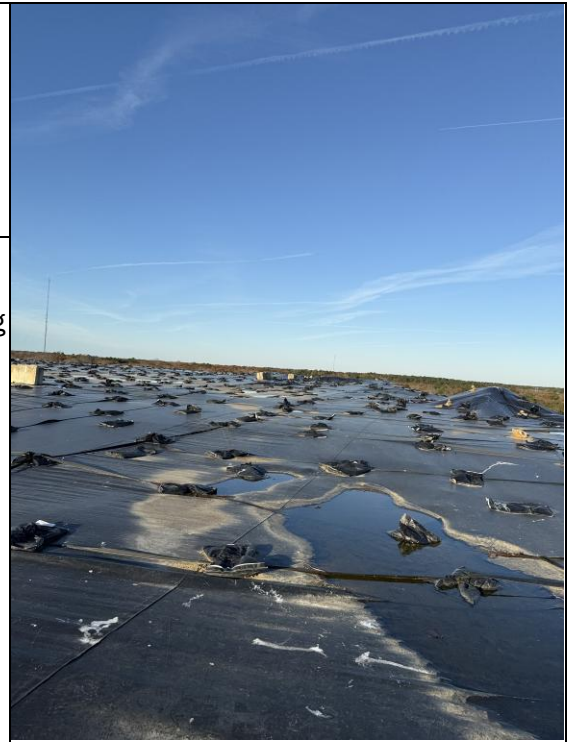
Image Number: 22
Date: 11/13/2025
Time: 7:59 AM
Direction: West-Northwest

Description:
A tarp has been installed over Phase II to prevent rainwater from coming into contact with coal combustion residuals (CCR). The tarp is well maintained with no observed tears, punctures, or identified damage. The ground feels firm and level beneath the tarp.

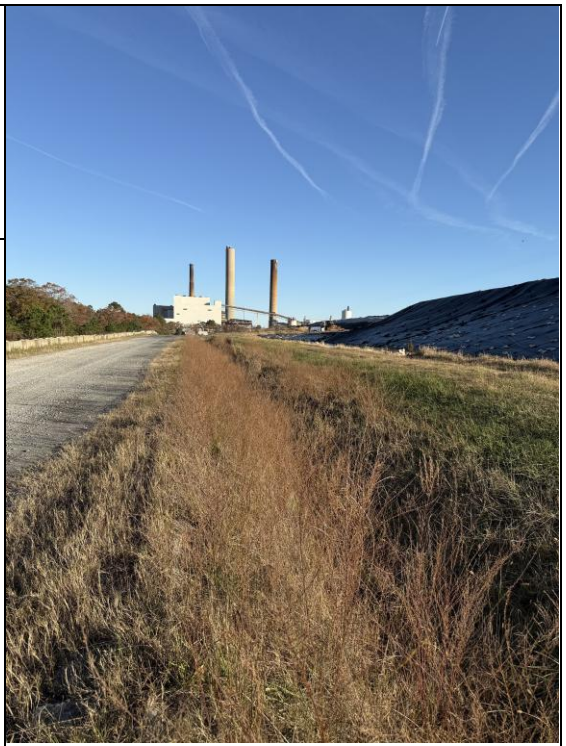
<p>Image Number: 23 Date: 11/13/2025 Time: 8:11 AM Direction: North-Northeast</p>

<p>Description: Perimeter landfill ditch segment is in good working condition with no obstructions.</p>

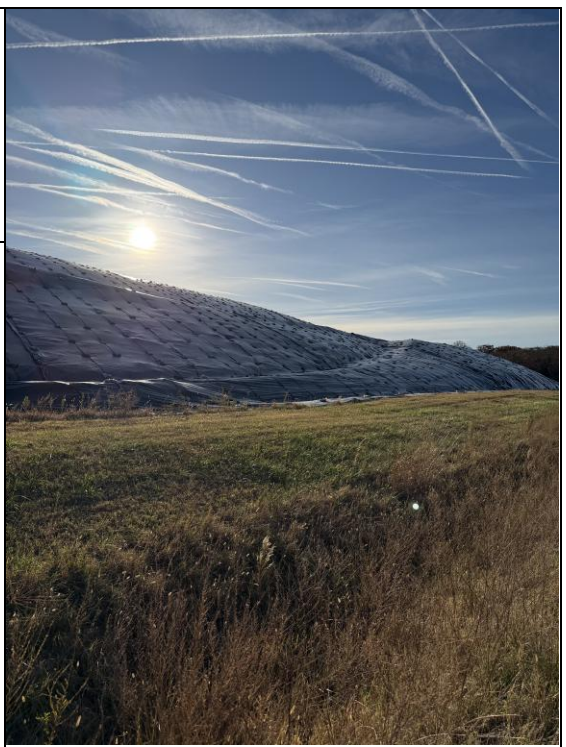
<p>Image Number: 24 Date: 11/13/2025 Time: 8:11 AM Direction: Southeast</p>

<p>Description: Perimeter landfill ditch segment is in good working condition with no obstructions.</p>

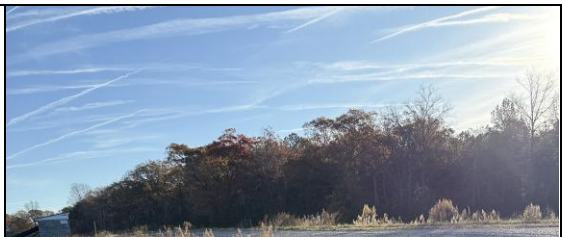
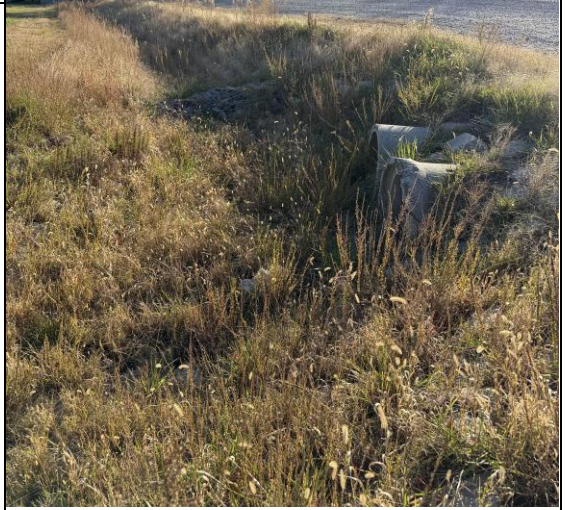
<p>Image Number: 25 Date: 11/13/2025 Time: 8:12 AM Direction: East-Southeast</p>

<p>Description: Culvert inlets that convey water from landfill final cover and intermediate cover to the Southeast Detention Basin. The culverts are free from obstructions and functioning as intended.</p>

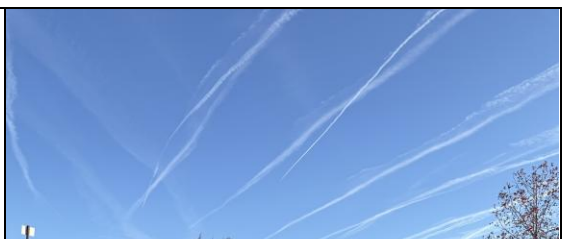
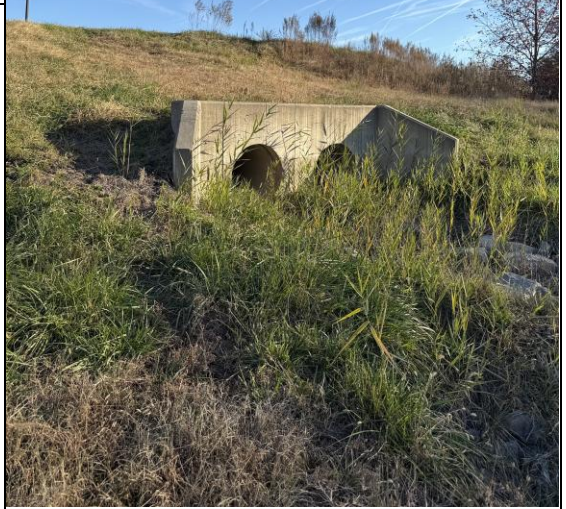
<p>Image Number: 26 Date: 11/13/2025 Time: 8:13 AM Direction: Northeast</p>

<p>Description: Inlet to Southeast Detention Basin forebay in good condition. Free of obstruction at inlets and outlets.</p>

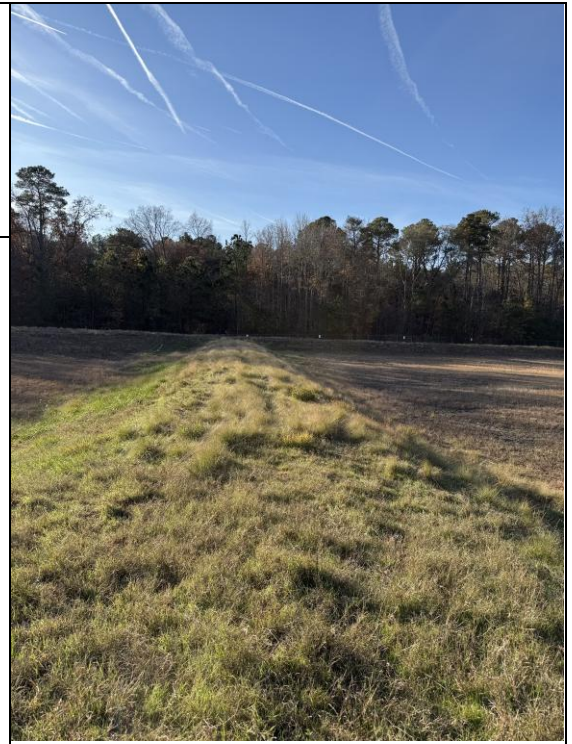
Image Number: 27
Date: 11/13/2025
Time: 8:15 AM
Direction: South

Description:
Southeast Detention Basin berm that divides the forebay and main basin storage area is well maintained.

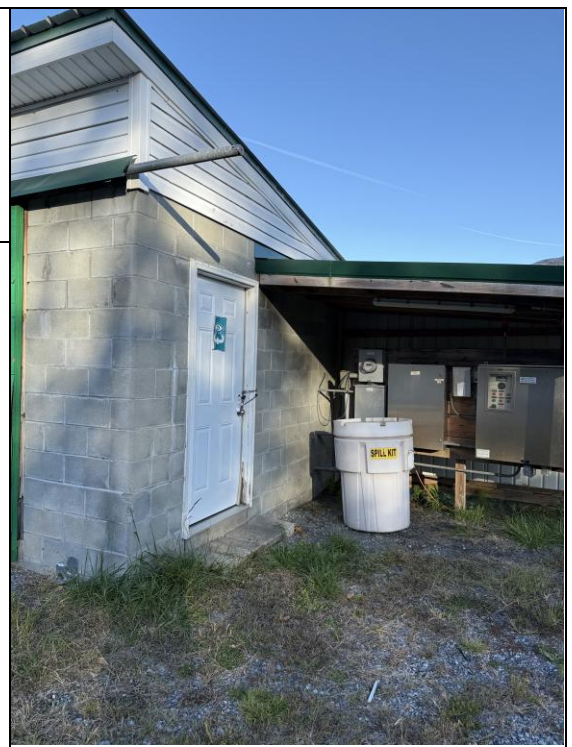
Image Number: 28
Date: 11/13/2025
Time: 8:17 AM
Direction: North-Northwest

Description:
Phase II, Cell 1 leachate pump house. Building exterior is in good condition. Building is appropriately marked (signage).

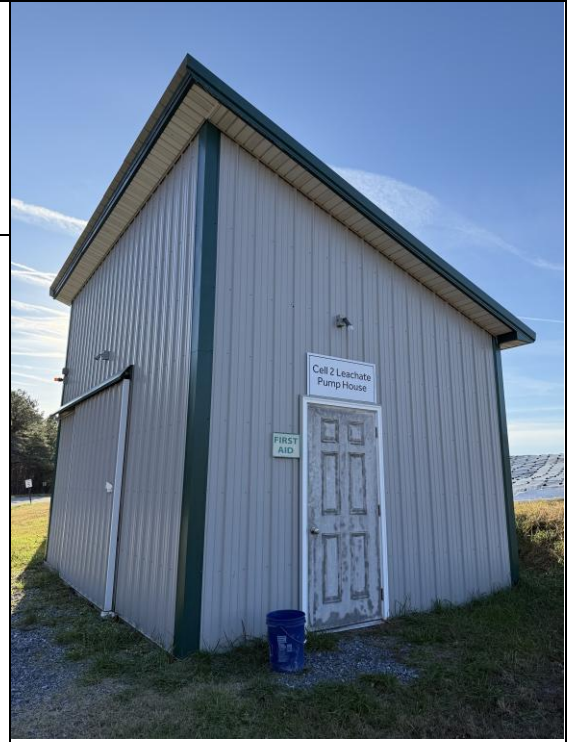
Image Number: 29
Date: 11/13/2025
Time: 8:22 AM
Direction: Southeast

Description:
Phase II, Cell 2 leachate pump house. Building exterior is in good condition. Building is appropriately marked (signage).

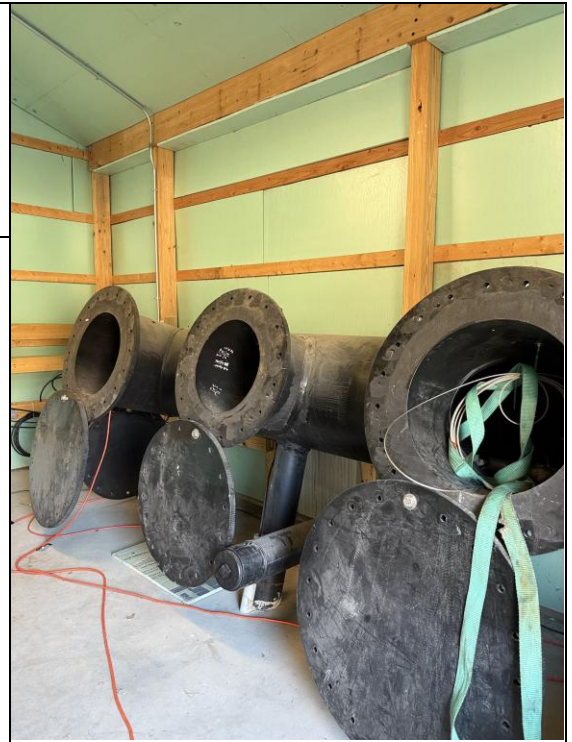
Image Number: 30
Date: 11/13/2025
Time: 8:22 AM
Direction: Southeast

Description:
Inside the Phase I, Cell 2 leachate pump house. Cleanout riser and pump risers with T-connections to forcemain are shown in this photograph. Building is well maintained.

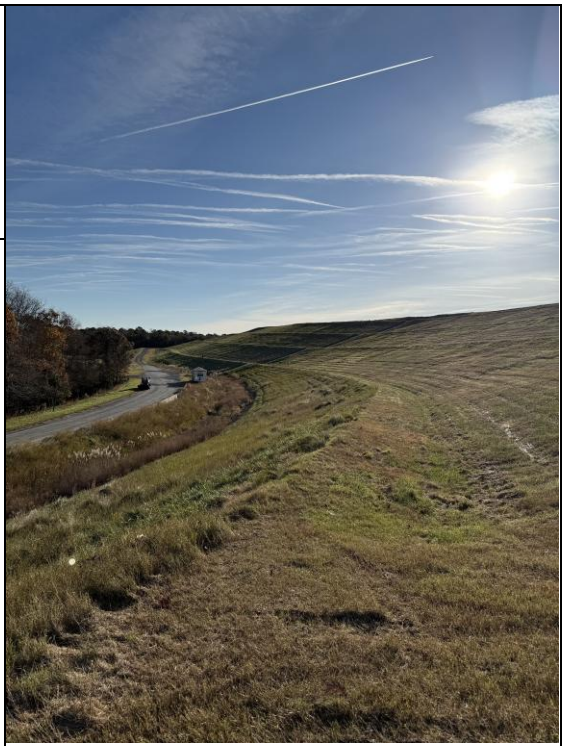
<p>Image Number: 31 Date: 11/13/2025 Time: 8:27 AM Direction: East-Southeast</p>

<p>Description: Landfill side slopes and terrace are well maintained. No evidence of slope stability issues or erosion.</p>

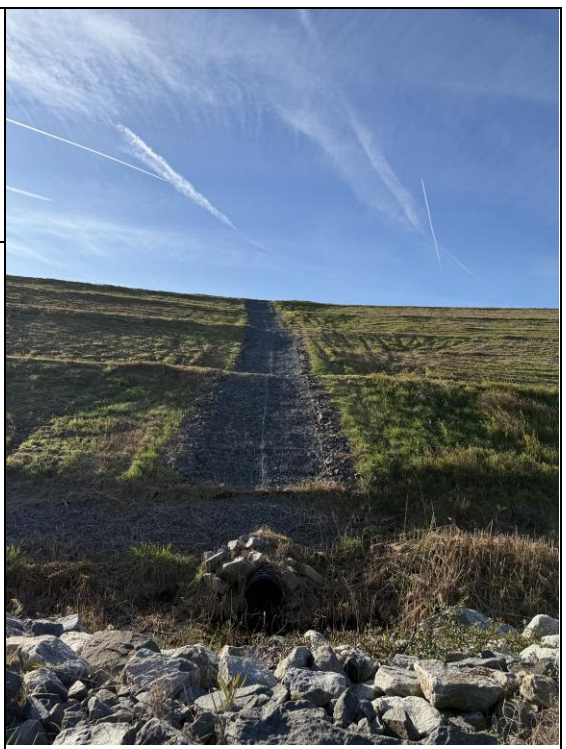
<p>Image Number: 32 Date: 11/13/2025 Time: 8:31 AM Direction: South</p>

<p>Description: Downchute near southwest forebay of the Northeast Detention Basin. Pipe and downchute are functioning appropriately.</p>

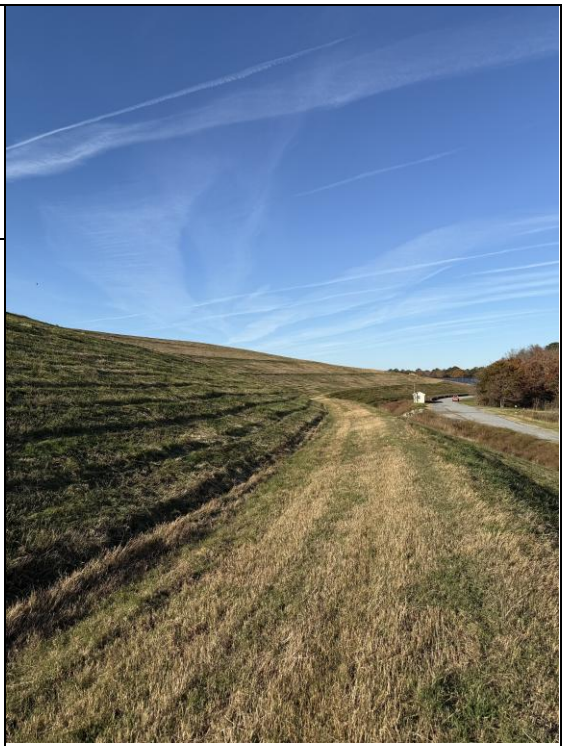
<p>Image Number: 33 Date: 11/13/2025 Time: 8:35 AM Direction: West</p>

<p>Description: Phase I final cover and terrace berm. Vegetation coverage is dense and healthy.</p>

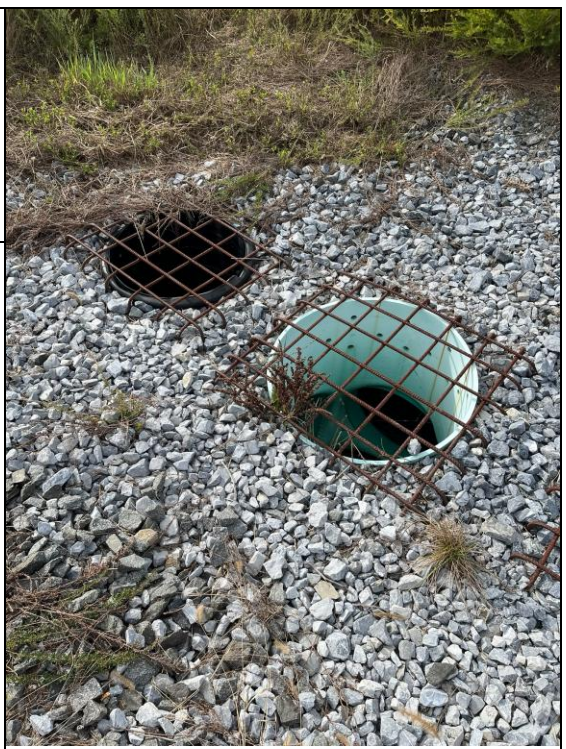
<p>Image Number: 34 Date: 11/13/2025 Time: 8:36 AM Direction: Southwest</p>

<p>Description: Downslope pipe inlets are well maintained and free of obstructions.</p>

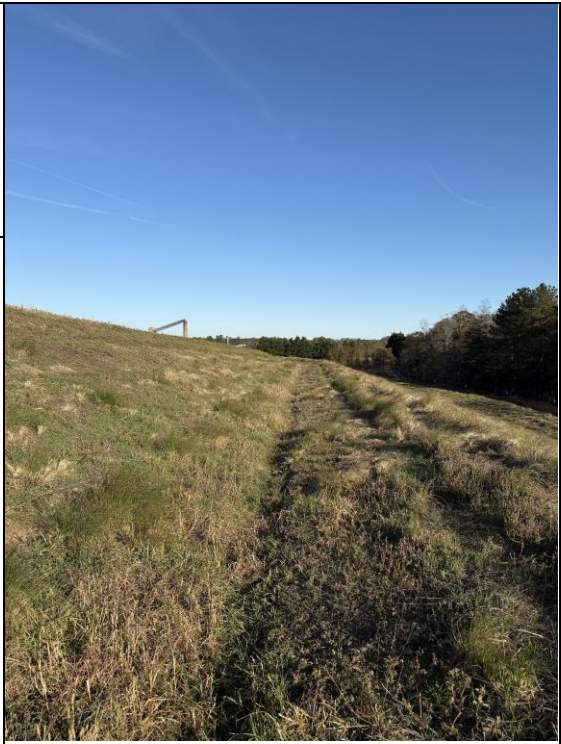
<p>Image Number: 35 Date: 11/13/2025 Time: 8:37 AM Direction: North-Northwest</p>

<p>Description: Phase I final cover. Vegetation has recently been mowed. Coverage is dense and healthy. No animal burrows, erosion, or sloughing were observed.</p>

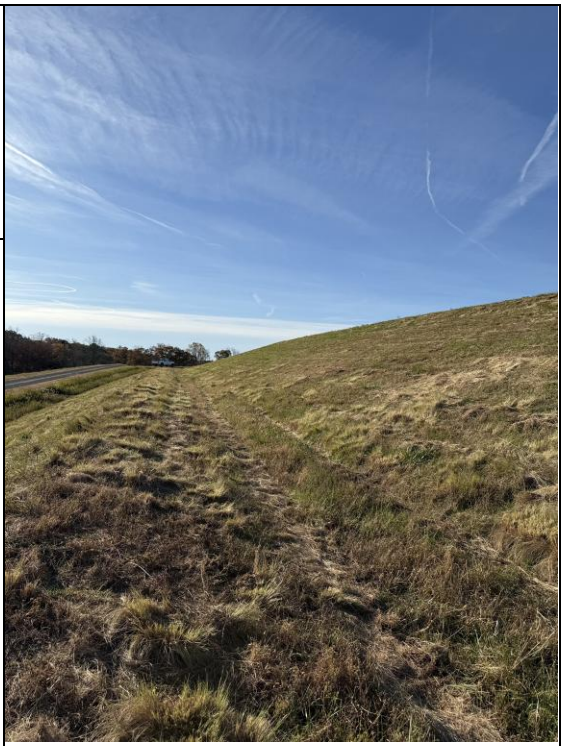
<p>Description: Phase I final cover. Vegetation has recently been mowed. Coverage is dense and healthy. No animal burrows, erosion, or sloughing were observed.</p>

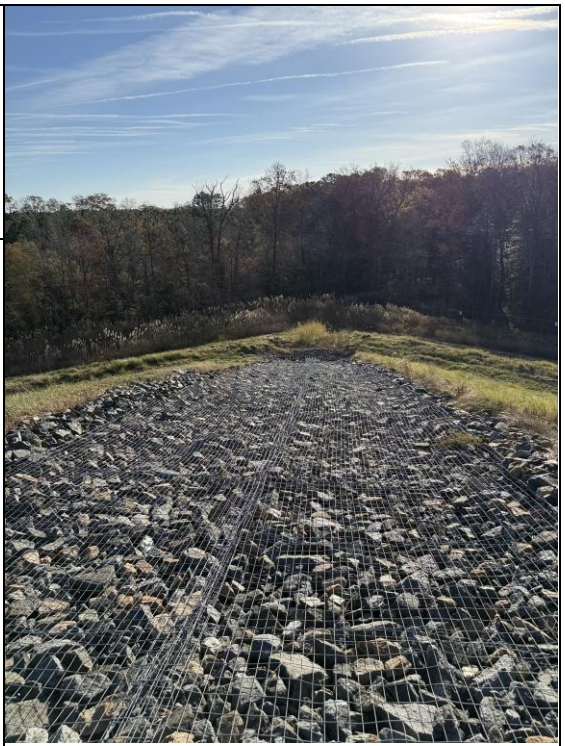
<p>Description: Phase I downchute riprap. Free of obstructions and functioning. No signs of wash out or erosion.</p>

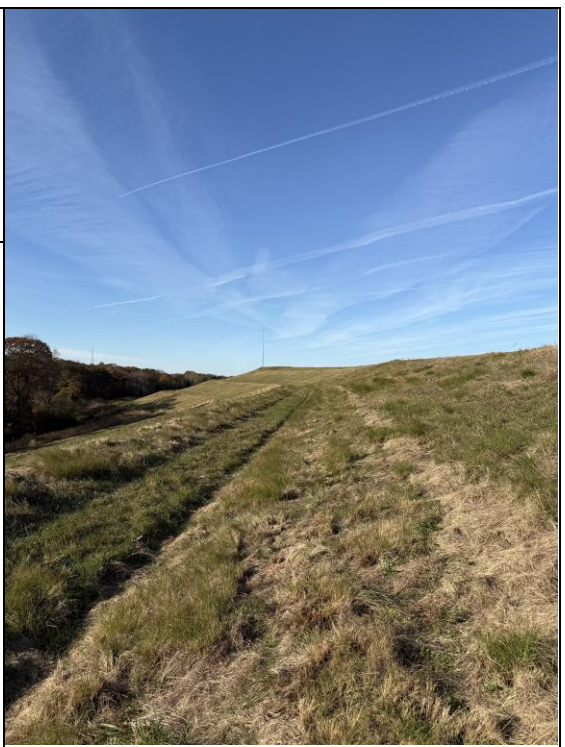
<p>Description: Phase I final cover. Vegetation coverage is dense and healthy. No animal burrows, erosion, or sloughing were observed.</p>

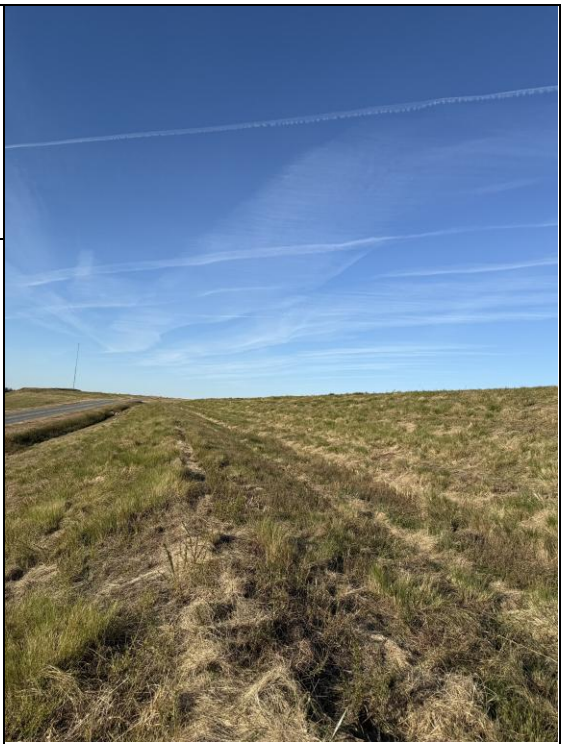
<p>Description: Phase I final cover. Vegetation coverage is dense and healthy. No animal burrows, erosion, or sloughing were observed.</p>

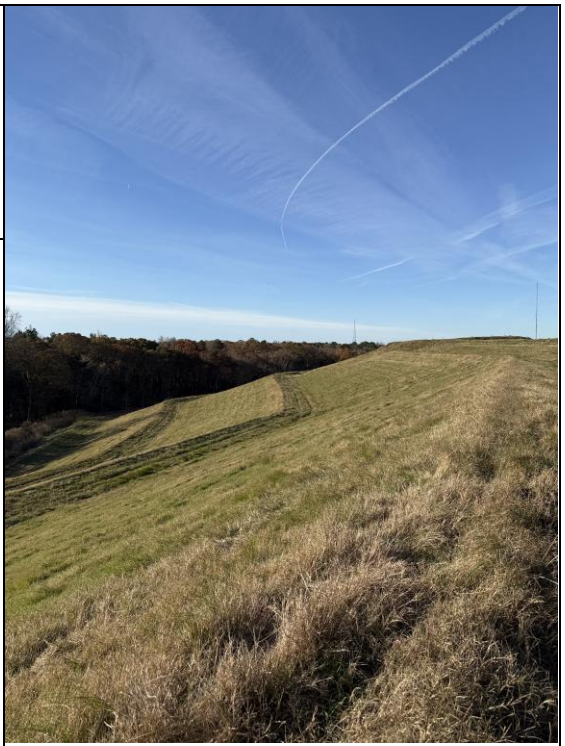
<p>Description: Phase I final cover. Vegetation coverage is dense and healthy. No animal burrows, erosion, or sloughing were observed.</p>

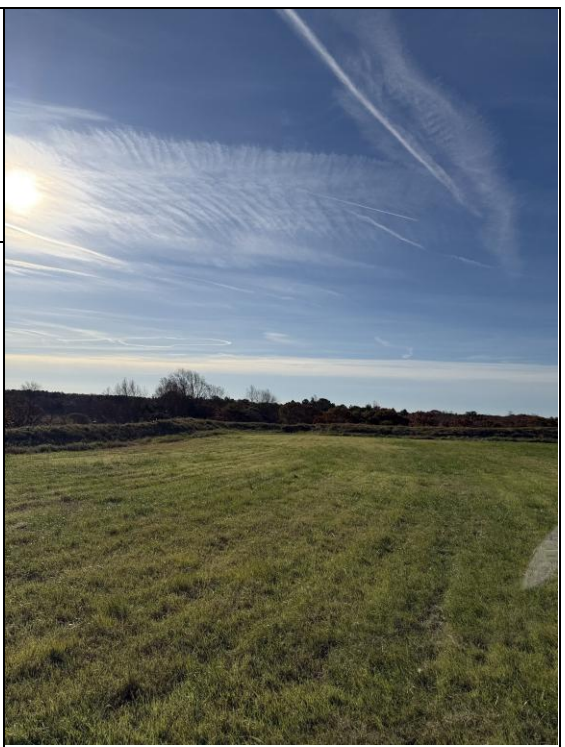
<p>Description: Final cover plateau area. Vegetation coverage is dense and healthy. No animal burrows, erosion, or sloughing were observed.</p>

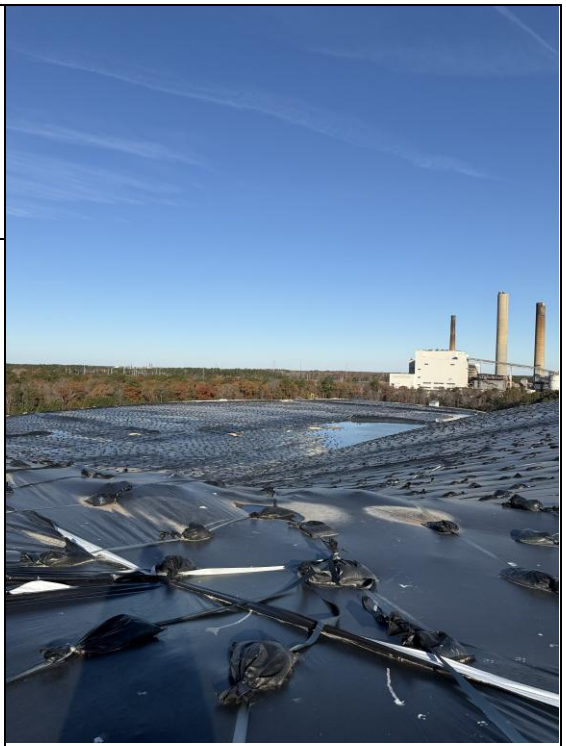
<p>Description:</p> <p>Overlooking Phase II, Cell 2 active area from Phase II, Cell 1 plateau. A tarp has been installed over Phase II to prevent rainwater from coming into contact with coal combustion residuals (CCR). The tarp is well maintained with no observed tears, punctures, or identified damage.</p>

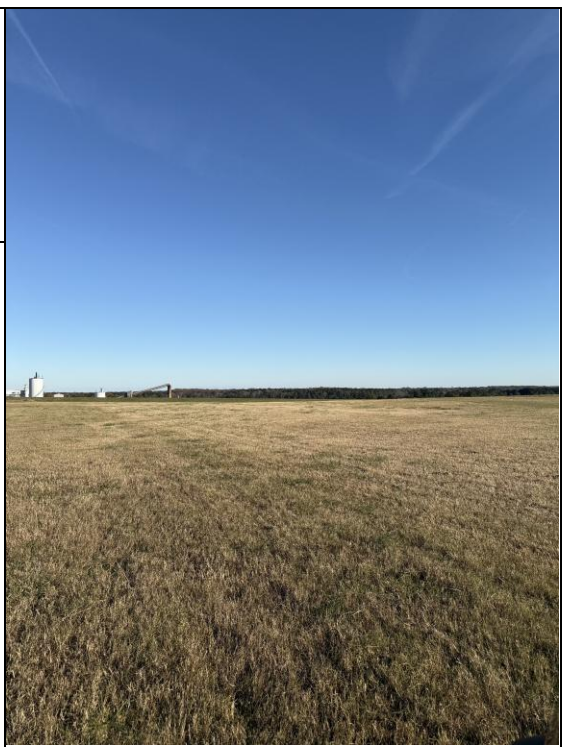
<p>Description:</p> <p>Final cover plateau area. Vegetation coverage is dense and healthy. No animal burrows, erosion, or sloughing were observed.</p>

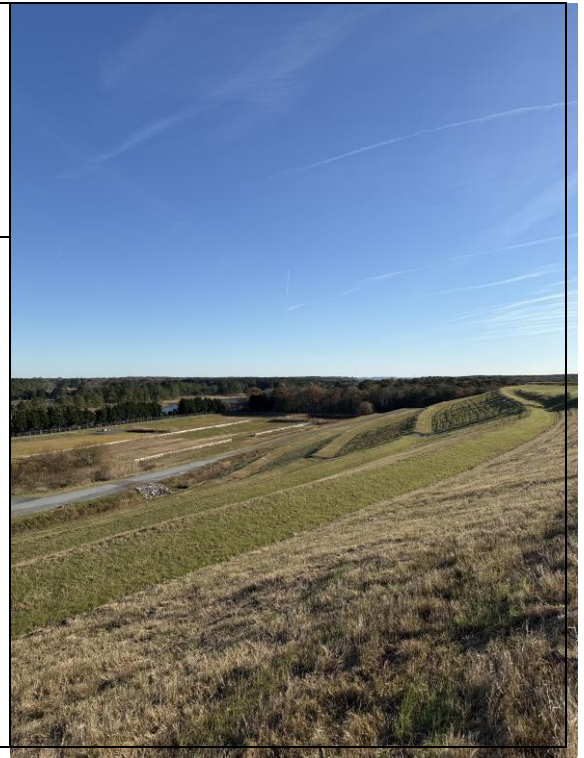
Description:
View from final cover plateau area overlooking sideslopes and Northwest Detention Basin. Vegetation coverage is dense and healthy. No animal burrows, erosion, or sloughing were observed.

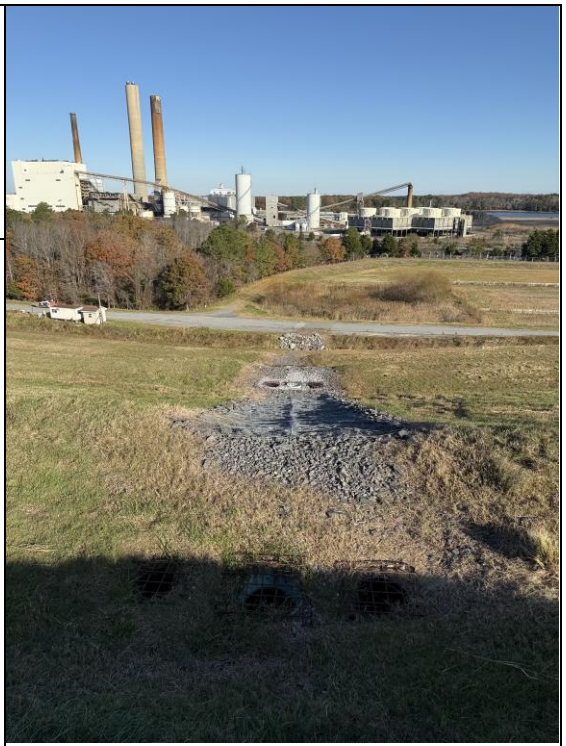
<p>Description: Phase I downchute riprap. Free of obstructions and functioning. No signs of wash out or erosion. Northwest Detention Basin shown in midground.</p>

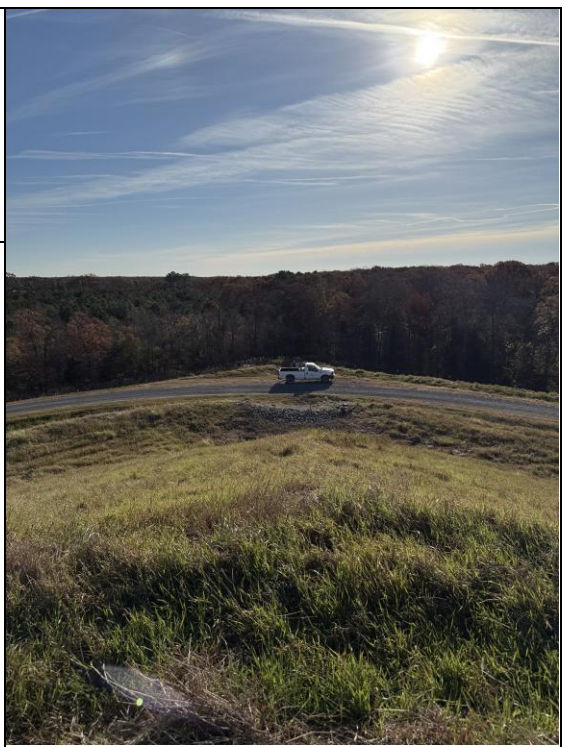
<p>Description: Phase I downchute riprap. Free of obstructions and functioning. No signs of wash out or erosion.</p>
