2025 ANNUAL CCR UNIT INSPECTION
INDIAN RIVER LANDFILL
NRG INDIAN RIVER STATION
DAGSBORO, DELAWARE

SCS ENGINEERS

25221158.00 | January 18, 2026

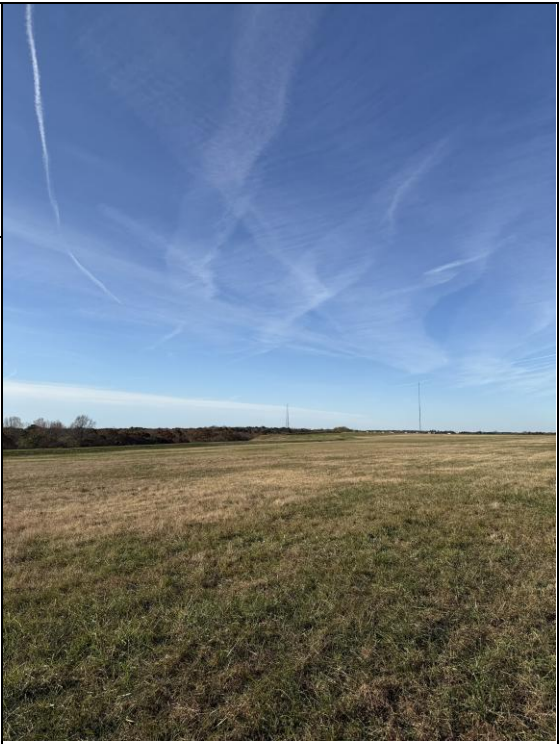
Description: Final cover plateau area. Vegetation coverage is dense and healthy. No animal burrows, erosion, or sloughing were observed.

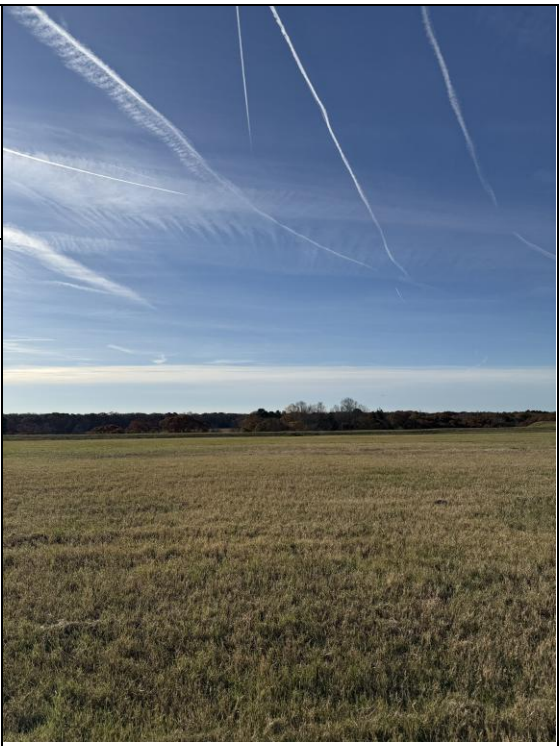
Description: Final cover plateau area. Vegetation coverage is dense and healthy. No animal burrows, erosion, or sloughing were observed.
