Midwest Generation, LLC

Joliet 29 Generating Station

2024 Structural Stability Assessment for Ash Pond 2

October 13, 2024

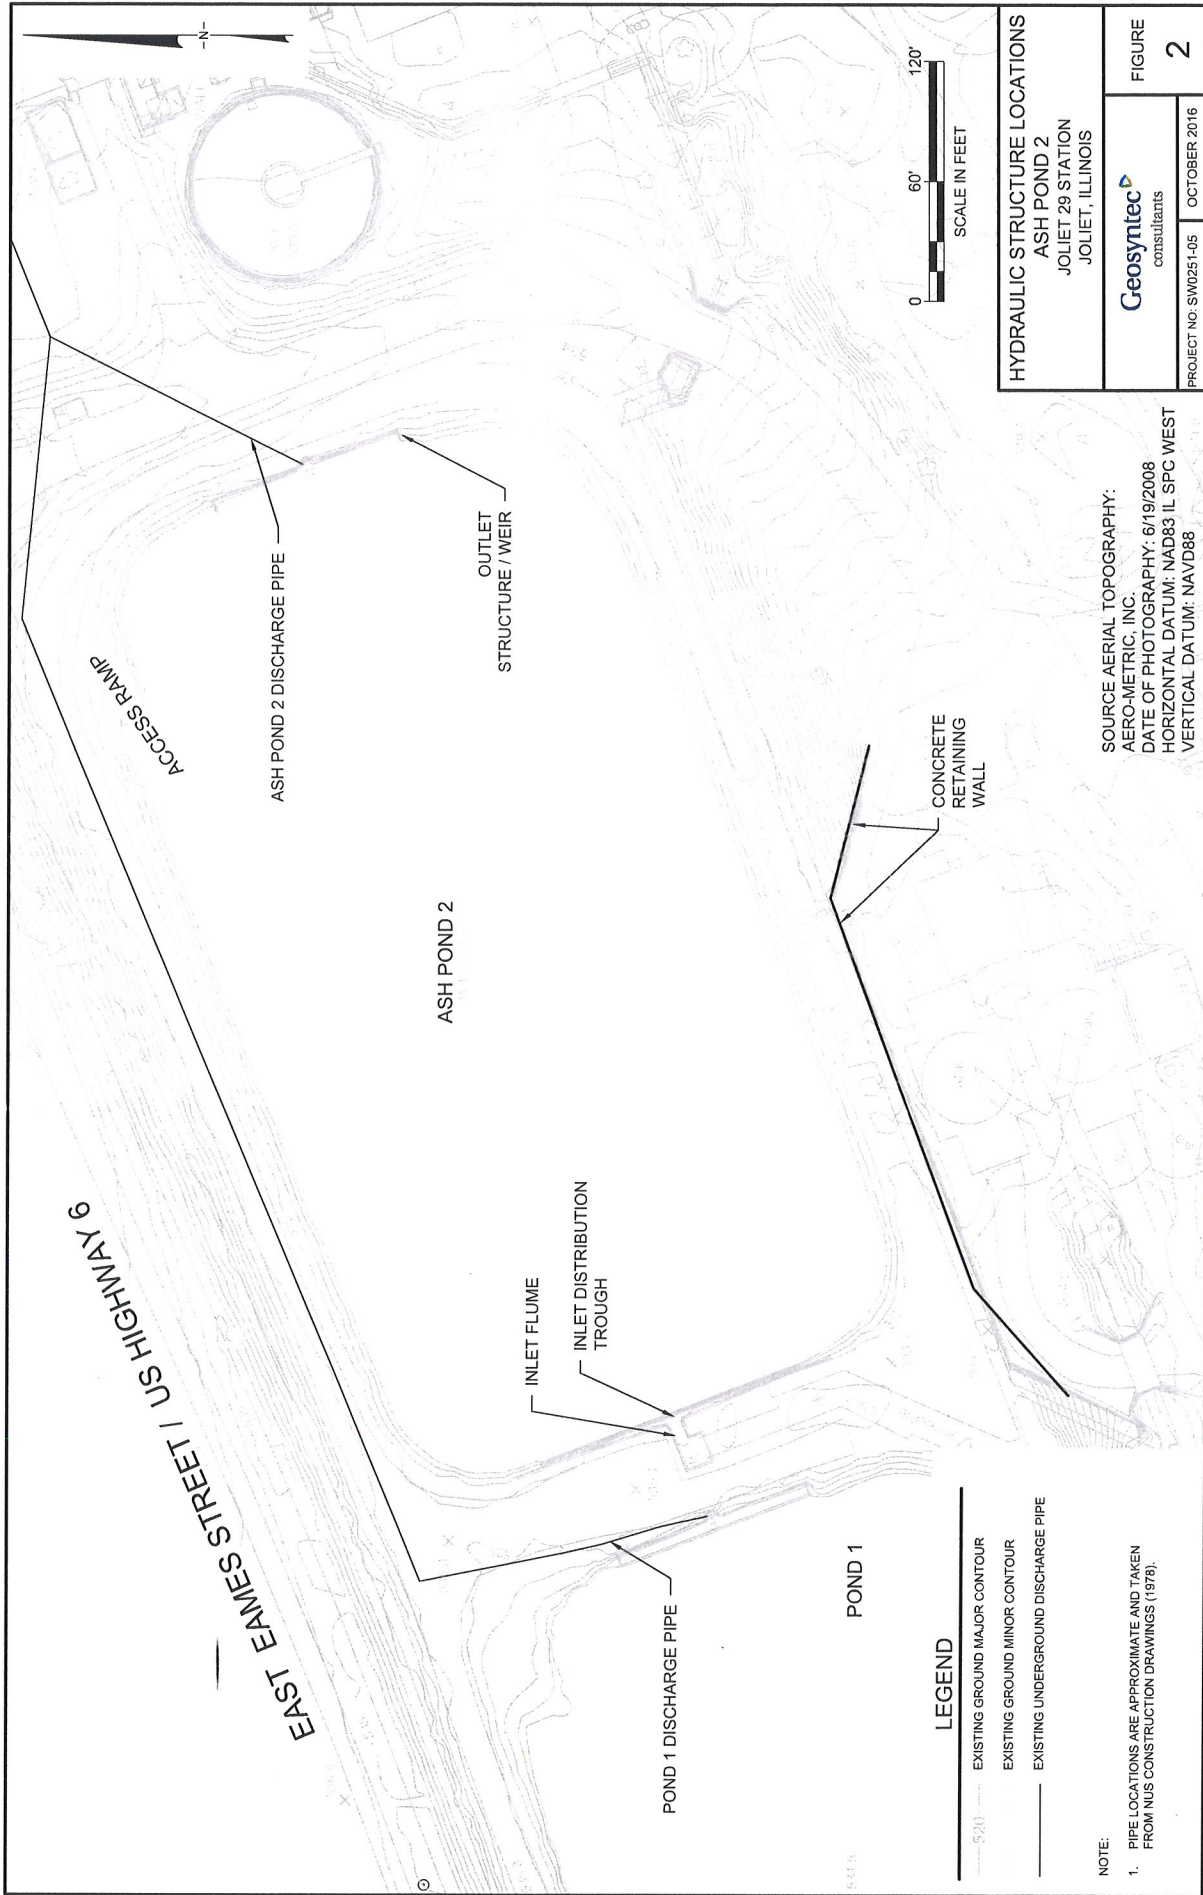
HYDRAULIC STRUCTURE LOCATIONS
 ASH POND 2
 JOLIET 29 STATION
 JOLIET, ILLINOIS

Hydraulic structures passing through or beneath the embankments of Ash Pond 2 consist of outlet pipes associated with Pond 1 and Ash Pond 2, as presented in Figure 2. These pipes were inspected on 9 June 2016 by a company specializing in video camera pipe inspections. No significant deterioration, deformation, distortion, bedding deficiencies, sedimentation, or

debris that would negatively affect operation of the pipes was observed during inspection of these outlet pipes.

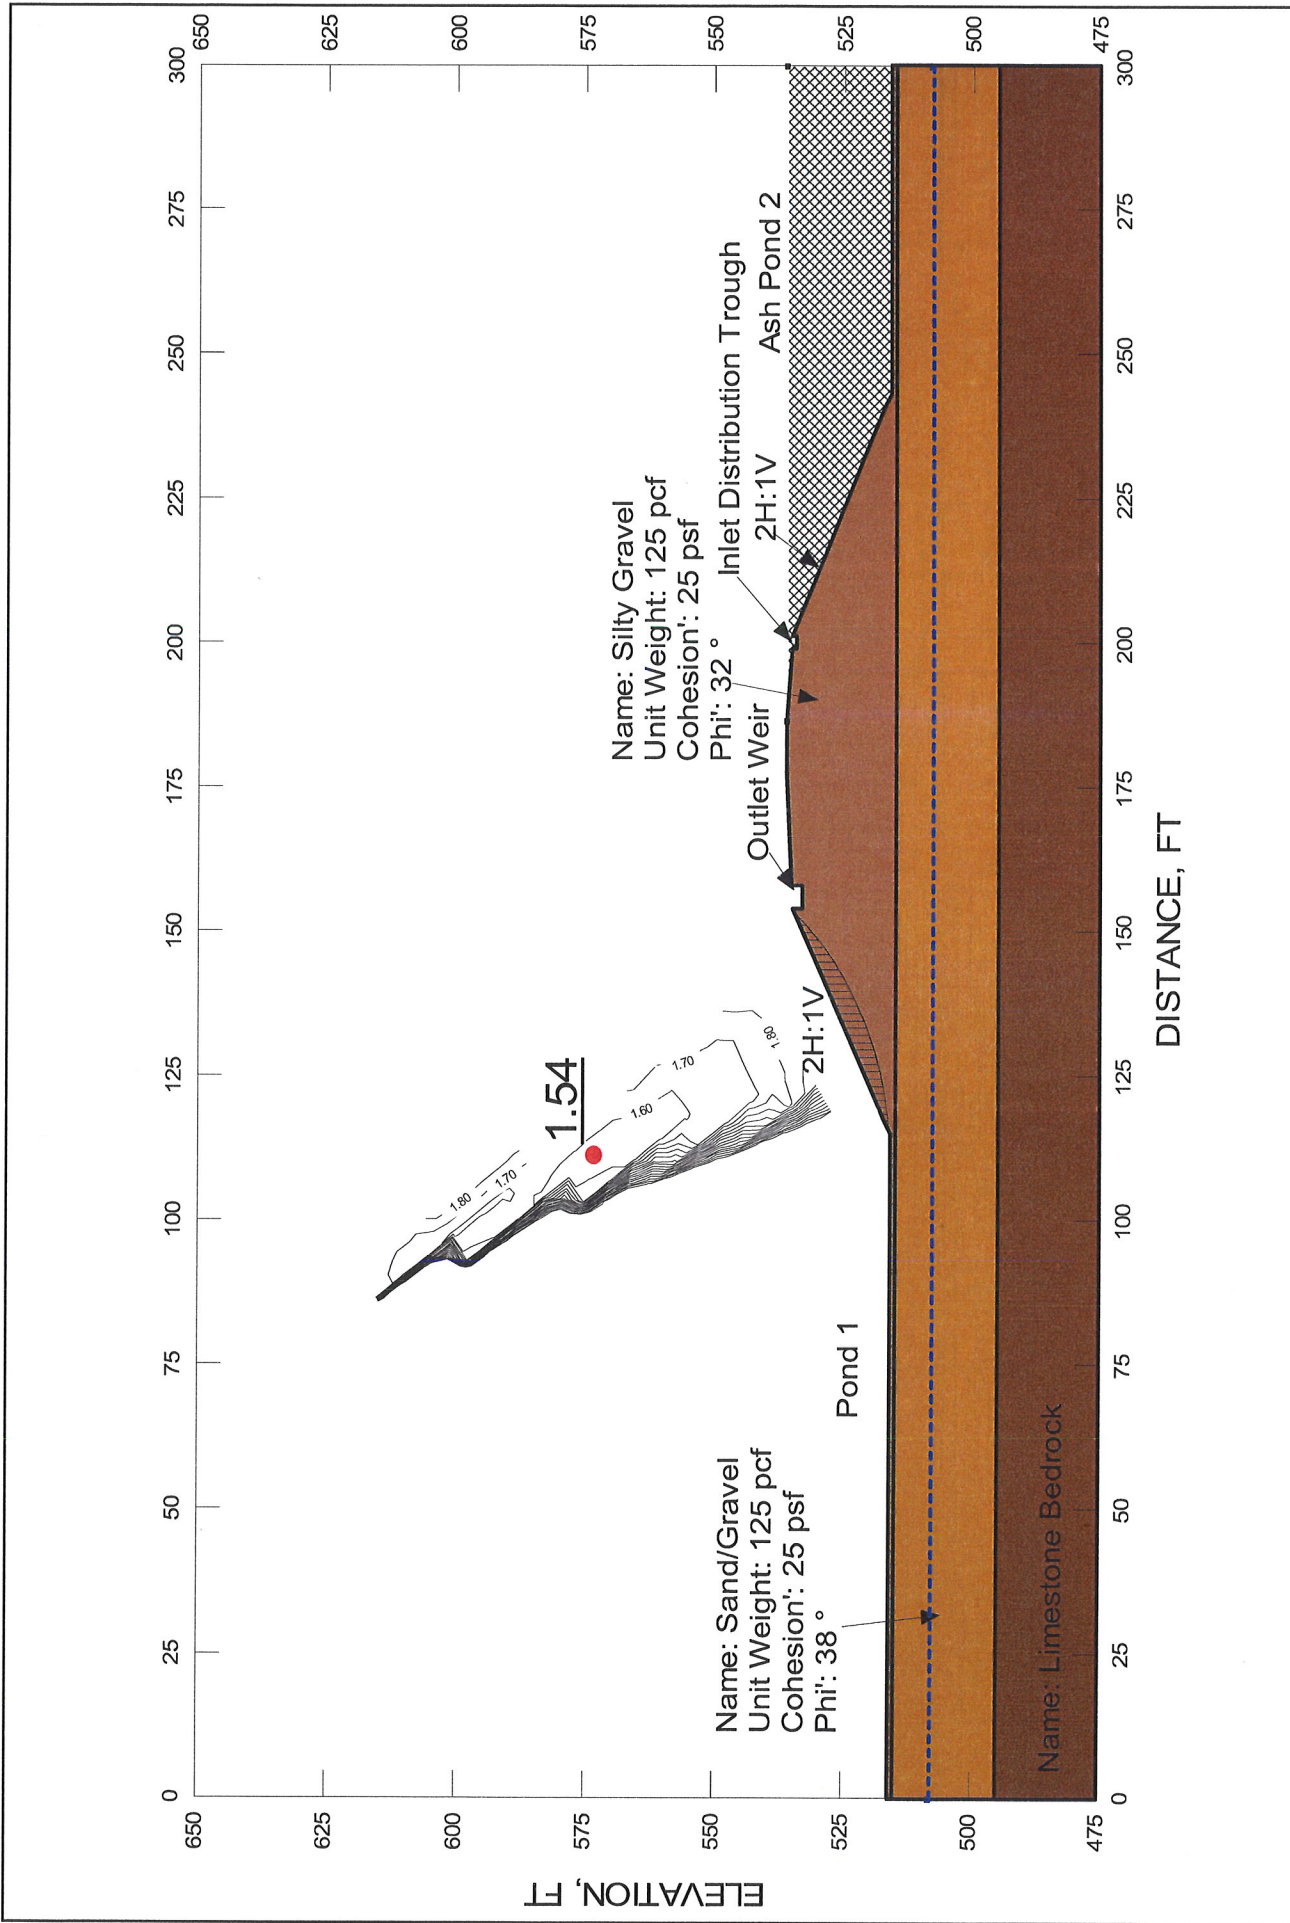
Figure 5 – Slope Stability Output, Section 1 - 257.73(e)(1)(ii)

The results of the slope stability analysis for the critical cross section of the Ash Pond 2 embankments are summarized in Table 1 below and presented in Figures 4 through 6 (Geosyntec 2016e).

The results of the slope stability analyses meet the minimum safety factors requirements presented in §257.73(e)(1)(i) through §257.73(e)(1)(iii).
