Midwest Generation, LLC

Joliet 29 Generating Station

2025 Structural Stability Assessment for Ash Pond 2

October 13, 2025

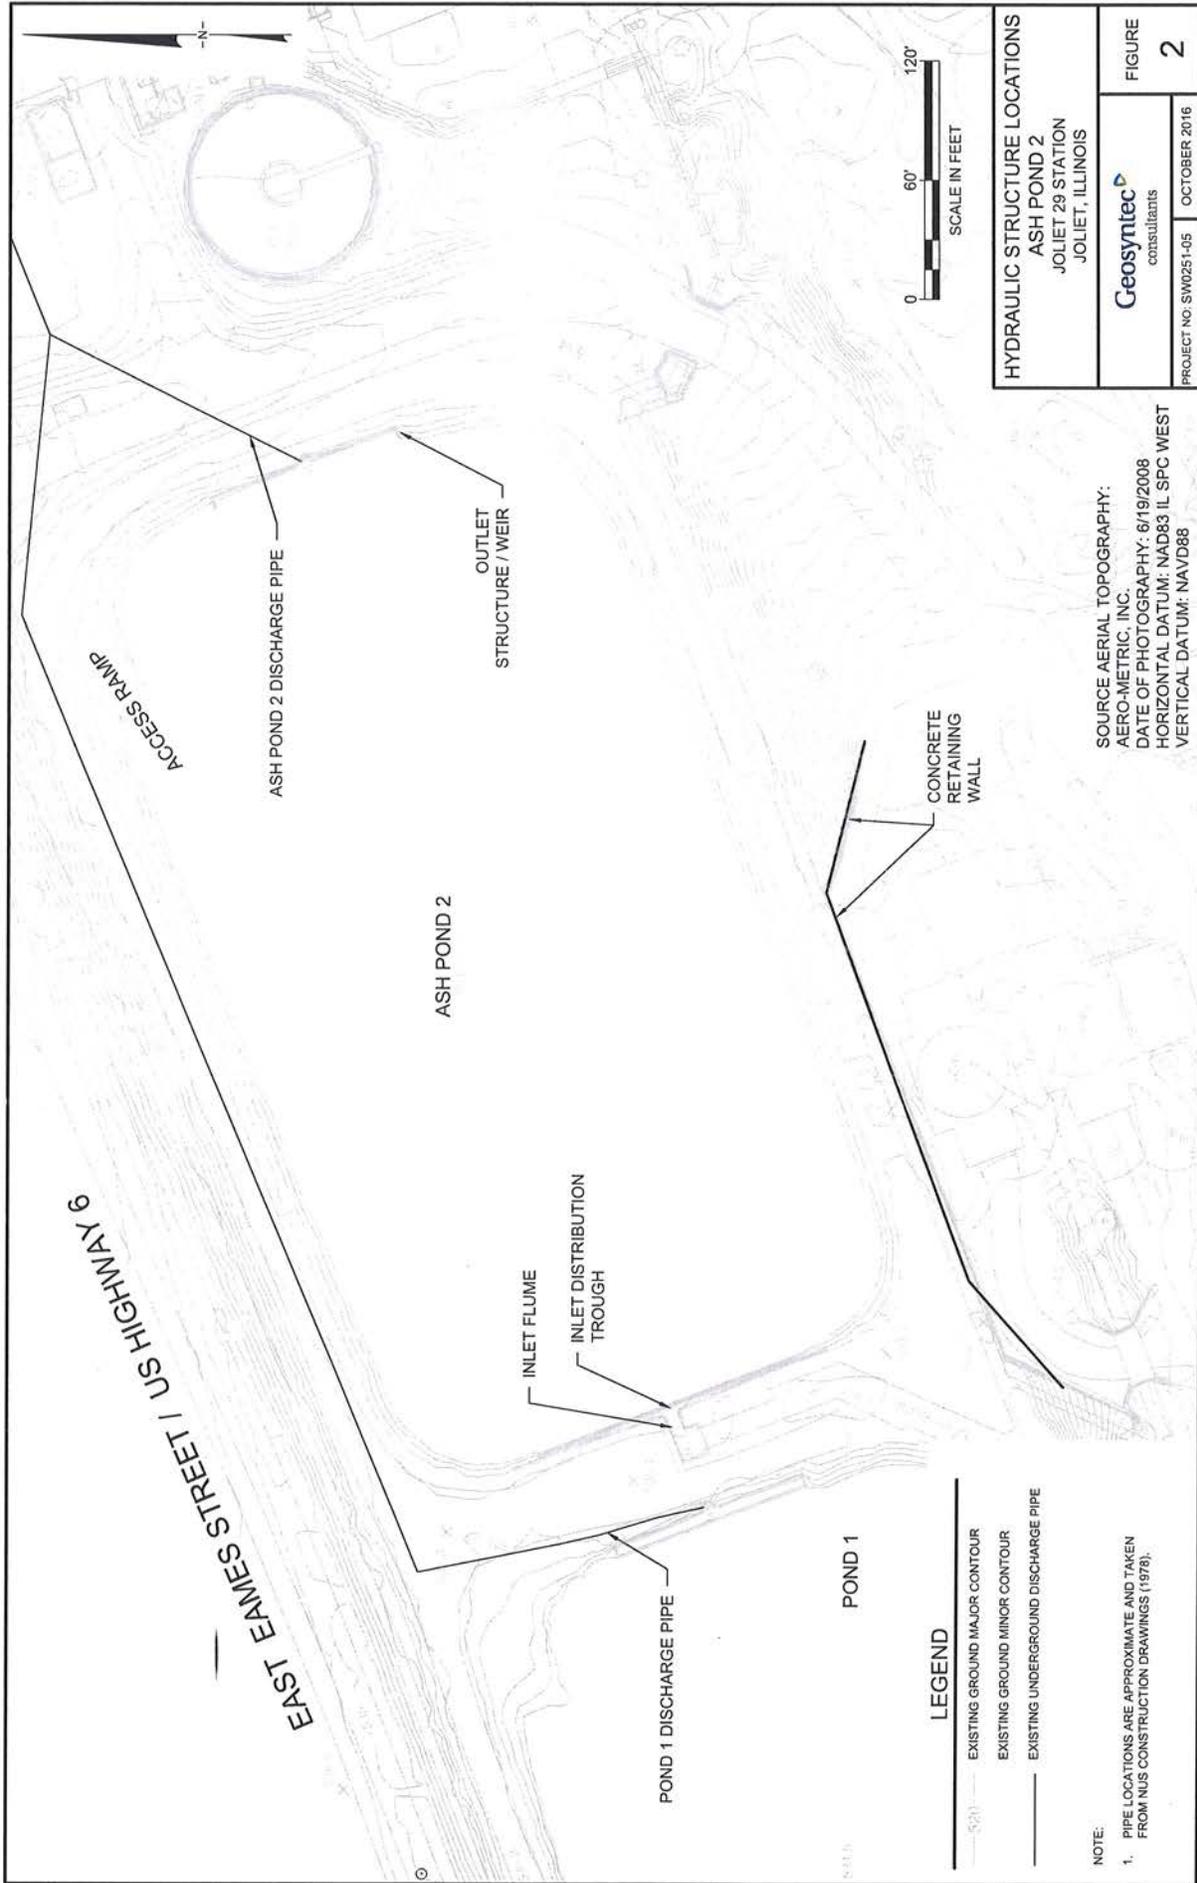
HYDRAULIC STRUCTURE LOCATIONS
 ASH POND 2
 JOLIET 29 STATION
 JOLIET, ILLINOIS

Portions of the discharge pipes from Pond 1 and from Ash Pond 2 underlie the latter's southern dike. The locations of these two pipes are shown on Figure 2 of the pond's initial federal structural stability assessment in Appendix A. As documented in the 2016 assessment, visual surveillance of these pipes was performed in May 2016 by a third party that specializes in video camera pipe inspections. No significant deterioration, deformation, distortion, bedding deficiencies, sedimentation, or debris that may negatively affect Ash Pond 2 were identified during this surveillance program. It is noted that a portion of Pond 1's discharge pipe passes under Ash Pond 2's northern crest, but this portion of Ash Pond 2 is effectively incised and, thus, is not considered to be at risk if the discharge pipe's integrity was to become compromised.

Hydraulic structures passing through or beneath the embankments of Ash Pond 2 consist of outlet pipes associated with Pond 1 and Ash Pond 2, as presented in Figure 2. These pipes were inspected on 9 June 2016 by a company specializing in video camera pipe inspections. No significant deterioration, deformation, distortion, bedding deficiencies, sedimentation, or

debris that would negatively affect operation of the pipes was observed during inspection of these outlet pipes.

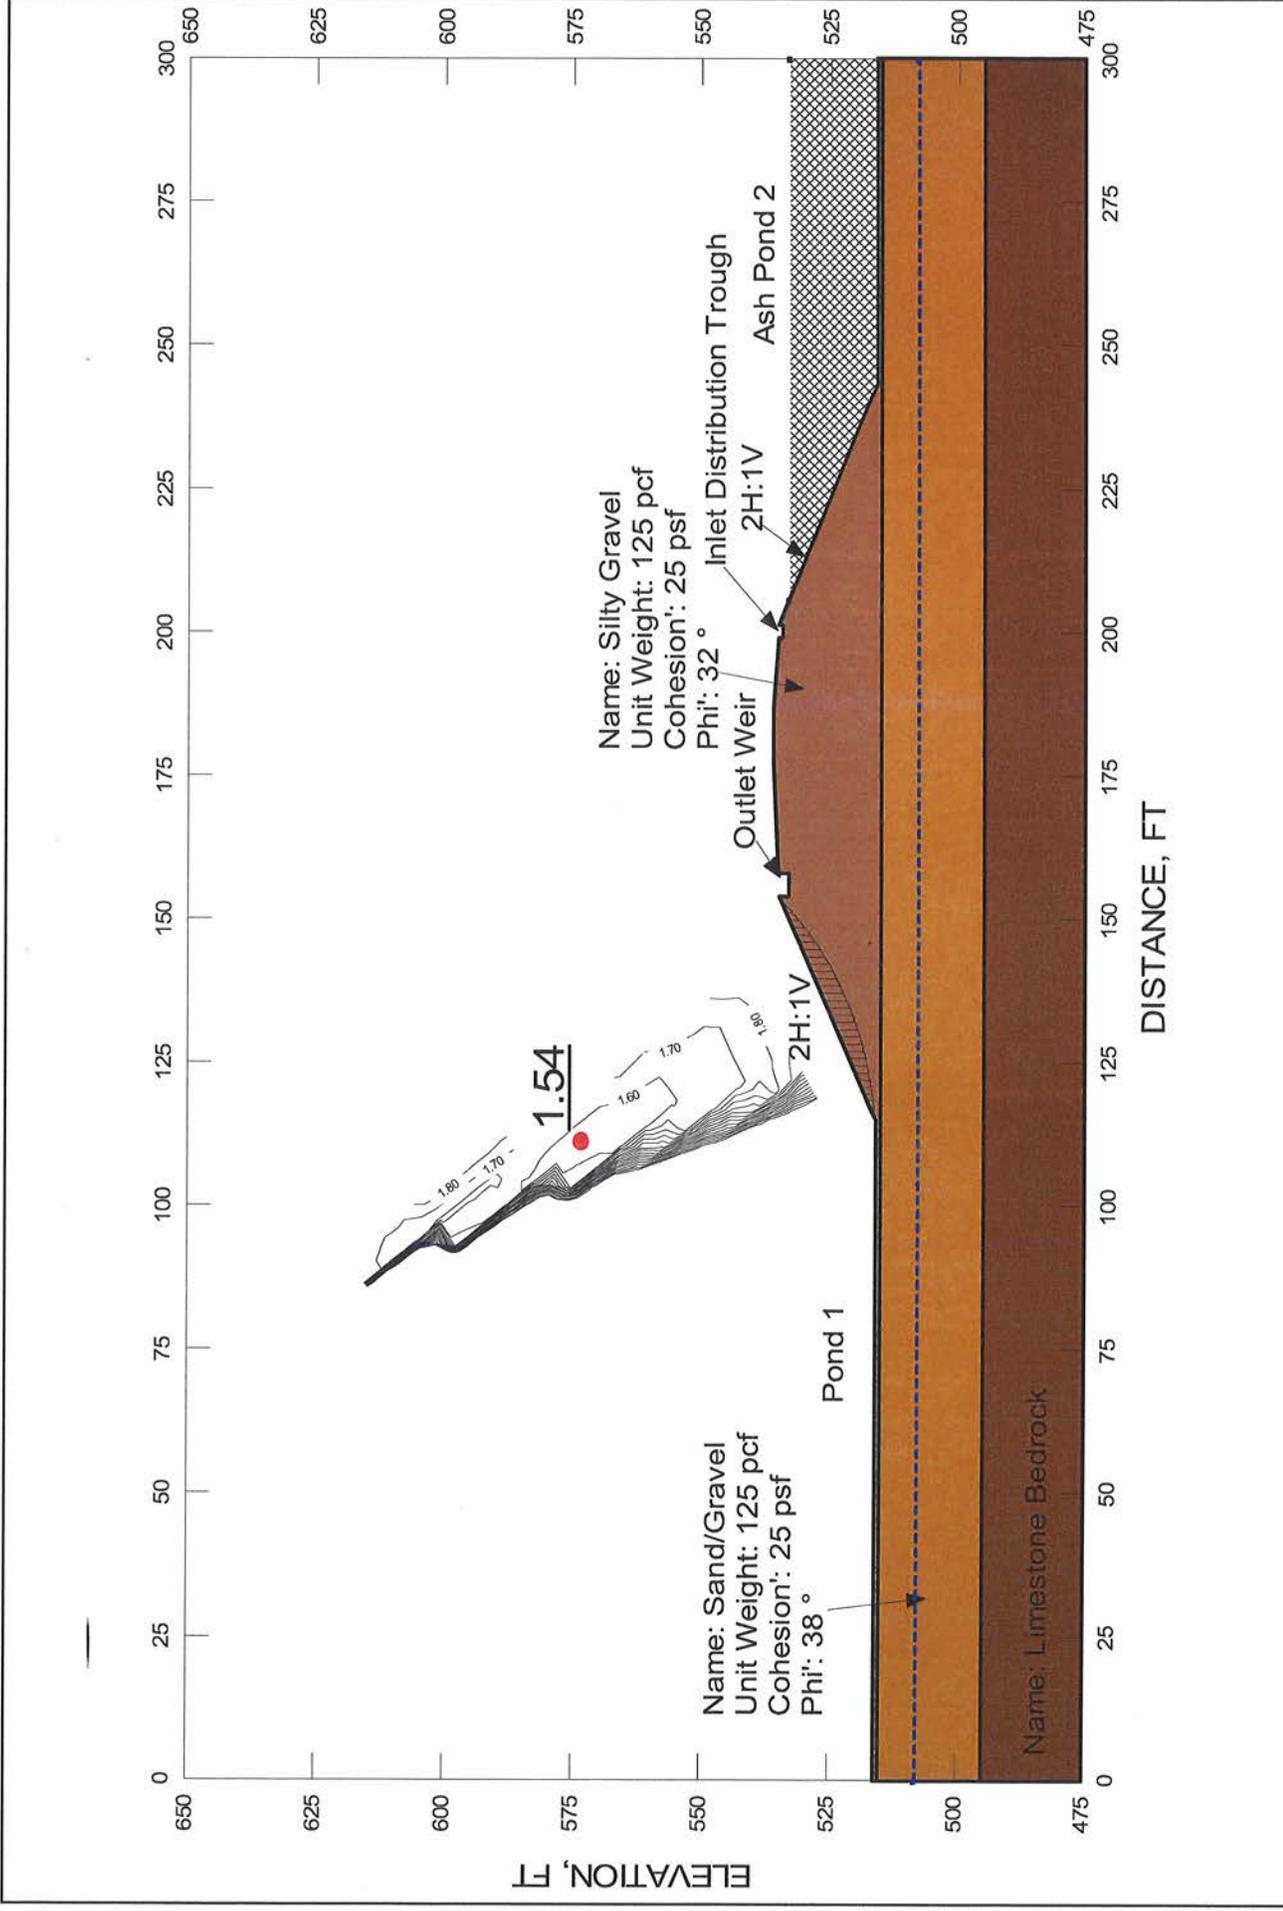
Analysis	Section 1 - \$257.73(e)(1)(i): Long Term, Maximum Storage Pool Loading		
Project	Joliet Ash Pond 2		
File Name	Joliet Ash Pond 2.Section 1.gsz	Analysis By	Cory Russell
		Date	October 2016

The results of the slope stability analysis for the critical cross section of the Ash Pond 2 embankments are summarized in Table 1 below and presented in Figures 4 through 6 (Geosyntec 2016e).

Section	Safety Factor			
	257.73(e)(1)(i)	257.73(e)(1)(ii)	257.73(e)(1)(iii)	257.73(e)(1)(iv)
1	≥1.50	≥1.40	≥1.00	N/A

The results of the slope stability analyses meet the minimum safety factors requirements presented in §257.73(e)(1)(i) through §257.73(e)(1)(iii).
