## Joliet 29 Generating Station

# 2024 Safety Factor Assessment for Ash Pond 2

**October 13, 2024**

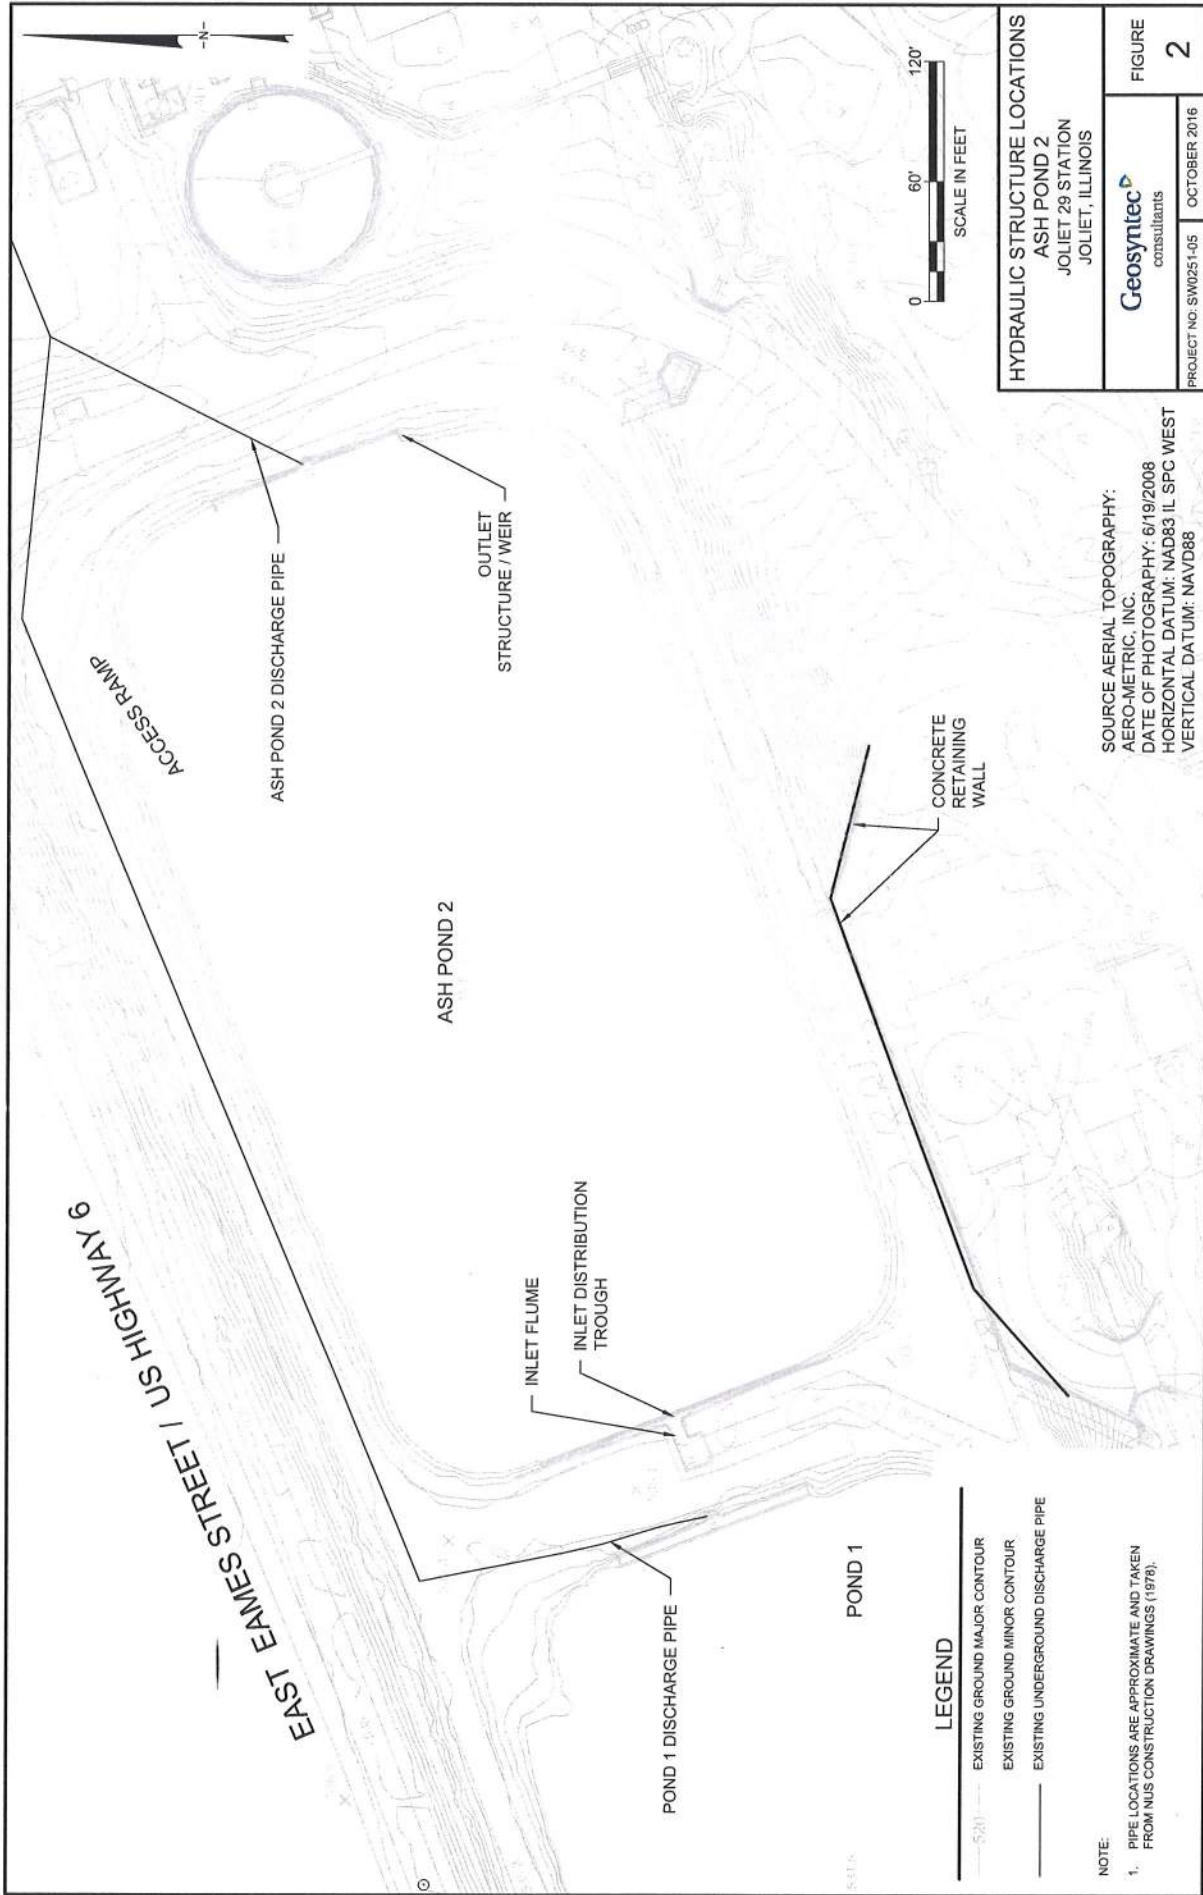
HYDRAULIC STRUCTURE LOCATIONS  
 ASH POND 2  
 JOLIET 29 STATION  
 JOLIET, ILLINOIS

Hydraulic structures passing through or beneath the embankments of Ash Pond 2 consist of outlet pipes associated with Pond 1 and Ash Pond 2, as presented in Figure 2. These pipes were inspected on 9 June 2016 by a company specializing in video camera pipe inspections. No significant deterioration, deformation, distortion, bedding deficiencies, sedimentation, or

debris that would negatively affect operation of the pipes was observed during inspection of these outlet pipes.

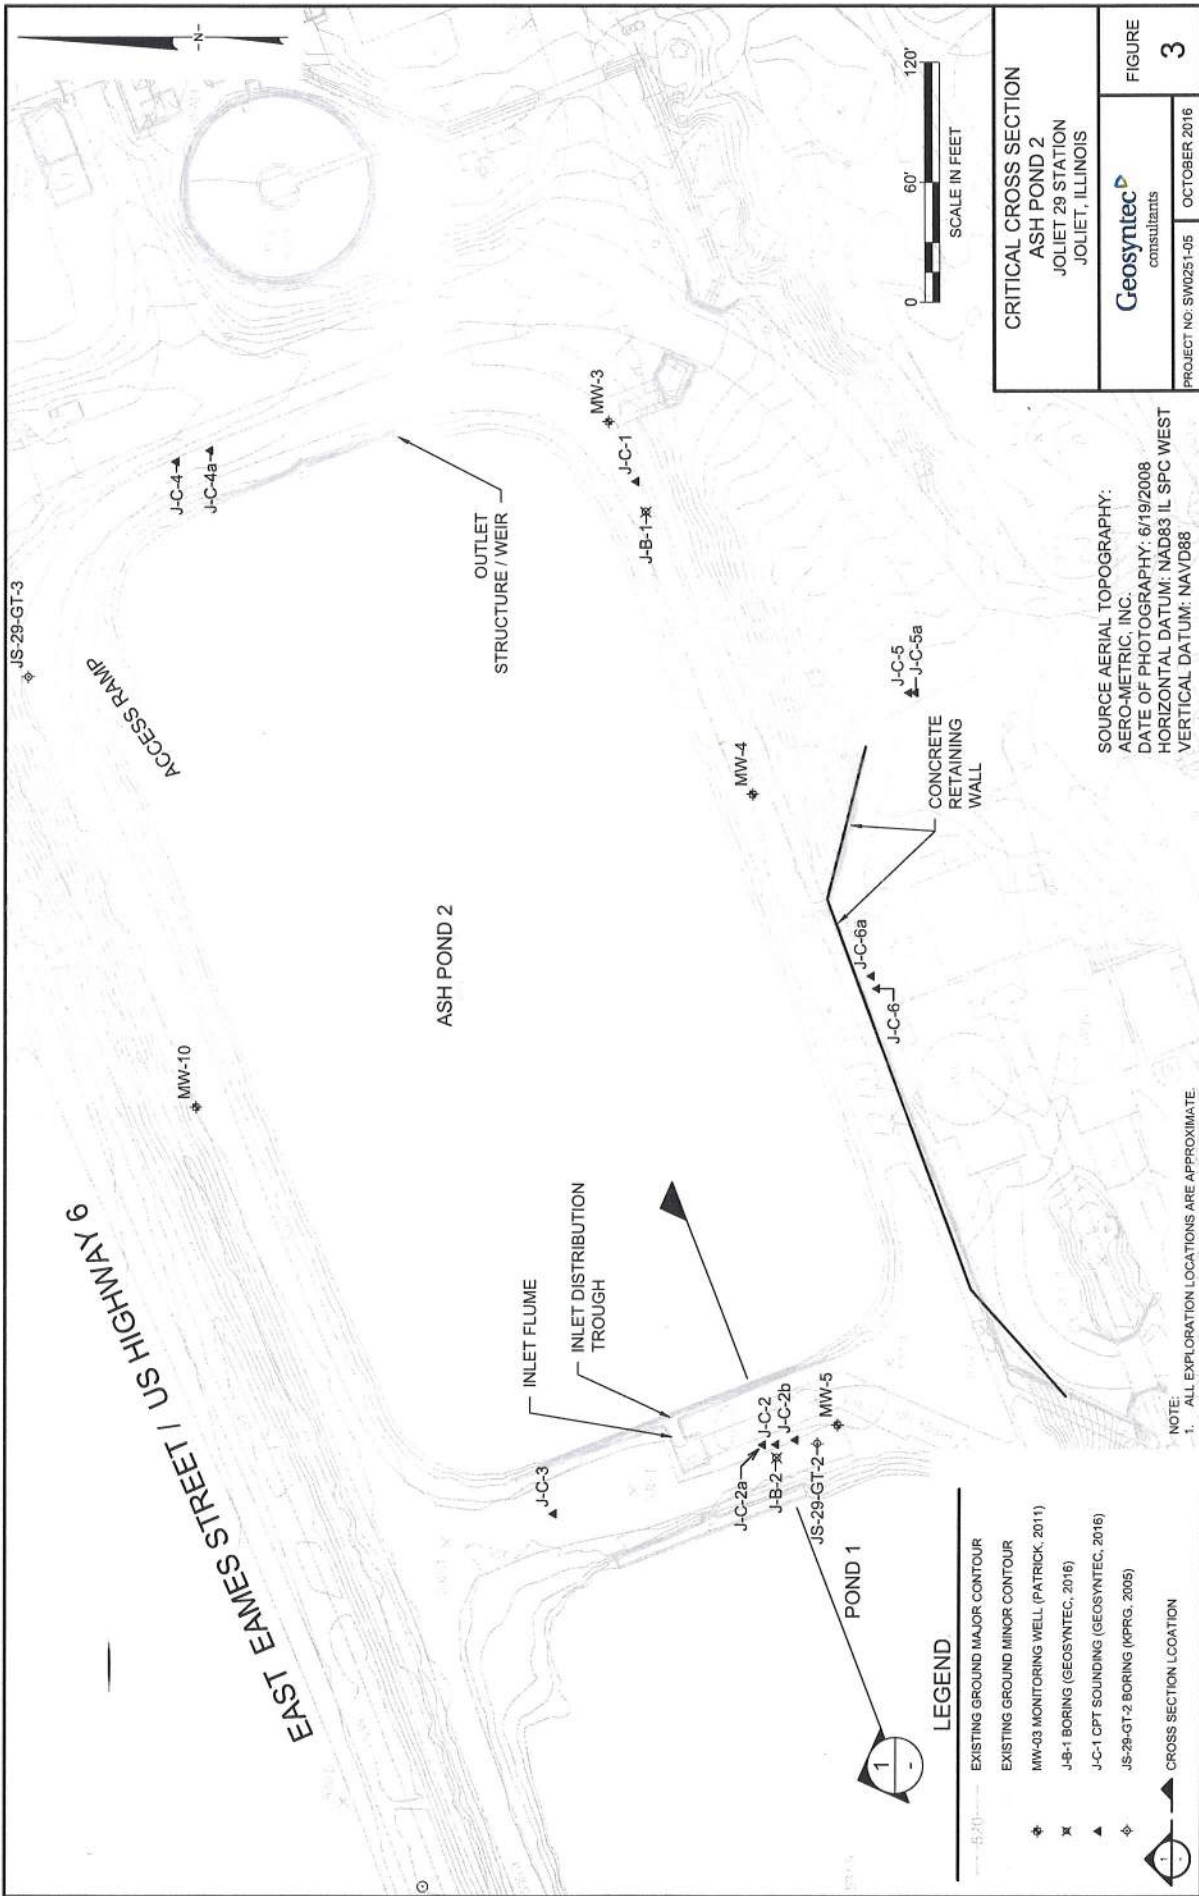
**Geosyntec**  
 consultants  
 PROJECT NO. SW0251-05    OCTOBER 2016  
**FIGURE 3**

**CRITICAL CROSS SECTION**  
**ASH POND 2**  
 JOLIET 29 STATION  
 JOLIET, ILLINOIS

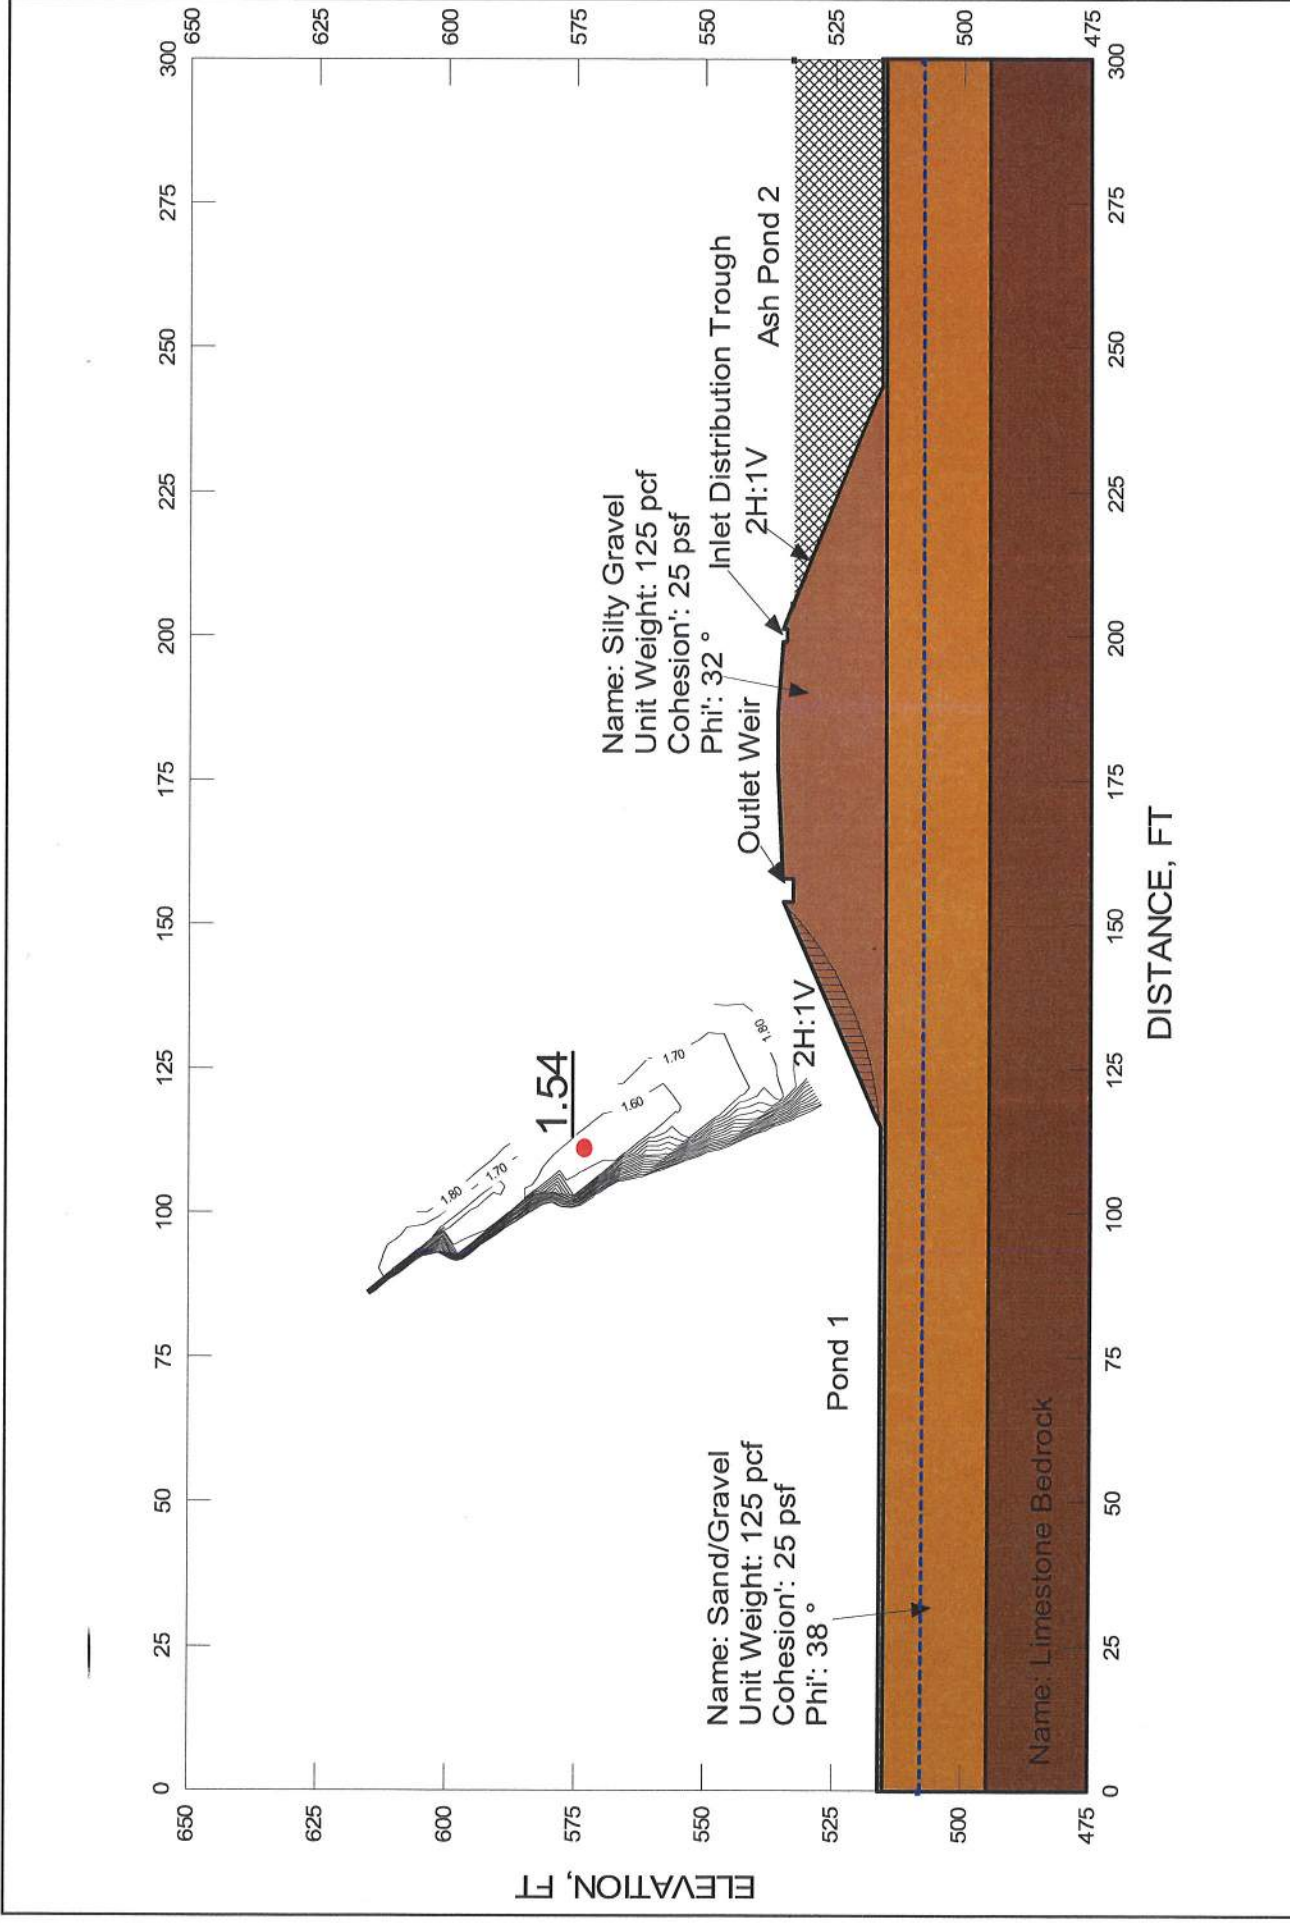
<b>Section 1 - \$257.73(e)(1)(i): Long Term, Maximum Storage Pool Loading</b>		<b>FIGURE 4</b>	
	Analysis	Joliet Ash Pond 2		Analysis By: Cory Russell
	Project	Joliet Ash Pond 2.Section 1.gsz		Date: October 2016

Pursuant to §257.73(e)(1)(i) a static, long-term condition with the maximum operating pool loading on the embankments was evaluated. For Ash Pond 2, this condition included a pool elevation at 2 feet below the top of the embankments (Geosyntec, 2016e).

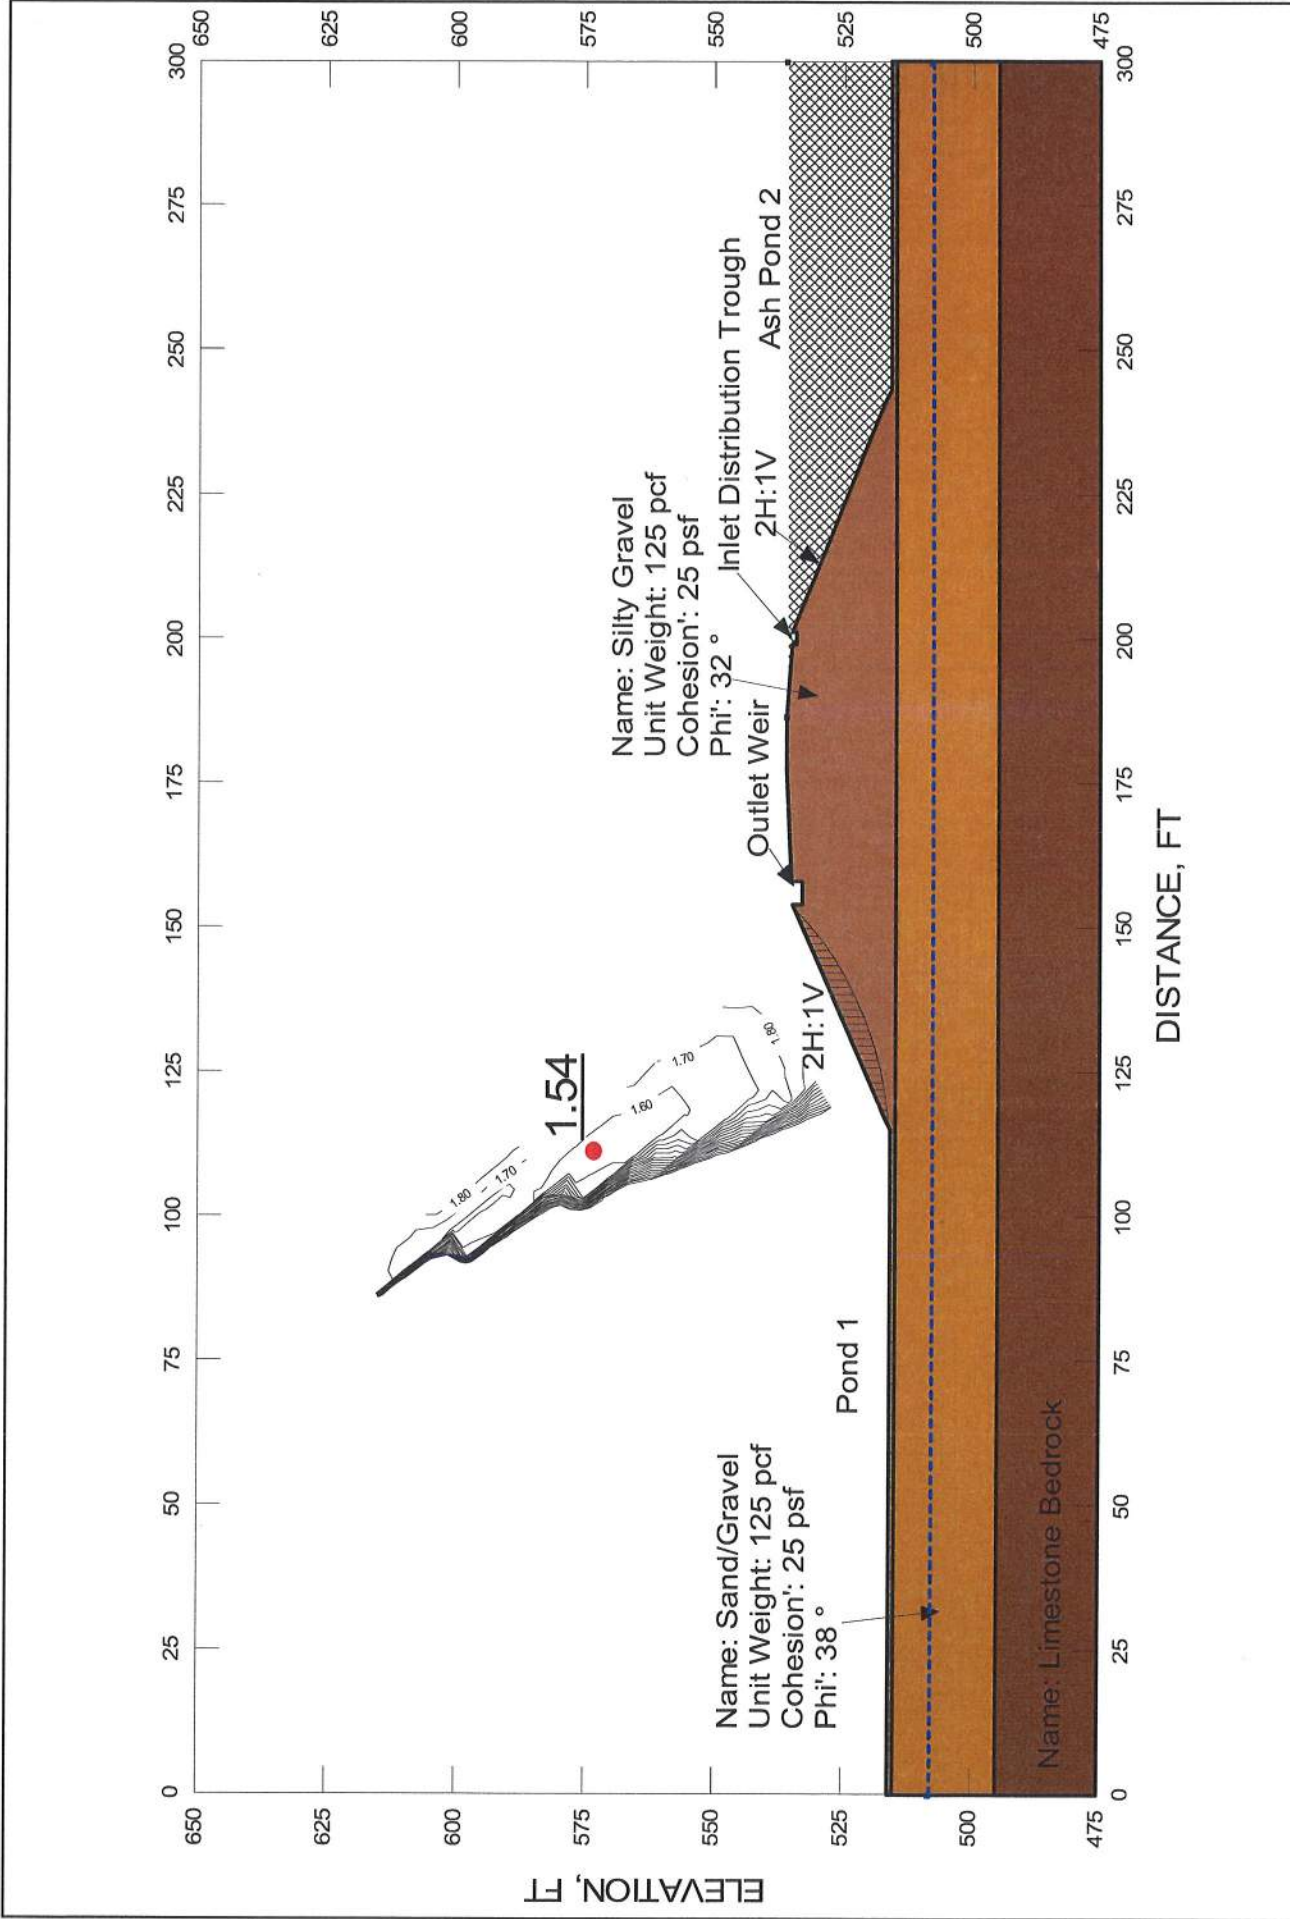
FIGURE  
5

The conditions for §257.73(e)(1)(ii) are identical to §257.73(e)(1)(i) with the exception of the pool elevation, which is set at the top of the embankment (Geosyntec, 2016e).

Analysis	Section 1 - \$257.73(e)(1)(ii): Maximum Surcharge Pool Loading
Project	Joliet Ash Pond 2
File Name	Joliet Ash Pond 2.Section 1.gsz
Analysis By	Cory Russell
Date	October 2016

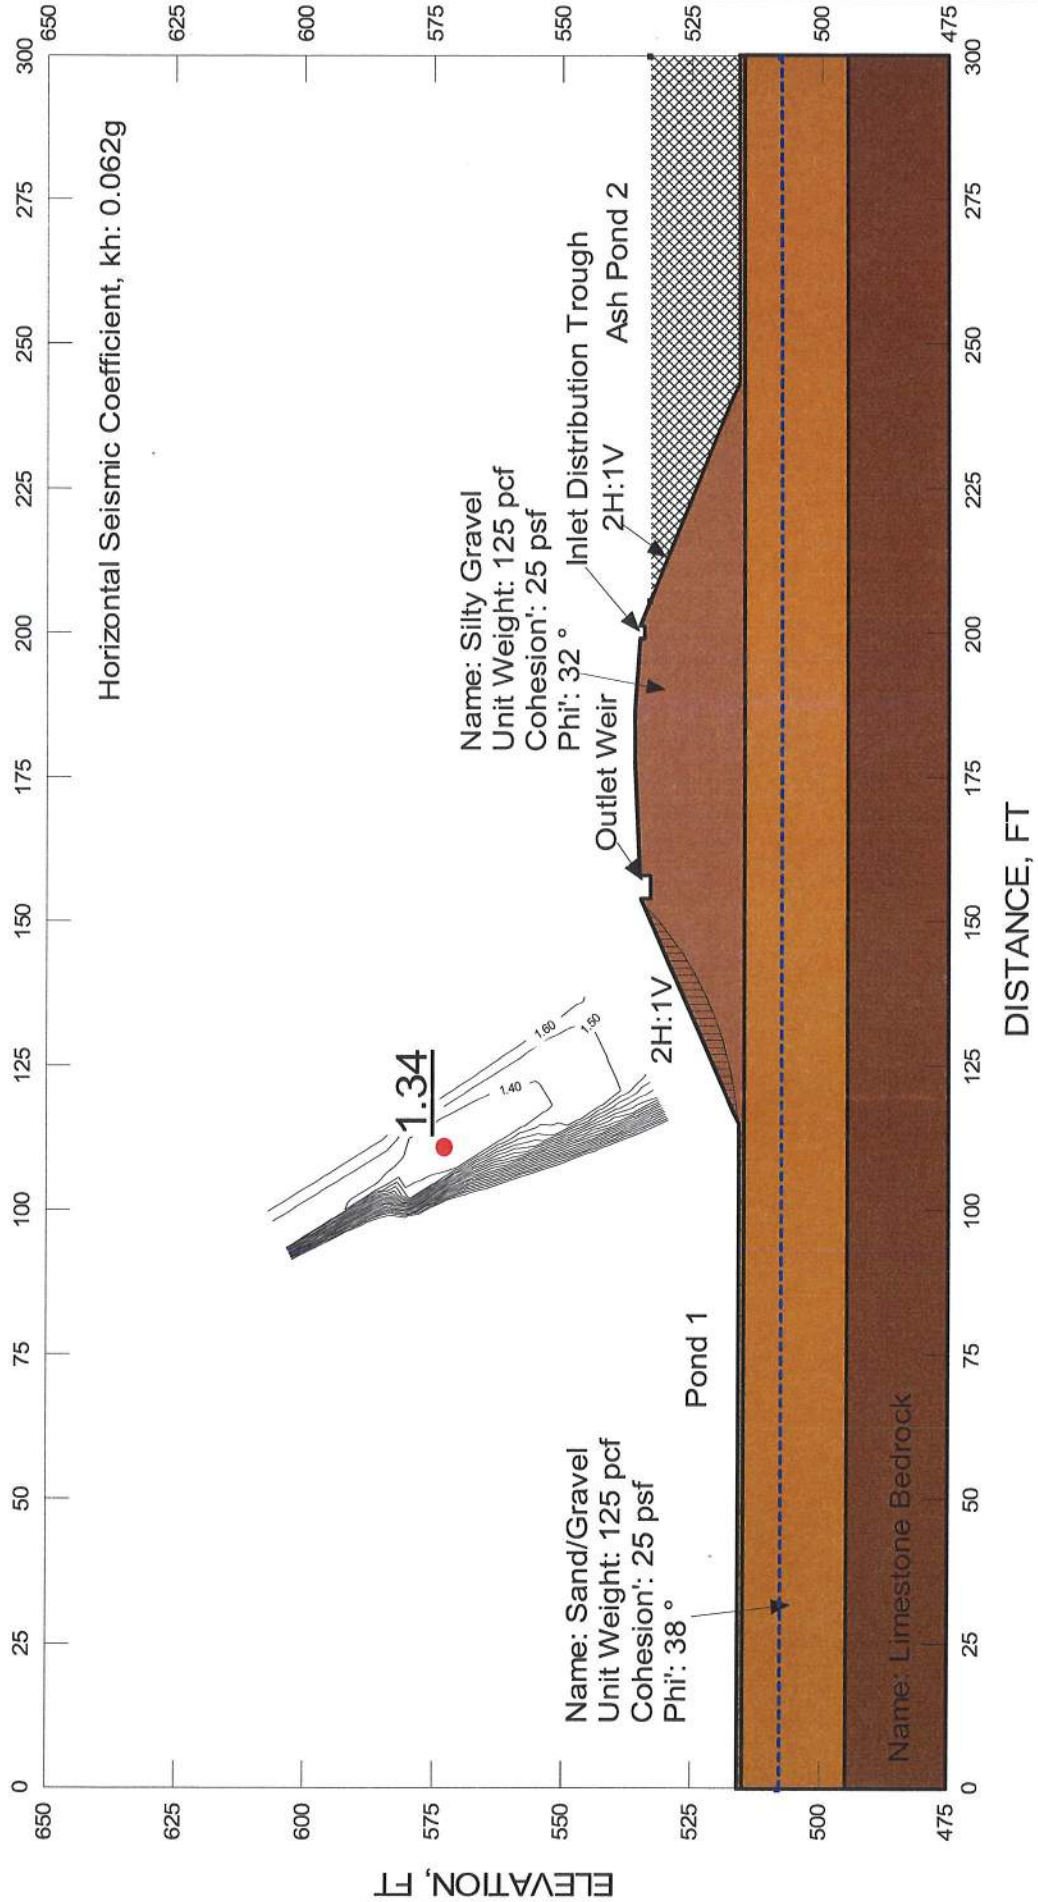
Figure 6 – Slope Stability Output, Section 1 - 257.73(e)(1)(iii)

Pursuant to §257.73(e)(1)(iii), a seismic condition for Ash Pond 2 was also analyzed. Seismic stability was evaluated with a pseudostatic analysis that uses constant horizontal accelerations to represent the effects of earthquake shaking. The horizontal accelerations are represented in SLOPE/W by a horizontal seismic coefficient. The horizontal seismic coefficient used for analysis was based on a peak ground acceleration with a 2 percent probability of exceedance in 50 years (Geosyntec, 2016g).
