**STRUCTURAL STABILITY AND FACTOR OF SAFETY ASSESSMENT
ASH POND 2
JOLIET 29 STATION
OCTOBER 2016**

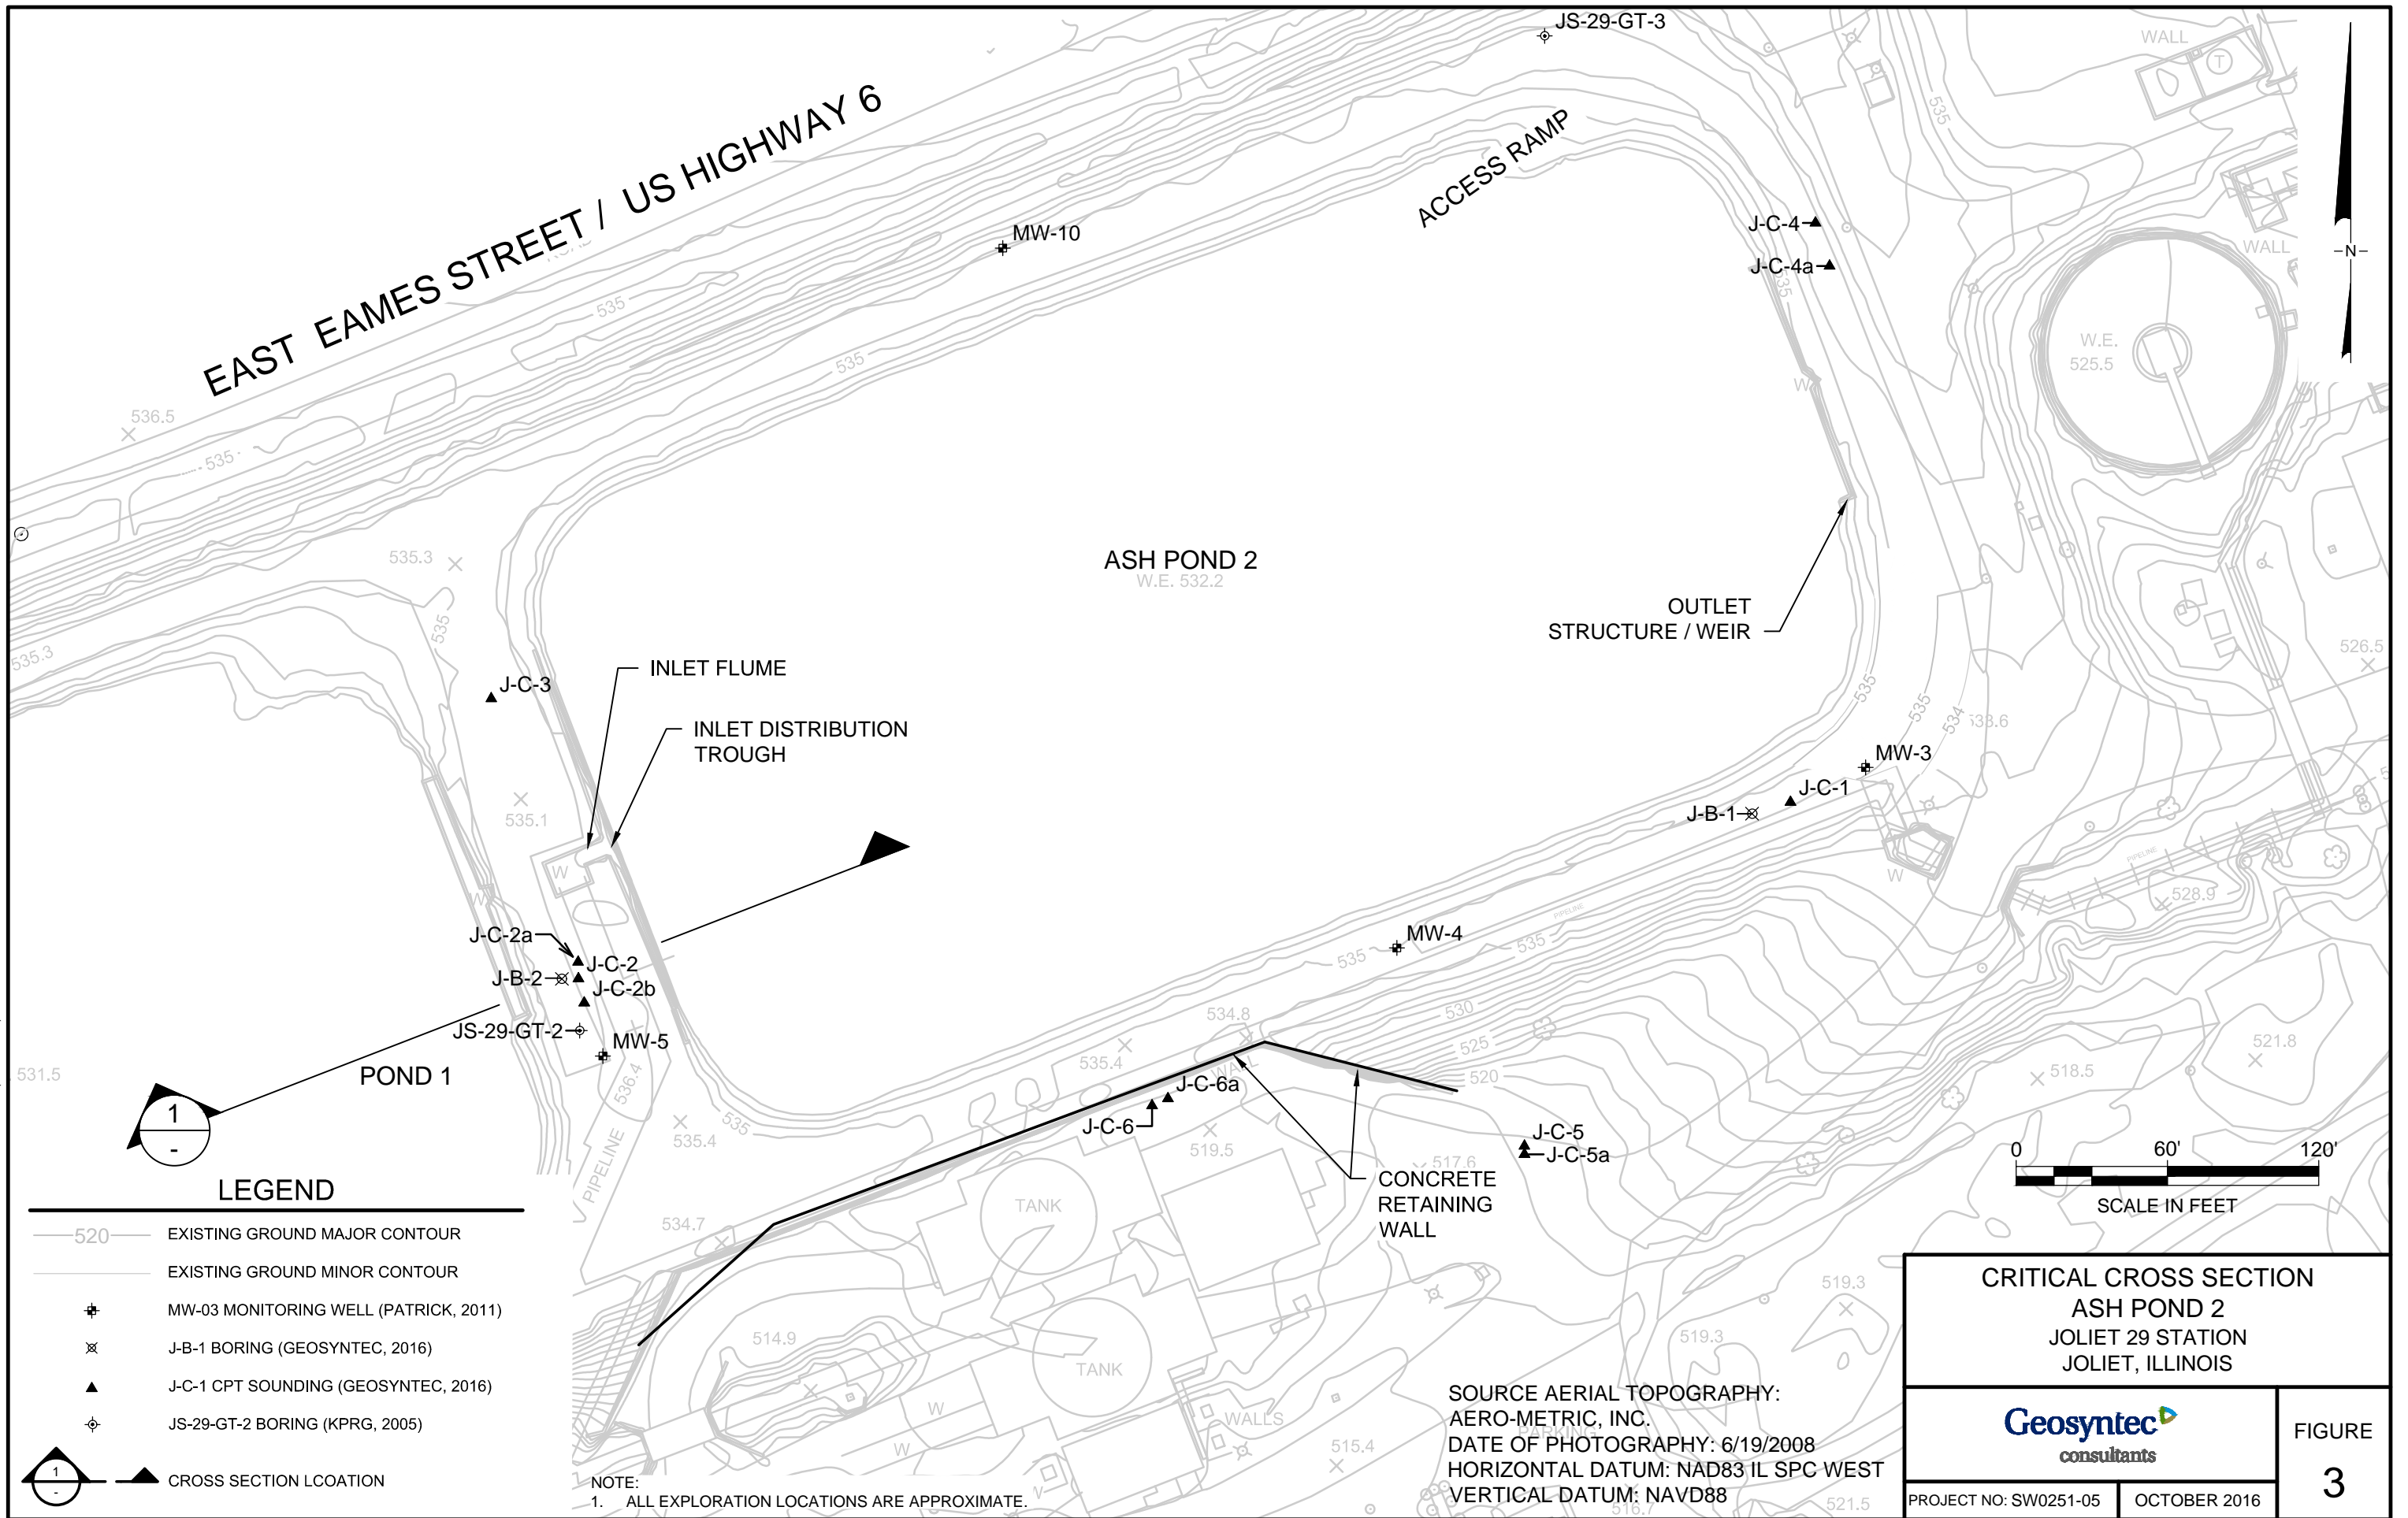
Figure 3 – Critical Cross Section

This section describes the initial safety factor assessment for Ash Pond 2 and the methodology used to perform the assessment in accordance with §257.73(e)(1). This assessment summarizes slope stability analyses of the critical embankment cross-section, shown in Figure 3, and evaluation of stability of the retaining wall southeast of the pond.

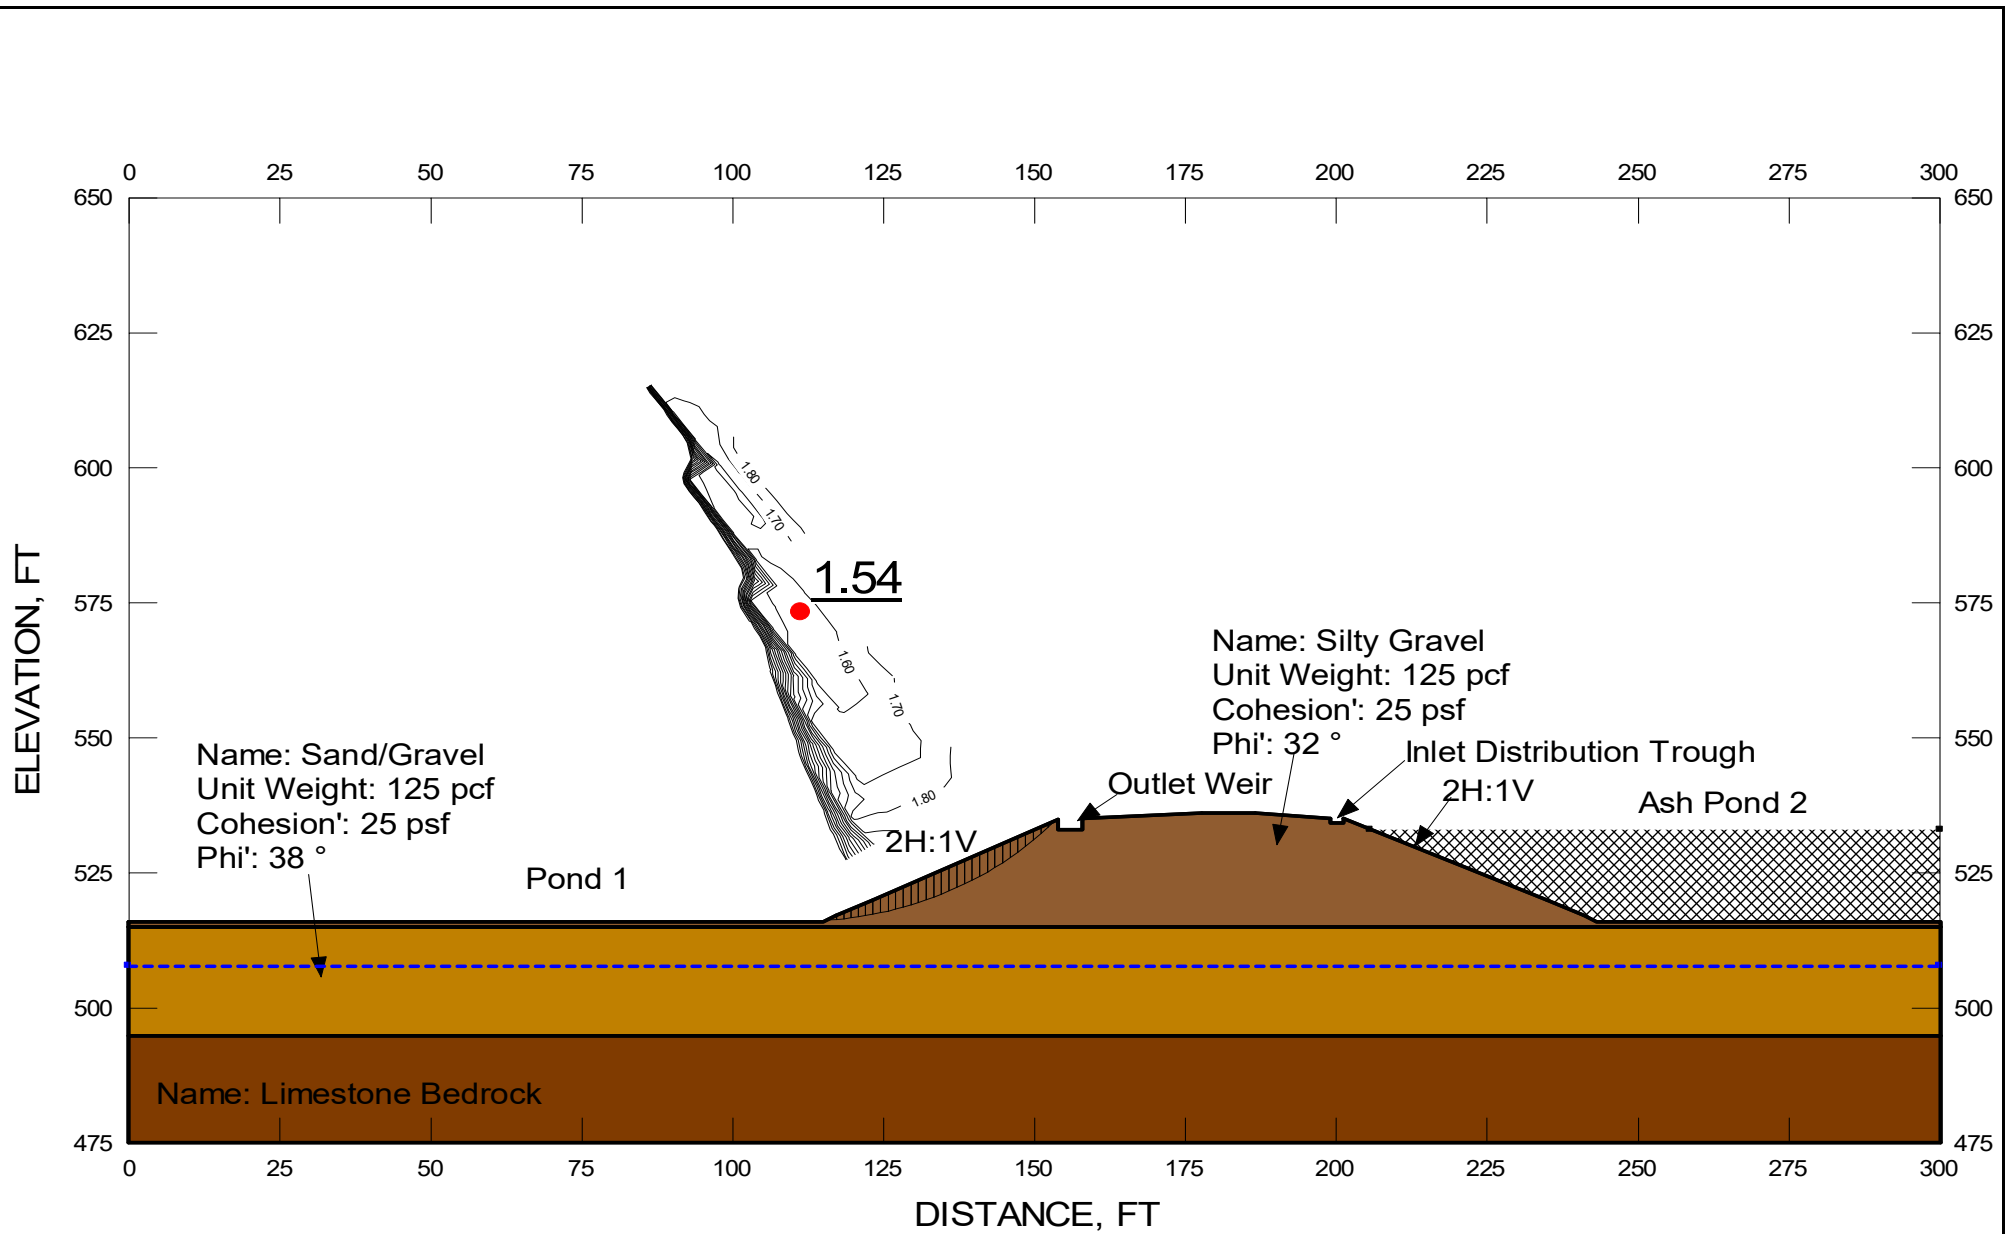
Figure 4 – Slope Stability Output, Section 1 - 257.73(e)(1)(i)

Pursuant to §257.73(e)(1)(i) a static, long-term condition with the maximum operating pool loading on the embankments was evaluated. For Ash Pond 2, this condition included a pool elevation at 2 feet below the top of the embankments (Geosyntec, 2016e).

The results of the slope stability analyses meet the minimum safety factors requirements presented in §257.73(e)(1)(i) through §257.73(e)(1)(iii).

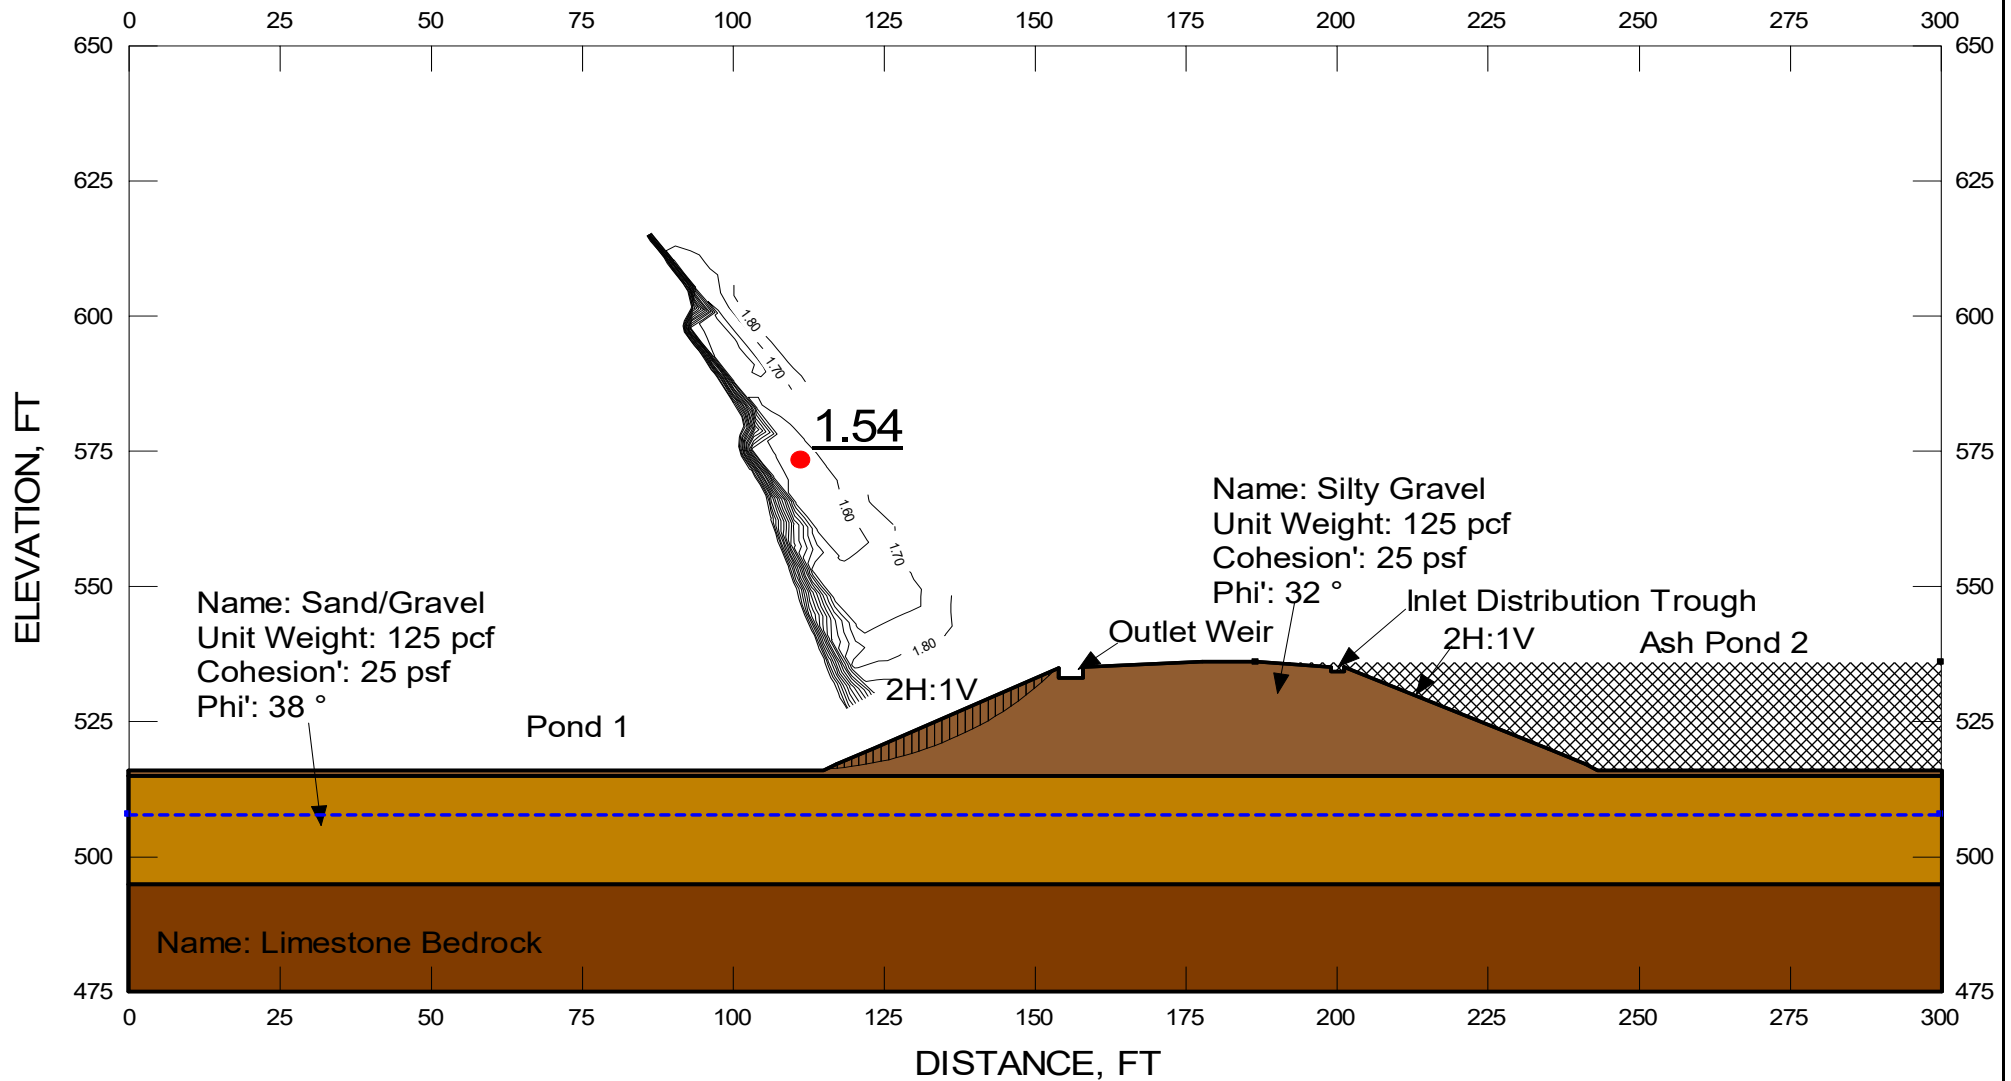
Figure 5 – Slope Stability Output, Section 1 - 257.73(e)(1)(ii)

The conditions for §257.73(e)(1)(ii) are identical to §257.73(e)(1)(i) with the exception of the pool elevation, which is set at the top of the embankment (Geosyntec, 2016e).

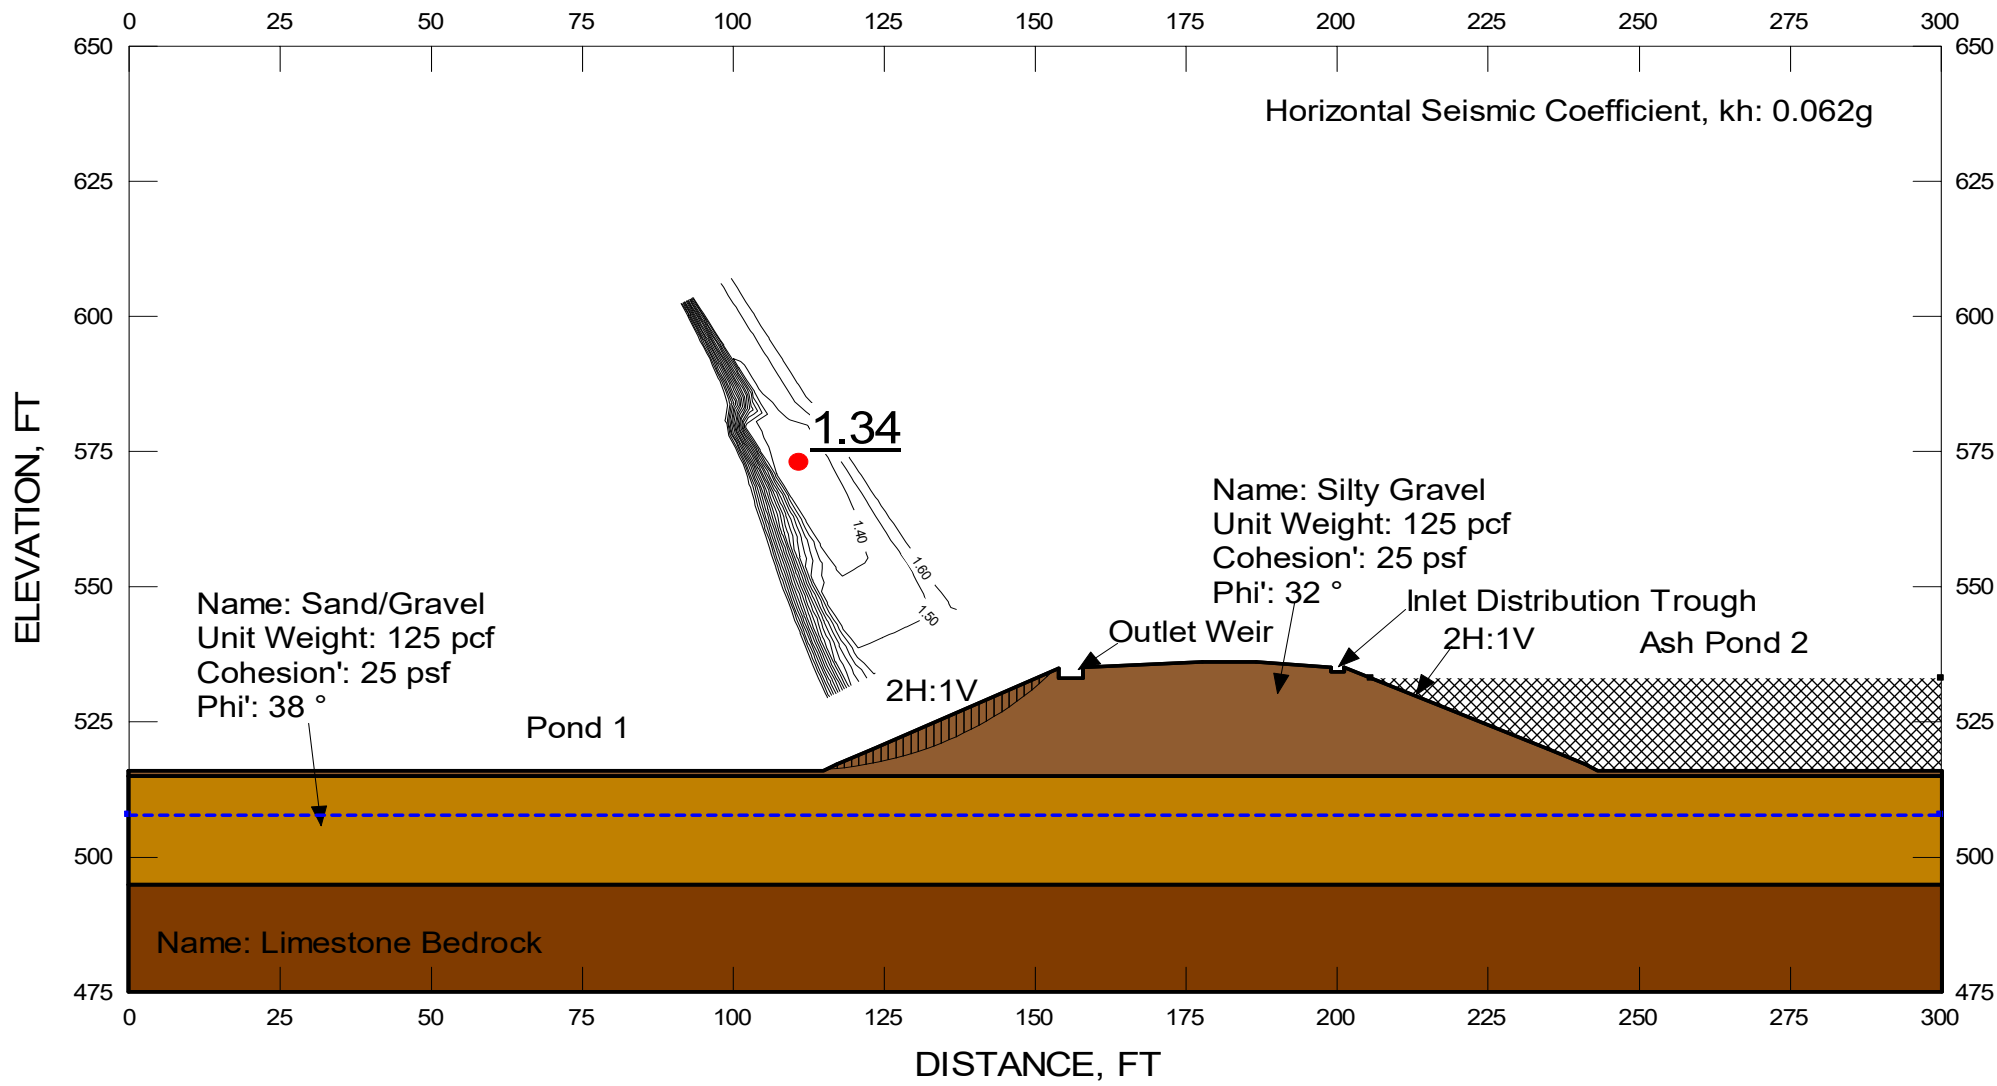
Figure 6 – Slope Stability Output, Section 1 - 257.73(e)(1)(iii)

Pursuant to §257.73(e)(1)(iii), a seismic condition for Ash Pond 2 was also analyzed. Seismic stability was evaluated with a pseudostatic analysis that uses constant horizontal accelerations to represent the effects of earthquake shaking. The horizontal accelerations are represented in SLOPE/W by a horizontal seismic coefficient. The horizontal seismic coefficient used for analysis was based on a peak ground acceleration with a 2 percent probability of exceedance in 50 years (Geosyntec, 2016g).
