2018 Annual Inspection of CCR Units

Limestone Electric Generating Station
Jewett, Texas

January 2019

NRG Texas Power LLC

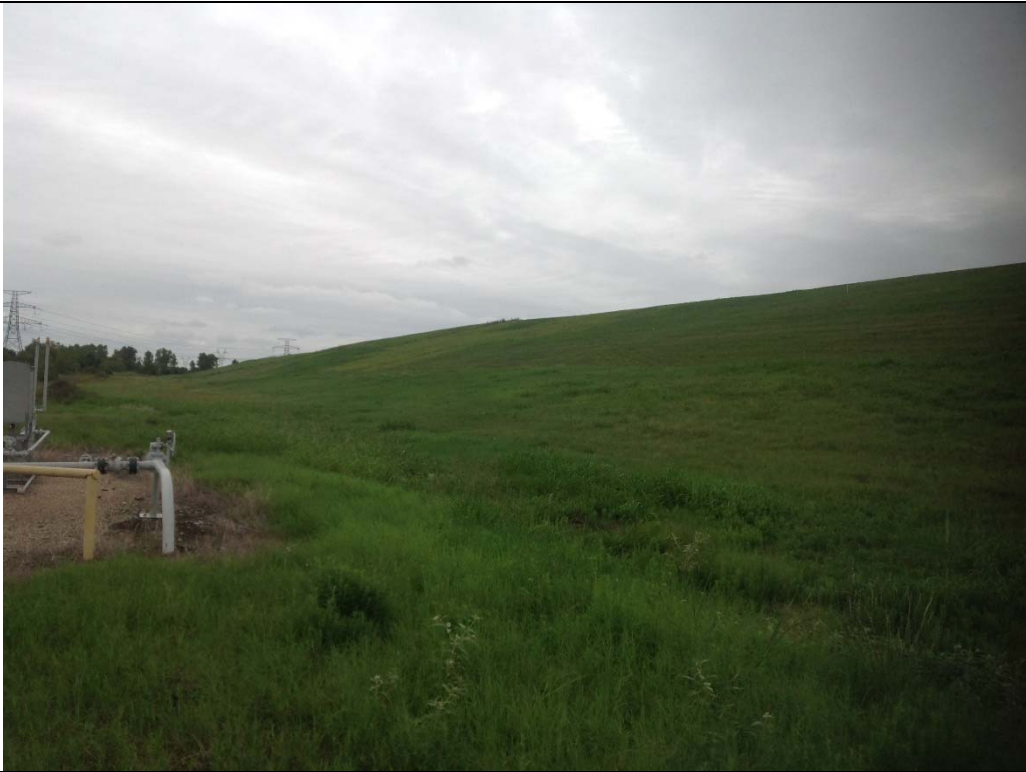
Although landfill Areas 1, 2, 3, 5, 6, 9 and 10 are considered to be capped areas, exposed slopes of CCR material are present in areas 1, 3, 6 and 10, where uncapped and areas under construction abut the existing CCR material. The plateaued portion of the capped areas is well vegetated and generally well graded to prevent the impoundment of storm water as depicted in Photographs P-1 through P-4.

The side slopes of the capped landfill areas are well vegetated and have appropriate interceptor ditches as depicted in Photographs P-1 through P-4.

Photograph P-1 Taken September 10, 2018 by Jason Leik, P.E. (during Location Certification)
Unit 004 Landfill – Looking north along west base and exterior slope of berm along areas 2, 5 and 9.

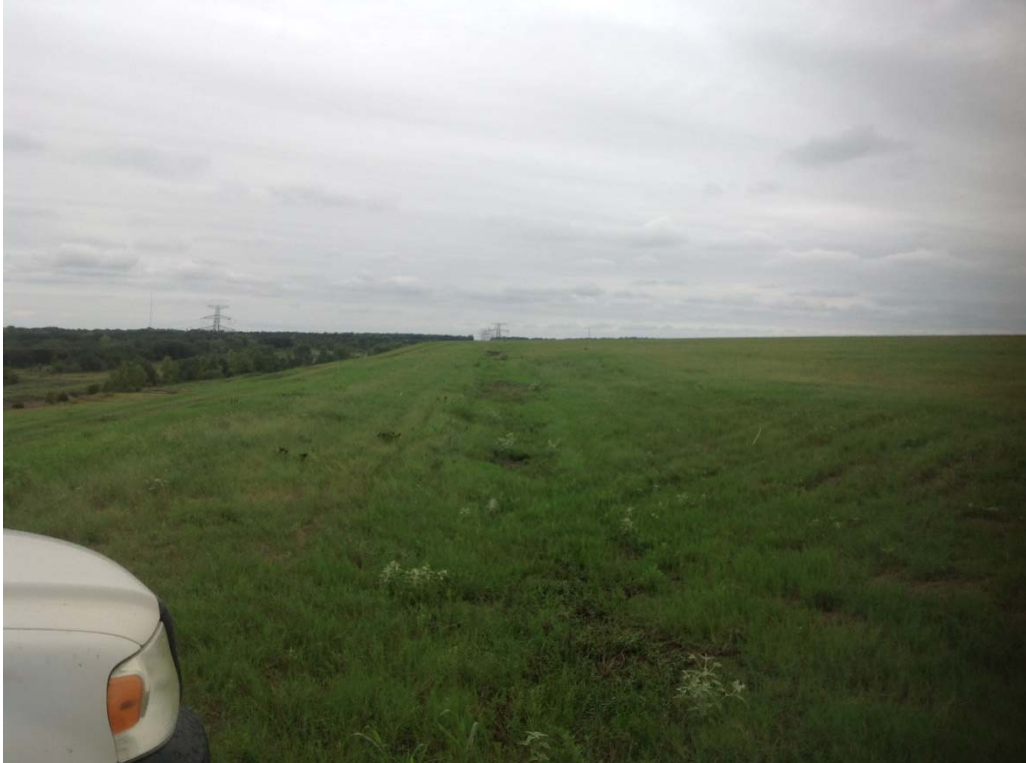
Photograph P-2 Taken September 10, 2018 by Jason Leik, P.E. (during Location Certification)
Unit 004 Landfill – Looking north along west crest and exterior slope of berm areas 2, 5 and 9.

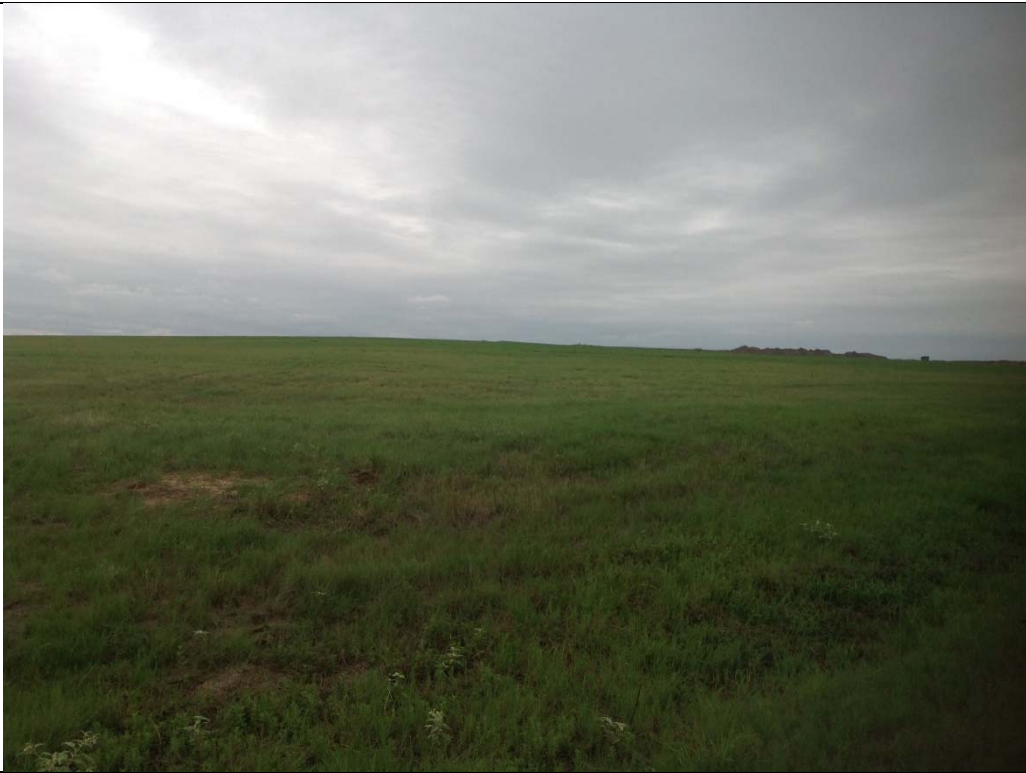
Photograph P-3 Taken September 10, 2018 by Jason Leik, P.E. (during Location Certification)
Unit 004 Landfill – Looking northeast across top of capped areas 2, 3, 5, 6, 9, and 10.

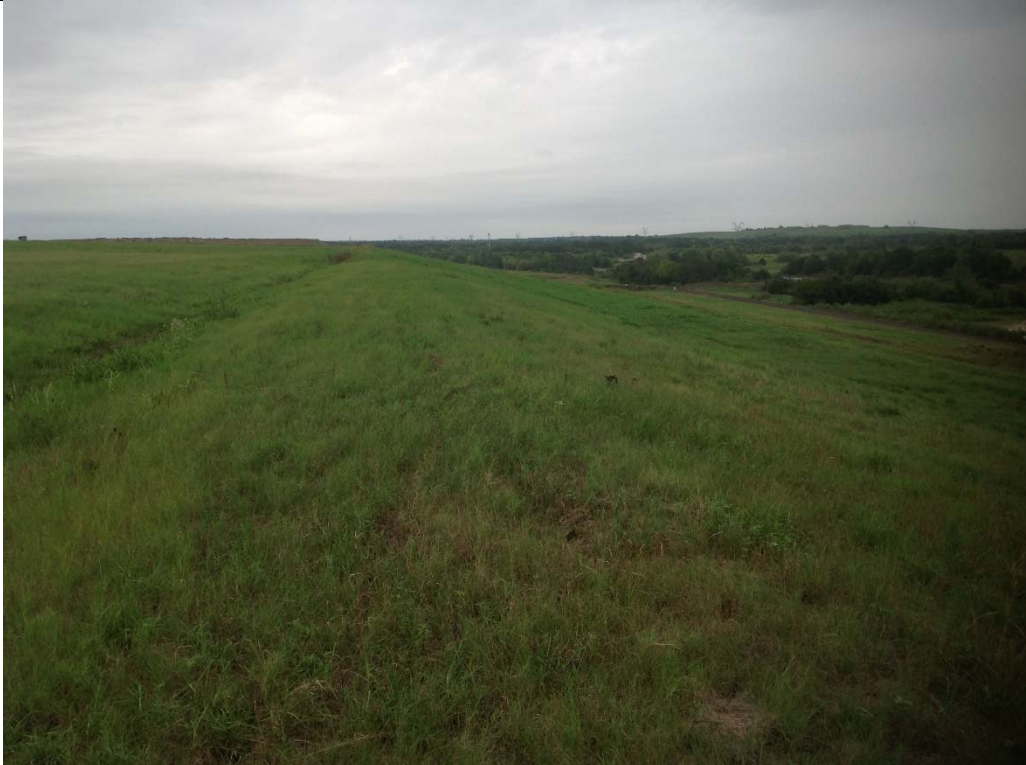
Photograph P-4 Taken September 10, 2018 by Jason Leik, P.E. (during Location Certification)
Unit 004 Landfill – Looking east across top of capped areas 9 and 10.

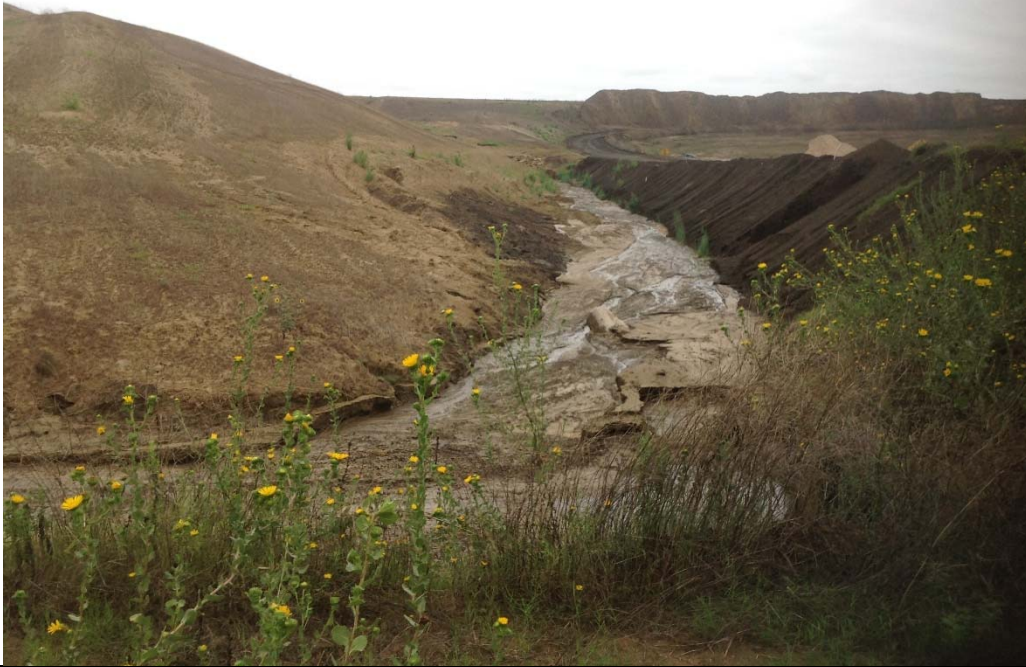
The haul road used to transport CCR materials to the top of the landfill is shown in Photograph P-5. During the site inspection, no ruts were observed despite some rainfall in the preceding days, demonstrating that the CCR materials can be placed in a relatively stable condition.

Photograph P-5 Taken September 10, 2018 by Jason Leik, P.E. (during Location Certification)
Unit 004 Landfill – Looking north up temporary carry down channel from uncapped area 11.

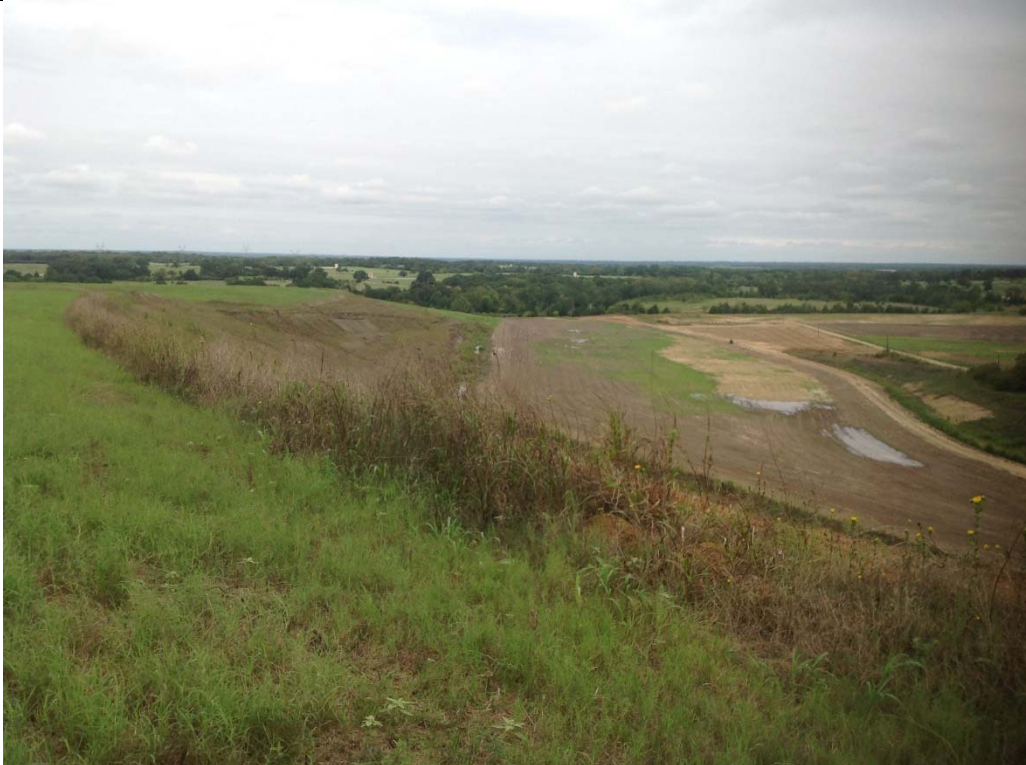
These uncapped CCR slopes drain down into the interceptor ditch as shown in Photographs P-6 and P-7. The interceptor ditch directs the storm water runoff and any eroded CCR material to Pond 002.

The earthwork activities to install the compacted clay liner in these areas is in various stages of construction. Photograph P-6 and P-7 show Areas 13, 14, 17, 19 and 20 that have partially completed clay liners. Photograph P-8 shows Area 12A where the clay liner protective cover is in place and a more distant area of partially lined landfill area under construction.

Photograph P-6 Taken September 10, 2018 by Jason Leik, P.E. (during Location Certification)
Unit 004 Landfill – Looking north from peak of capped areas 9 and 10 towards areas 13, 14, and 17.

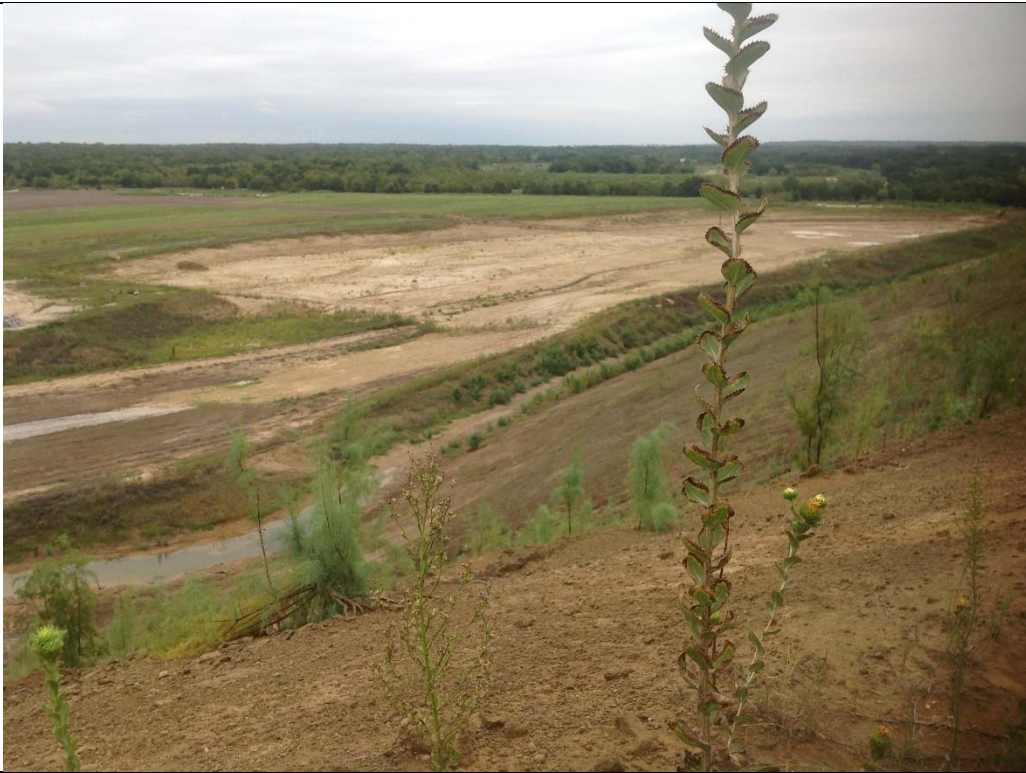
Photograph P-7 Taken September 10, 2018 by Jason Leik, P.E. (during Location Certification)
Unit 004 Landfill – Looking east from peak of capped areas 9 and 10 towards areas 19 and 20.

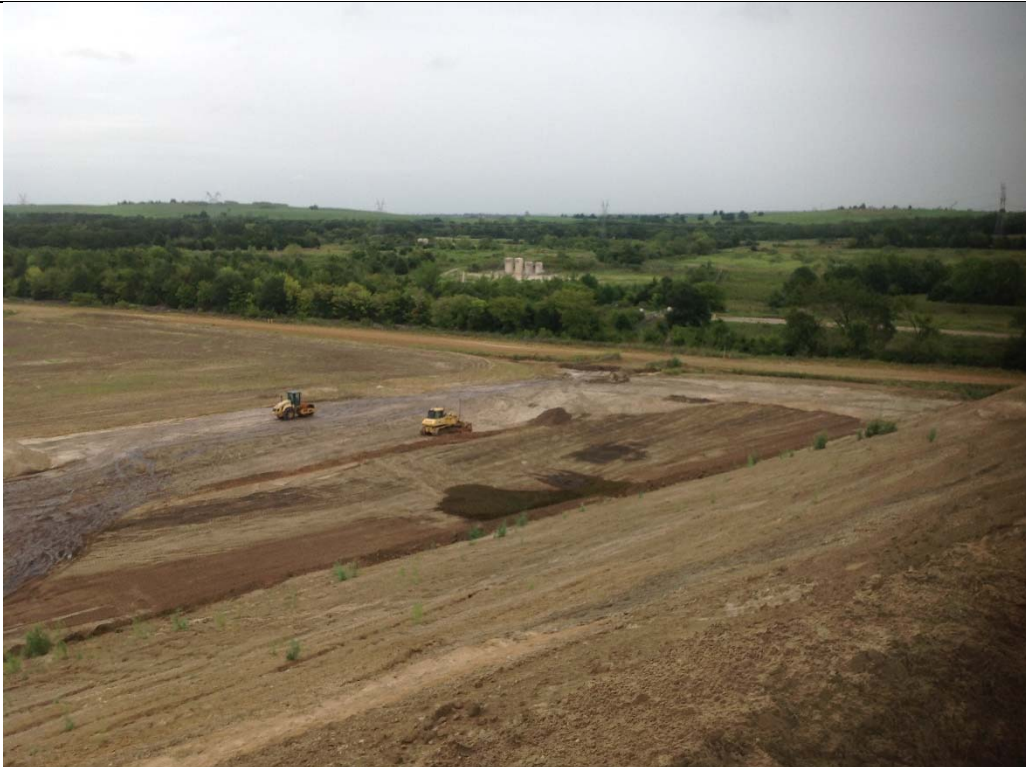
Photograph P-8 Taken September 10, 2018 by Jason Leik, P.E. (during Location Certification)
Unit 004 Landfill – Looking southeast from area 11 towards areas 12A.

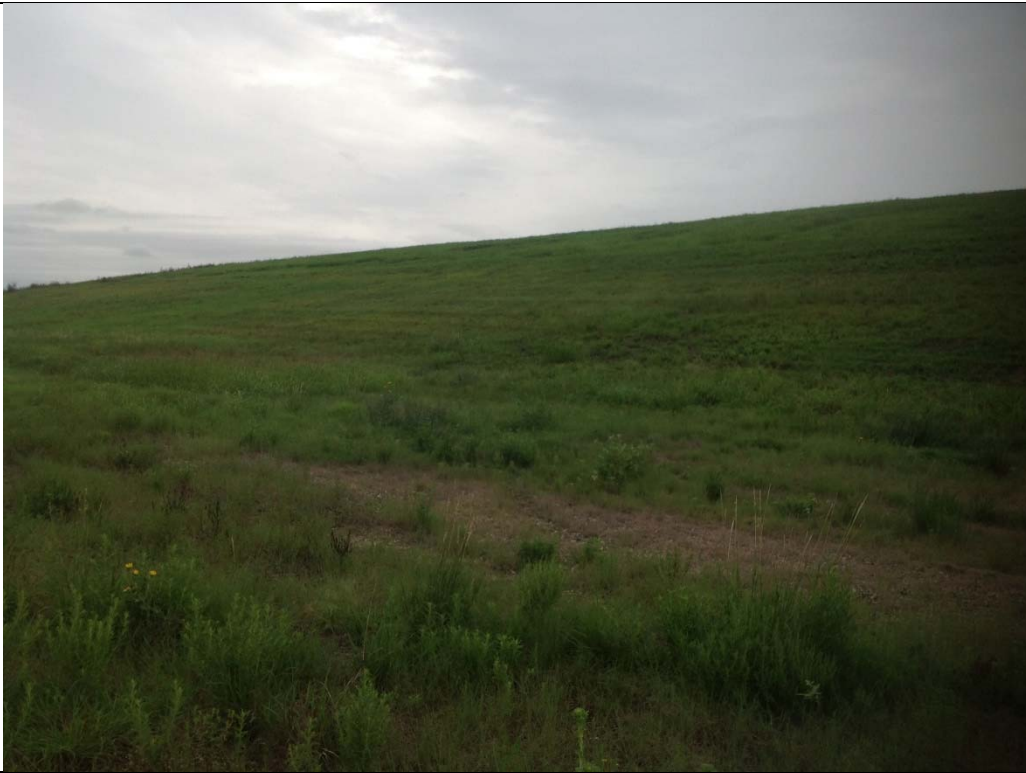
Photograph P-9 Taken September 10, 2018 by Jason Leik, P.E. (during Location Certification)
Unit 004 Landfill – Looking east from northwest base of capped areas 1.

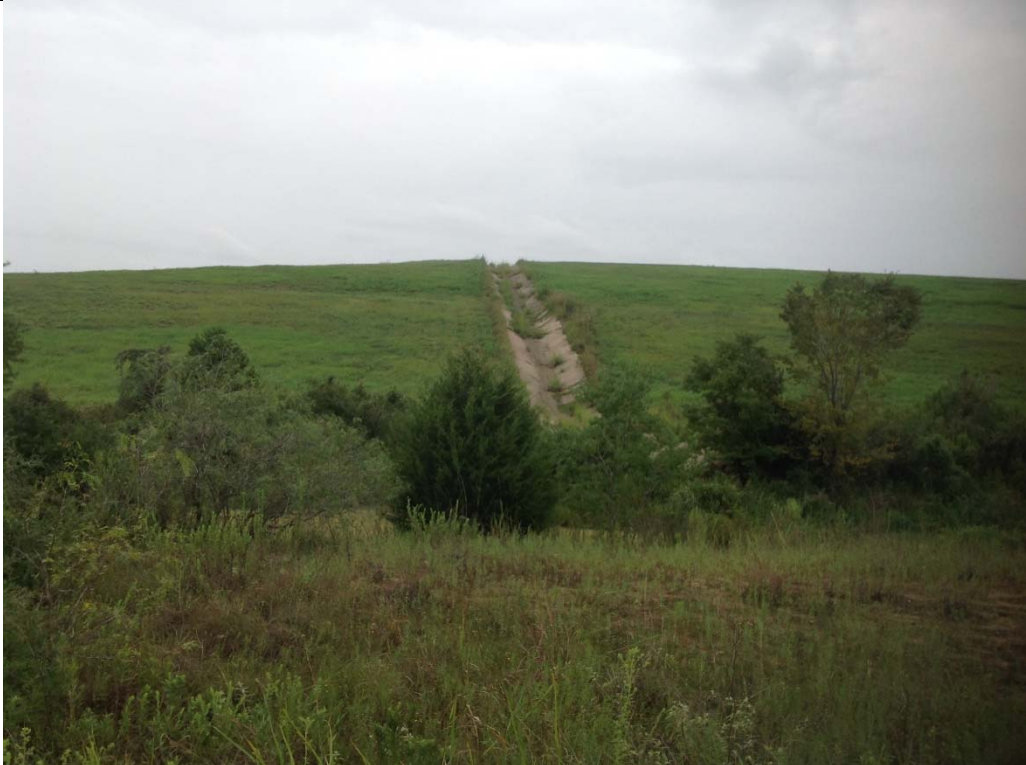
Photograph P-10 Taken September 10, 2018 by Jason Leik, P.E. (during Location Certification)
Unit 004 Landfill – Looking southeast east from west of area 1. Lined carry down trench visible.

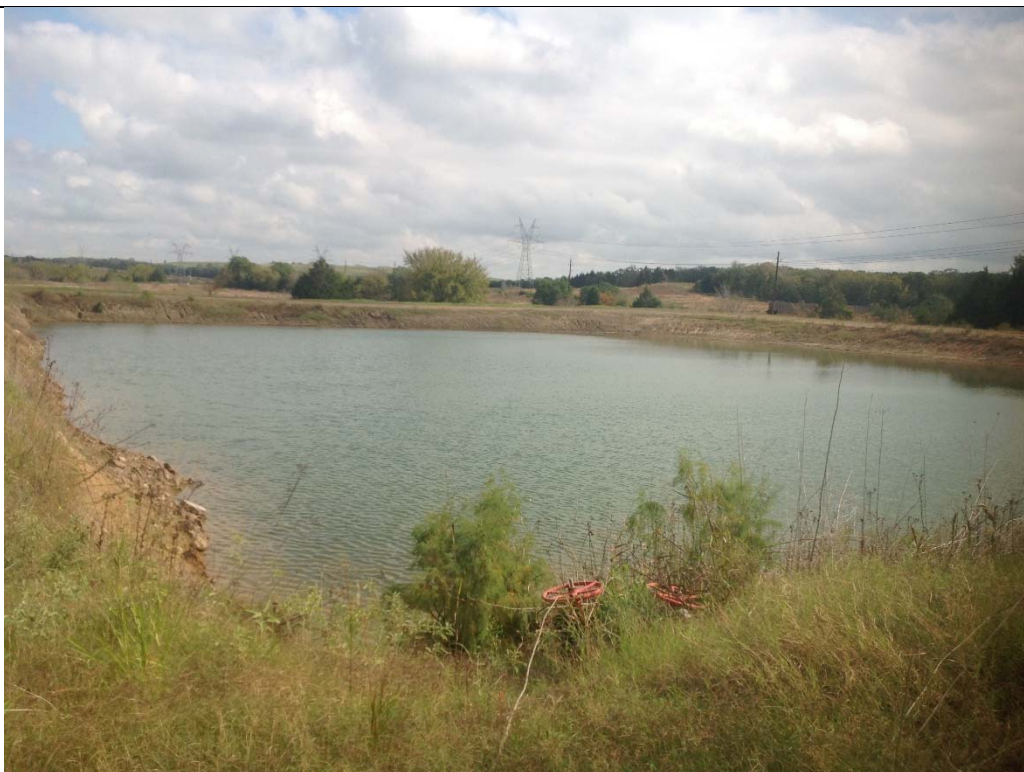
At the time of the TRC inspection, The Secondary E Pond was partially filled with water, with piles of stabilized CCR material extending above the dike crest in the northern half of the impoundment. The exposed CCR material, including excavated material that projects to approximately the same height as the berm crest (Photographs P-13 and P-14) appears to be well stabilized rigid material.

Photograph P-11 Taken November 6, 2018 by Jason Leik, P.E.
Unit 003 Secondary E Pond – Looking southeast towards center of southern half of E Pond.

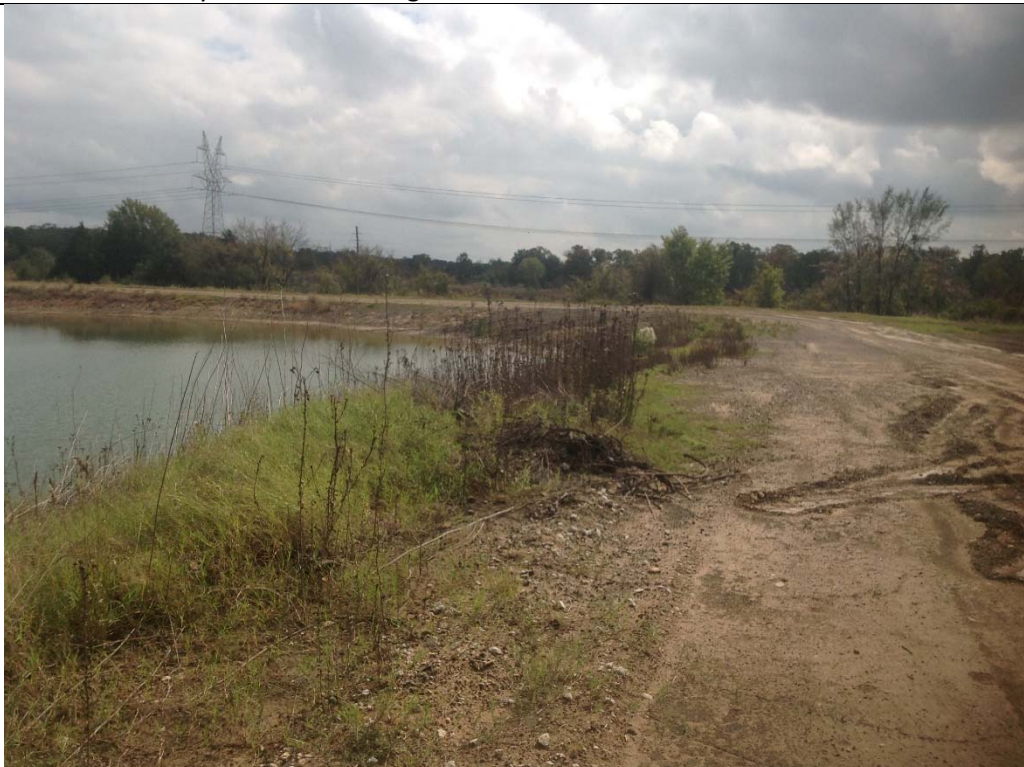
Photograph P-12 Taken November 6, 2018 by Jason Leik, P.E.
Unit 003 Secondary E Pond – Looking south along top of and interior of west berm

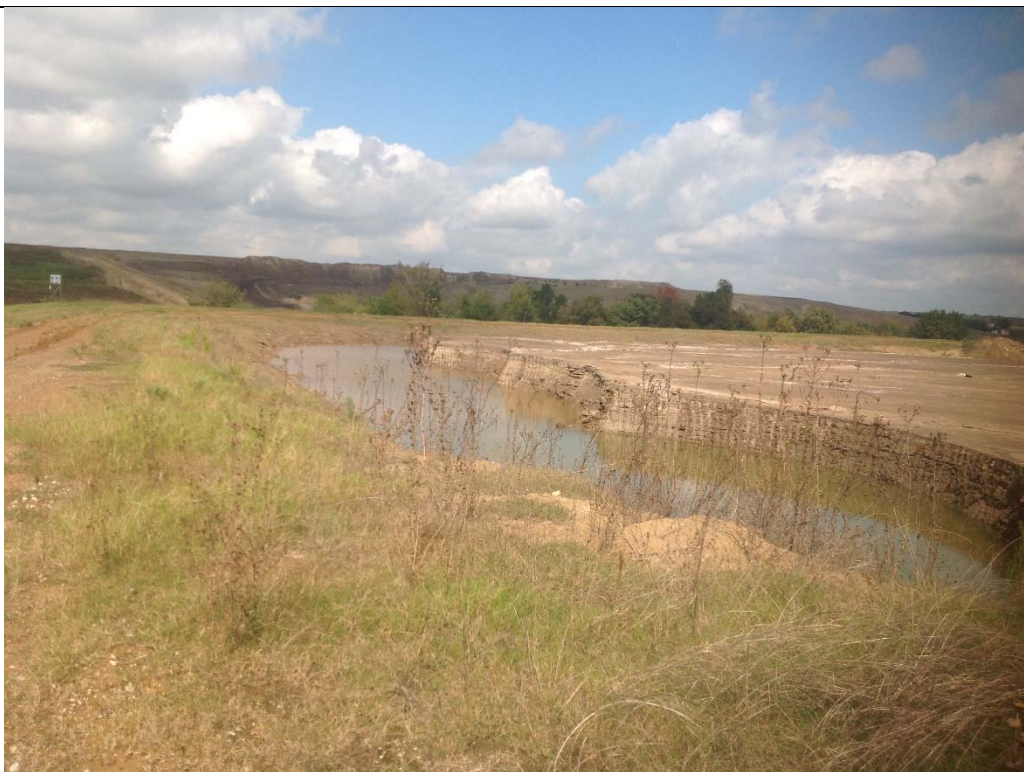
Photograph P-13 Taken November 6, 2018 by Jason Leik, P.E.
Unit 003 Secondary E Pond – Looking north along top of and interior of west berm

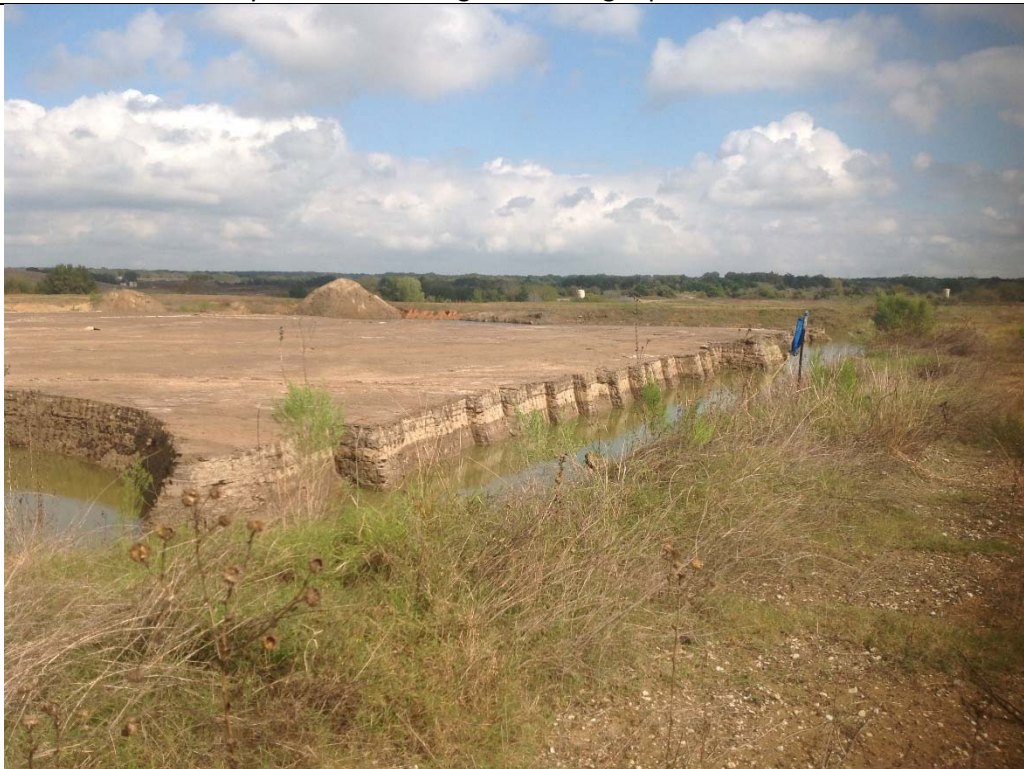
Drainage structures constructed to transfer storm water from the top of the capped areas down to the perimeter ditch consist of concrete lined rundown channels. One rundown channel is present in Area 1 and a second in Area 5. These channels do exhibit some cracks but are considered to be in good condition as shown in Photograph P-14.

Photograph P-14 Taken November 6, 2018 by Jason Leik, P.E.
Unit 003 Secondary E Pond – Looking northeast towards center of north half of pond
