2019 Annual Inspection of CCR Units

**Limestone Electric Generating Station
Jewett, Texas**

January 2020

NRG Texas Power LLC

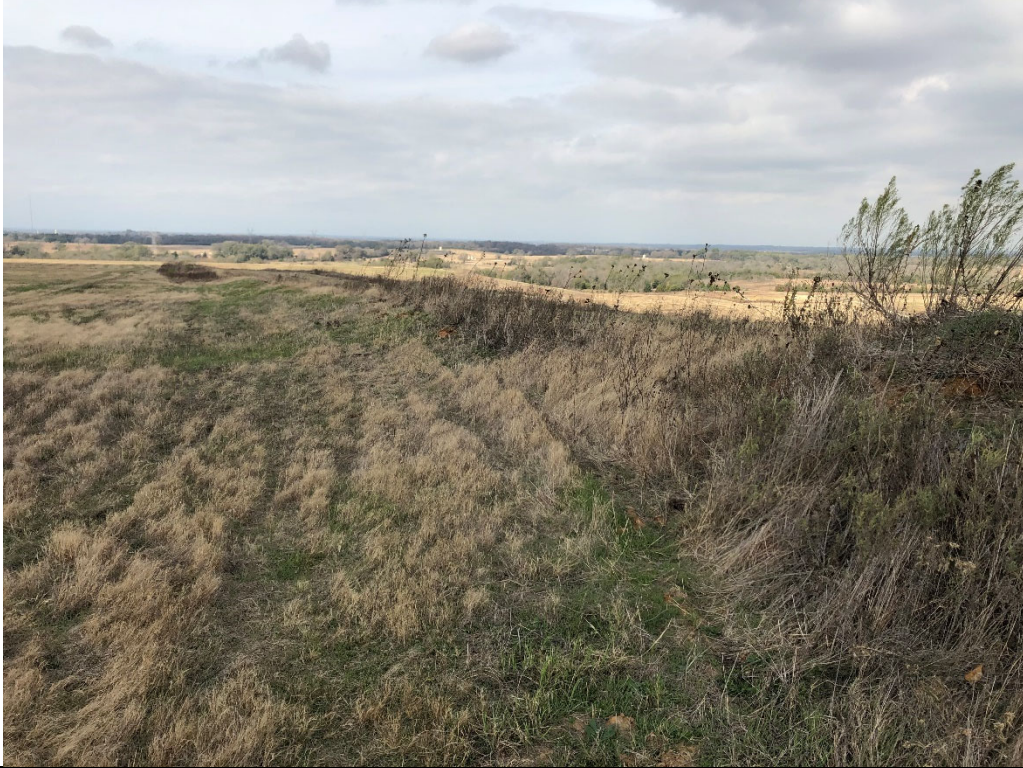
Photograph P-1: View looking north of berm on top of landfill. This berm separates runoff from the capped and closed portion of the landfill from the uncapped portion. This berm is located in Area 3.

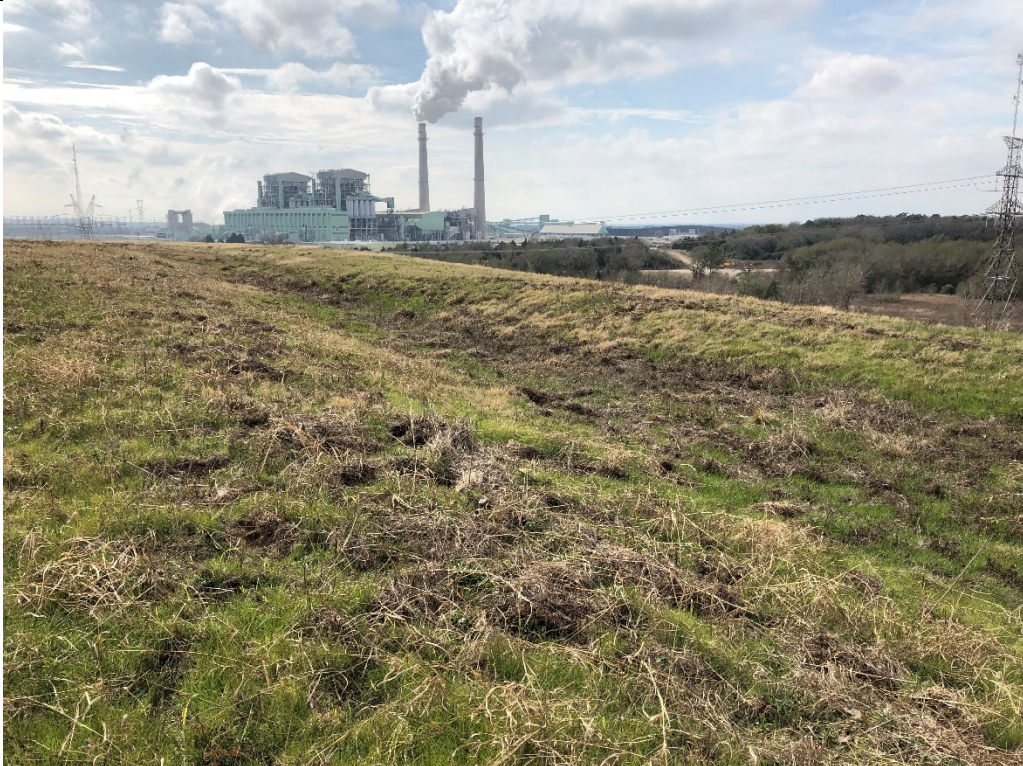
Photograph P-2: View looking south from top of Area 2. There is a drainage ditch that captures runoff from the top of the landfill and diverts it to one of two concrete drainage features.

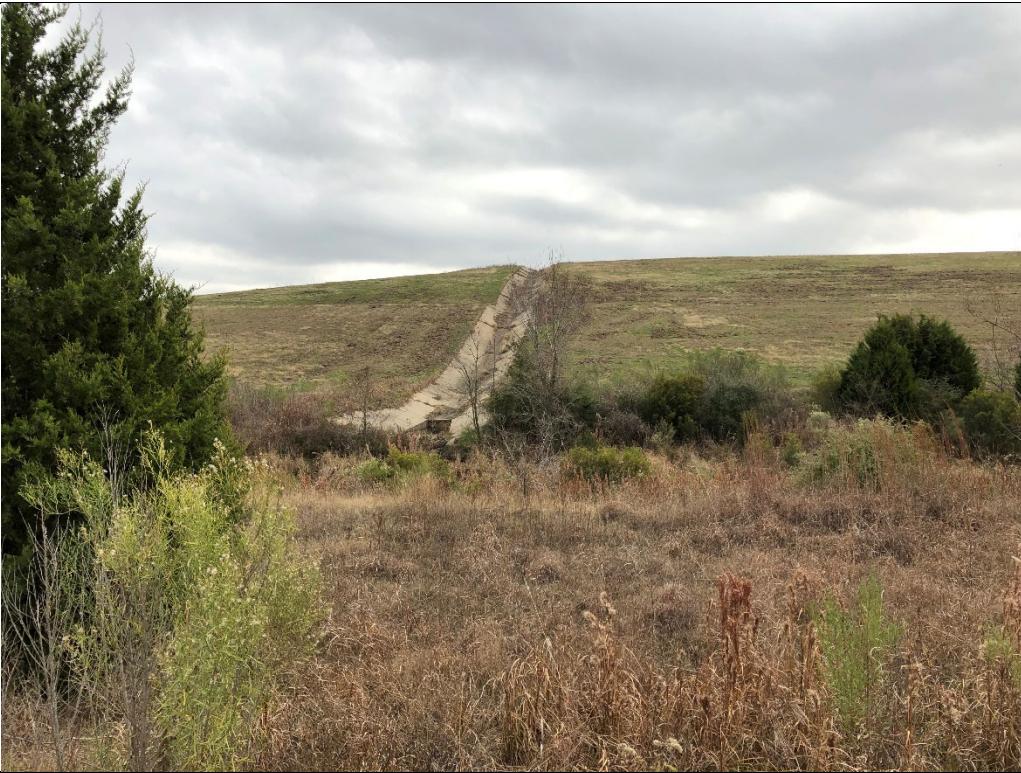
Drainage structures constructed to transfer stormwater from the top of the capped areas down to the perimeter ditch consist of concrete lined rundown channels. One rundown channel is present in Area 1 and a second in Area 5. These channels do exhibit some cracks but are considered to be in good condition as shown in Photograph P-3.

The side slopes of the capped landfill areas are well vegetated and have appropriate perimeter ditches as depicted in Photographs P-3, P-4, and P-5.

Photograph P-3: View looking southeast at Area 1 of the Unit 004 Landfill. The landfill slopes were well vegetated. The concrete drainage structure conveys runoff from the top of the Unit. It empties into an unseen drainage ditch separated from the viewer by a berm.

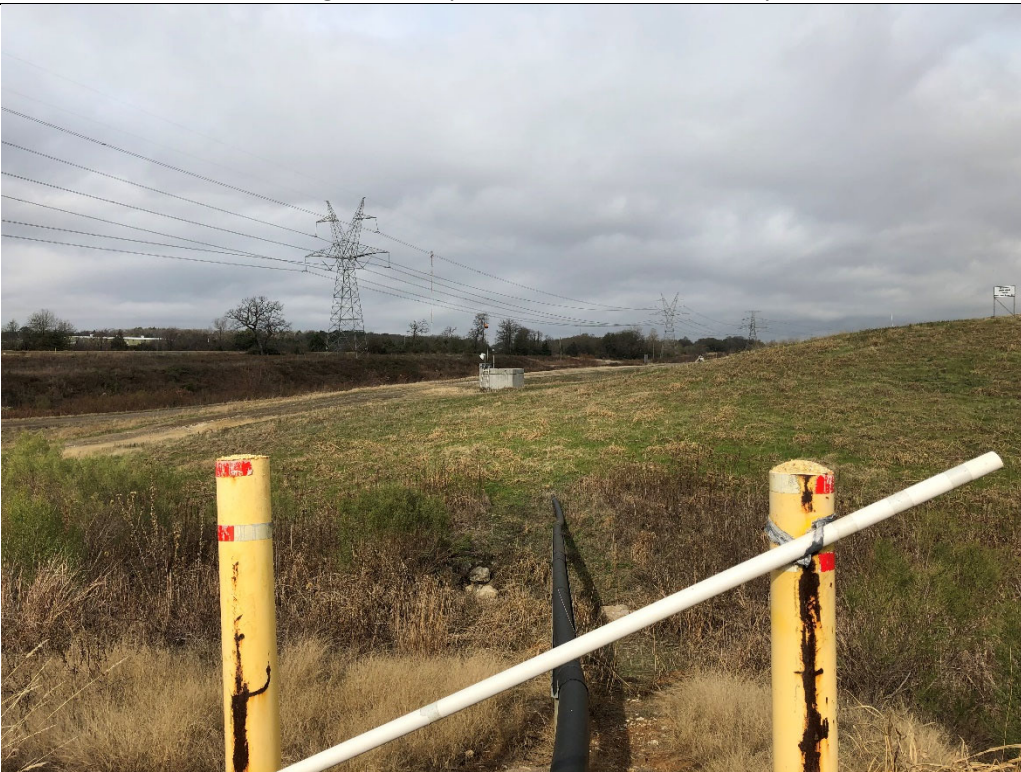
Historical reports indicate that some water seepage was observed at the landfill toe near the southern corner of Area 9. A series of French drains were installed with drainage into a sump (Photograph P-4) as indicated in previous reports. The sump discharges to Pond 002 (Photograph P-5). TRC did not observe any evidence of ongoing seepage.

Photograph P-4: View looking north-northwest of sump on southwest corner of Unit 004 Landfill. A French drain system empties into the concrete sump, which is then pumped through the black pipe (bottom center) into Pond 002.

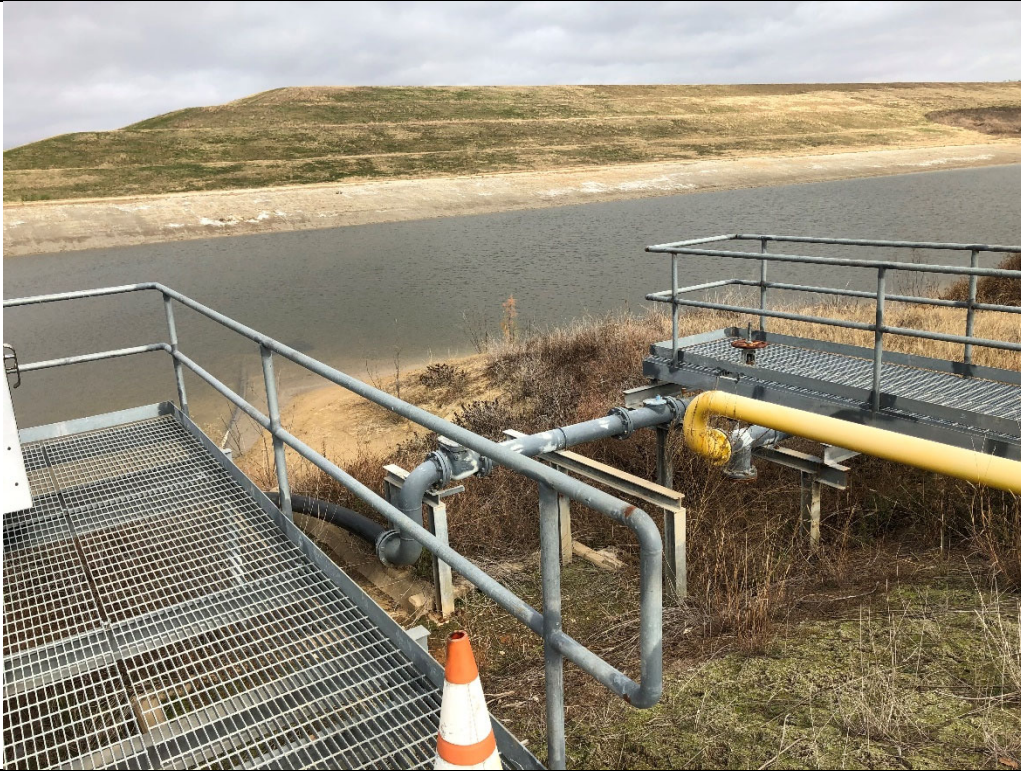
Photograph P-5: View looking north from equipment skid across Pond 002 at sidewall of the Unit 004 Landfill. The sidewalls of Areas 9 and 10 are visible in this photograph.

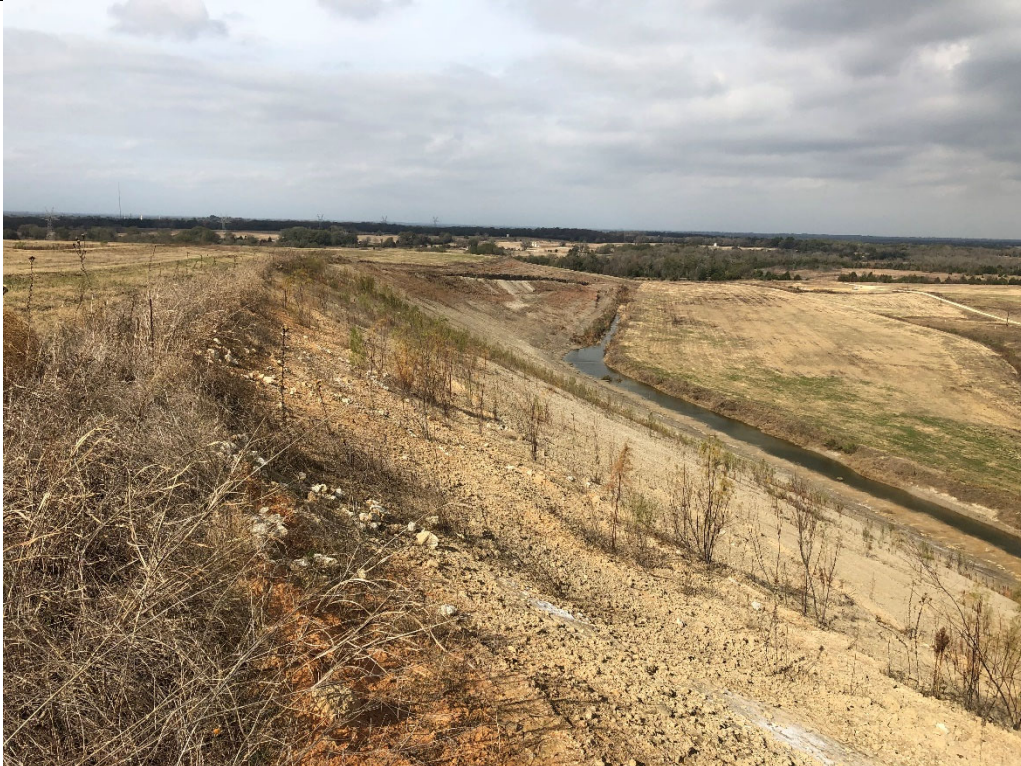
As mentioned above, Areas 4, 7, and 8 have been partially closed (Photograph P-6), but are considered “uncapped” because significant portions of these areas have uncapped CCR slopes or surfaces. These slopes appear to be stable due to the cohesive nature of the waste material (Photographs P-6 through P-9). In particular, a large portion of Area 8 has been closed, and a drainage feature separates stormwater runoff from the capped portion of this area from the uncapped portion. This feature bridges the interceptor ditch used to capture CCR contact water (Photograph P-10).

Areas 12B, 12C, and 13 through 20 are future expansion areas. A clay liner and a cover layer of top soil has been constructed in these areas. As shown in Photographs P-6 and P-9 the cover layer has been well vegetated with grass.

Photograph P-6: View looking northwest of sidewall of Area 4. The top of this area (far left of photograph) is capped. The sidewall of Area 4 (center of photograph) is not capped. The exposed waste is rigid CCR waste. The contact water interceptor ditch is visible on the right side of the photograph. Area 17 is visible to the right of the interceptor ditch.

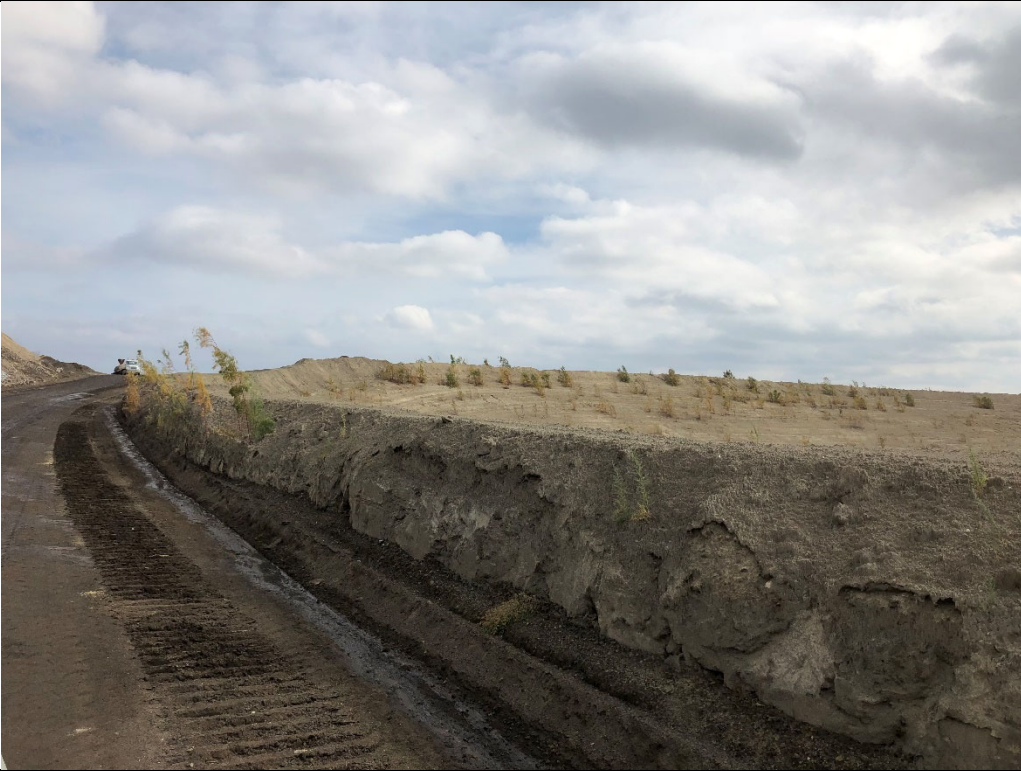
Photograph P-7: View looking east at uncapped CCR waste material and a CCR material berm/sidewall in Area 7. One of the landfill haul roads (improved with bottom ash) with no significant rutting is visible to the left. As evidenced by the sheer sidewall visible here, the CCR waste is a rigid material.

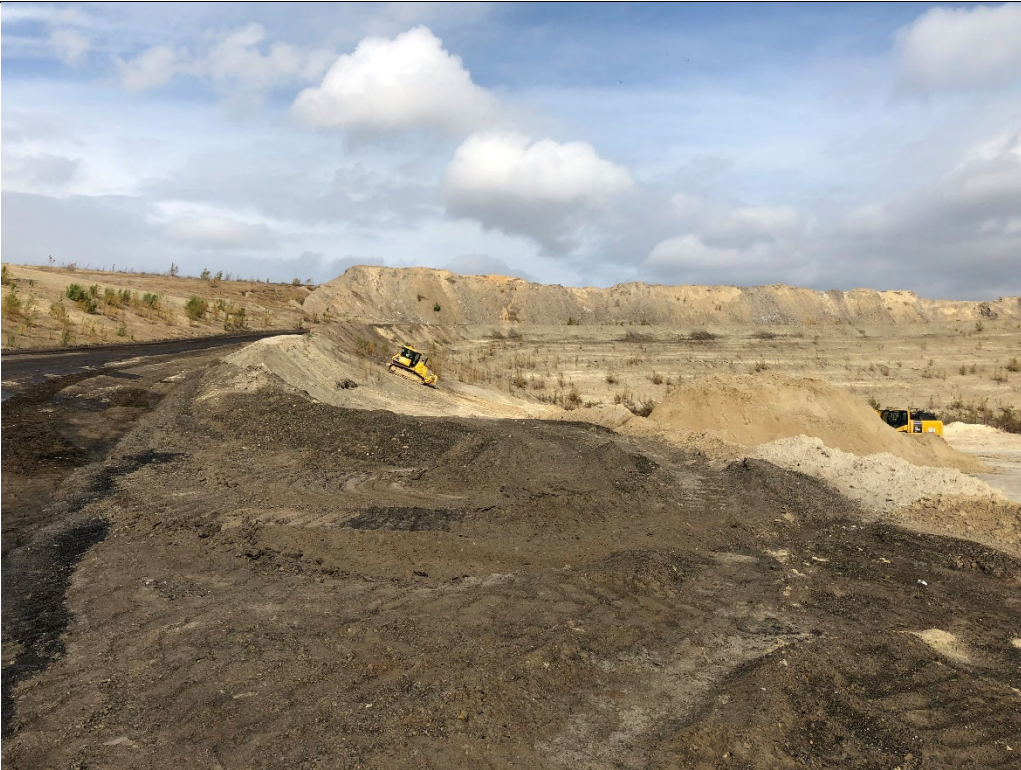
Area 11 is an actively managed area where marketable CCR materials are stockpiled prior to their sale and off-site transportation. Photograph P-8 depicts the conditions present in this area during TRC’s site visit. Area 12A (Photograph P-9) is an active portion of the landfill where CCR materials and Class 2 wastes are currently being interred.

Photograph P-8: View looking north of CCR material. Uncapped CCR slopes in Areas 6 and 10 and the haul road are visible to the left, the marketable CCR material stackout area in Area 11 is visible in the right foreground, and bermed CCR material in Areas 7 and 8 is visible in the center and right background.

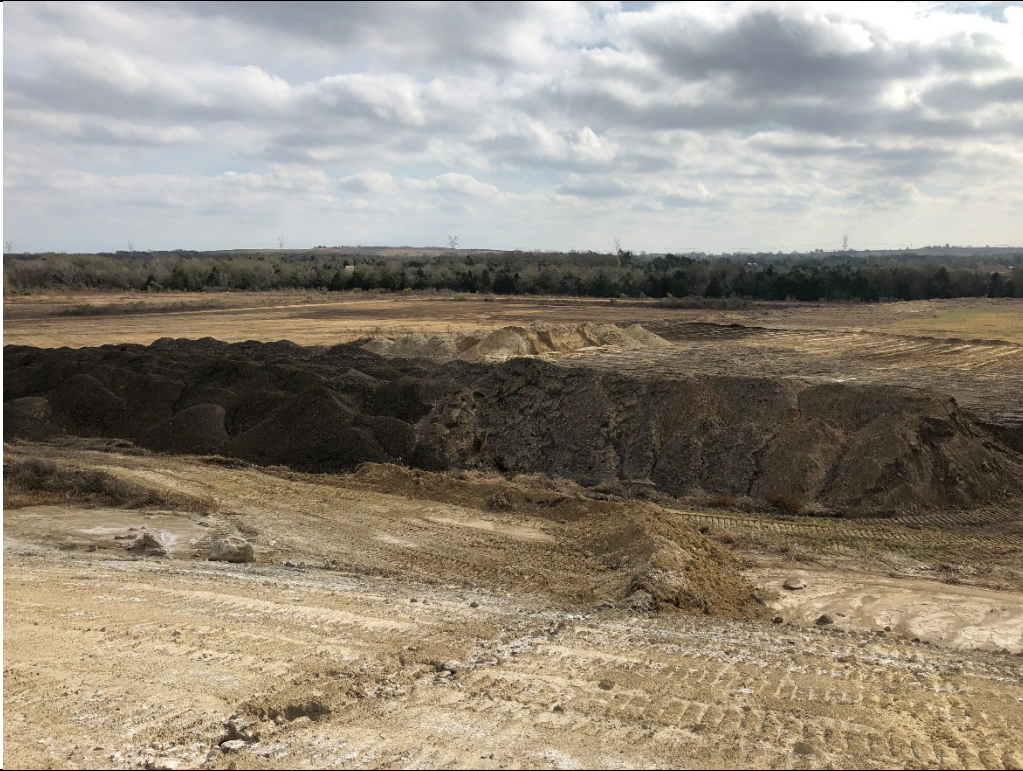
Photograph P-9: View looking southeast from Area 8 of active waste disposal in Area 12A. Area 12B is visible in the left background of this photograph. The stabilized slope of CCR material from Area 8 towards Area 12A is also visible (bottom of photograph).

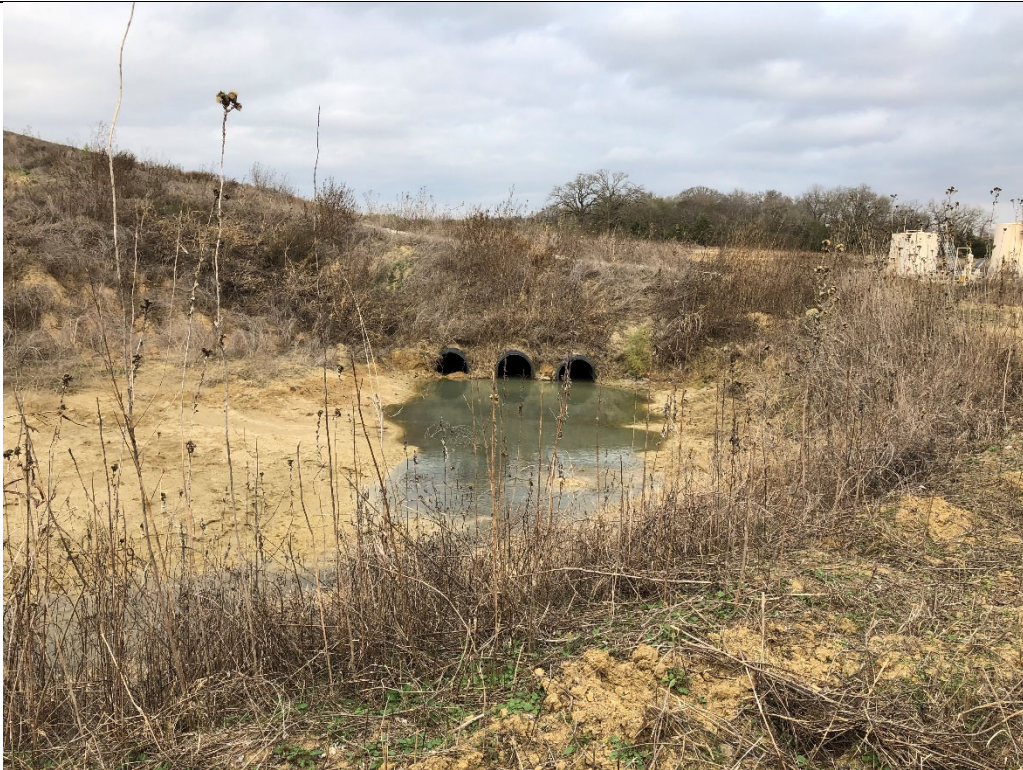
Contact water from all of the uncapped CCR slopes and disposal areas drains down into the interceptor ditch as shown in Photographs P-10 and P-11. The interceptor ditch is located adjacent to the outer perimeter of these areas and directs the stormwater runoff and any eroded CCR material to Pond 002.

Photograph P-10: View looking east-northeast of CCR contact water interceptor ditch. The interceptor ditch is bridged in this location by a second drainage feature that conveys stormwater from the capped portion of Area 8 to the non-contact water drainage ditch.

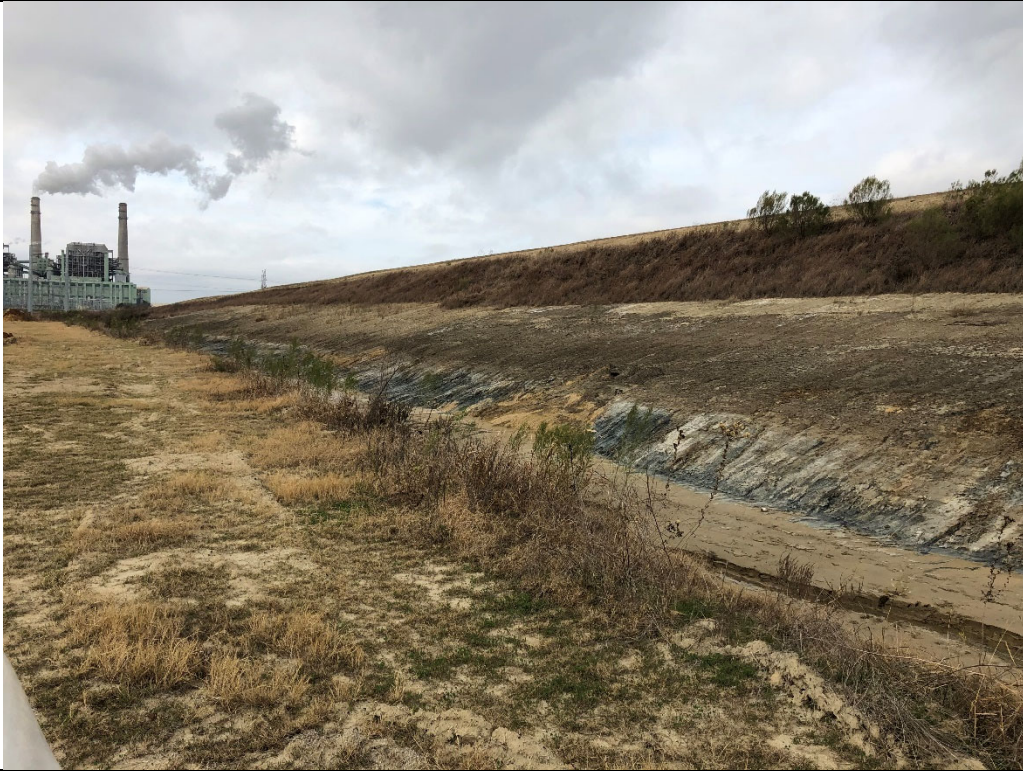
Photograph P-11: View looking west of CCR contact water interceptor ditch. The sidewall of Area 10 is visible on the right side of this photograph. The sidewall is either well vegetated or stabilized to prevent erosion.

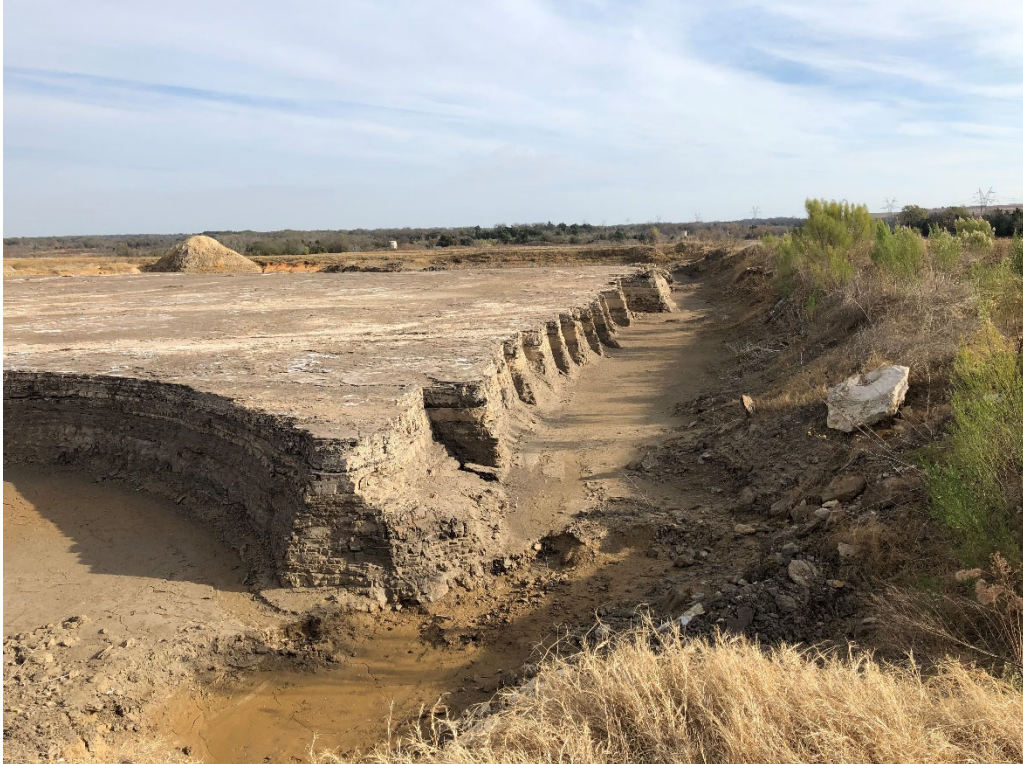
Photograph P-12: View looking east-northeast of the northern half of the Unit 003 Secondary E Pond. The central, separating berm is visible on the right and the rigid stabilized waste material is visible on the left. The waste has been partially excavated from the perimeter of this portion of the pond. The stockpile (left background) is CCR waste material stockpiled inside of the pond.

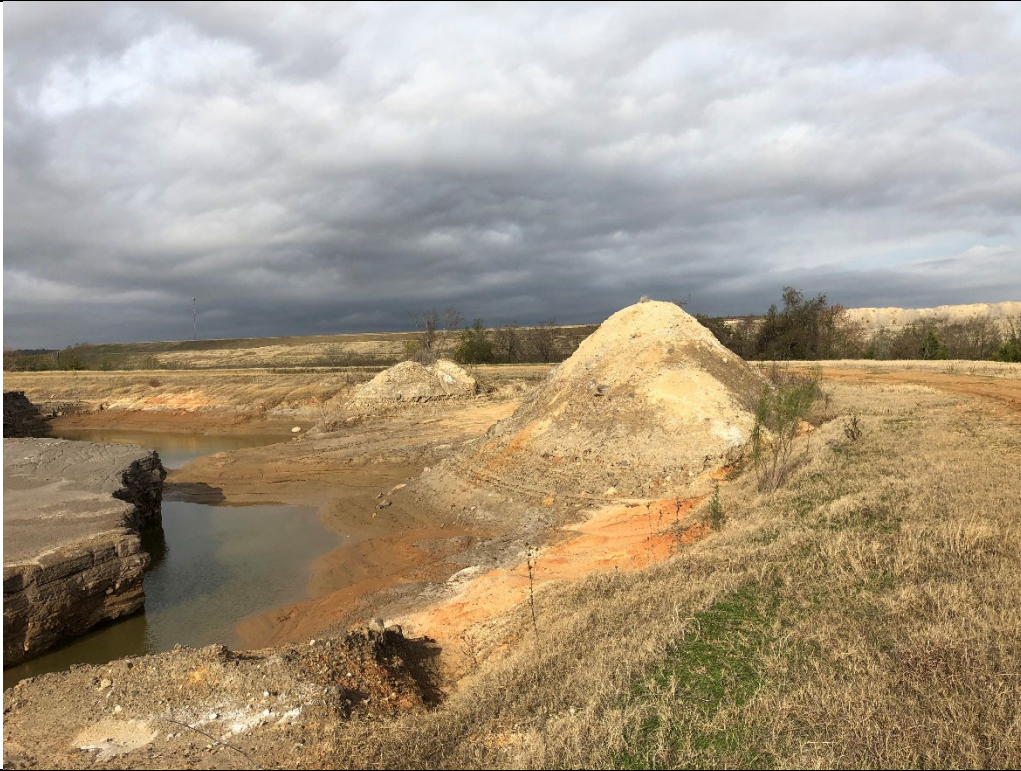
Some of the excavated waste from the perimeter of the north half was stockpiled inside the pond (Photograph P-13). The height of this stockpiled material extended above the dike crest in the northern half of the impoundment. Due to the nature of this material TRC does not consider this stockpile to be an operational or safety issue for the facility. There was also a small amount of water (approximately one foot) in the excavated portions of the northern half of the pond.

Photograph P-13: View looking northwest of the CCR waste stockpiled in the Unit 003 Secondary E Pond. The sidewall of the Unit 004 Landfill is visible in the background of this photograph.

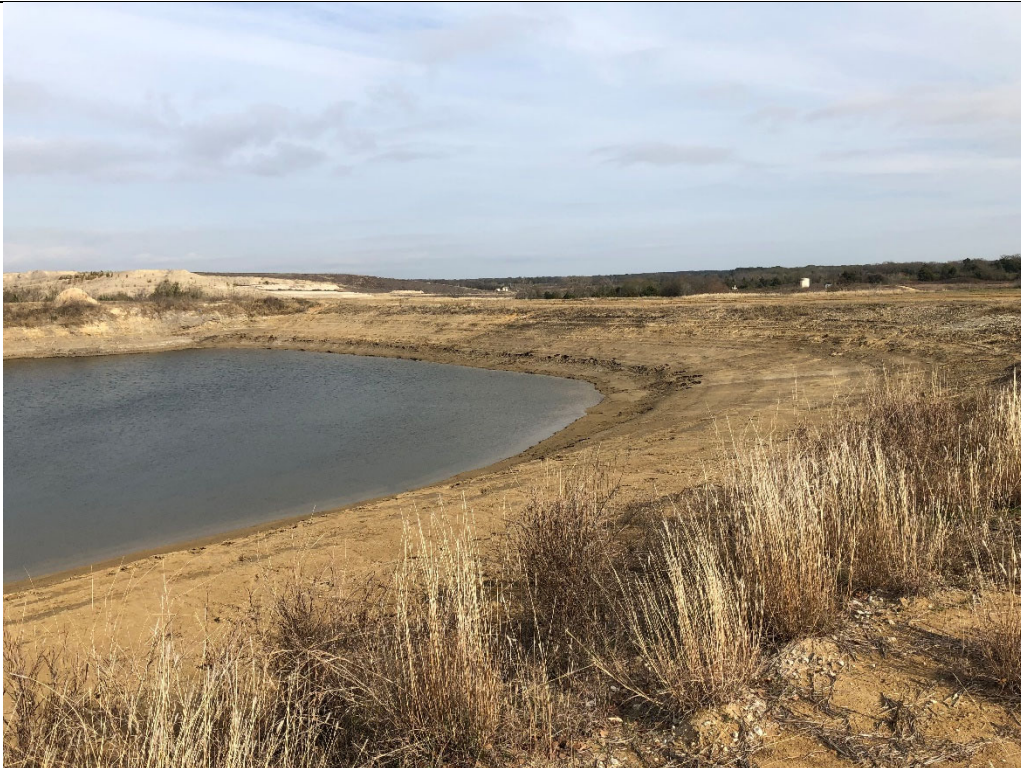
The southern section appeared to contain a low level (1 to 2 feet) of stormwater (Photograph P-14). No CCR waste material was observed in the southern half of the impoundment.

Photograph P-14: View looking northeast of the water in the southern half of the Unit 003 Secondary E Pond. The interior berm sidewalls were in good condition, the exterior berm sidewalls were vegetated with grass.
