2020 Annual Inspection of CCR Unit

**Limestone Electric Generating Station
Jewett, Texas**

January 2021

NRG Texas Power LLC

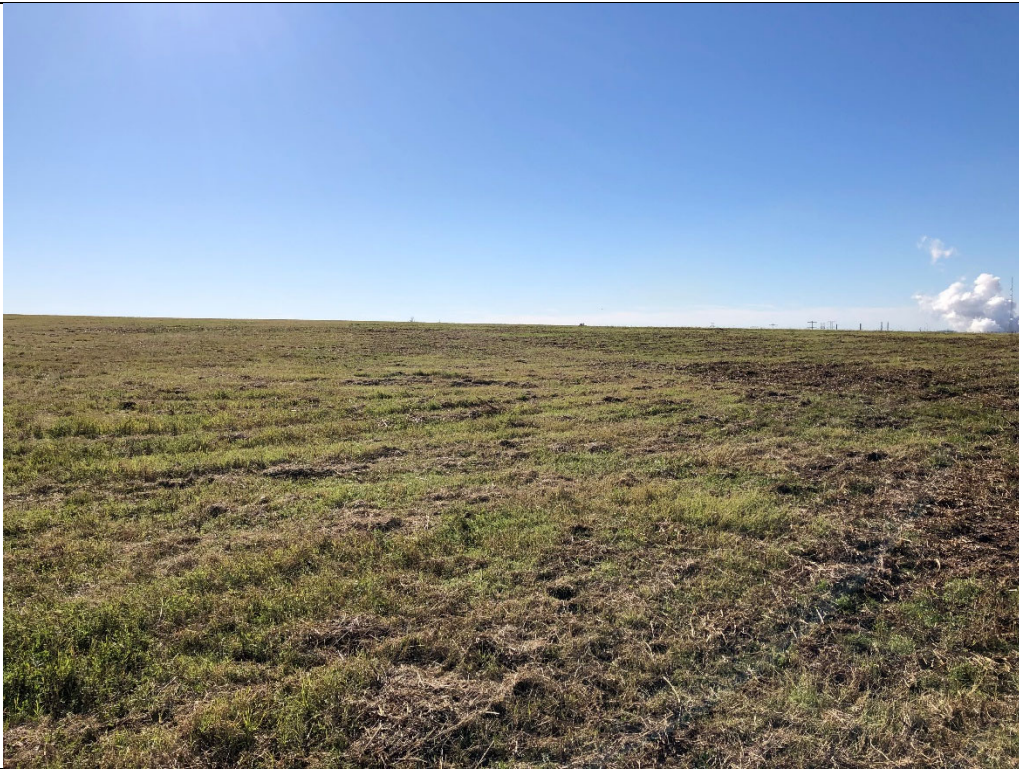
Although landfill Areas 1, 2, 3, 5, 6, 9, and 10 are considered to be capped, exposed slopes of CCR are present in Areas 1, 3, 6, and 10, where uncapped and future expansion areas will abut the existing CCR material (Figure 2). The plateaued portion of the capped areas is well vegetated and generally well graded to prevent the localized ponding of stormwater and to direct the flow of stormwater as depicted in Photographs P-1, P-2, and P-3. Photograph P-1 also shows the grassed berms used to separate stormwater between the capped and uncapped areas.

Photograph P-1: View looking west across the capped surfaces of Area 2. The landfill cap appeared to be well vegetated and appropriately sloped.

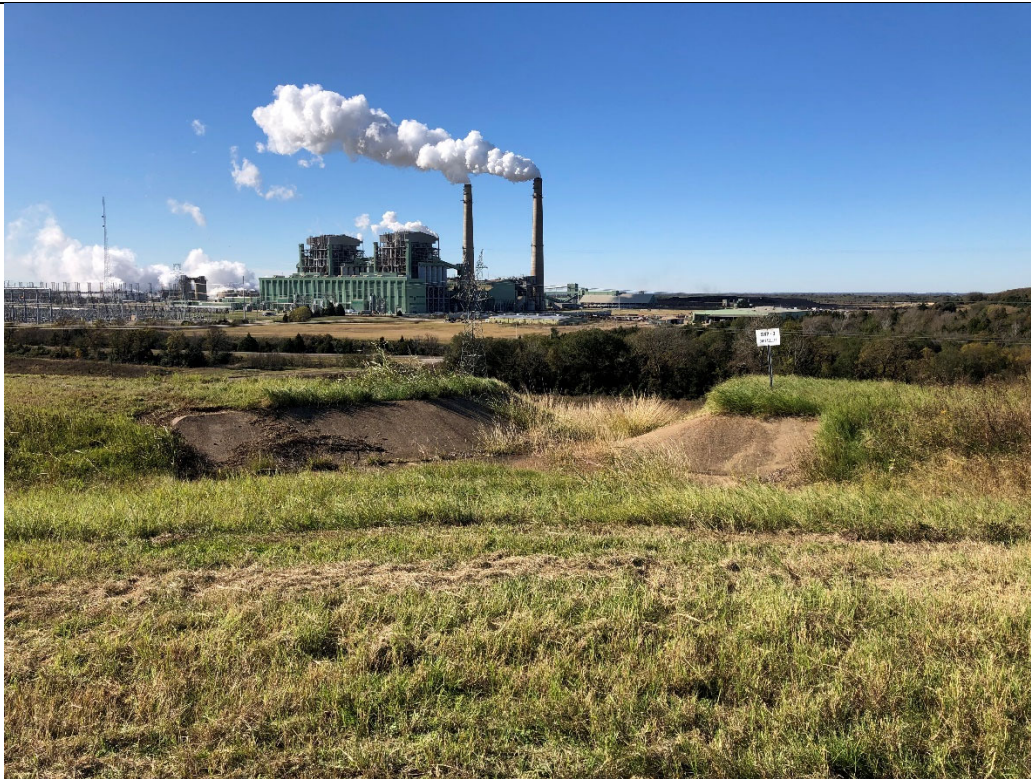
Photograph P-2: View looking west-southwest of Limestone Electric Generating Station from top of Area 5. A concrete drainage structure that conveys drainage from the top of the capped portion of the landfill to the non-contact water perimeter ditch.

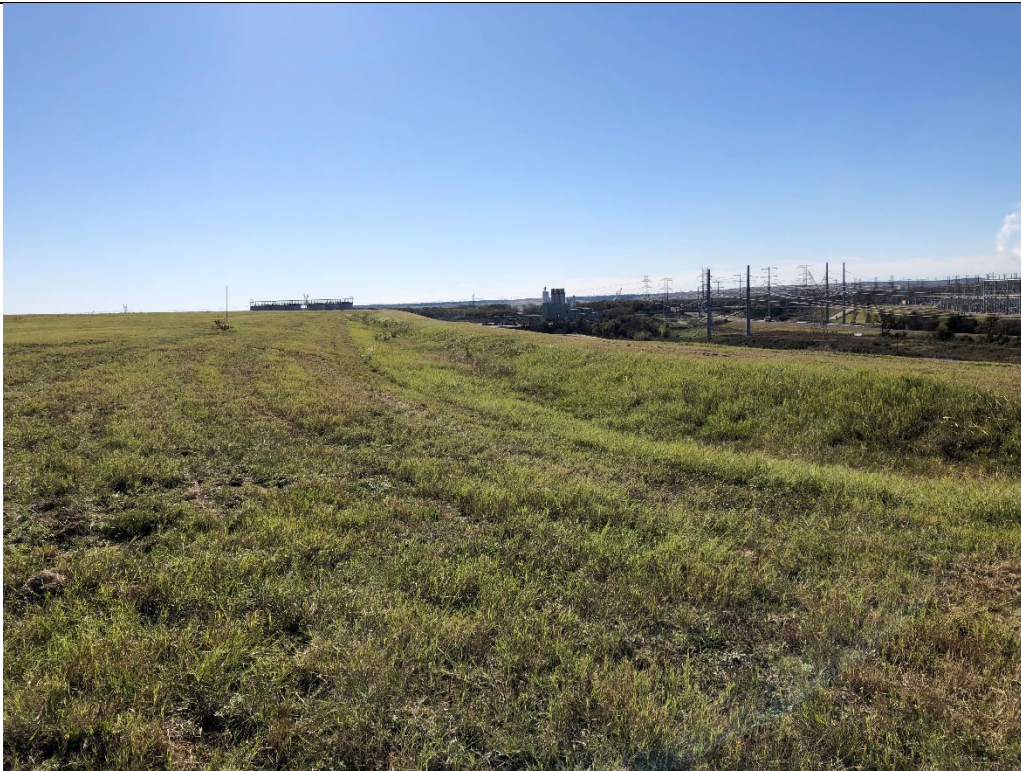
Photograph P-3: View looking south of a stormwater ditch directing drainage from the top of the landfill in Area 5 to the concrete drainage structure shown in Photograph P-3.

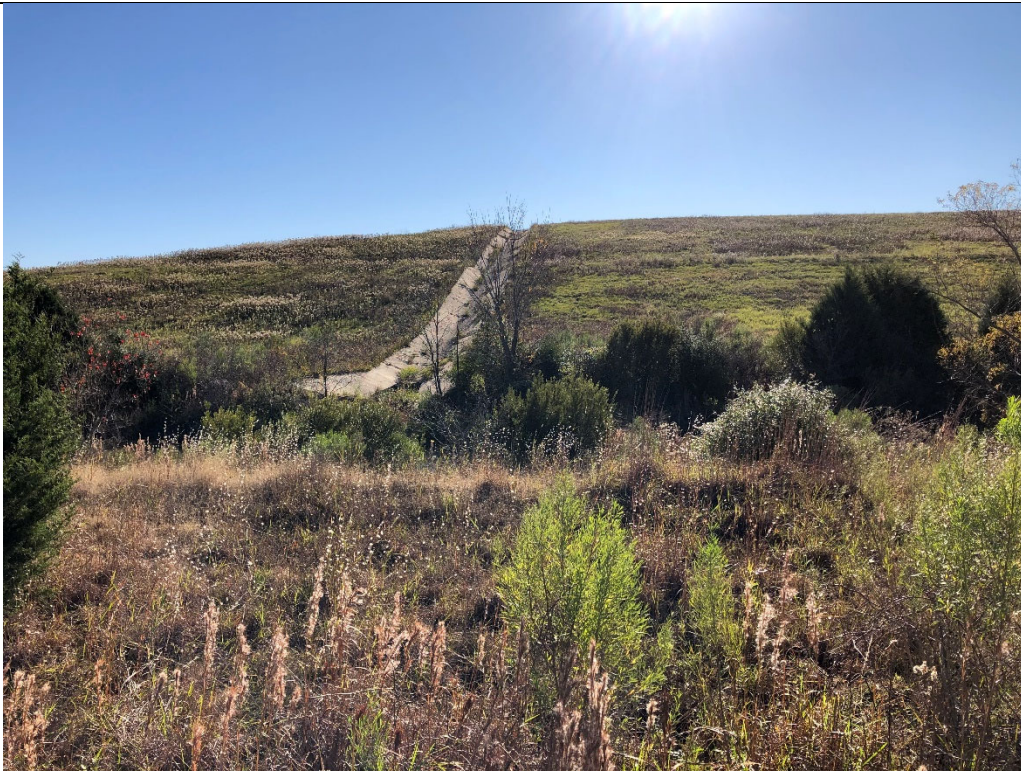
Drainage structures constructed to transfer stormwater from the top of the capped areas to the perimeter ditch consist of concrete lined rundown channels. One rundown channel is present in Area 1 and a second is present in Area 5. Some cracking was observed in these rundown channels, but they are considered to be in good condition as shown in Photograph P-4.

The side slopes of the capped landfill areas are well vegetated and have appropriate perimeter ditches as depicted in Photographs P-4, P-5, and P-12. As mentioned above, the east sidewalls of Areas 1 and 3, the southeast corner of Area 6, and the east sidewall of Area 10 are not vegetated. These areas abut active or future expansion areas of the landfill. The exposed CCR material sidewalls of these areas are shown in Photographs P-6, P-7, and P-8. Stormwater that comes into contact with the exposed CCR material is captured in the contact water perimeter ditch system and directed to Pond 002.

Photograph P-4: View looking southeast at Area 1 of the Unit 004 Landfill. The landfill slopes were well vegetated. The concrete drainage structure conveys runoff from the top of the Unit. It empties into an unseen drainage ditch separated from the viewer by a berm..

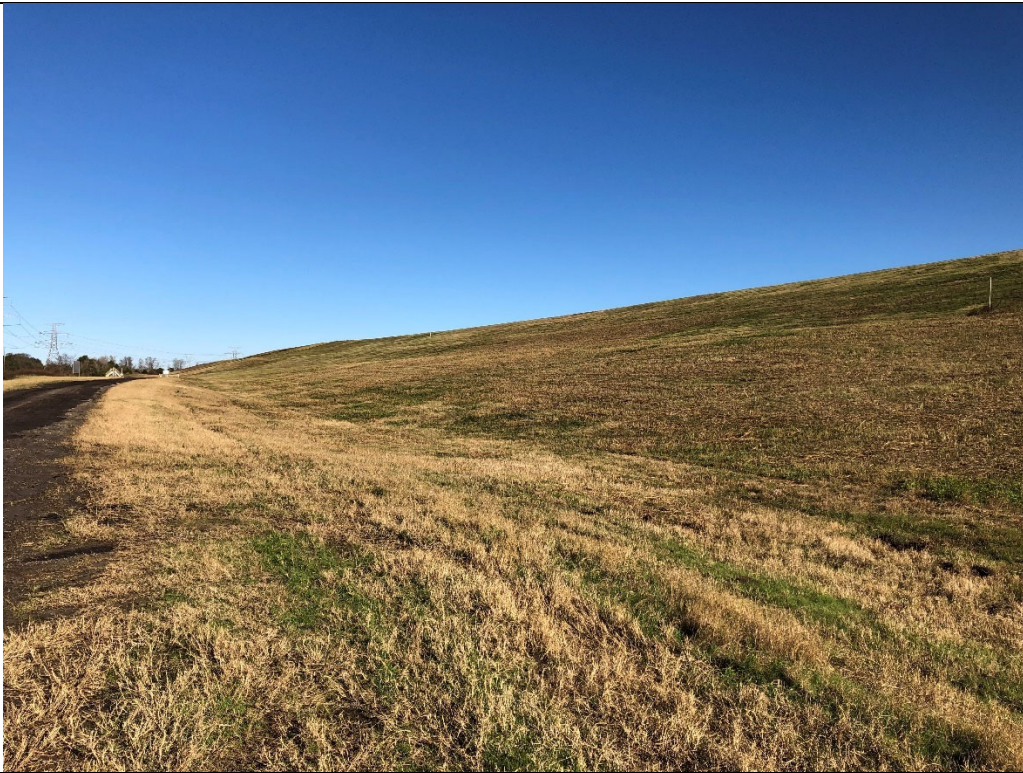
Photograph P-5: View looking northwest of capped southwest sidewall of Area 9. The sidewalls and capped surface of the landfill were well vegetated.

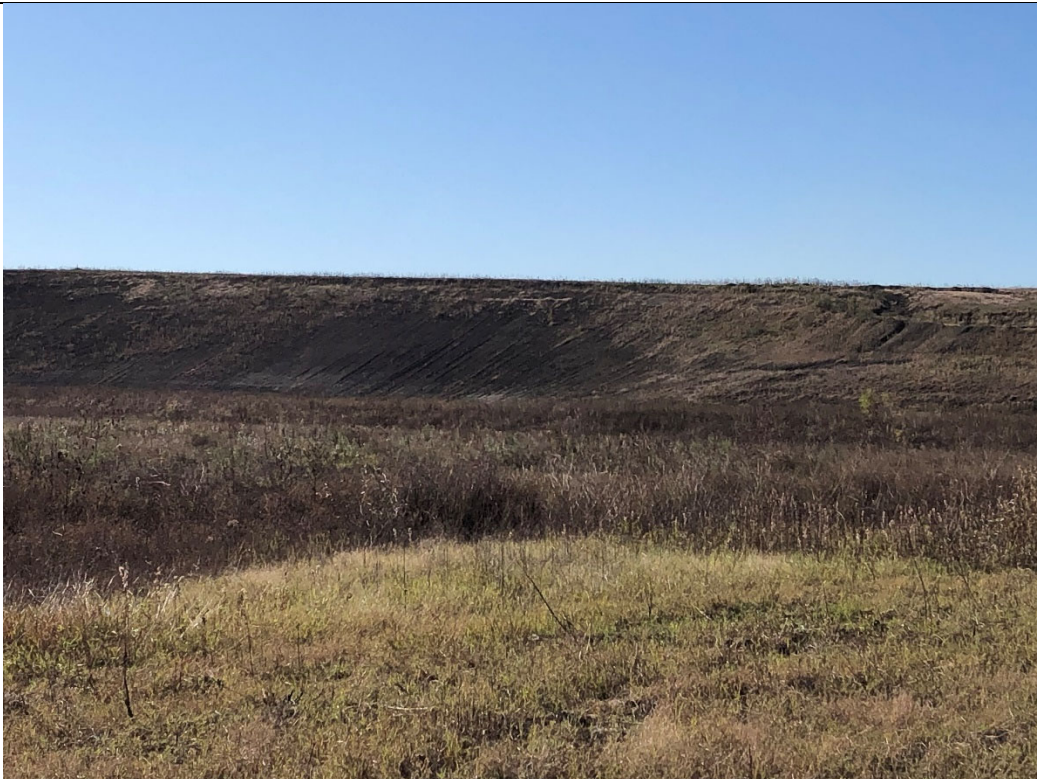
Given the dynamic nature of active landfill areas, the comments presented herein are based on the TRC observations made on November 30, 2020 and may or may not represent the conditions present at other times. The “work in progress” nature of active landfill areas result in exposed slopes of CCR that will either be capped, or where future expansion areas will be filled and the existing CCR slope will be abutted by material placed in the new area. These exposed CCR slopes are encompassed by the interceptor ditch that collects stormwater runoff from uncapped areas and collects any CCR that may erode or slough off the exposed CCR slopes. CCR slopes can be steep (Photographs P-6 through P-8), but the stabilized material hardens to form an erosion and slough resistant slope.

As discussed above, Areas 4, 7, and 8 have been partially closed (Photograph P-7), but are considered “uncapped” because significant portions of these areas have uncapped CCR slopes or surfaces. These slopes appear to be stable due to the cohesive nature of the CCR (Photographs P-6 through P-8). In particular, a large portion of Area 8 has been closed, and a drainage feature separates stormwater runoff from the capped portion of this area from the uncapped portion. This feature bridges the interceptor ditch used to capture CCR contact water.

Photograph P-6: View looking south across Area 13 of the uncapped northeast sidewall of Area 1.

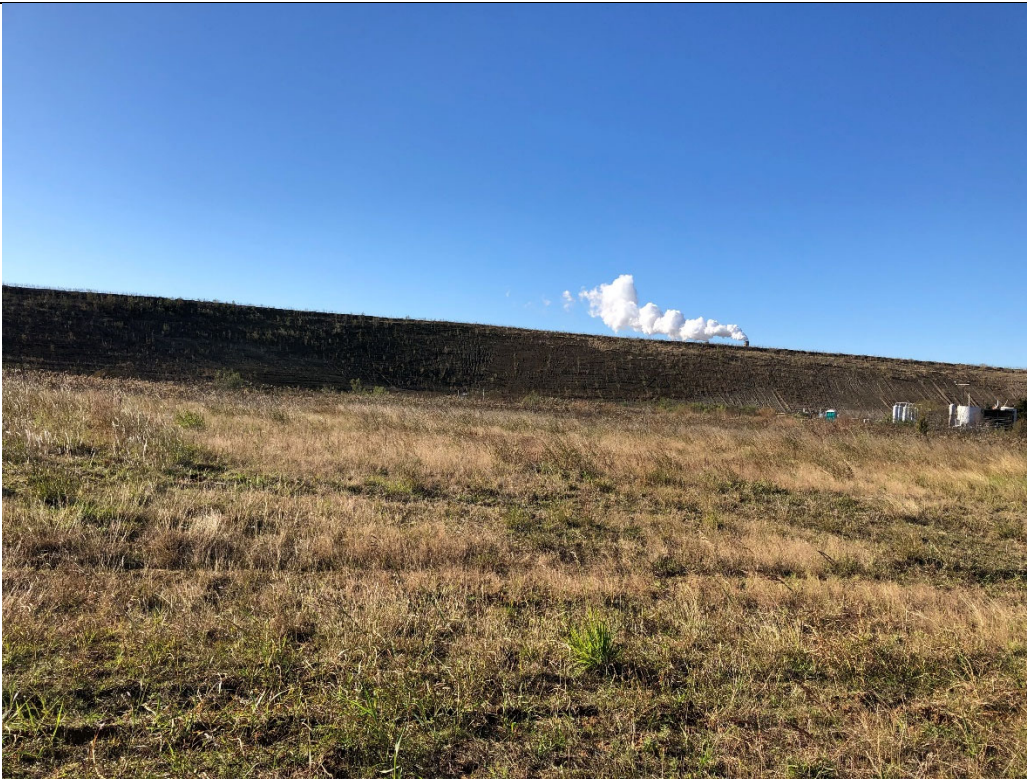
There are currently two haul roads used to transport CCR to the active portions of the landfill. The road passing through Areas 11, 7, 8, and 12A is shown in Photographs P-7 and P-8. The second haul road passes through Area 12A and 12B. Both roads have been improved with bottom ash and neither had significant rutting.

Photograph P-7: View looking southwest across Area 19 of the uncapped northern sidewall of Area 4.

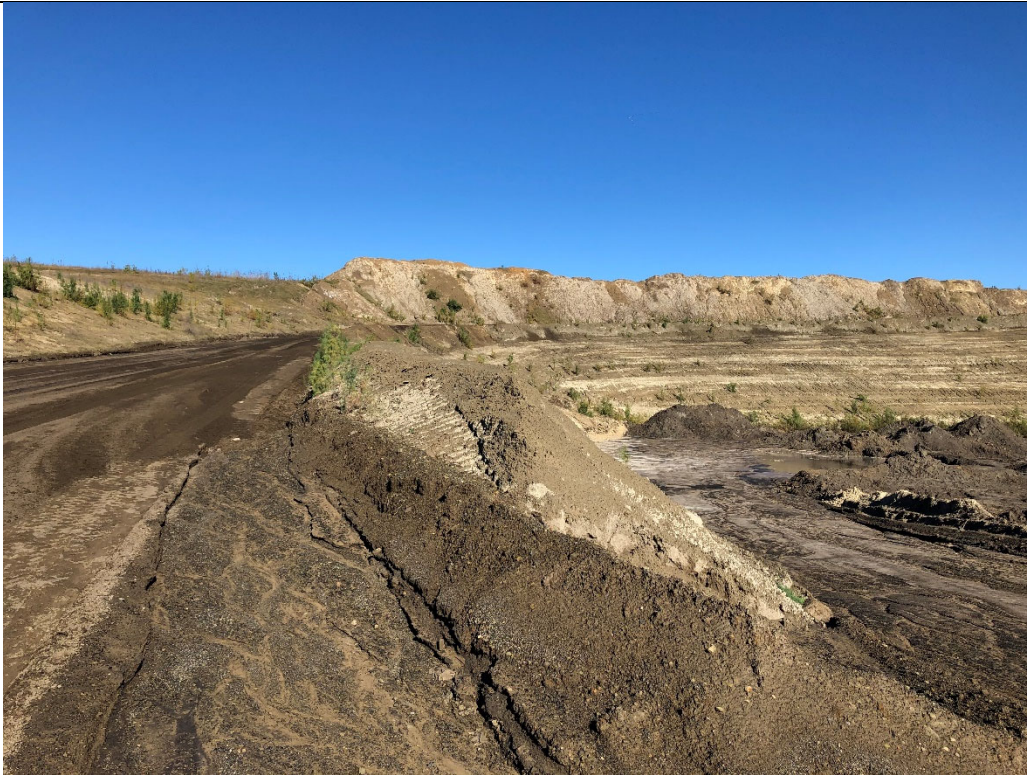
Area 11 is an actively managed area where marketable CCR is stockpiled prior to sale and off-site transportation. Photograph P-8 depicts the conditions present in this area during TRC’s inspection. Area 12A (Photographs P-9 through P-11) is an active portion of the landfill where CCR and Class 2 wastes are currently being placed. Area 12B, located immediately to the east of Area 12A, is also an active portion of the landfill where CCR is being placed (Photographs P-9 through P-12).

Photograph P-8: View looking north of CCR material. Uncapped CCR slopes in Areas 6 and 10 and the haul road are visible to the left, the marketable CCR material stackout area in Area 11 is visible in the right foreground, and bermed CCR material in Areas 7 and 8 is visible in the center and right background.

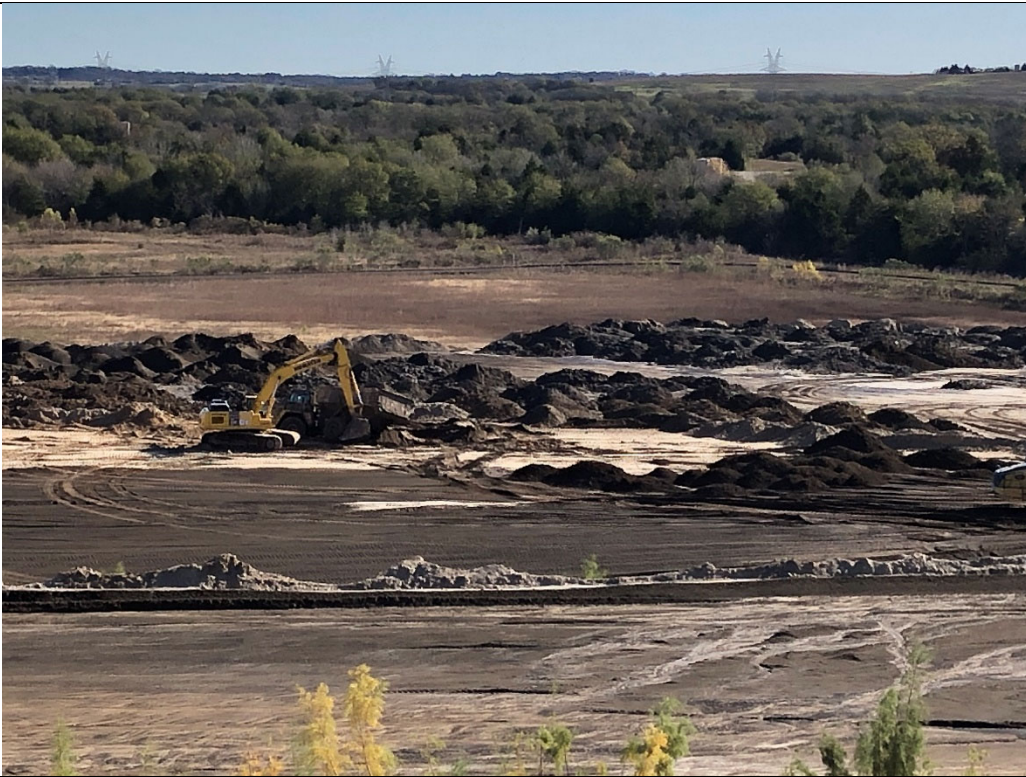
Areas 4, 7, 8, 11, 12A, and 12B are considered to be uncapped areas. Areas 4, 7, and 8 have been partially closed, but are considered to be “uncapped” because significant portions of these areas have uncapped CCR slopes or surfaces. Area 11 is an active area where marketable CCR is stockpiled prior to sale and off-site transportation. Finally, Areas 12A and 12B are an active portion of the landfill where CCR is currently being placed. These operations are shown in Photographs P-9, P-10, P-11, and P-12.

Photograph P-9: View looking east of active landfilling operations in Areas 12A (foreground) and 12B (center background). Area 12C is visible on the far side of area 12B.

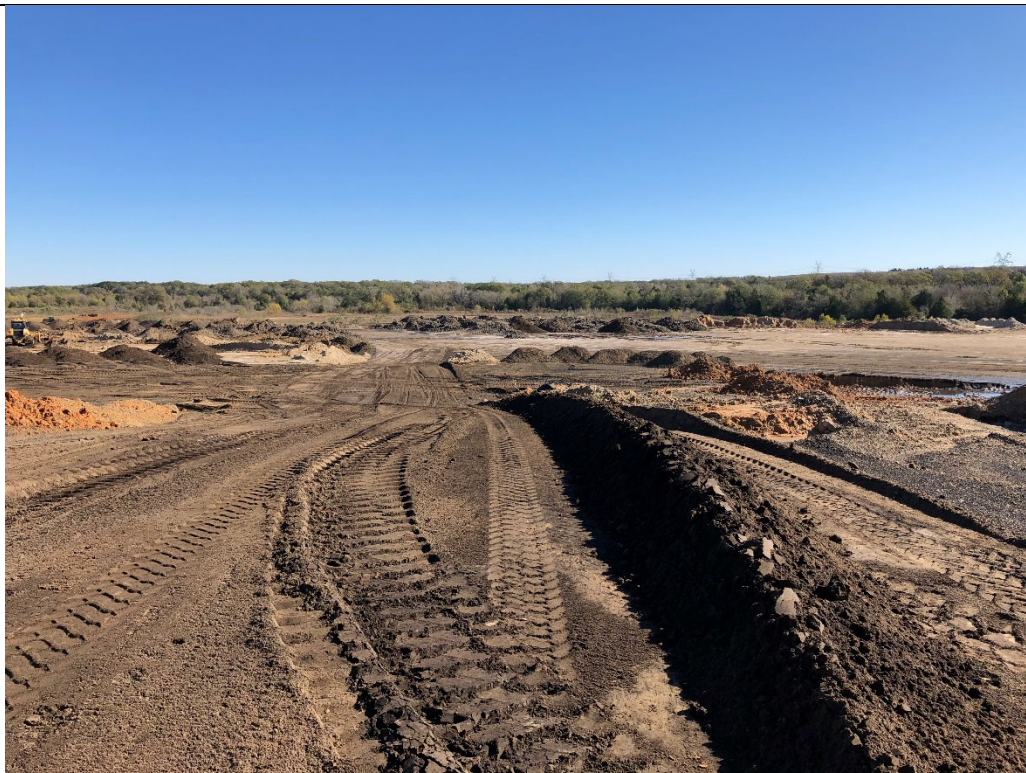
Photograph P-10: View looking east of active landfilling operations in Area 12A.

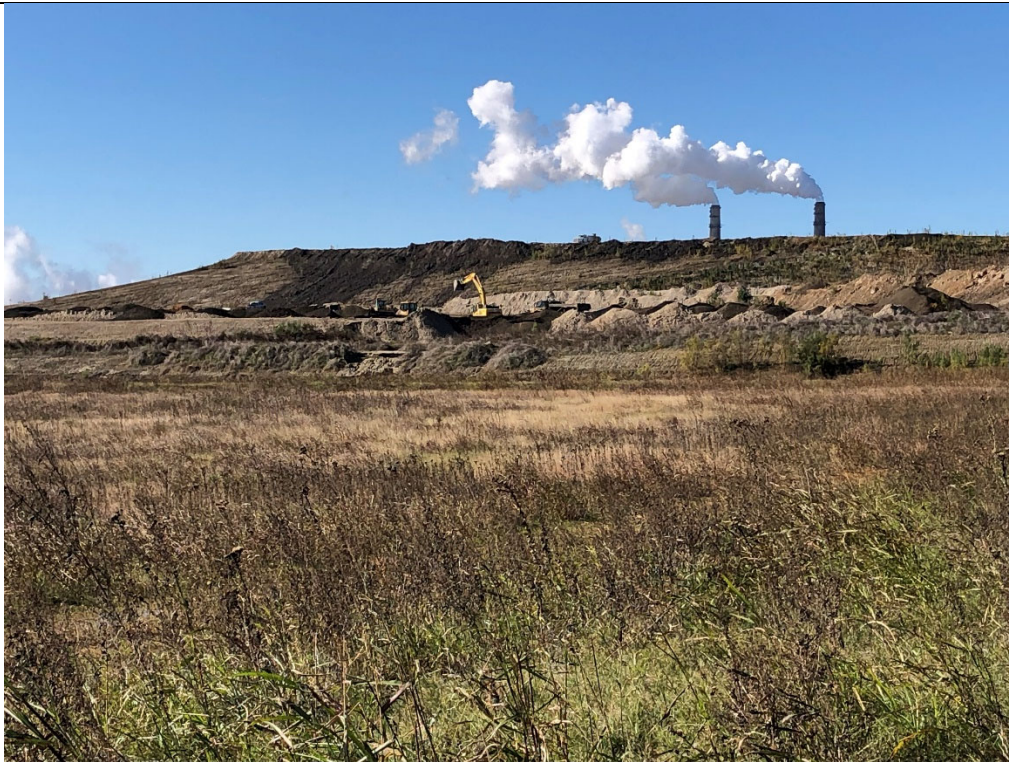
Photograph P-11: View looking west across Area 12C of active landfilling operations in Areas 12A and 12B.

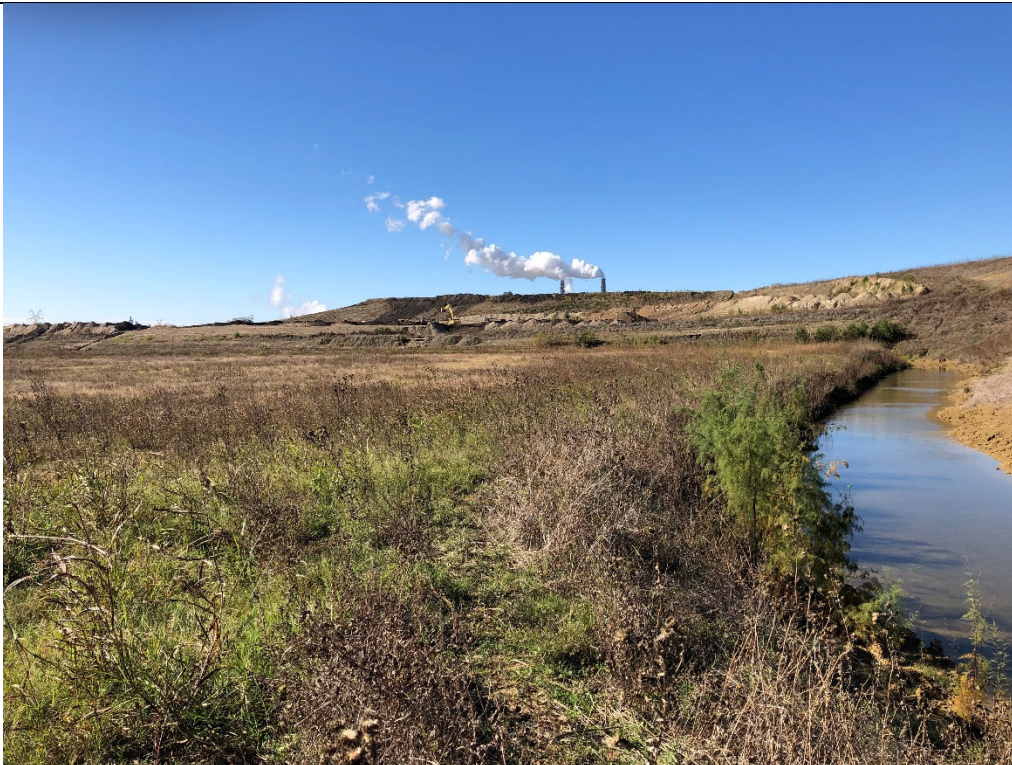
Contact water from all of the uncapped CCR slopes and disposal areas discharges into the interceptor ditch as shown in Photograph P-12. The interceptor ditch is located adjacent to the outer perimeter of these areas and directs the stormwater runoff and any eroded CCR to Pond 002.

Photograph P-12: View looking west-southwest of contact water ditch (right) and Area 12B (center background). Water visible in the ditch was from a heavy rain that fell prior to the November 30, 2020 site visit.
