2022 Annual Inspection of CCR Unit

**Limestone Electric Generating Station
Jewett, Texas**

January 2023

NRG Texas Power LLC

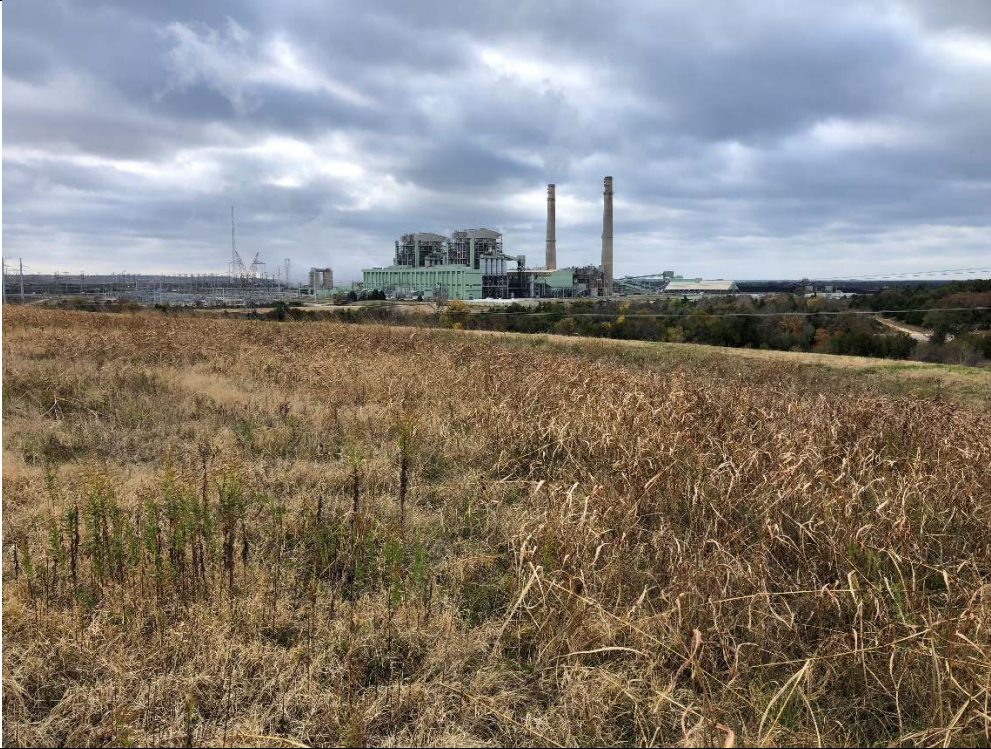
Although landfill Areas 1, 2, 3, 5, 6, 9, and 10 are considered to be capped, exposed slopes of CCR are present in Areas 1, 3, 6, and 10, where uncapped and future expansion areas will abut the existing CCR material (Figure 2). The plateaued portion of the capped areas is well vegetated and generally well graded to prevent the localized ponding of stormwater and to direct the flow of stormwater as depicted in Photographs P-1 through P-4.

Photograph P-1: View looking southwest across the capped surfaces of Areas 1 and 2. The landfill cap appeared to be well vegetated and appropriately sloped. Higher grass is visible in a ditch running along the edge of the landfill crest.

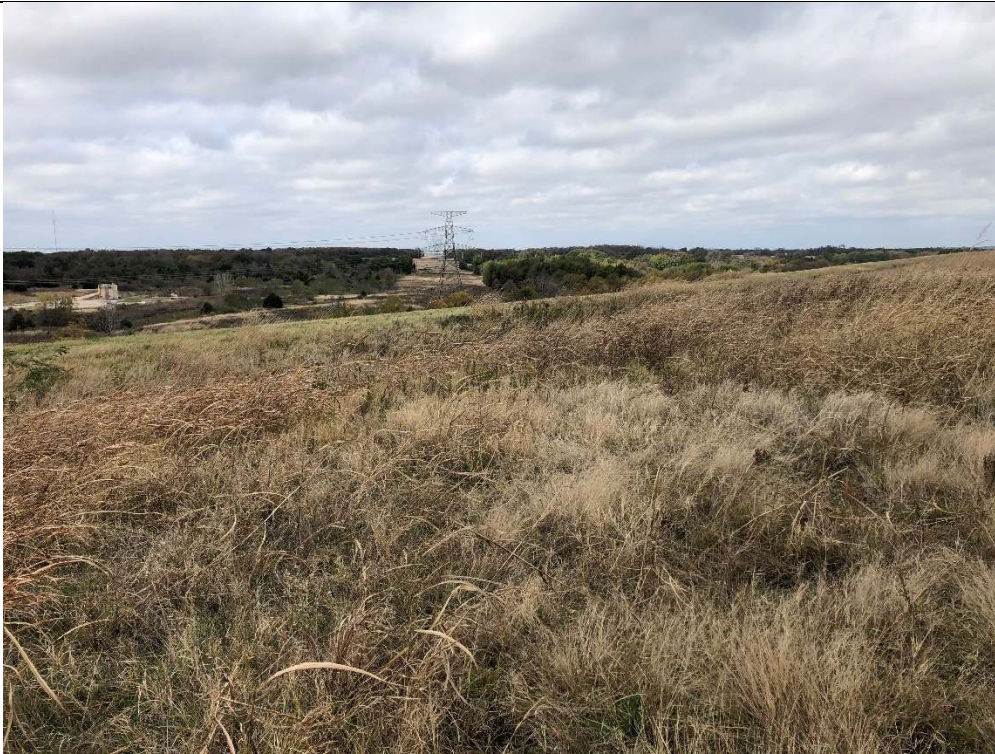
Photograph P-2: View looking west of well vegetated, closed cap of Area 5.

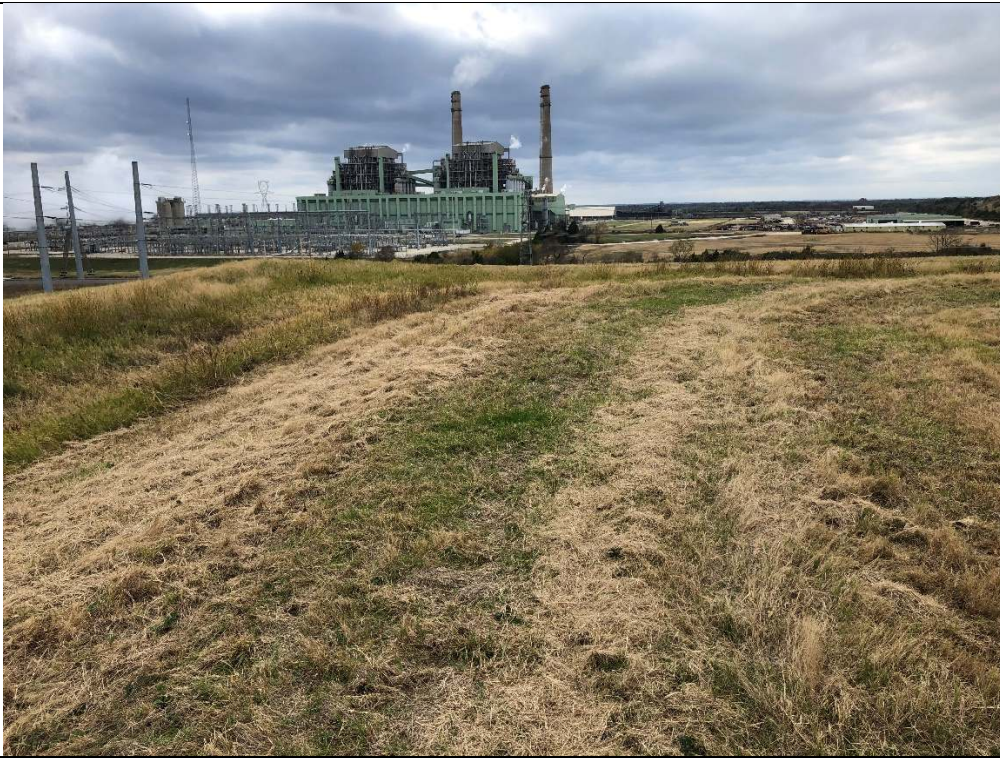
Photograph P-3: View looking southwest from Area 9 of the Unit 004 Landfill.

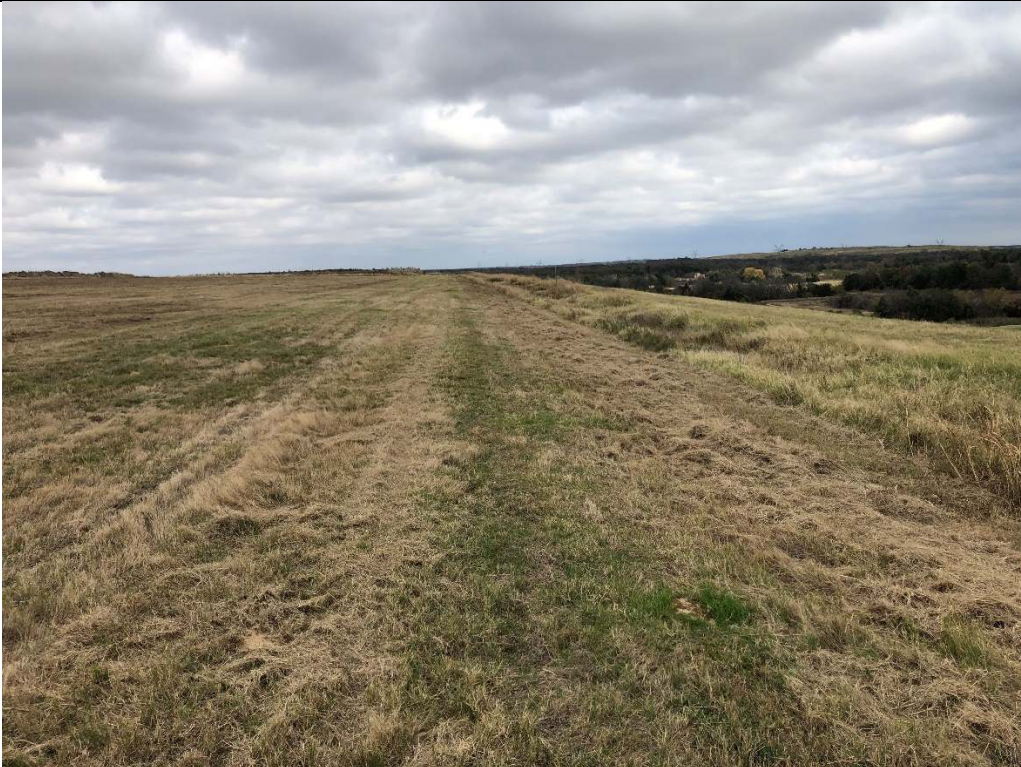
Photograph P-4: View looking northeast across closed cap of Areas 9 and 10.

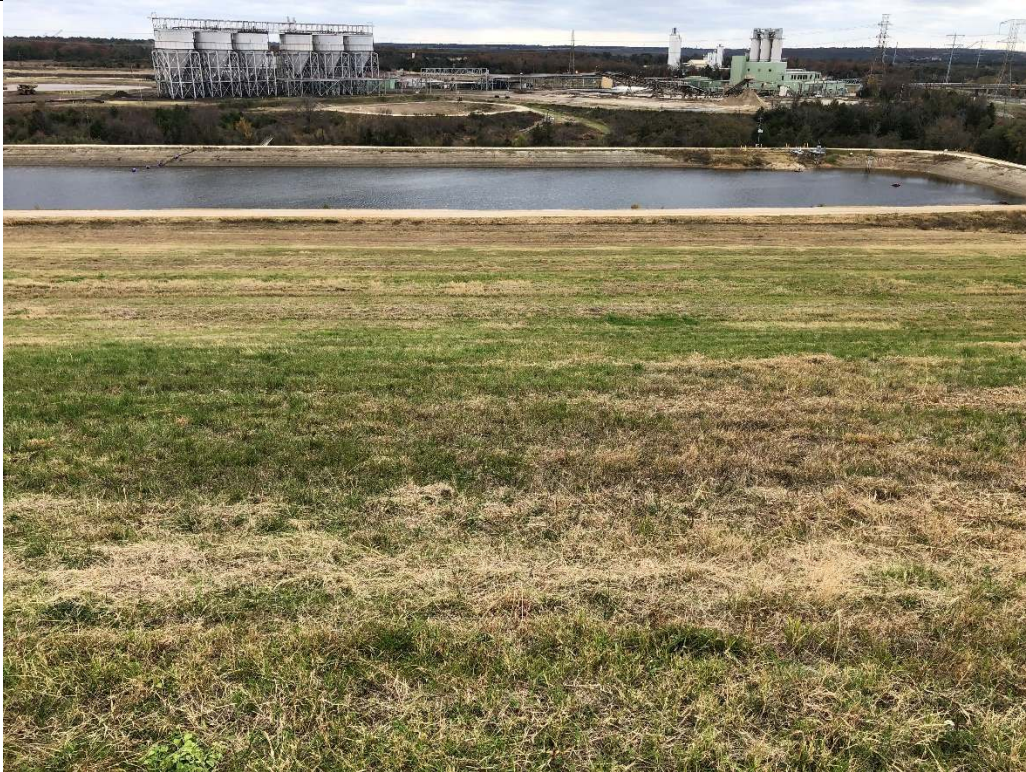
The side slopes of the capped landfill areas are well vegetated and have appropriate perimeter ditches as depicted in Photographs P-5, P-6, P-11, and P-12. As mentioned above, the east sidewalls of Areas 1 and 3, the southeast corner of Area 6, and the east sidewall of Area 10 are not vegetated. These areas abut active or future expansion areas of the landfill. The exposed CCR material sidewalls of Areas 6 and 10 these areas are shown in Photograph P-8. Stormwater that comes into contact with the exposed CCR material is captured in the contact water perimeter ditch system and directed to Pond 002.

Photograph P-5: View looking south-southeast across down the side slope of Area 9 and across Pond 002. The slope is well vegetated with no visible sloughing or erosional issues. Pond 002 is a stormwater pond where contact stormwater is managed.

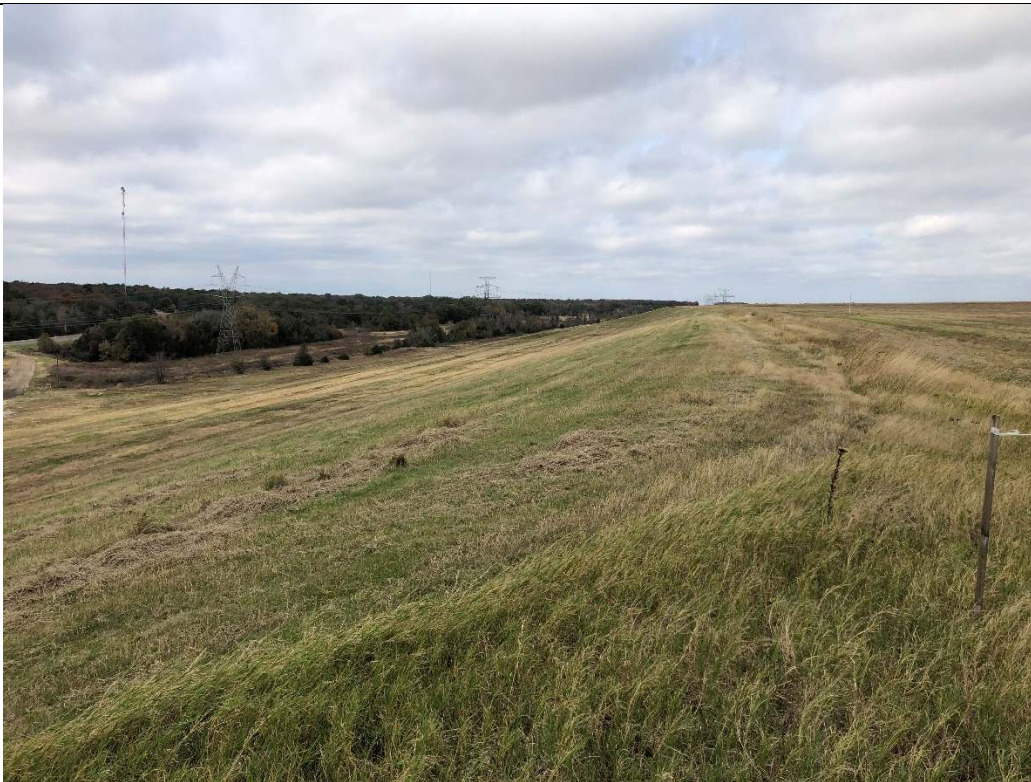
Photograph P-6: View looking northwest along Area 9 side slope. The slope is well vegetated with no visible sloughing or erosional issues.

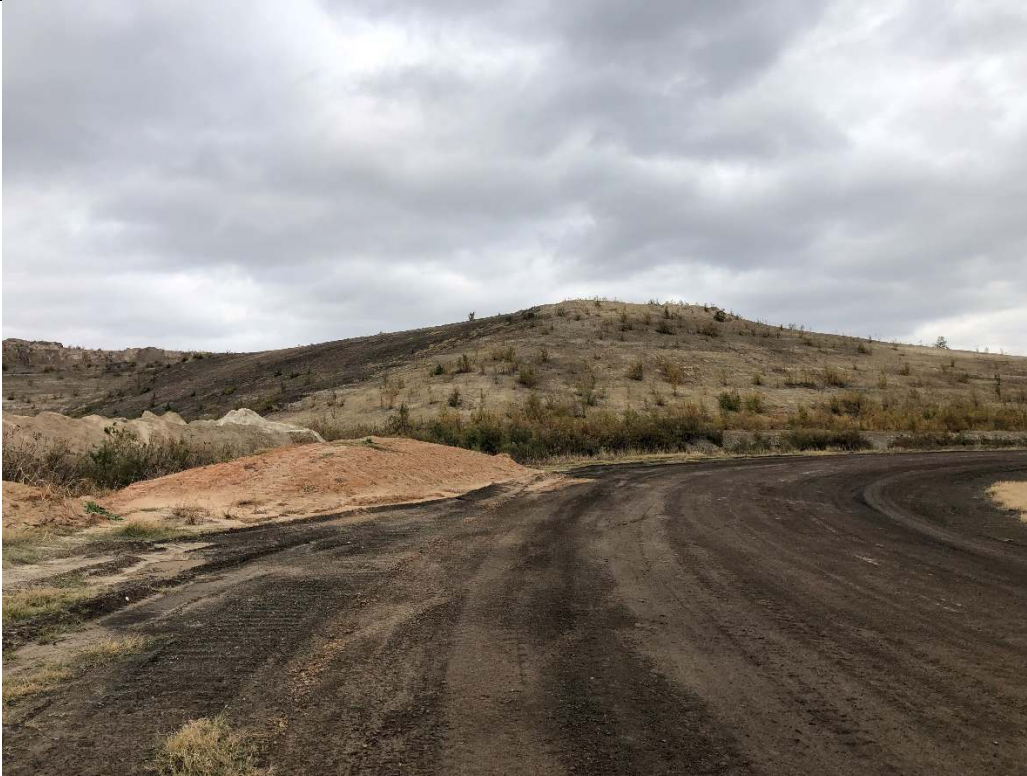
Areas 4, 7, 8, 11, 12A, and 12B are considered to be uncapped areas. Areas 4, 7, and 8 have been partially closed, but are considered to be “uncapped” because significant portions of these areas have uncapped CCR slopes or surfaces. Area 11 is an active area where marketable CCR was formerly stockpiled prior to sale and off-site transportation. Areas 11 and 12A are an active portion of the landfill where CCR is currently being placed. These operations are shown in Photographs P-7, P-8, and P-9.

Photograph P-7: View looking north from perimeter road (improved with bottom ash) at Area 11. A clay stockpile (red to tan material) is visible in the center left of this photograph.

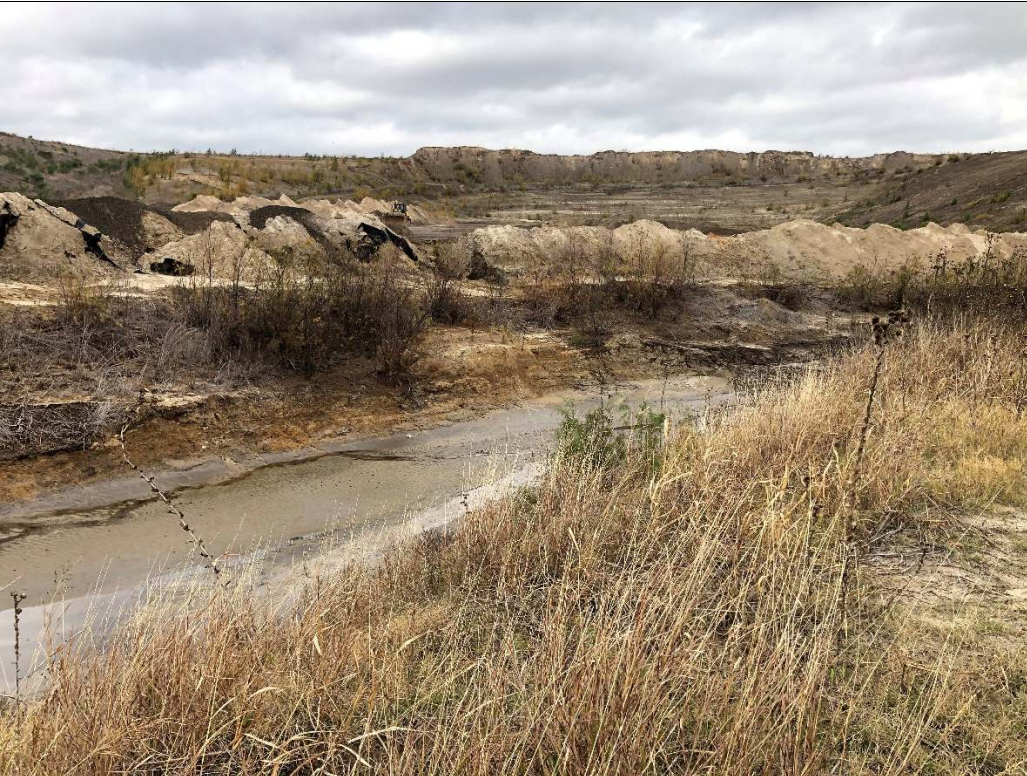
Photograph P-8: View looking west of Area 11, where CCR material has been stockpiled prior to disposal.

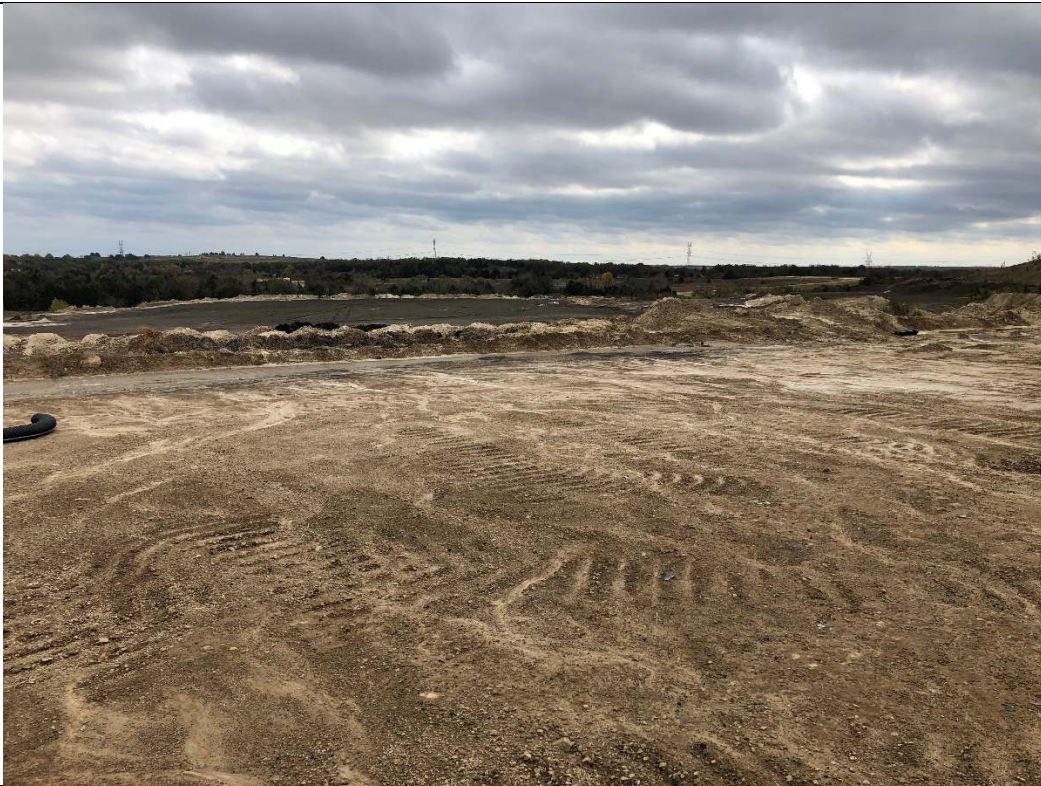
Photograph P-9: View looking east from Cell 11 towards Cell 12A, where active landfilling is occurring.

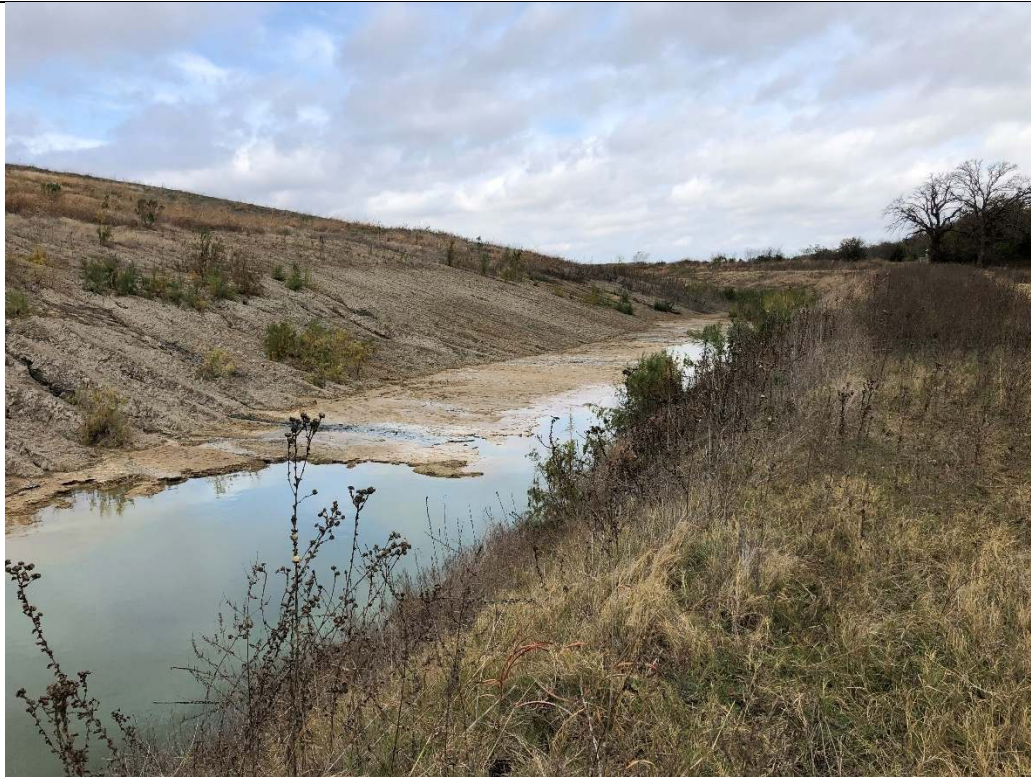
Contact water from all of the uncapped CCR slopes and disposal areas discharges into the interceptor ditch as shown in Photograph P-10. The interceptor ditch is located adjacent to the outer perimeter of these areas and directs the stormwater runoff and any eroded CCR to Pond 002.

Photograph P-10: View of exposed CCR sidewall of Area 8. This is the eastern sidewall of Area 8.

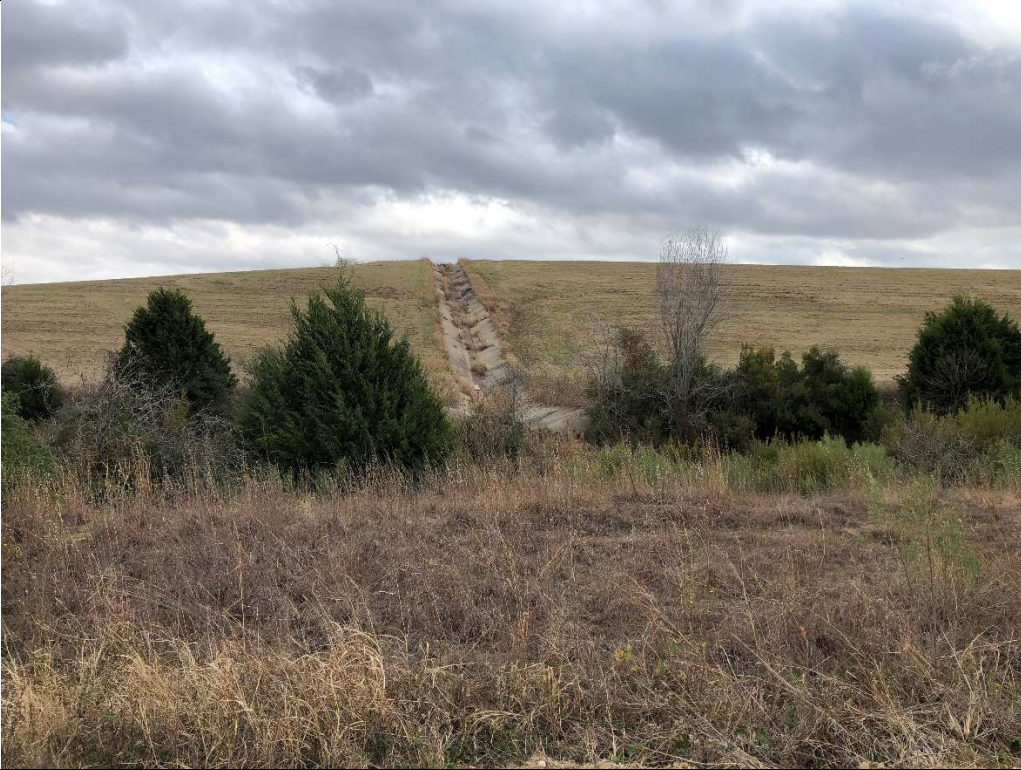
Drainage structures constructed to transfer stormwater from the top of the capped areas to the perimeter ditch consist of concrete lined rundown channels. One rundown channel is present in Area 1 and a second is present in Area 5. Some cracking was observed in these rundown channels, but they are considered to be in good condition as shown in Photograph P-11.

Photograph P-11: View looking southeast at the concrete drainage structure located in Area 1. The slope is well vegetated with no visible sloughing or erosional issues.

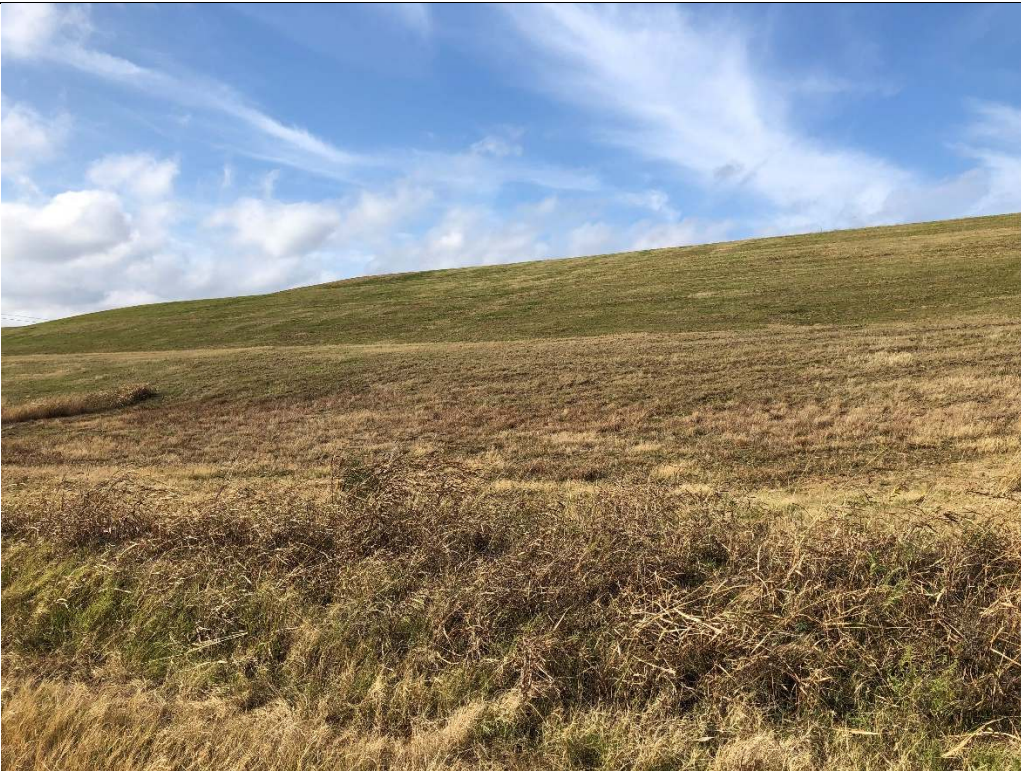
Photograph P-12: View looking north-northwest up sidewall of Area 10. The slope is well vegetated with no visible sloughing or erosional issues.
