2023 Annual Inspection of CCR Unit

**Limestone Electric Generating Station
Jewett, Texas**

January 2024

NRG Texas Power LLC

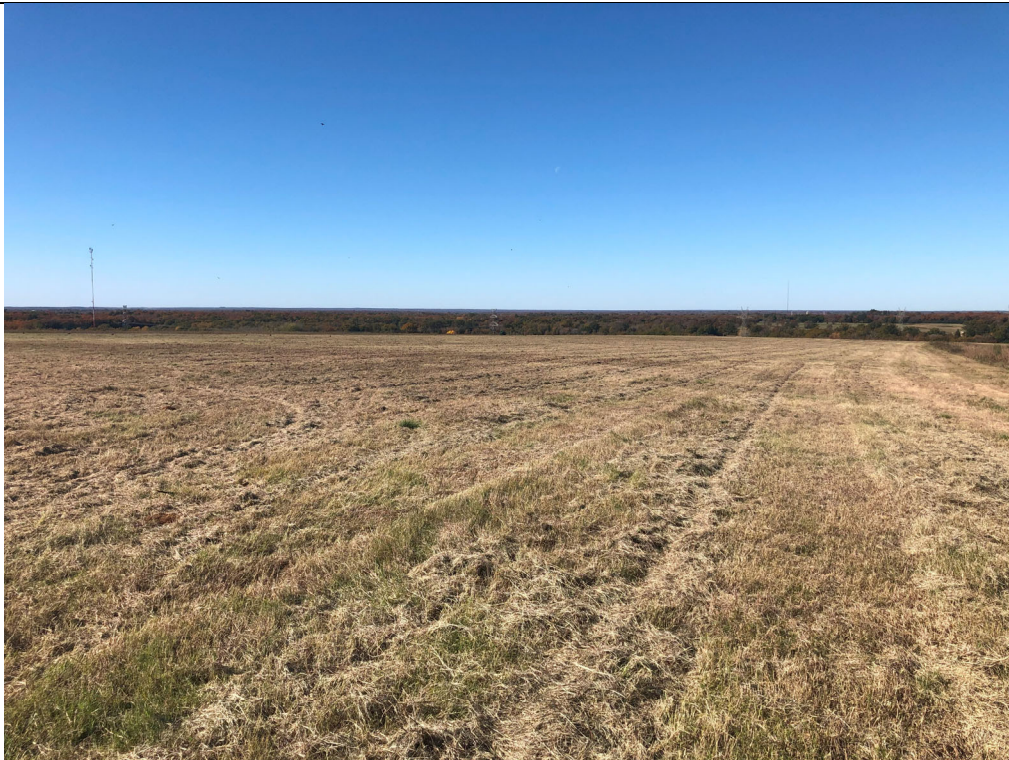
Although landfill Areas 1, 2, 3, 5, 6, 9, and 10 are considered to be capped, exposed slopes of CCR are present in Areas 1, 3, 6, and 10, where uncapped and future expansion areas will abut the existing CCR material (Figure 2). The plateaued portion of the capped areas is well vegetated and generally well graded to prevent the localized ponding of stormwater and to direct the flow of stormwater as depicted in Photographs P-1, P-2, and P-5.

Photograph P-1: View looking southwest across the capped surfaces of Areas 3 and 2. The landfill cap appeared to be well vegetated and appropriately sloped. Higher grass is visible in a ditch running along the edge of the landfill crest.

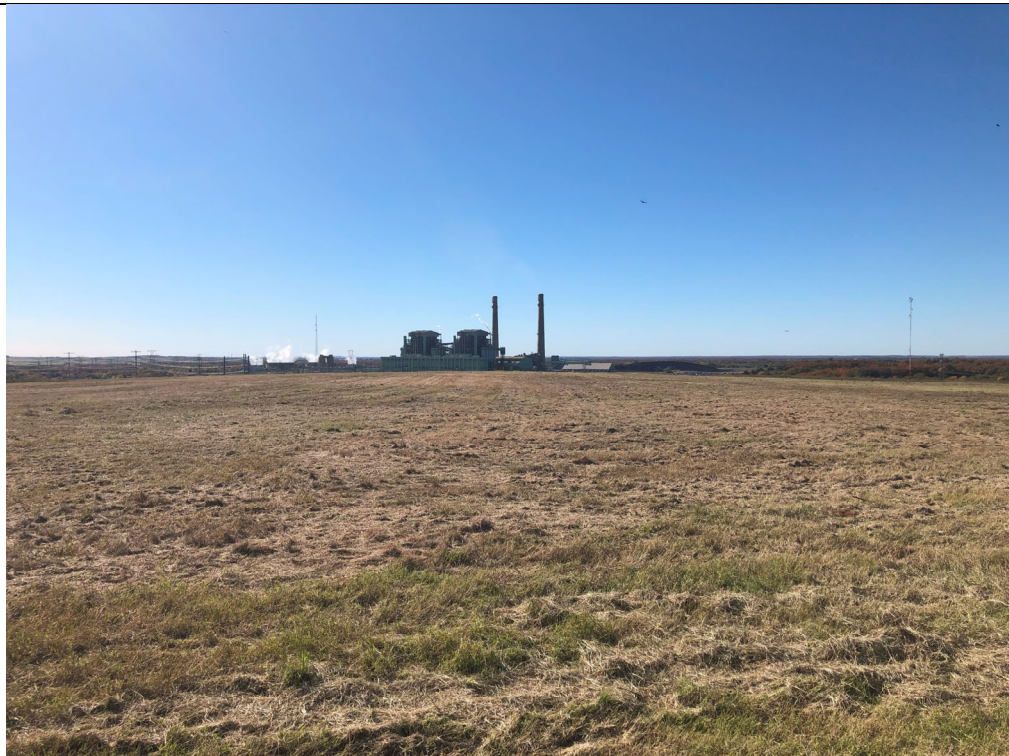
Photograph P-2: View looking west of well vegetated, closed cap of Area 6 and 5.

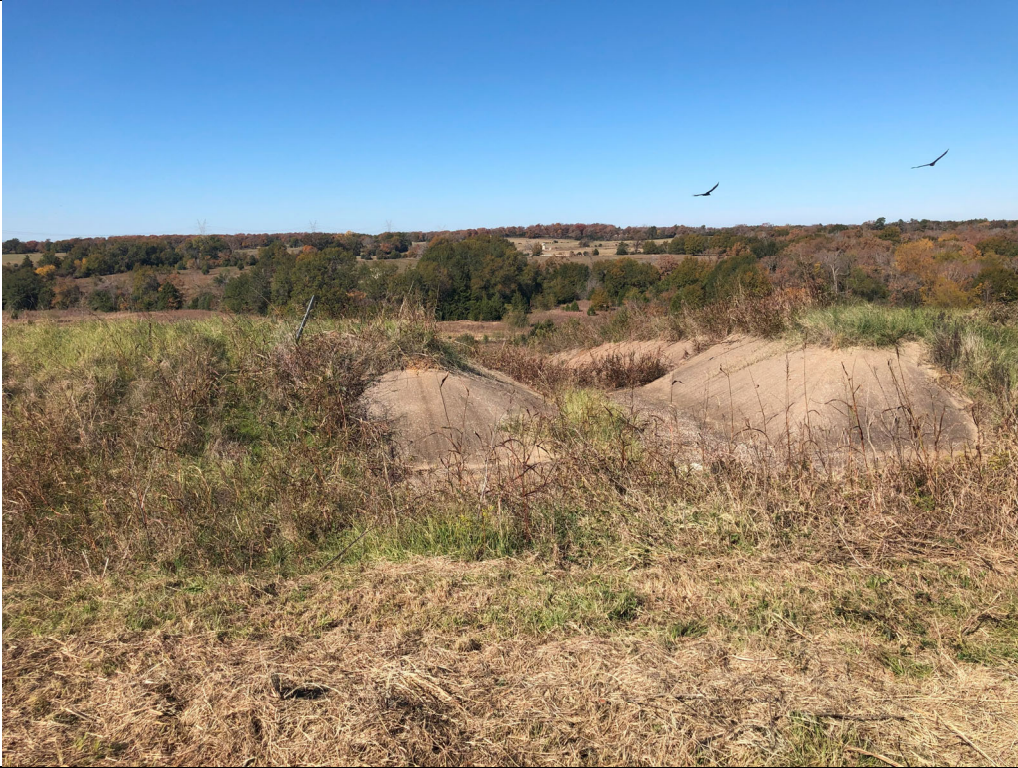
Drainage structures constructed to transfer stormwater from the top of the capped areas to the perimeter ditch consist of concrete lined rundown channels. One rundown channel is present in Area 1 and a second is present in Area 5. Some cracking and vegetation growth was observed in these

rundown channels, but they are considered to be in good condition as shown in Photographs P-3 and P-4.

Photograph P-3: View looking west-southwest from Area 5. A stormwater ditch located along the perimeter of the top of the landfill drains to this concrete outfall (also shown in photograph P-4). The ditch appeared to flow well, without significant rutting or standing water.

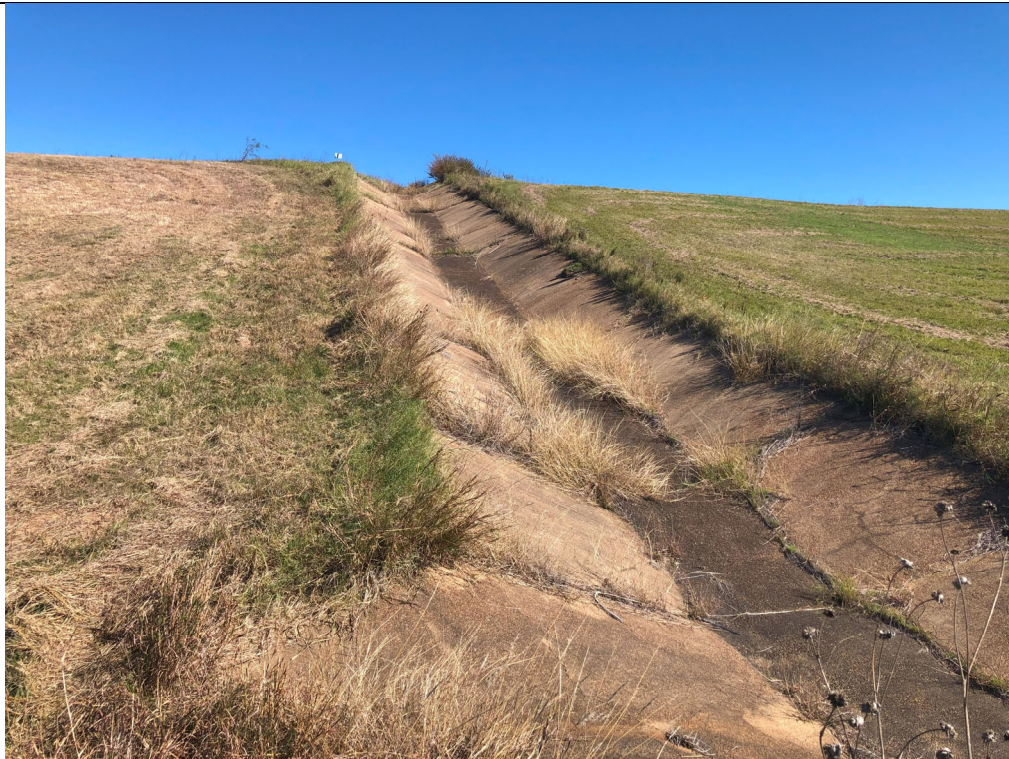
The side slopes of the capped landfill areas are well vegetated and have appropriate perimeter ditches as depicted in Photographs P-4 and P-6. As mentioned above, the east sidewalls of Areas 1 and 3, the southeast corner of Area 6, and the east sidewall of Area 10 are not vegetated. These areas abut active or future expansion areas of the landfill. The exposed CCR material sidewall of Area 11 is shown in Photograph P-8. Photograph P-11 shows the lined future expansion Area 13 and the exposed CCR sidewalls of Areas 1, 3, and 4. Stormwater that comes into contact with the exposed CCR material is captured in the contact water perimeter ditch system and directed to Pond 002.

Photograph P-4: View looking east-northeast up the concrete stormwater outfall in Area 5.

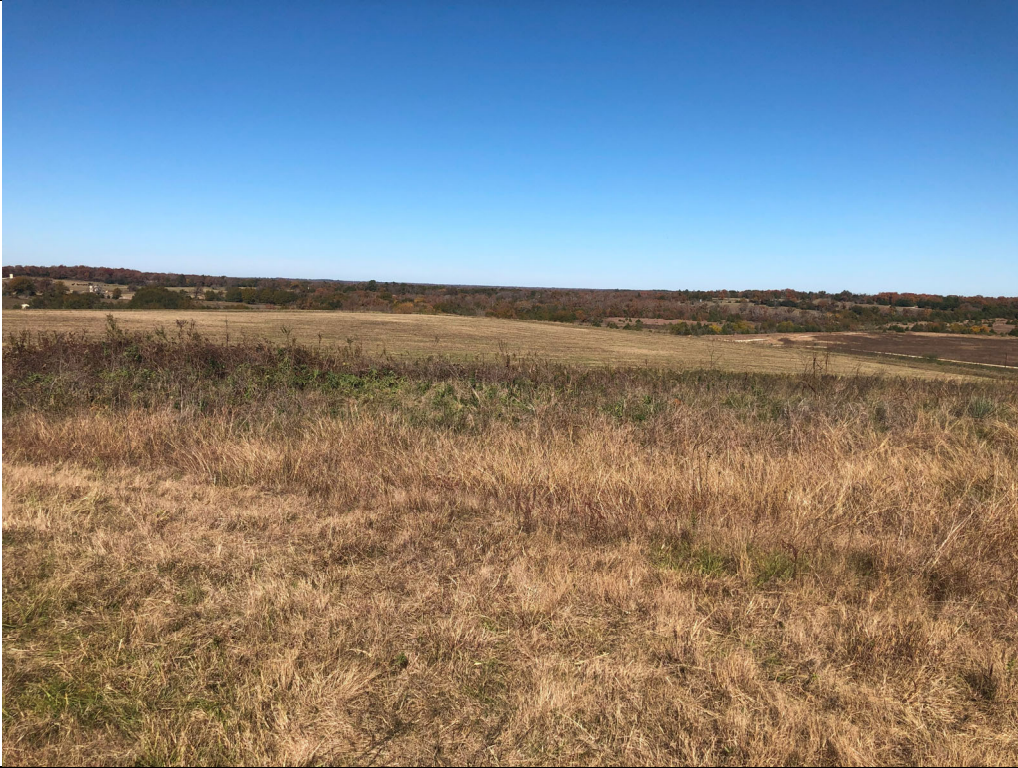
Photograph P-5: View looking northeast across a portion of the closed cap in Area 2 where mowing was imminent.

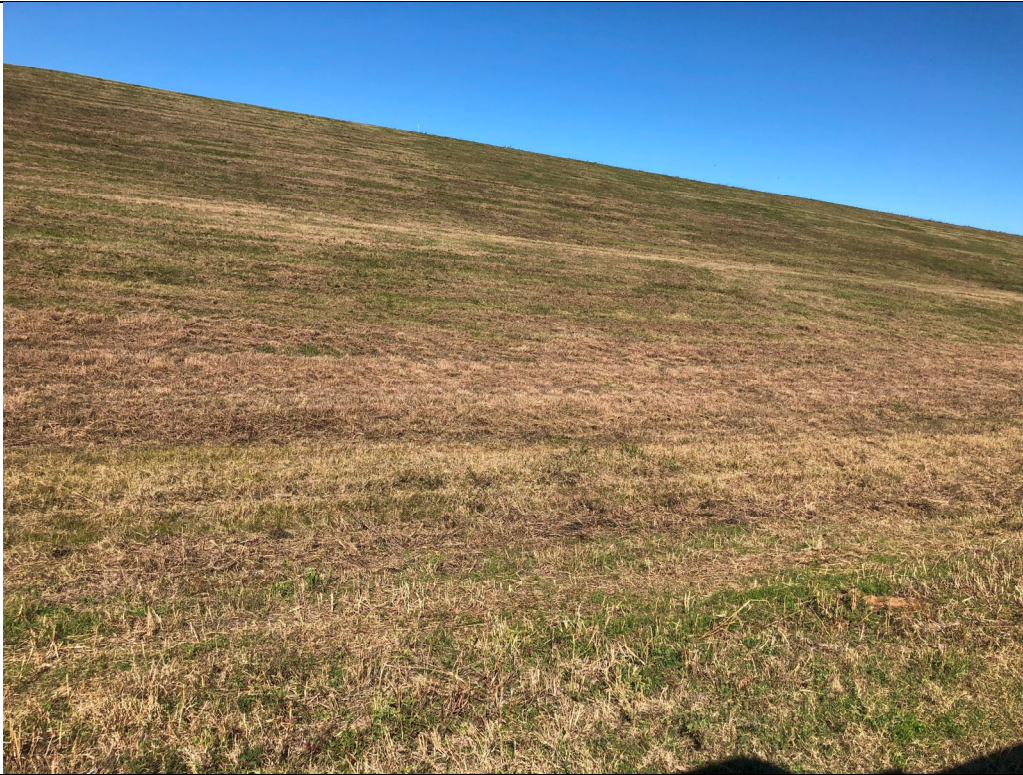
Photograph P-6: View looking north up the side slope of Area 9. The terraced slope is well vegetated with no visible sloughing or erosional issues.

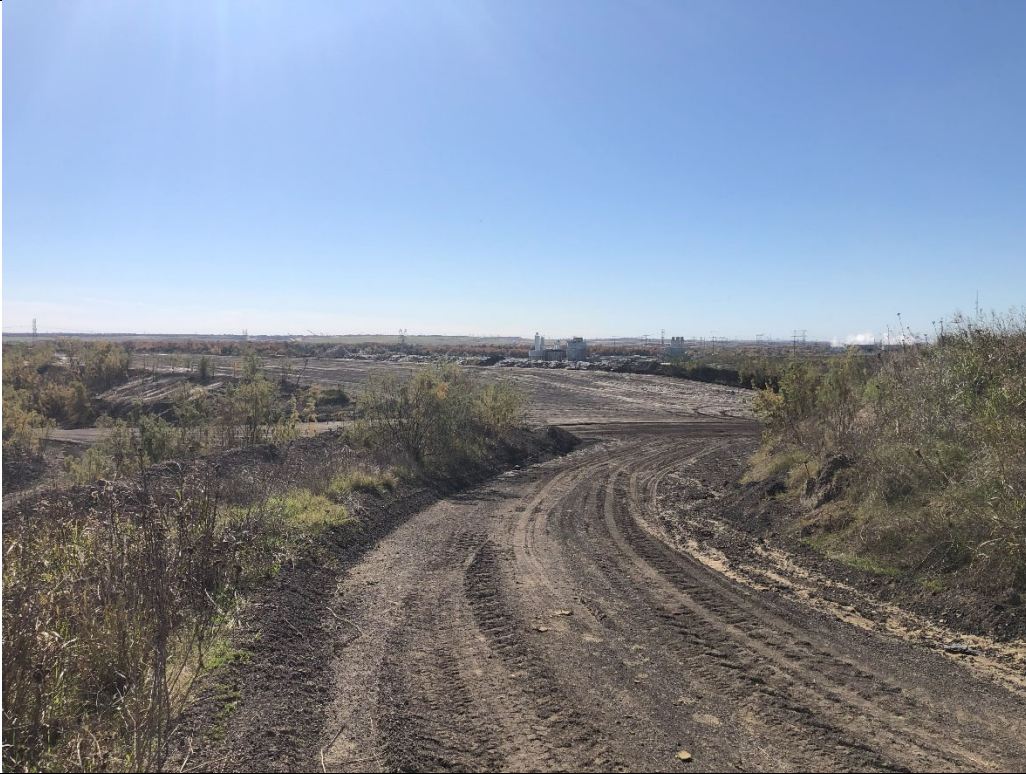
There are currently two haul roads used to transport CCR to the active portions of the landfill. One of the haul roads passes through Areas 11, 7, 8, and 12A. The second haul road passes through Area 12A. Both roads have been improved with bottom ash and neither had significant rutting.

Photograph P-7: View looking south of haul road in Area 11.

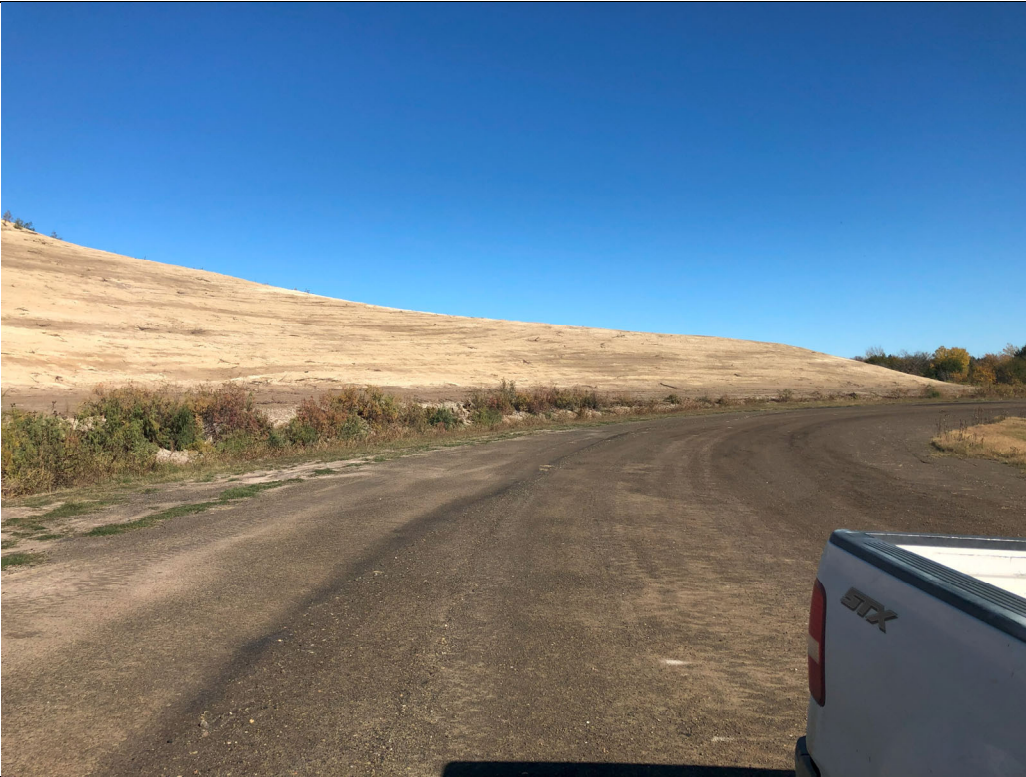
Contact water from all of the uncapped CCR slopes and disposal areas discharges into the interceptor ditch as shown in Photographs P-8 and P-12. The interceptor ditch is located adjacent to the outer perimeter of these areas and directs the stormwater runoff and any eroded CCR to Pond 002.

Photograph P-8: View looking northeast from perimeter road across perimeter interceptor ditch at side slope of Area 11.

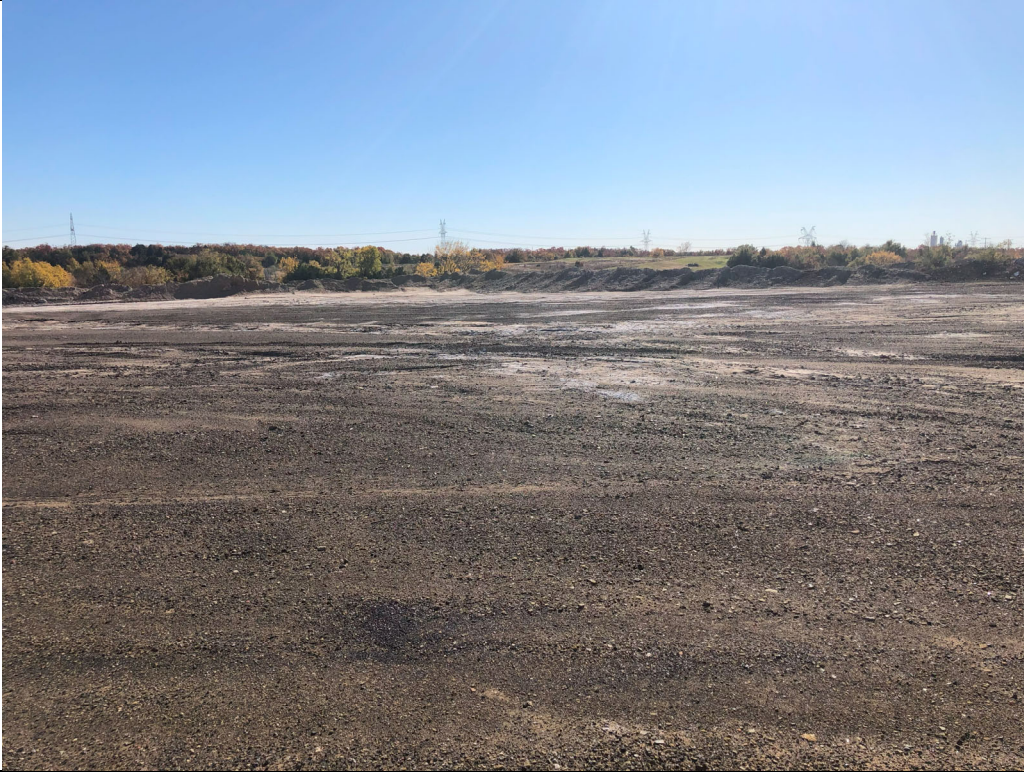
Photograph P-9: View looking east of exposed waste surface in Area 12A.

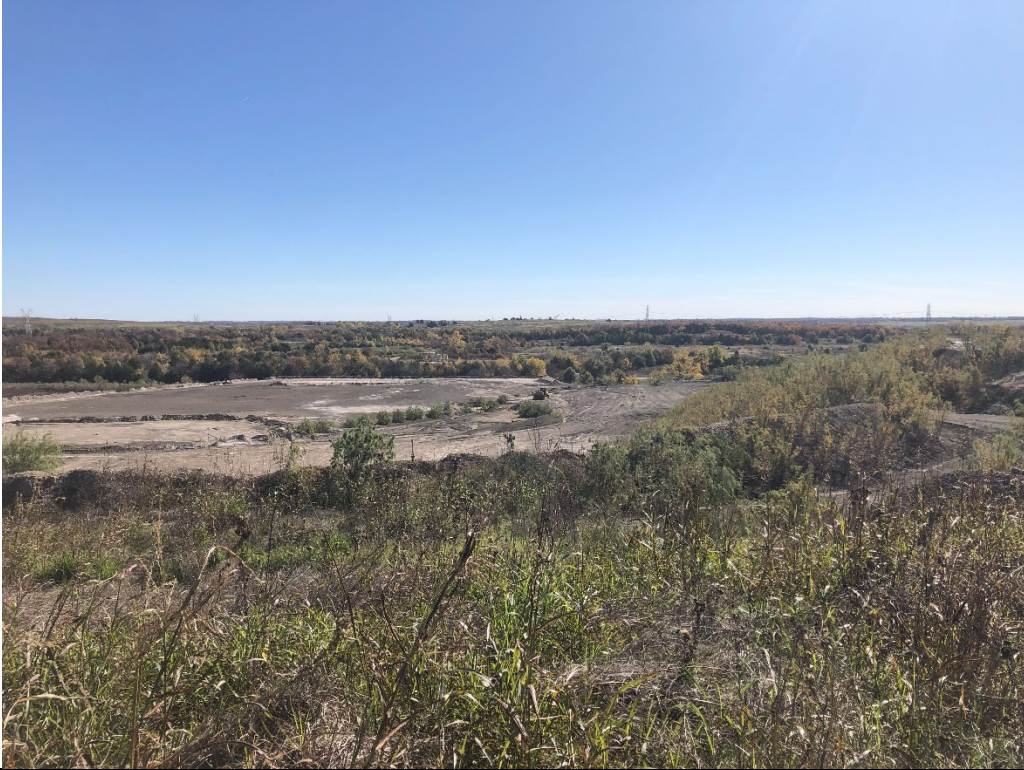
Photograph P-10: View looking southeast from Area 11 toward Area 12A.

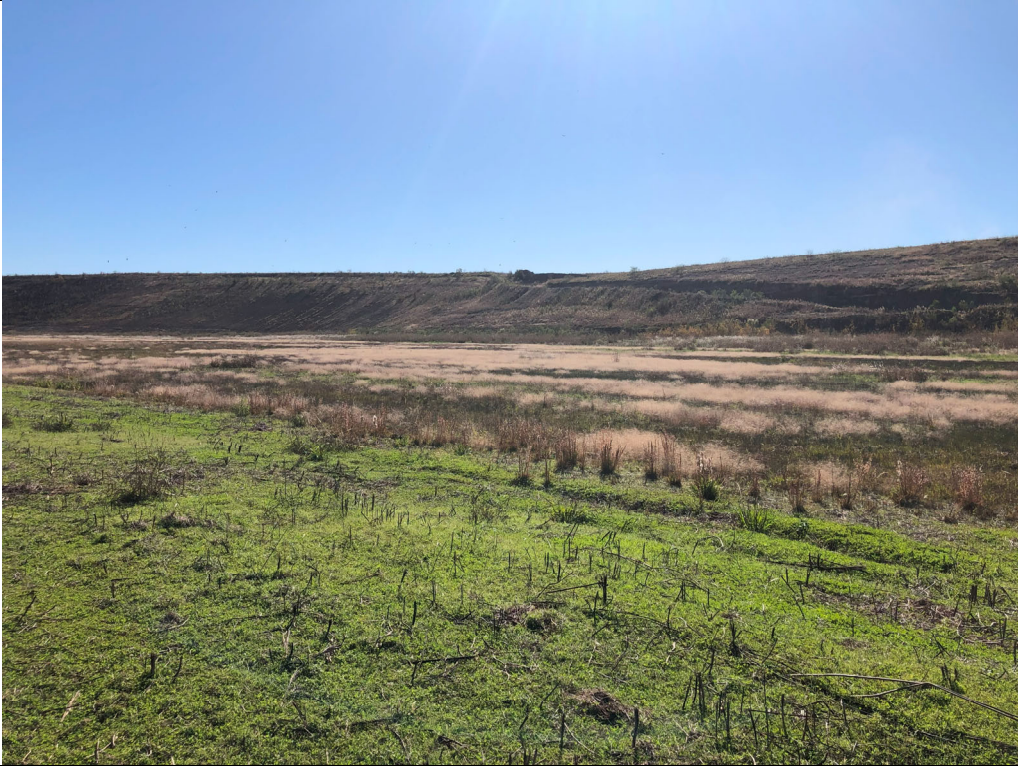
Photograph P-11: View looking south across future expansion Area 13 towards the side slope of Areas 1, 3, and 4.

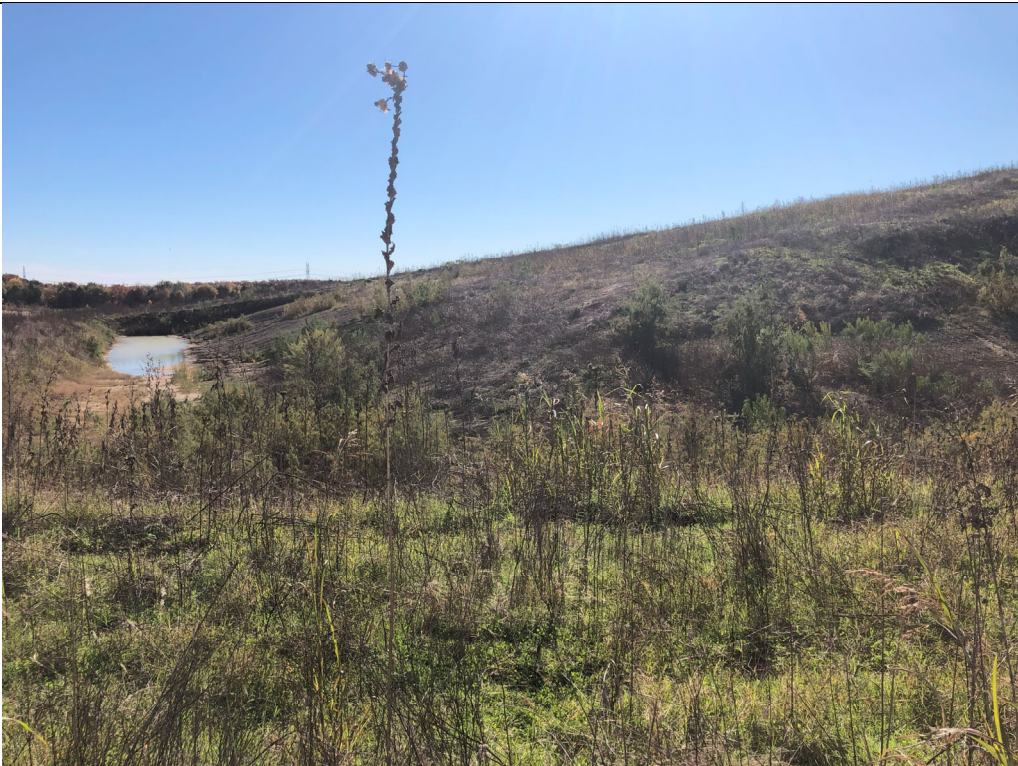
Photograph P-12: View looking southwest of perimeter interceptor ditch.
