**NRG TEXAS POWER, LLC
LIMESTONE STATION, UNITS 1 & 2**

ANNUAL INSPECTION OF CCR IMPOUNDMENTS AND LANDFILL

SL Report No.: SL-013201
Revision 0
Date: January 15, 2016
Project No.: 12661-042

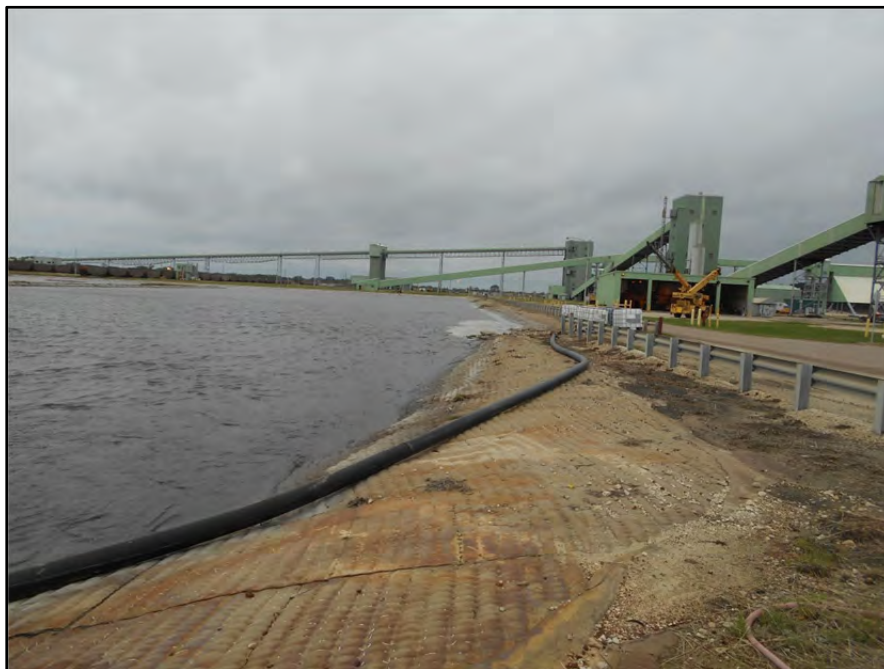
Photograph P-3 – Taken November 11, 2015 by David E. Nielson
Pond K: Looking west along the northern bank, which is incised.
This verifies that the Federal CCR Rule regarding inspections does not apply to Pond K.

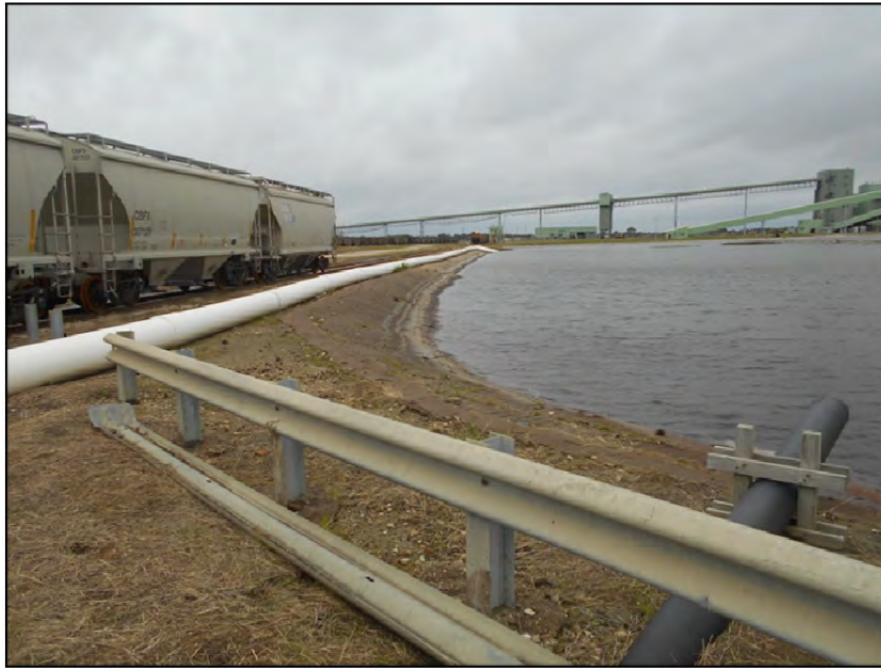
Photograph P-4 – Taken November 11, 2015 by David E. Nielson
Pond K: Looking west at the southern pond edge, which is incised.
This verifies that the Federal CCR Rule regarding inspections does not apply to Pond K.

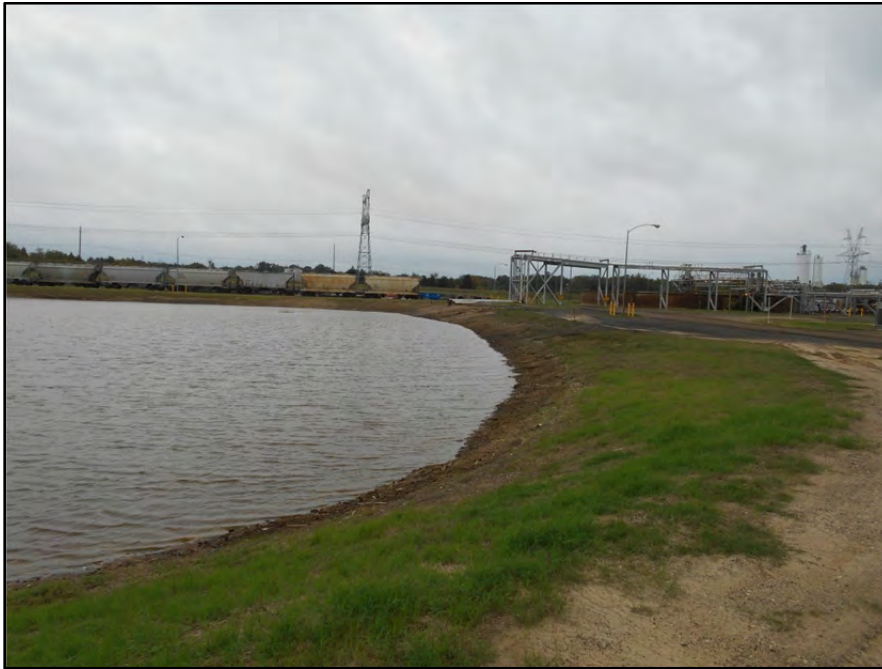
The south and west sides of Pond E are incised as shown on Photographs P-6 and P-8. The risk of catastrophic failure in these areas is minimal since the surface of the water and CCR materials is lower than the surrounding ground surface. A fabriform concrete splash pad was present in the southern portion

Photograph P-6 – Taken November 11, 2015 by David E. Nielson
Pond E: Looking south along west pond interior slope of western edge, which is incised. Note minor vegetation deficiencies, which do not result in significant risk due to incised condition.

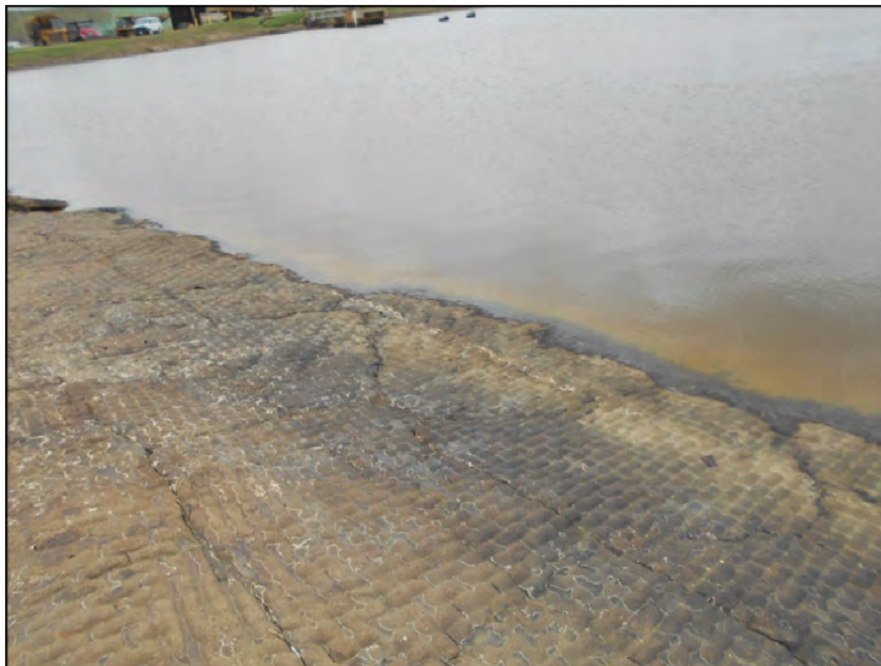
of the western wall as depicted in Photograph P-7. Although this splash pad exhibited some cracking, it appeared to be functioning as intended to prevent erosion from the overhead pipe discharge.

Photograph P-7 – Taken November 11, 2015 by David E. Nielson
Pond E: Looking west at the fabriform erosion protection blanket on the southern bank at the pipe discharge. Although cracks are present, it is functional in preventing erosion.

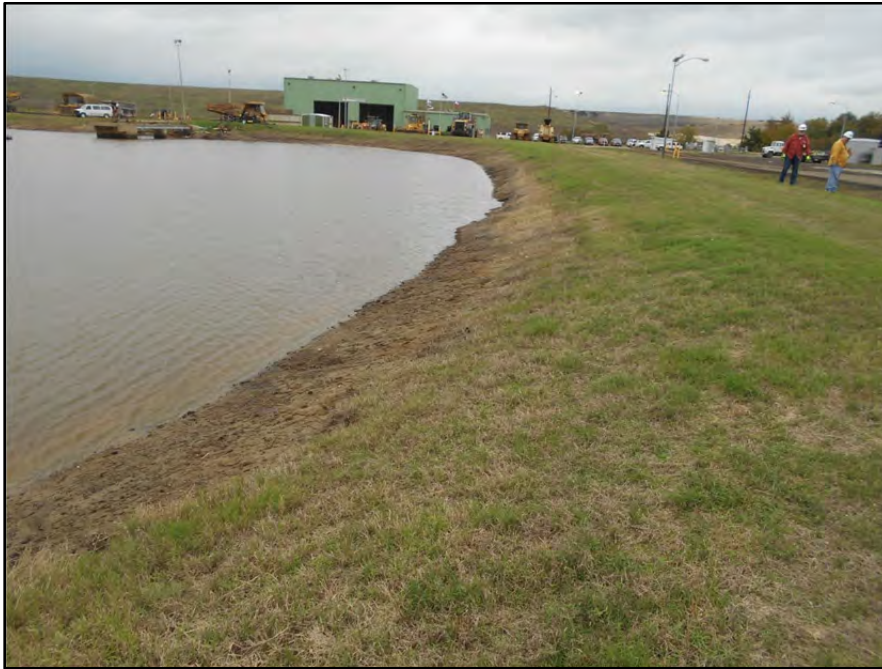
The east dike is shown in Photographs P-9 and P-10. This dike is in good condition with good grass vegetation. Photograph P-10 shows some minor slope irregularity, which is manifest by the slightly meandering shoreline. Careful evaluation of this area indicates this is most likely the result of pond cleaning activity and not slope instability. No slope instability was observed.

Photograph P-10 – Taken November 11, 2015 by David E. Nielson
Pond E: Looking north at the inside slope of the eastern dike.
Although, some minor slope irregularity was noted,
there was no evidence of structural instability observed.

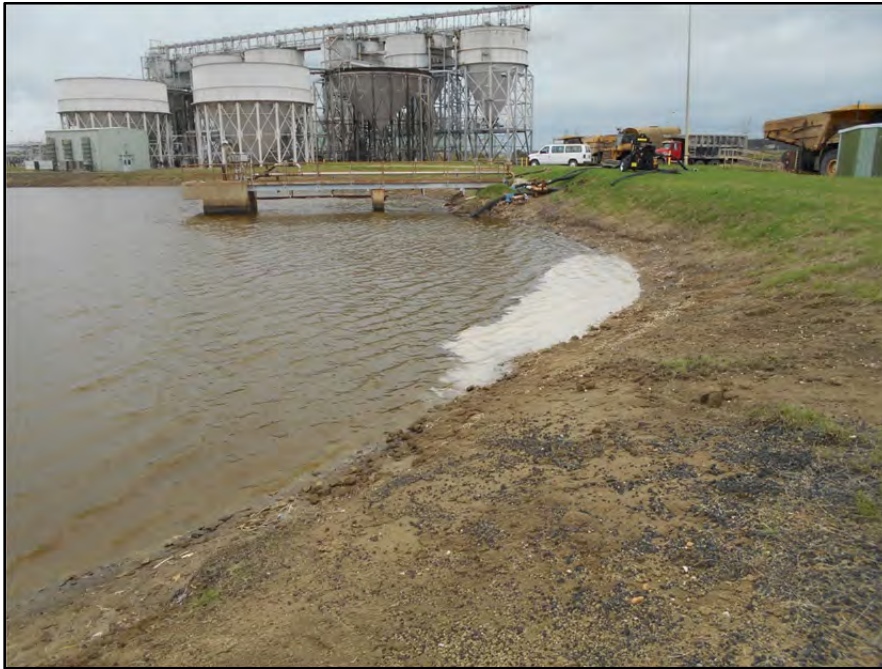
Photograph P-12 – Taken November 11, 2015 by David E. Nielson
Pond E: Looking west at the inside slope of the north dike.
Note the slope appears to be steeper than typical. The steep slope appears to be the result of excavations to remove collected solids from inside the pond.

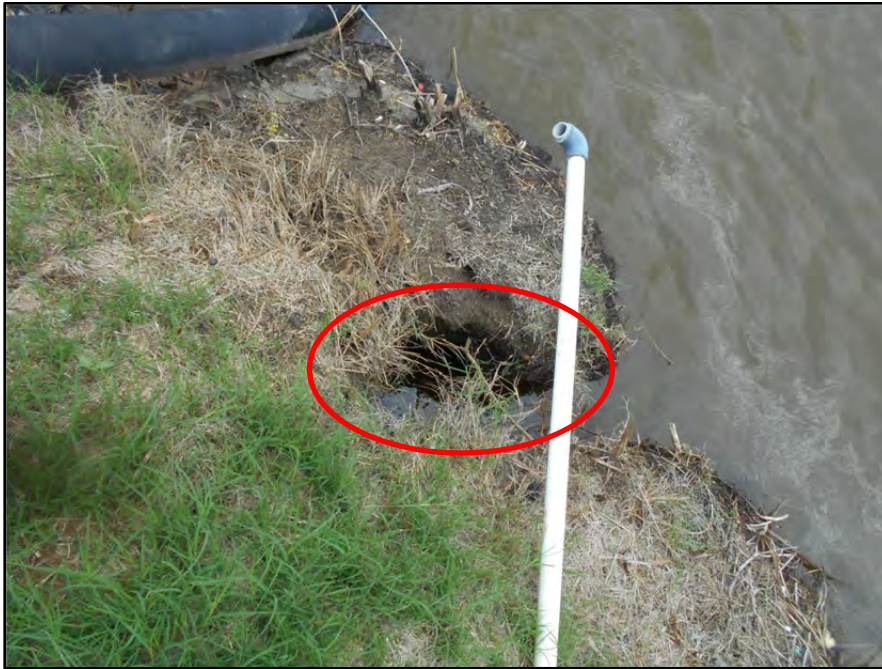
The crest of the north dike is relatively wide and the outside slope (downstream slope) is relatively gentle as shown on Photograph P-11. The inside slope (upstream slope) of the north dike is generally well sloped, with some localized exceptions of steep areas. These steep areas are shown in Photographs P-12 and P-13. This appears to be the result of incomplete cleaning of the CCR material, not a misalignment from the initial construction nor a deformation of the dike slope. Photograph P-13 also shows the stump of a former tree that had been cut. A small erosional feature was noted in the inside slope of the north dike near the valve and pump hose installation as shown of Photograph P-14.

Photograph P-14 – Taken November 11, 2015 by David E. Nielson
Pond E: Looking at the inside slope of the north dike where an erosional feature
in slope appears to be a broken stormwater pipe discharging into pond.

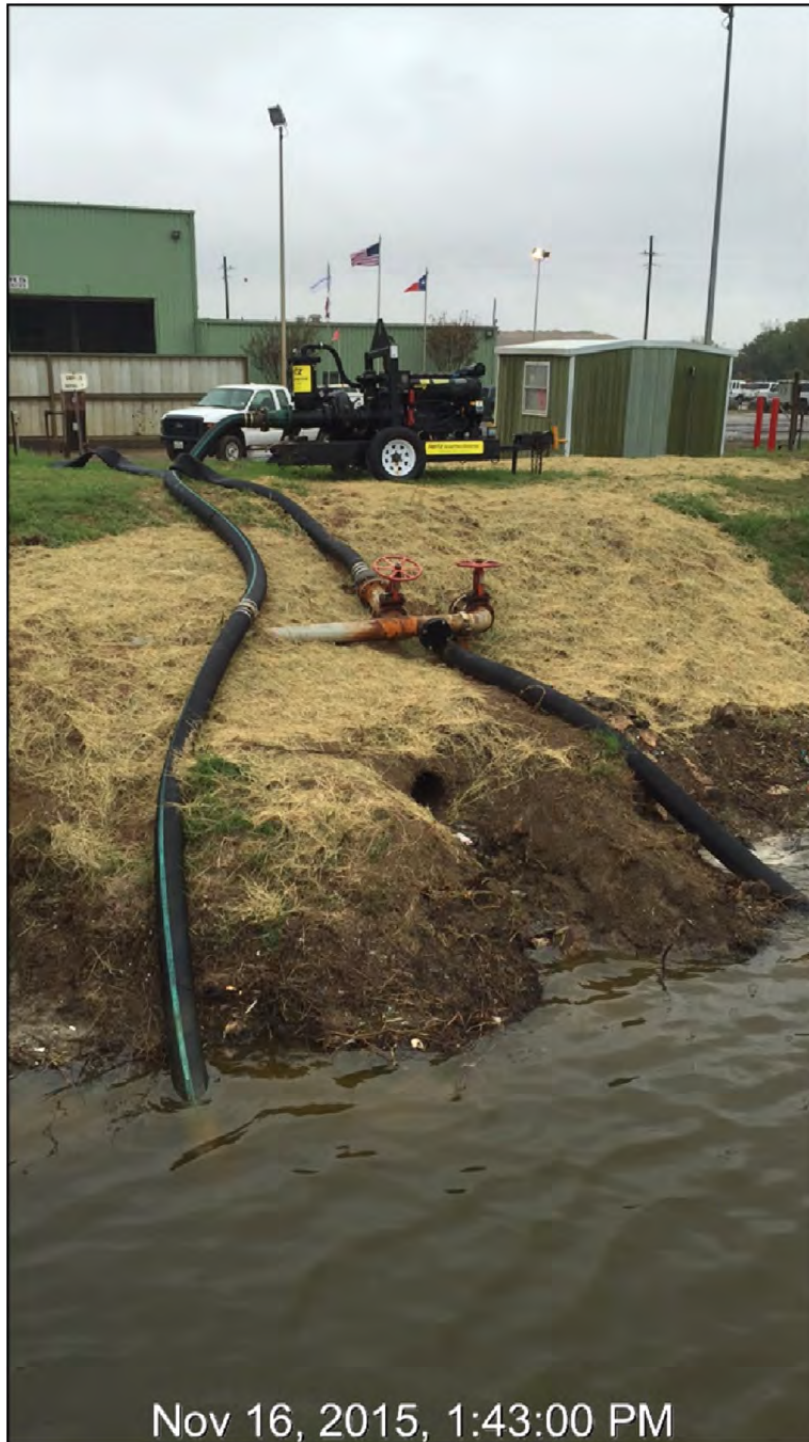
Photograph P-15 – Taken November 16, 2015 by NRG
Pond E: Looking north at the inside slope of the north dike
(the area of Photographs P-13 and P-14). Note pipe discharge has been exposed.
The valve and hose area has been cleaned up and the area has been seeded.

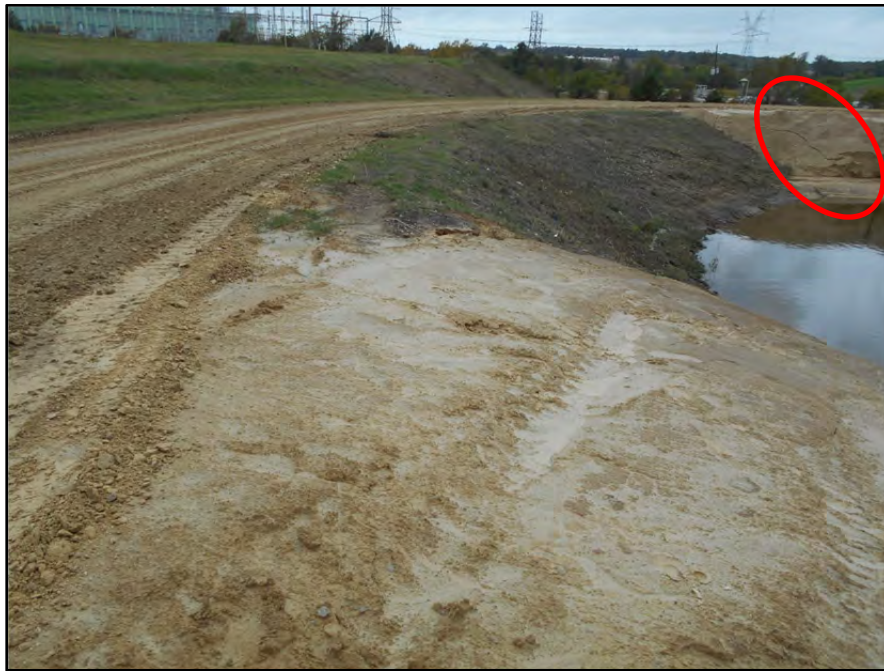
The south and east sides of Pond ST-18 are incised as shown on Photographs P-17 and P-18. The risk of catastrophic failure in these areas is minimal since the surface of the water and CCR materials is lower than the surrounding ground surface. Moreover, since the slopes up to other areas are well vegetated and reasonably graded, the risk of upslope areas exhibiting instability and deforming into Pond ST-18 visually appears to be quite low.

Photograph P-17 – Taken November 11, 2015 by David E. Nielson
Pond ST-18: Looking west at inside slope of southern edge of incised portion of pond.
Tension crack (circled in red) was in loose CCR material that is to be removed from the pond.
No instability of the pond dikes was observed.

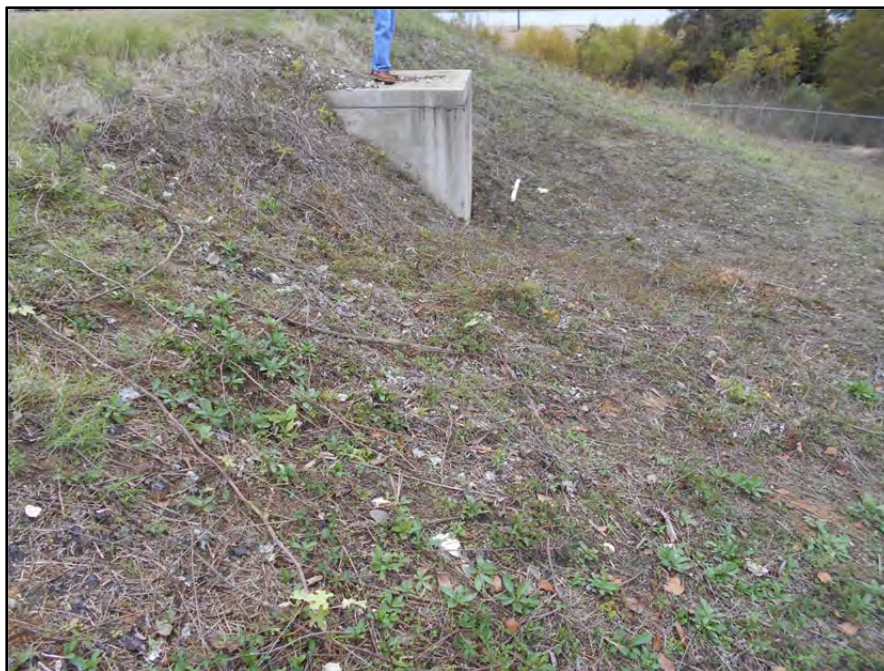
The inside slope of the north dike looked to be constructed and maintained in a reasonable manner as shown in Photograph P-19. The outside slope of the north dike exhibited a section near the outlet structure manhole that was steeper than the industry standard as shown in Photographs P-20 and P-21. Although this area does not exhibit evidence of instability, placement of additional fill is recommended to match the slopes of the other dikes.

Photograph P-20 – Taken November 11, 2015 by David E. Nielson
Pond ST-18: Looking west at outside slope of northern edge of pond.
Note the steep dike section in the vicinity of the outlet structure manhole. This dike is steeper than typical. Additional fill should be placed and compacted to lessen the steepness of the slope and increase the dike stability. No evidence of dike instability was noted.

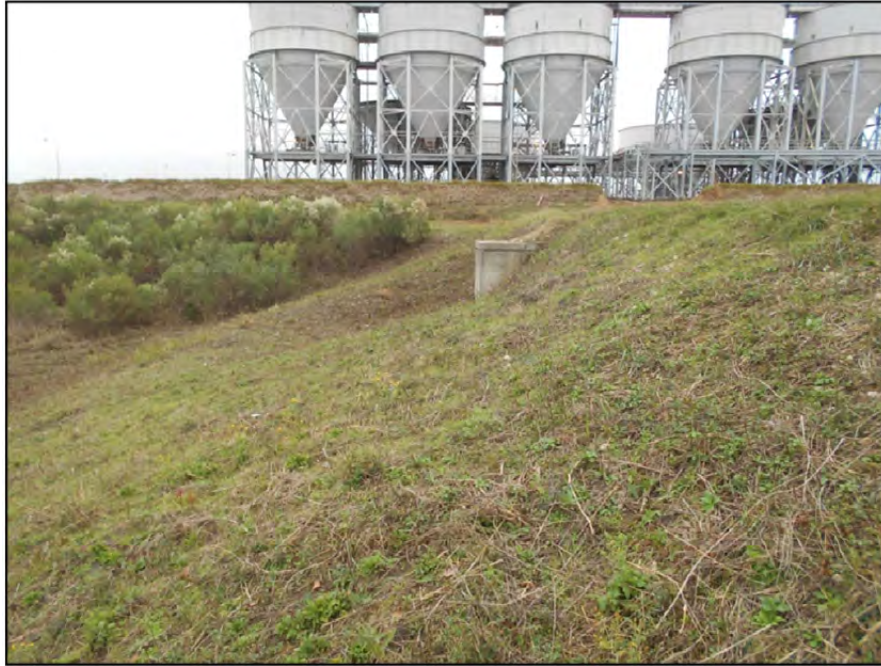
Photograph P-21 – Taken November 11, 2015 by David E. Nielson
Pond ST-18: Looking east at outside slope of northern edge of pond.
Note the steep dike section in the vicinity of the outlet structure manhole.
This dike is steeper than typical. Additional fill should be placed and compacted to lessen the steepness of the slope and increase the dike stability.
No evidence of dike instability was noted.

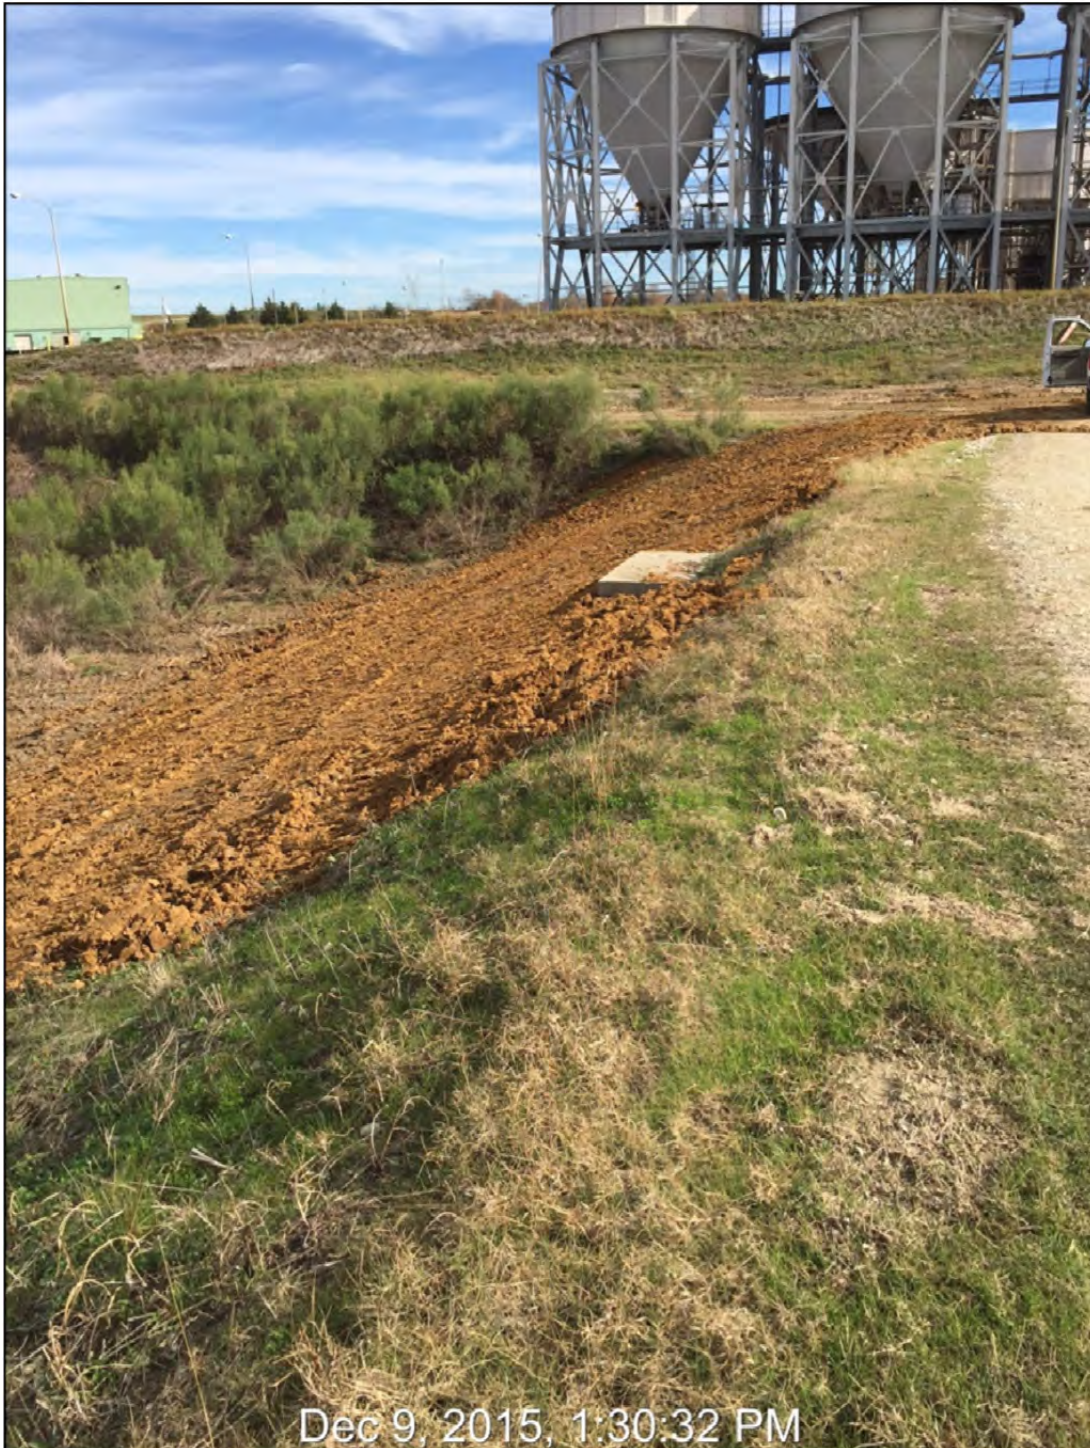
Photograph P-22 – Taken December 9, 2015 by NRG
Pond ST-18: Looking east at outside slope of northern edge of pond.
Note the steep dike section depicted in Photographs P-20 and P-21
has been corrected with the addition of compacted fill.
Grass cover should be established over new fill.

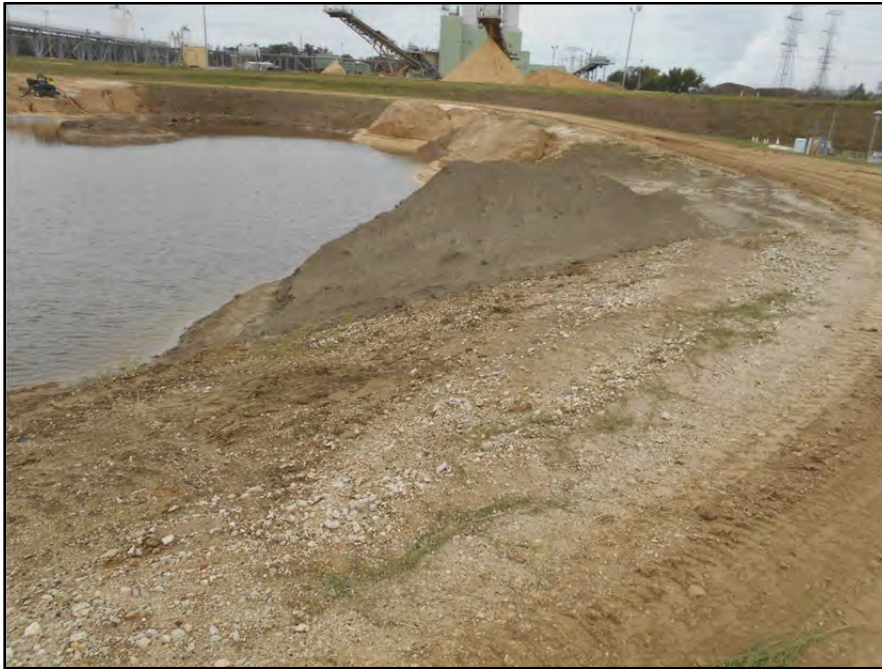
The inside face of the west dike was found to be in good to excellent condition without any visual evidence of instability. However, CCR material piled inside the pond is very steep (Photograph P-23) with evidence of instability of the CCR piles as shown in Photograph P-17. The outside side slope of the western dike was generally in good condition as shown in Photographs P-24 and P-26. However, based on the Google Earth photograph (Photograph P-16) and based on the significant woody vegetation debris observed (Photographs P-24 through P-26) it appears the slope was overgrown with larger vegetation that prevented a good grass cover. Since the woody vegetation has been cut, this and other areas that exhibit sparse grass should be seeded to establish a grass cover for erosion control. Inactive rodent burrows were also observed on the outside slope of the western dike as shown in Photograph P-25. Probing these burrows indicated they are less than 18 in. deep. These burrows should be filled with soil and if rodent populations return and new burrows are found, the rodents should be relocated to protect the dike from future burrows.

Photograph P-23 – Taken November 11, 2015 by David E. Nielson
Pond ST-18: Looking south at inside slope of western dike.

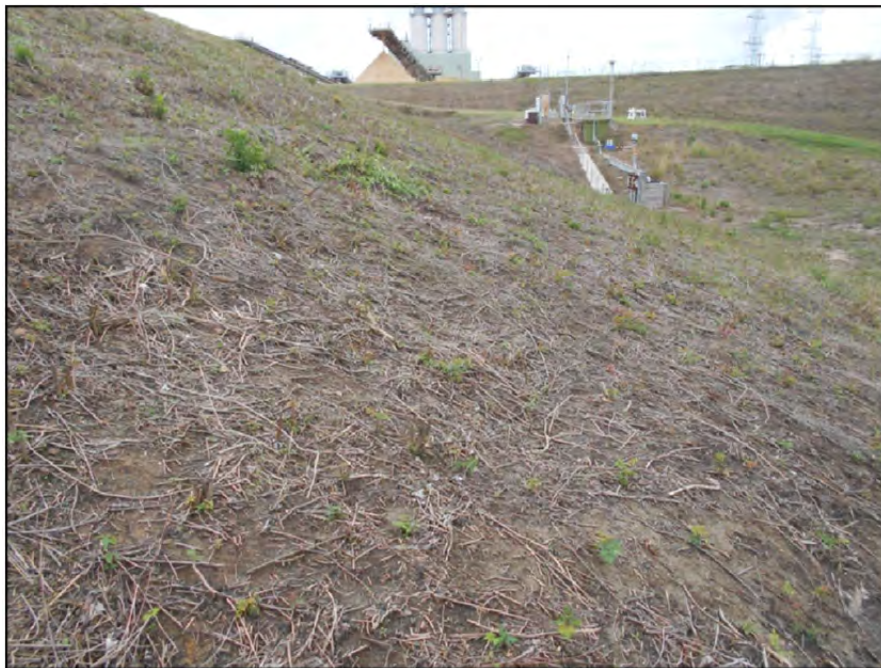
Photograph P-24 – Taken November 11, 2015 by David E. Nielson
Pond ST-18: Looking south at outside slope western dike.
Evidence of recent vegetation cutting was observed.
Grass should be reestablished to reduce the risk of erosion of the outside slope.

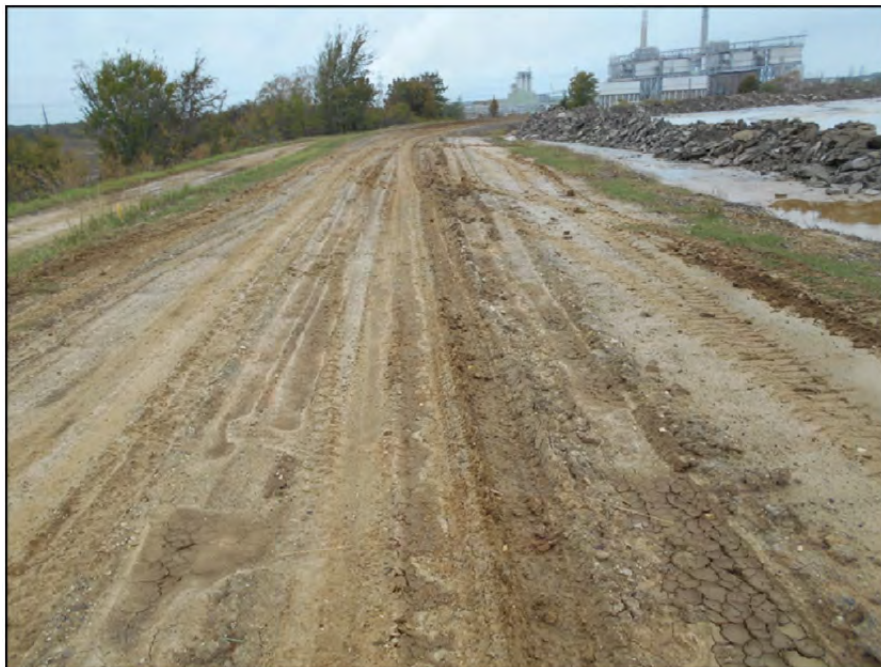
Photograph P-29 – Taken November 11, 2015 by David E. Nielson
Secondary E Pond: Looking west along the southern dike crest and inside slope.
Note rutting of dike crest.

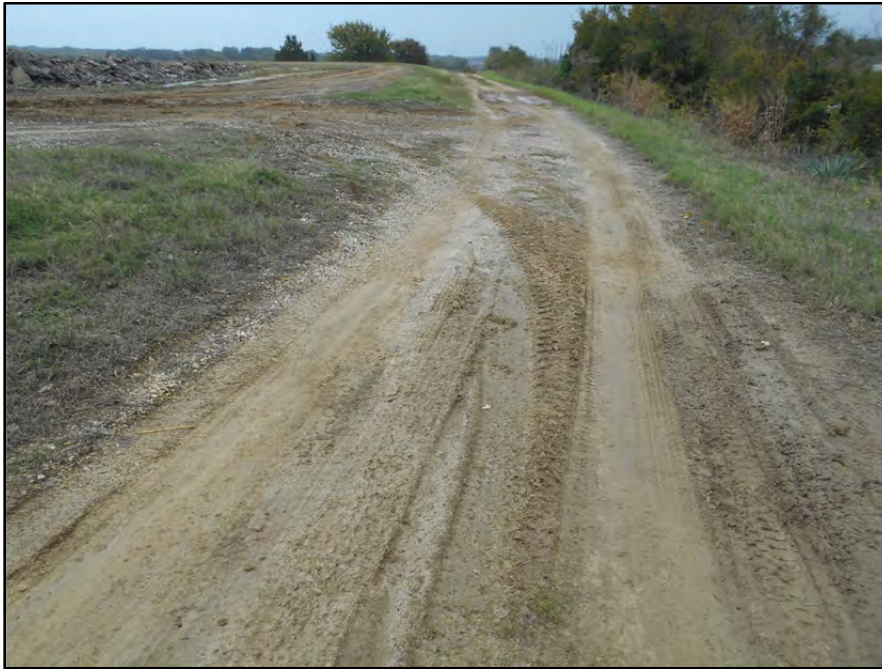
Photograph P-30 – Taken November 11, 2015 by David E. Nielson
Secondary E Pond: Looking east along the wide crest of southern dike.
Note water ponding in ruts along roadway.

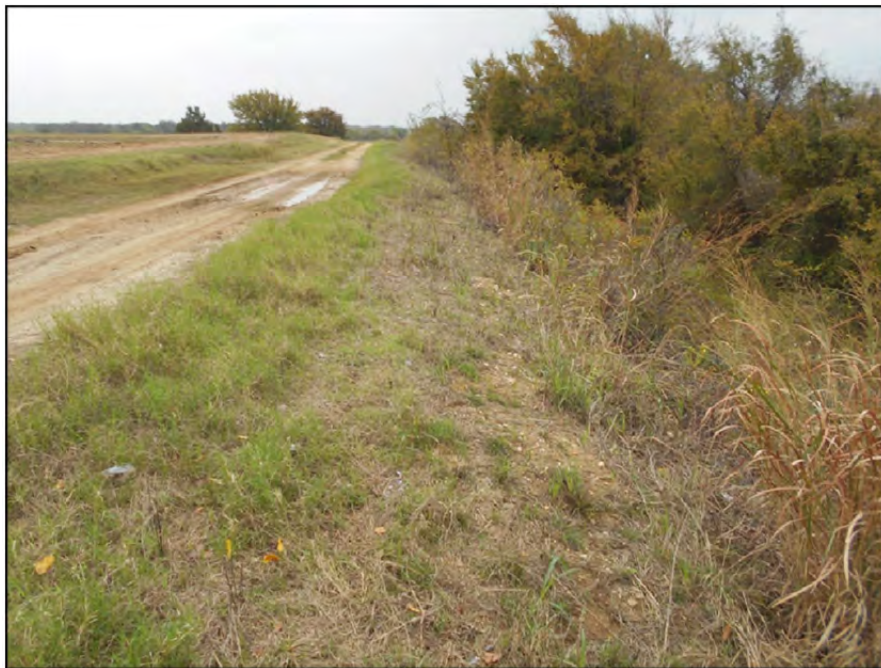
Photograph P-31 – Taken November 11, 2015 by David E. Nielson
Secondary E Pond: Looking east at outside slope of southern dike.
Note the rutting and ponded water in the roadway.
Also note excessive vegetation a significant distance from pond.
Given this distance, roots of woody vegetation have little impact on pond performance.

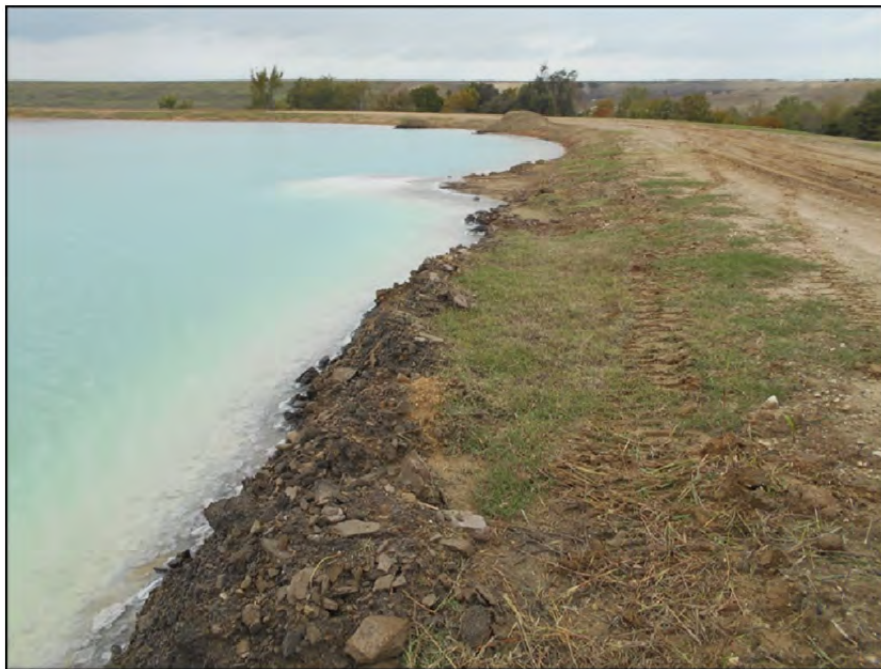
Photograph P-33 – Taken November 11, 2015 by David E. Nielson
Secondary E Pond: Looking north from central dike along the inside slope of the eastern dike.
The non-linear shoreline is likely a result of dredging activity and not dike instability.

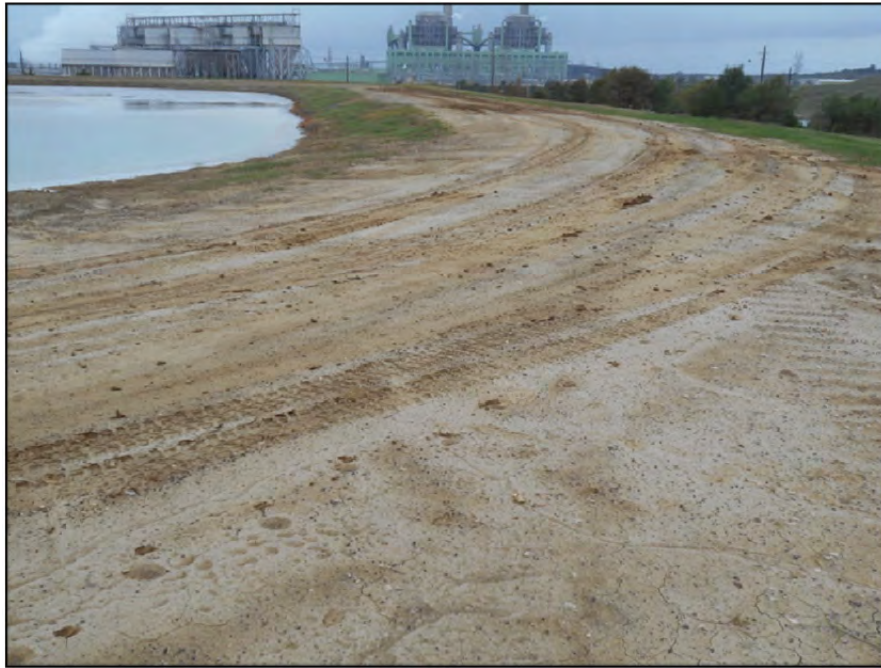
Photograph P-36 – Taken November 11, 2015 by David E. Nielson
Secondary E Pond: Looking west at inside slope of the northern dike.
Note traffic rutting of top of dike.

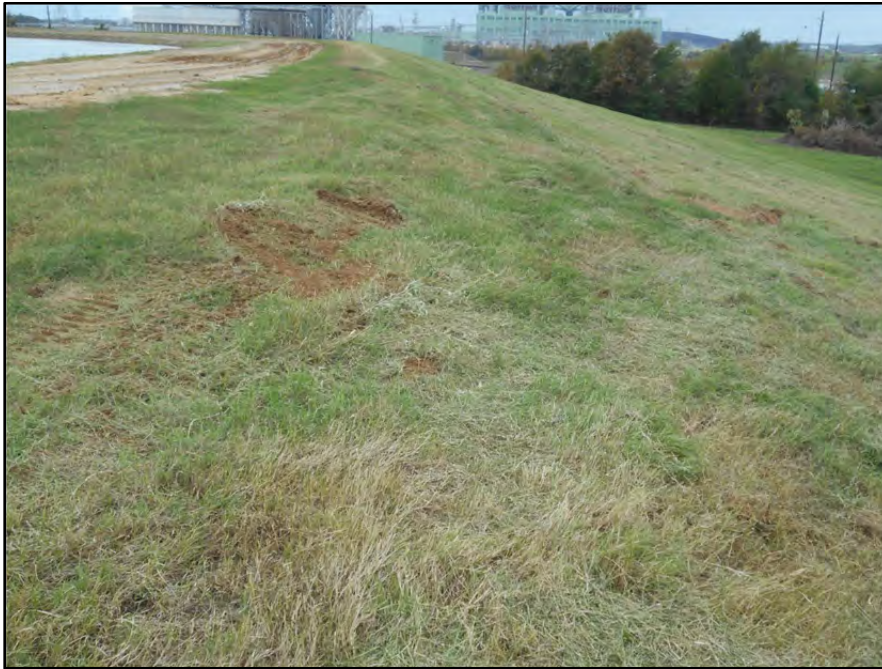
The outside slopes of the Secondary E Pond dikes are generally appropriately sloped and well vegetated with grass as shown in Photographs P-35, P-38, P-39 and P-42. Several localized small areas of disturbed grass were observed (Photograph P-38). However, it is estimated that in the spring growing season these areas will fill in with grass from the surrounding turf.

Photograph P-38 – Taken November 11, 2015 by David E. Nielson
Secondary E Pond: Looking west along the outside slope of the northern dike.
Note good grass vegetation in most areas, with some bare areas.

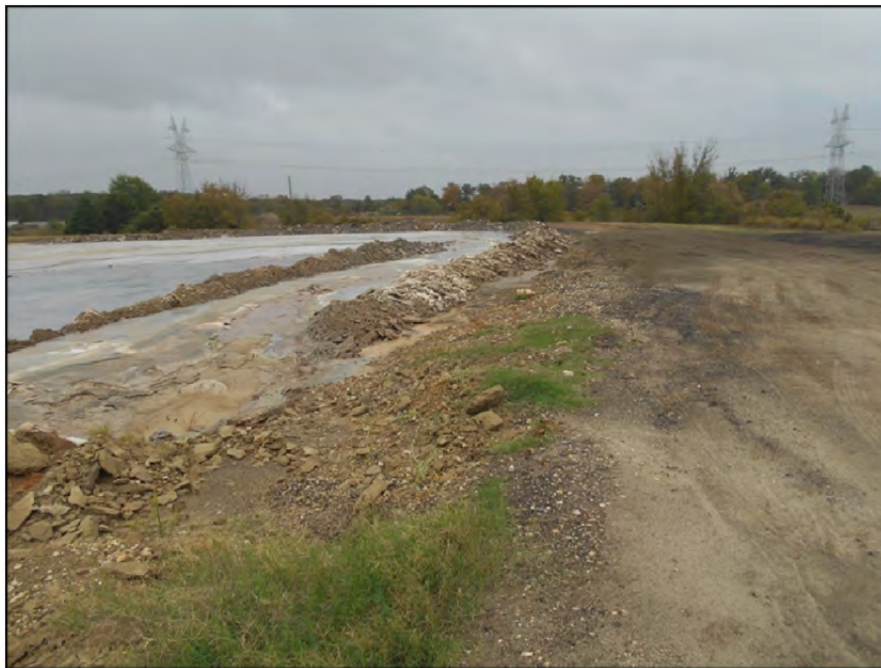
Photograph P-41 – Taken November 11, 2015 by David E. Nielson
Secondary E Pond: Looking south at inside slope of western dike and dike crest.
Note rigid consistency of excavated stabilized sludge. The Secondary E Pond has significant accumulations of stabilized sludge that promotes stability of the dike system.

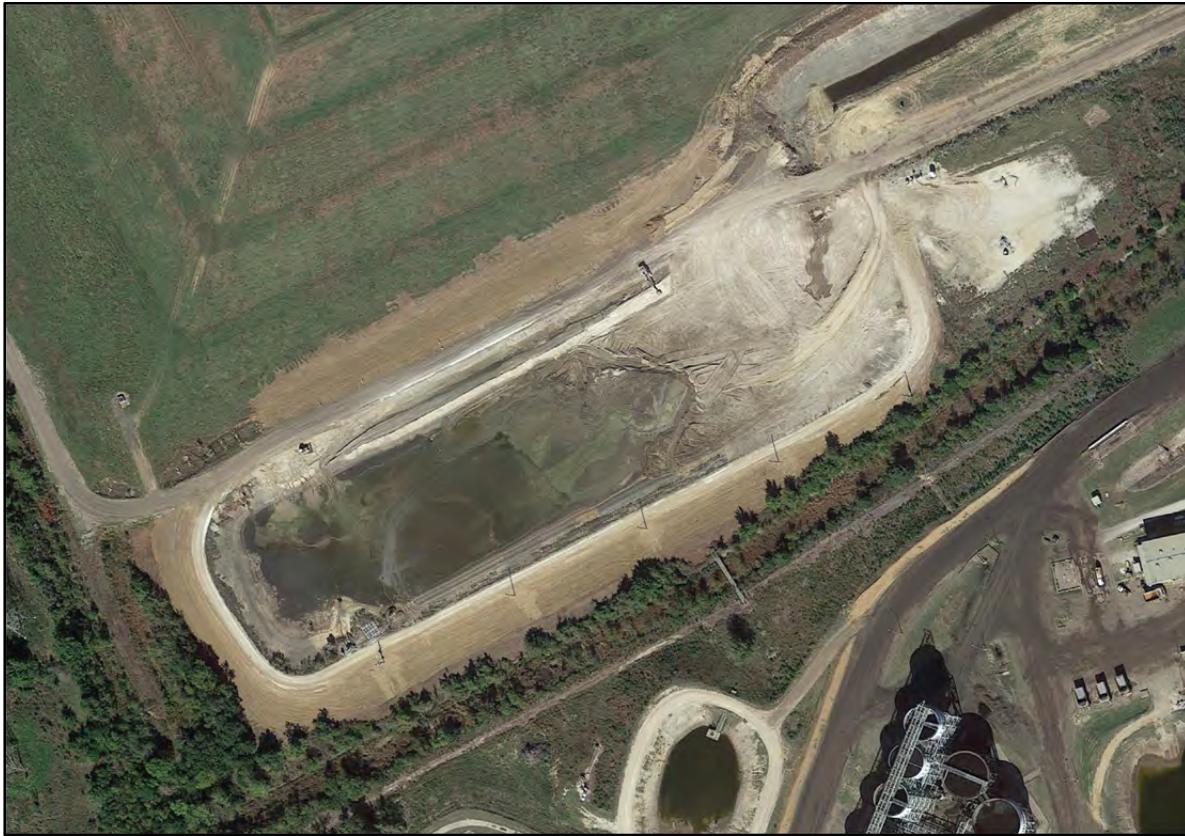
The outside slopes of Pond 002 dikes are generally appropriately sloped as shown on Photographs P-47 and P-50. Numerous areas of insufficient vegetation are noted in these photographs as well as the Google Earth Photograph P-44. A more substantial vegetative cover should be established around the outside slopes of Pond 002.

Photograph P-44 – From Google Earth Pro Downloaded January 1, 2016
Pond 002: Aerial view.

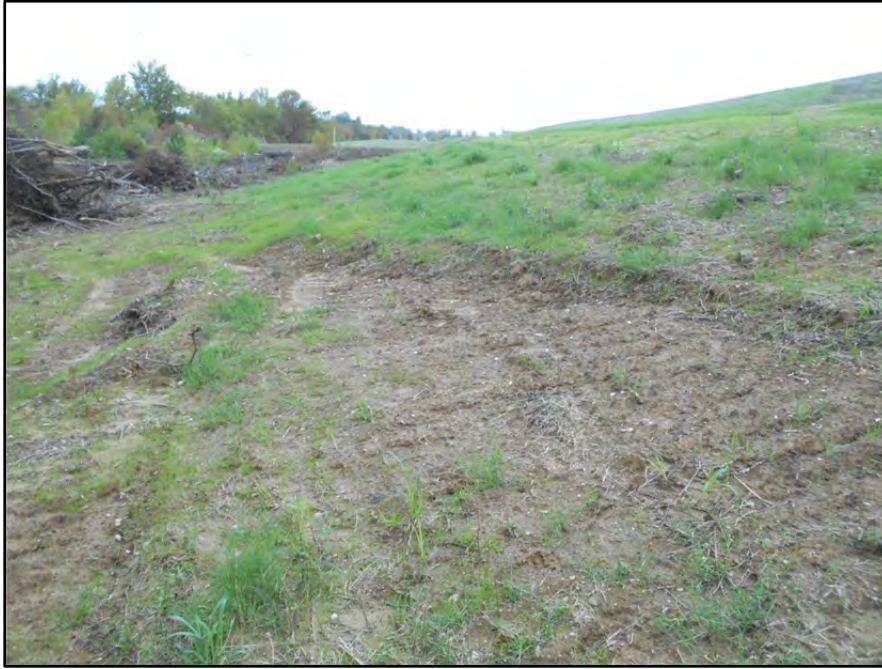
Photograph P-47 – Taken November 11, 2015 by David E. Nielson
Pond 002: Looking north at outside slope and toe of slope of the western dike.

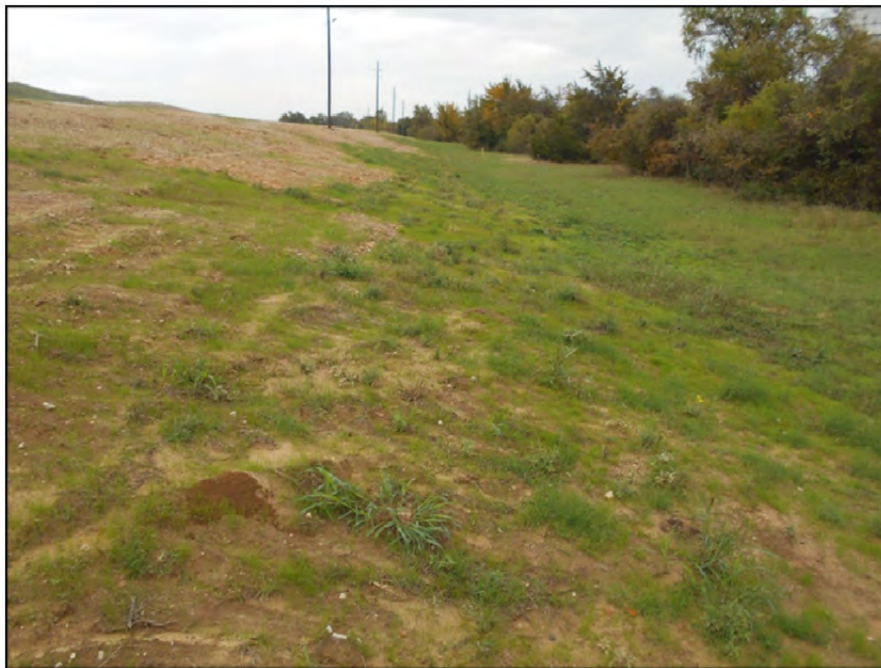
Photograph P-50 – Taken November 11, 2015 by David E. Nielson
Pond 002: Looking east along the outside slope and toe of slope of the southern dike.

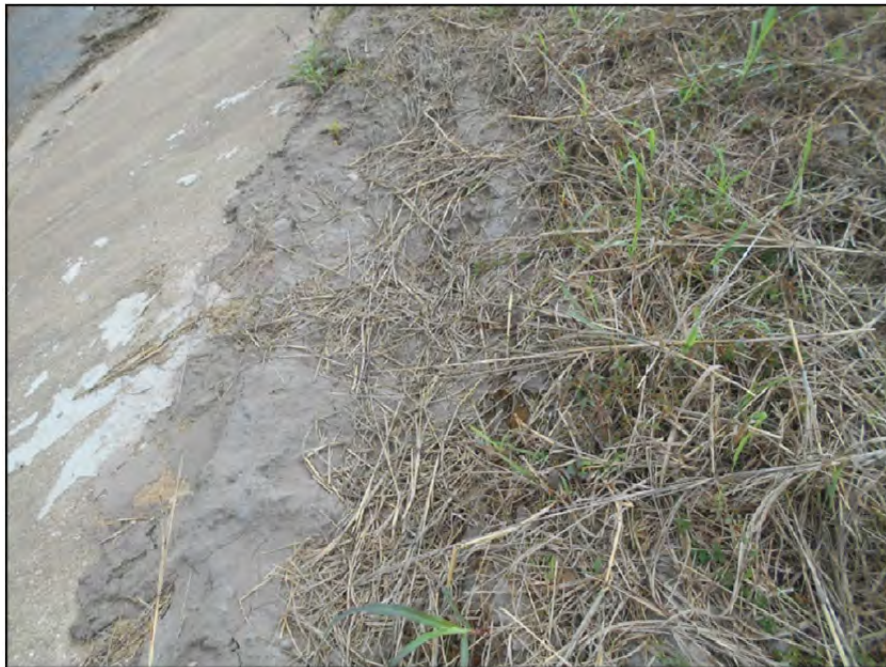
Drainage structures constructed to transfer stormwater from the top of the capped areas down to the perimeter ditch consist of concrete lined rundown channels. One rundown channel is present in Area 1 and a second in Area 5. These channels do exhibit some cracks but are considered to be in good condition as shown in Photographs P-54, P-55, P-56, P-59, P-61 and P-65. NRG had noted some undermining of the rundown channel in Area 1 and grouted beneath the slab as shown in Photograph P-57.

Photograph P-57 – Taken November 11, 2015 by David E. Nielson
Landfill Area 1: Looking at grouted repair of an area of stormwater concrete lined rundown channel that was previously undermined.

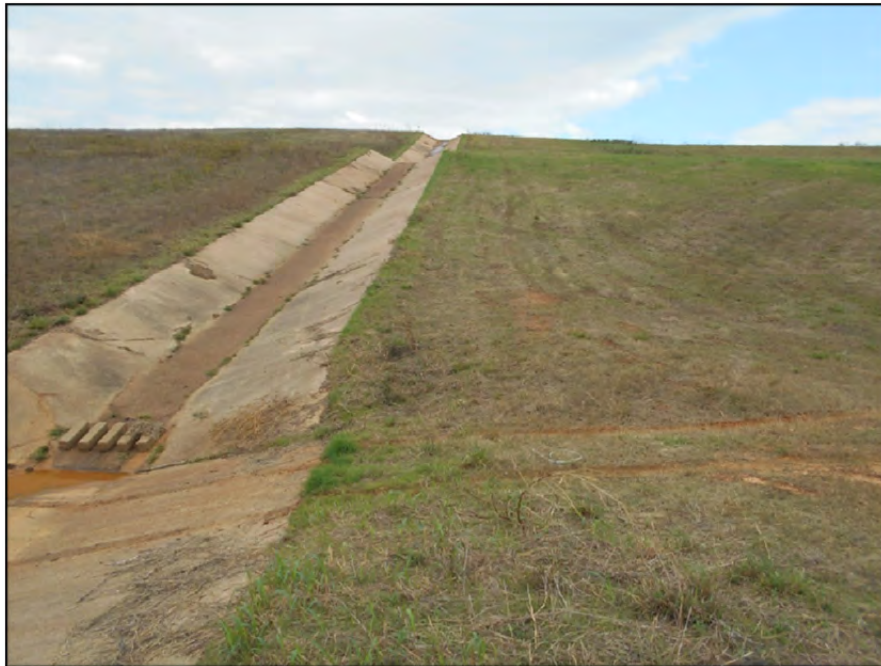
Photograph P-65 – Taken November 11, 2015 by David E. Nielson
Landfill Area 5: Looking northeast at concrete lined stormwater rundown channel.
Note generally good condition of the concrete lining, energy dissipation blocks and vegetation.
Several minor areas of sparse grass are noted.

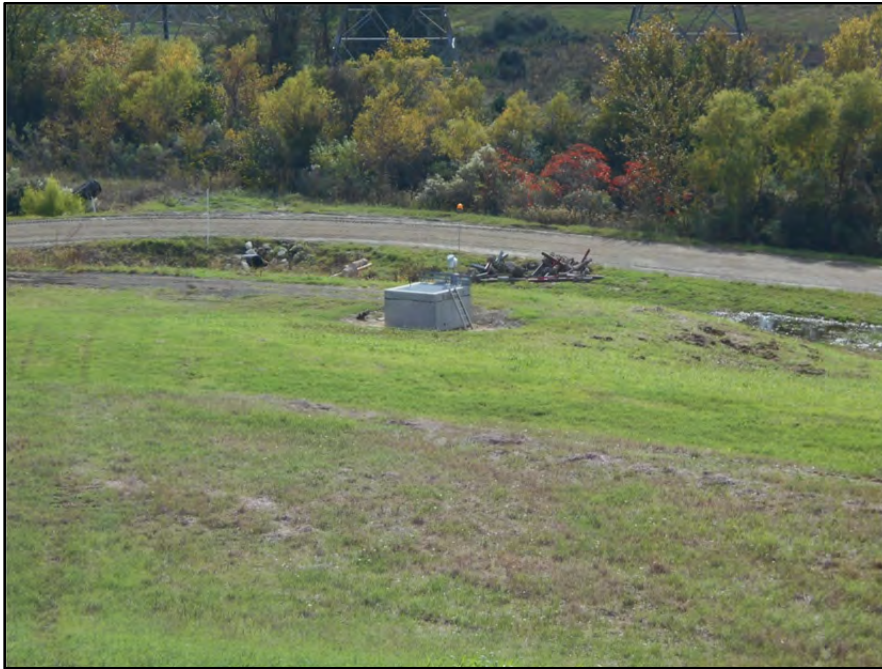
Historical reports indicate that some water seepage was observed at the landfill toe near the southern corner of Area 9. A series of French drains were installed with drainage into a sump as shown in Photograph P-70. S&L did not observe any evidence of ongoing seepage.

Photograph P-70 – Taken November 11, 2015 by David E. Nielson
Landfill Area 9: Looking south at pump station for French drains
located at toe of capped landfill slope.
Note disturbed vegetation right of pump station (see Photograph P-71).

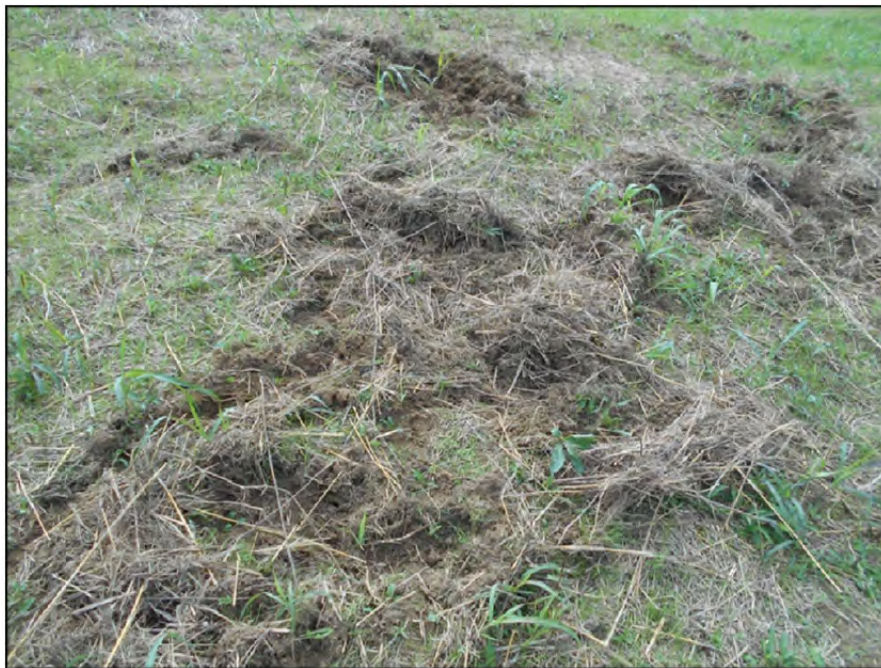
Photograph P-71 – Taken November 11, 2015 by David E. Nielson
Landfill Area 9: Looking at damage to vegetation shown in Photograph P-70, which was
caused by feral hogs. Some areas damaged by feral hogs included holes less than 4 inches
deep. Note shallow depth of disturbance and likelihood of re-vegetation
due to intact grass roots.
