2021 Annual Inspection of CCR Unit

**Limestone Electric Generating Station
Jewett, Texas**

January 2022

NRG Texas Power LLC

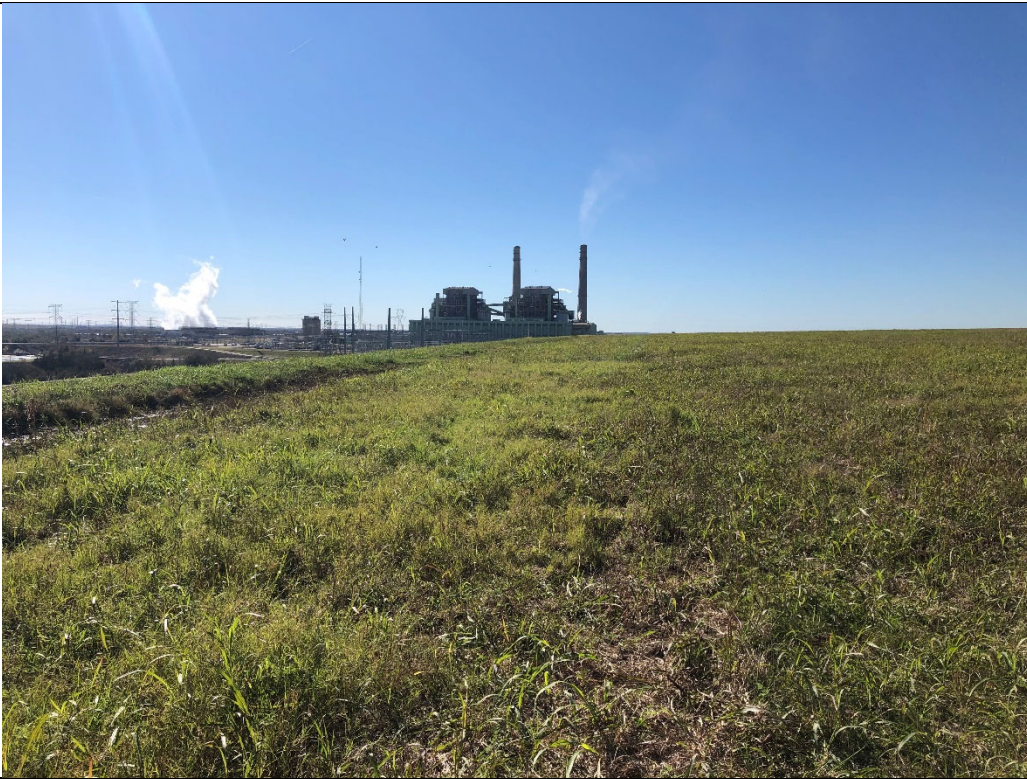
Although landfill Areas 1, 2, 3, 5, 6, 9, and 10 are considered to be capped, exposed slopes of CCR are present in Areas 1, 3, 6, and 10, where uncapped and future expansion areas will abut the existing CCR material (Figure 2). The plateaued portion of the capped areas is well vegetated and generally well graded to prevent the localized ponding of stormwater and to direct the flow of stormwater as depicted in Photographs P-1 and P-2.

Photograph P-1: View looking southwest across the capped surfaces of Areas 9 and 10. The landfill cap appeared to be well vegetated and appropriately sloped.

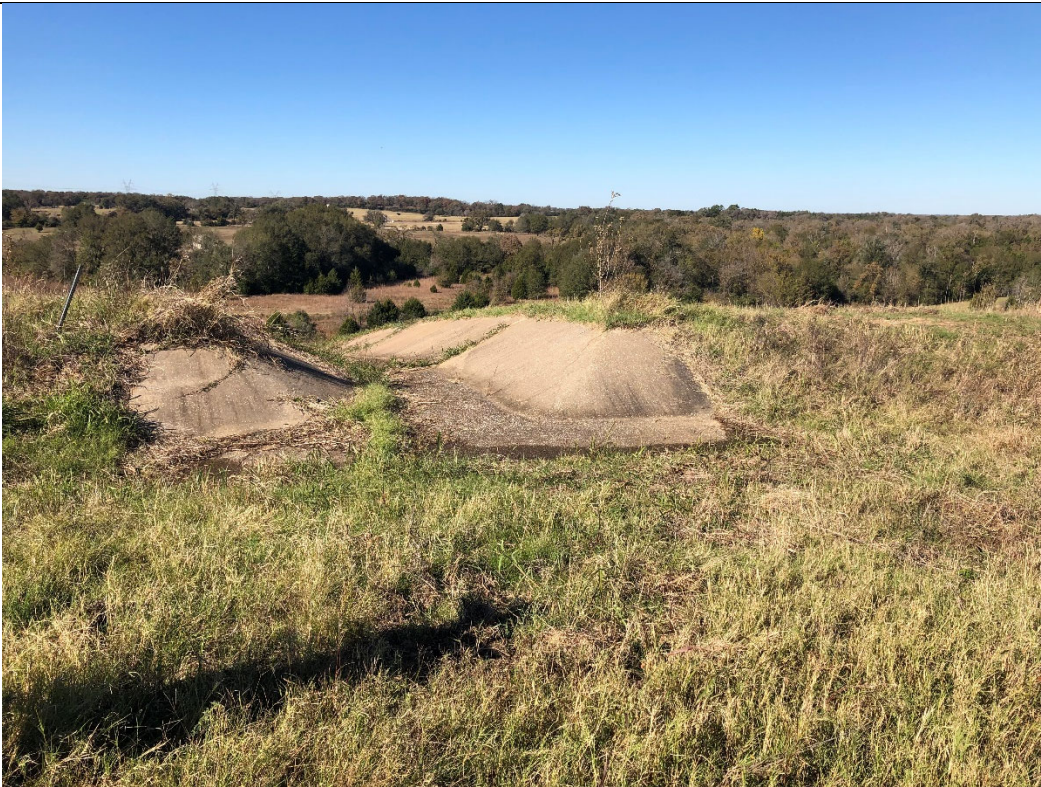
Photograph P-2: View looking west of concrete drainage structure in Area 5 that conveys drainage from the top of the capped portion of the landfill to the non-contact water perimeter ditch.

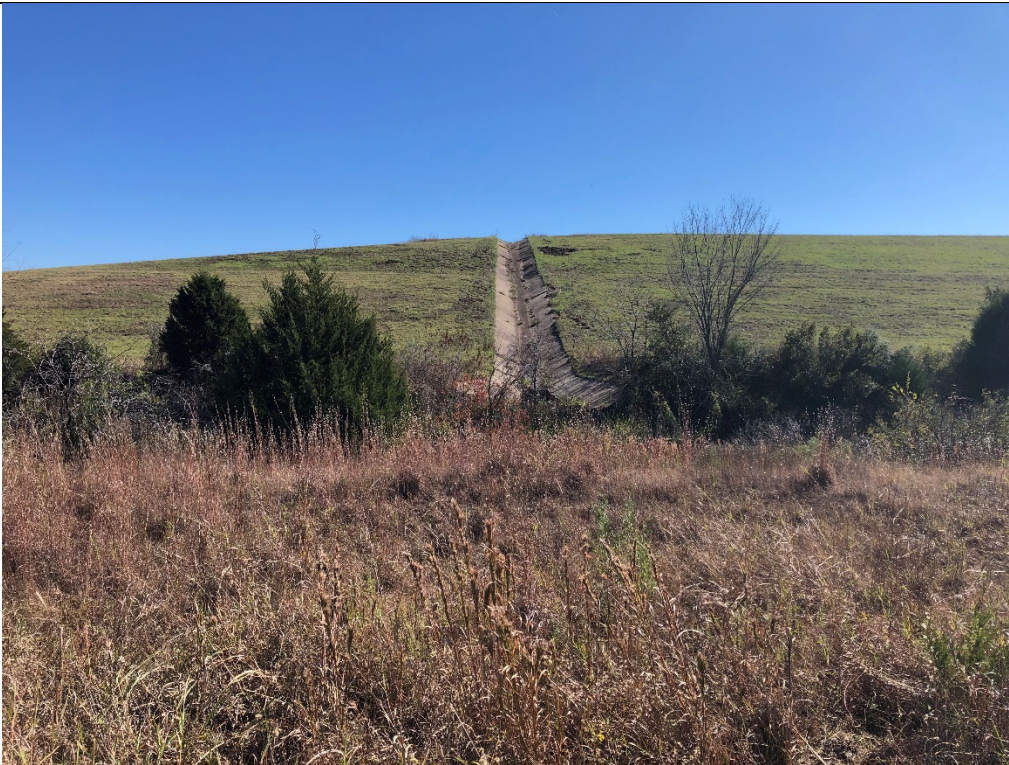
Drainage structures constructed to transfer stormwater from the top of the capped areas to the perimeter ditch consist of concrete lined rundown channels. One rundown channel is present in Area 1 and a second is present in Area 5. Some cracking was observed in these rundown channels, but they are considered to be in good condition as shown in Photograph P-3.

Photograph P-3: View looking southeast at Area 1 of the Unit 004 Landfill. The landfill slopes were well vegetated. The concrete drainage structure conveys runoff from the top of the Unit. It empties into an unseen drainage ditch separated from the viewer by a berm.

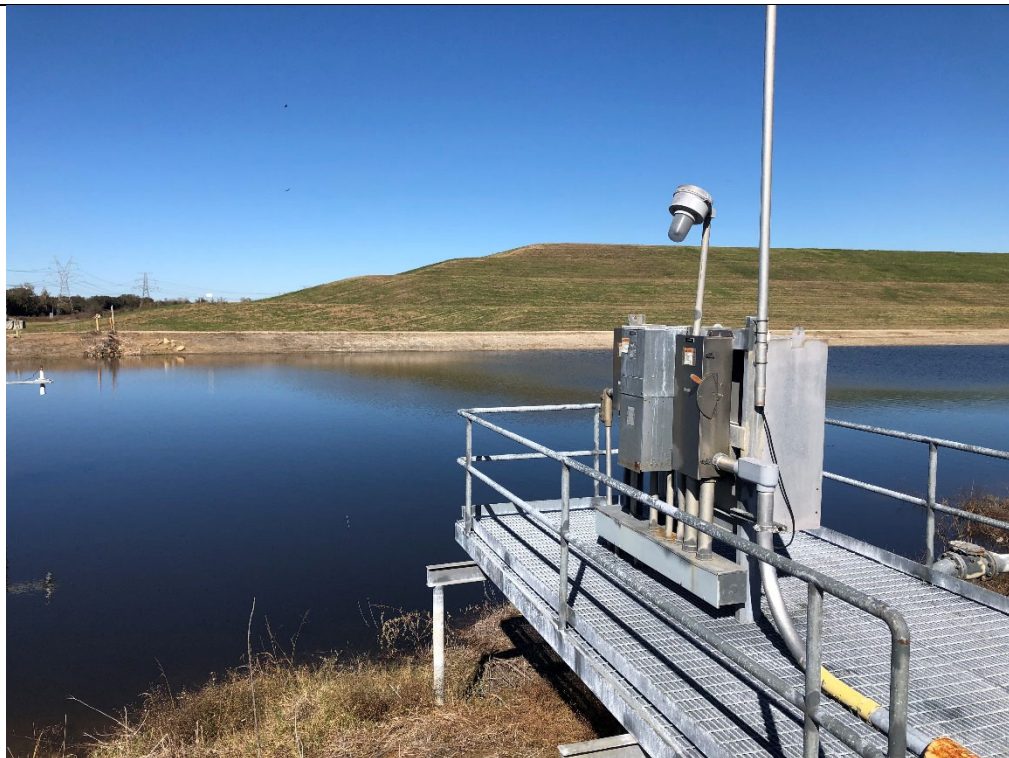
The side slopes of the capped landfill areas are well vegetated and have appropriate perimeter ditches as depicted in Photographs P-3 and P-4. As mentioned above, the east sidewalls of Areas 1 and 3, the southeast corner of Area 6, and the east sidewall of Area 10 are not vegetated. These areas abut active or future expansion areas of the landfill. The exposed CCR material sidewalls of these areas are shown in Photographs P-5 and P-11. Stormwater that comes into contact with the exposed CCR material is captured in the contact water perimeter ditch system and directed to Pond 002.

Photograph P-4: View looking north at Pond 002 (a stormwater pond) and the capped and closed sidewall of Area 9. The landfill slopes were well vegetated.

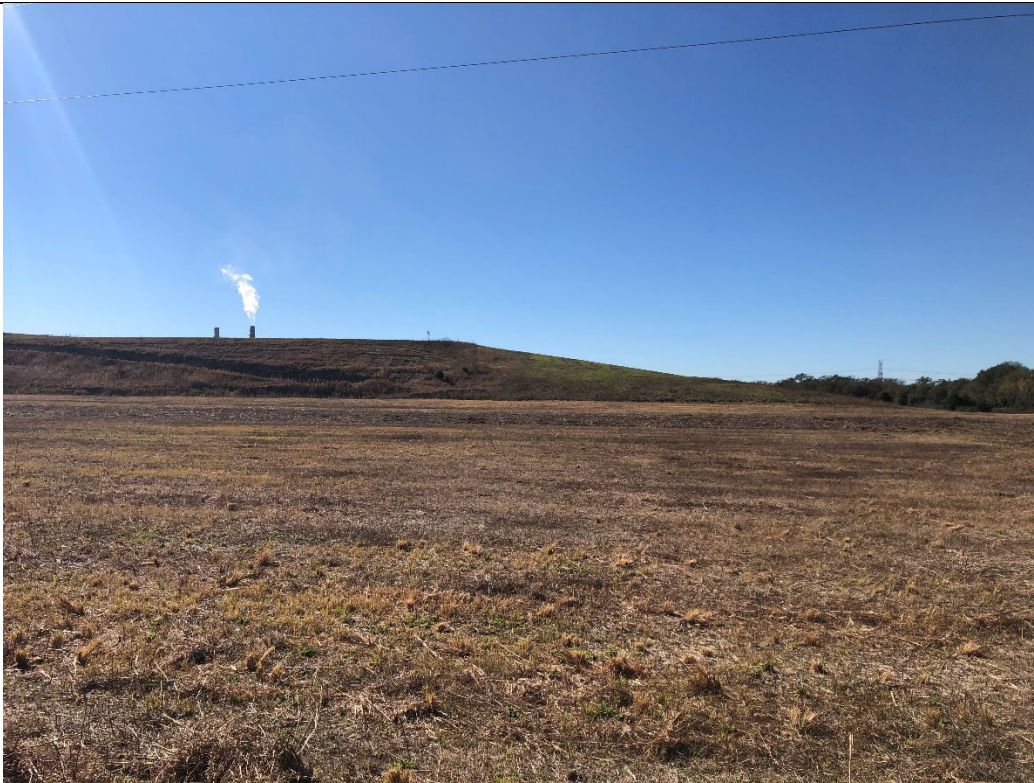
Photograph P-5: View looking southwest across Area 13 (a lined portion of the landfill that will be used in the future) at the sidewall of Area 1.

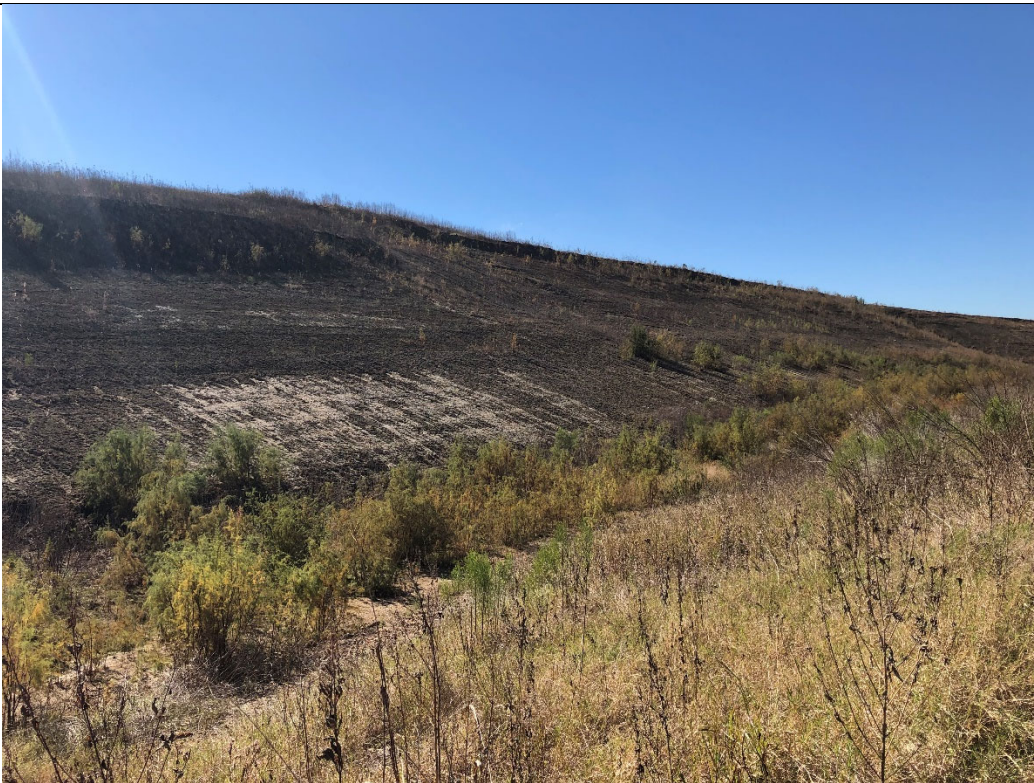
As discussed above, Areas 4, 7, and 8 have been partially closed (Photograph P-6), but are considered “uncapped” because significant portions of these areas have uncapped CCR slopes or surfaces. These slopes appear to be stable due to the cohesive nature of the CCR. In particular, a large portion of Area 8 has been closed, and a drainage feature separates stormwater runoff from the capped portion of this

Photograph P-6: View looking across contact water ditch of Area 4 sidewall.

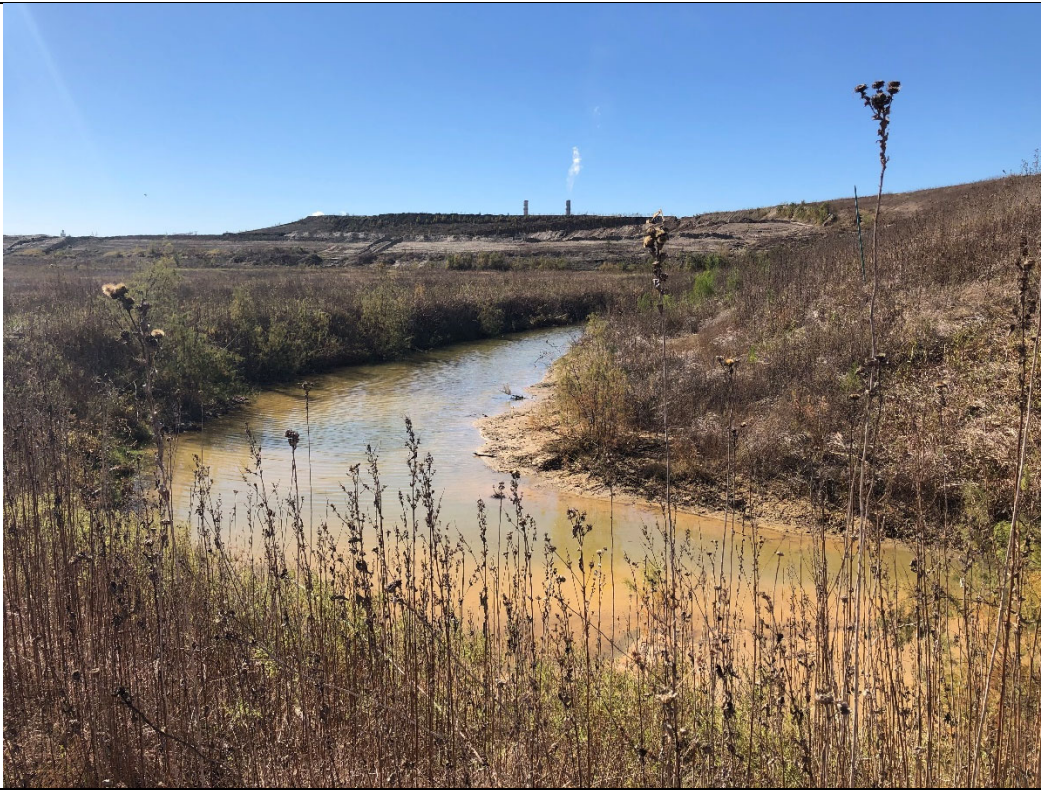
Contact water from all of the uncapped CCR slopes and disposal areas discharges into the interceptor ditch as shown in Photograph P-7. The interceptor ditch is located adjacent to the outer perimeter of these areas and directs the stormwater runoff and any eroded CCR to Pond 002.

Photograph P-7: View looking west across contact water ditch adjacent to the southeast corner of Area 8. Area 12A (the current active waste disposal area) is visible in the center background.

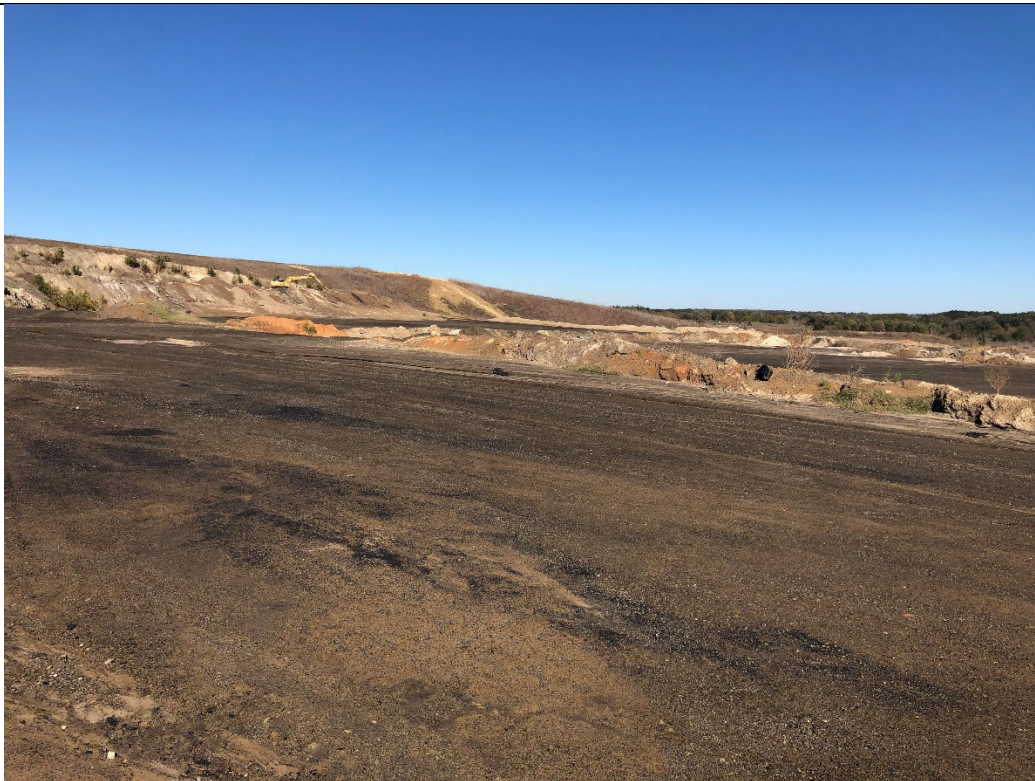
Photograph P-8: View looking north of Area 12A, where CCR is currently being disposed. An uncapped CCR slope in Area 8 is visible in the left background of the photograph.

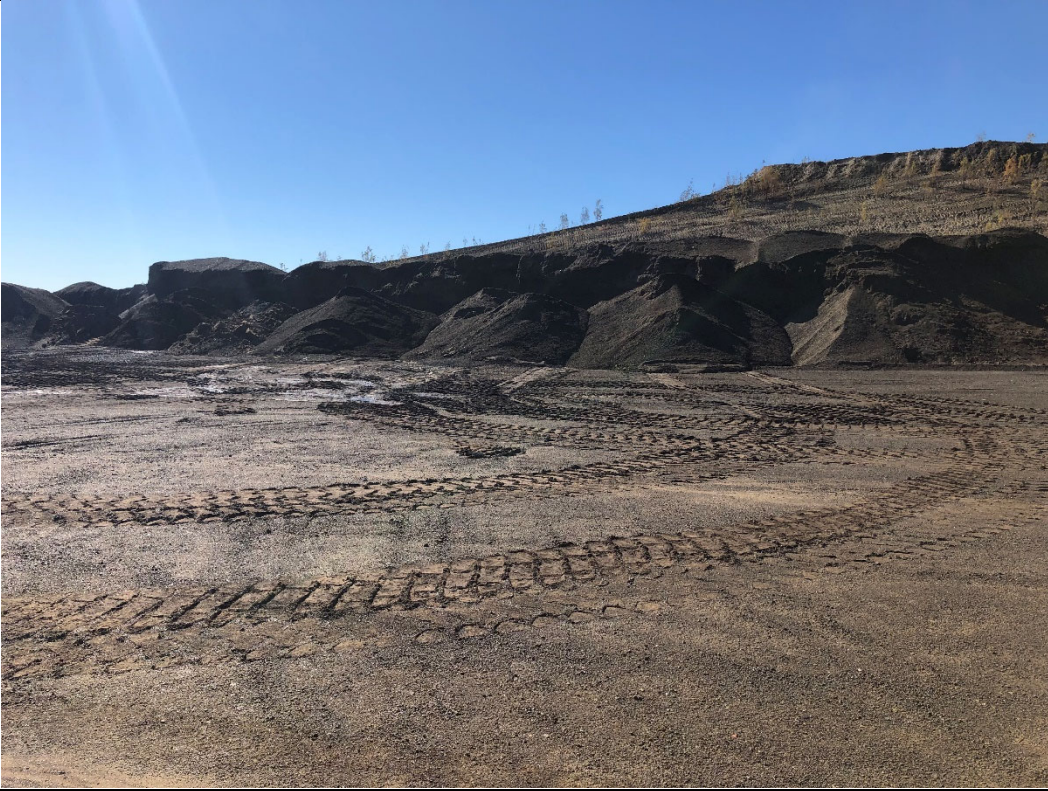
Photograph P-9: Another view of CCR material in Area 12A. An uncapped sidewall of CCR material in Area 11 is visible in the right background.

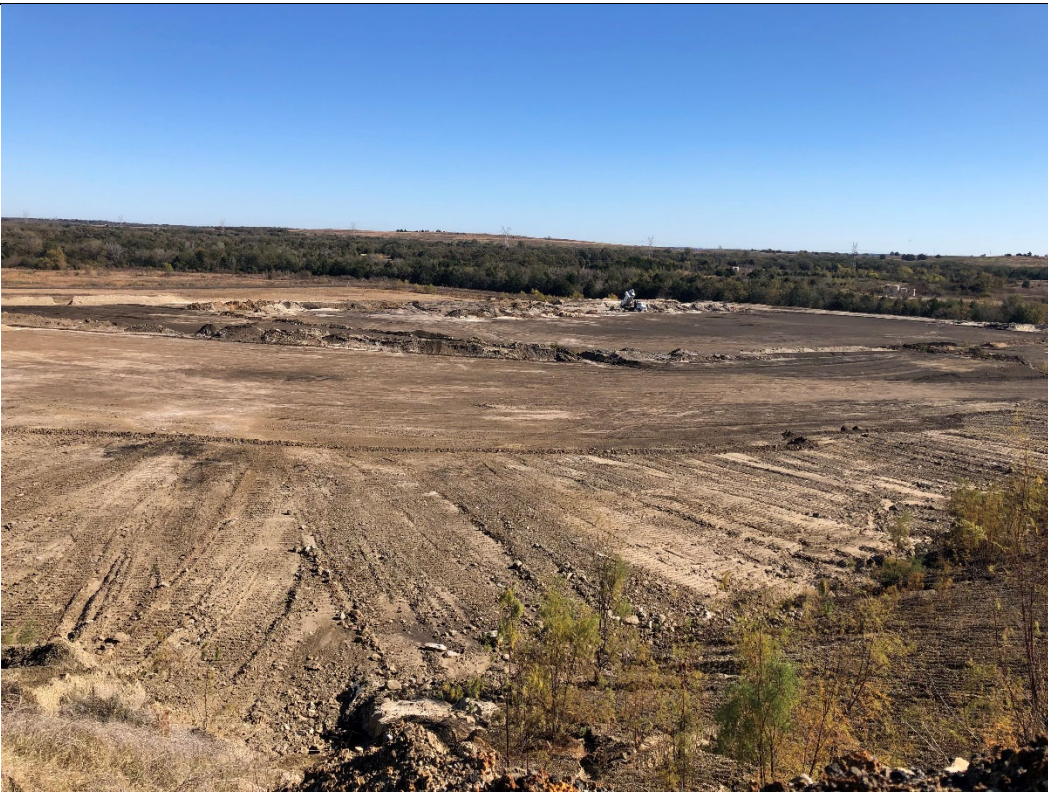
Photograph P-10: Another view of Area 12A as seen from Area 11.

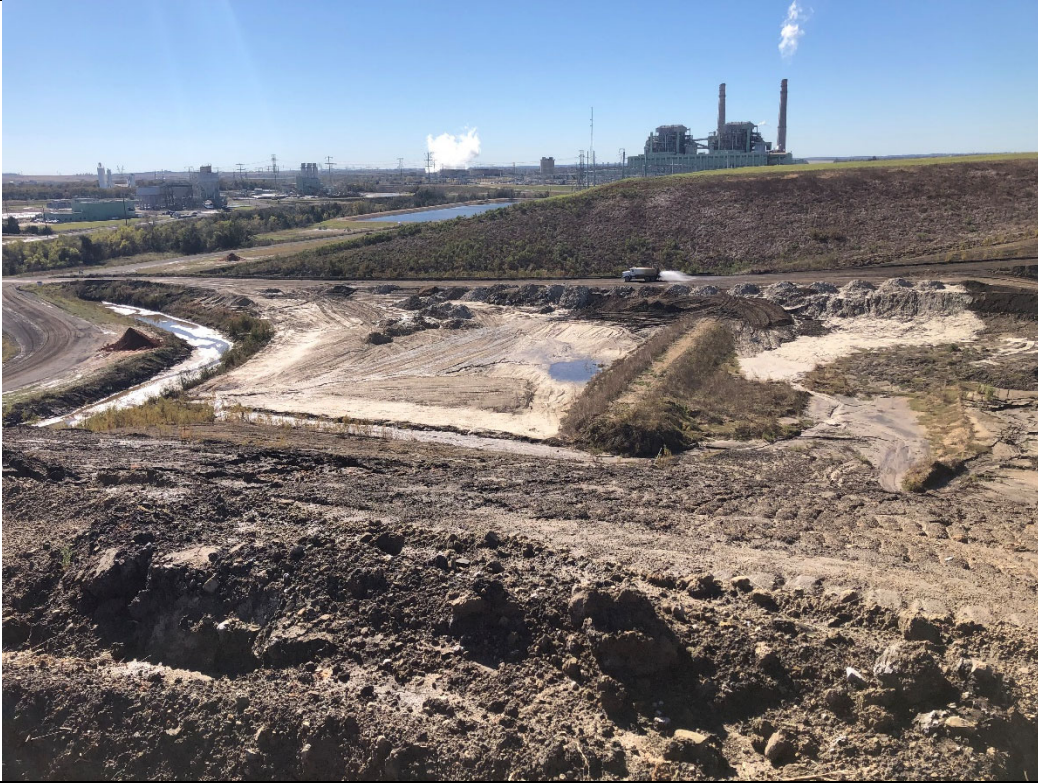
Photograph P-11: View looking west across Area 11. This area was formerly a storage area for marketable CCR, but will be an active disposal area in the landfill in the future. The sidewall of Area 10 is visible in the background.
