2024 Annual Inspection of CCR Unit

**Limestone Electric Generating Station
Jewett, Texas**

January 2025

NRG Texas Power LLC

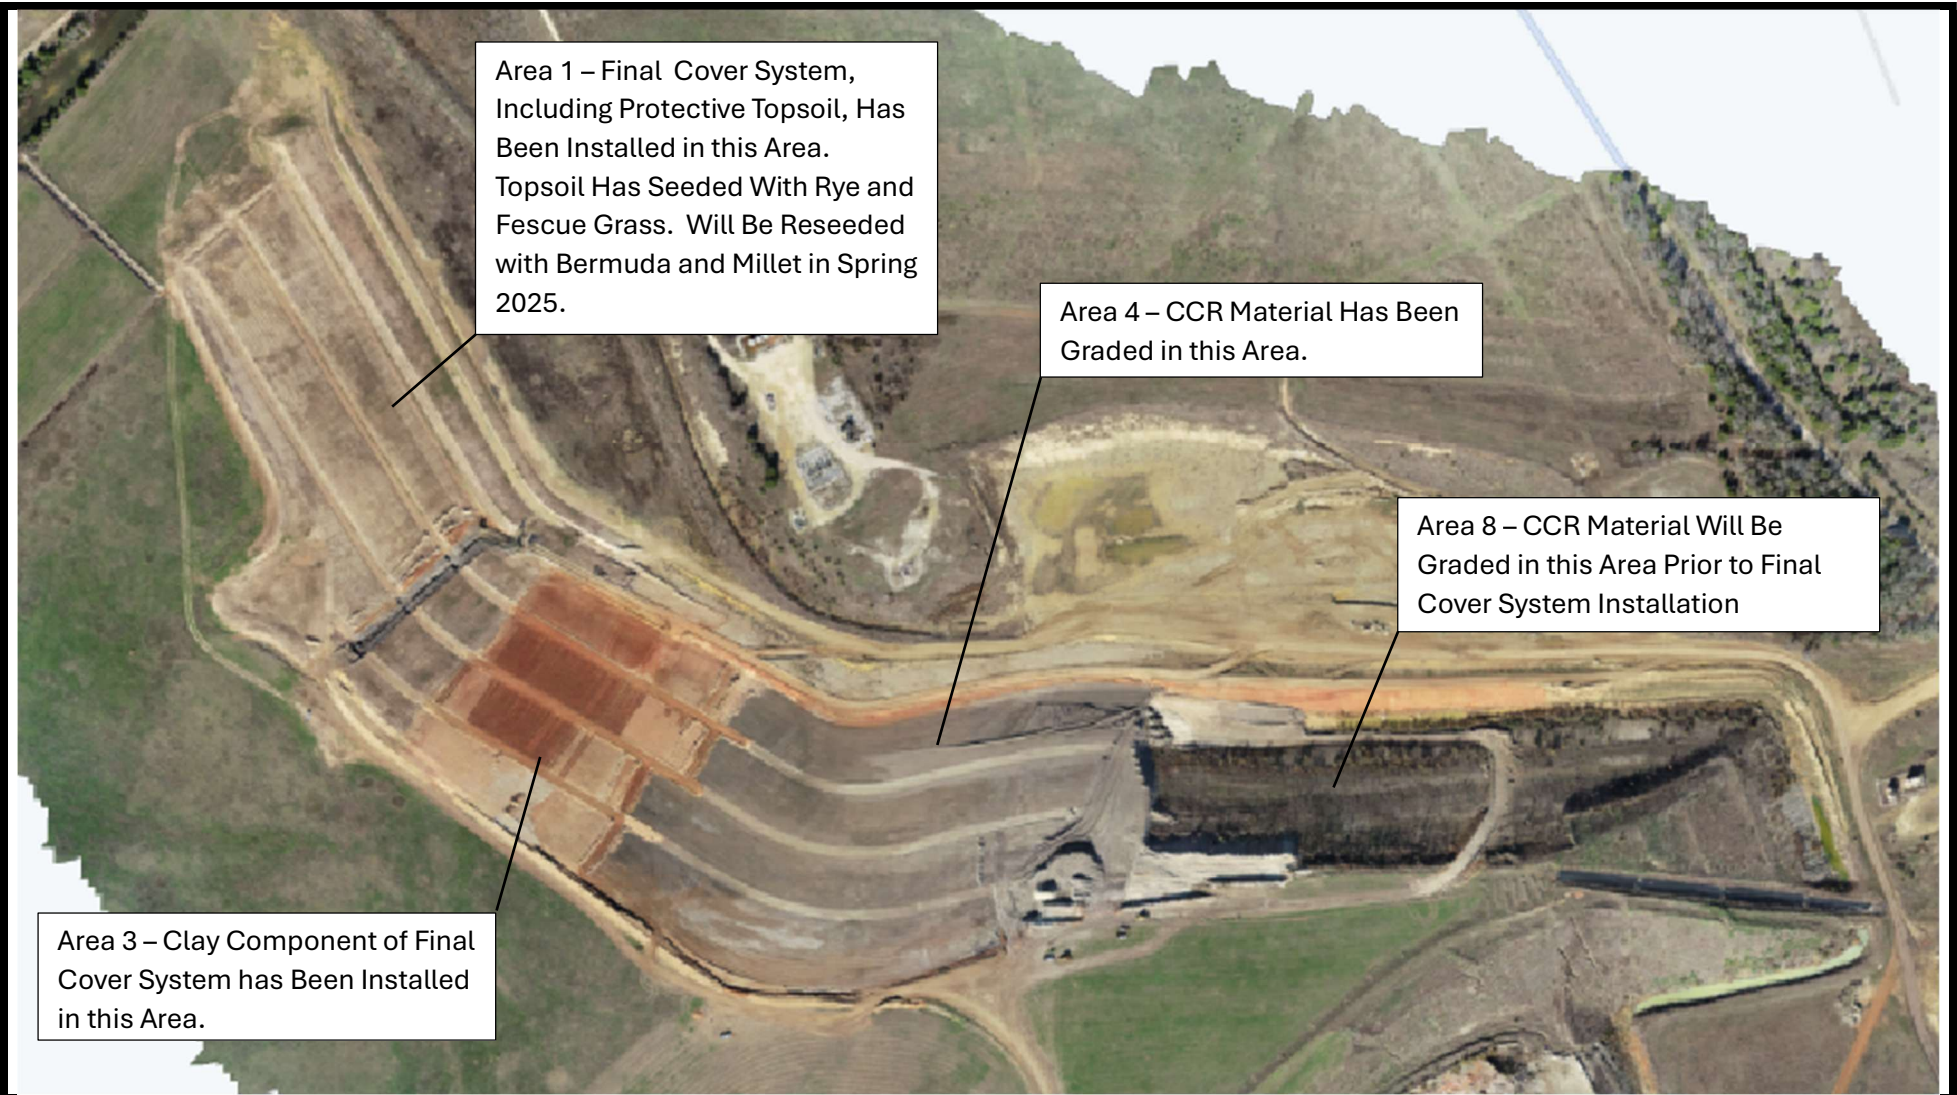
FIGURE 3

Area 1 – Final Cover System, Including Protective Topsoil, Has Been Installed in this Area. Topsoil Has Seeded With Rye and Fescue Grass. Will Be Reseeded with Bermuda and Millet in Spring 2025.

Area 4 – CCR Material Has Been Graded in this Area.

Area 8 – CCR Material Will Be Graded in this Area Prior to Final Cover System Installation

Area 3 – Clay Component of Final Cover System has Been Installed in this Area.

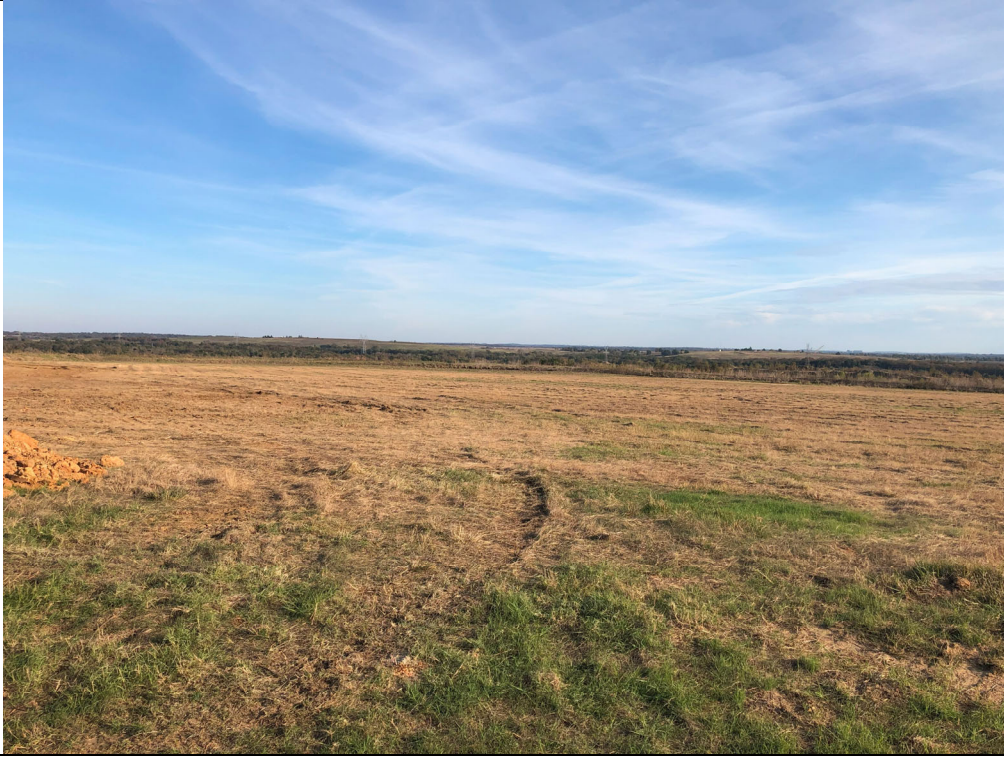
The exposed CCR slopes of Areas 6 and 10 abut active portions of the landfill which will be filled and closed in the future (Figure 2). The plateaued portion of the capped areas is well vegetated and generally well graded to prevent the localized ponding of stormwater and to direct the flow of stormwater as depicted in Photographs P-1, P-2, and P-4.

Photograph P-1: View looking southeast across the capped surfaces of Areas 1 and 2. The landfill cap appeared to be well vegetated and appropriately sloped.

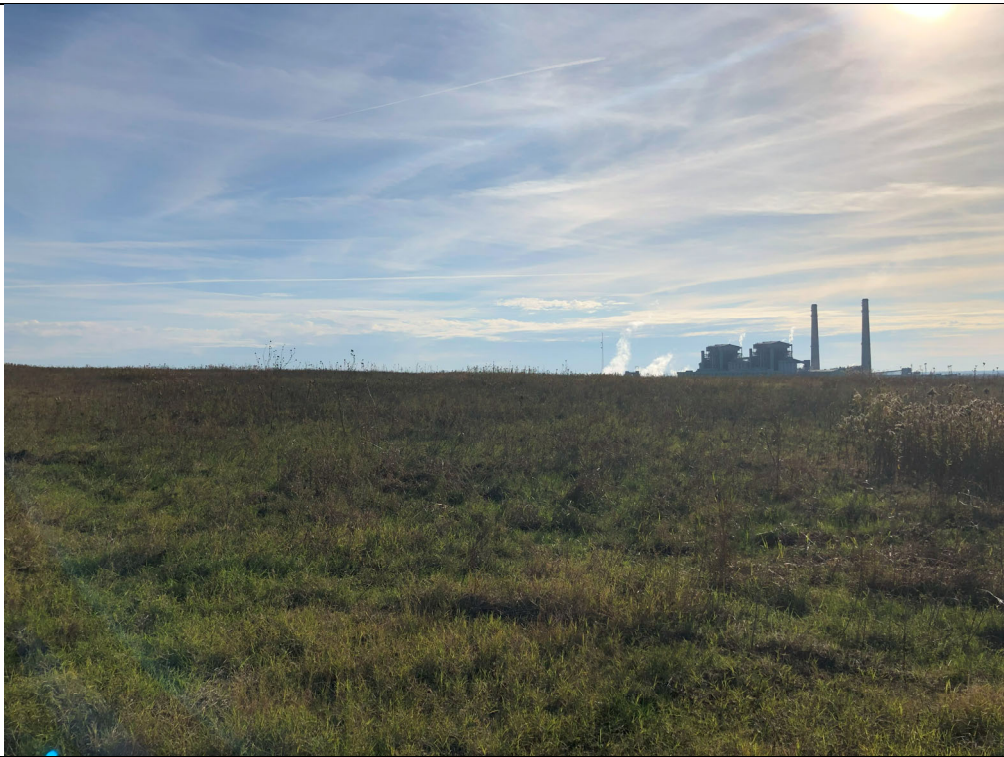
Photograph P-2: View looking west of well vegetated, closed cap of Area 6 and 5.

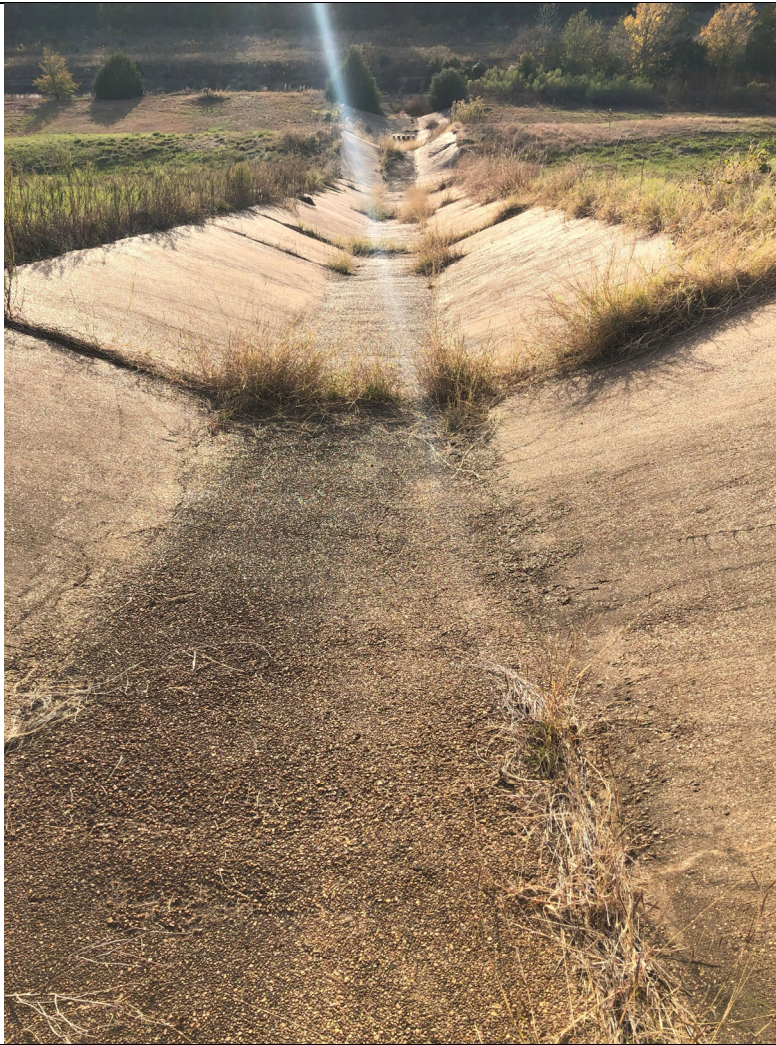
Drainage structures constructed to transfer stormwater from the top of the capped areas to the perimeter ditch consist of concrete lined rundown channels. One rundown channel is present in Area 1 and a second is present in Area 5. Some cracking and vegetation growth was observed in these rundown channels, but they are considered to be in good condition as shown in Photograph P-3.

Photograph P-3: View looking west-southwest down concrete outfall in Area 5. A stormwater ditch located along the perimeter of the top of the landfill drains to this concrete outfall (also in Photograph P-4).

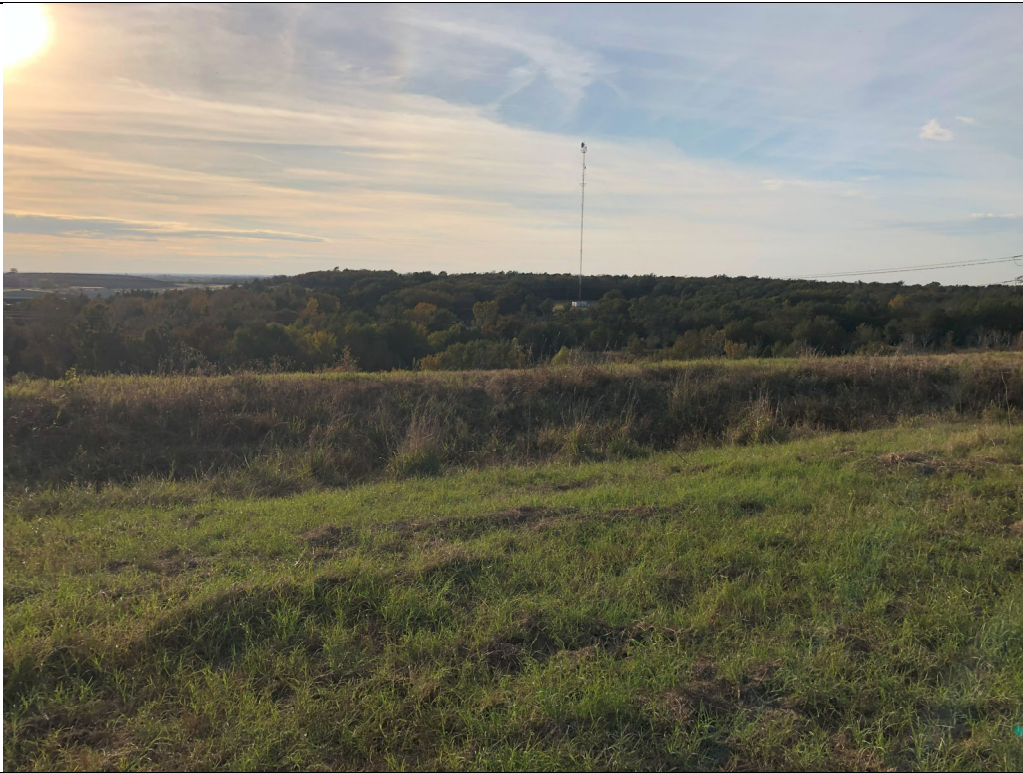
Photograph P-4: View looking west-northwest at the drainage ditch located along the perimeter of the top of the landfill. This ditch drains to the concrete outfall structure shown in Photograph P-3. The ditch appeared to flow well, without significant rutting or standing water.

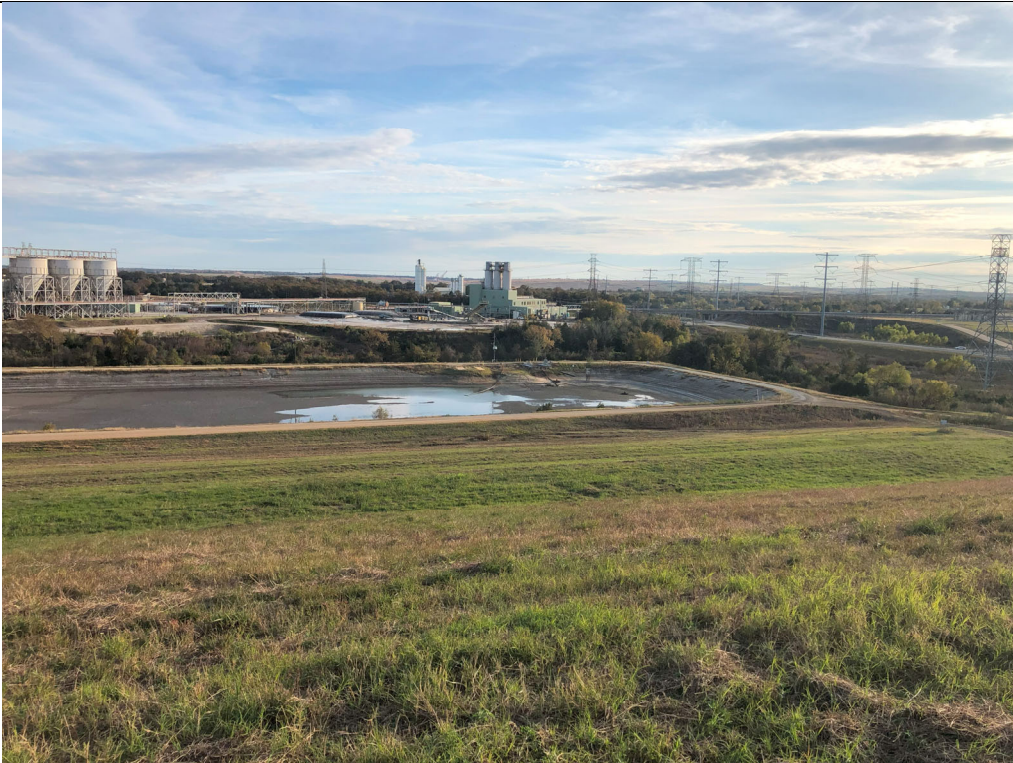
The rundown channels discharge into a perimeter drainage ditch that flows around the west and south sides of the landfill. Since the flow in these channels consists of stormwater from the capped areas of the landfill that has not come into contact with CCR, this stormwater flow is managed separately from the perimeter interceptor ditch that collects stormwater that has come into contact with CCR from uncapped areas of the landfill (“contact water”). The perimeter interceptor ditch directs contact water to Pond 002. The perimeter interceptor ditch for contact water is visible in Photograph P-10, and the 002 Pond is visible in Photograph P-5.

Photograph P-5: View looking south-southeast across the 002 Pond from top of Area 9. The 002 Pond had been drained so it could be cleaned.

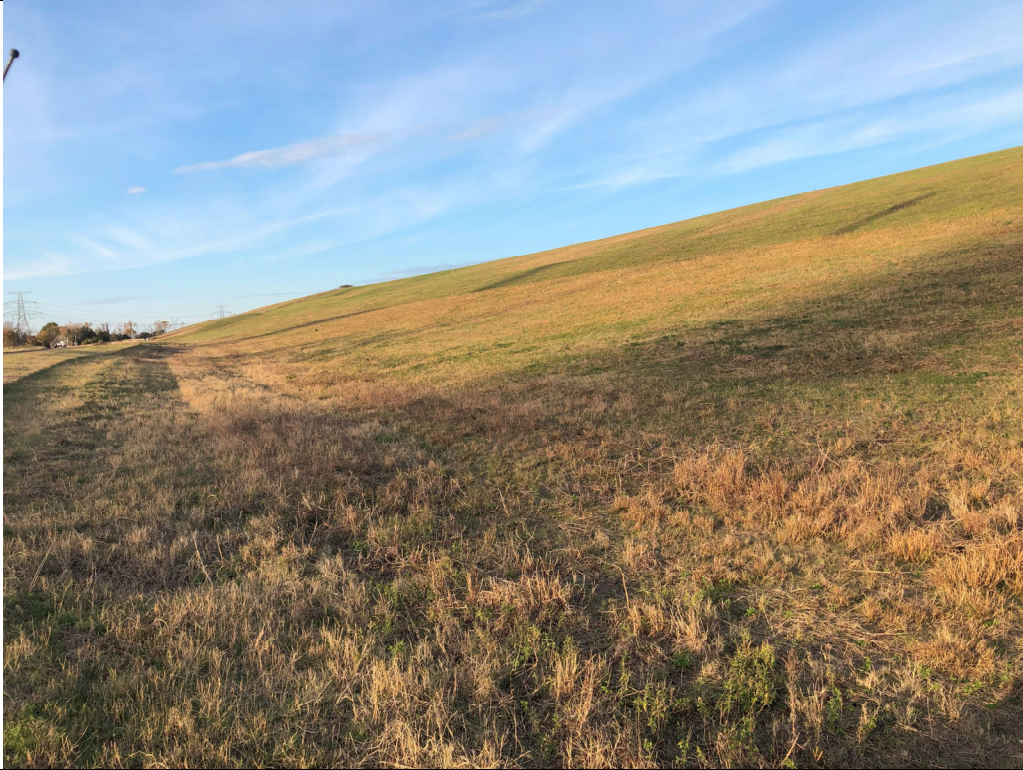
The side slopes of the capped landfill areas are well vegetated and have appropriate perimeter ditches as depicted in Photographs P-5, P-6, P-7, and P-10. As mentioned above, the southeast corner of Area 6 and the east sidewall of Area 10 are not vegetated. These areas abut active areas of the landfill. The exposed CCR material sidewall of Area 11 is shown in Photograph P-8. Photograph P-9 shows Area 12A, which is also an active portion of the landfill.

Photograph P-6: View looking north up the side slope of Area 2. The terraced slope is well vegetated with no visible sloughing or erosional issues.

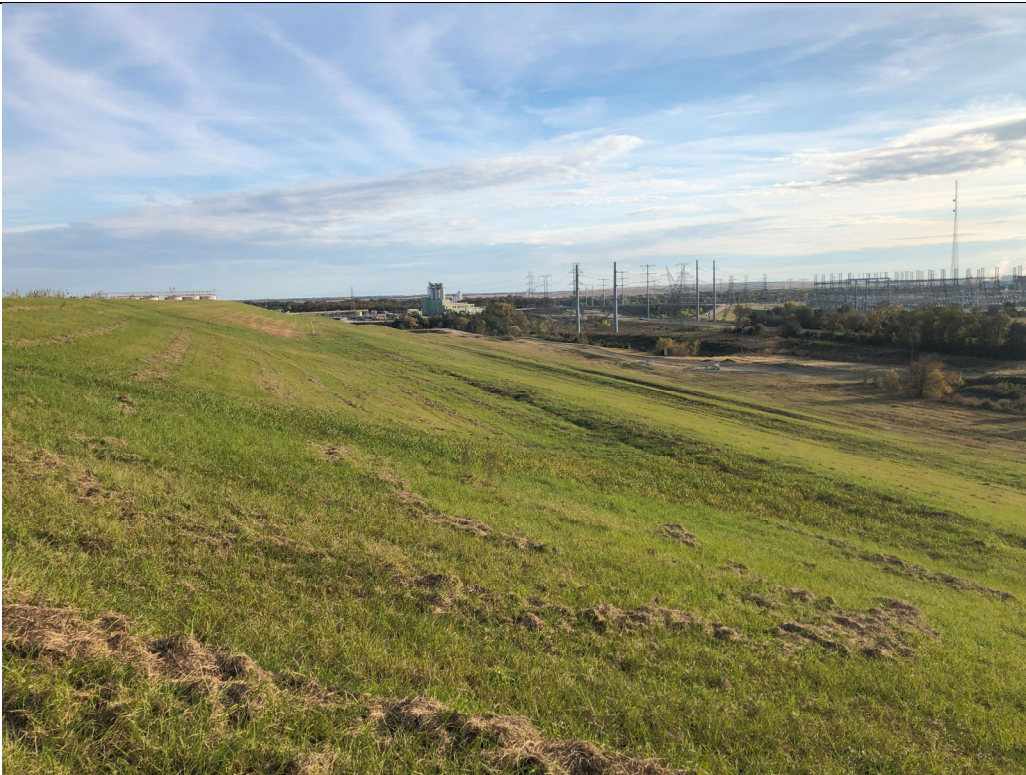
Photograph P-7: View looking north up the side slope of Area 2.

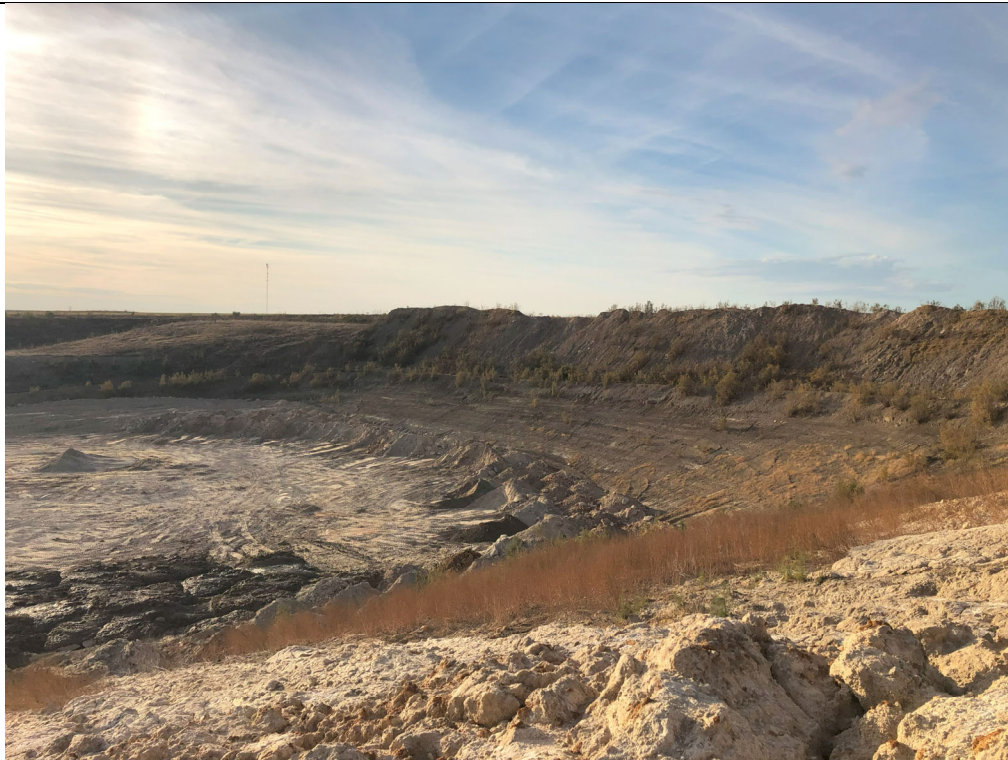
Areas 4, 7, 8, 11, 12A, and 12B are considered to be uncapped areas. Areas 4, 7, and 8 have been partially closed, but are considered to be “uncapped” because significant portions of these areas have uncapped CCR slopes or surfaces. Area 11 is an active area where marketable CCR was formerly stockpiled prior to sale and off-site transportation. Areas 11 and 12A are an active portion of the landfill where CCR is currently being placed. These operations are shown in Photographs P-8 through P-9.

Photograph P-8: View looking southwest across Area 11, an active section of the landfill.

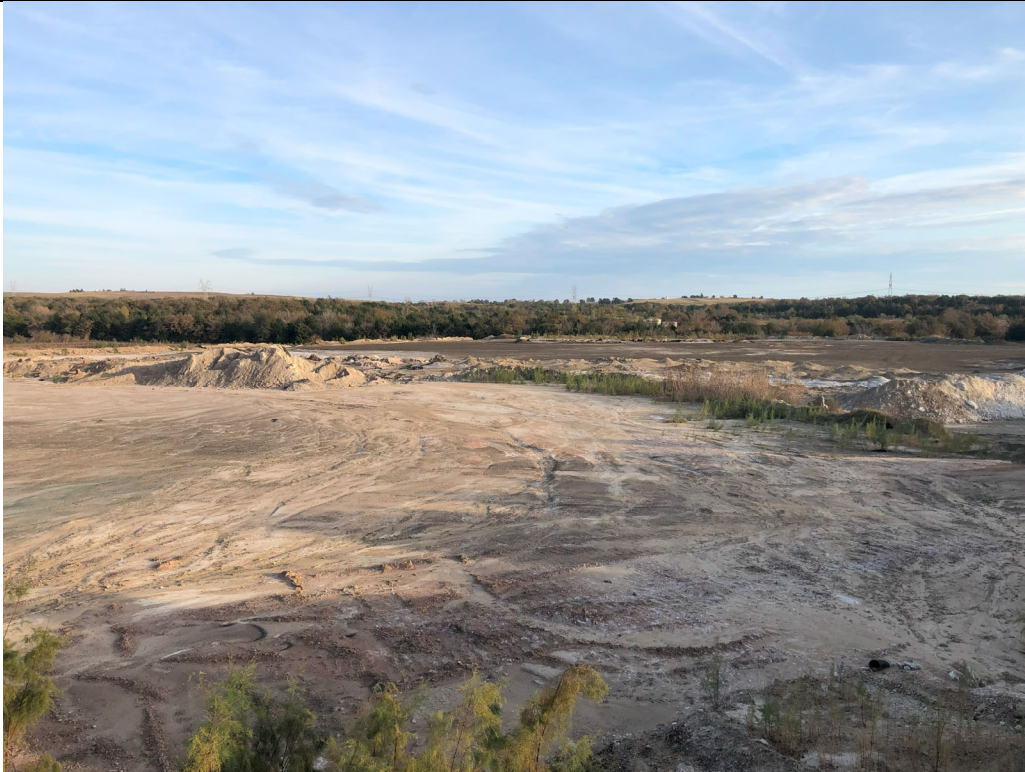
Photograph P-9: View looking east of exposed waste surface in Area 12A.

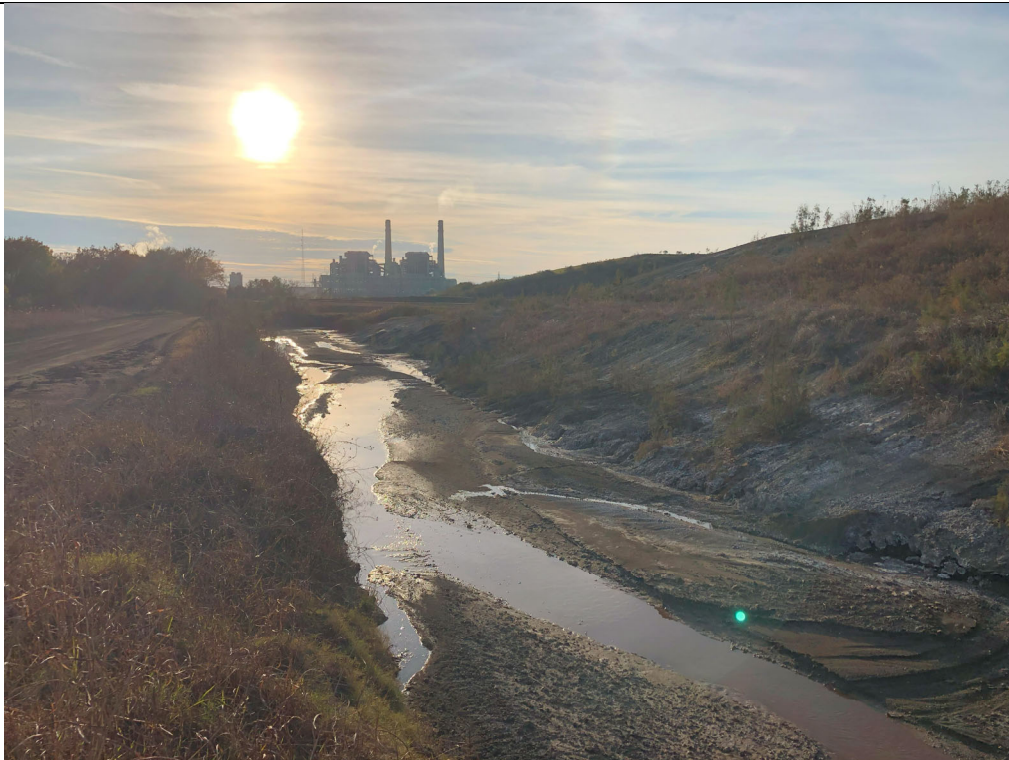
Contact water from all of the uncapped CCR slopes and disposal areas discharges into the interceptor ditch as shown in Photograph P-10. The interceptor ditch is located adjacent to the outer perimeter of these areas and directs the stormwater runoff and any eroded CCR to Pond 002.

Photograph P-10: View looking west-southwest at the contact water ditch draining to the 002 Pond.

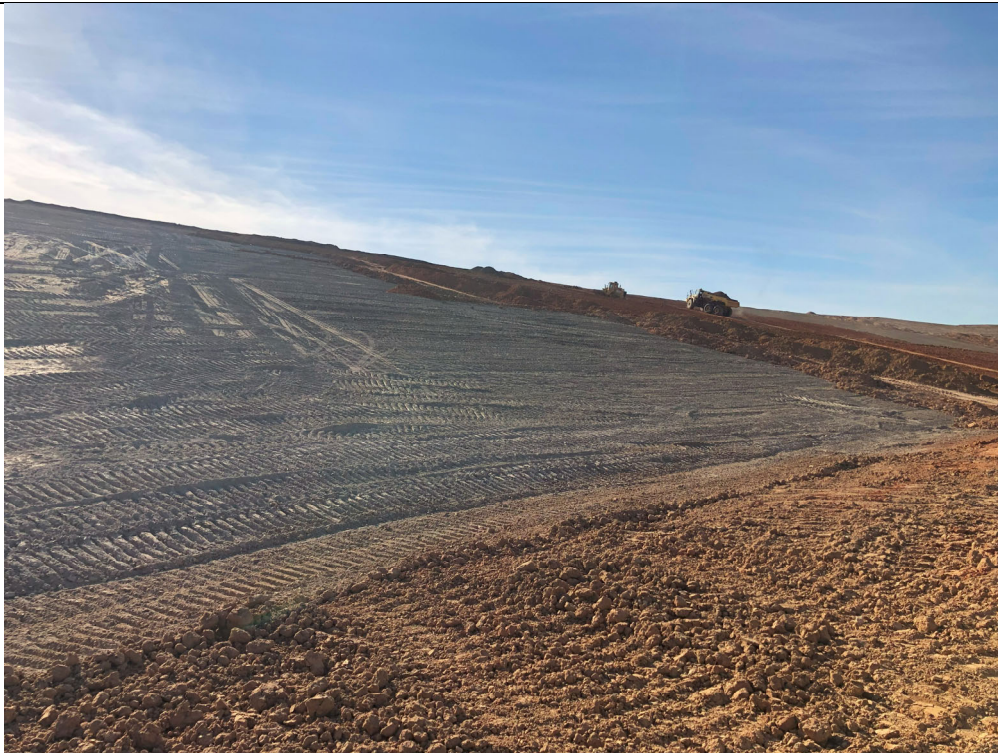
Photograph P-11 shows a portion of Area 4 where the CCR waste has been graded to a 4:1 slope, similar to the other capped and closed portions of the landfill. Twenty-foot wide terraces have been cut to catch and redirect stormwater flow so that it will drain across versus down the slope. The terraces are located at 100-foot intervals (as measured down the slope). Photographs P-12 and P-13 depict the active installation of a final cover system in Areas 1, 3 and 4 of the landfill.

Photograph P-11: View looking west of graded CCR waste in Area 4. A final cover system will be installed on this portion of the landfill.

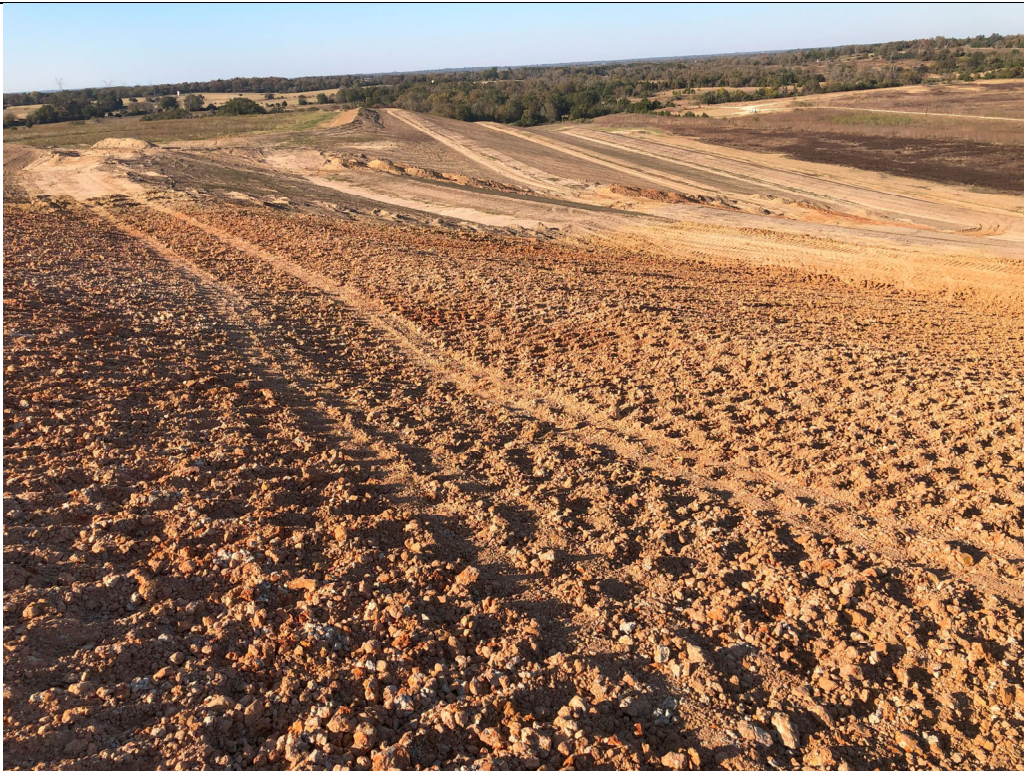
As shown in Figure 2 and in Photographs P-11 through P-13 the previously open side slopes of Areas 1, 3, 4 and a portion of Area 8 are currently being closed by NRG. This portion of the landfill being capped is also shown in more detail in Figure 3 – a December 19, 2024 aerial photograph of that section of the landfill. Once the final cover system in this area has been completed, non-contact stormwater will drain to the north, to a tributary of Lynn Creek, instead of to the south, around the landfill, and into Pond 002. The final cover system being installed in this area consists of a minimum of 18 inches of compacted clay with a maximum hydraulic conductivity of 1×10^{-7} centimeters per second (cm/sec). Quality assurance (QA) testing including nuclear density gauge testing and laboratory hydraulic conductivity analyses are being performed on the compacted clay component. Once the compacted clay cover component is completed, a protective layer of at least six inches of topsoil has been or will be placed on top of the clay cover system stratum. Where installed the protective layer of topsoil is covered with emergent grass.

Photograph P-12: View looking north across installed clay cover system in Area 3.

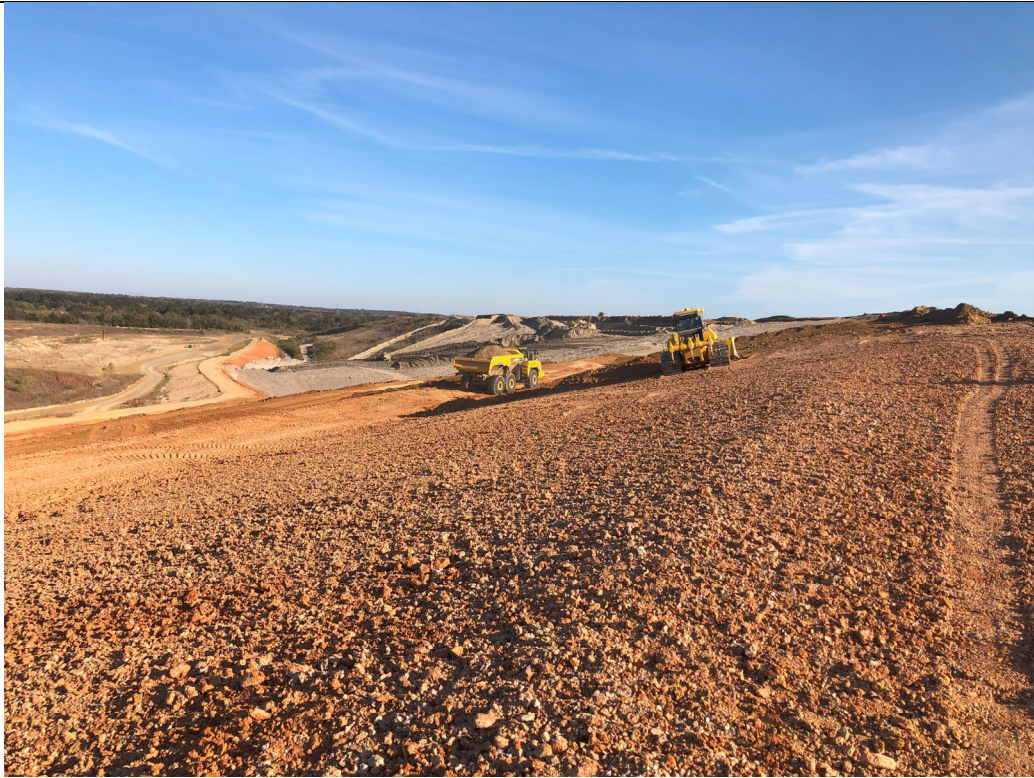
Photograph P-13: View looking east-southeast at clay cover system.
