2025 Annual Inspection of CCR Unit

**Limestone Electric Generating Station
Jewett, Texas**

January 2026

NRG Texas Power LLC

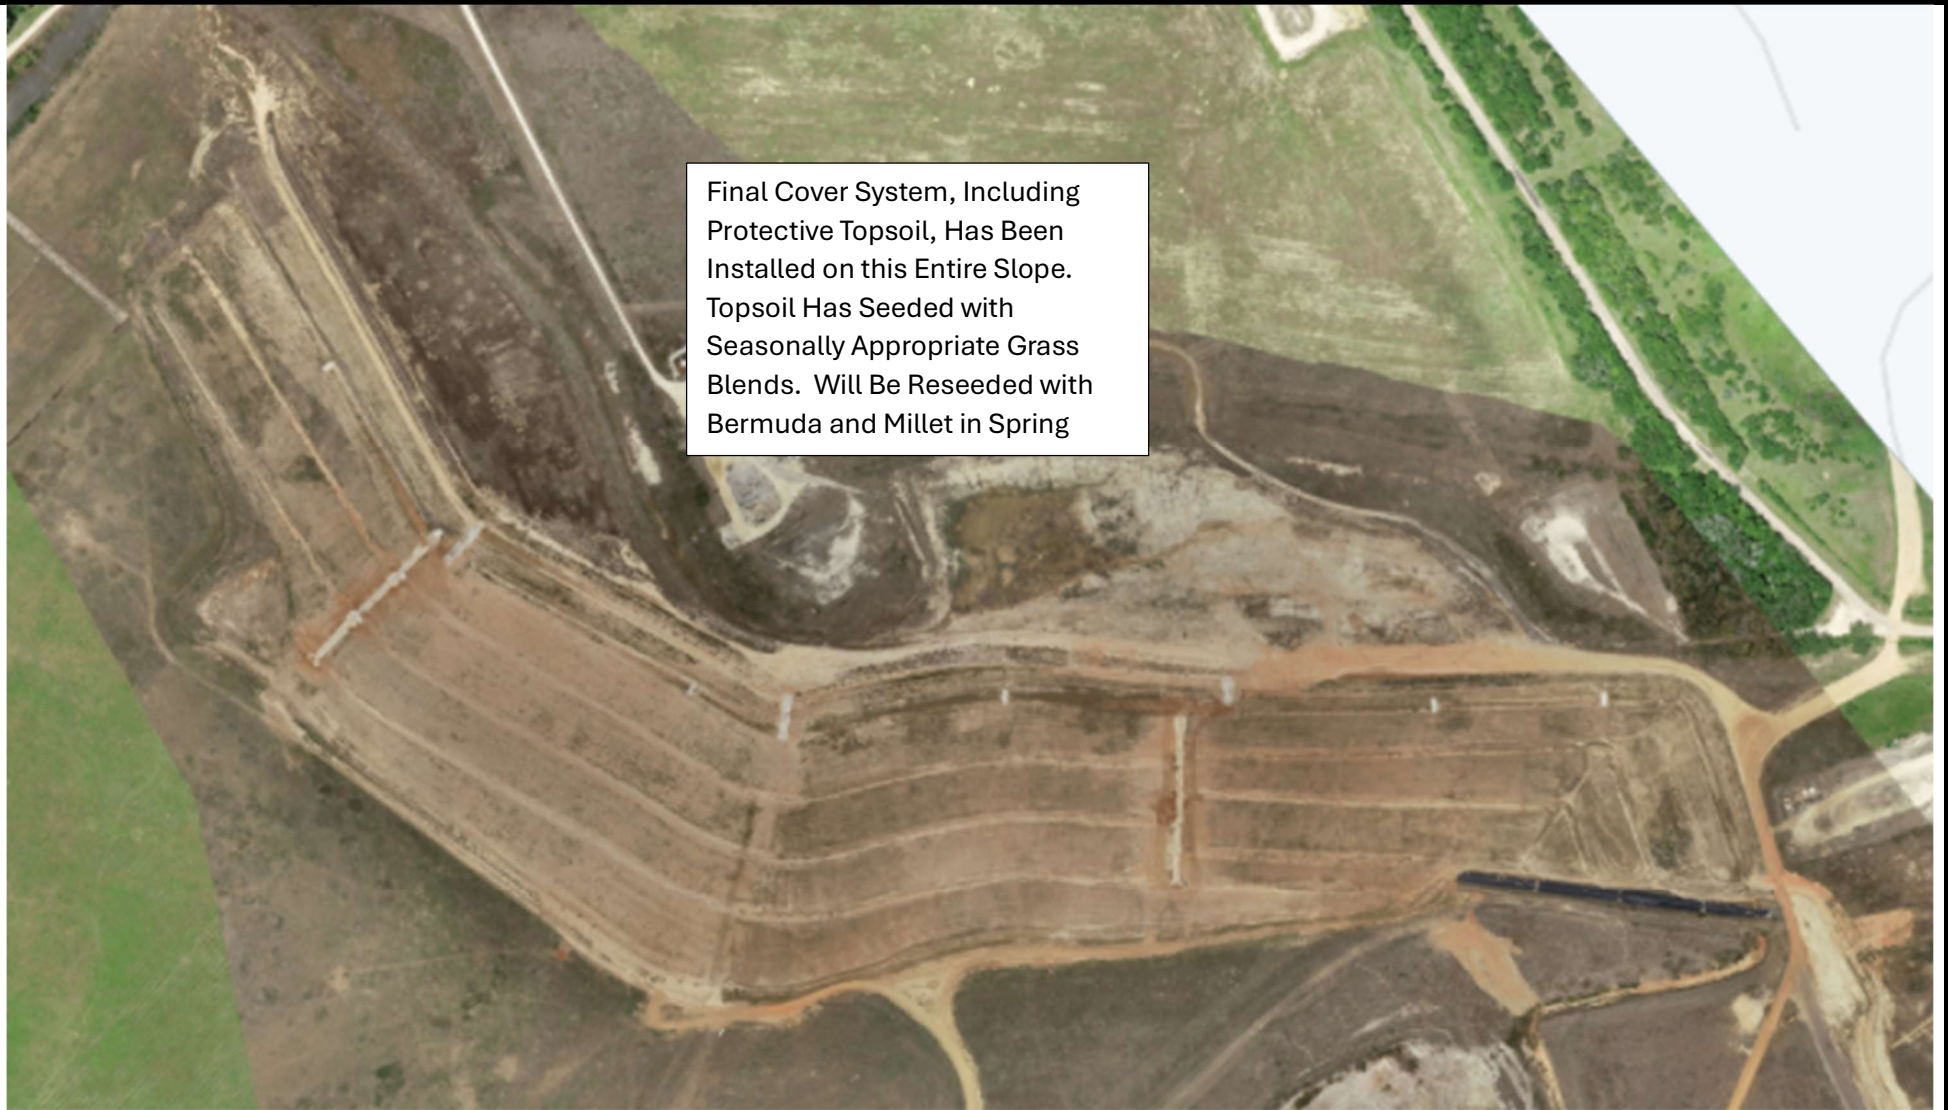
FIGURE 3

In 2025 NRG completed a project to cap a portion of the open landfill. The final cover system installed in this section of the landfill consists of a minimum of 18 inches of compacted clay covered with a minimum of six inches of vegetated topsoil. Quality control and assurance testing is being performed for this completed project. The newly constructed cap is depicted in Figure 3.

Final Cover System, Including Protective Topsoil, Has Been Installed on this Entire Slope. Topsoil Has Seeded with Seasonally Appropriate Grass Blends. Will Be Reseeded with Bermuda and Millet in Spring

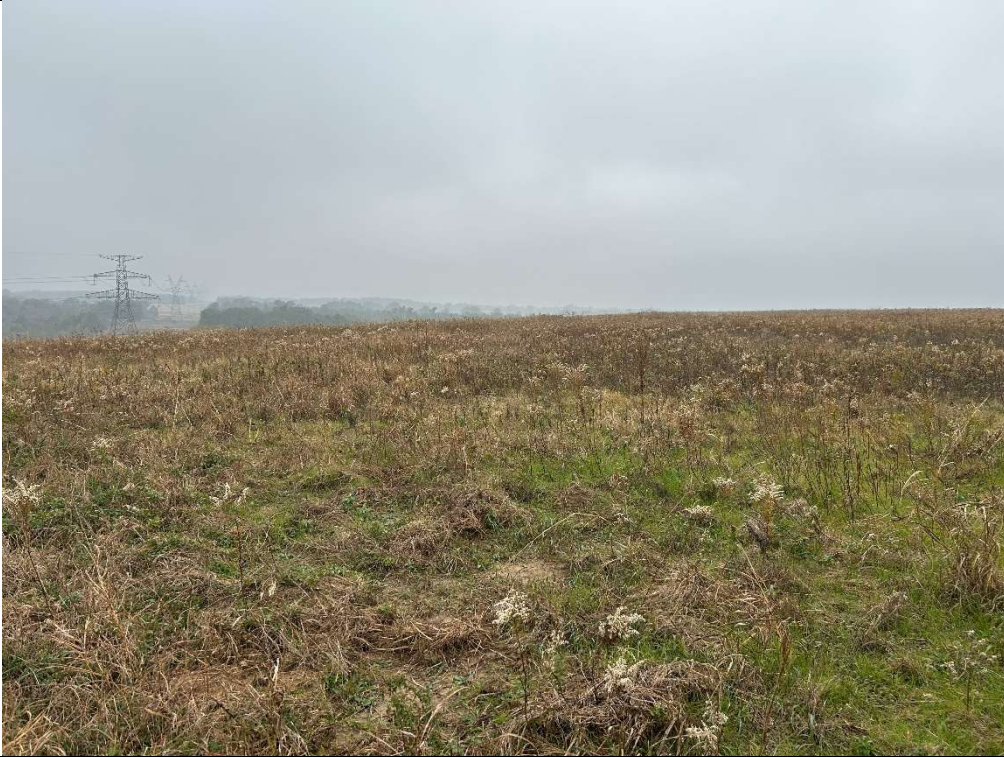
Although landfill Areas 1, 2, 3, 5, 6, 9, and 10 are considered to be capped, exposed slopes of CCR were present in Areas 1, 3, 6, and 10. The exposed CCR slopes of Areas 1 and 3 are part of the newly capped area. The exposed CCR slopes of Areas 6 and 10 abut active portions of the landfill which will be filled and closed in the future (Figure 2). The plateaued portion of the capped areas is well vegetated and generally well graded to prevent the localized ponding of stormwater and to direct the flow of stormwater as depicted in Photographs P-1, P-2, P-4, and P-8.

Photograph P-1: View looking southeast across the capped surfaces of Areas 1 and 2. The landfill cap appeared to be well vegetated and appropriately sloped.

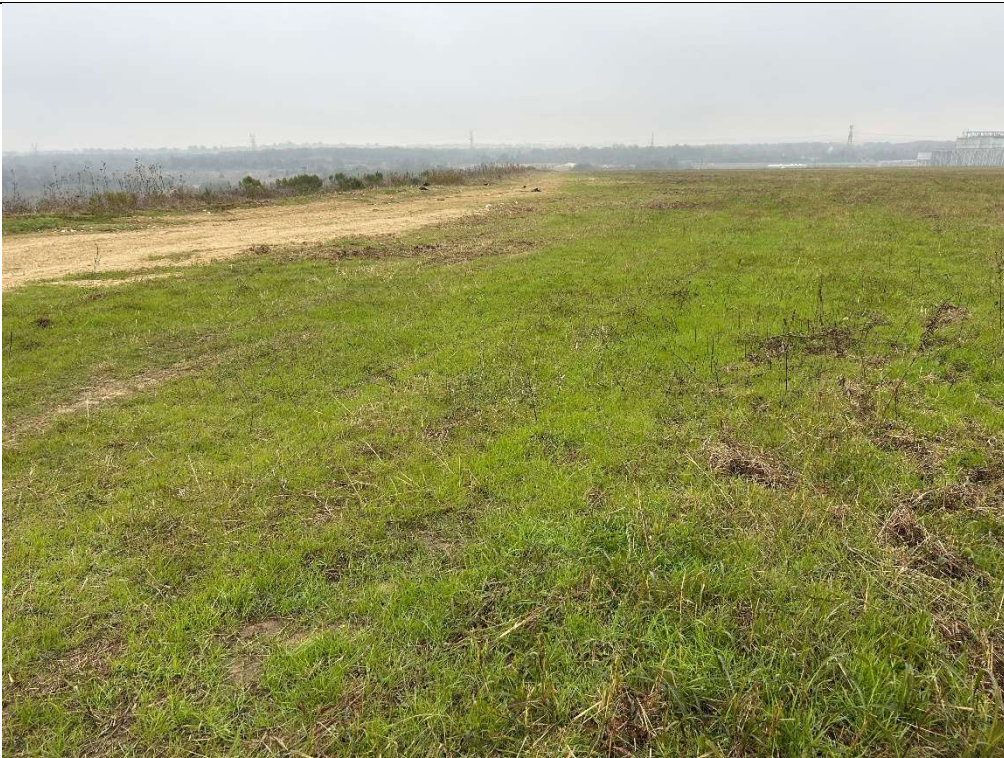
Photograph P-2: View looking southwest of well vegetated, closed cap of Area 6 and 5.

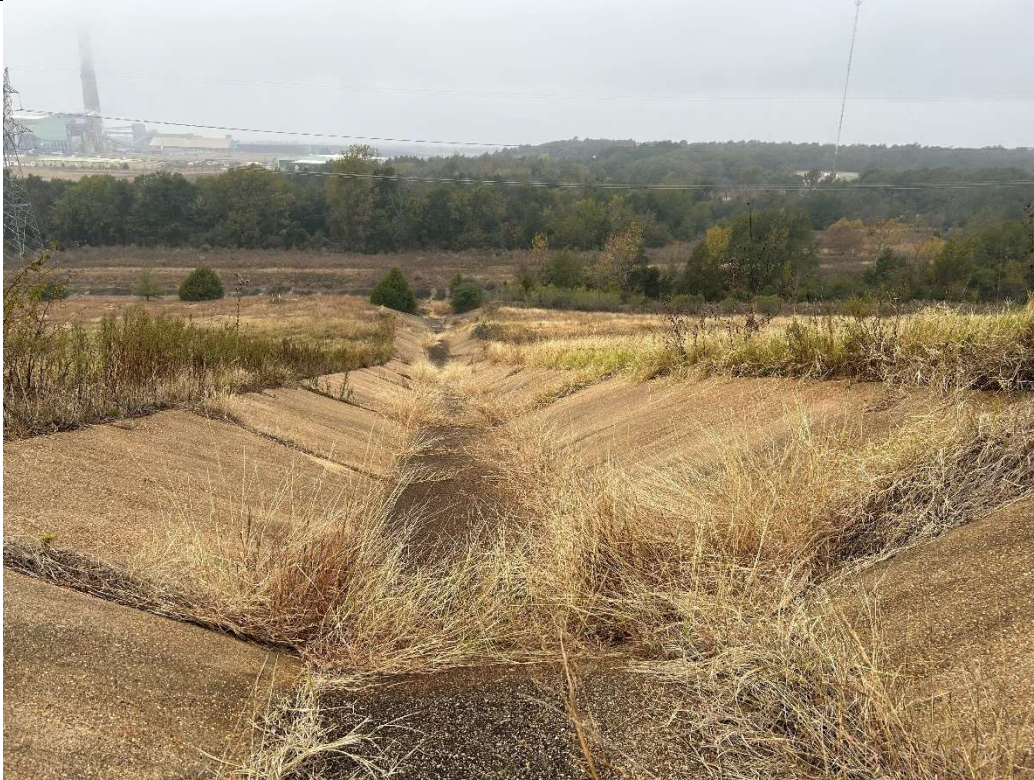
Photograph P-3: View looking west-southwest down concrete outfall in Area 5. A stormwater ditch located along the perimeter of the top of the landfill drains to this concrete outfall (also in Photograph P-4).

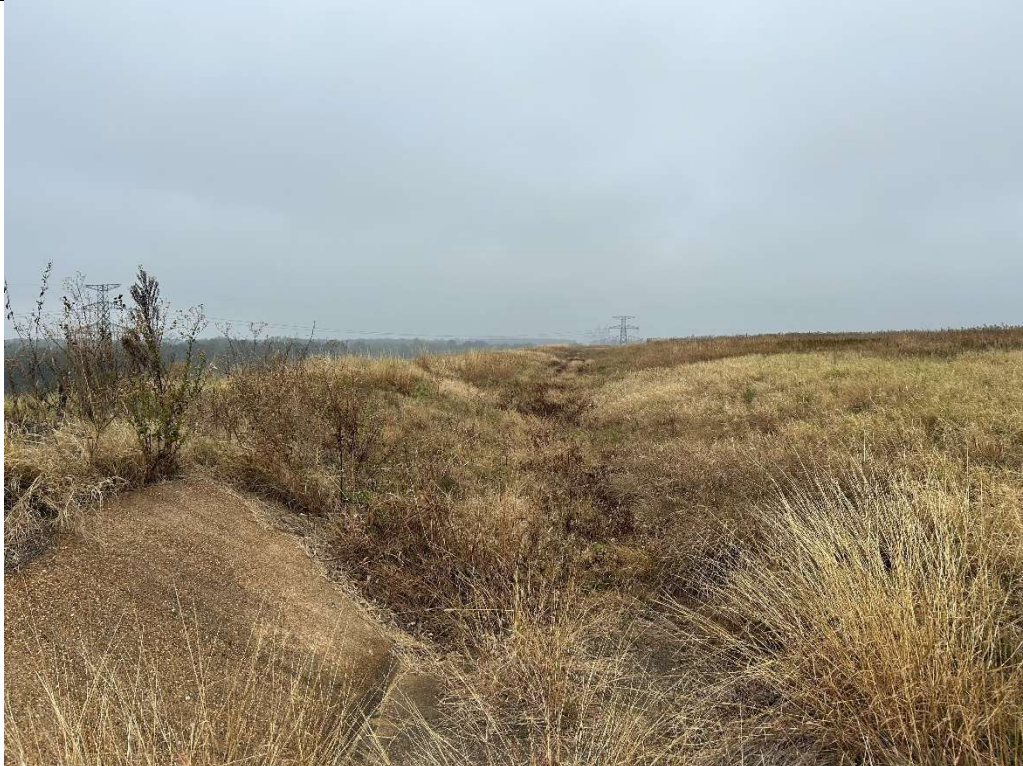
Photograph P-4: View looking north at the drainage ditch located along the perimeter of the top of the landfill. This ditch drains to the concrete outfall structure shown in Photograph P-3. The ditch appeared to flow well, without significant rutting or standing water.

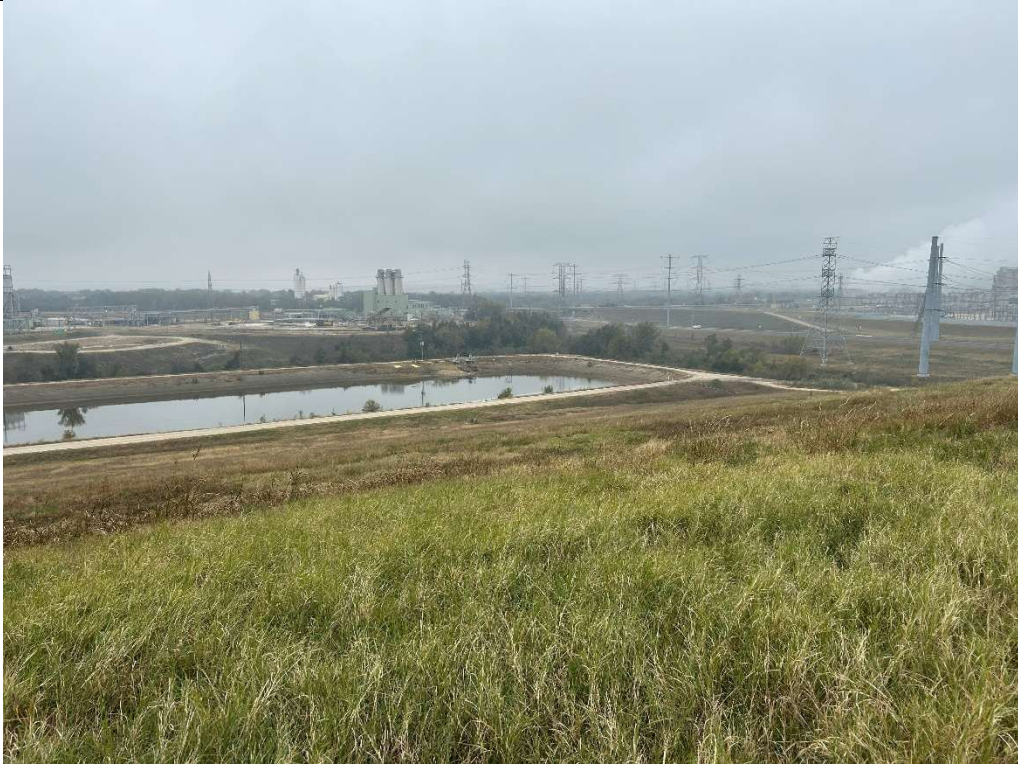
Photograph P-5: View looking south-southeast across the 002 Pond from top of Area 9. The water level in the 002 Pond is low because it had recently been drained so it could be cleaned.

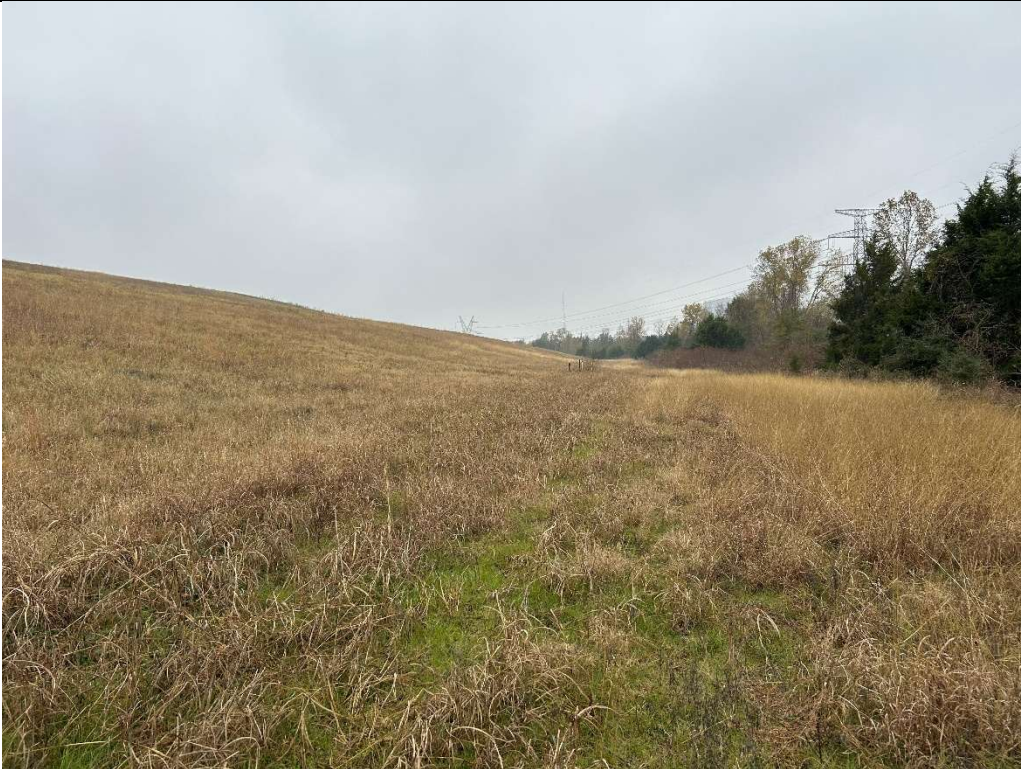
The side slopes of the capped landfill areas are well vegetated and have appropriate perimeter ditches as depicted in Photographs P-5, P-6, P-7, and P-10. The newly capped area of Area 1, 3, 4, and 8 is lightly vegetated due to the season, but additional vegetation is currently being established. As mentioned above, the southeast corner of Area 6 and the east sidewall of Area 10 are not vegetated. These areas abut active areas of the landfill. The exposed CCR material sidewall of Area 11 is shown in Photograph P-8.

Photograph P-6: View looking southeast up the side slope of Area 2. The terraced slope is well vegetated with no visible sloughing or erosional issues.

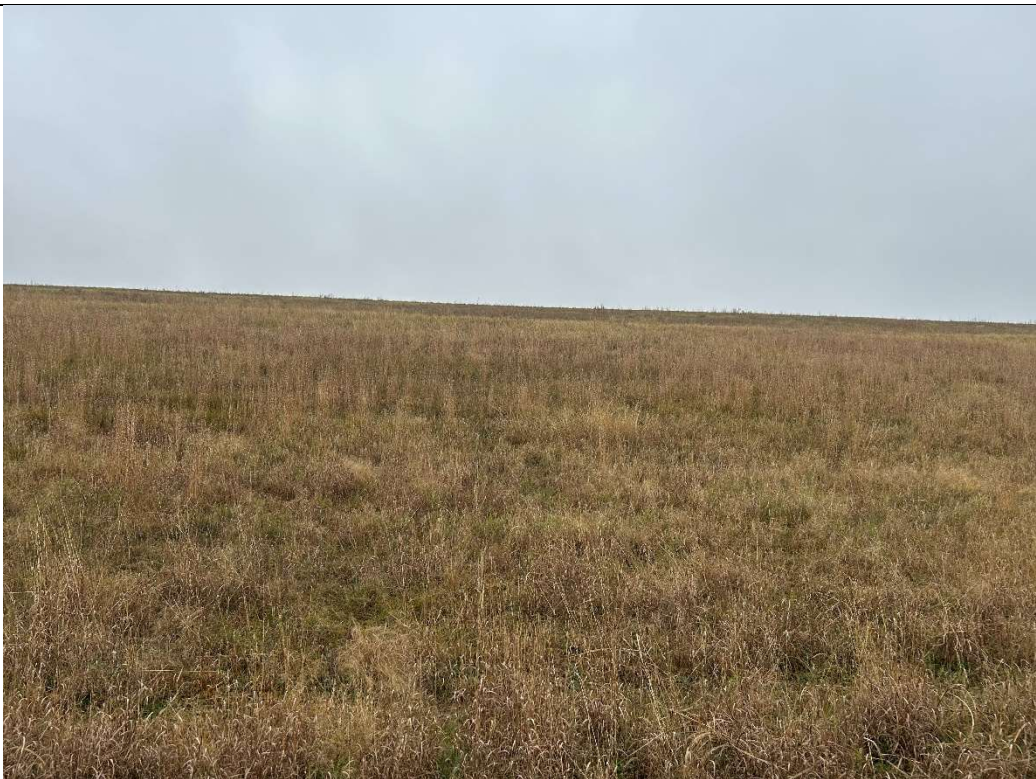
Photograph P-7: View looking east up the side slope of Area 2.

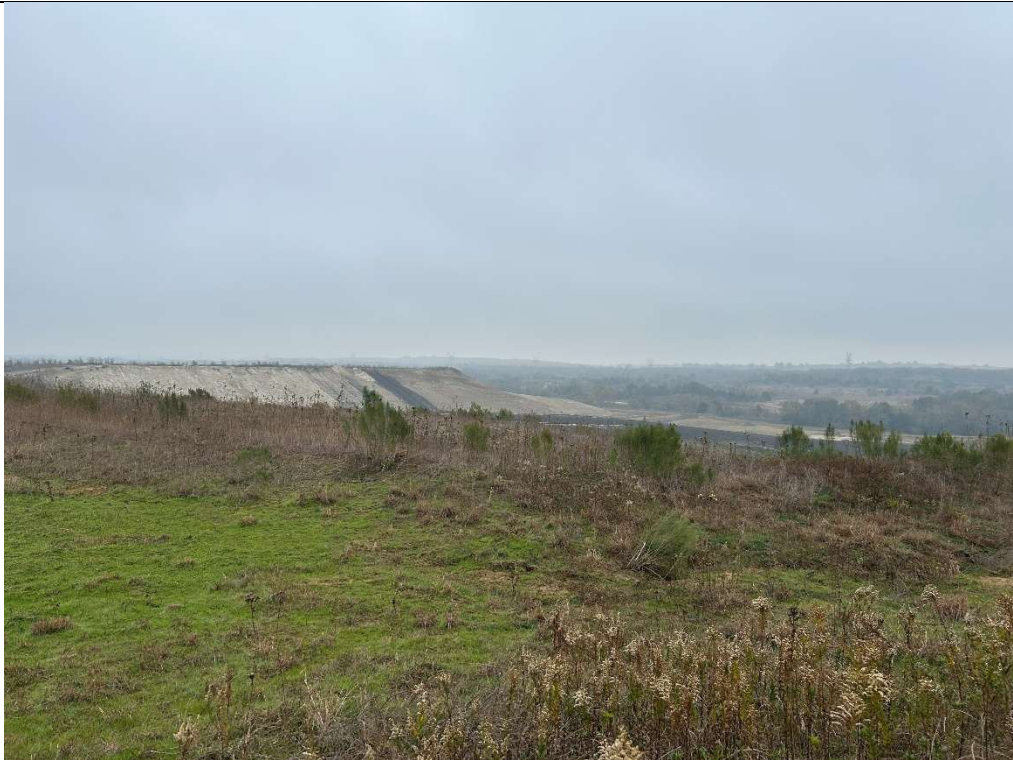
Photograph P-8: View from Area 10 looking east across Area 11, an active section of the landfill.

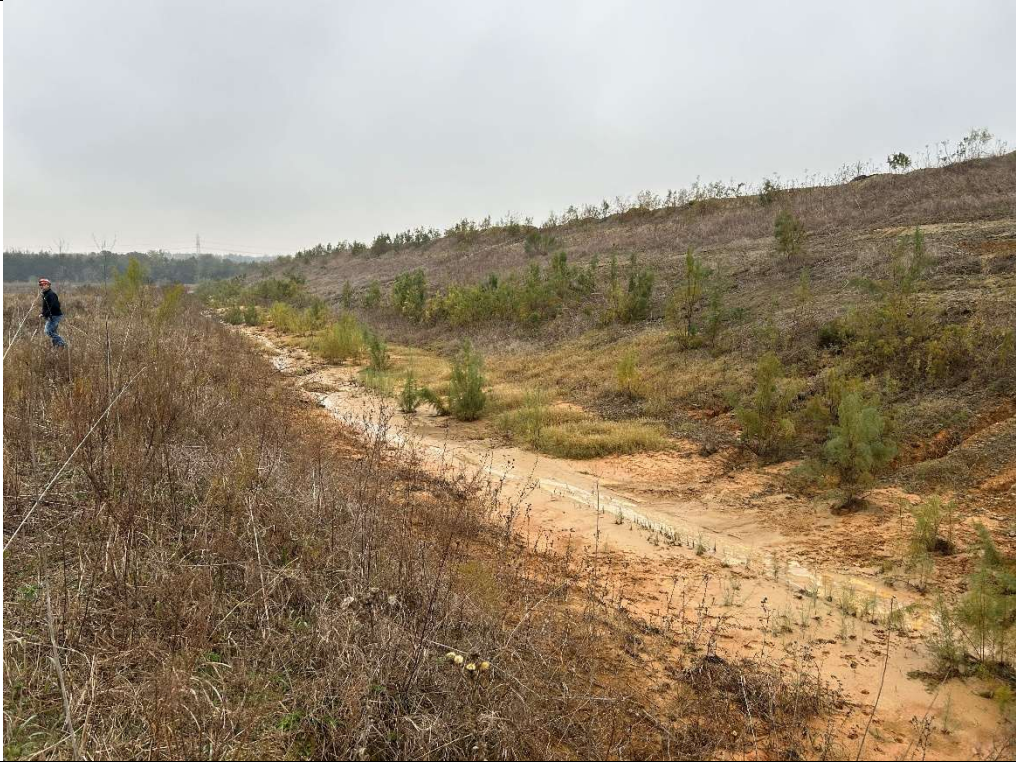
Contact water from all of the uncapped CCR slopes and disposal areas discharges into the interceptor ditch as shown in Photograph P-9. The interceptor ditch is located adjacent to the outer perimeter of these areas and directs the stormwater runoff and any eroded CCR to Pond 002.

Photograph P-9: View looking south at the contact water ditch draining to the 002 Pond.

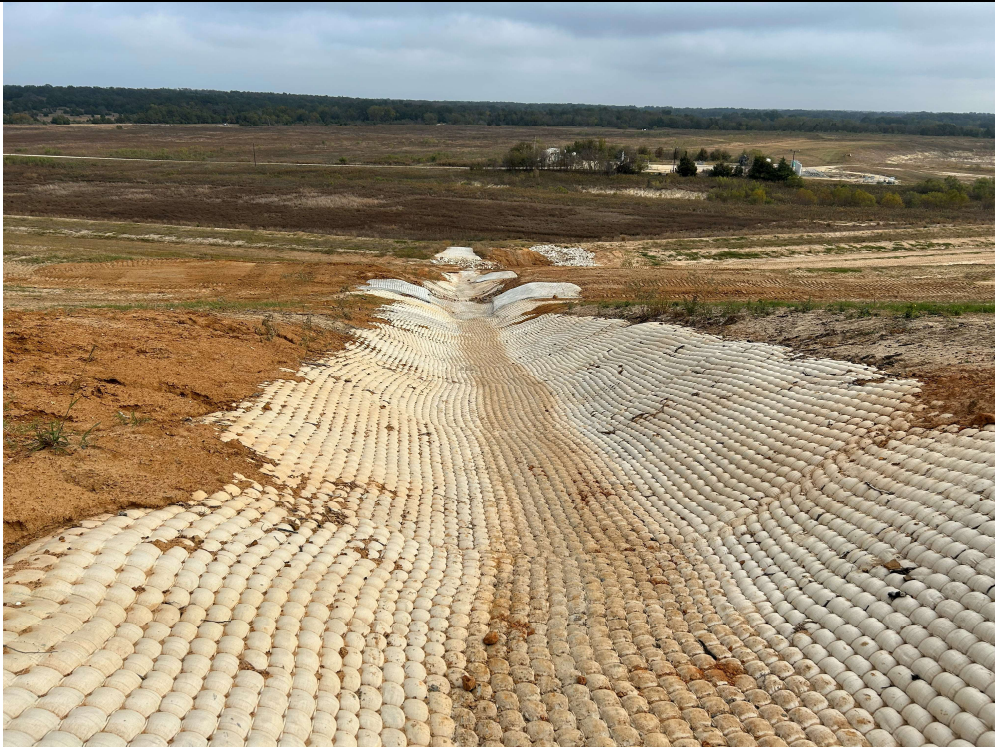
Drainage structures constructed to transfer stormwater from the top of the capped areas to the perimeter ditch consist of concrete lined rundown channels. One rundown channel is present in Area 1 and a second is present in Area 5. Additional rundown channels were installed as part of the new cover system in Areas 1/3 and Area 8. Some cracking and vegetation growth was observed in the rundown channels in Areas 1 and 5, but they are considered to be in good condition as shown in Photograph P-3. No cracking was observed in the two new rundown channels, which are constructed of fabric formed concrete as shown in Photograph P-10.

Photograph P-10: View looking northeast down concrete rundown channel in Area 3.

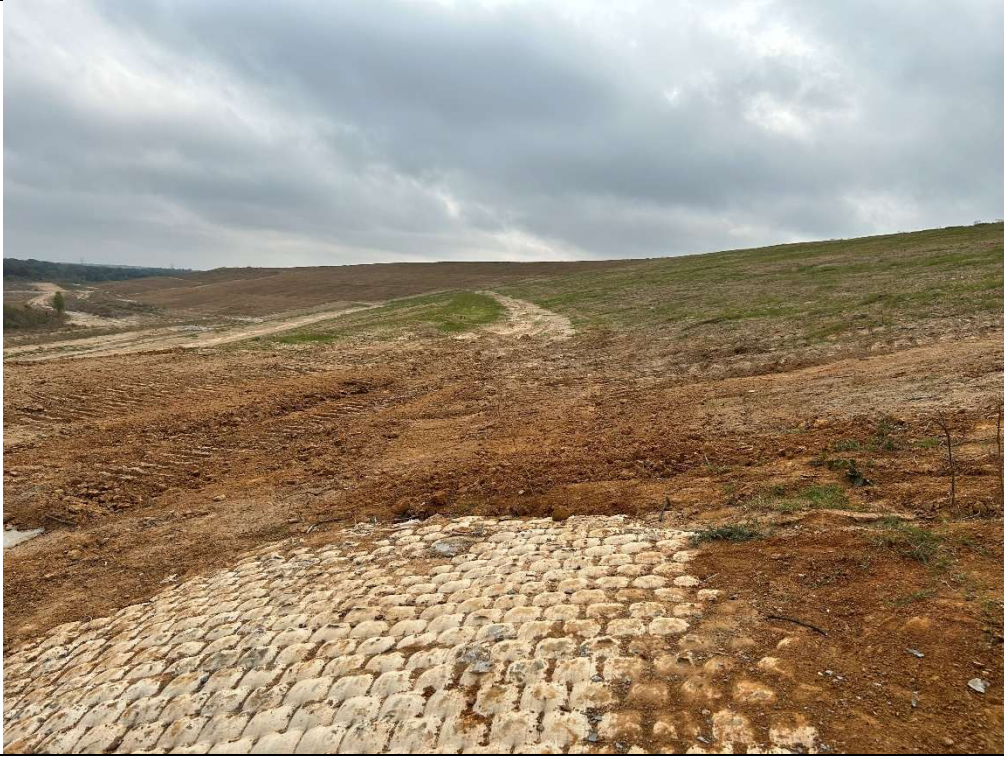
As shown in Figure 2 and in Photographs P-11 and P-12, the previously open side slopes of Areas 1, 3, 4 and a portion of Area 8 have been closed by NRG. This portion of the landfill that has been newly capped is also shown in more detail in Figure 3 – a November 20, 2025 aerial photograph of that section of the landfill. Now that the final cover system in this area has been completed, non-contact stormwater drains to the north, to a tributary of Lynn Creek, instead of to the south, around the landfill, and into Pond 002. The final cover system installed in this area consists of a minimum of 18 inches of

Photograph P-11: View looking east of newly installed final cover system in Area 4. Revegetation is in progress.

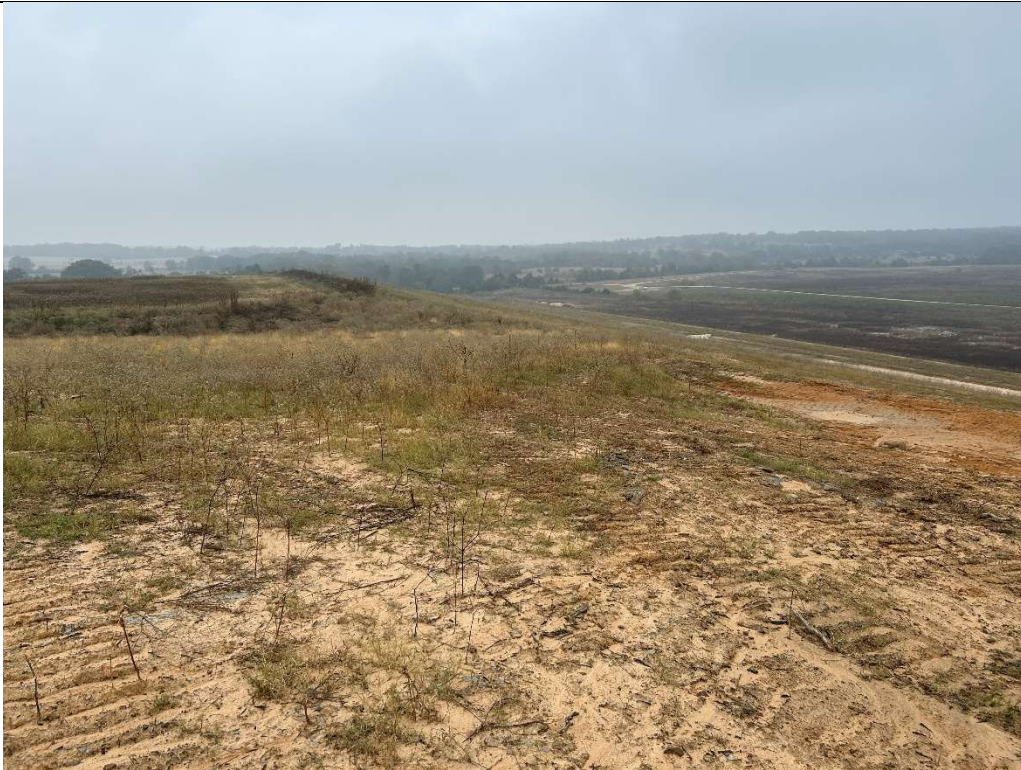
Photograph P-12: View looking north across installed clay cover system in Area 3.

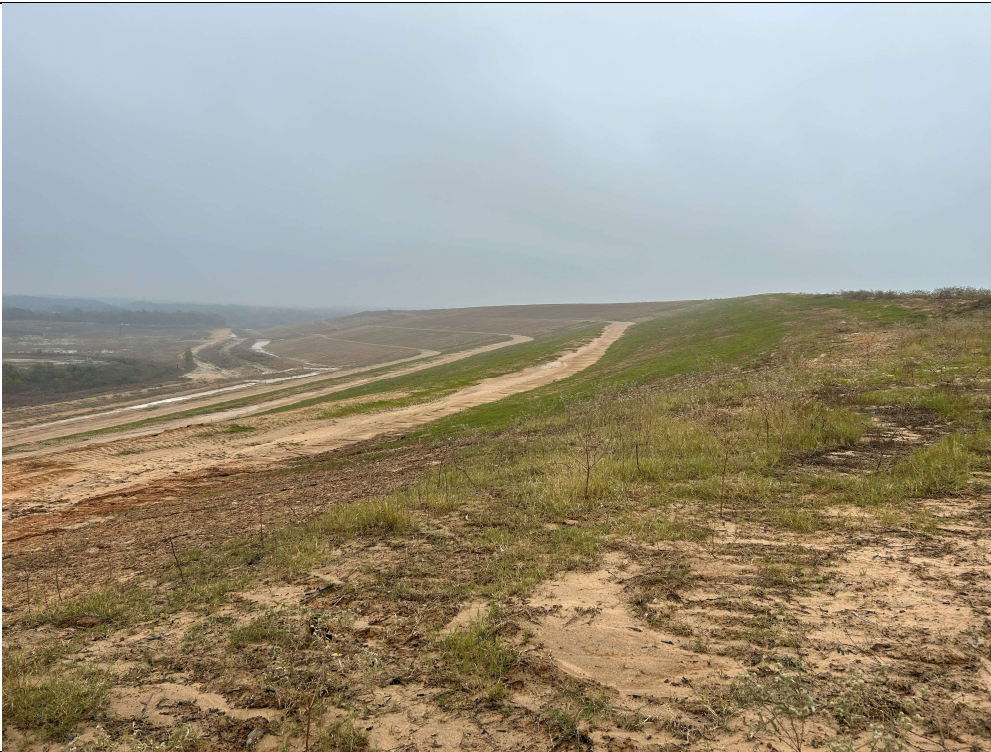
Photographs P-11 through P-14 shows depict the newly installed final cover system in Areas 1, 3, and 4. Twenty-foot wide terraces have been cut to catch and redirect stormwater flow so that it will drain across versus down the slope. The terraces are located at 100-foot intervals (as measured down the slope).

Photograph P-13: View looking southeast across recently installed final cover system in Area 1.

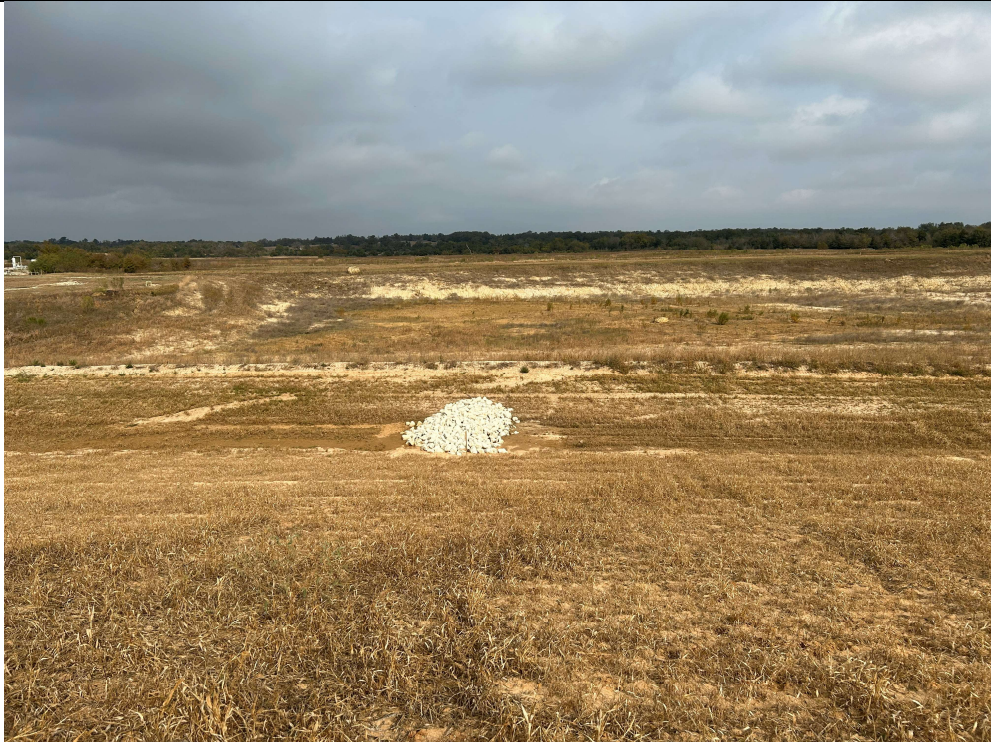
Photograph P-14: View from Area 4 looking northeast across non-contact stormwater ditch that drains to the northwest.
