**MIDWEST GENERATION
JOLIET/LINCOLN STONE QUARRY LANDFILL
2978090002—Will County
Permit No. 1994-241-LFM (Modification No. 24)**

**1st ANNUAL CCR SURFACE IMPOUNDMENT REPORT
YEAR ENDING DECEMBER 31ST, 2022**

**Prepared By:
KPRG and Associates, Inc.
14665 W. Lisbon Rd., Suite 1A
Brookfield, WI 53005**

January 30, 2023

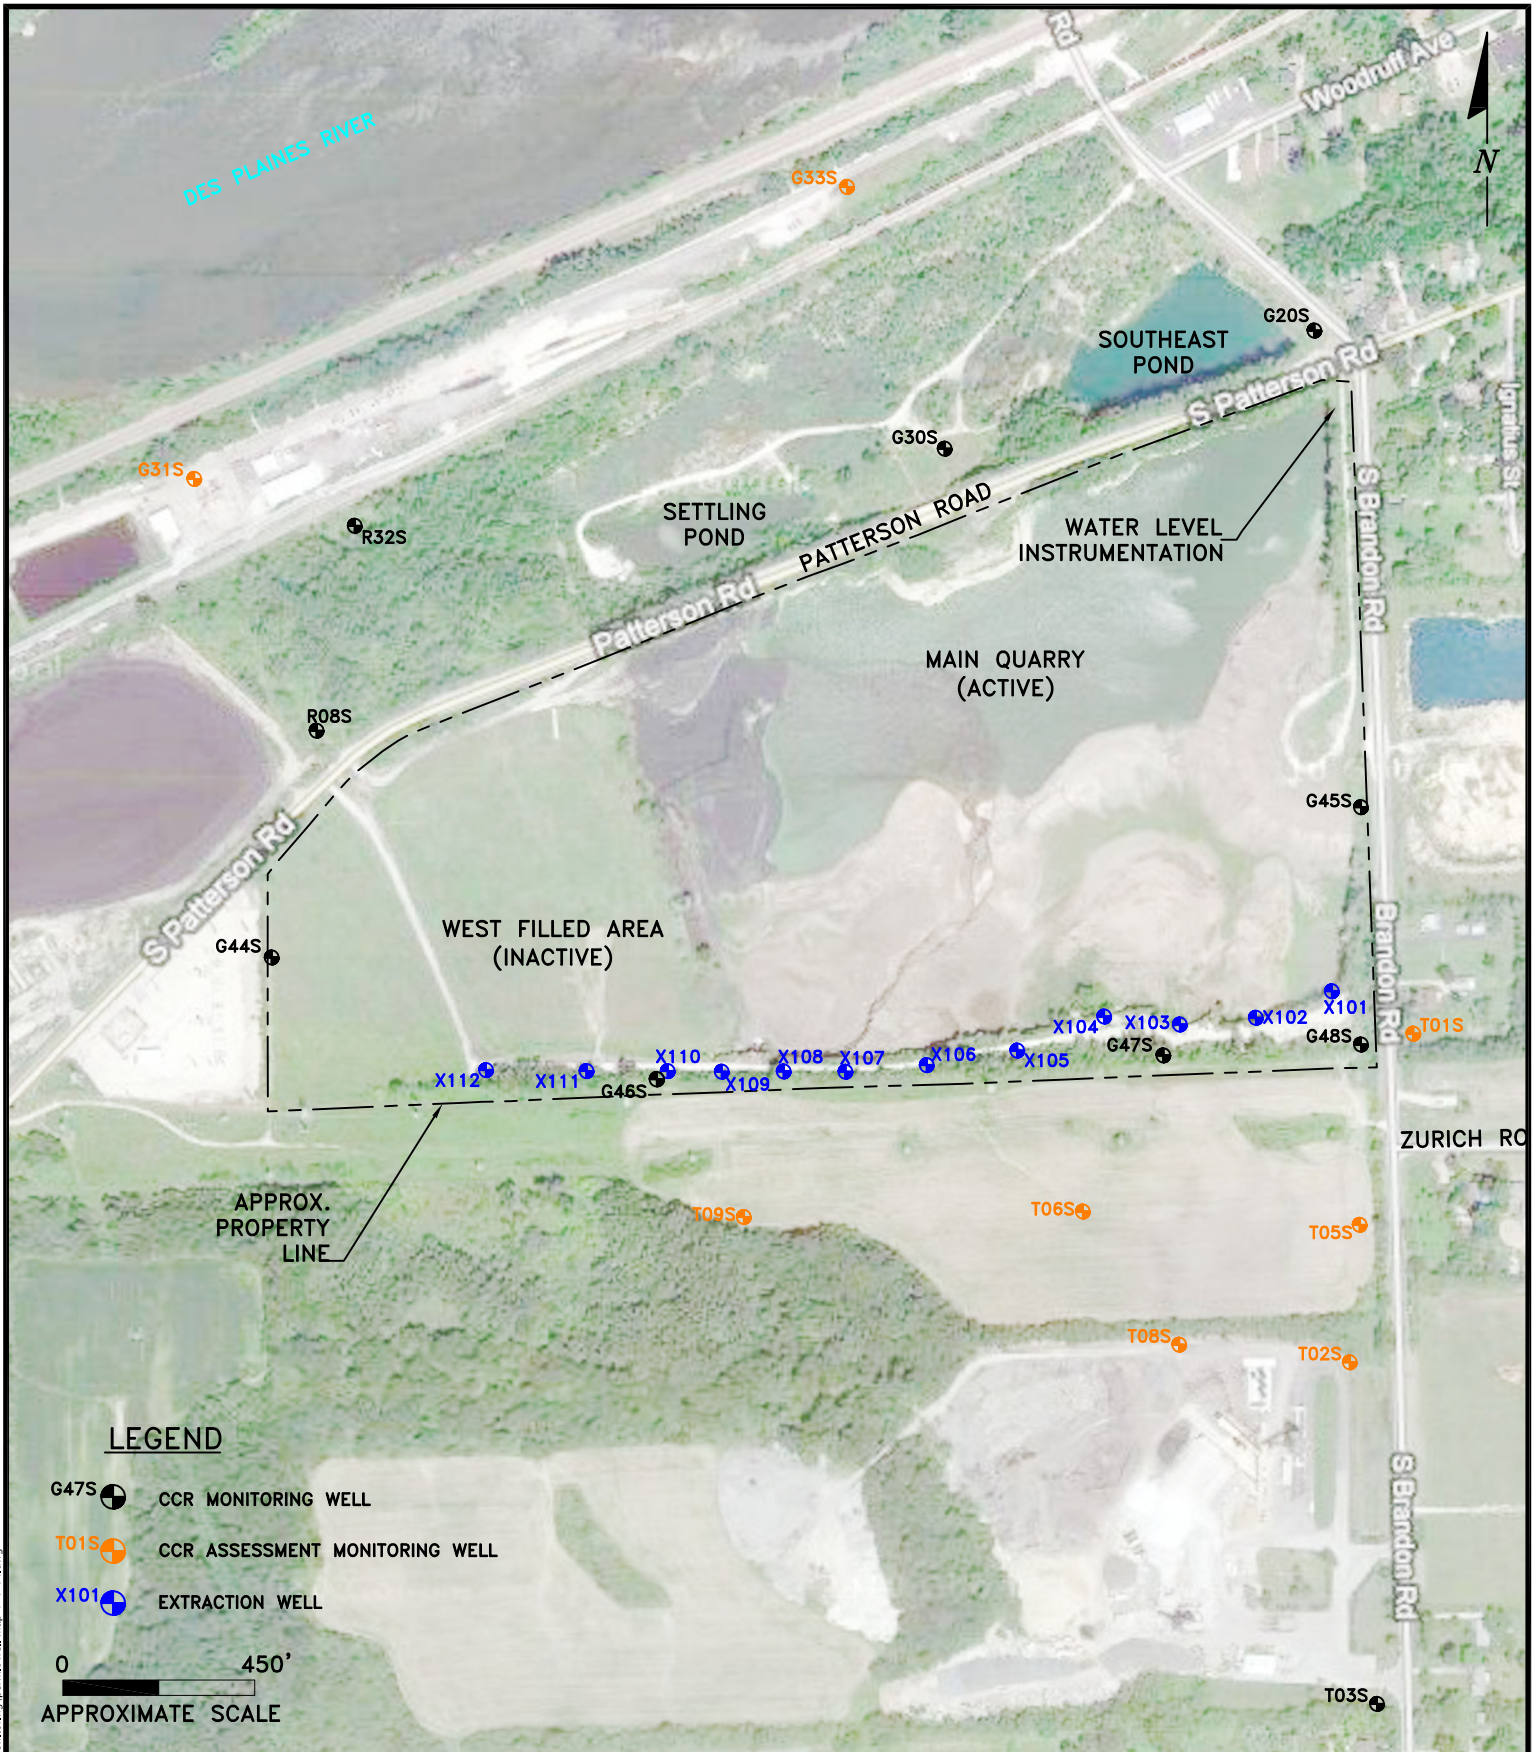
FIGURE 1

Water level instrumentation (pressure transducer, data logger, and radio antenna to transmit data to a website accessible by MWG) for LSQ is located near the northeast corner of the site (Figure 1). Water levels are recorded daily and delivered wirelessly to QED Environmental. Water level alerts are transmitted via email to relevant personnel with Midwest Generation and KPRG.
