**MIDWEST GENERATION
JOLIET/LINCOLN STONE QUARRY LANDFILL
2978090002—Will County
Permit No. 1994-241-LFM (Modification No. 24)**

**4th ANNUAL CCR SURFACE IMPOUNDMENT REPORT
YEAR ENDING DECEMBER 31ST, 2024**

January 22, 2025

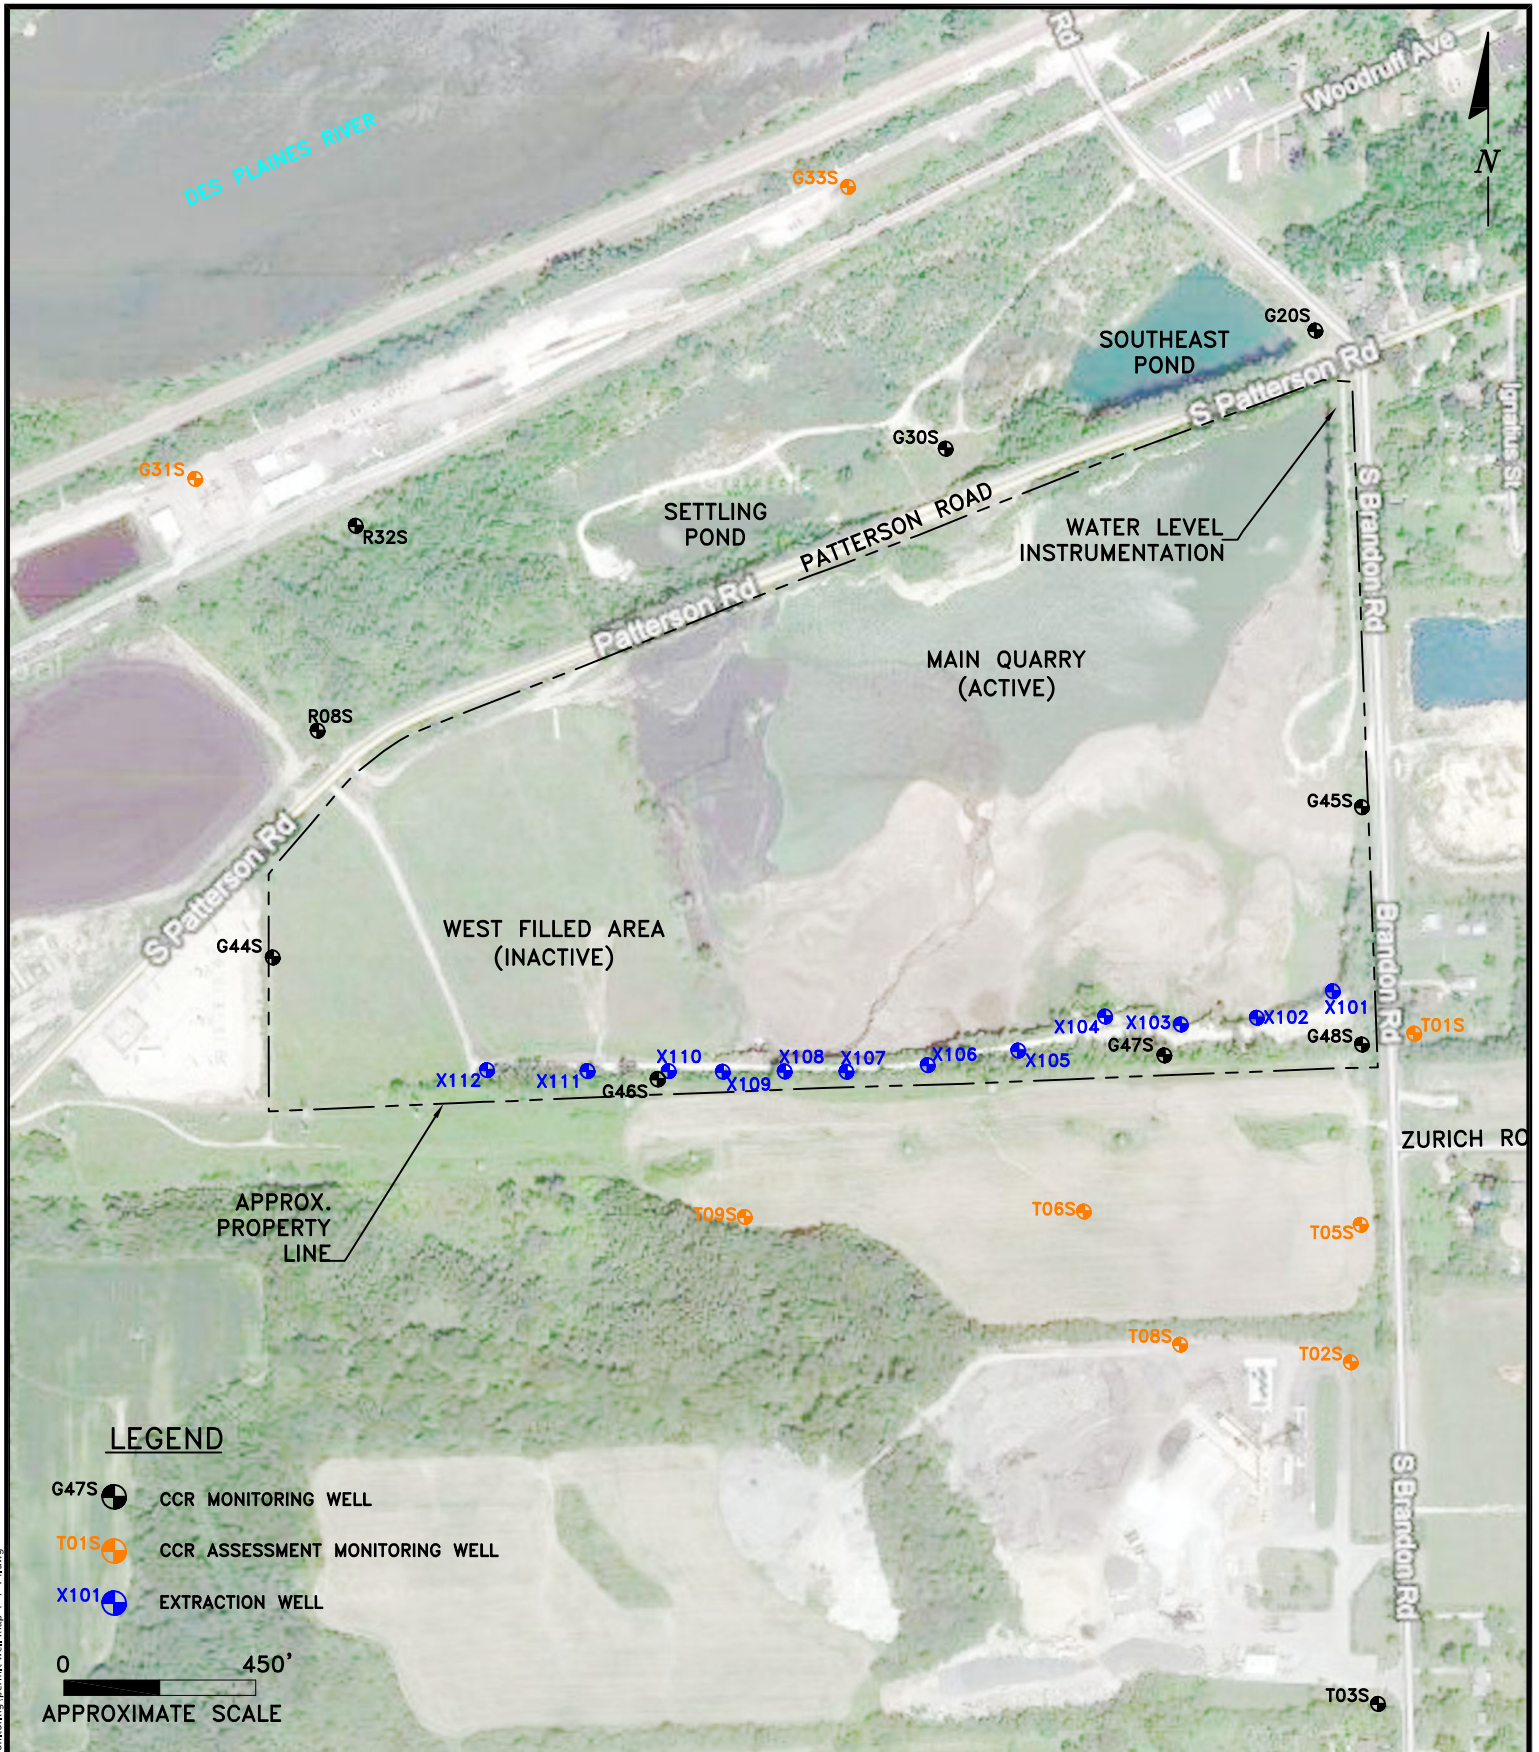
FIGURE 1

Water level instrumentation (pressure transducer, data logger, and radio antenna to transmit data to a website accessible by MWG) for LSQ is located near the northeast corner of the site (Figure 1). Water levels are recorded daily and delivered wirelessly to QED Environmental. Water level alerts are transmitted via email to relevant personnel with Midwest Generation and KPRG.
