**MIDWEST GENERATION
JOLIET/LINCOLN STONE QUARRY LANDFILL
2978090002—Will County
Permit No. 1994-241-LFM (Modification No. 24)**

**5th ANNUAL CCR SURFACE IMPOUNDMENT REPORT
YEAR ENDING DECEMBER 31ST, 2025**

**Prepared By:
KPRG and Associates, Inc.
14665 W. Lisbon Rd., Suite 1A
Brookfield, WI 53005**

January 27, 2026

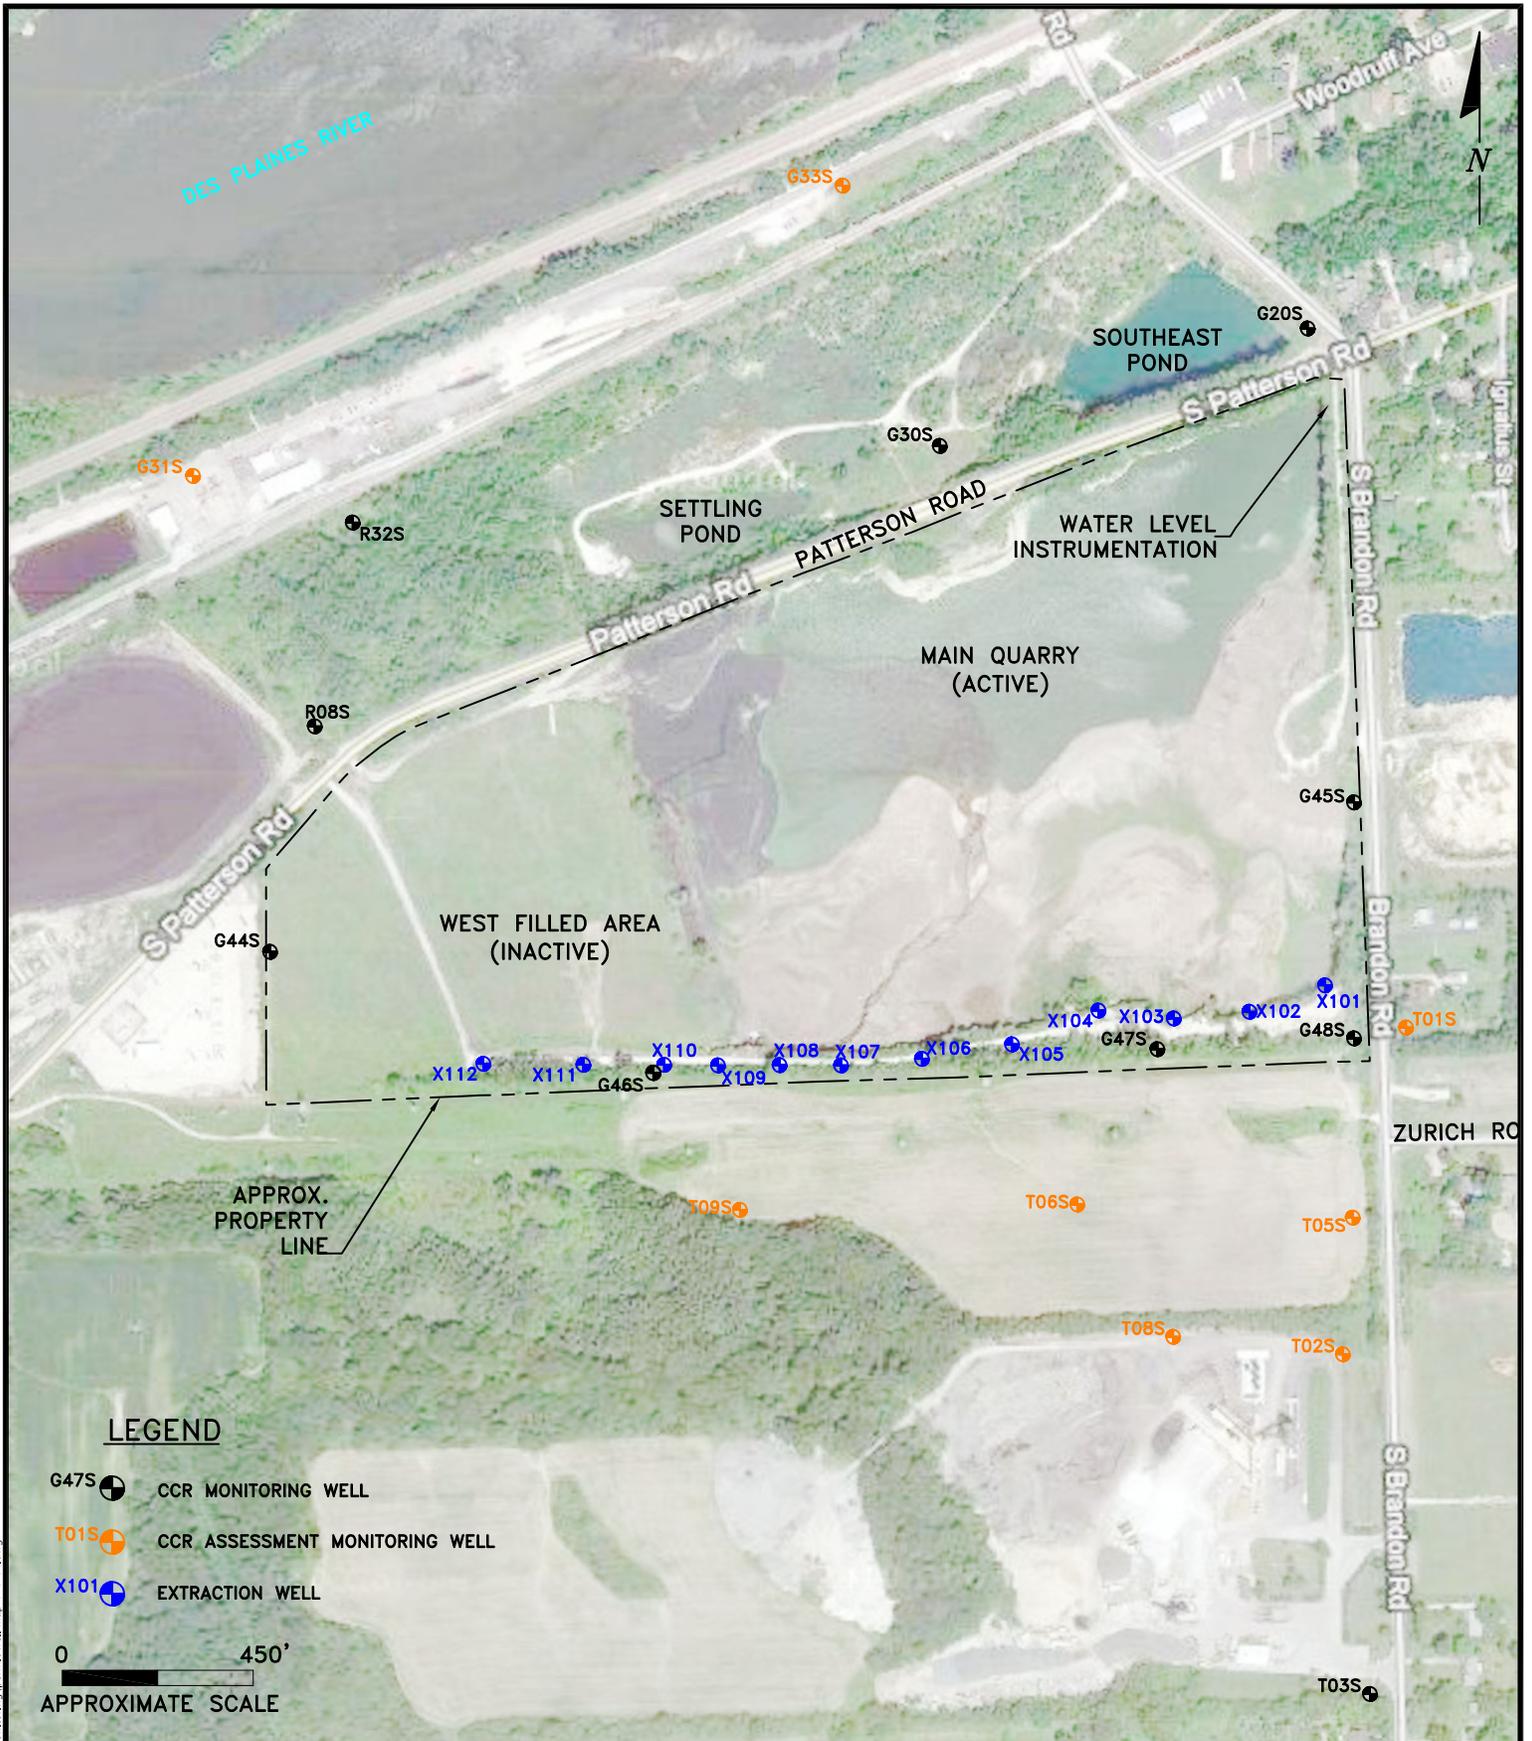
FIGURE 1

Water level instrumentation (pressure transducer, data logger, and radio antenna to transmit data to a website accessible by MWG) for LSQ is located near the northeast corner of the site (Figure 1). Water levels are recorded daily and delivered wirelessly to QED Environmental. Water level alerts are transmitted via email to relevant personnel with Midwest Generation and KPRG.
