Letter No. 12661-181-SL-IEPA-0005  
June 17, 2024  
Project No. File No. 12661-181

**Re: Integrity Test Results for Existing Bypass Basin Liner**

RE: Leak Location Survey for the Bypass Basin liner at the Powerton Generating Station located in Pekin, IL.

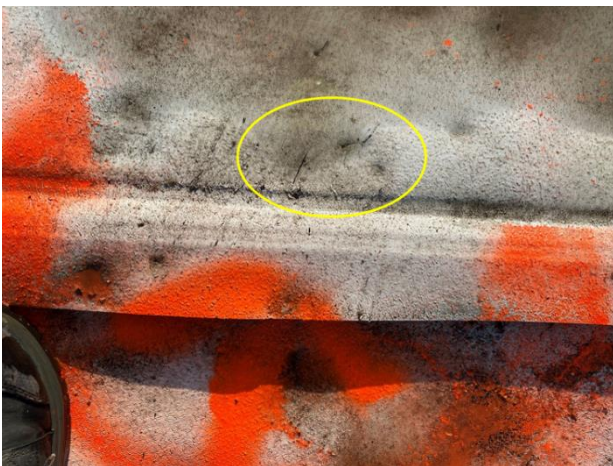
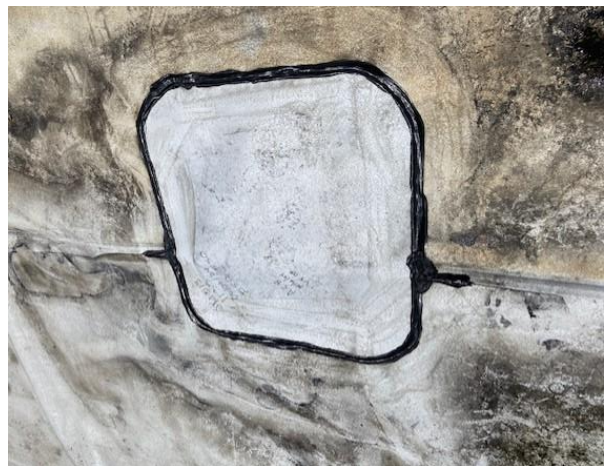
**Figure 1. Repair of Location 1 Near Seam Between Liner Panels P2 and P12.**

As detailed in the Weaver Report, Weaver identified three locations in the Bypass Basin's geomembrane liner. Location 1 was near the seam between geomembrane liner panels P2 and P12. Locations 2 and 3 were at the bases of the pipe boots installed over the marker posts in geomembrane liner panels P36 and P18, respectively. These locations are identified on Figure 1 of the Weaver's Report, and photographs of the aberrations are shown in Appendix A of the report.

*(a) Weaver Photograph (#5)  
of Location 1*

After the survey was completed, Clean Air and Water (CAAW) Systems repaired the three locations identified by Weaver.<sup>1</sup> Figures 1, 2, and 3 show the repairs juxtaposed with the photographs that Weaver took during the survey. As shown in Figure 1, an HDPE geomembrane patch was placed over Location 1 near the seam between panels P2 and P12; the patch was extrusion-welded to the base sheets on both sides of the seam. Per Figure 2, additional extrudate was placed around the base of the marker post in panel P36, effectively covering the original weld at Location 2. Per Figure 3, Location 3 at the marker post in panel P18 was repaired in the same manner. At each location, CAAW Systems subsequently tested the integrity of the extrusion weld in accordance with ASTM D5641, "Standard Practice for Geomembrane Seam Evaluation by Vacuum Chamber." None of the locations exhibited leakage during the vacuum chamber test. Therefore, the repairs made at the three locations identified by Weaver are competent.

*(b) HDPE Geomembrane Patch  
Welded Over Location 1*

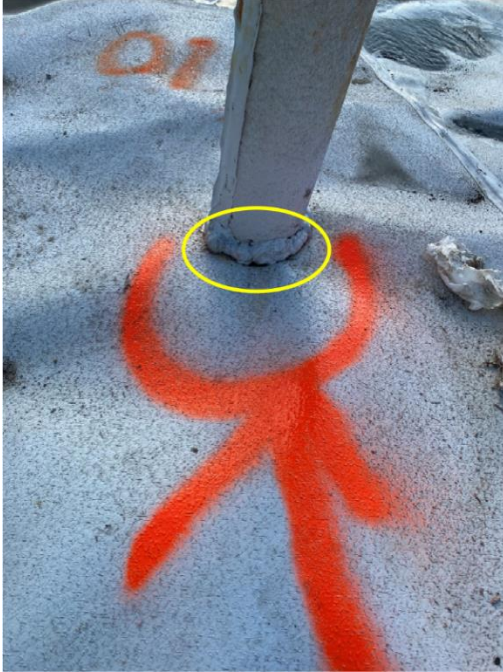
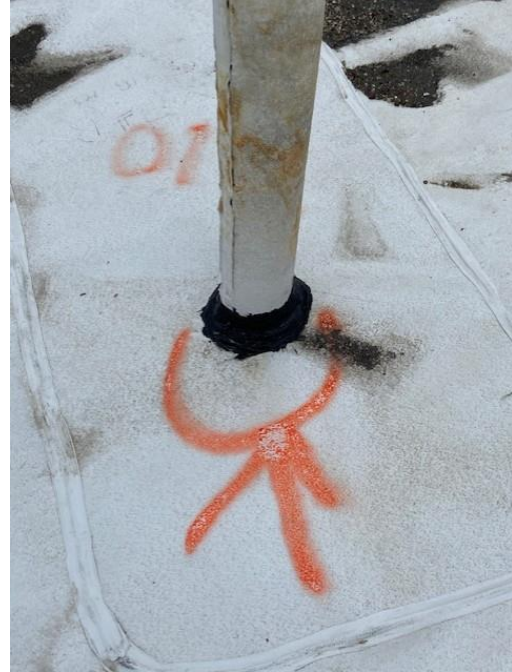
**Figure 2. Repair of Location 2 at Base of Marker Post in Liner Panel P36.**

*(a) Weaver Photograph (#6)  
of Location 2*

*(b) Additional Extrudate Placed  
Around Marker Post*

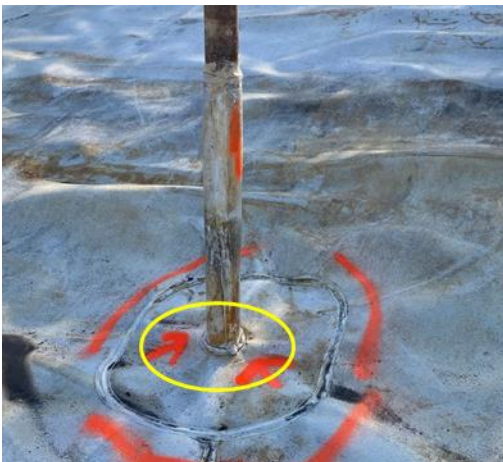
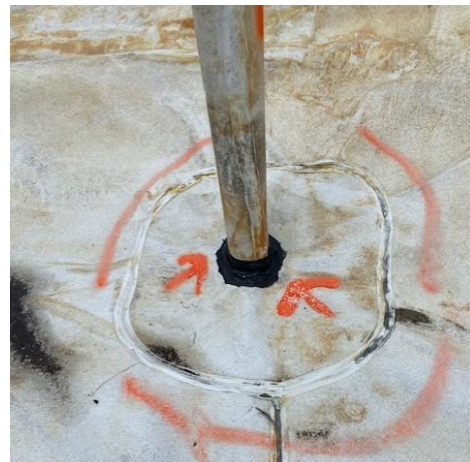
**Figure 3. Repair of Location 3 at Base of Marker Post in Liner Panel P18.**

*(a) Weaver Photograph (#7)  
of Location 3*

*(b) Additional Extrudate Placed  
Around Marker Post*

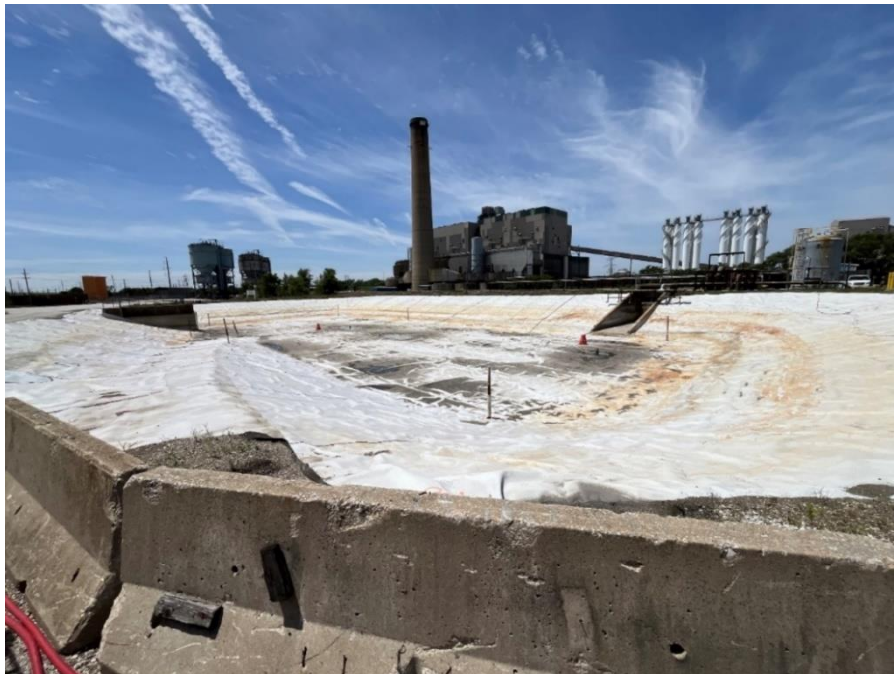
**Figure 4. Cleaned and Decontaminated Bypass Basin (Looking Southwest).**

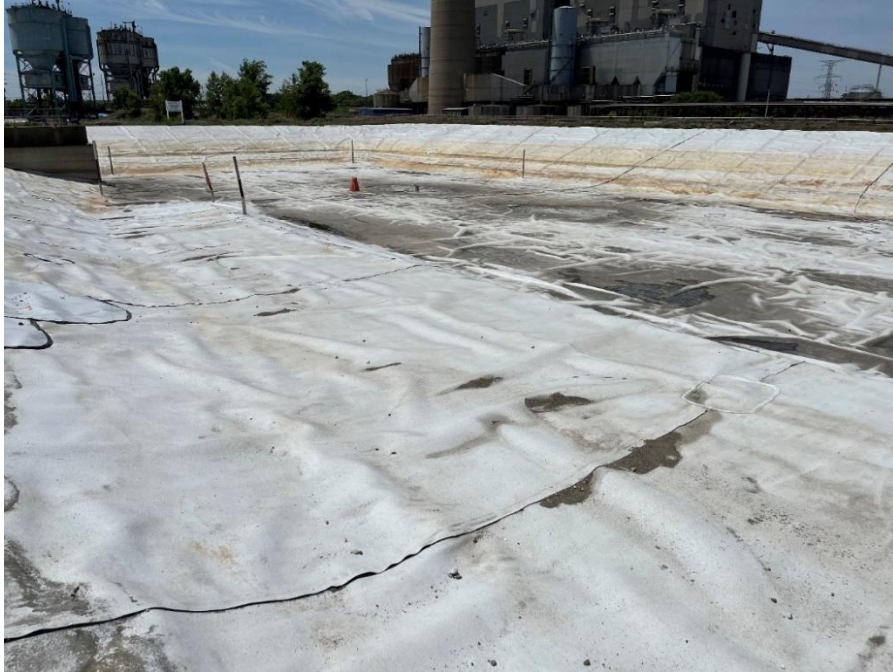
**Figure 5. Cleaned and Decontaminated Bypass Basin (Looking Southwest).**

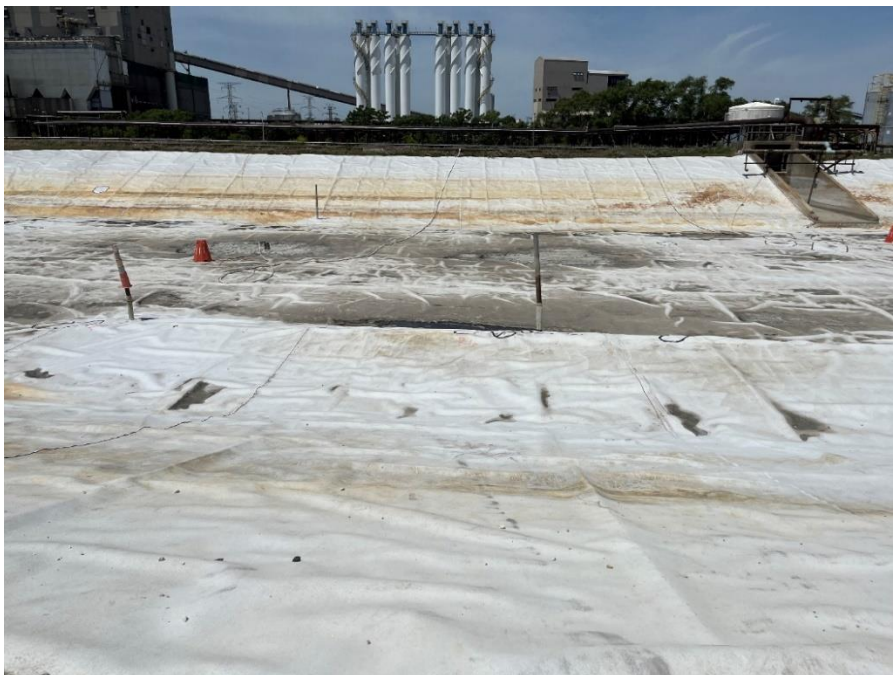
**Figure 6. Cleaned and Decontaminated Bypass Basin (Looking West).**

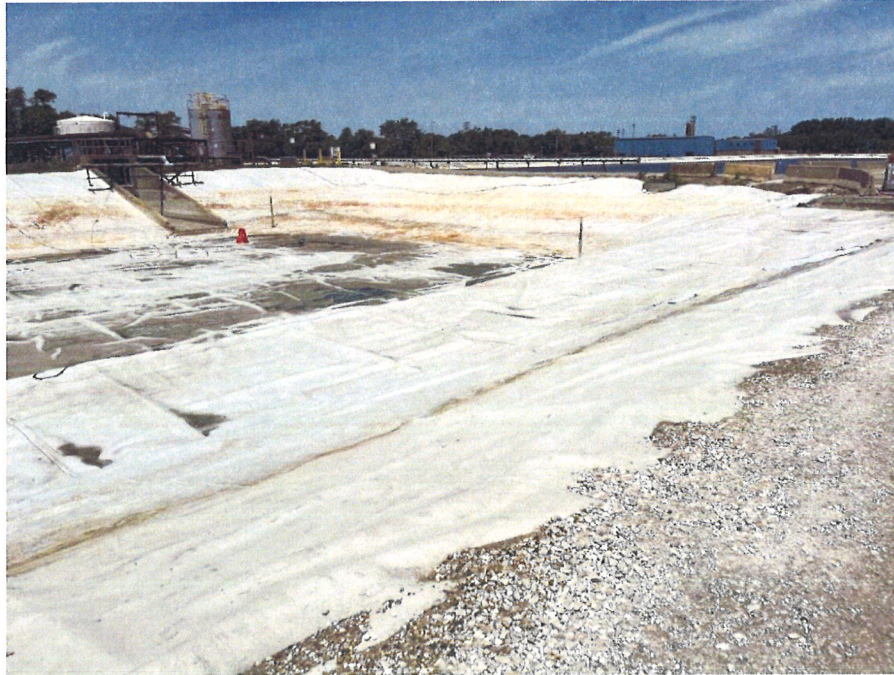
**Figure 7. Cleaned and Decontaminated Bypass Basin (Looking Northwest).**

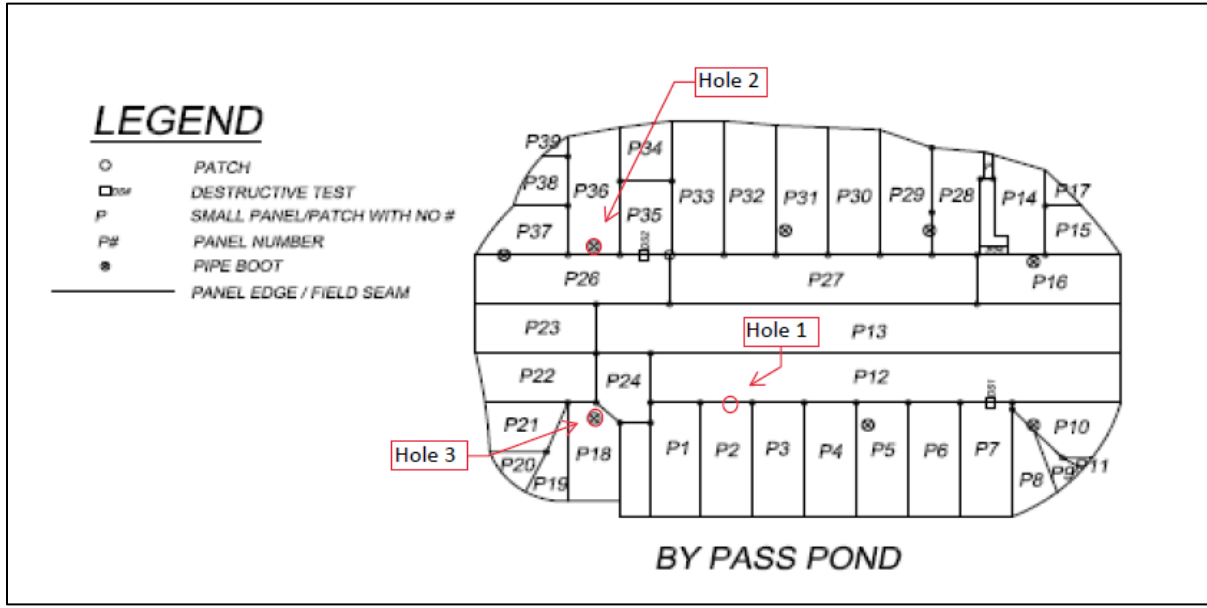
**Figure 1**

Three (3) locations were found to produce elevated readings indicative of the presence of a leak or hole. These locations are as shown in Figure 1. Each location is shown in the photographs in Appendix A. Over the remainder of the lined area there were no other signals indicating the presence of a hole or leak in the geomembrane. Additionally, during the leak location survey visual observations of the surface of the geomembrane were performed looking for indications of the presence of a hole. No additional holes were observed visually.

The electrical leak location survey performed on the basin liner identified three (3) holes as shown in Figure 1.

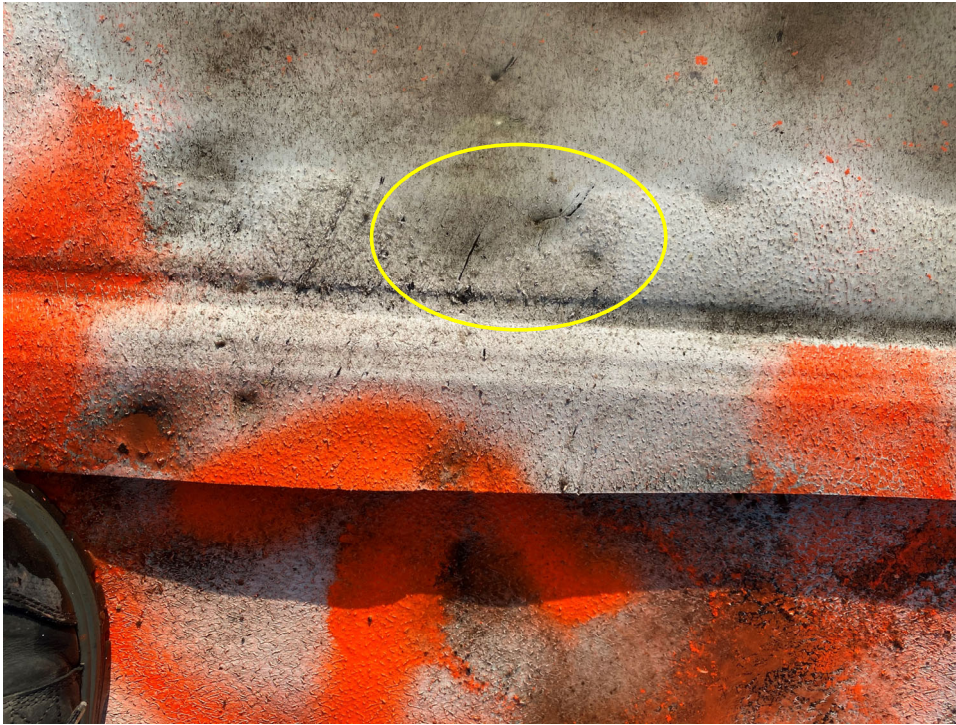
**Photograph #5**

Hole location #1. Two deep scratches through the geomembrane.

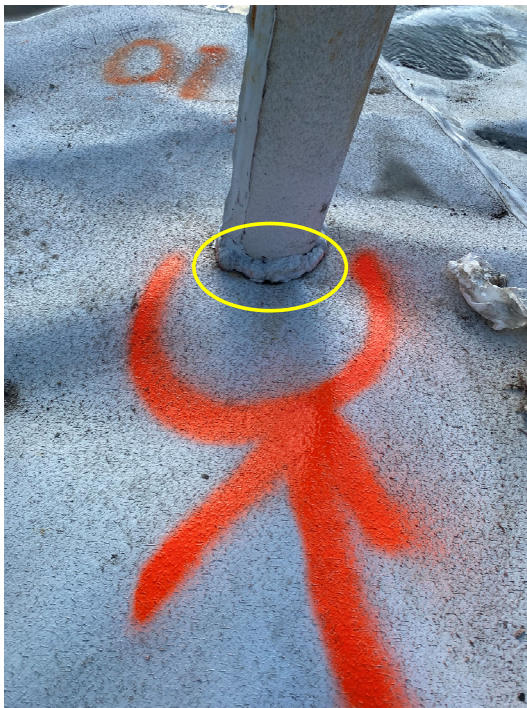
**Photograph #6**

Hole location #2. The leak signal was at the base of the extrusion weld of the pipe penetration boot along the west side.

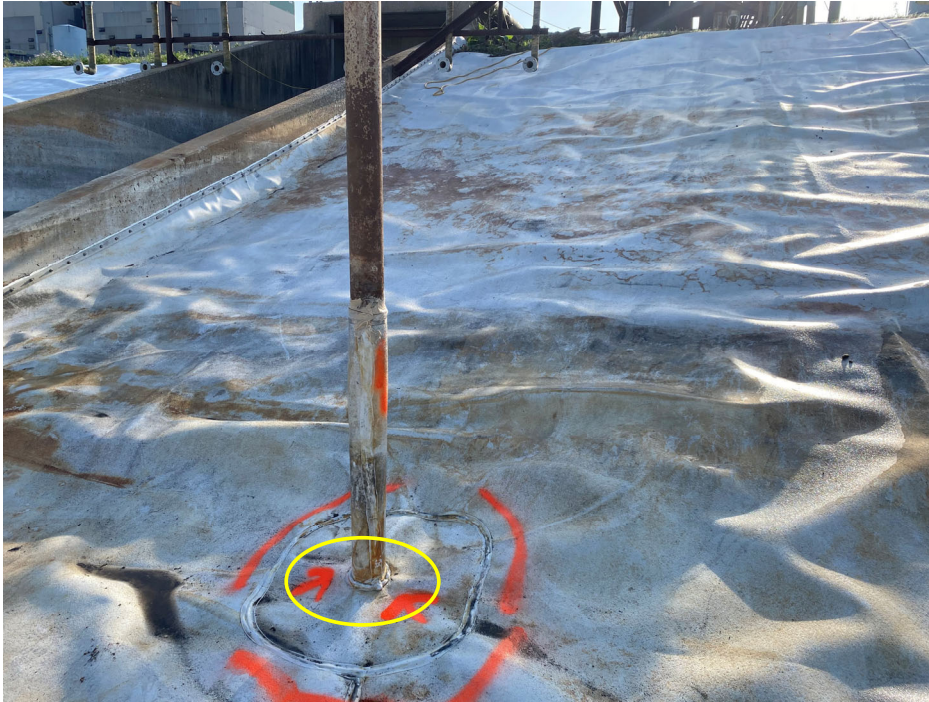
**Photograph #7**

Hole location #3. The leak signal was at the base of the extrusion weld of the pipe penetration boot along the north, south, and west side.
