## Powerton Generating Station

# 2024 Structural Stability Assessment for Ash Surge Basin, Bypass Basin, & Former Ash Basin

October 13, 2024

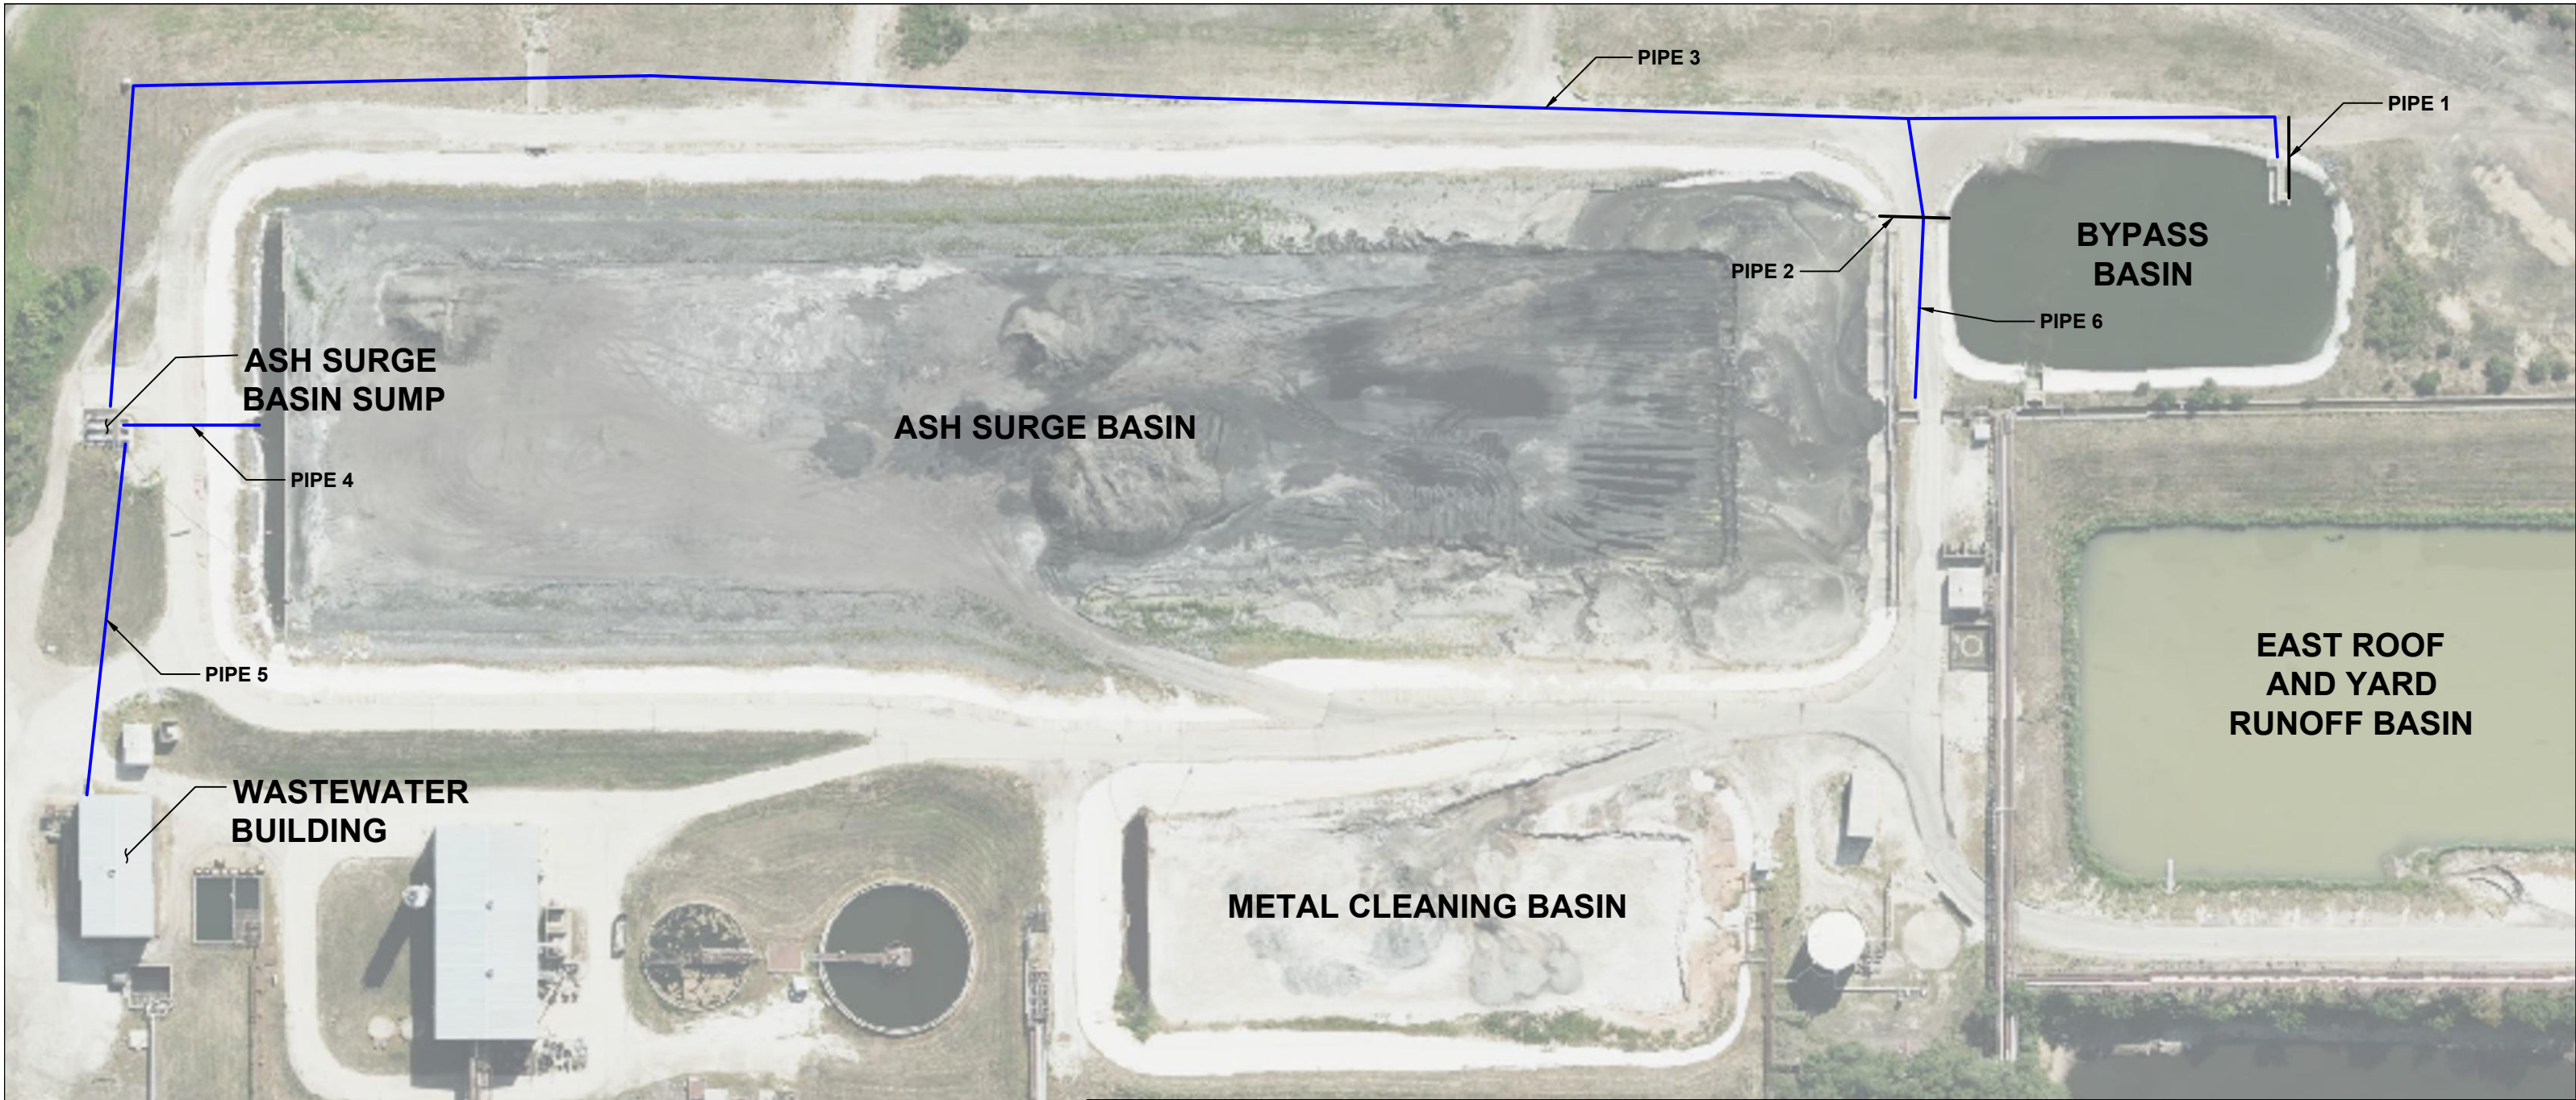
**FIGURE 1**

Figure 1: Embedded Pipes at Ash Surge & Bypass Basins, Powerton Generating Station

As documented in the Ash Surge Basin's initial federal structural stability assessment (Ref. 4), visual surveillance of the pipes passing through the Ash Surge Basin's dikes was performed in May 2016. No significant deterioration, deformation, distortion, bedding deficiencies, sedimentation, or debris that may negatively affect the basins were identified during the surveillance program. No similar pipe surveillance

programs have been performed for Pipes 4 and 5 since the initial video camera inspection in May 2016. However, no visual signs of distress at the north dike surface that could be indicative of deterioration, failure, deformation, *etc.* (e.g., soft spots caused by leaking water, distortions in dike alignment) were observed during S&L's August 2024 site visit. Moreover, the Ash Surge Basin has been taken out of service and is being actively dewatered. Following dewatering, only intermittent flow is expected in Pipe 4. However, it is recommended that the Station conduct a visual surveillance program to confirm this pipe is in good, working condition and is free of significant material defects that could impact the pipe's integrities as a part of the planned retrofit construction activities for the basin.

In accordance with the recommended corrective measure stated in the 2023 structural stability assessment for the Bypass Basin (see Table 2-1, Ref. 24), Pipe 3 was assessed in 2024 to prepare for the Bypass Basin retrofit construction. The results of this assessment verified that the discharge pipe is in good operational condition, and no significant deterioration, deformation, distortion, bedding deficiencies, sedimentation, or debris that may negatively affect the basin were identified.

The new Pipe 6 installed in the Bypass Basin's north dike was installed by excavating a trench, placing a coarse aggregate bedding layer, placing the pipe, and backfilling the trench with well-graded crushed stone / gravel. All fill material under and around Pipe 6 was compacted to 95% of the material's maximum dry density, as determined by ASTM D1557 (i.e., modified Proctor). Given the pipe is new and was installed in accordance with recognized and generally accepted engineering practices, Pipe 6 is in good operational condition, and there are no significant deterioration, deformation, distortion, bedding deficiencies, sedimentation, or debris that may negatively affect the basin.

In accordance with 35 Ill. Adm. Code 845.450(a)(6), it is recommended that the Station continue to perform visual inspections of the Bypass Basin's discharge pipe (Pipe 3) and the new CHDE pipe for non-CCR wastewater (Pipe 6) to confirm that the pipes' structural integrities continue to be maintained.
