**STRUCTURAL STABILITY AND FACTOR OF SAFETY ASSESSMENT  
ASH SURGE BASIN AND BYPASS BASIN  
POWERTON STATION  
OCTOBER 2016**

This report presents documentation of the initial periodic structural stability and initial safety factor assessments for the Ash Surge Basin and Bypass Basins (the Basins) at the Powerton Station (Site) in Pekin, Illinois (Figure 1). This report addresses the initial structural stability and safety factor assessment requirements of the Coal Combustion Residuals (CCR) regulations, Code of Federal Regulations Title 40, Part 257, Subpart D (referred to as the CCR Rule). These regulations were published in the Federal Register on 17 April 2015 and became effective on 19 October 2015. The Powerton Station is owned and operated by Midwest Generation, LLC (Midwest Generation). Based on the results provided in this report, the Ash Surge Basin and Bypass Basin meet the requirements of §257.73(d) and §257.73(e) of the CCR Rule.

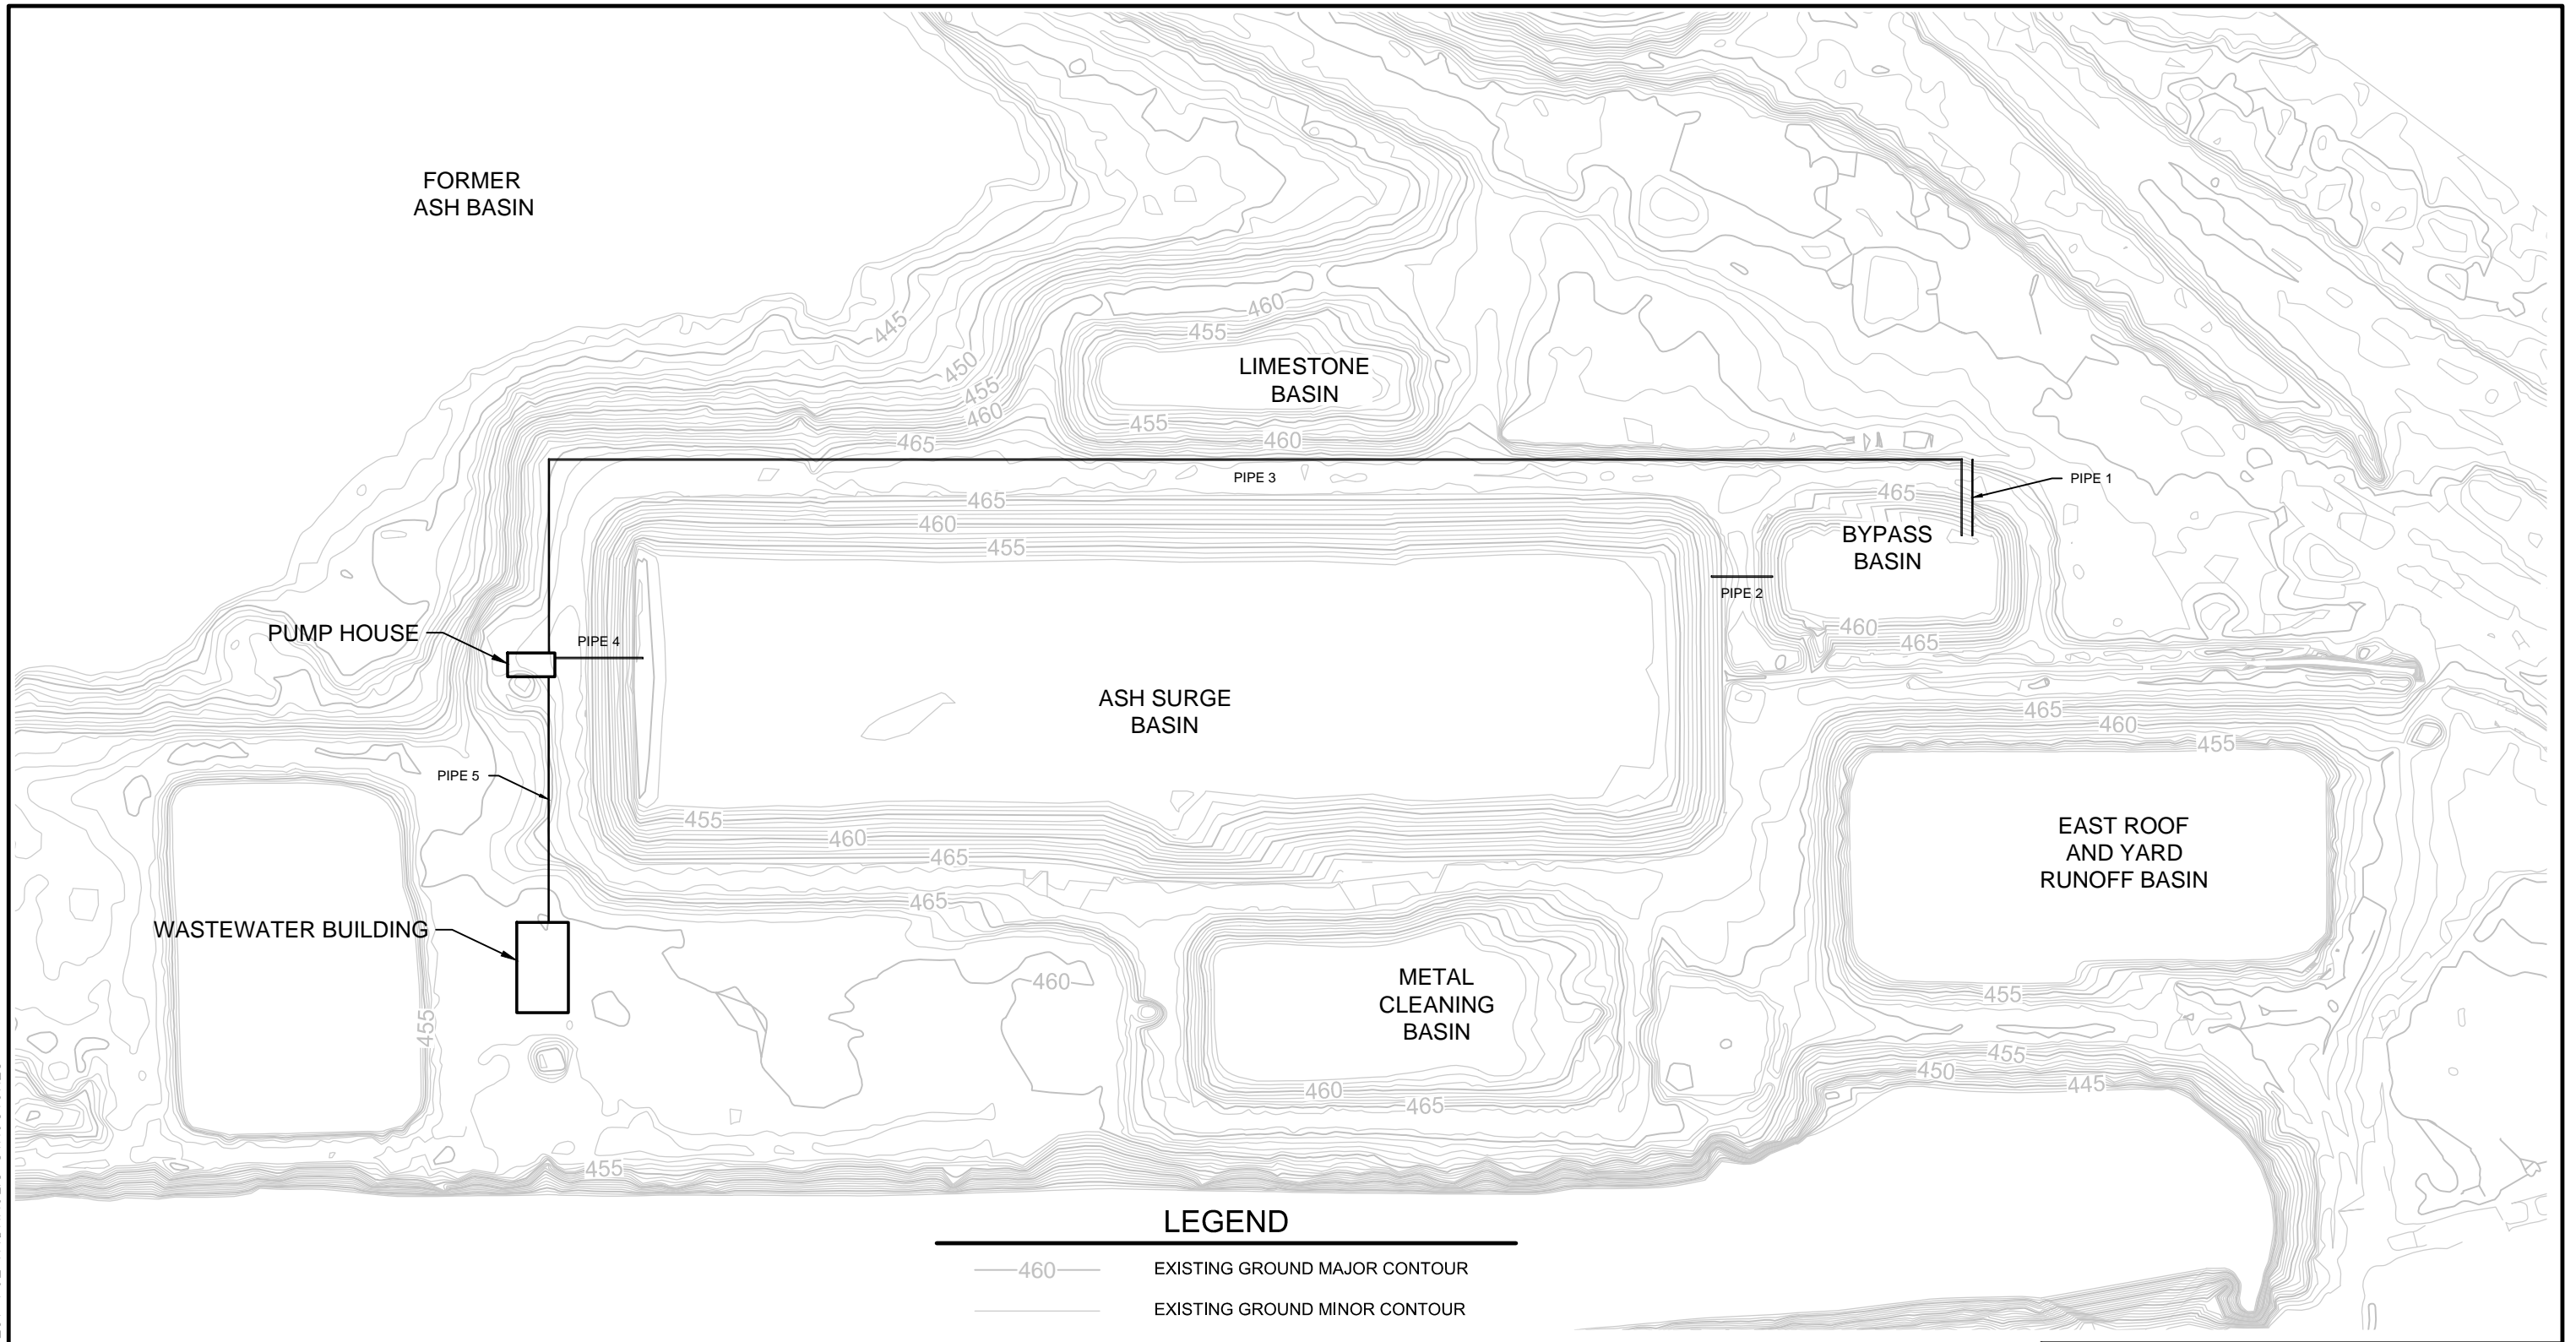
FIGURE  
**2**

Hydraulic structures passing through or beneath the embankments of the Bypass Basin and Ash Surge Basin consist of several pipes and conveyance structures associated with the inlet and outlet structures of the Basins. These structures and pipes were inspected periodically between 10 May 2016 and 24 May 2016 by a company specializing in video camera pipe inspections. The inspected structures and pipes related to the Basins included are presented on Figure 2. The video inspections did not identify significant deterioration, deformation, distortion, bedding deficiencies, sedimentation, or debris that would negatively affect operation of the pipes was observed.

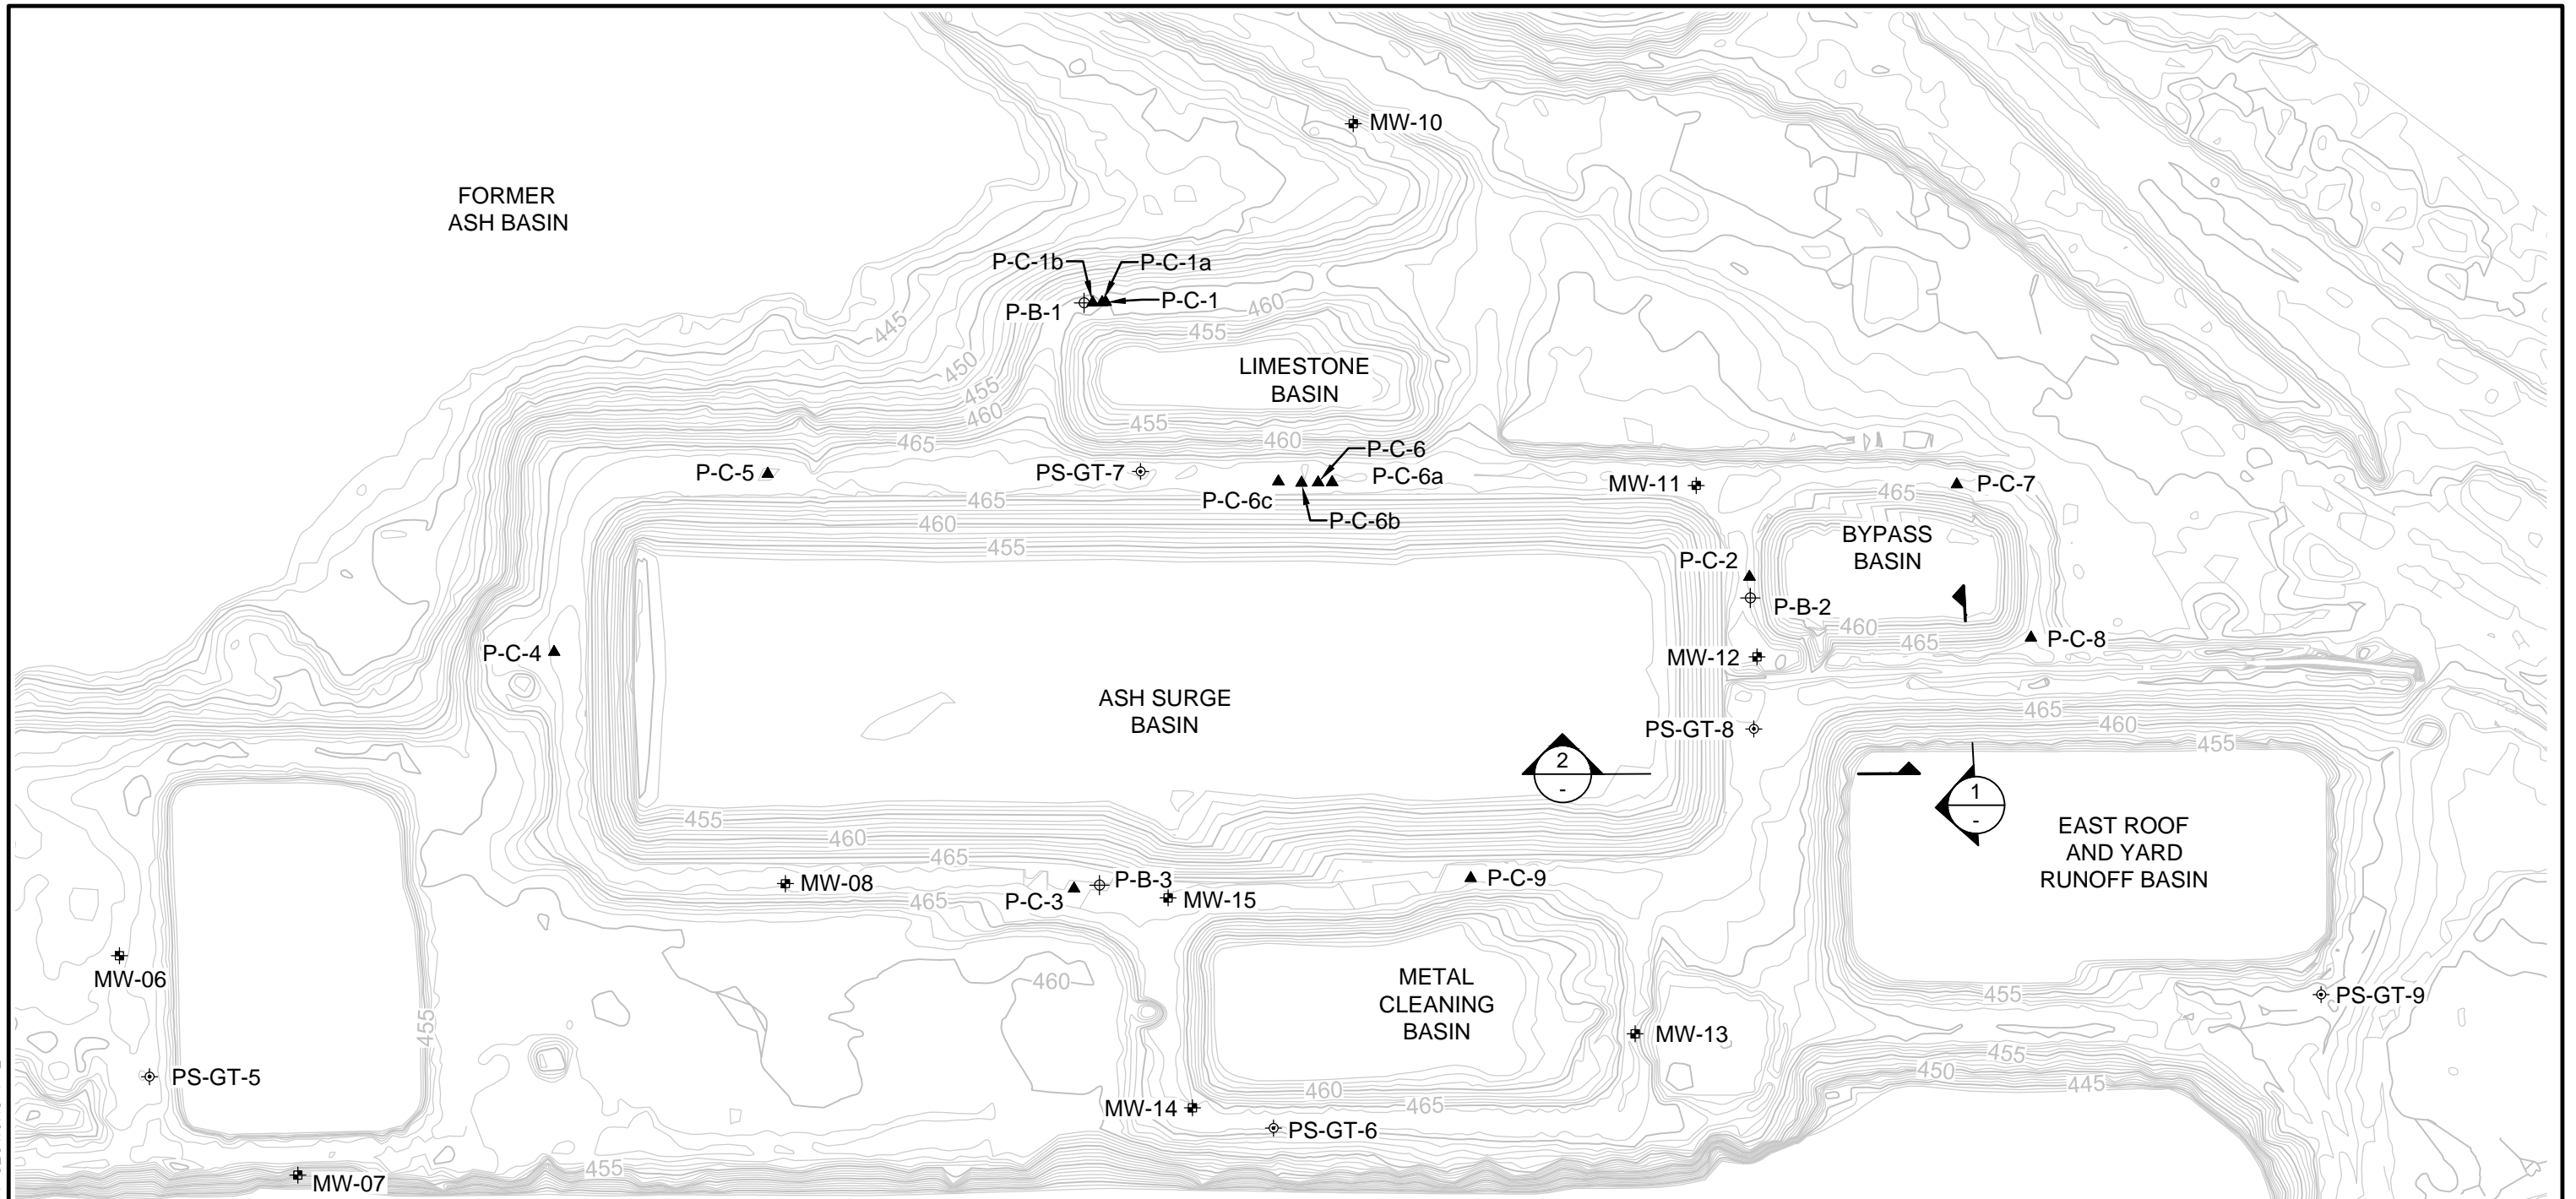
<b>STABILITY SECTIONS</b> ASH SURGE AND BYPASS BASINS POWERTON STATION PEKIN, ILLINOIS	
PROJECT NO: SW0251-07	OCTOBER 2016
<b>FIGURE</b> <span style="font-size: 2em;">3</span>

Ponds or water bodies near downstream slopes of the Ash Surge Basin and Bypass Basin are identified on Figure 3 and include:

- The Metal Cleaning Basin located west of the Ash Surge Basin. This basin is lined with an HDPE geomembrane.
- The ERYR Basin located west of the Bypass Basin and south of the Ash Surge Basin;
- The inactive Limestone Basin located east of the Ash Surge Basin; and
- The FAB located northeast of the Ash Surge Basin.

This section describes the initial safety factor assessment for the Ash Surge Basin and Bypass Basin and the methodology used to perform the assessment in accordance with §257.73(e)(1). This assessment includes slope stability analyses of the critical embankment cross-section for each basin, shown in Figure 3.

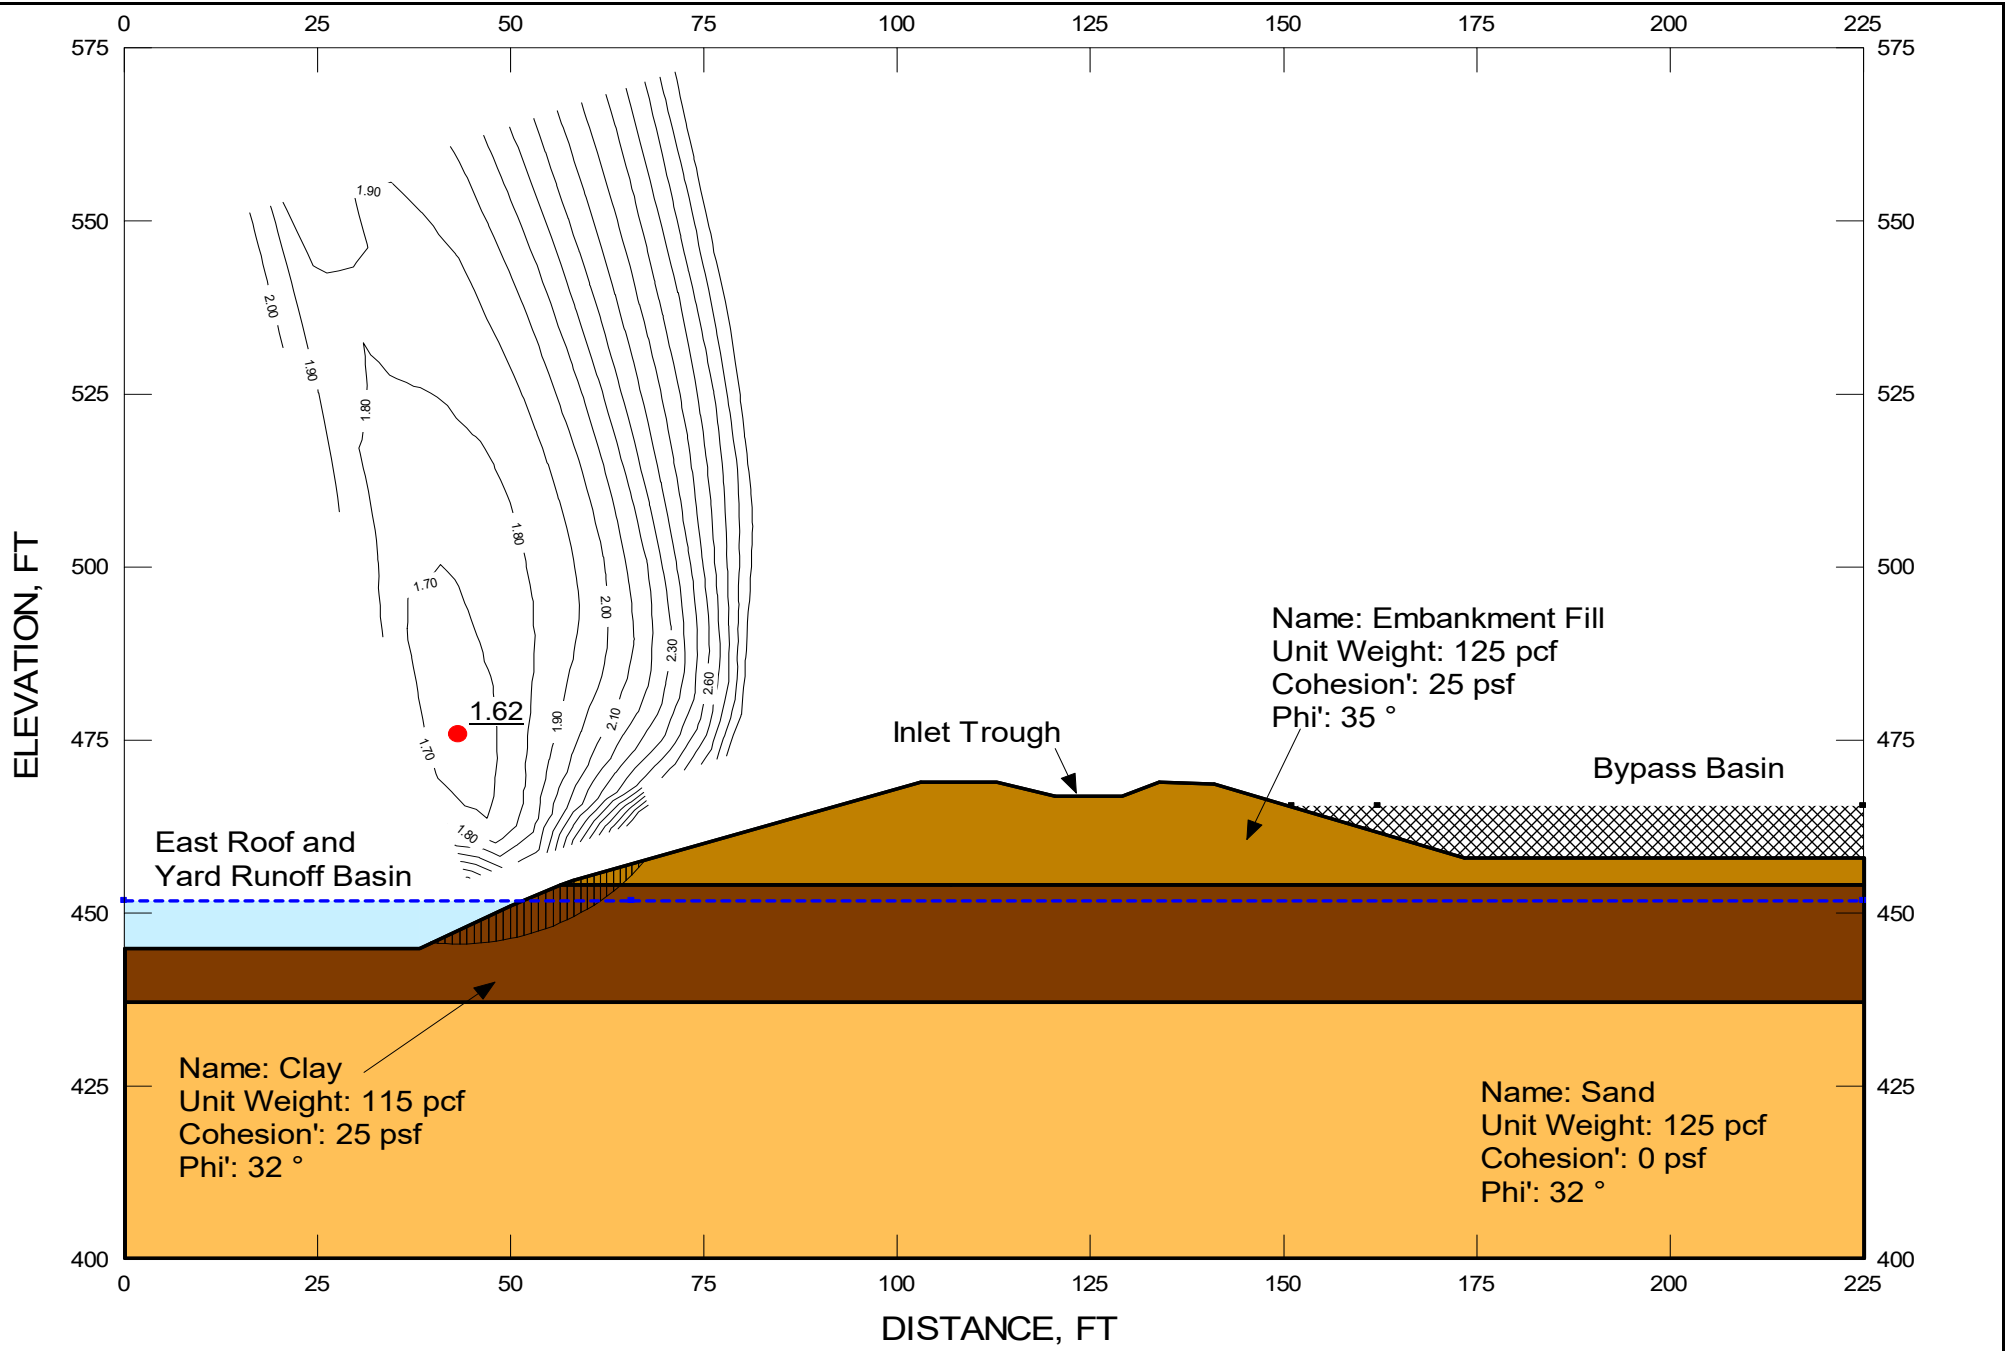
Figure 4 – Slope Stability Output, Section 1 - 257.73(e)(1)(i)

Pursuant to §257.73(e)(1)(i) a static, long-term condition with the maximum operating pool loading on the embankments was evaluated. For the Ash Surge Basin and Bypass Basin, this condition included a pool elevation at 465 feet MSL<sup>1</sup> for the Ash Surge Basin and 465.5 feet MSL for the Bypass Basin, and a groundwater elevation of 451.8 feet MSL (Geosyntec, 2016e).

Section	Safety Factor			
	257.73(e)(1)(i)	257.73(e)(1)(ii)	257.73(e)(1)(iii)	257.73(e)(1)(iv)
1	≥1.50	≥1.40	≥1.00	≥1.20
2	≥1.50	≥1.40	≥1.00	≥1.20

These results meet the factor of safety requirements presented in §257.73(e)(1)(i) through §257.73(e)(1)(iv).

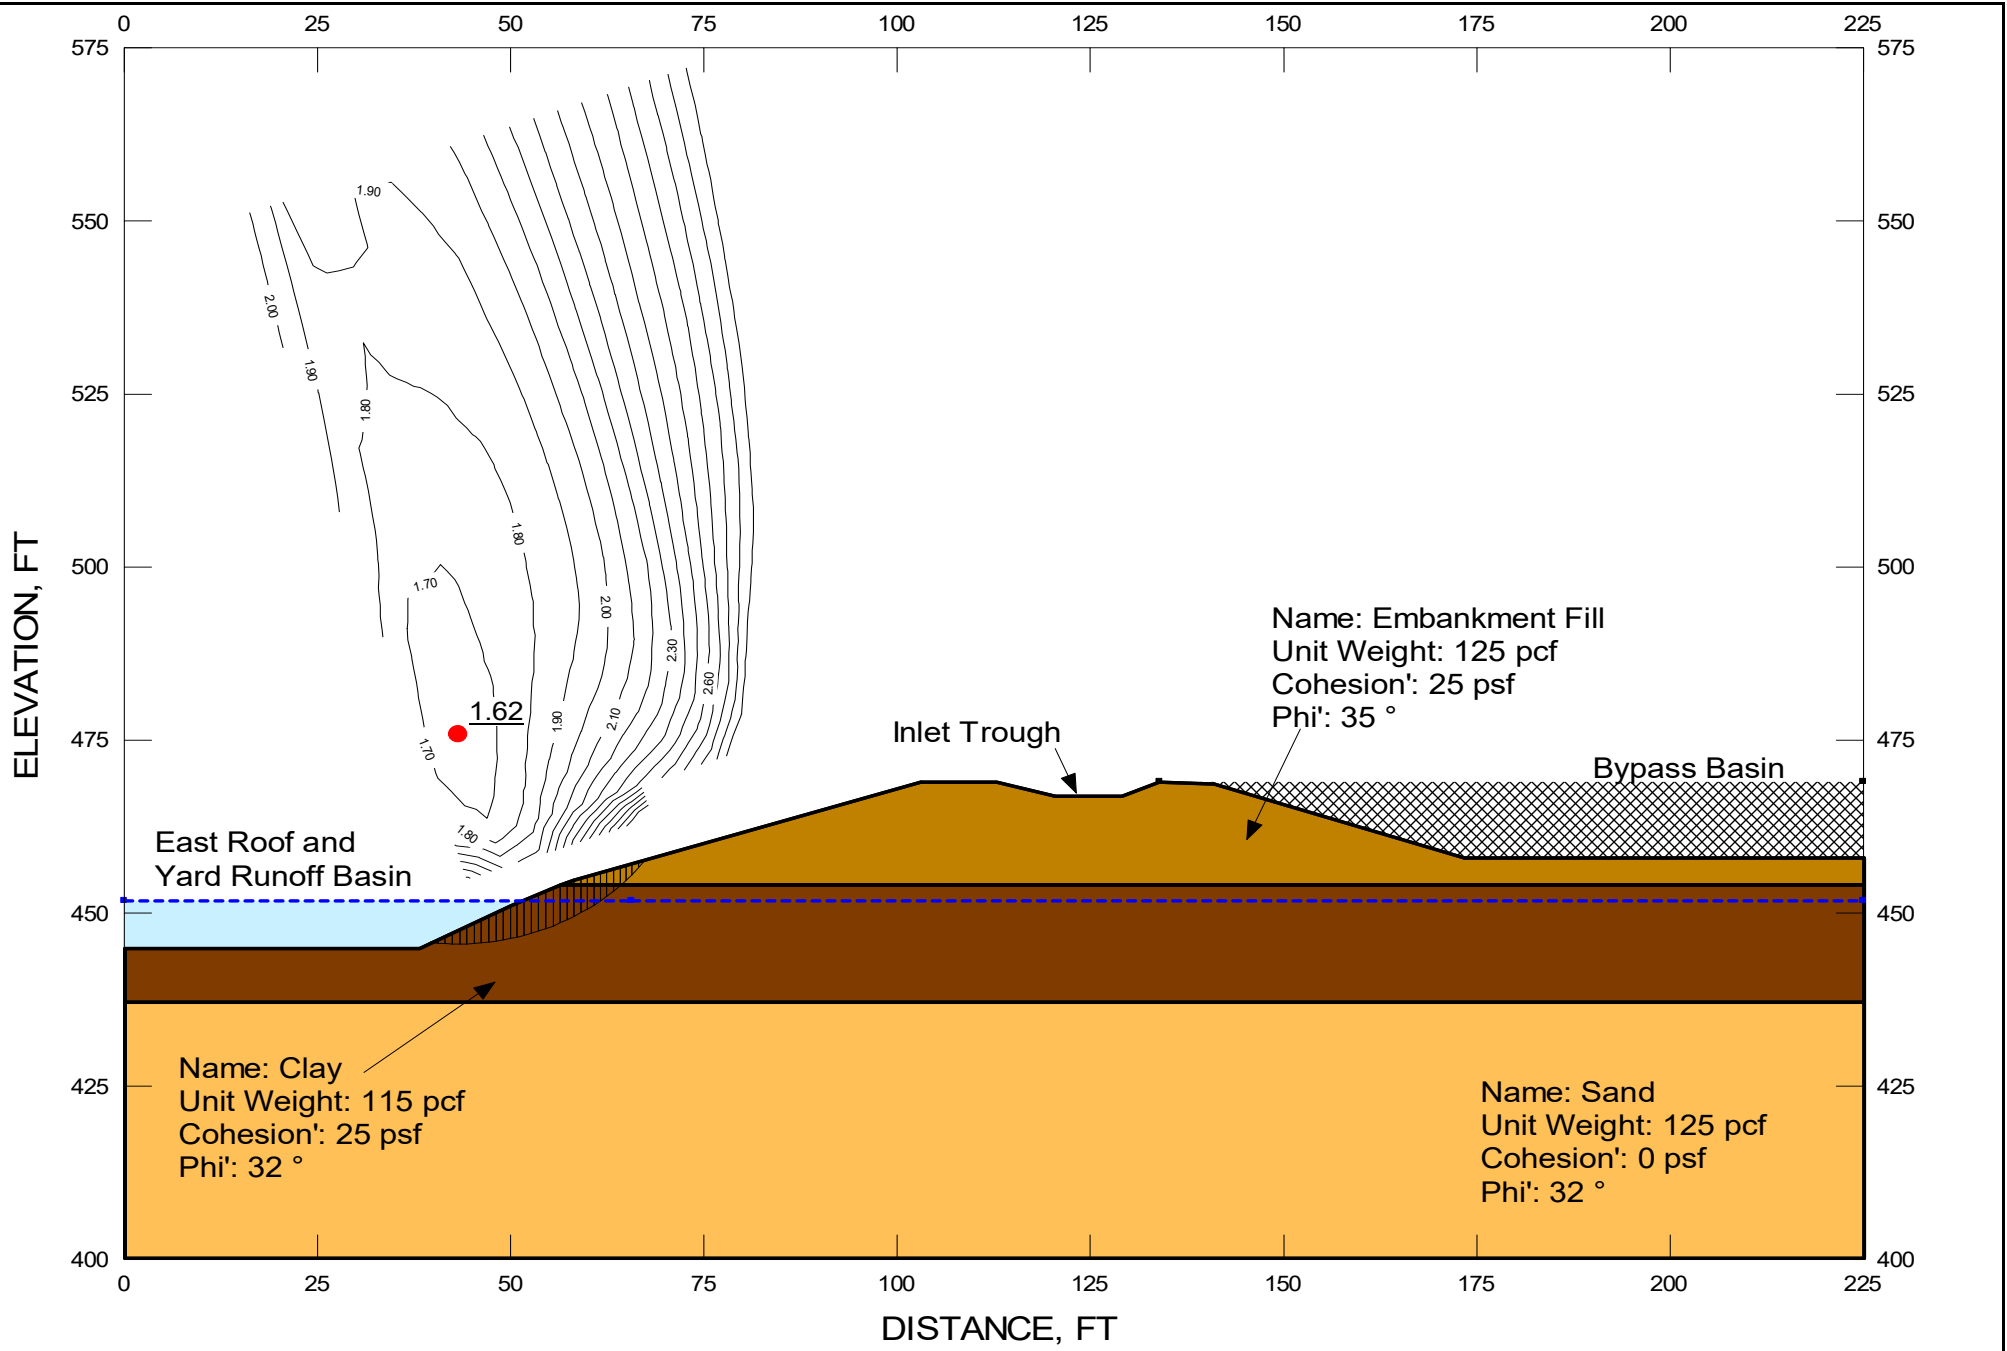
FIGURE 5

The conditions for §257.73(e)(1)(ii) are identical to §257.73(e)(1)(i) with the exception of the pool elevation, which is set at the lowest points of the embankment crest (Geosyntec, 2016e).

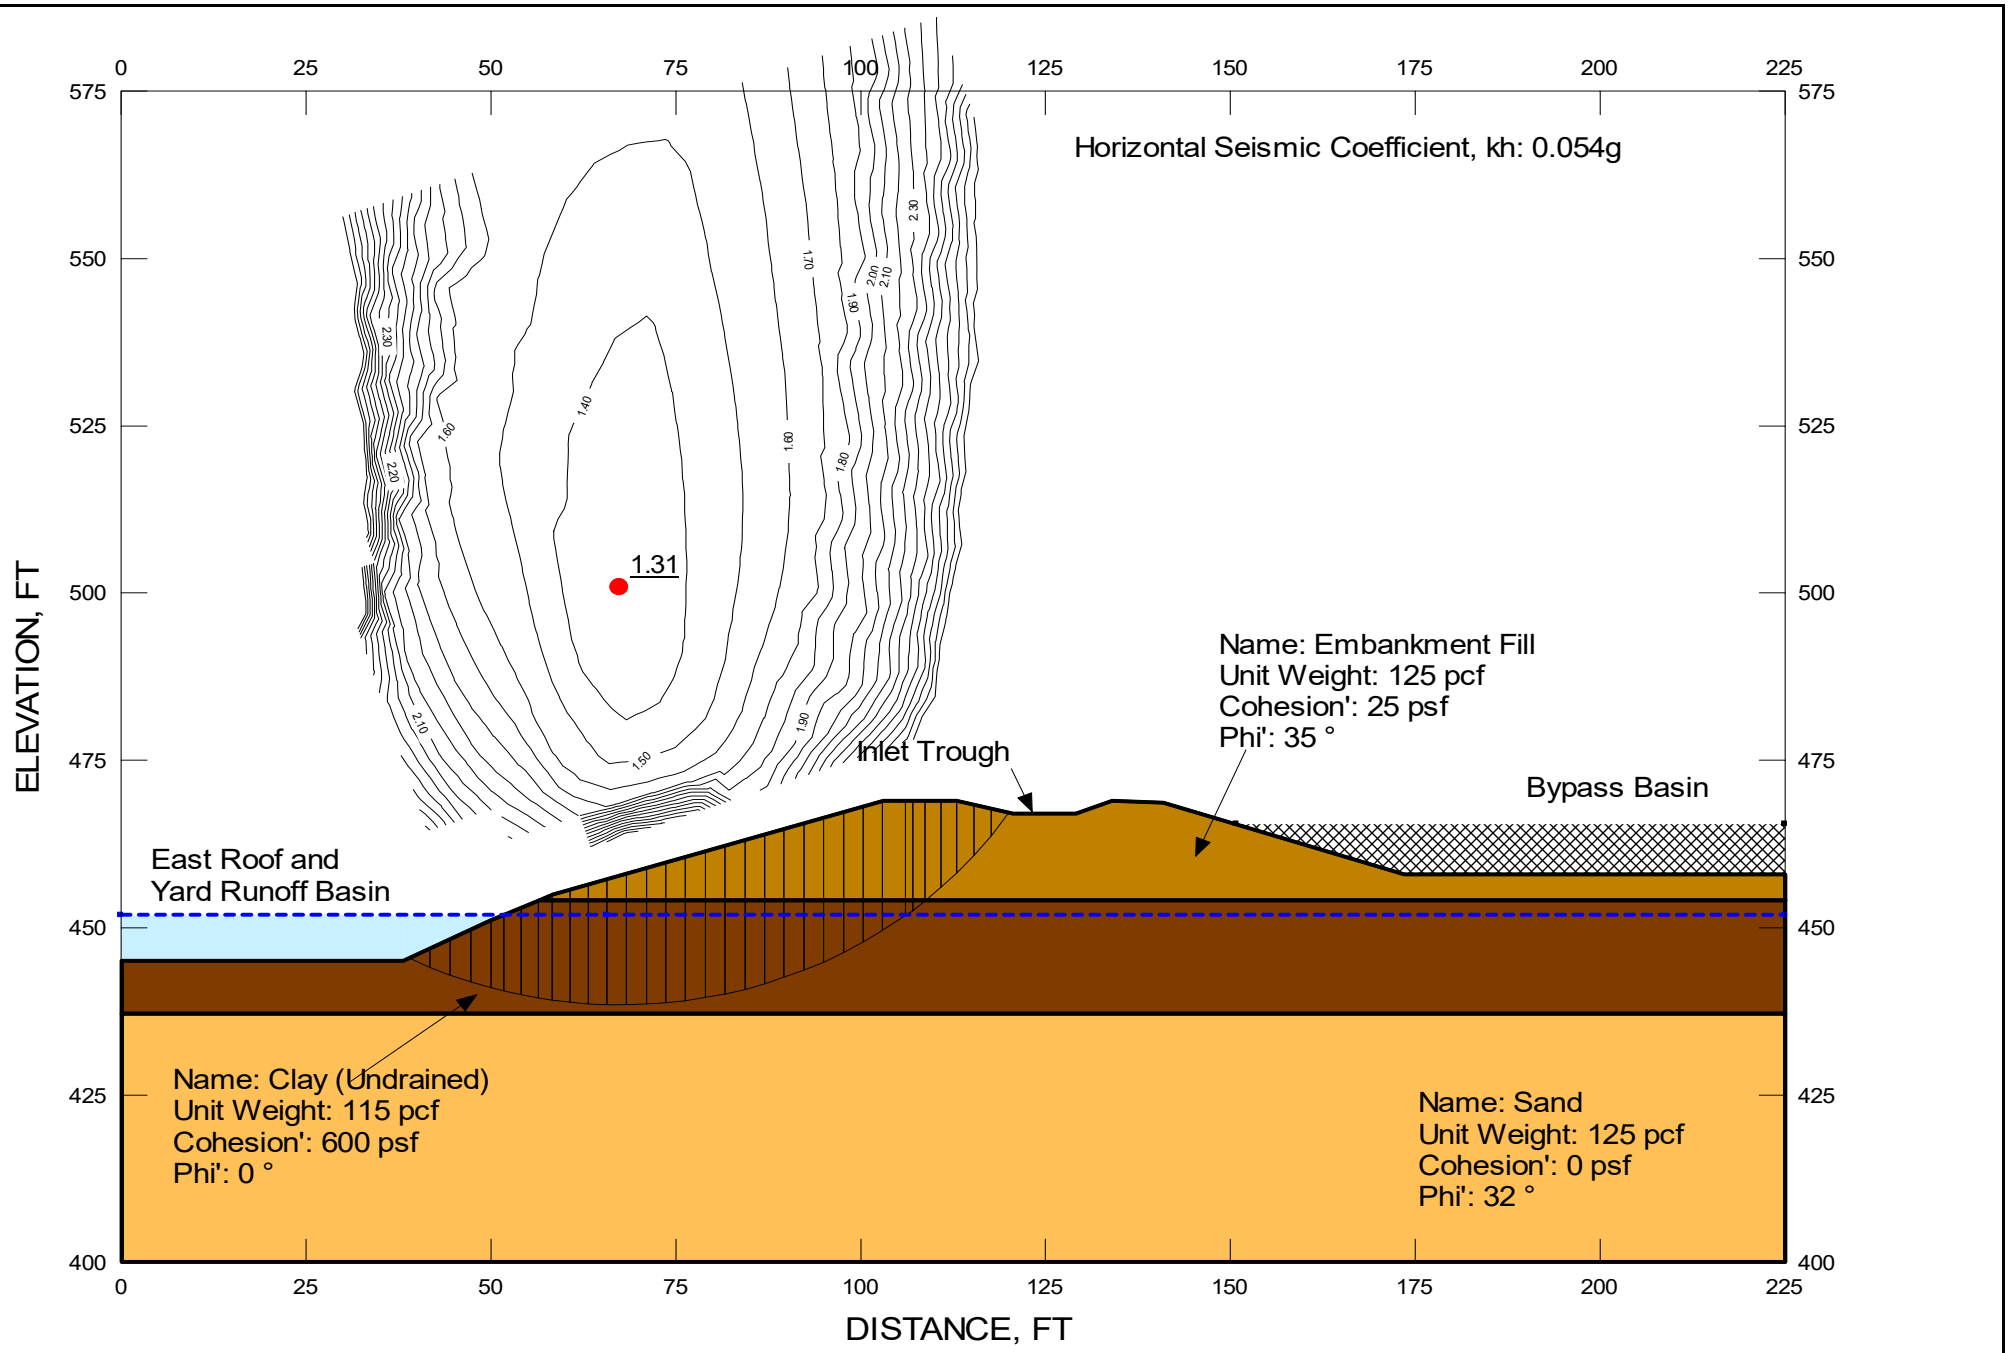
Figure 6 – Slope Stability Output, Section 1 - 257.73(e)(1)(iii)

Pursuant to §257.73(e)(1)(iii), a seismic condition for Ash Surge Basin and Bypass Basin was also analyzed. Seismic stability was evaluated with a pseudostatic analysis that uses constant horizontal accelerations to represent the effects of earthquake shaking. The horizontal accelerations are represented in SLOPE/W by a horizontal seismic coefficient. The horizontal seismic coefficient used for analysis was based on a peak ground acceleration with a 2 percent probability of exceedance in 50 years (Geosyntec, 2016g).
