WEEKLY SUMMARY REPORT

Week Ending: 09/05/2024 (Thursday)

Report No.: W-04-090524

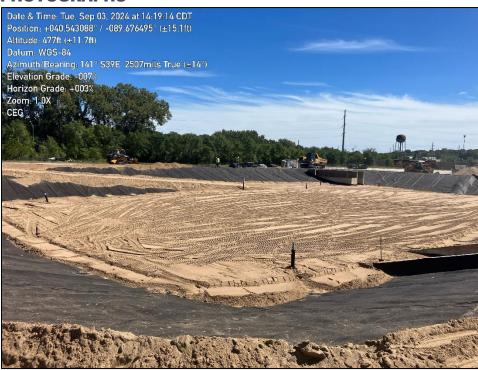
Photo 1: shows completed sand filter layer along bottom of basin.

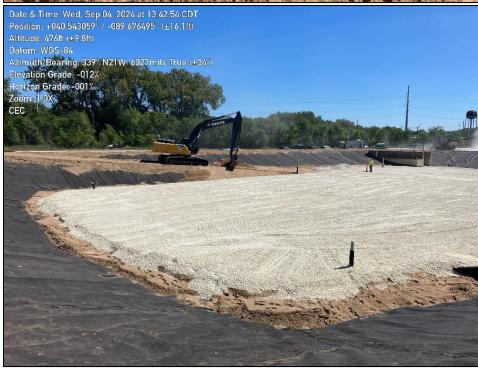
Photo 2: shows completed protective warning layer and placement of sand filter along slopes.

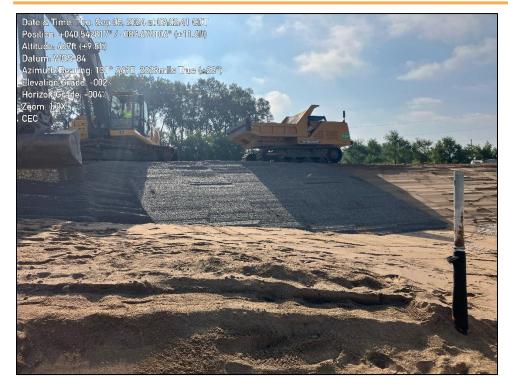
Photo 3: shows placement of rip rap bedding layer along eastern slope.

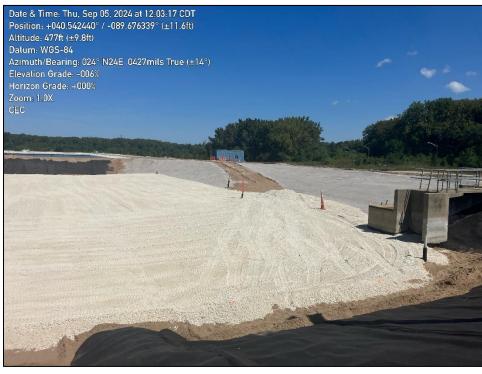
Photo 4: shows basin with protective warning layer and rip rap bedding layer.
