WEEKLY SUMMARY REPORT

Week Ending: 09/13/2024 (Friday) Report No.: W-05-091324 Page 1 of 3

BYPASS BASIN RETROFIT CQA		
Powerton Generating Station	CEC PROJECT NO:	343-014.0200
S&L Bypass Basin Retrofit Project	WEATHER:	Mostly Sunny
07/12/24	TEMP. RANGE (°F)	64-89
	Powerton Generating Station S&L Bypass Basin Retrofit Project	Powerton Generating StationCEC PROJECT NO:S&L Bypass Basin Retrofit ProjectWEATHER:

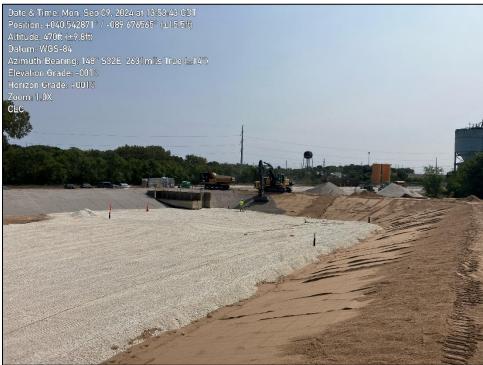
Photo 1: shows completed sand filter layer along slopes and rip rap bedding layer being placed.

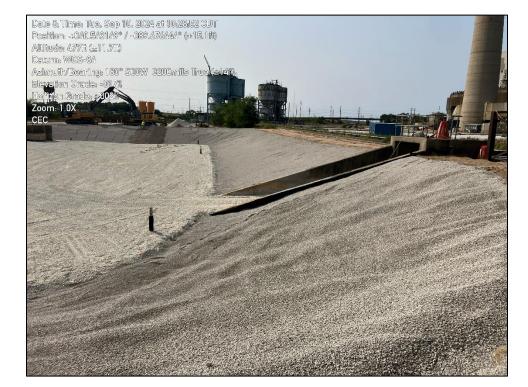
Photo 2: shows completed rip rap bedding layer along basin's slopes.

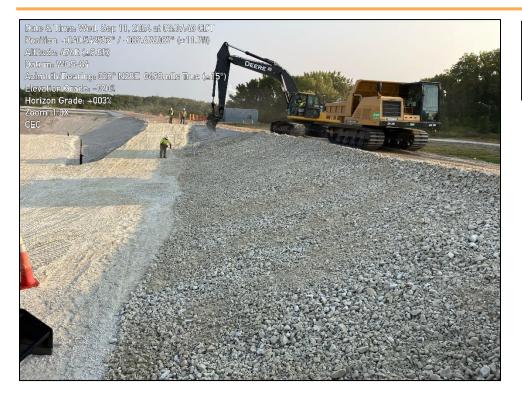
Photo 3: shows placement of rip rap layer along eastern slope.

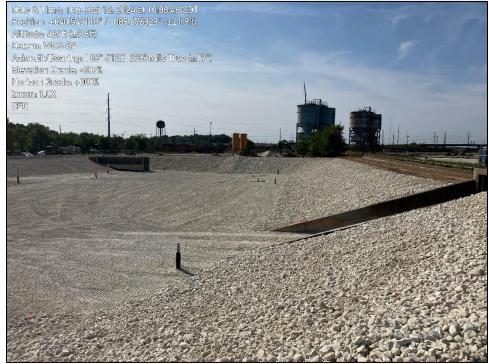
Photo 4: shows basin with completed layers of aggregates.
