Powerton Generating Station

2025 Structural Stability Assessment for Ash Surge Basin, Bypass Basin, & Former Ash Basin

October 13, 2025

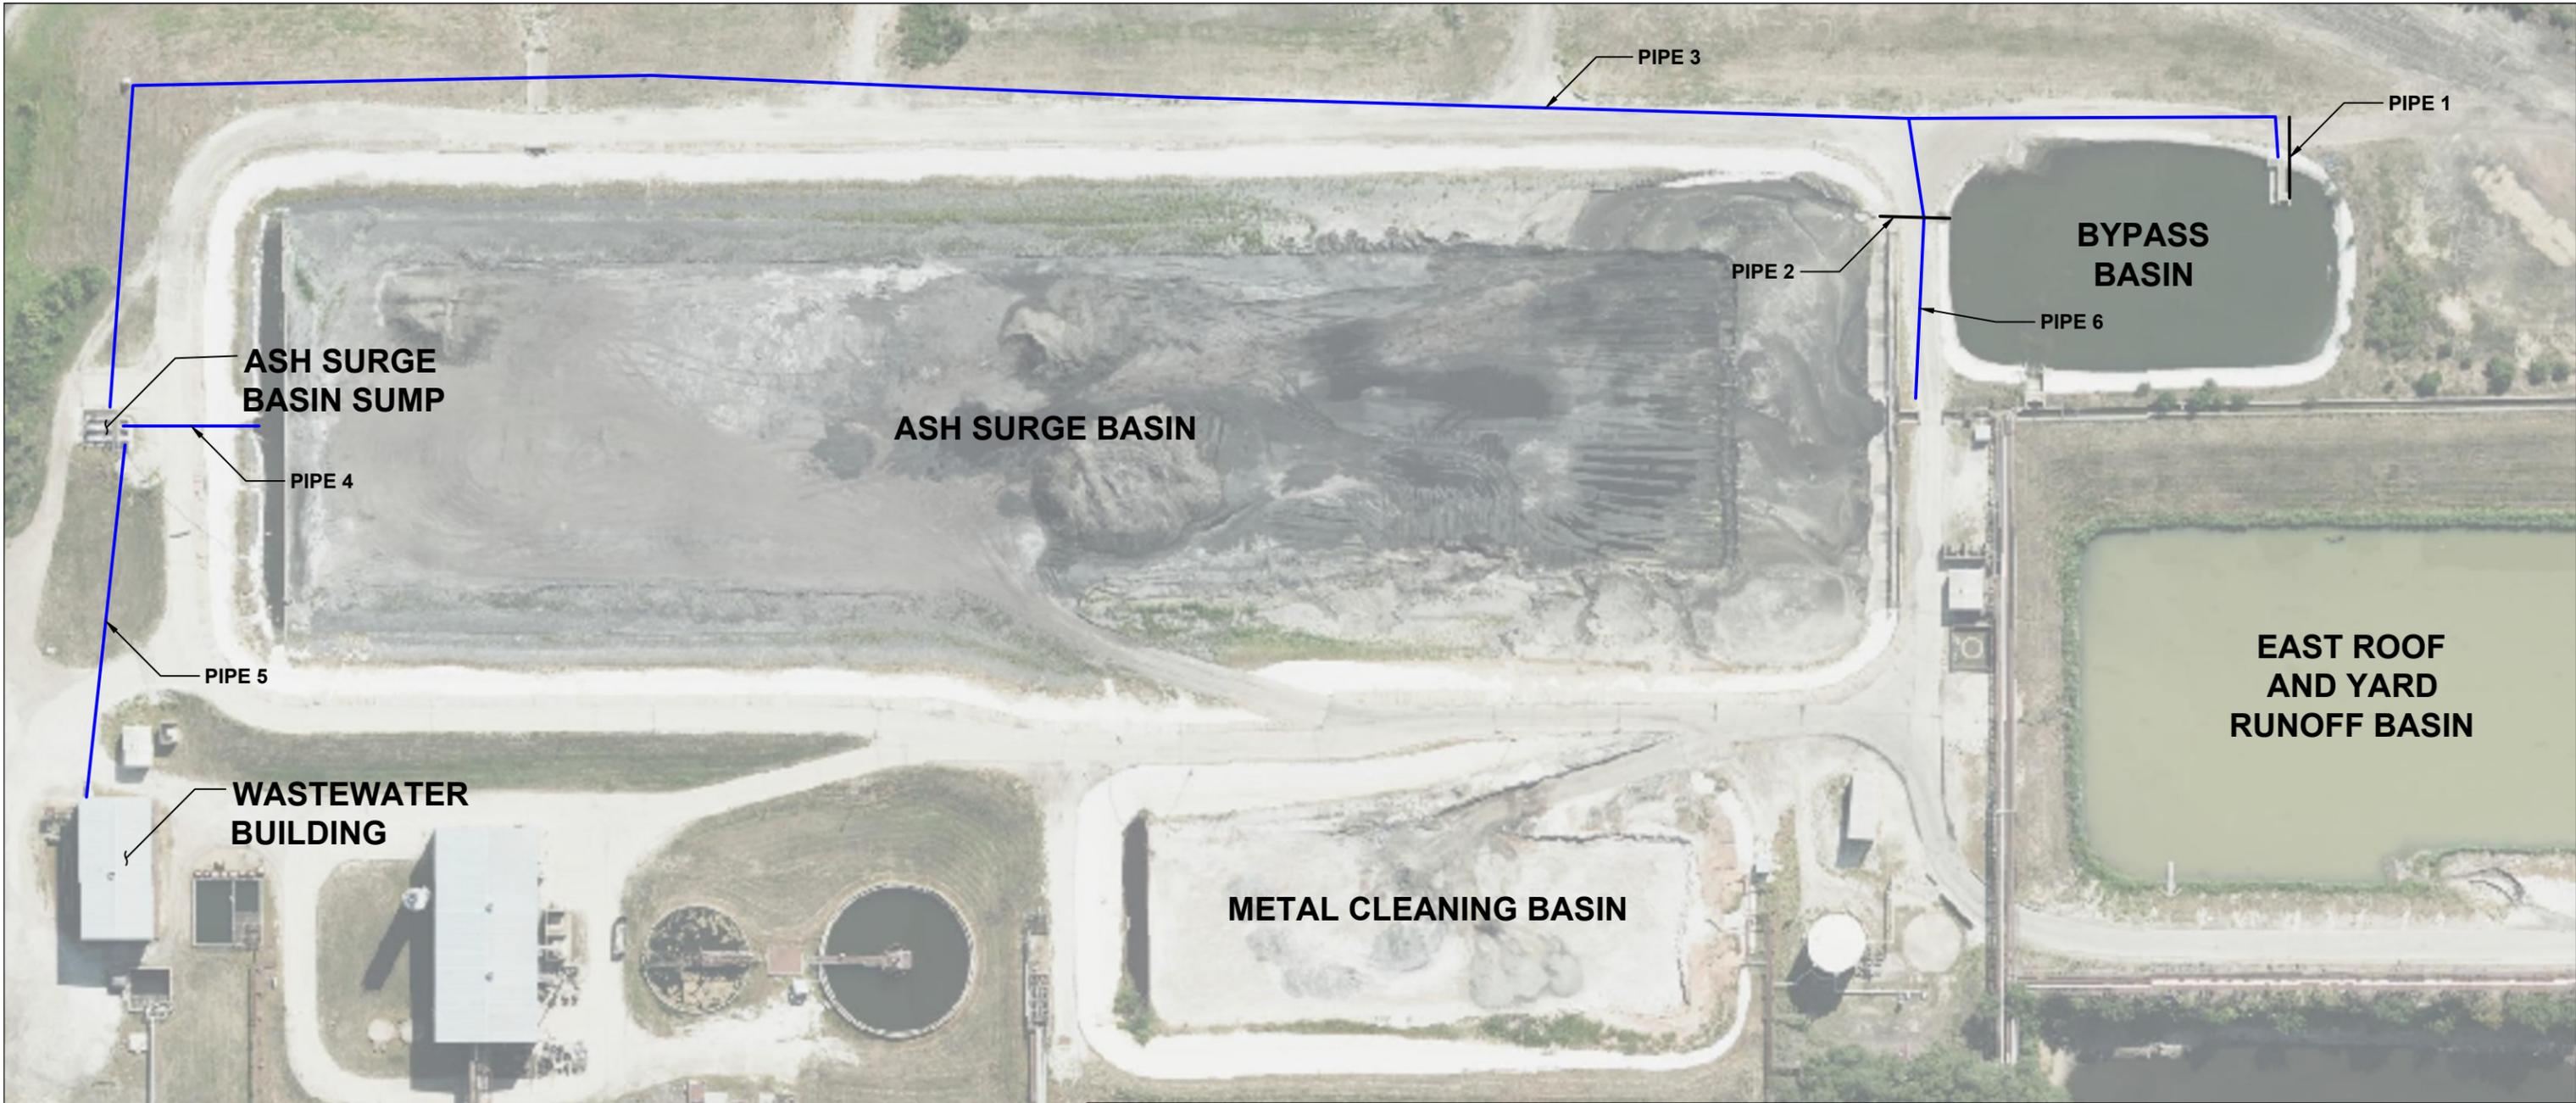
FIGURE 1

As shown on Figure 1, there are four active pipes and one decommissioned pipe that underlie or pass through the Ash Surge Basin's dikes. Pipe 4 is the Ash Surge Basin's outlet pipe to the Ash Surge Basin Sump. Pipe 5 is the common header into which the three pumps in the Ash Surge Basin Sump pump water to the wastewater building identified on Figure 1. Refer to Section 3.2.5 for a discussion of Pipes 2, 3, and 6.

As documented in the Ash Surge Basin's initial federal structural stability assessment (Ref. 4), visual surveillance of the pipes passing through the Ash Surge Basin's dikes was performed in May 2016. No significant deterioration, deformation, distortion, bedding deficiencies, sedimentation, or debris that may negatively affect the basins were identified during the surveillance program. No similar pipe surveillance programs have been performed for Pipes 4 and 5 since the initial video camera inspection in May 2016. However, no visual signs of distress at the north dike surface that could be indicative of deterioration, failure,

deformation, *etc.* (e.g., soft spots caused by leaking water, distortions in dike alignment) were observed during S&L's September 2025 site visit. Moreover, the Ash Surge Basin has been taken out of service and is being actively dewatered. Following dewatering, only intermittent flow is expected in Pipe 4. However, it is recommended that the Station conduct a visual surveillance program to confirm this pipe is in good, working condition and is free of significant material defects that could impact the pipe's integrities as a part of the planned retrofit construction activities for the basin.

In accordance with the recommended corrective measure stated in the 2024 structural stability assessment for the Bypass Basin (see Table 2-1, Ref. 26), Pipe 3 was assessed in 2025 following the Bypass Basin retrofit construction. The results of this assessment verified that the discharge pipe is in good operational condition, and no significant deterioration, deformation, distortion, bedding deficiencies, sedimentation, or debris that may negatively affect the basin were identified.

The new Pipe 6 installed in the Bypass Basin's north dike was installed by excavating a trench, placing a coarse aggregate bedding layer, placing the pipe, and backfilling the trench with well-graded crushed stone / gravel. All fill material under and around Pipe 6 was compacted to 95% of the material's maximum dry density, as determined by ASTM D1557 (i.e., modified Proctor). Given the pipe is new and was installed in accordance with recognized and generally accepted engineering practices, Pipe 6 is in good operational condition, and there are no significant deterioration, deformation, distortion, bedding deficiencies, sedimentation, or debris that may negatively affect the basin.

EMBEDDED PIPES AT ASH SURGE & BYPASS BASINS
POWERTON GENERATING STATION

In accordance with 35 Ill. Adm. Code 845.450(a)(6), it is recommended that the Station continue to perform visual inspections of the Bypass Basin's discharge pipe (Pipe 3) and the new CHDE pipe for non-CCR wastewater (Pipe 6) to confirm that the pipes' structural integrities continue to be maintained.
