**STRUCTURAL STABILITY ASSESSMENT
FORMER ASH BASIN
POWERTON STATION
APRIL 2018**

Former Ash Basin, Powerton Station
Structural Stability Assessment
April 2018

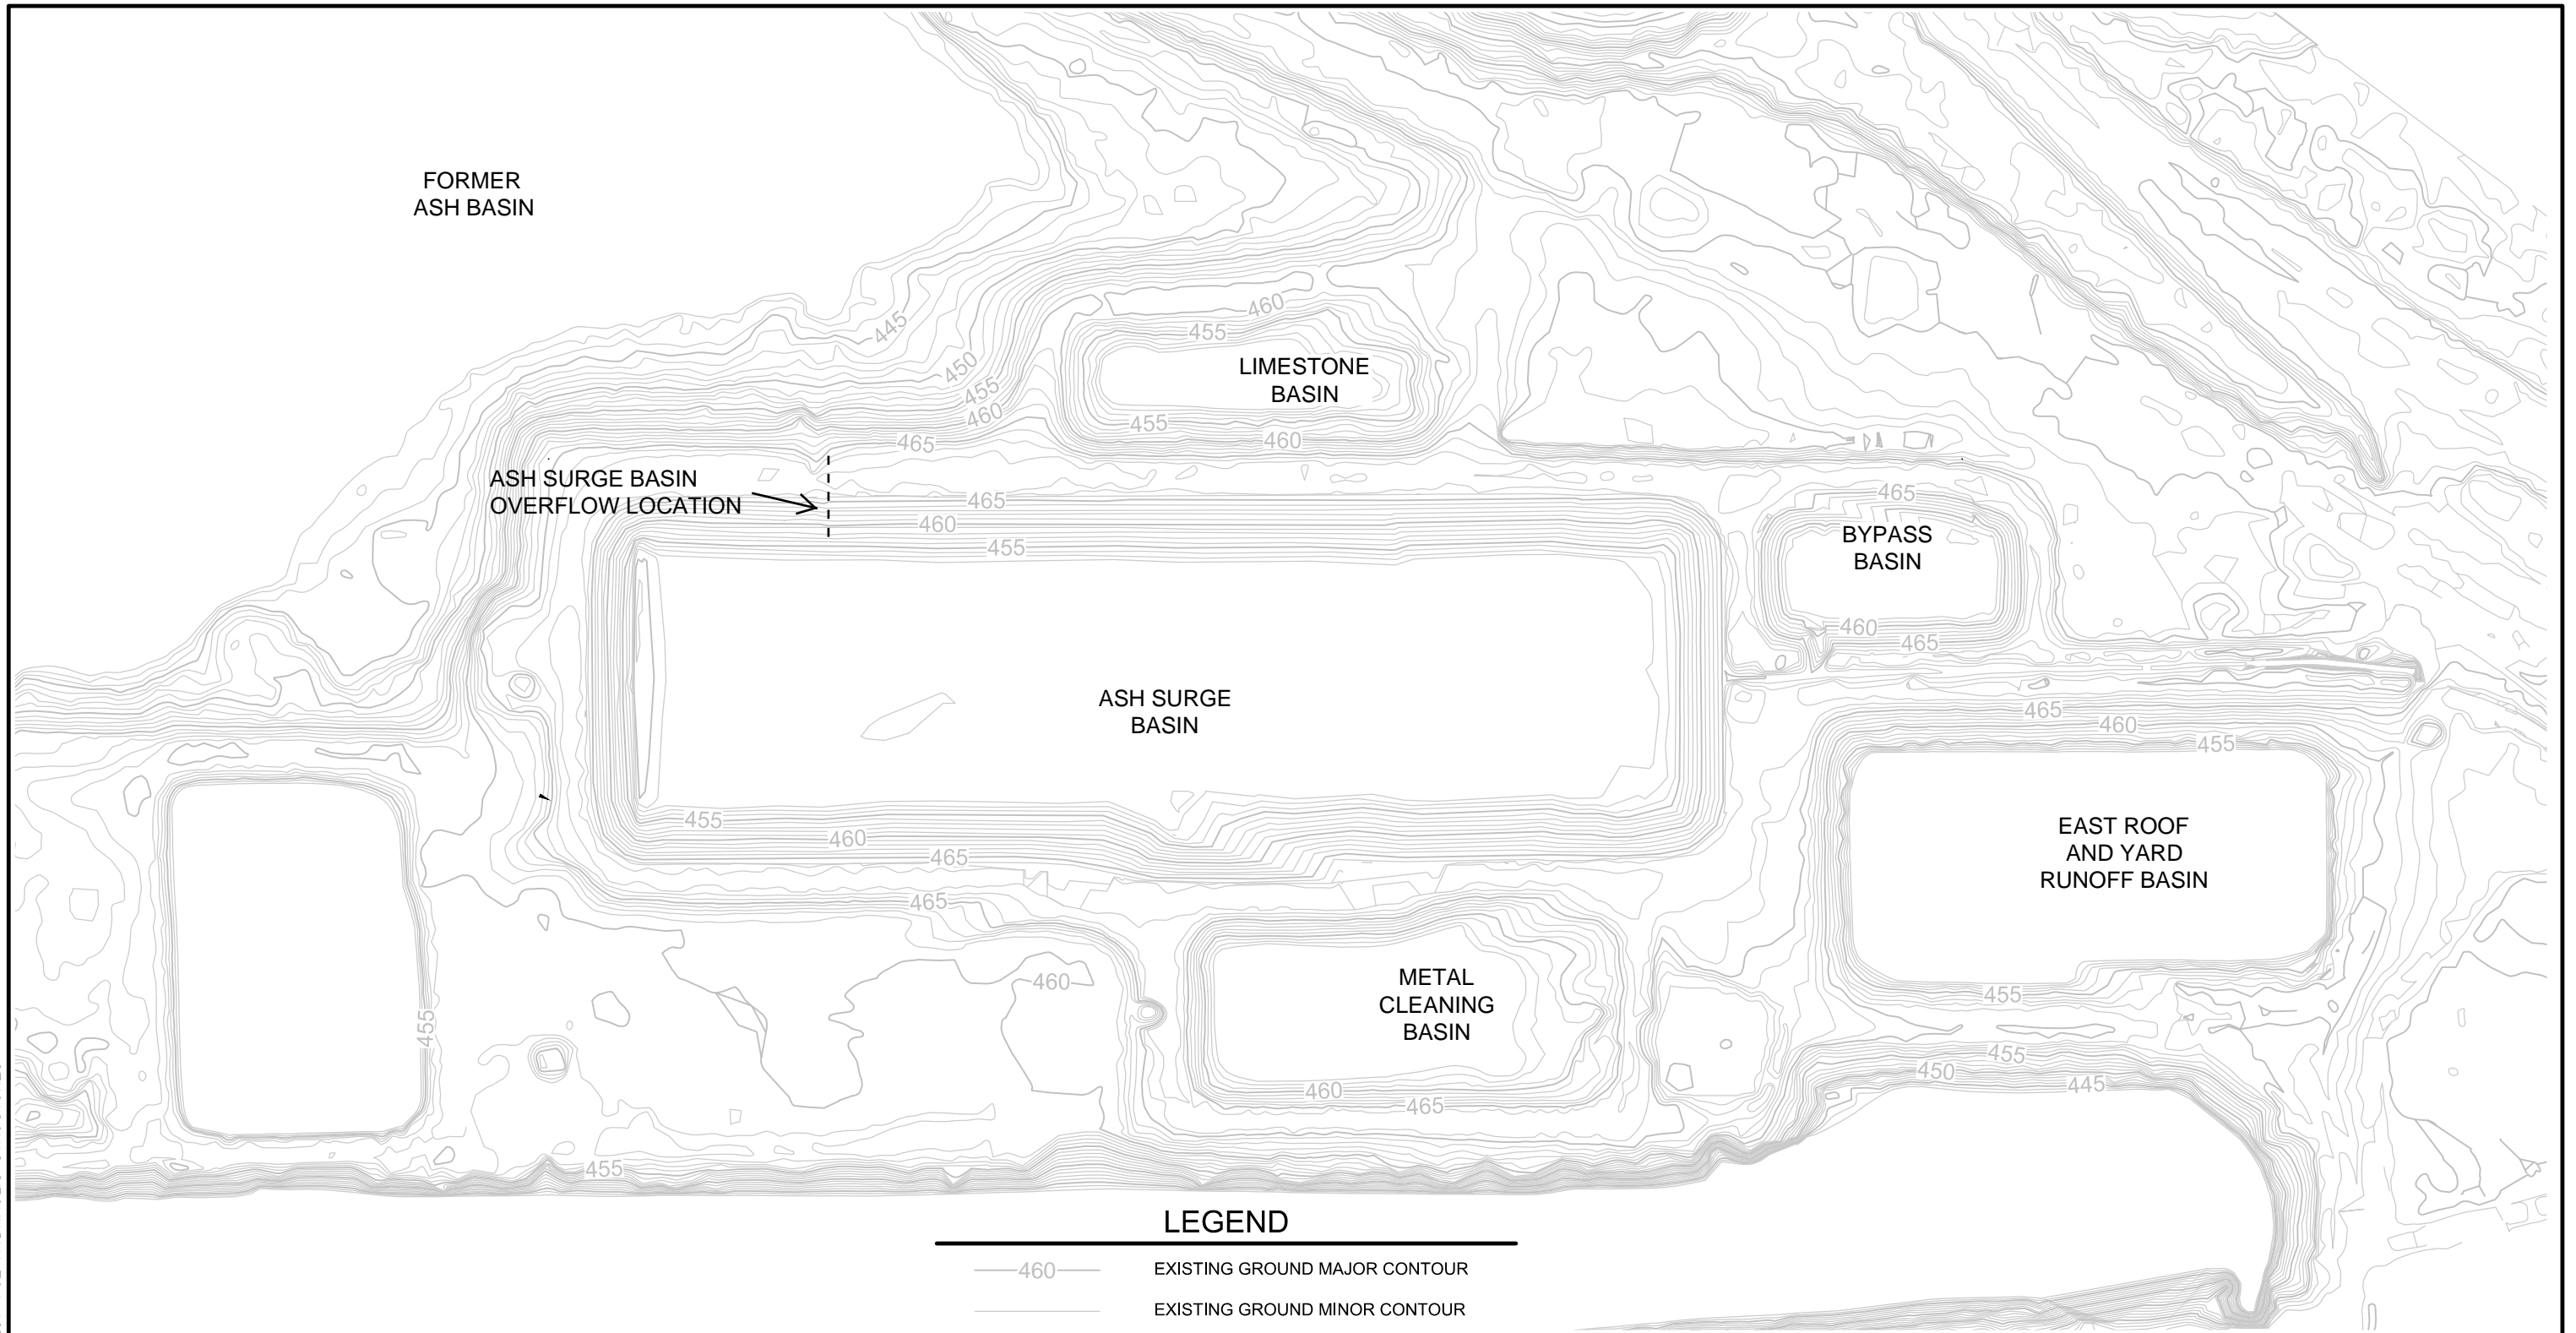
HYDRAULIC STRUCTURE LOCATIONS
 FORMER ASH BASIN
 POWERTON STATION
 PEKIN, ILLINOIS

Documentation of as-built or construction conditions for the FAB was not available at the time of this report due to the age of the FAB. An Ash Surge Basin Overflow Structure, shown on Figure 3, is known to pass through the embankments of the FAB on the west side of the South Pond. The spillway is constructed in the Ash Surge Basin with two box culverts, each approximately 4.5 feet in width and approximately 1.5 feet in height that extend beneath the Ash Surge Basin embankment crest into the FAB (Geosyntec, 2016b). A concrete apron is located east of the box culvert terminating in the FAB. Downstream of the concrete apron is rip rap. Calculations for the original design of the overflow structure were not available at the time of this report. The integrity or deficiencies of this structure that would negatively affect operation of the structure is not known at this time.
