**ANNUAL INSPECTION REPORT
FORMER ASH BASIN
POWERTON STATION
JULY 2017**

**POWERTON STATION
 FORMER ASH BASIN
 PEKIN, ILLINOIS**

SITE PLAN

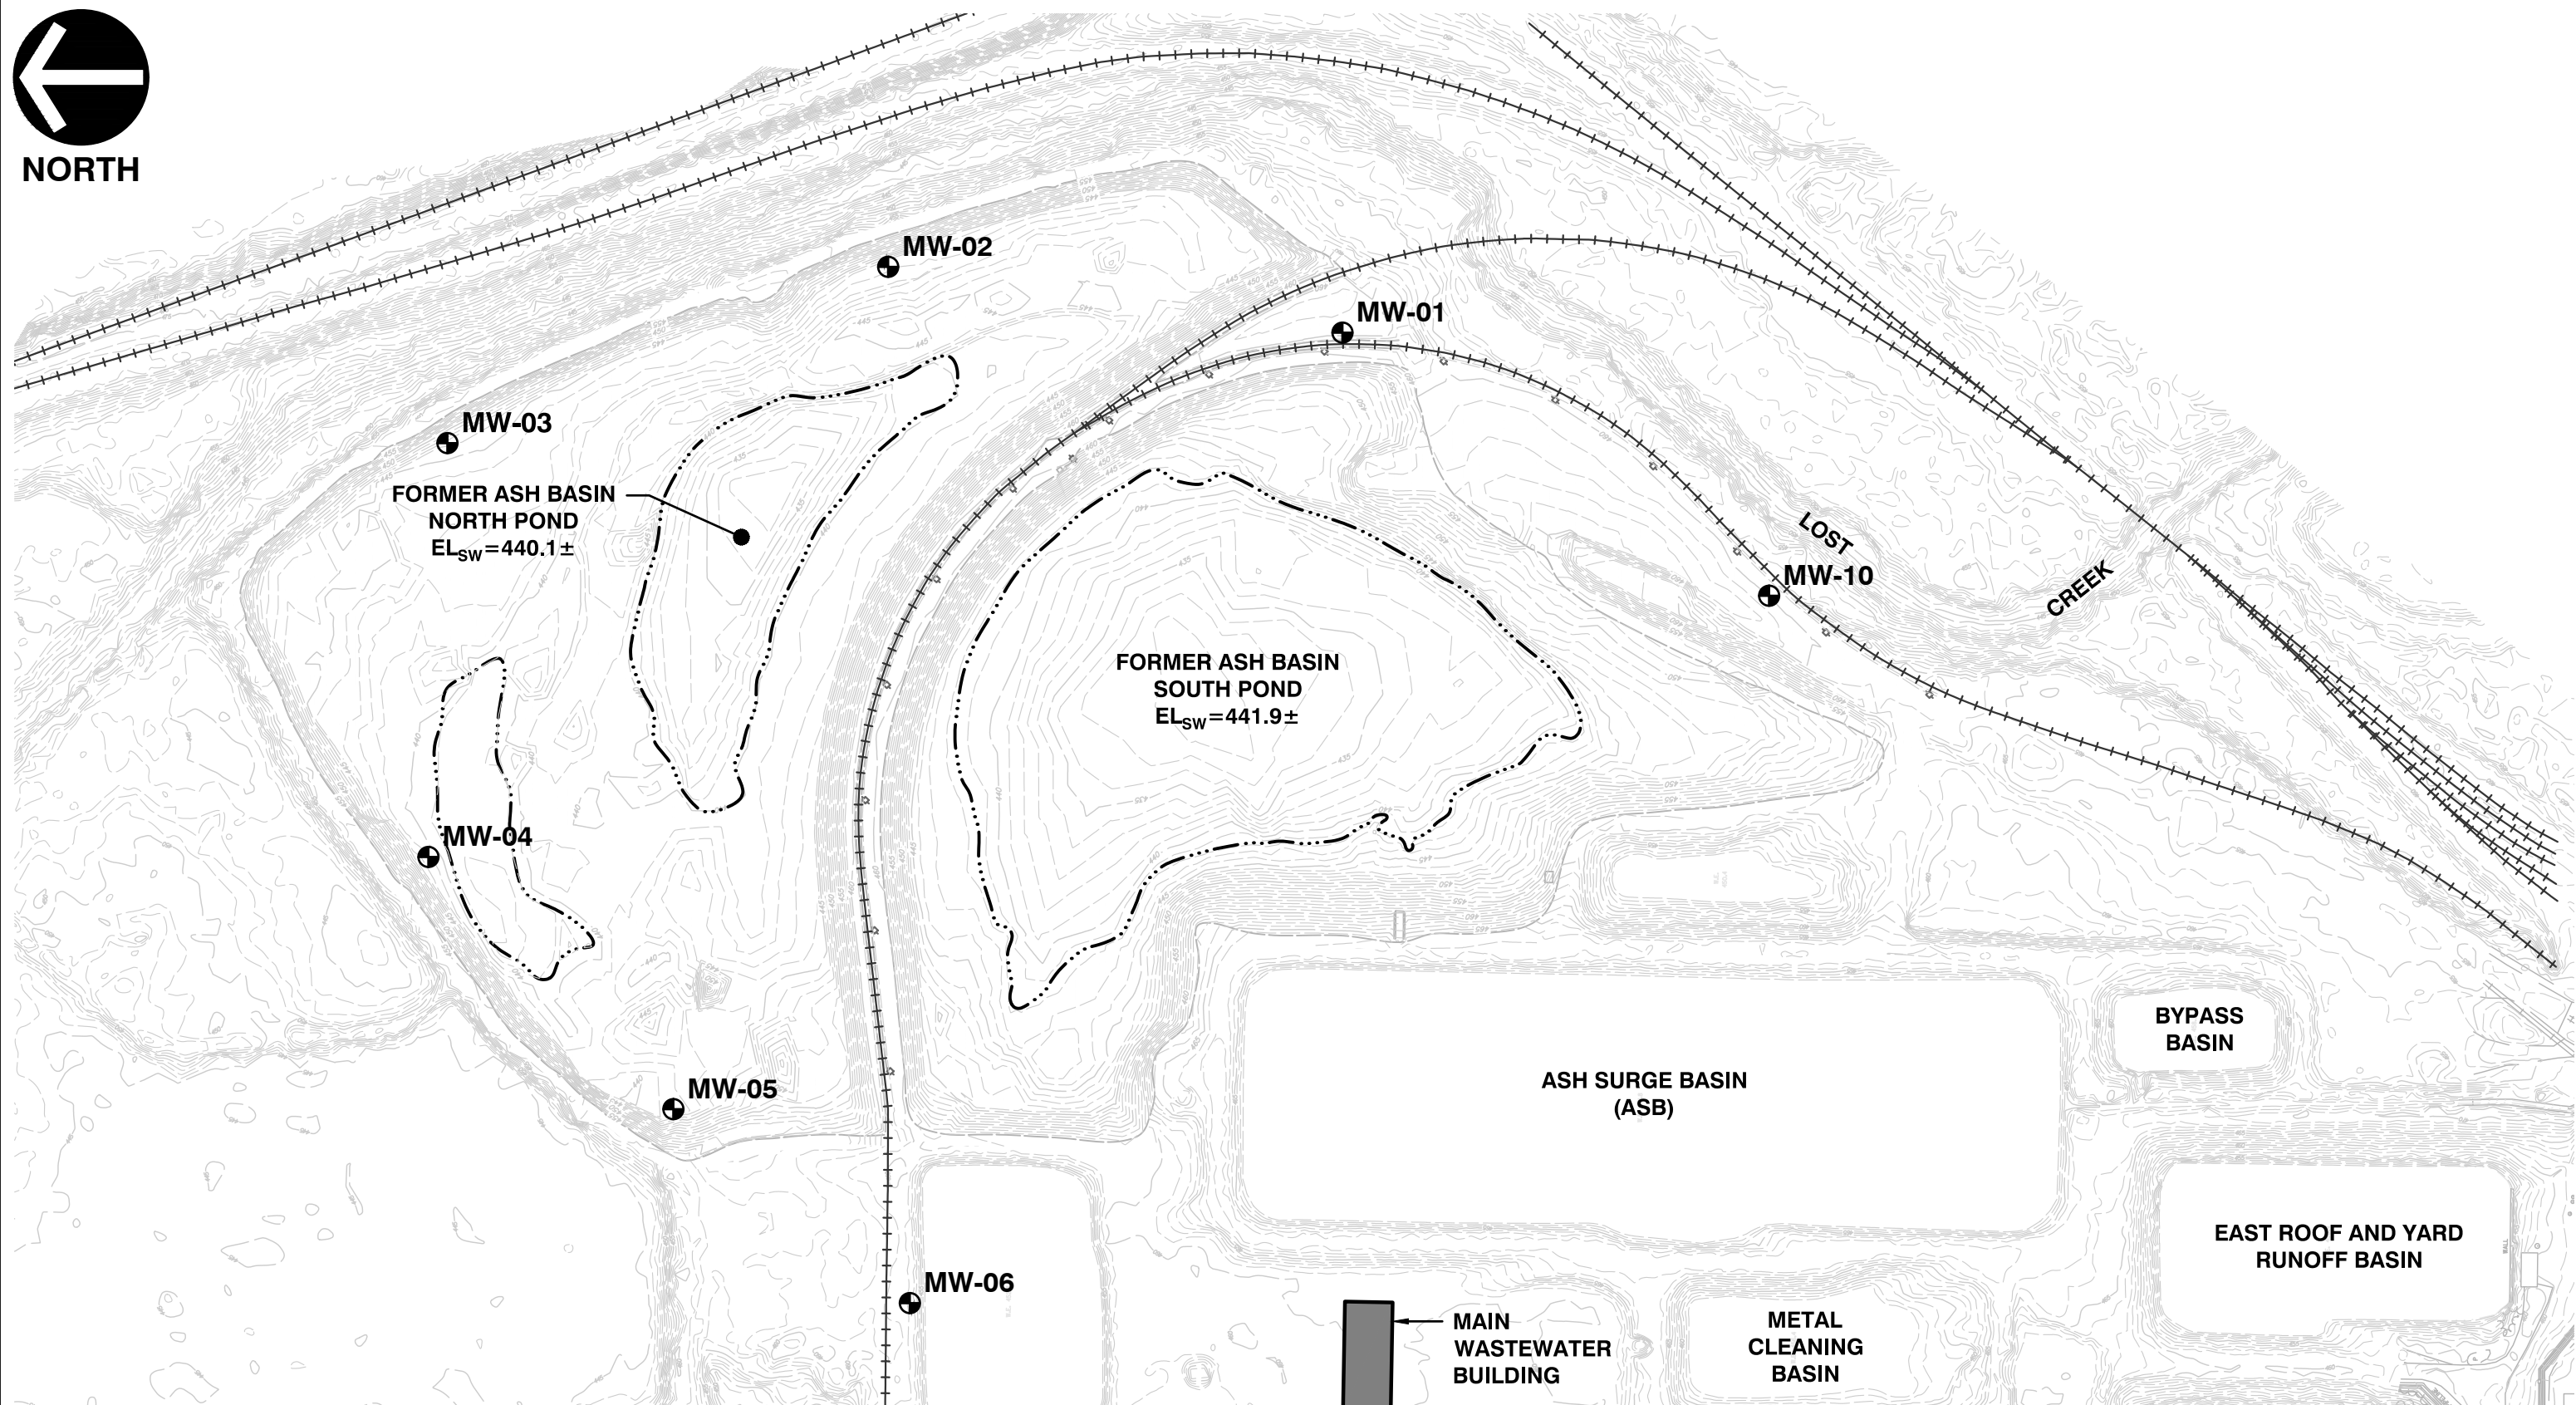
The FAB is an inactive surface impoundment that is scheduled for closure. Approximately 30 acres in size, the FAB has not received bottom ash or ash slag since the late 1980s. In 2010, the FAB was sectioned into a North Pond and South Pond to accommodate a new railroad embankment and the geometry has remained unchanged since. A site plan of the FAB attached as Figure 1.

Instrumentation associated with North and South FAB includes a series of monitoring wells as shown on Figure 1. Monitoring wells adjacent to North FAB included MW-02 through MW-05, and South FAB MW-01, MW-06 and MW-10. Instrumentation associated with the hydraulic structures, impoundment embankments, and/or slope performance do not exist and are not necessary. Maximum and minimum water levels recorded for each of the monitoring wells since February 2015 are provided below in Table 1.
