**ANNUAL HAZARD POTENTIAL CLASSIFICATION ASSESSMENT REPORT**  
**POWERTON STATION - METAL CLEANING BASIN**  
**JUNE 2023**

NRG/MIDWEST GENERATION LLC  
POWERTON STATION  
METAL CLEANING BASIN HAZARD POTENTIAL  
PEKIN, TAZEWELL COUNTY, ILLINOIS

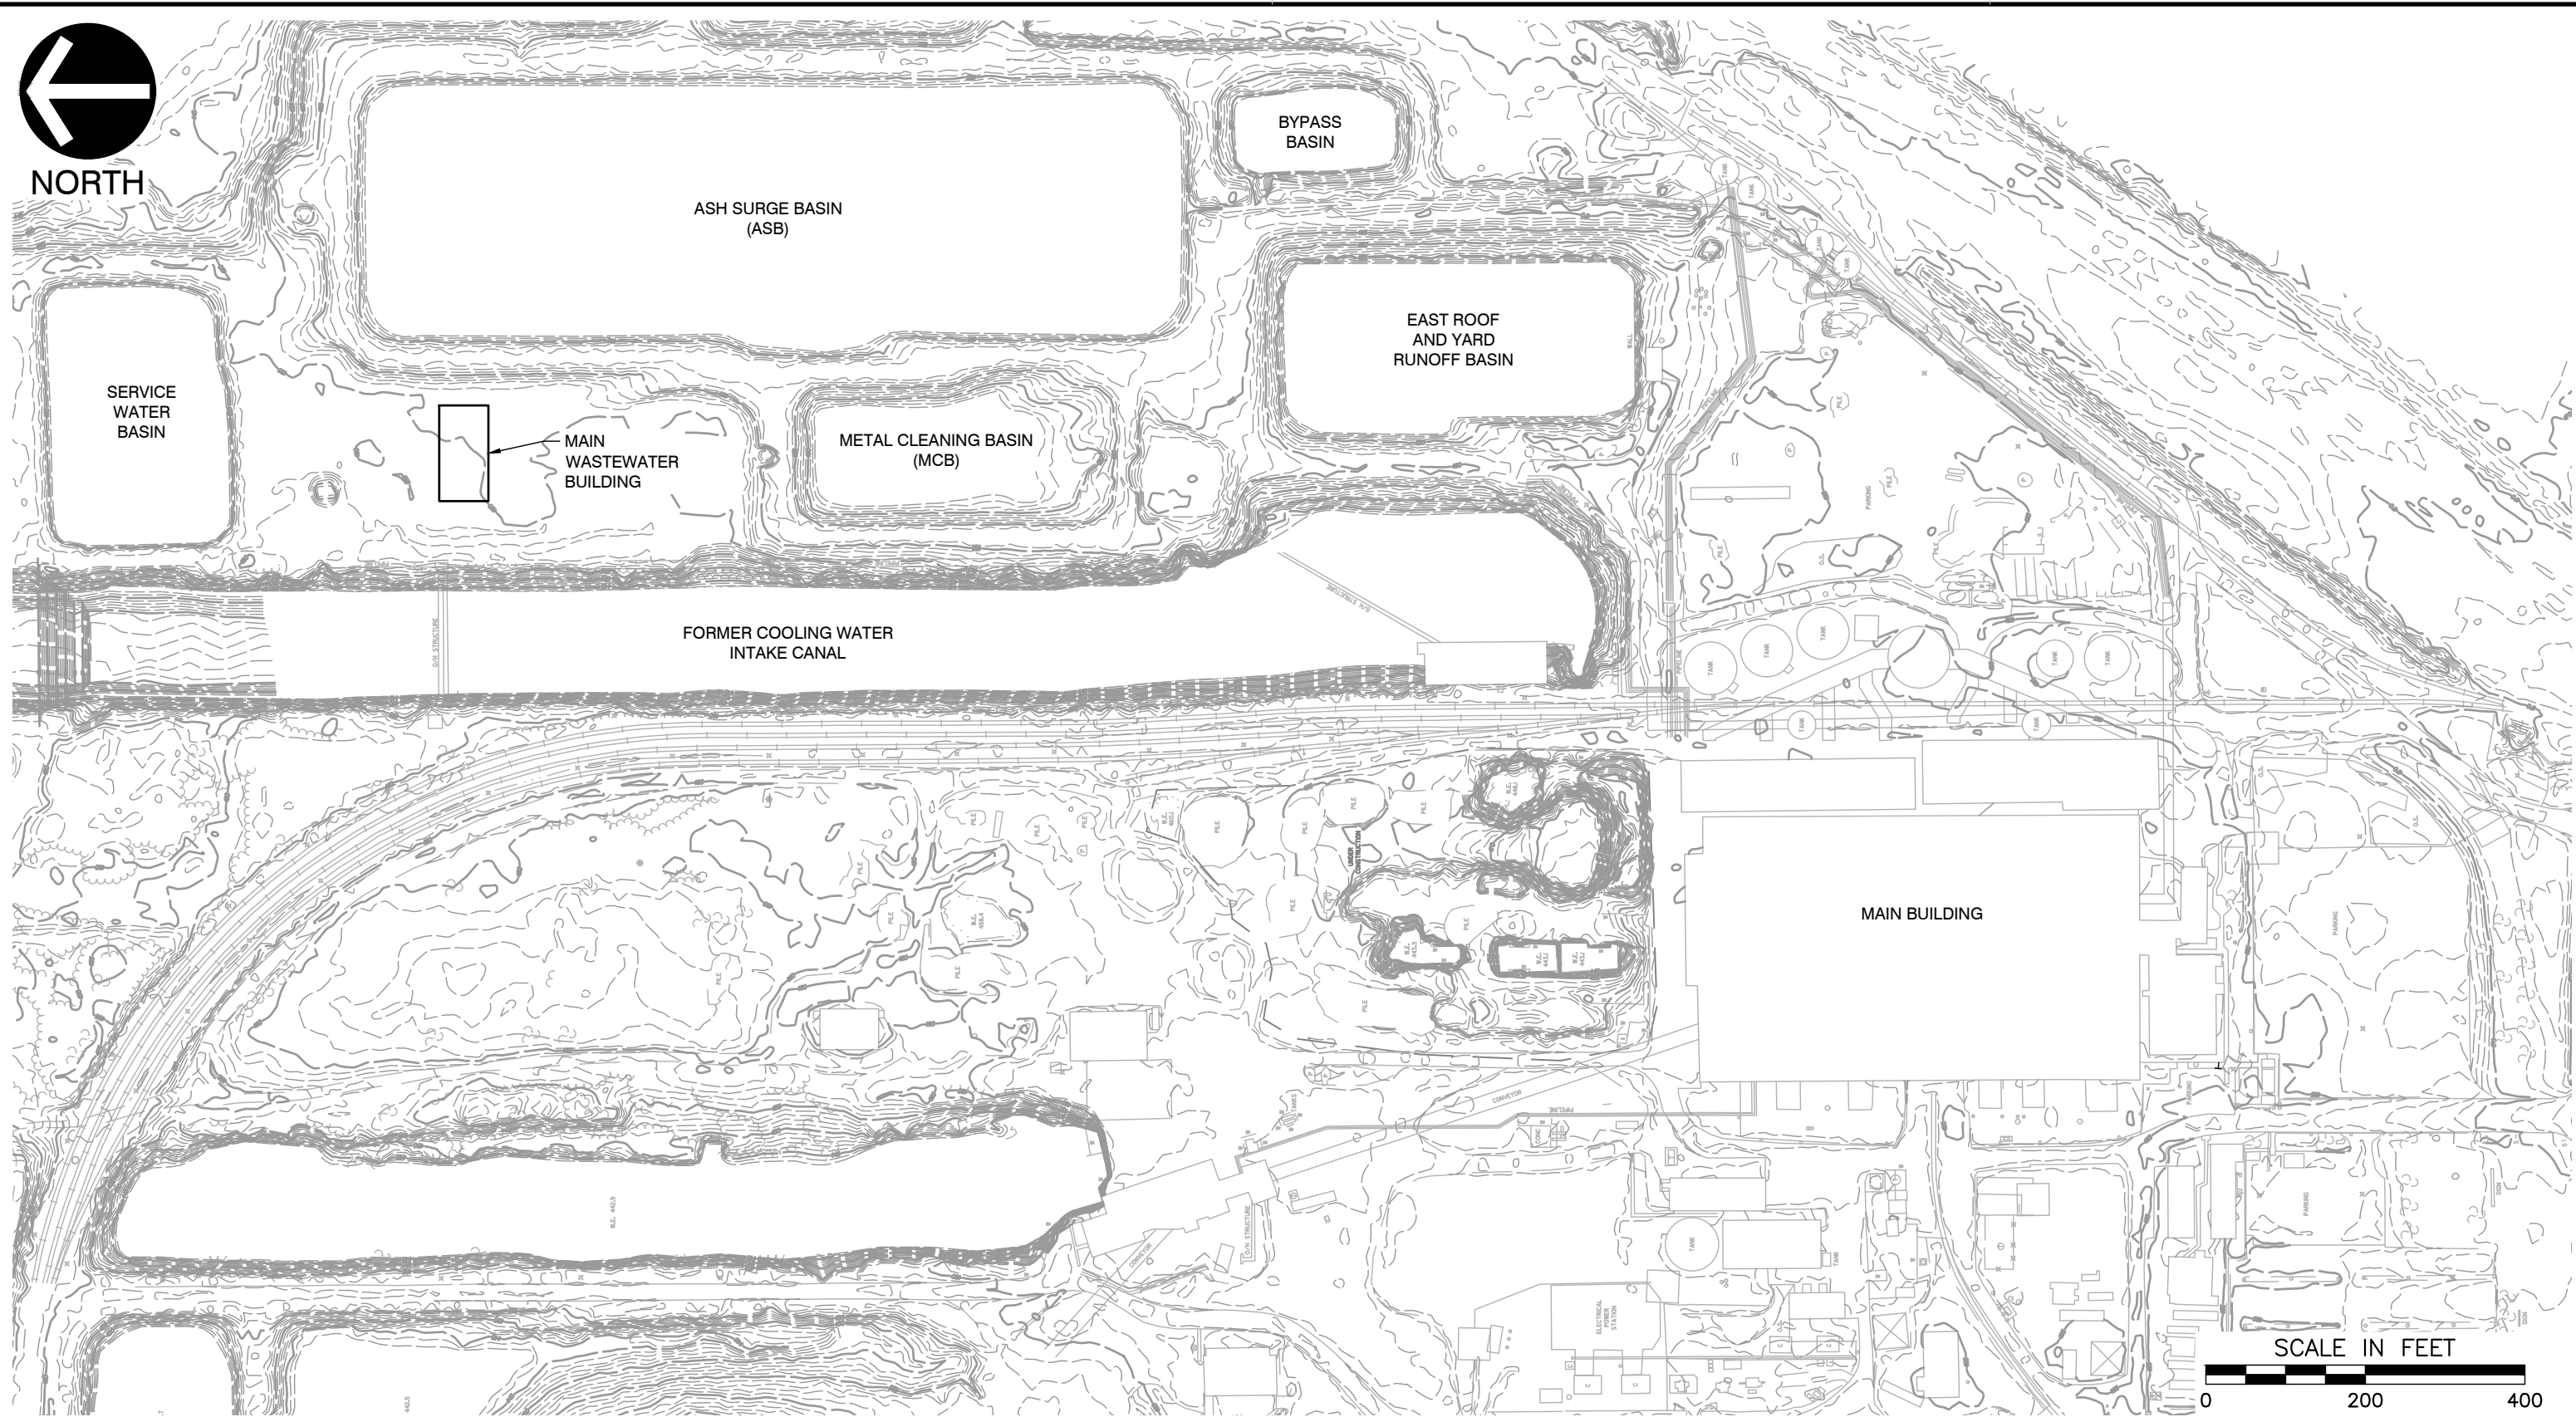
**FIGURE 1**

The MCB is located at Powerton Station in Pekin, Illinois, situated northeast of the main power building, south of the Wastewater Building and between the Ash Surge Basin and former Cooling Water Intake Channel (see Figure 1). Measuring 450 feet long and 225 feet wide, the MCB is lined with a 60 mil high-density polyethylene liner. Gravel access roads are located along the north, east, and west sides.

The MCB is a partially incised impoundment with the north, south, and east boundary of the MCB at grade. The west boundary of the MCB is constructed with an earthen embankment. As shown in Figure 1, the former cooling water intake channel is located approximately 75 feet west of the MCB. Except for an above grade pipe rack and piping, the area between the MCB and former intake channel has no structures or buildings.

- The north, south and east sides are incised and not susceptible to a release from the MCB due to catastrophic failure or mis-operation.
- The west side is constructed with an earthen embankment. In the event of catastrophic failure or mis-operation, the downstream inundation area between the MCB and former intake channel has no buildings and is infrequently entered.
