**STRUCTURAL STABILITY AND FACTOR OF SAFETY ASSESSMENT**  
**METAL CLEANING BASIN**  
**POWERTON STATION**  
**JUNE 2021**

This report has been prepared for the Metal Cleaning Basin (herein referred to as the Basin) at Powerton Station pursuant to Sections 845.450 Structural Stability Assessment and 845.460 Safety Factor Assessment of Title 35 Subtitle G Subchapter I Subchapter j Coal Combustion Waste Surface Impoundments. The purpose of this project is to perform the initial structural stability and factor of safety assessments for the Basin by a licensed professional engineer. Civil & Environmental Consultants, Inc. (CEC) completed this structural stability and factor of safety assessment as described in the following sections.

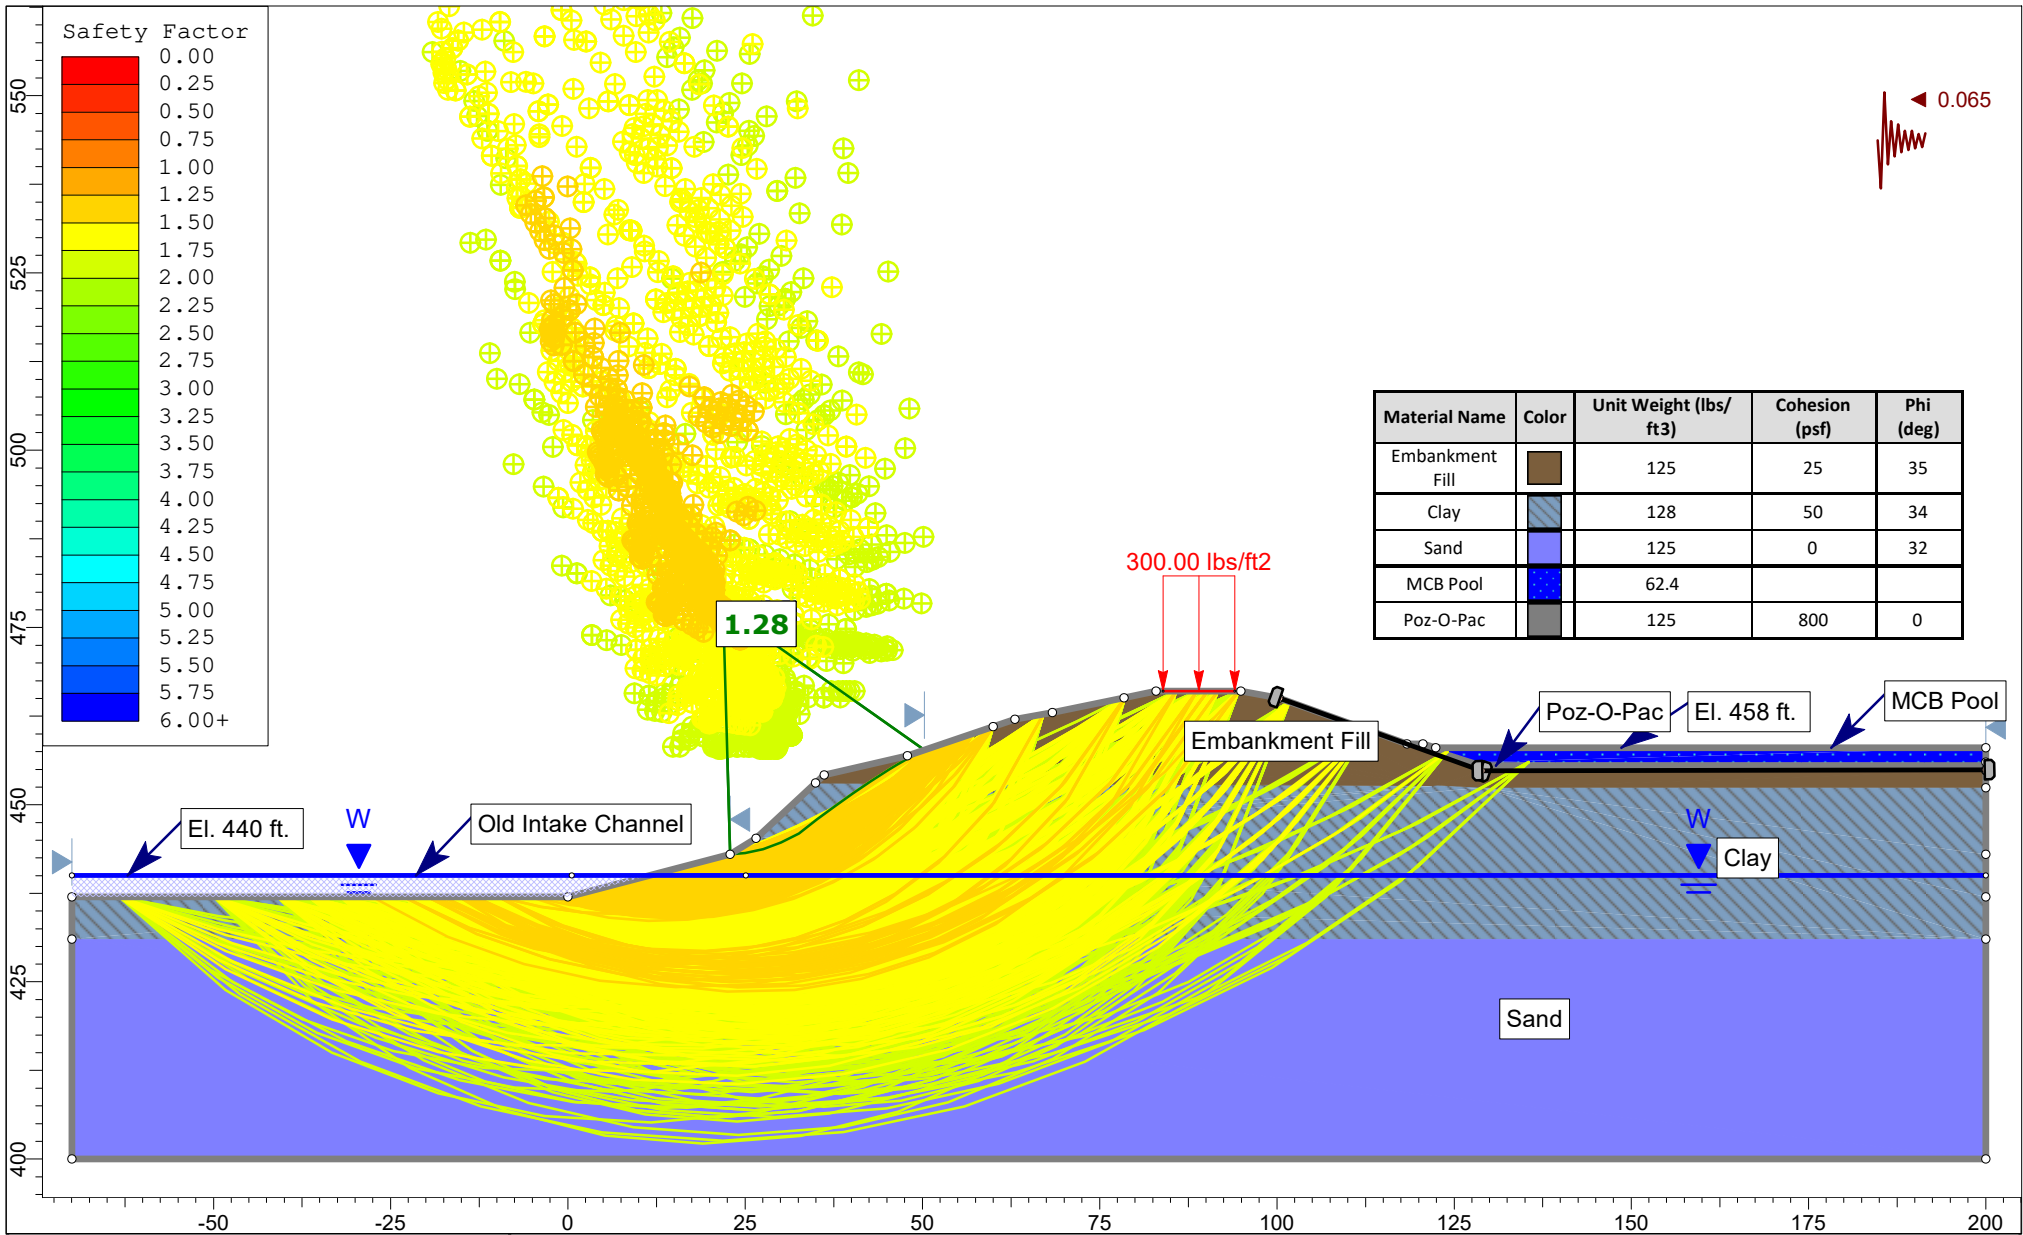
Seismic analysis was performed by incorporating pseudo static seismic loading scenarios in the long-term global stability analysis calculations. A pseudo-static seismic horizontal load was applied to the long-term maximum storage pool loading condition model.

<b>Loading Condition</b>	<b>Required FS</b>	<b>Calculated FS</b>
Static, Long Term - 845.460(a)(2)	1.50	1.50
Static, Maximum Storage Pool - 845.460(a)(3)	1.40	1.50
Seismic - 845.460(a)(4)	1.00	1.28
Liquefaction - 845.460(a)(5)	1.20	>1.20
