MEMORANDUM

FTN Associates, Ltd.

SUBJECT: 2018 Annual Inspection of CCR Dust Control System for PPES CCR Landfill
FTN No. 14590-1981-001

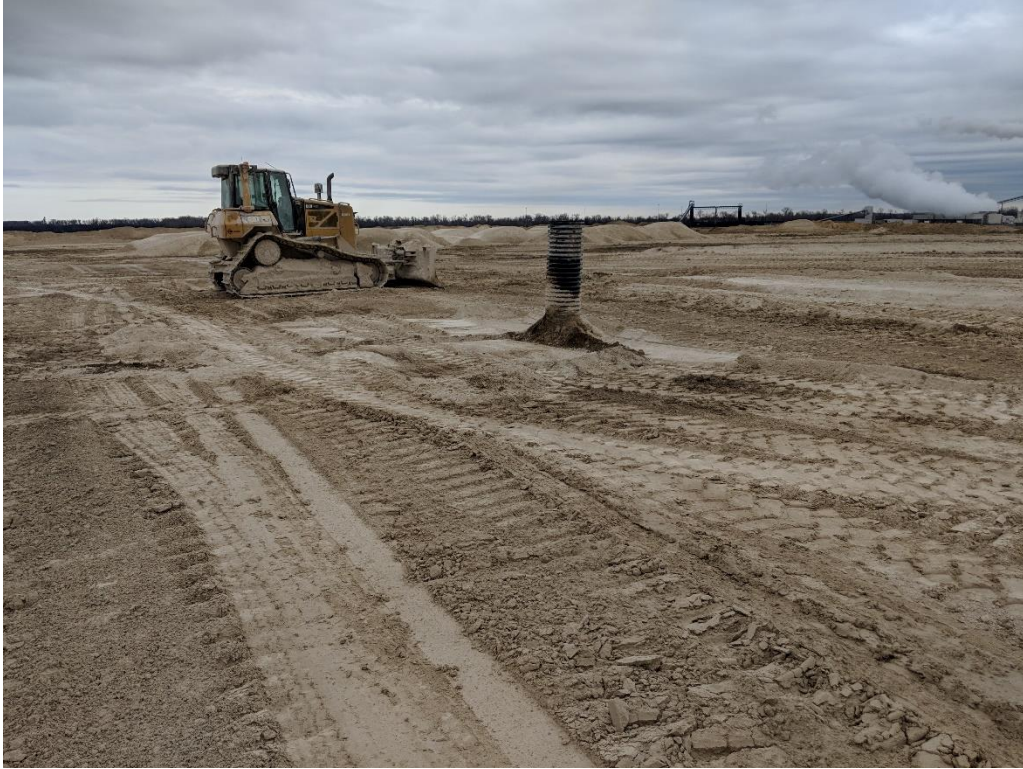
Photo 1. Rolled and sealed top of open disposal cell (Cell 3)

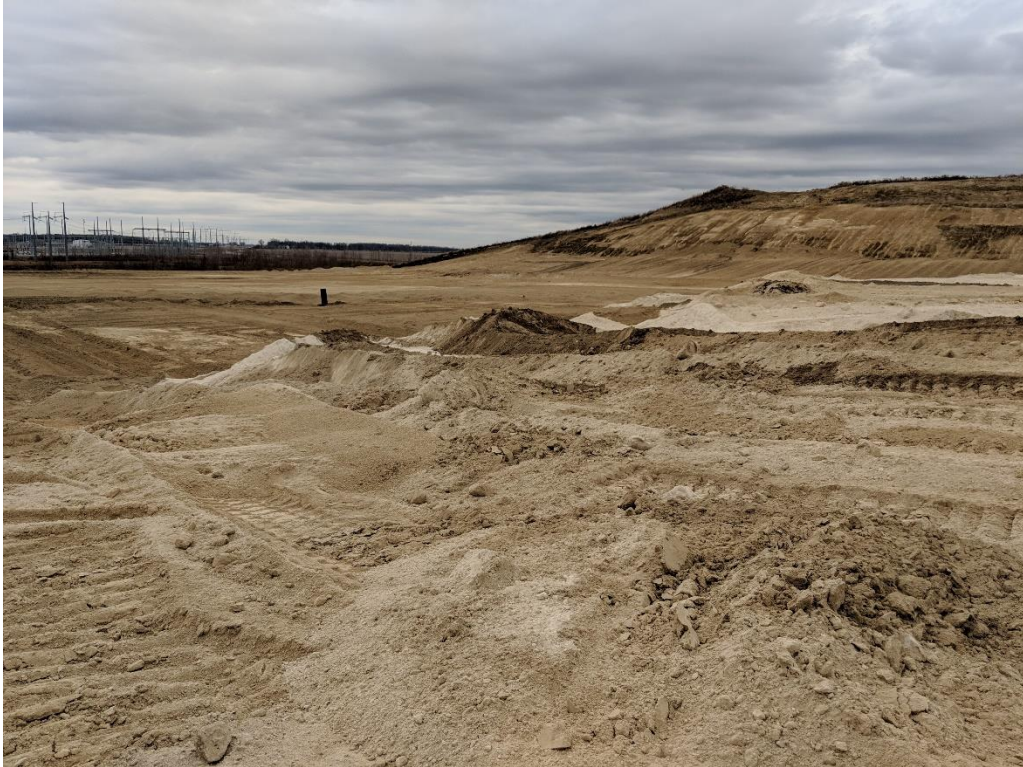
Photo 2. Active working face (Cell 3).

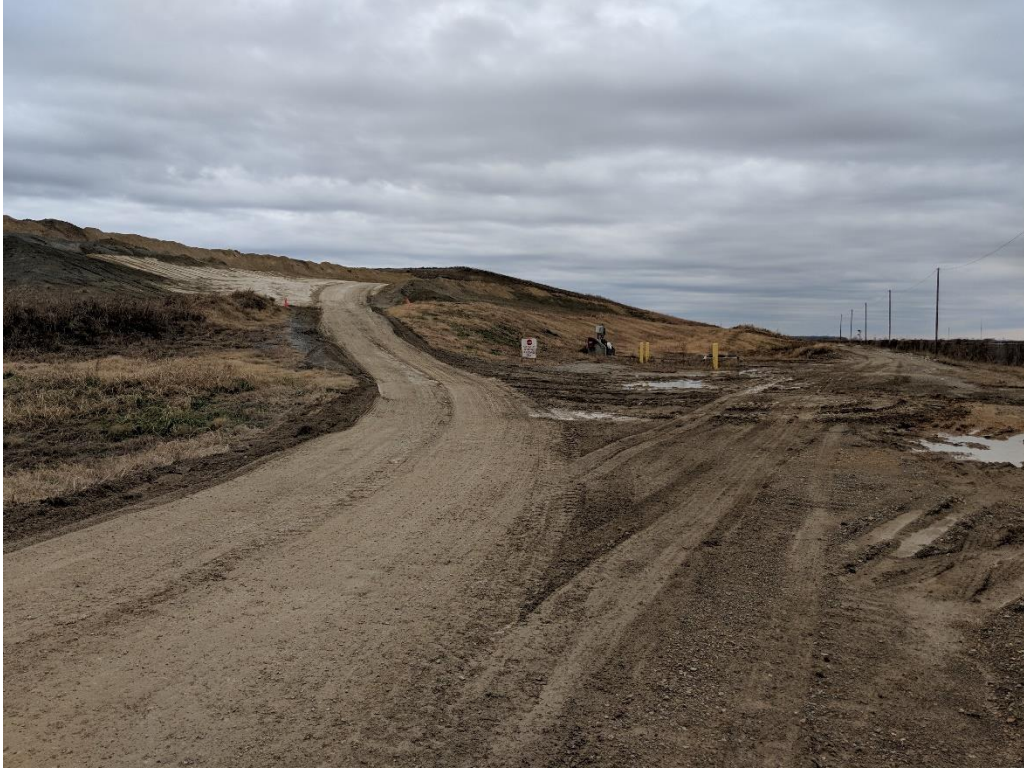
Photo 3. Haul road looking towards Cell 3

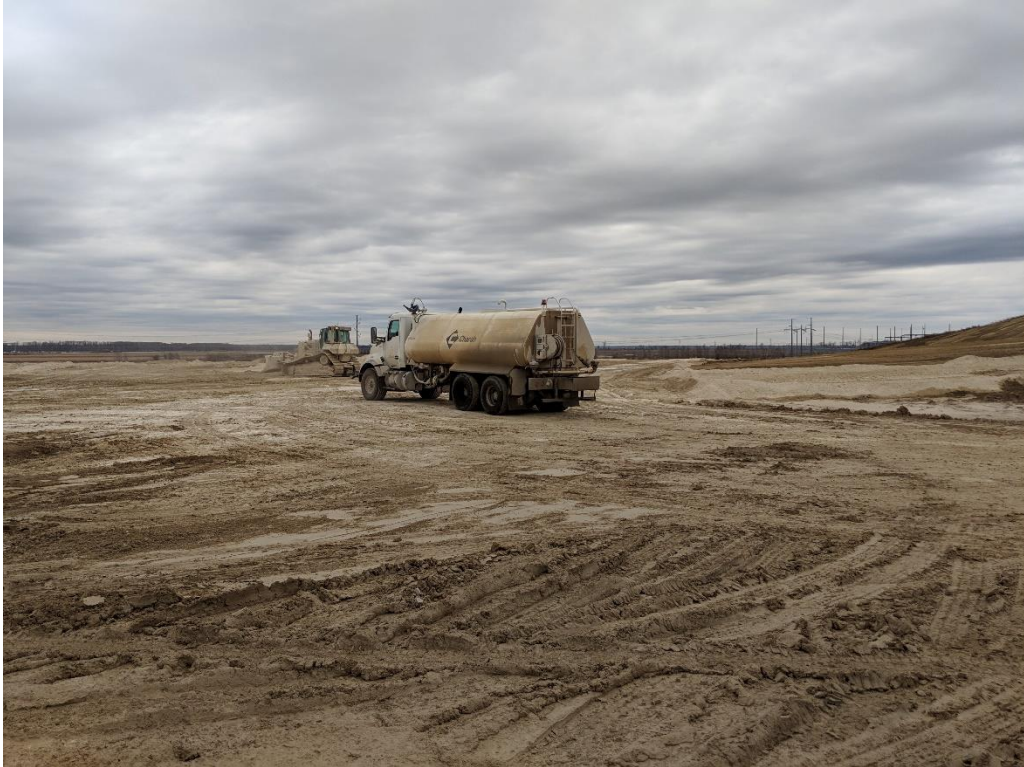
Photo 4. Water truck preparing to wet Cell 3

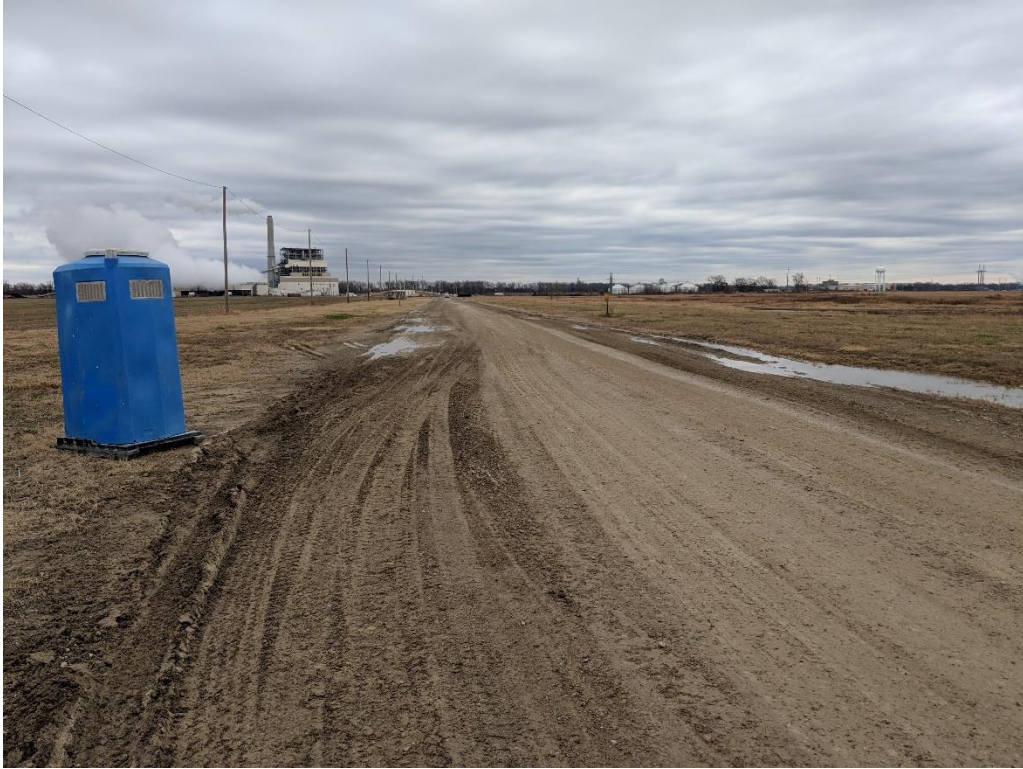
Photo 5. Landfill access road looking towards plant

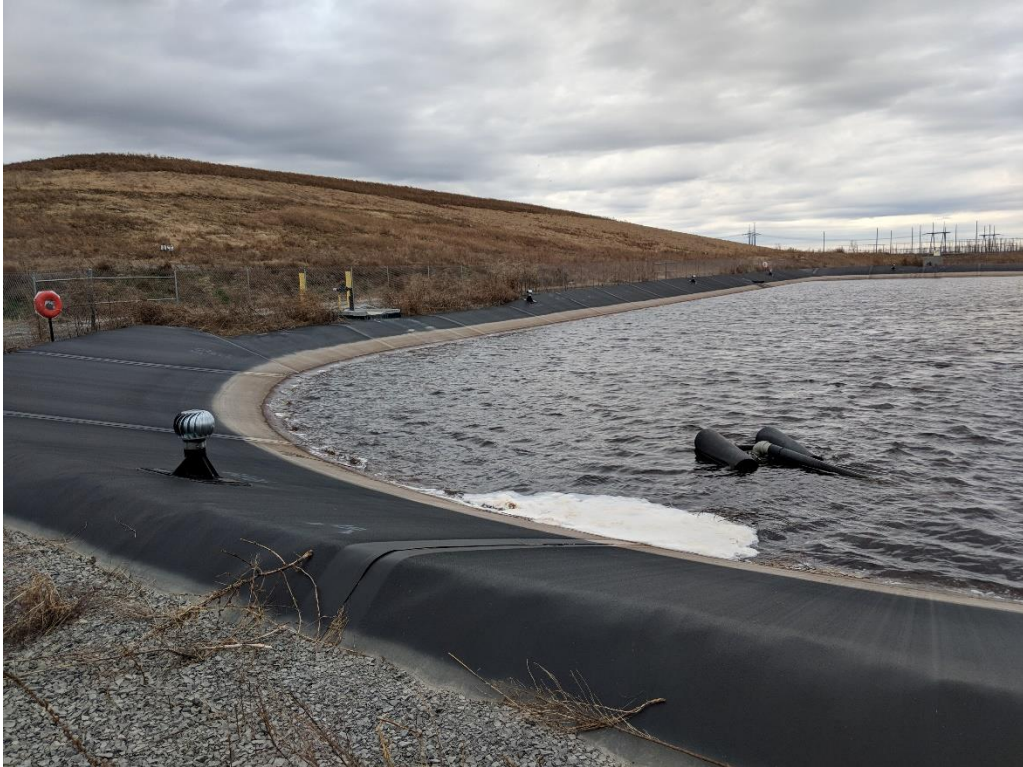
Photo 6. West slope Cell 1 under interim cover with leachate pond in foreground

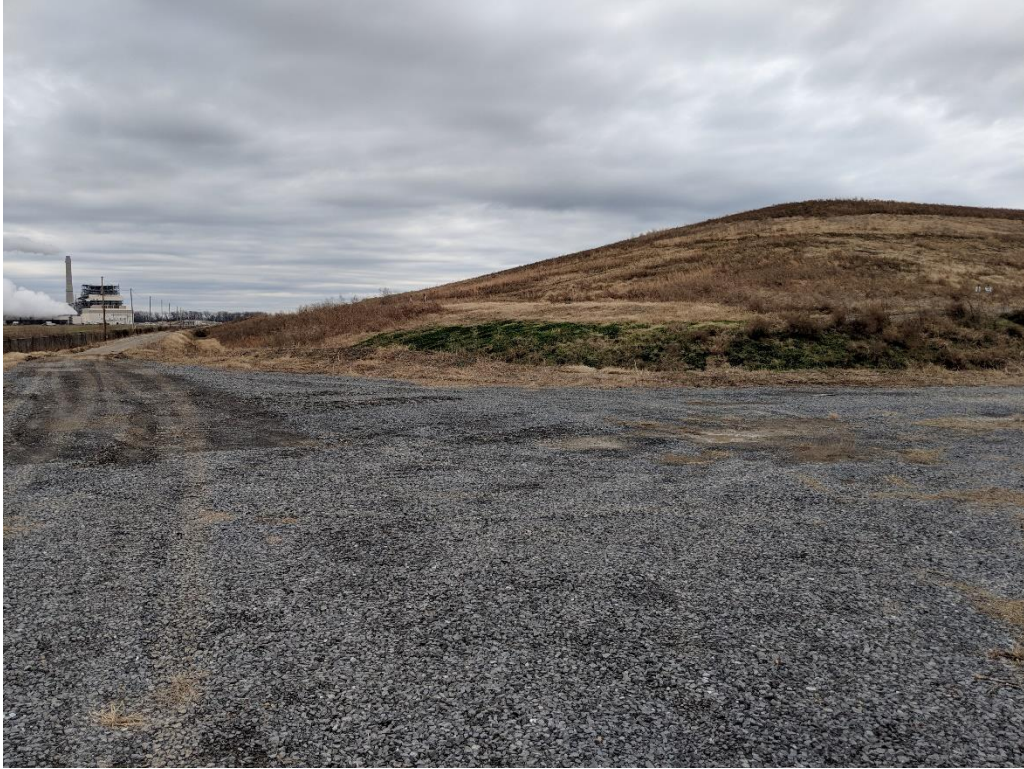
Photo 7. Cell 1 from northwest.
