MEMORANDUM

FTN Associates, Ltd.

SUBJECT: 2022 Annual Inspection of CCR Dust Control System for PPES CCR Landfill
FTN No. 14590-2797-001

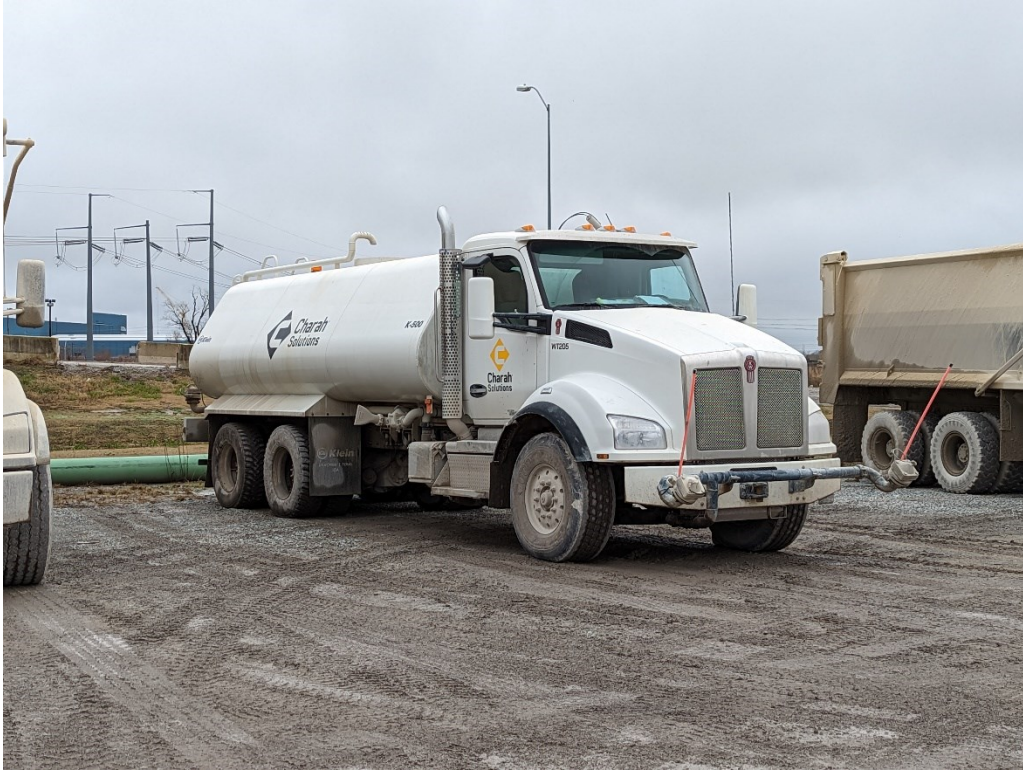
Photo 1. Water truck staged in shop parking lot.

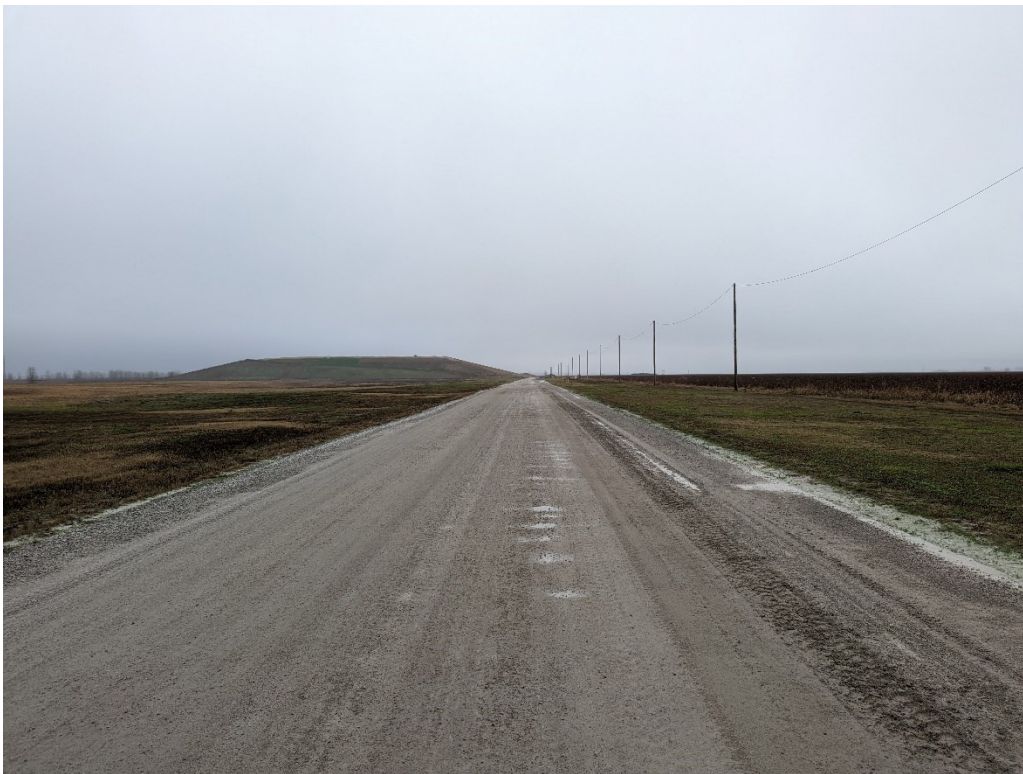
Photo 2. Haul road to landfill from East.

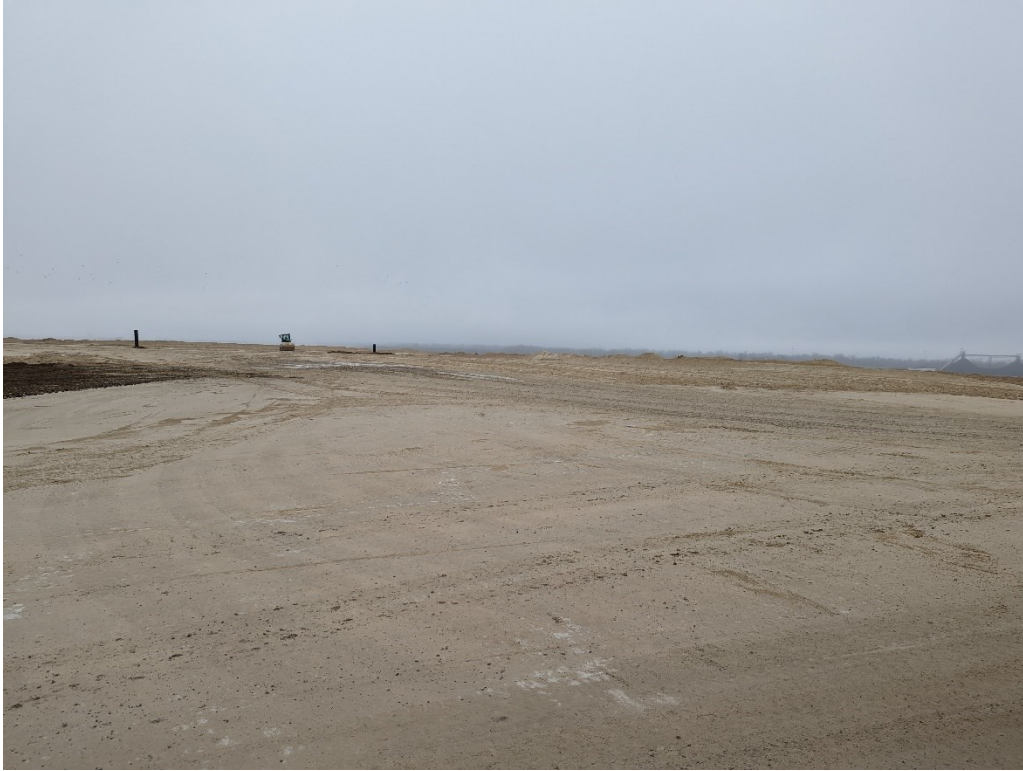
Photo 3. Active working face, fly ash (Cell 3).

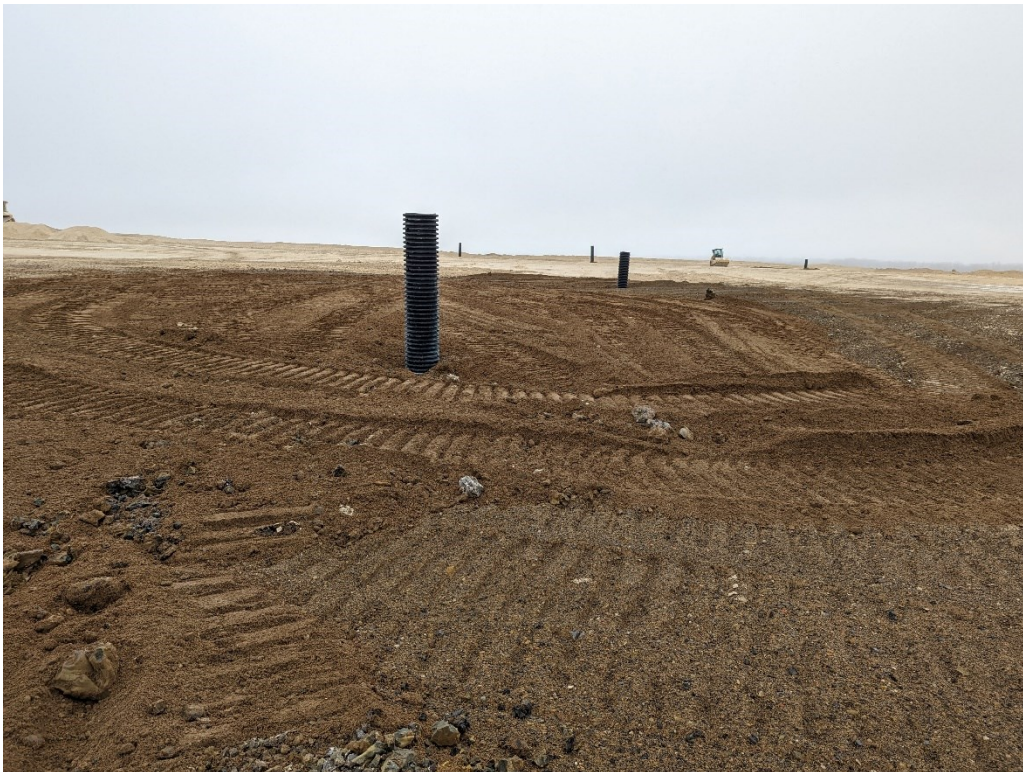
Photo 4. Active working face, bottom ash with chimney drains (Cell 3).

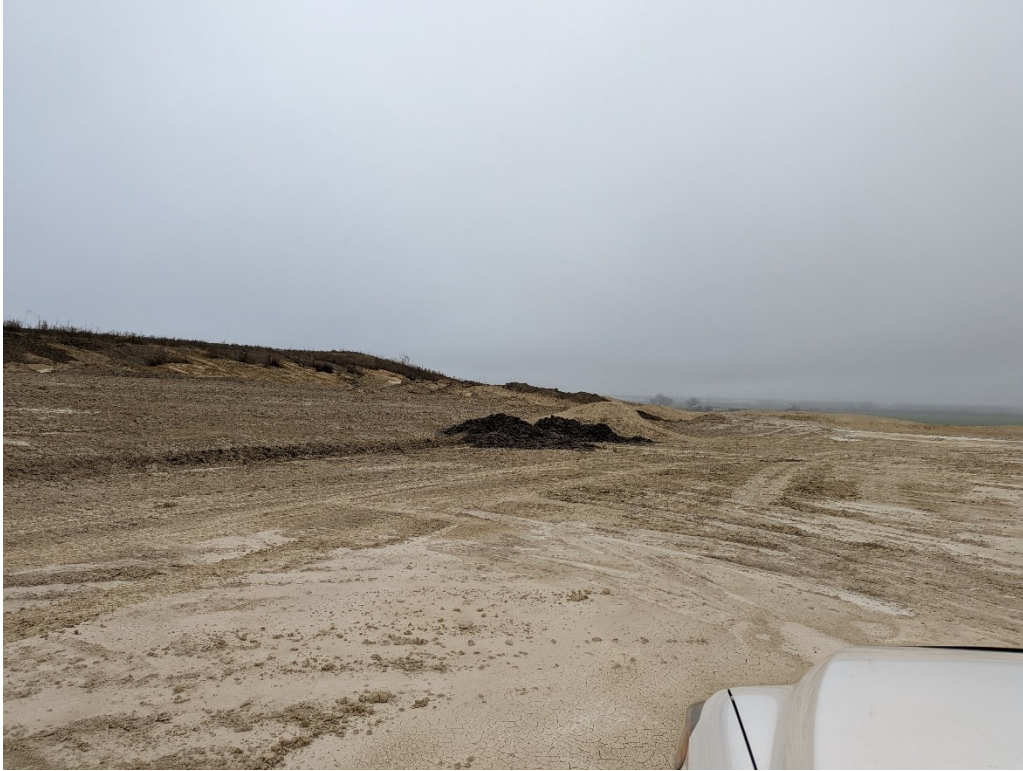
Photo 5. Cell 3 working face looking Northwest at Cell 1 top elevation.

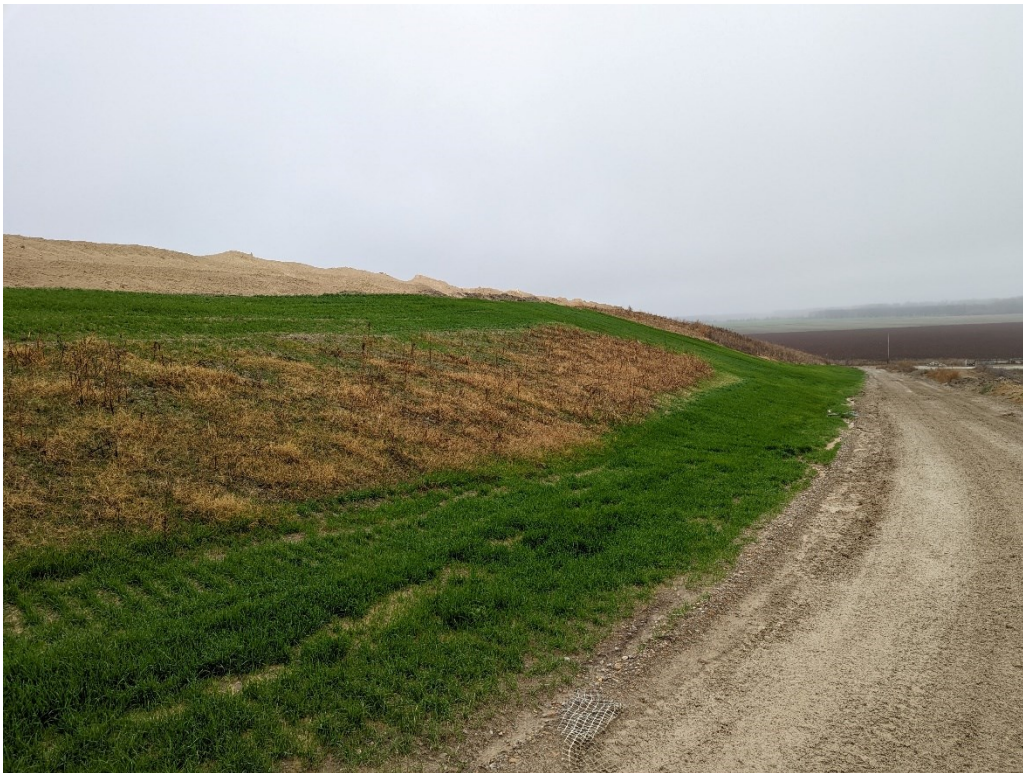
Photo 6. Cell 3 East slope intermediate cover and haul road.

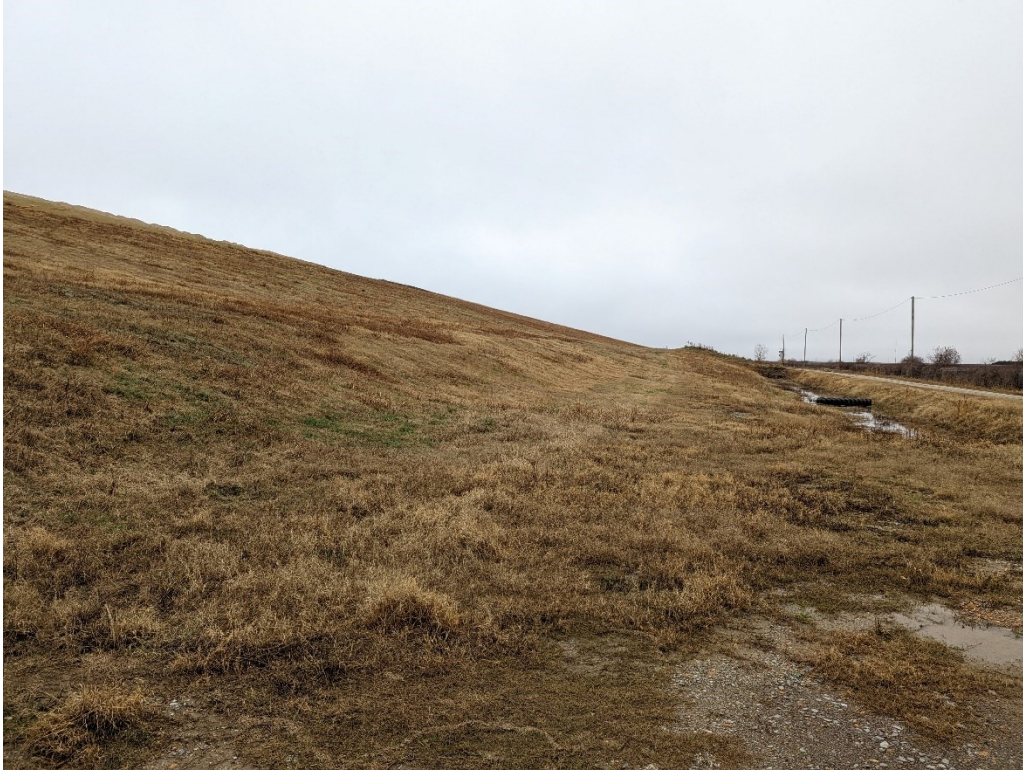
Photo 7. Cell 3 North slope intermediate cover.
