2016 ANNUAL ENGINEERING INSPECTION REPORT

PLUM POINT ENERGY STATION CLASS 3N LANDFILL

**PERMIT NO. 0303-S3N
AFIN: 47-00461**

JANUARY 18, 2017

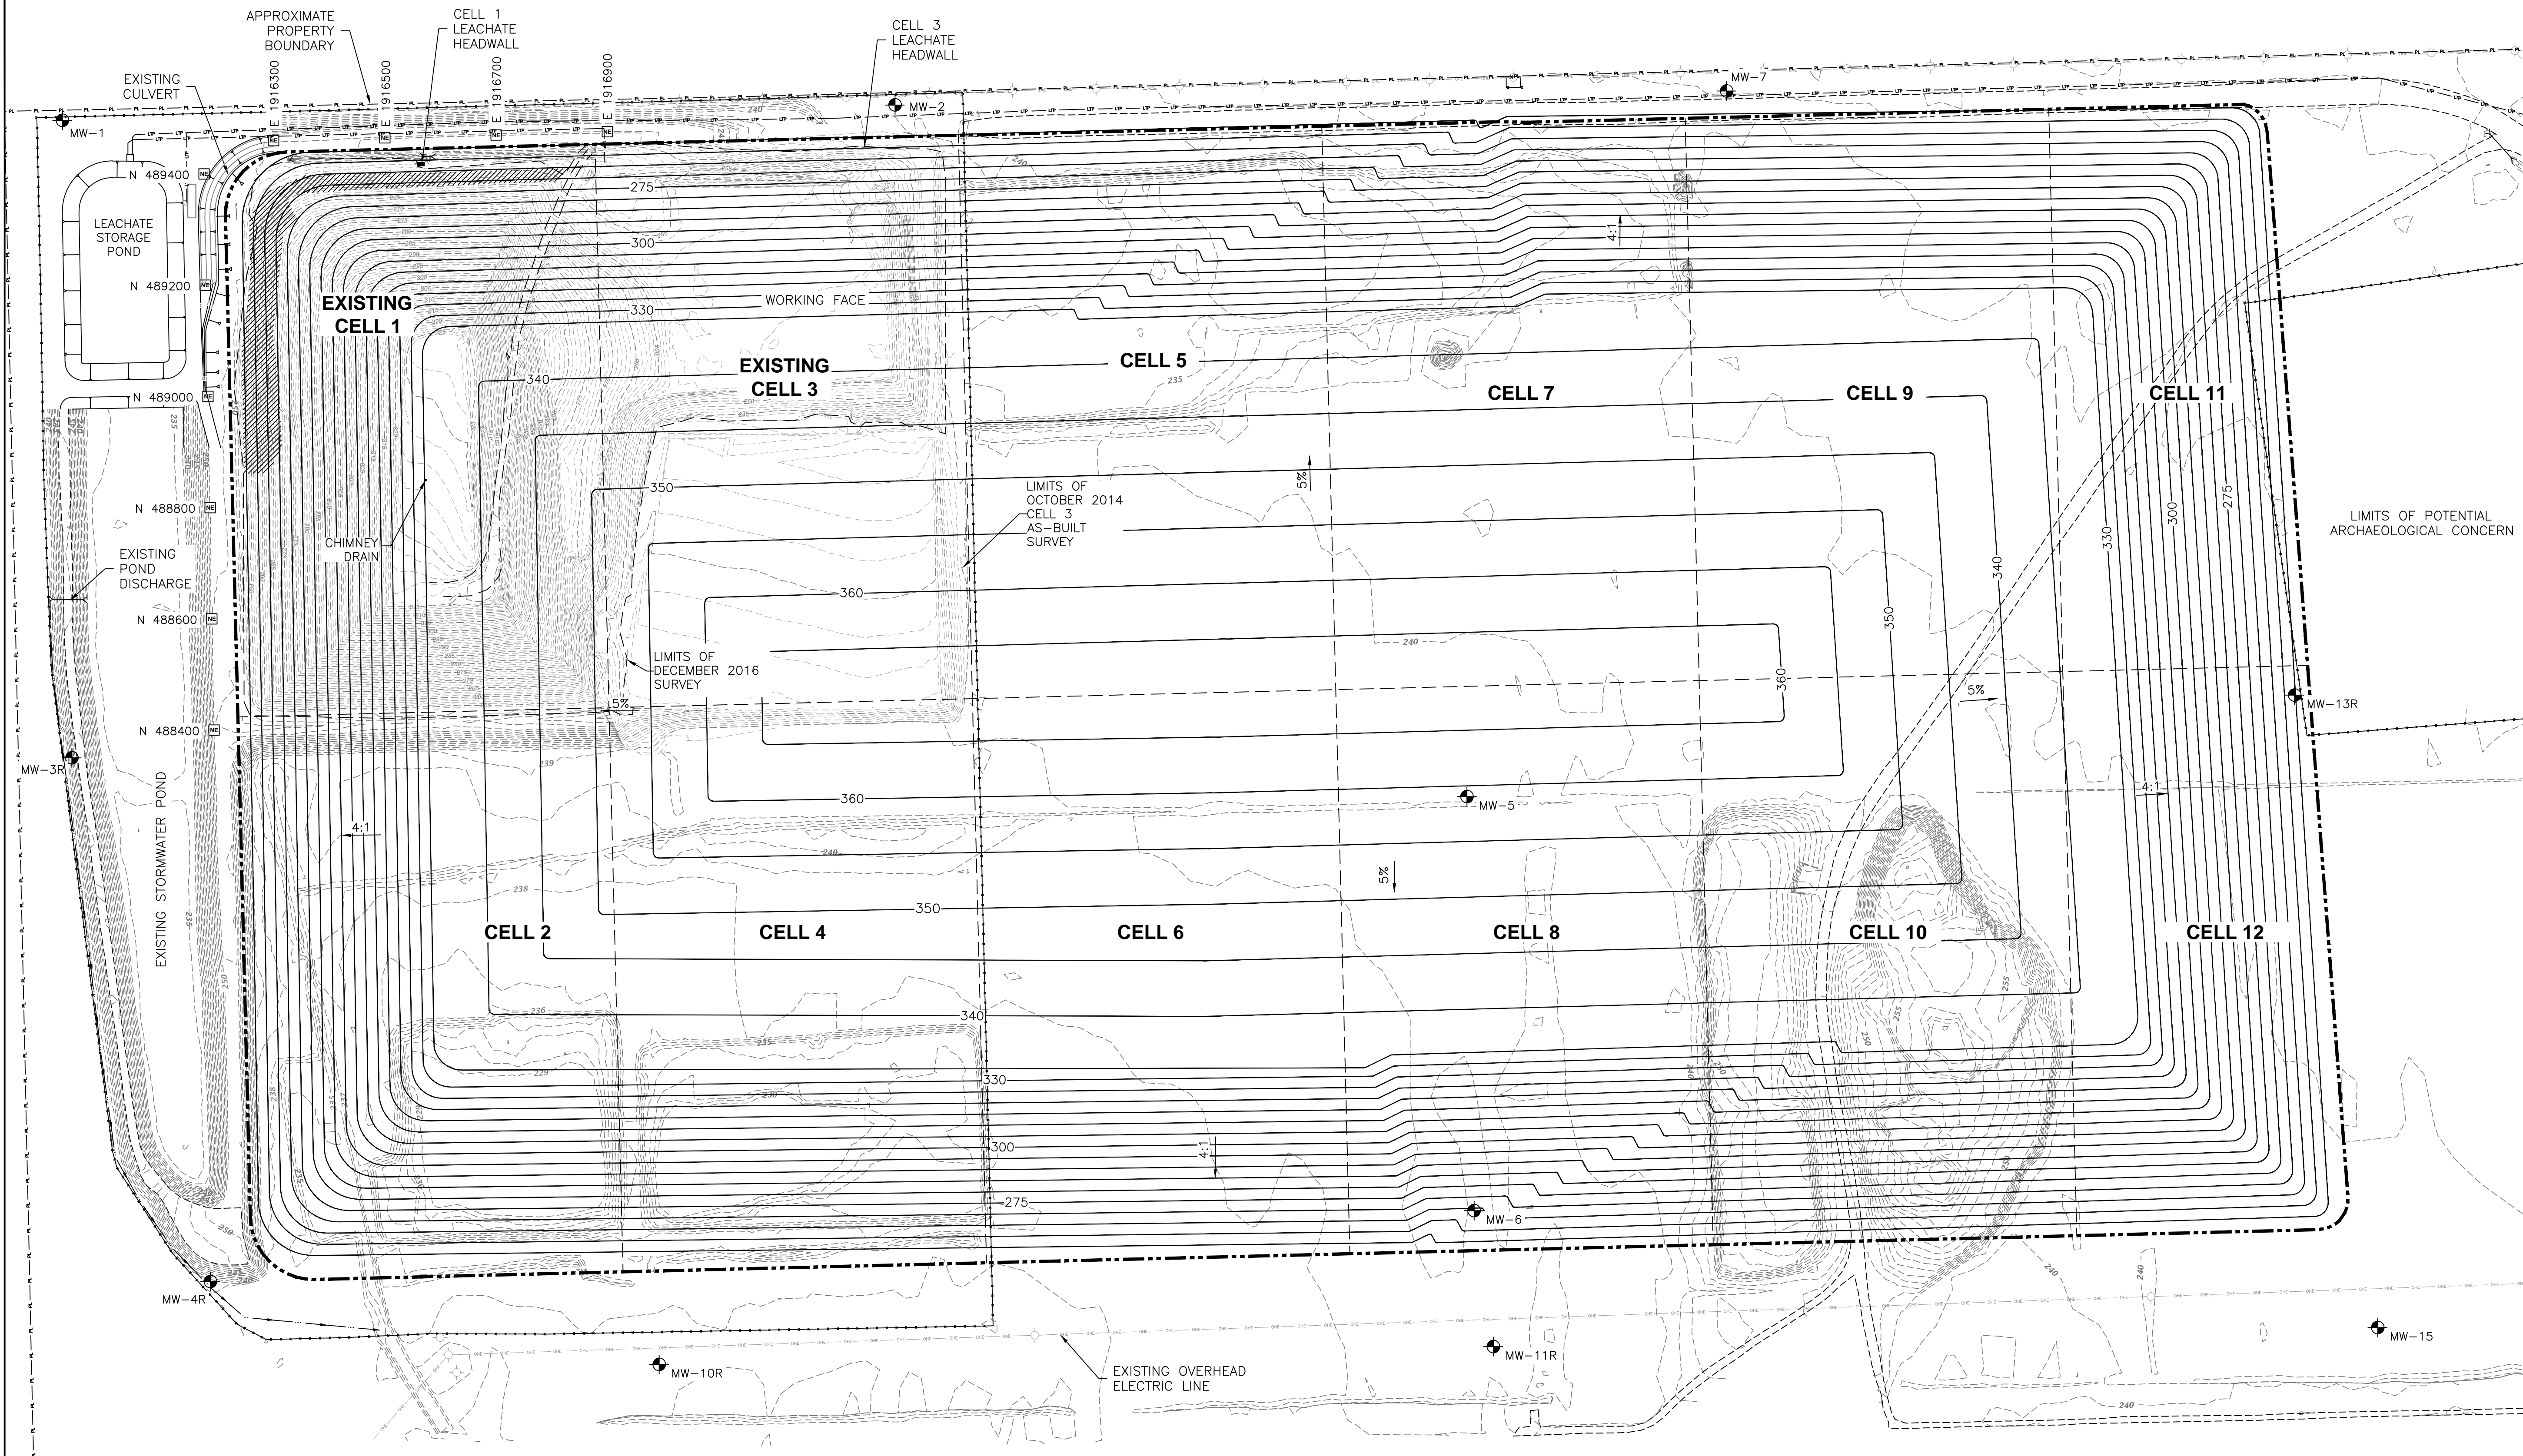
FIGURE 3
PERMITTED FINAL COVER

As noted, no final cover system has been installed on Waste Cells 1 and 3. Figure 3 presents contours for the currently permitted final cover system.

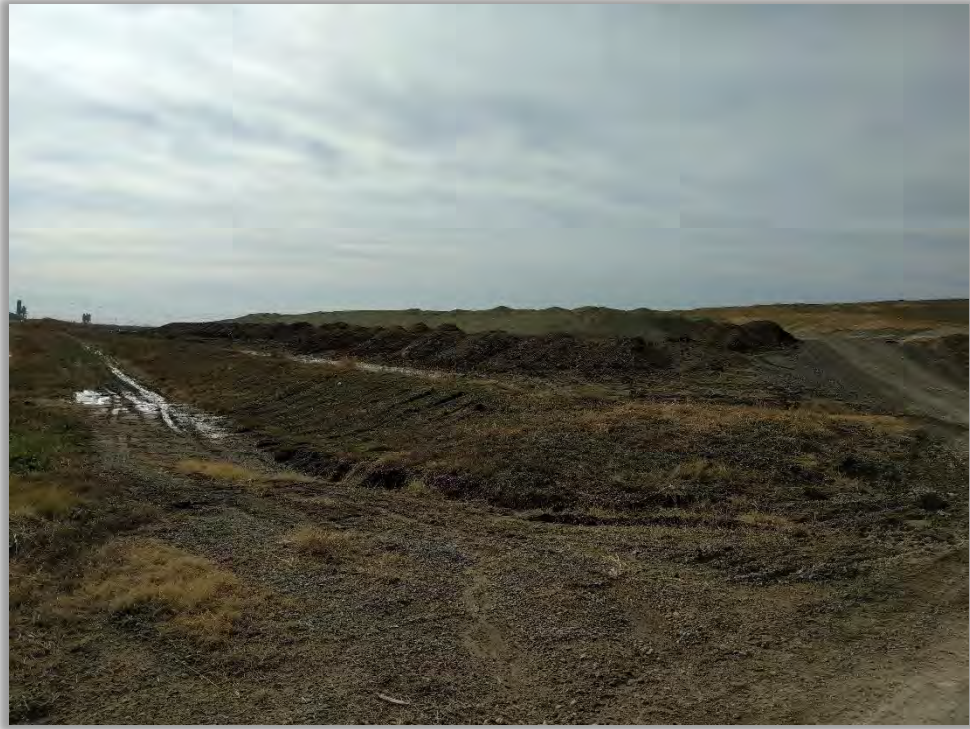
Photo 1: Cell 3 from northwest.

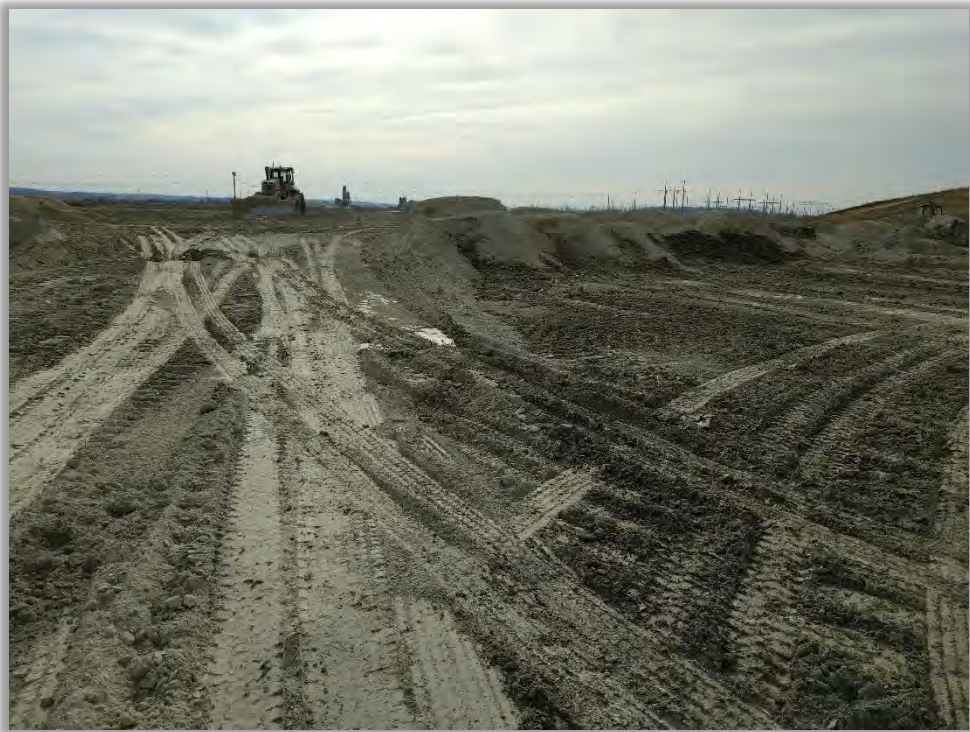
Photo 2: Cell 3 active disposal area.

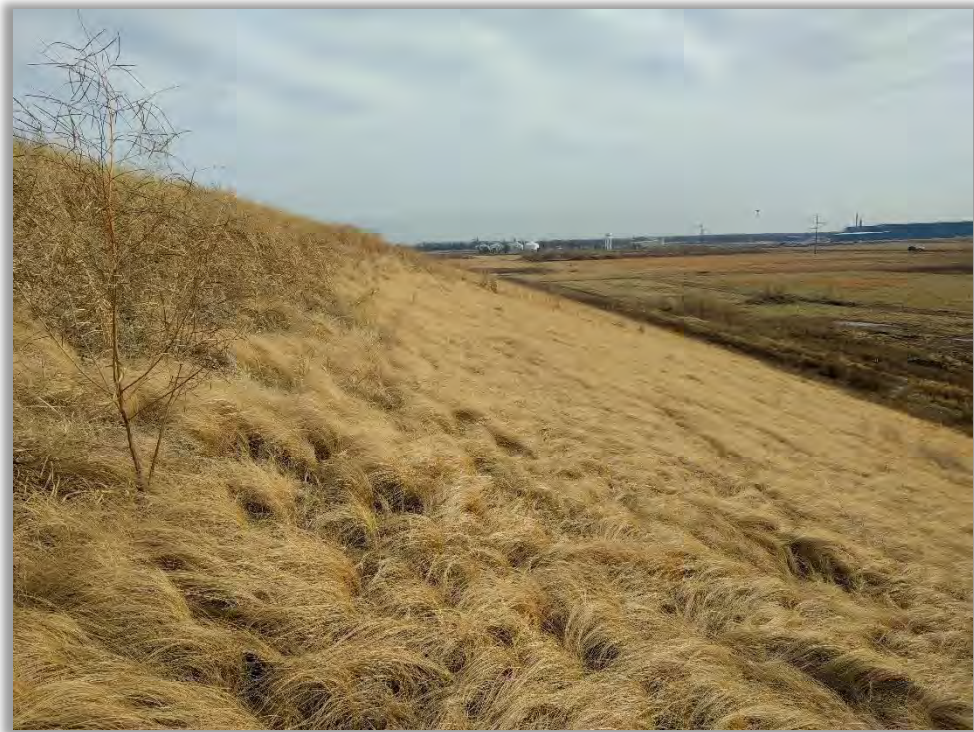
Photo 3: Side slope of landfill, typical of north, west and south sides of Cell 1.

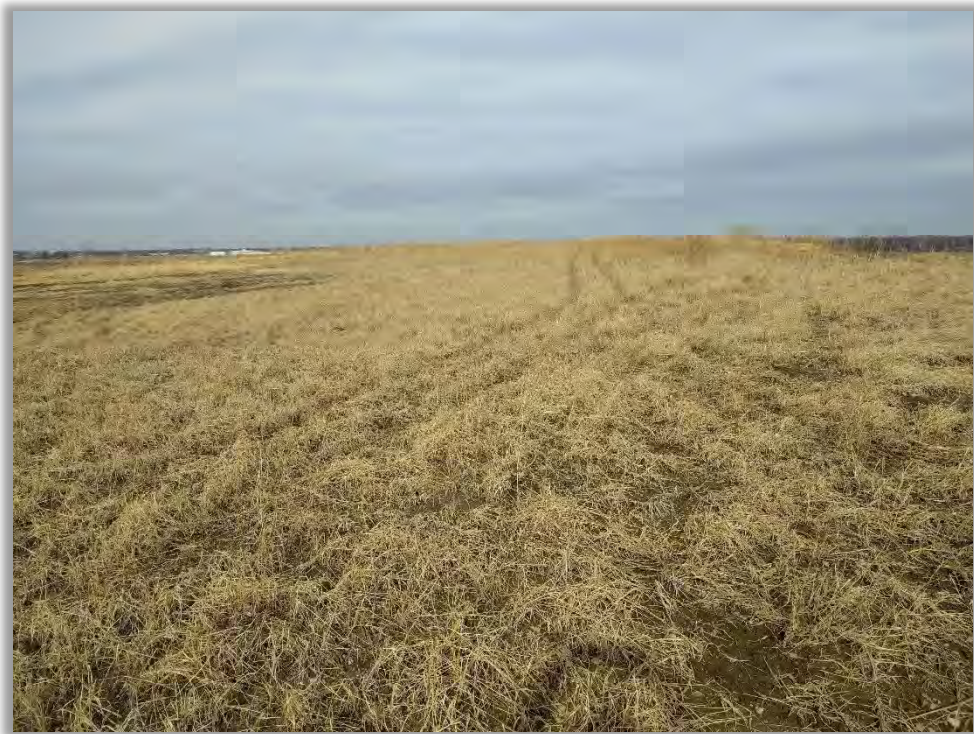
Photo 4: Top of Cell 1, looking north.

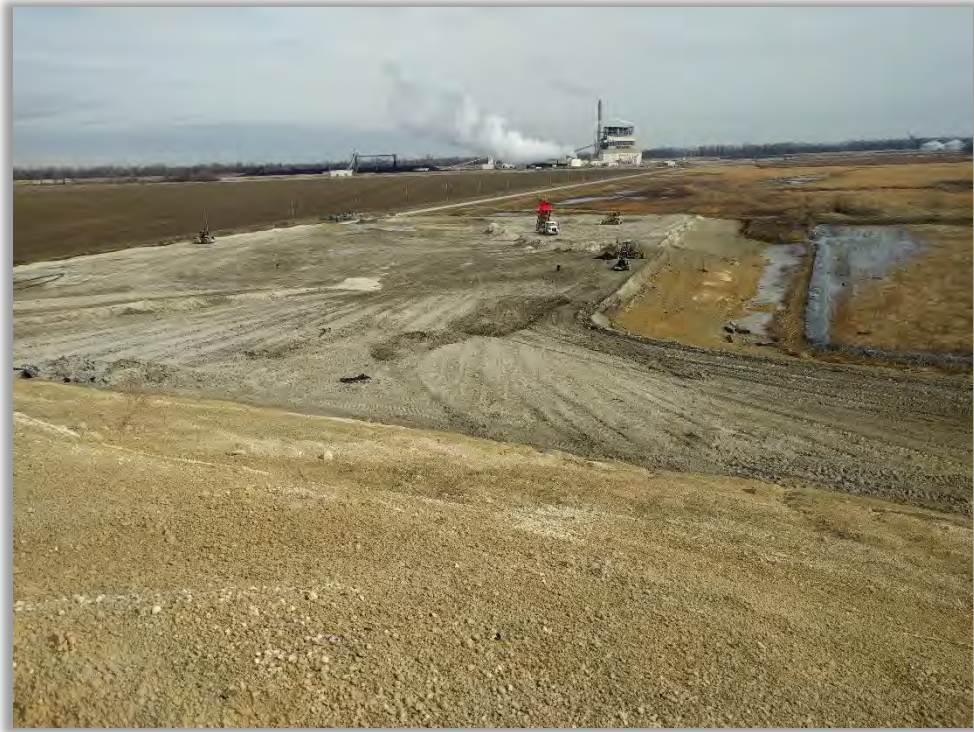
Photo 5: Active disposal area, Cell 3, from west.

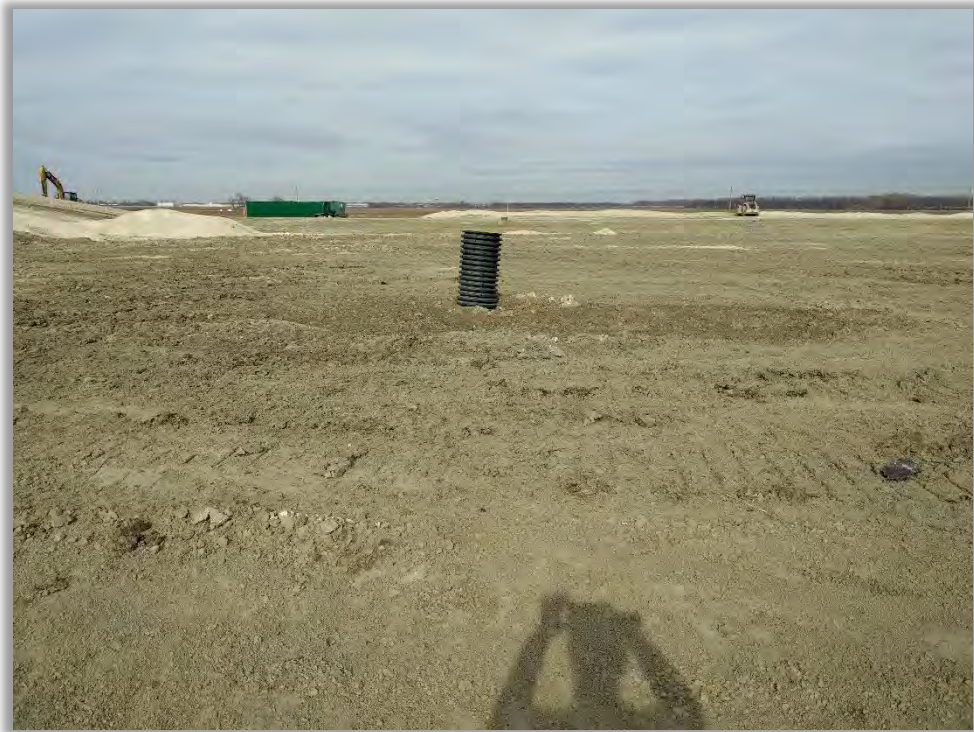
Photo 6: Typical Cell 3 chimney drains.

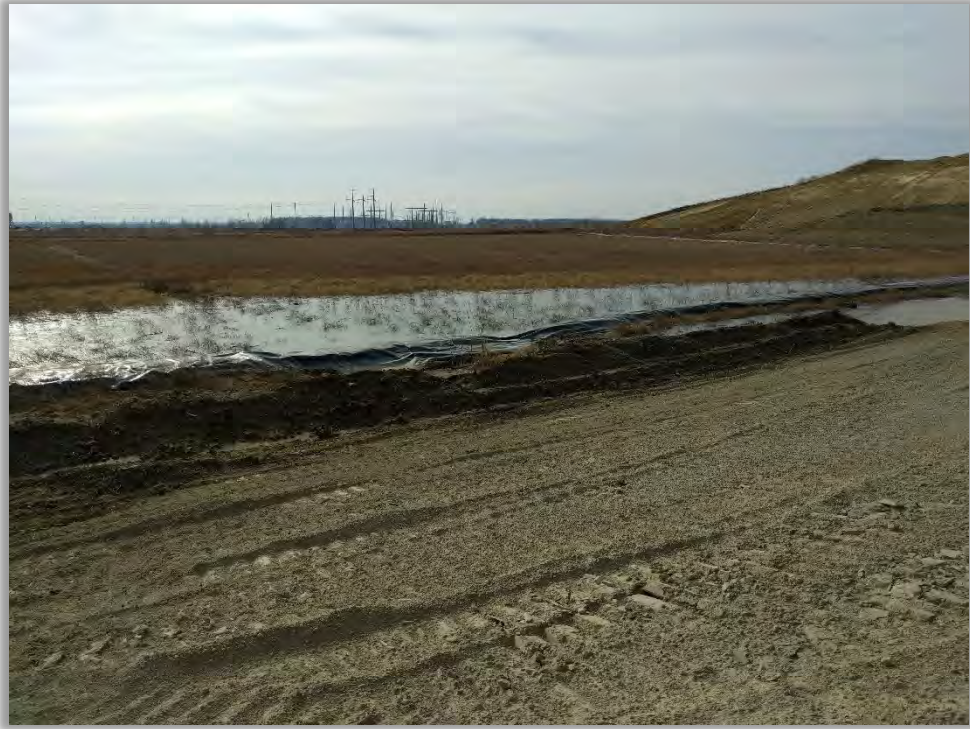
Photo 7: Cell 3 stormwater separation berm, from northeast.

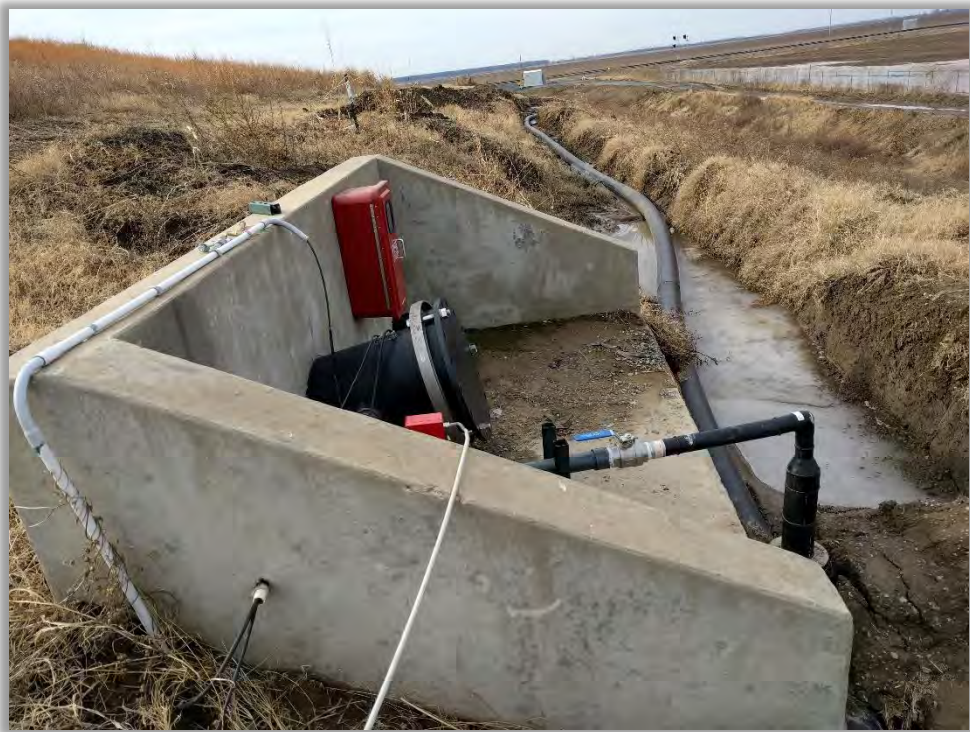
Photo 8: Cell 1 leachate pumping system. Note construction of forcemain to leachate storage pond.

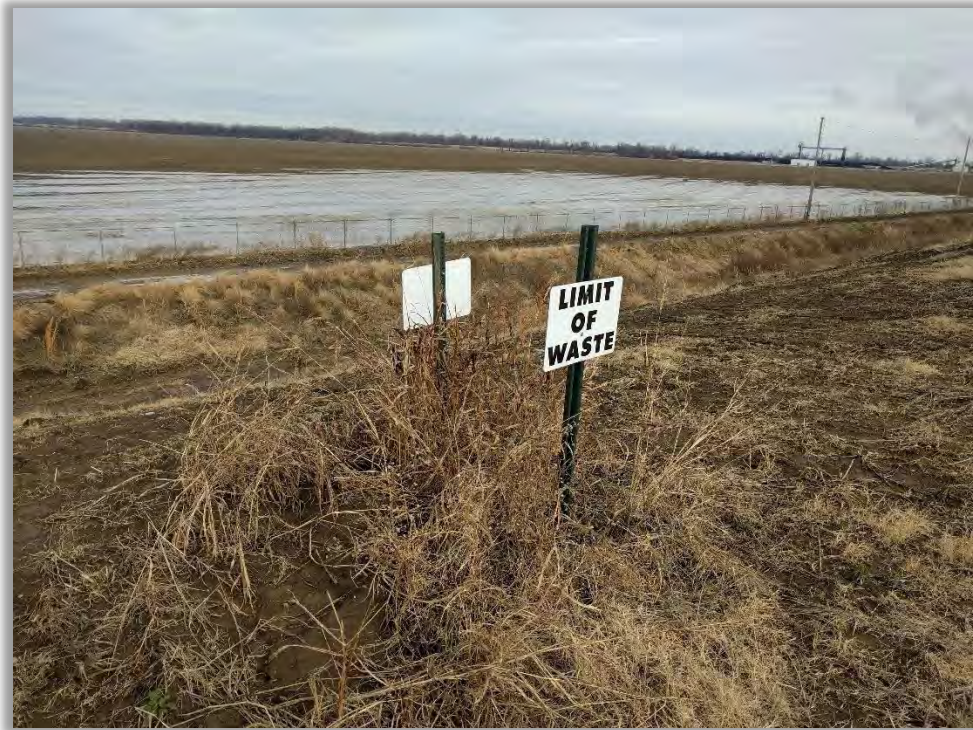
Photo 9: Typical 'Limit of Waste' and 'Edge of Liner' signage.

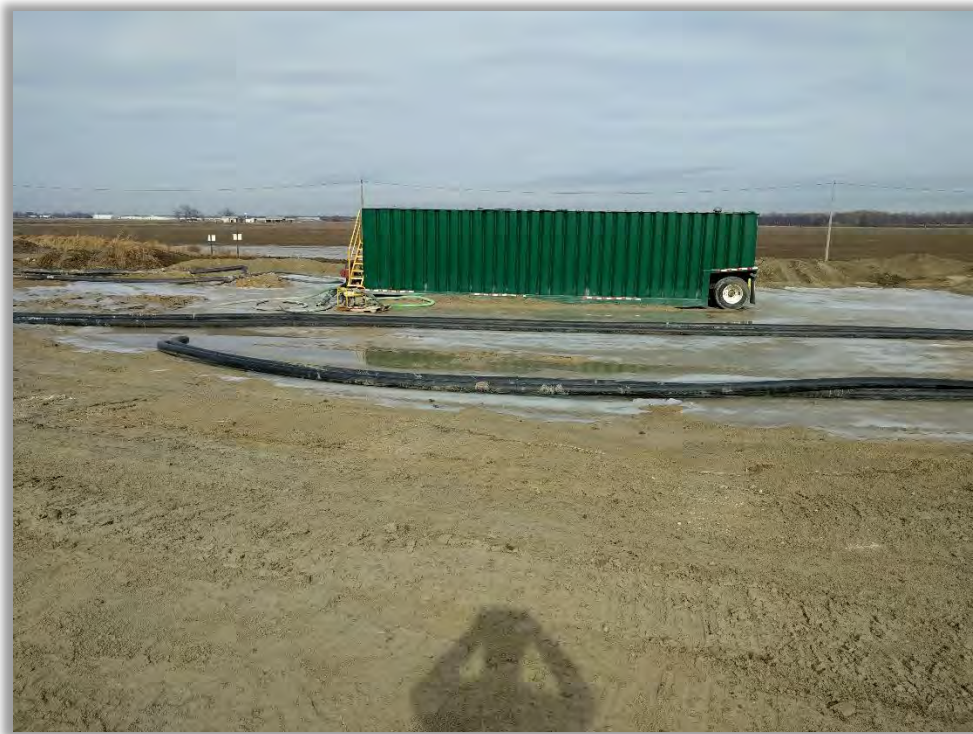
Photo 10: Leachate storage tanks, relocated to within Cell 3.

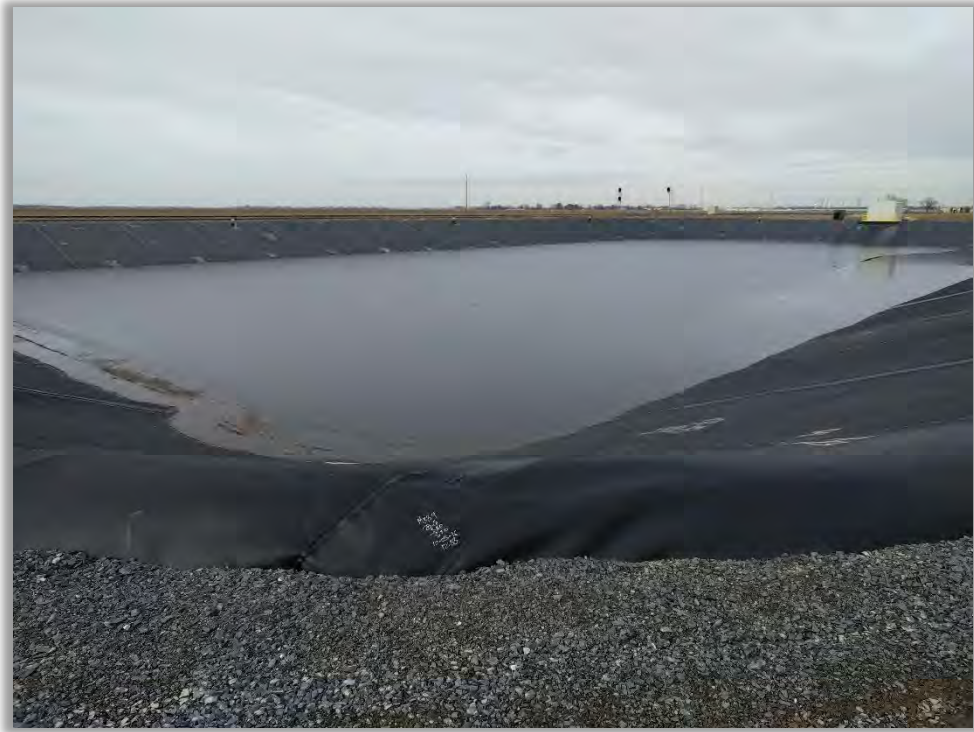
Photo 11: New leachate storage pond from southeast.

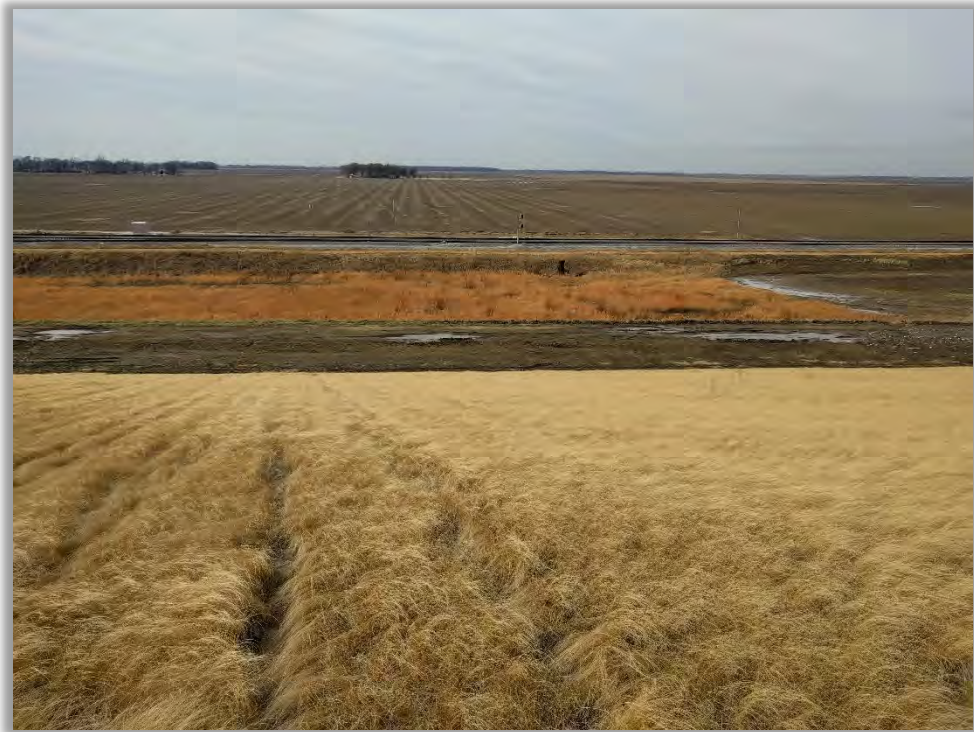
Photo 12: West slope of Cell 1 and stormwater pond looking west.

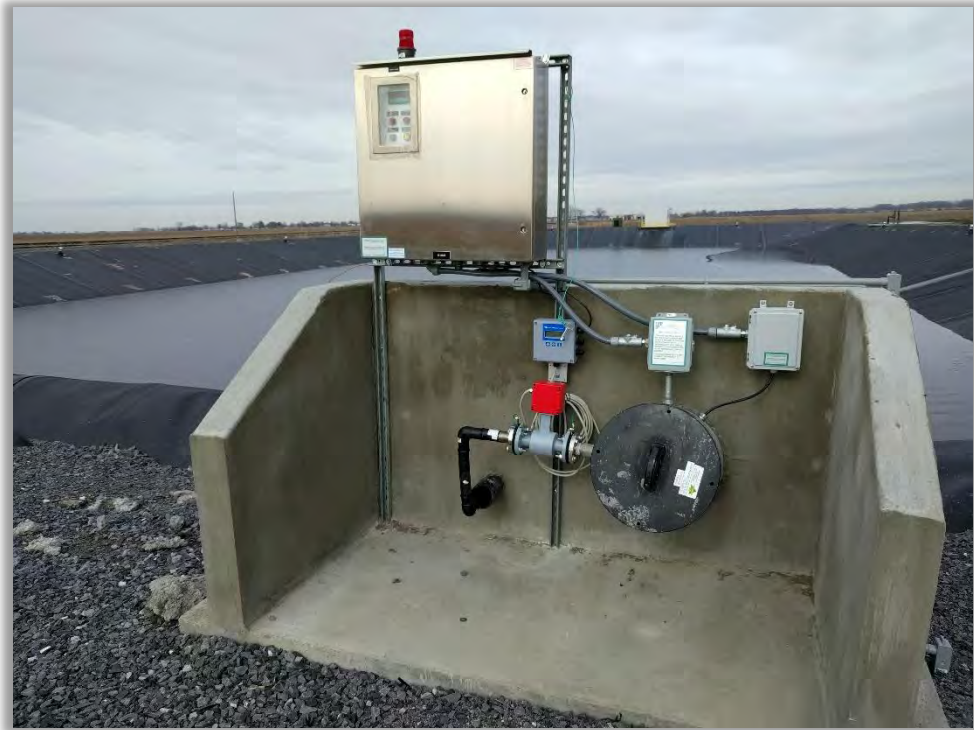
Photo 13: Leachate storage pond leak detection system pumping system.

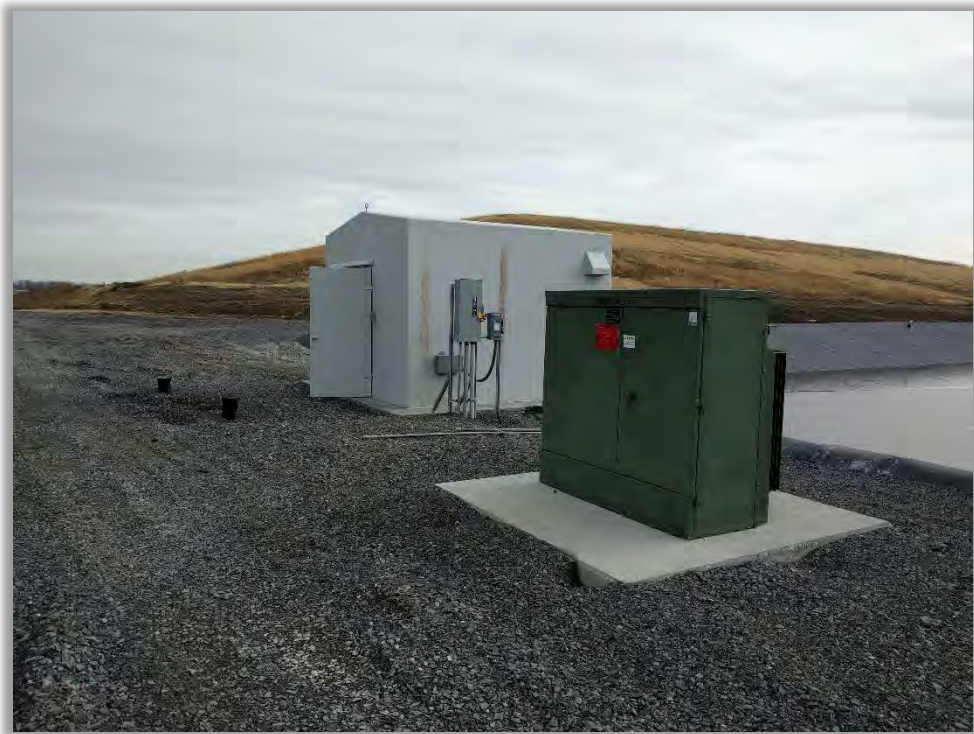
Photo 14: Leachate pump station.

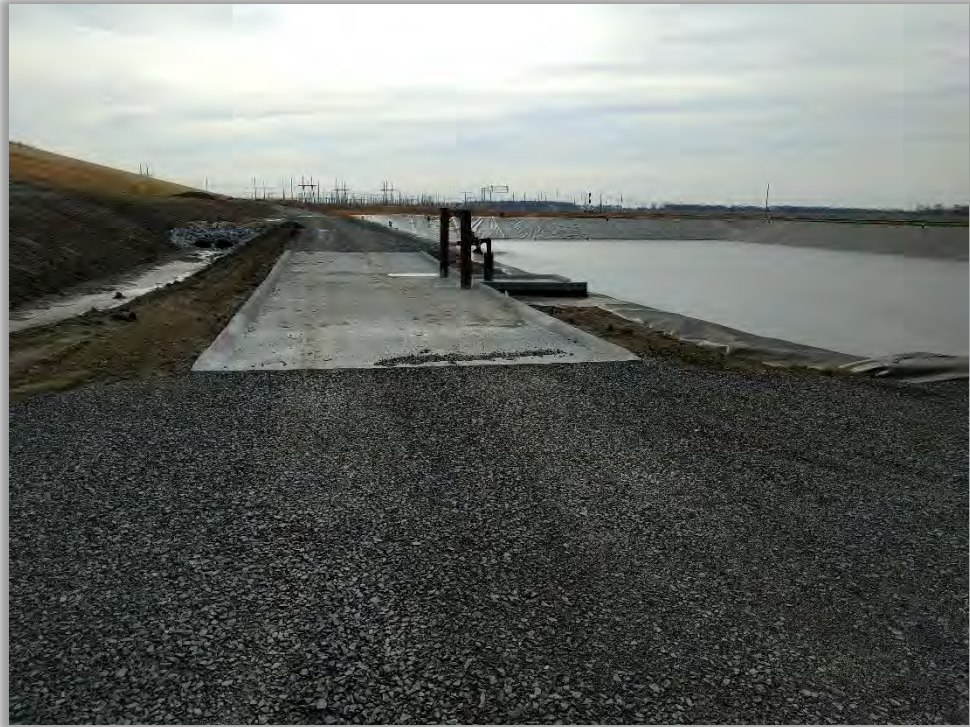
Photo 15: New leachate truck loading station and spill pad.

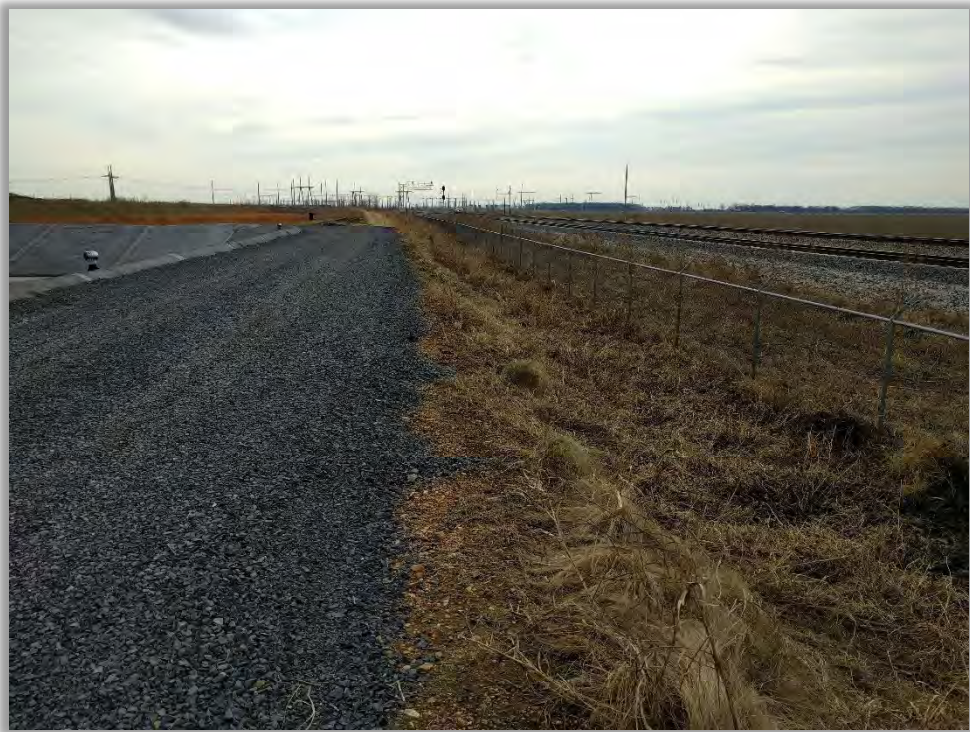
Photo 16: West perimeter stormwater ditch.
