2017 ANNUAL ENGINEERING INSPECTION REPORT

PLUM POINT ENERGY STATION CLASS 3N LANDFILL

**PERMIT NO. 0303-S3N
AFIN: 47-00461**

JANUARY 18, 2018

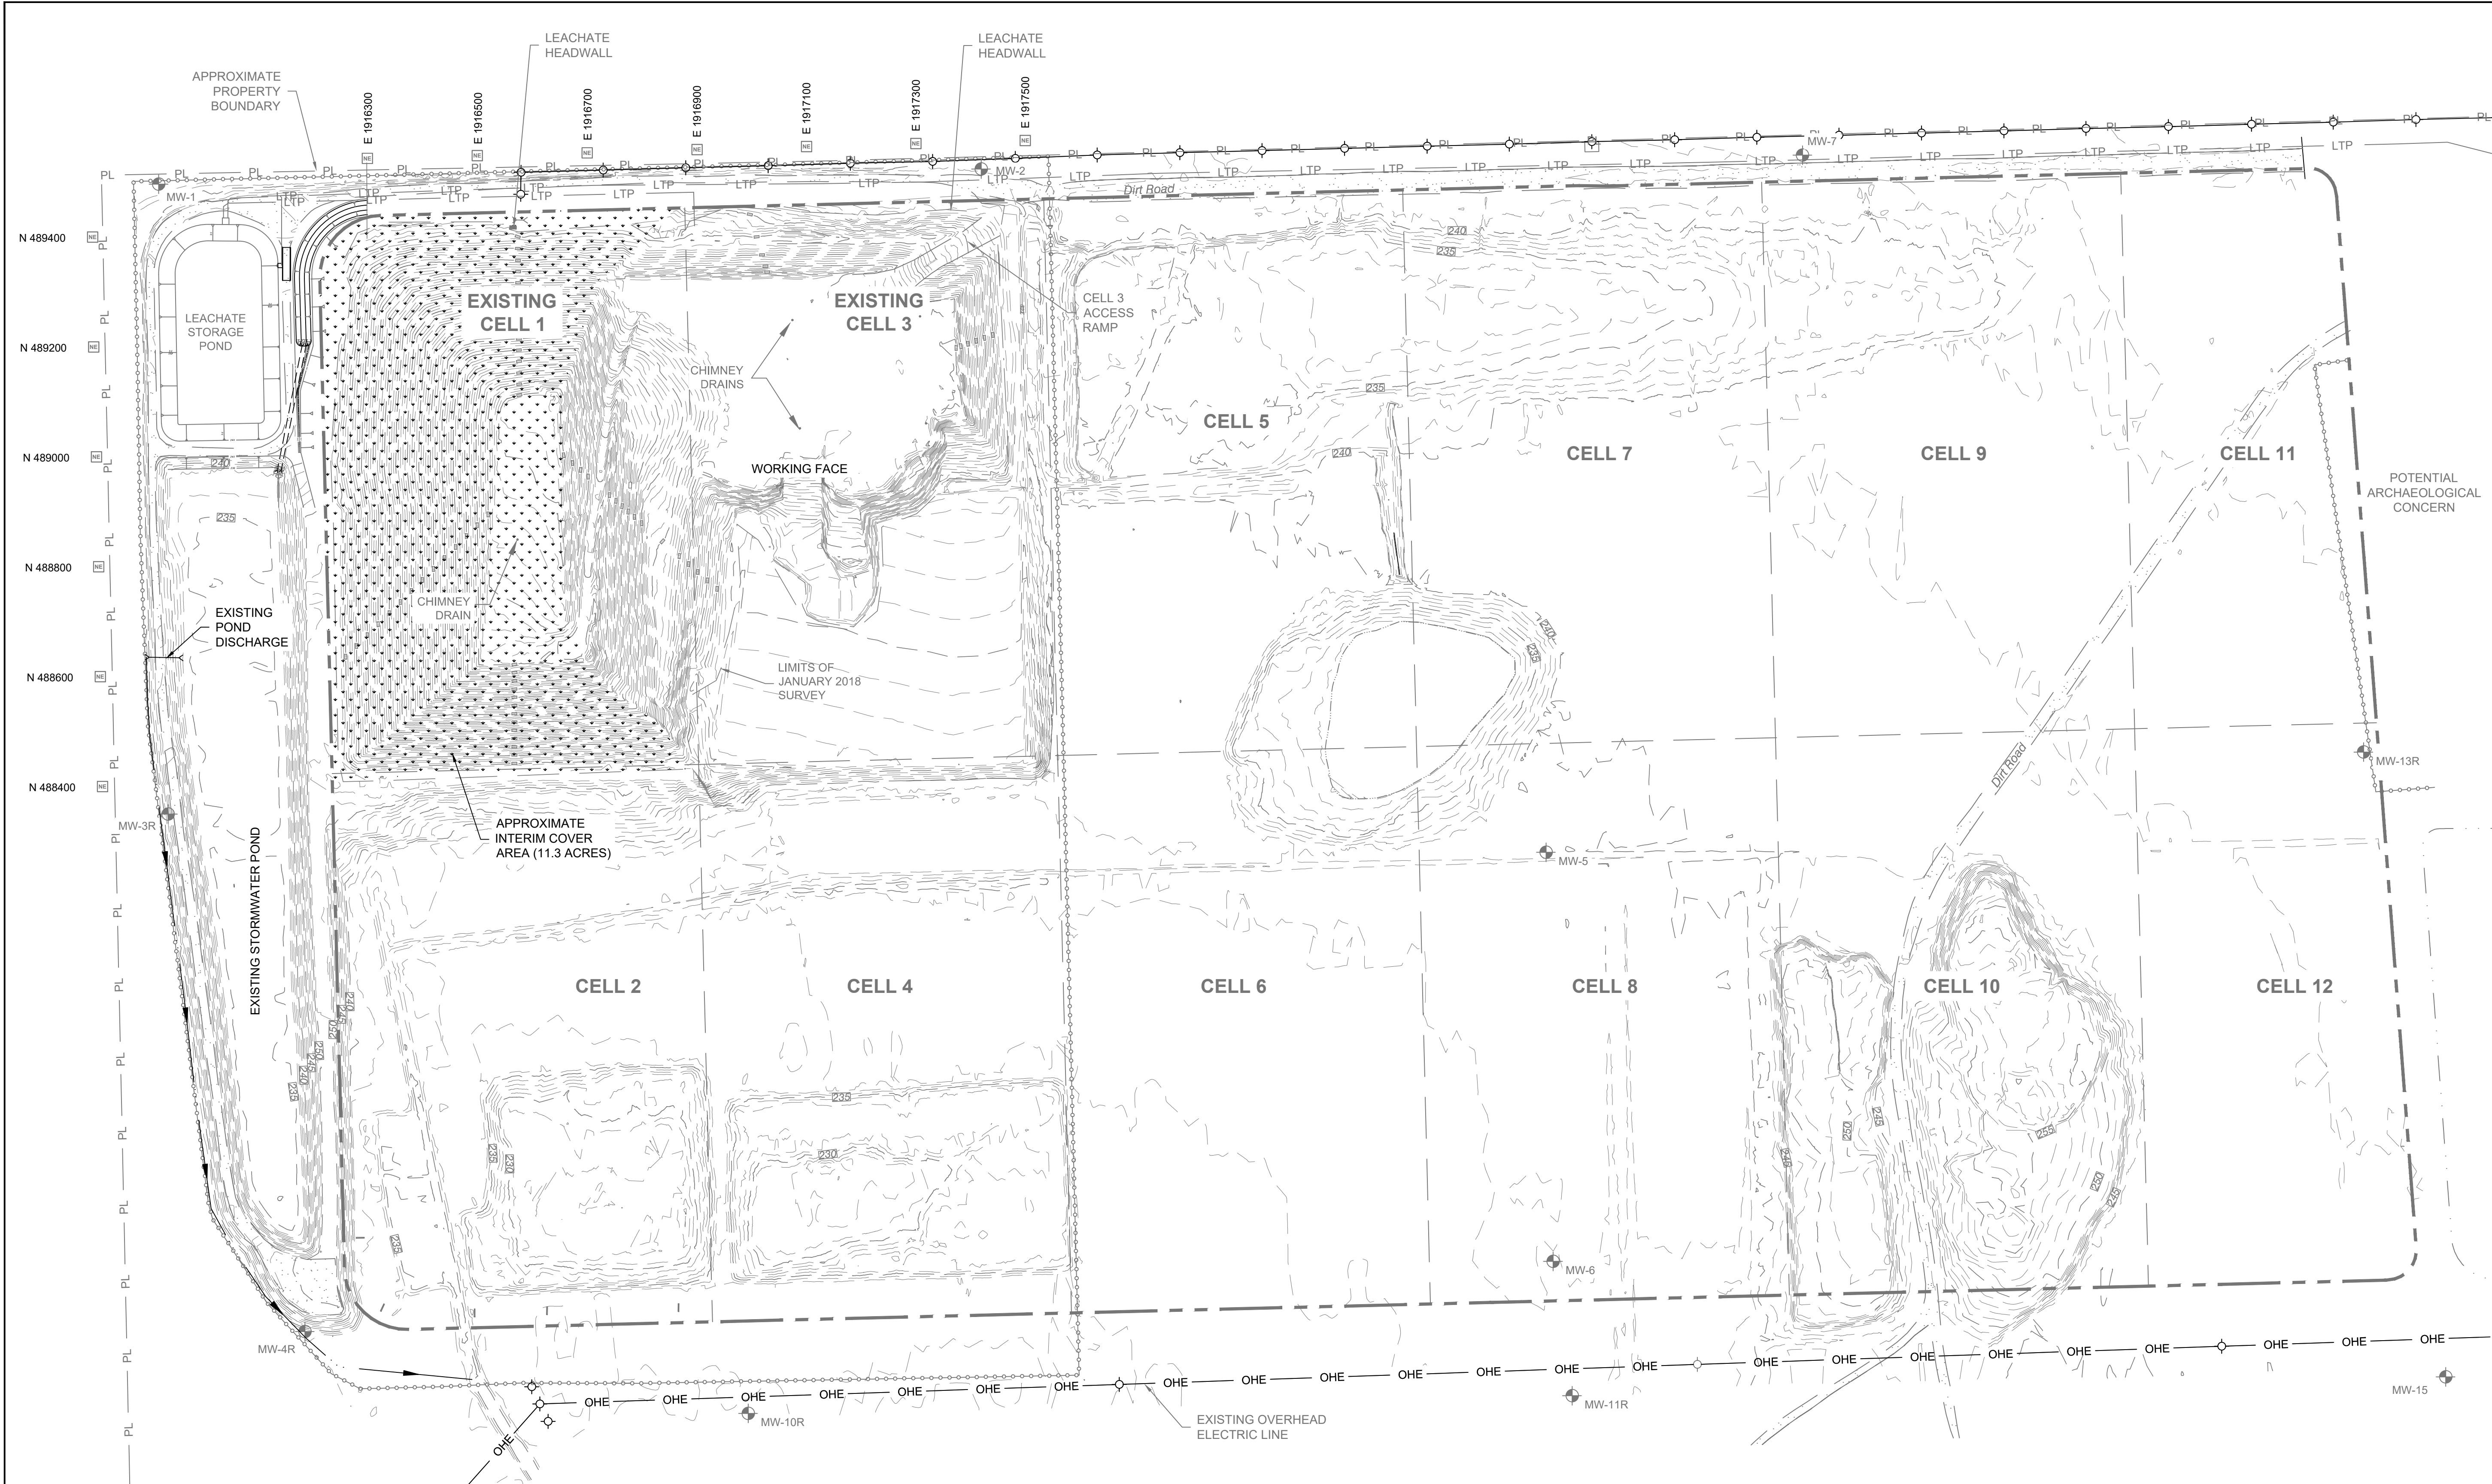
FIGURE 2
EXISTING CONDITIONS

Both active cells remain open. Interim cover soil has been placed, as noted, on all of Cell 1 except for the east slope into Cell 3. Interim cover has also been installed on the north and east slopes of Cell 3, progressing upward as the current fill elevation increases.

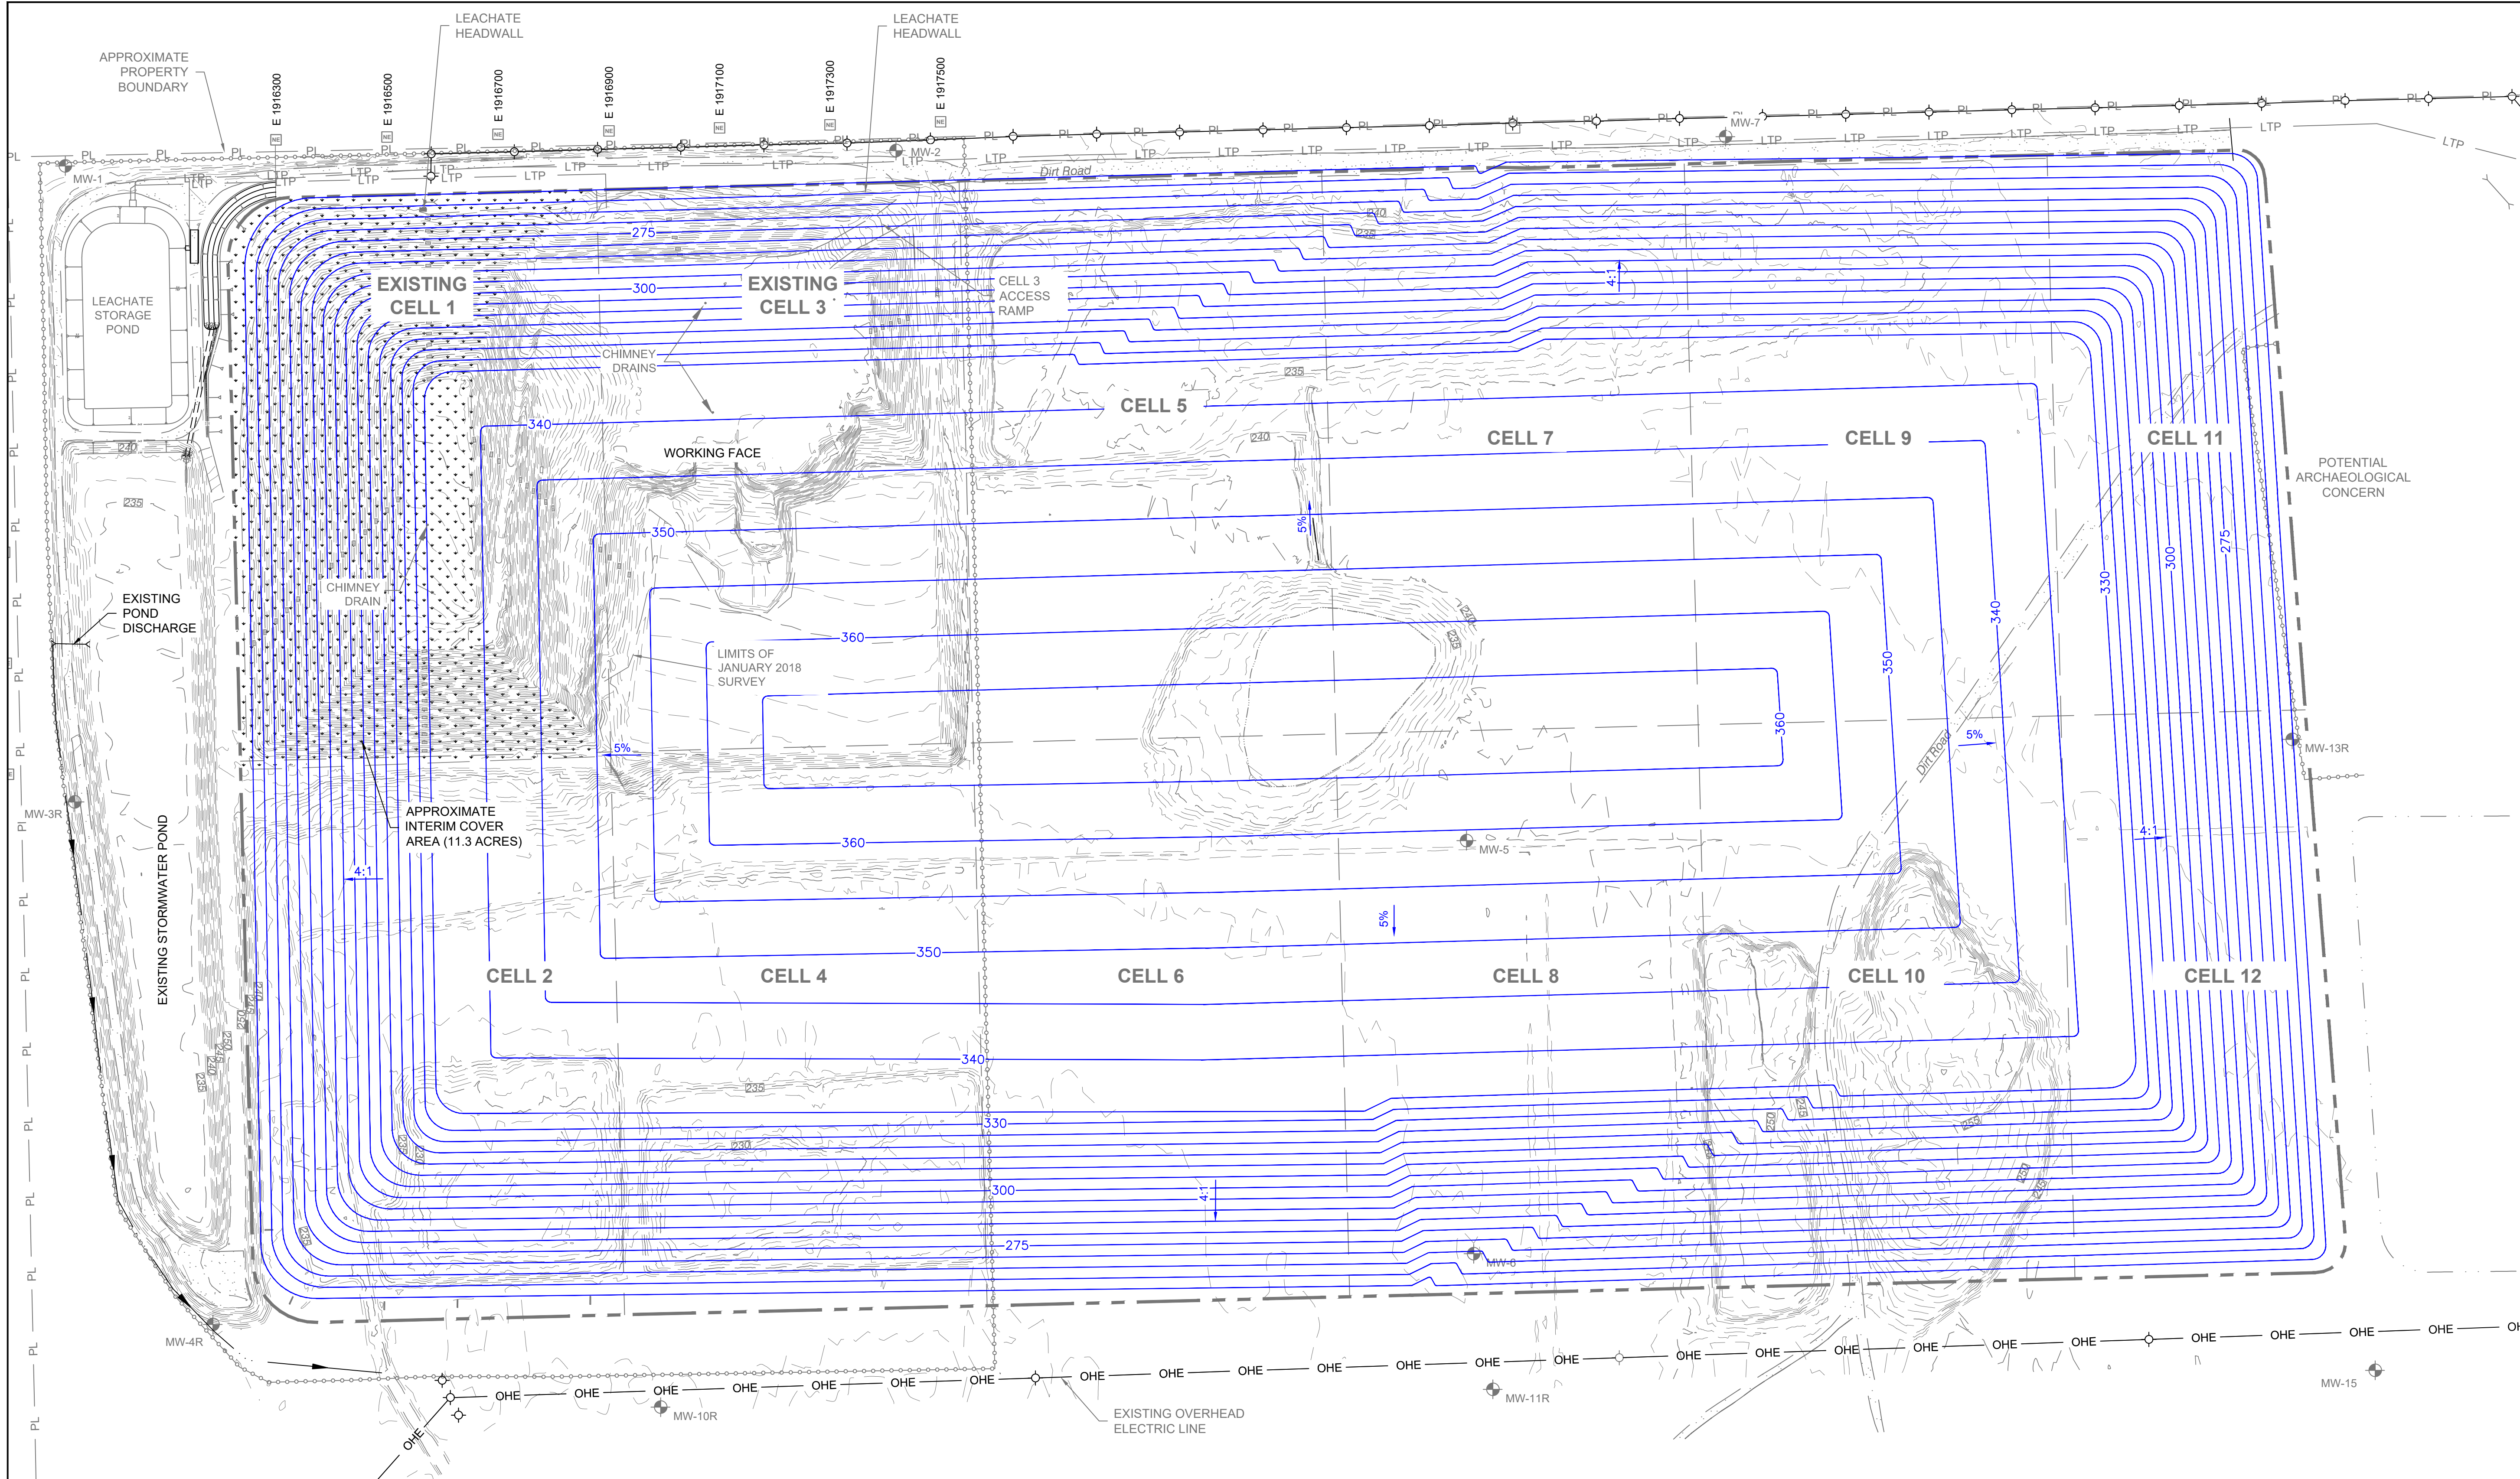
FIGURE 3
PERMITTED FINAL COVER

As noted, no final cover system has been installed on Waste Cells 1 and 3. Figure 3 presents contours for the currently permitted final cover system.

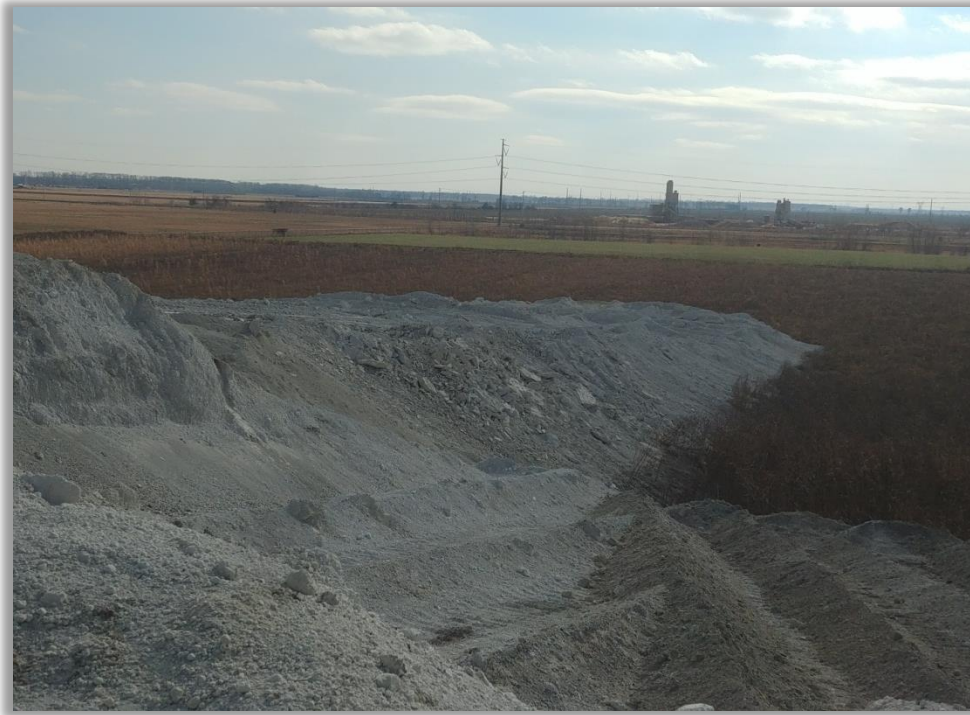
Photo 1: Cell 3 disposal expansion into south half of cell.

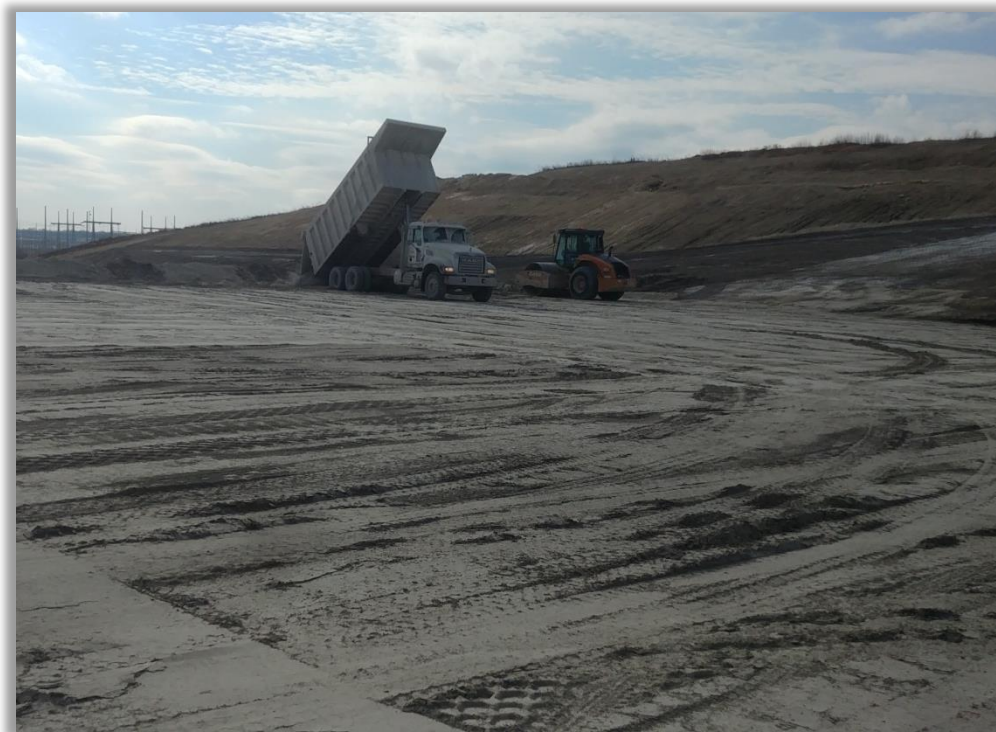
Photo 2: Cell 3 active disposal area.

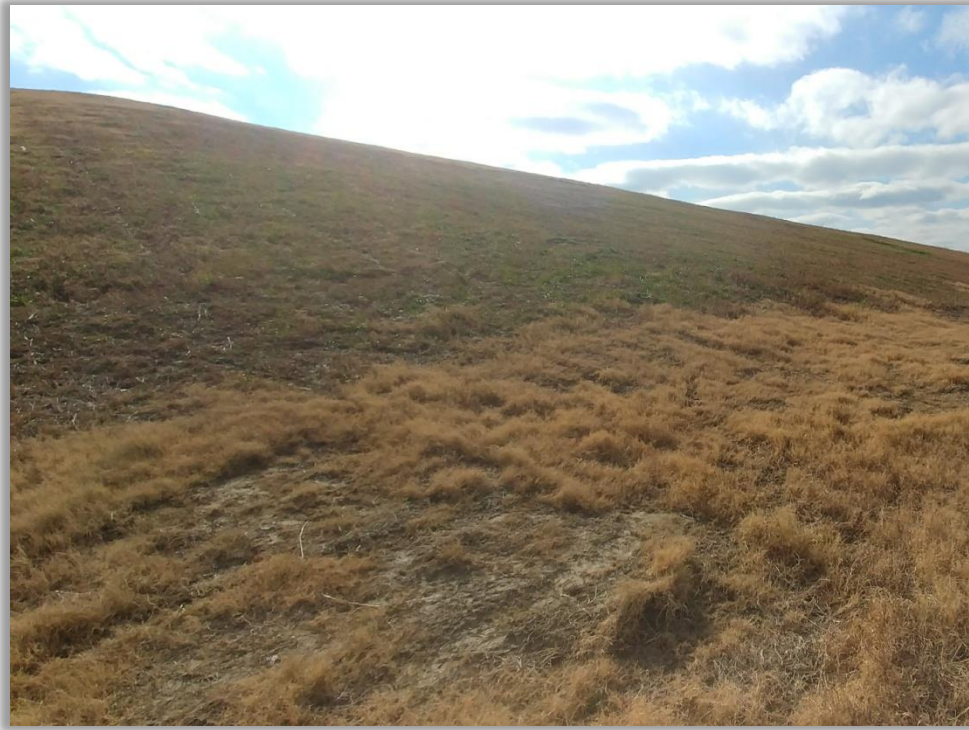
No tension cracks, seeps, or other features that indicate a potential slope failure were observed during the site inspection. In addition, no active seeps were noted on the exterior slopes.

Photo 3: Side slope of landfill, typical of north, west and south sides of Cell 1.

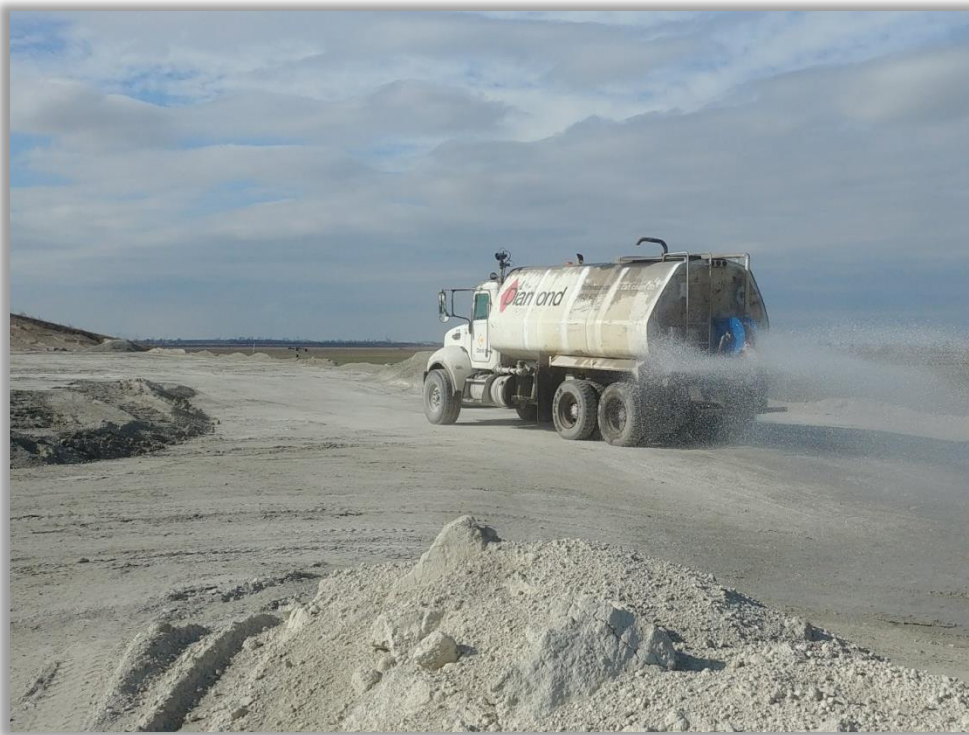
Fly ash is transported to the landfill using end-dump trucks with tarps. The ash is mixed with water in the pug mill at an appropriate ration to minimize fugitive dust problems during truck loading and dumping, but not create excess free liquids. Water is applied, when necessary, for dust suppression on roads and the landfill using a water truck. Disposal activities observed during the annual inspection resulted in little, if any, dust which appeared to be confined to the active area.

Photo 4: Water truck applying water for dust suppression.

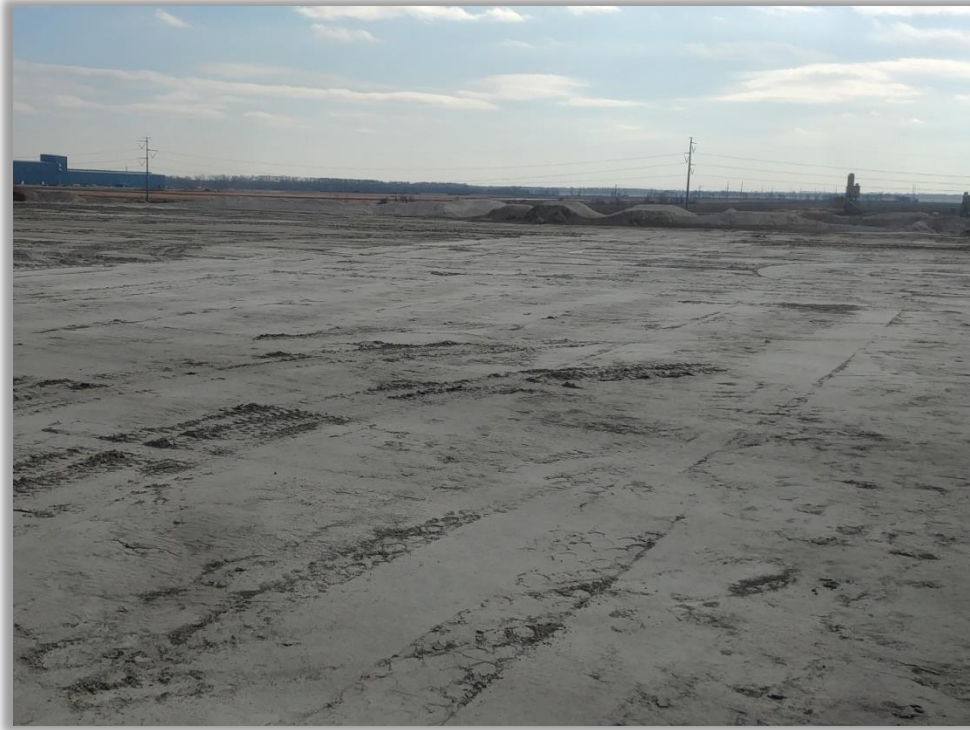
Photo 5: Active disposal area, Cell 3, from northwest.

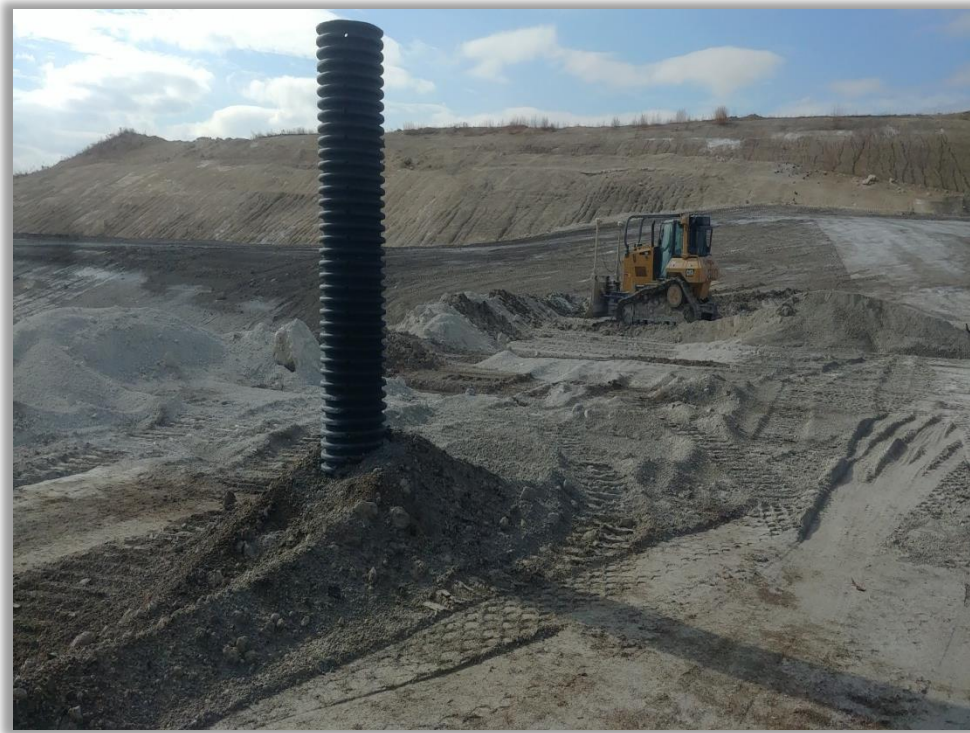
Photo 6: Typical Cell 3 chimney drains.

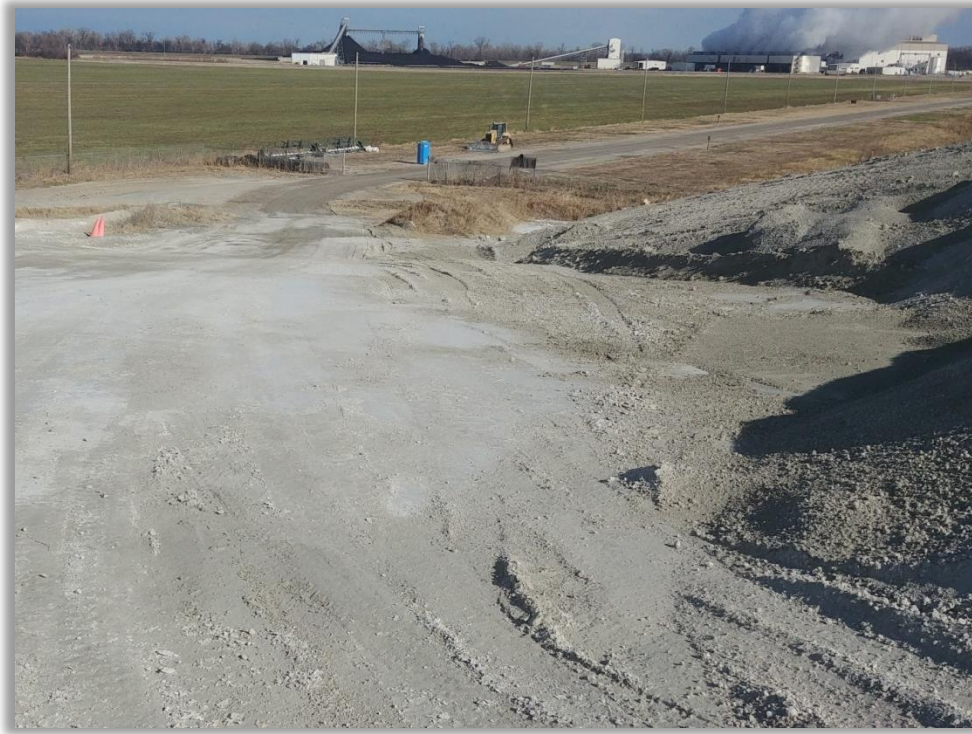
Photo 7: Haul road from top of cell 3.

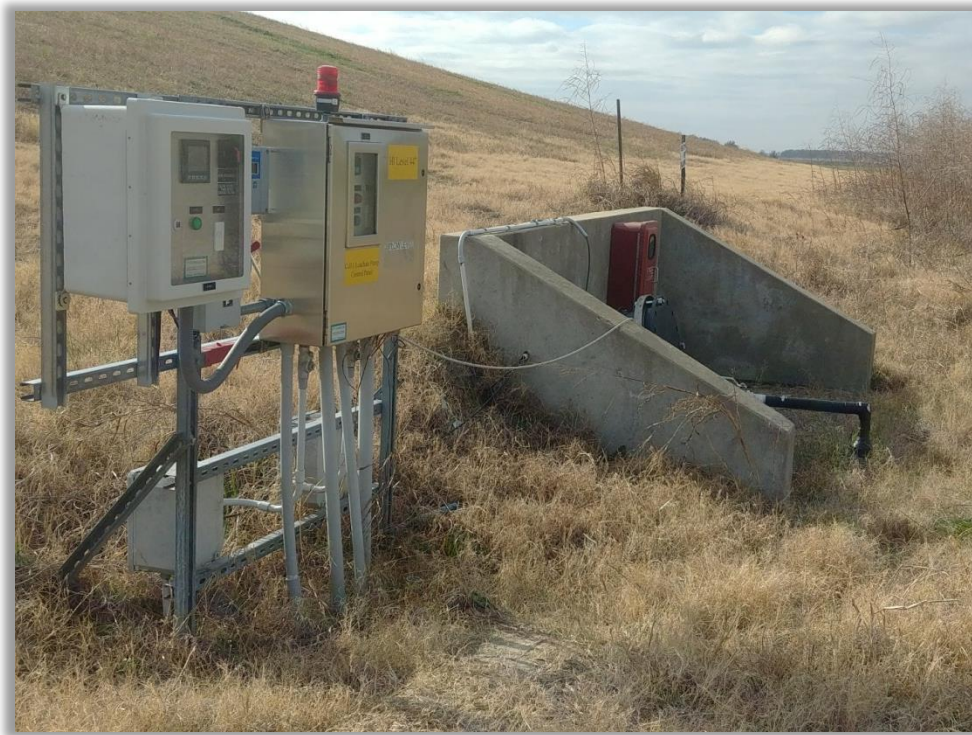
Photo 8: Cell 1 leachate pumping system.

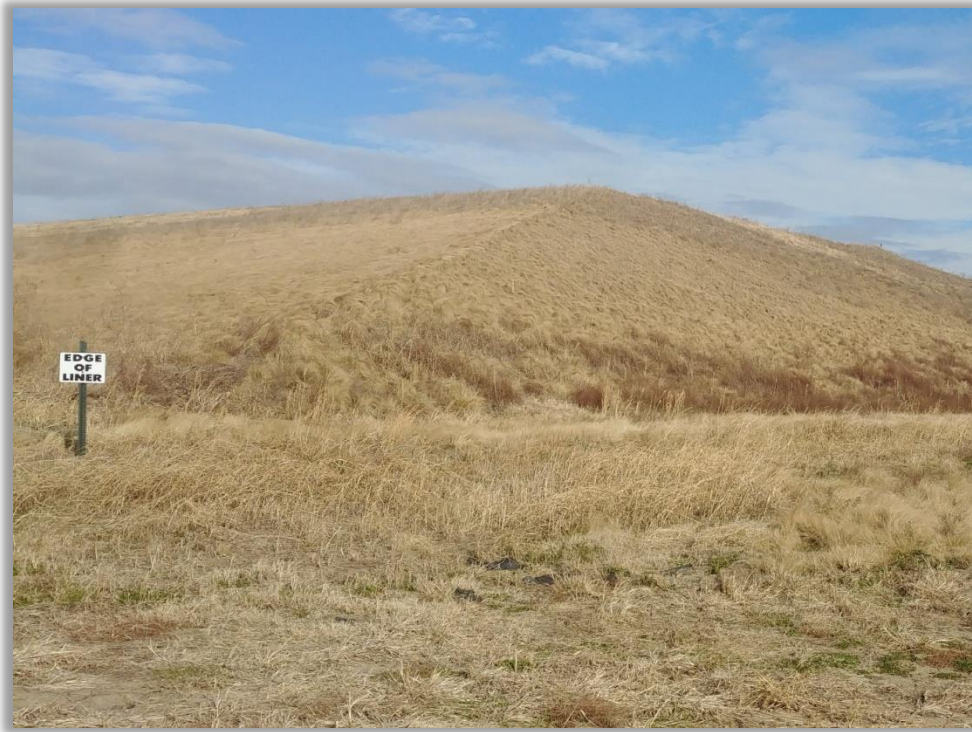
Photo 9: Cell 1 from northwest and typical 'Edge of Liner' signage.

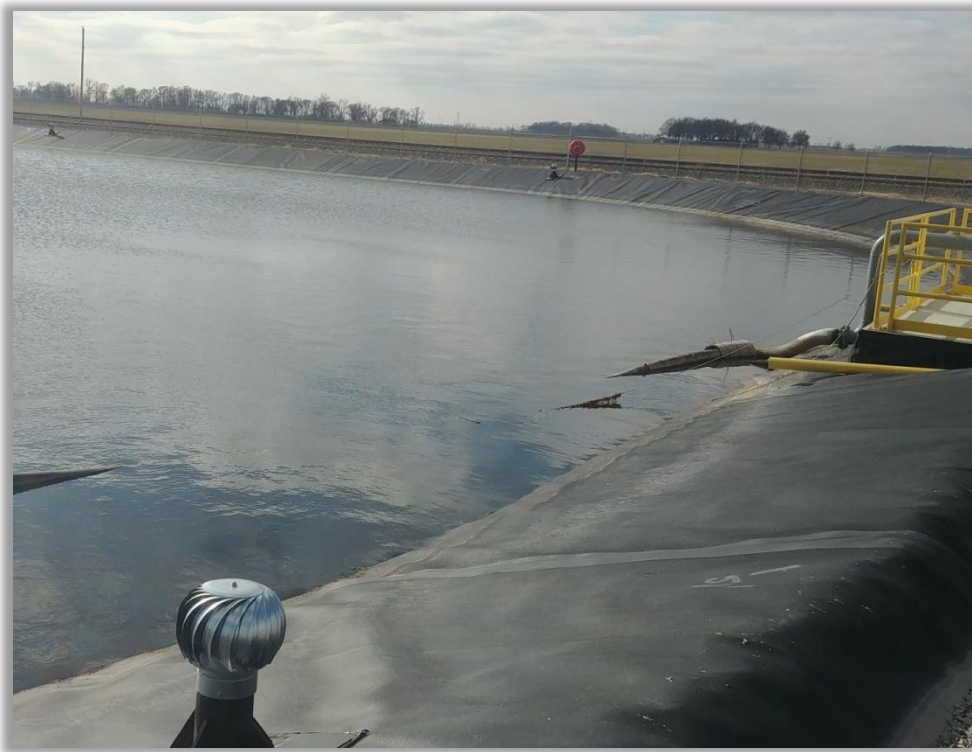
Photo 10: Leachate storage pond from north.

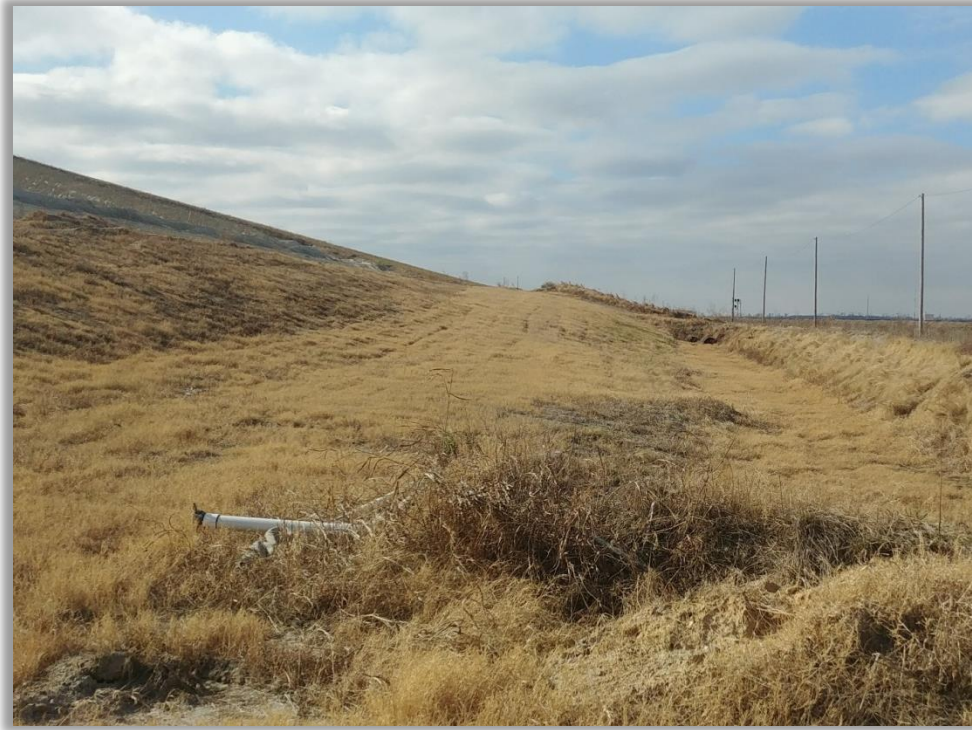
Stormwater at the landfill site flows west to the stormwater pond on the western side of Cell 1. To prevent run-on, a stormwater channel and berm was constructed along the north side of the landfill, routing stormwater west around the landfill. Additionally, clay perimeter berms prevent both run-on and run-off. Stormwater from the covered slopes drains to the onsite stormwater pond located west of Cell 1. Stormwater channels, culverts and discharge structures were in good operational condition.

Photo 11: North slope of Cell 1 and perimeter stormwater channel.

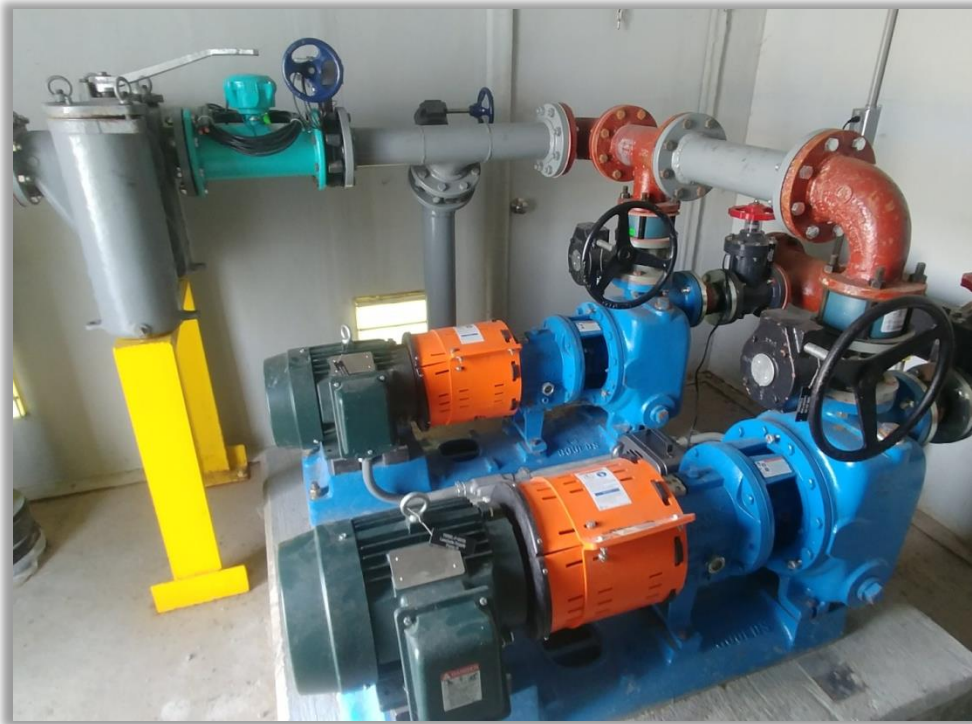
Photo 12: Leachate transfer station pumps.

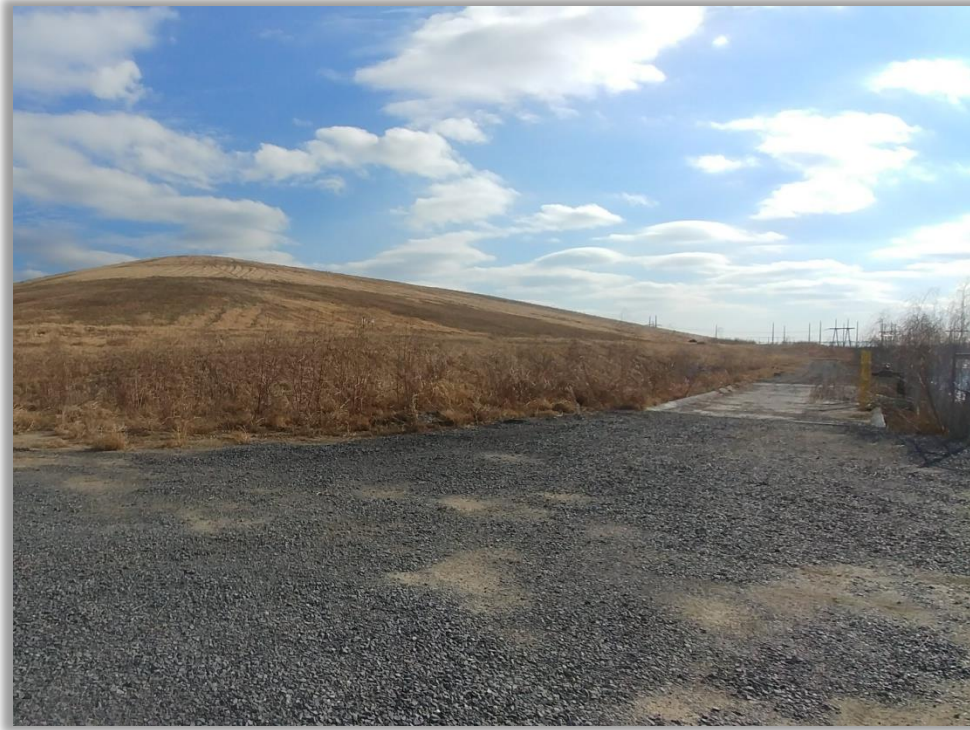
Photo 13: Northwest corner of cell 1 and leachate truck loading station.

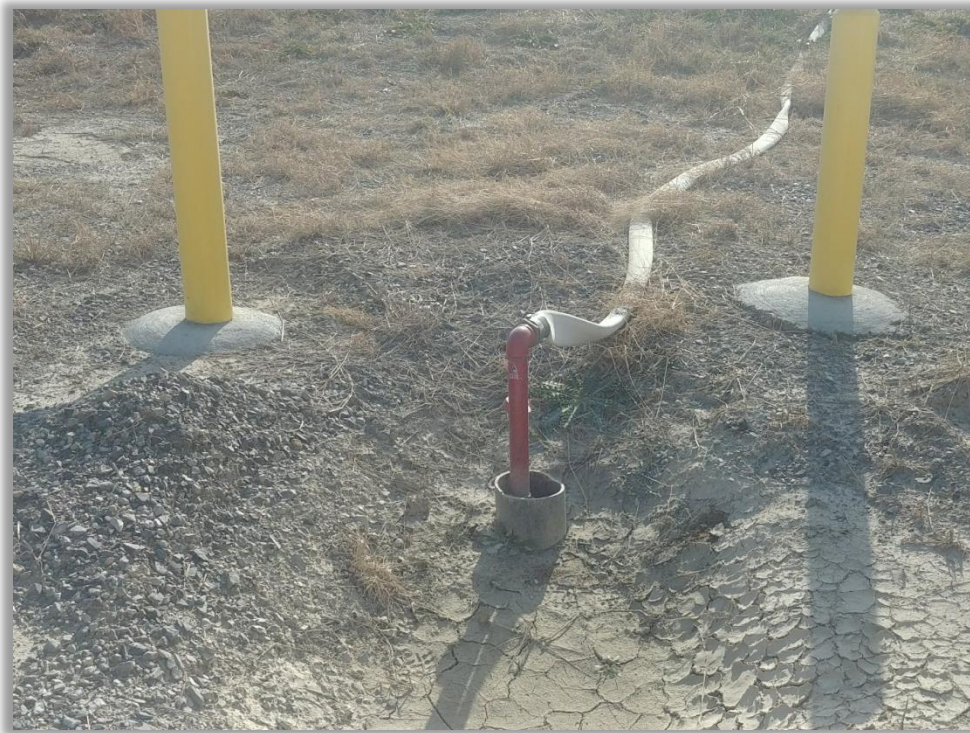
Photo 14: Dust control hydrant north side of Cell 3.
