# **2018 ANNUAL ENGINEERING INSPECTION REPORT**

## **PLUM POINT ENERGY STATION CLASS 3N LANDFILL**

**PERMIT NO. 0303-S3N  
AFIN: 47-00461**

**JANUARY 18, 2019**

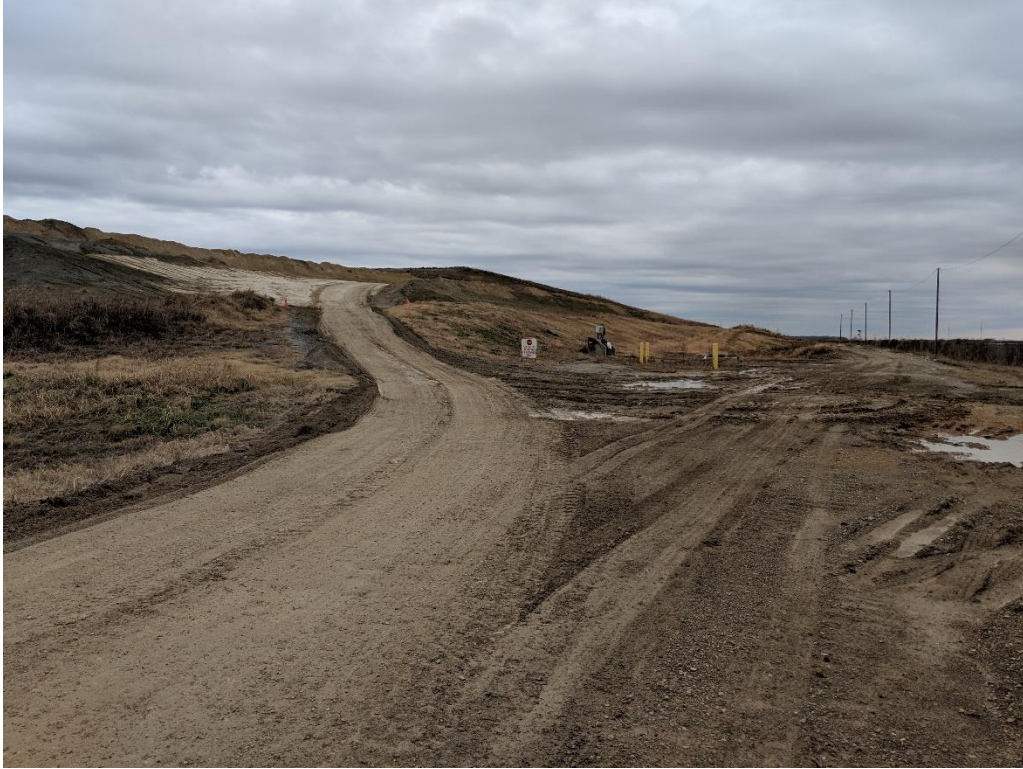
Photo 3. Haul road looking towards Cell 3

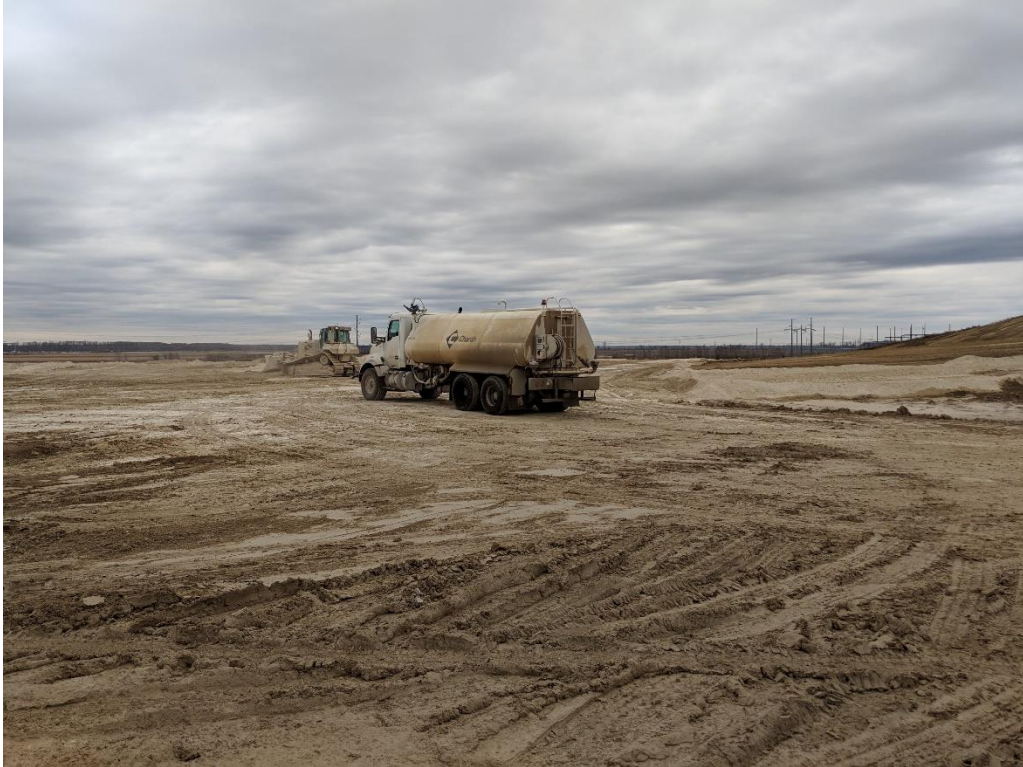
Photo 4. Water truck preparing to wet Cell 3
