# **2020 ANNUAL ENGINEERING INSPECTION REPORT**

## **PLUM POINT ENERGY STATION CLASS 3N LANDFILL**

**PERMIT NO. 0303-S3N  
AFIN: 47-00461**

**JANUARY 15, 2021**

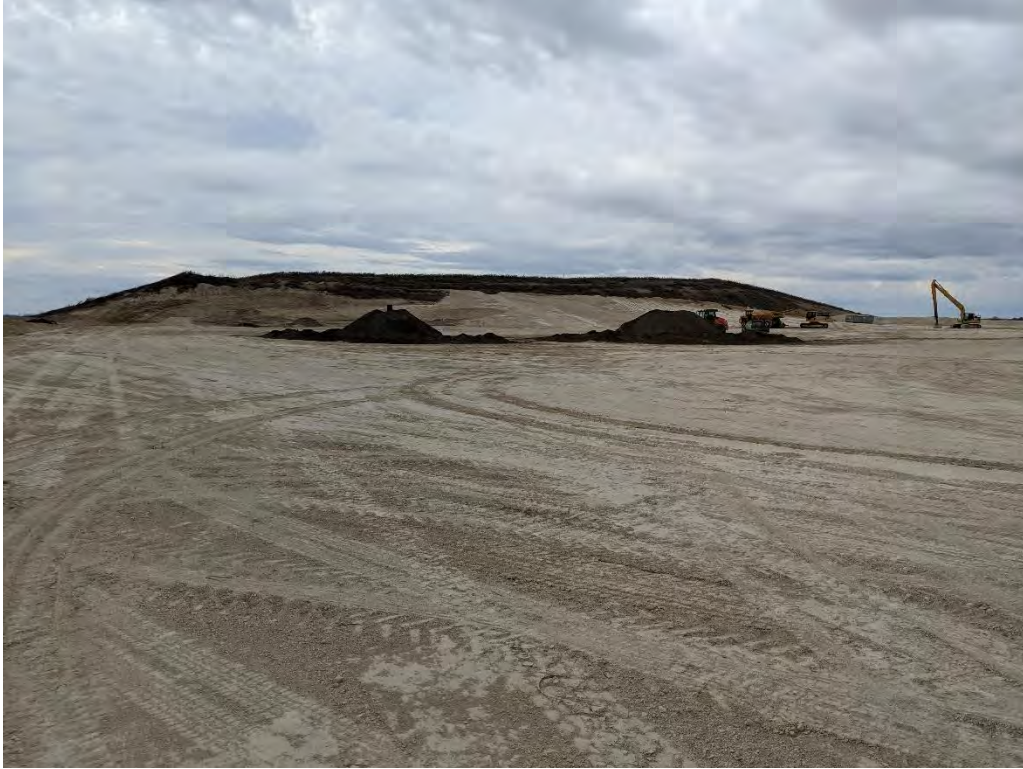
Photo 1. Rolled and sealed top of open disposal cell (Cell 3)

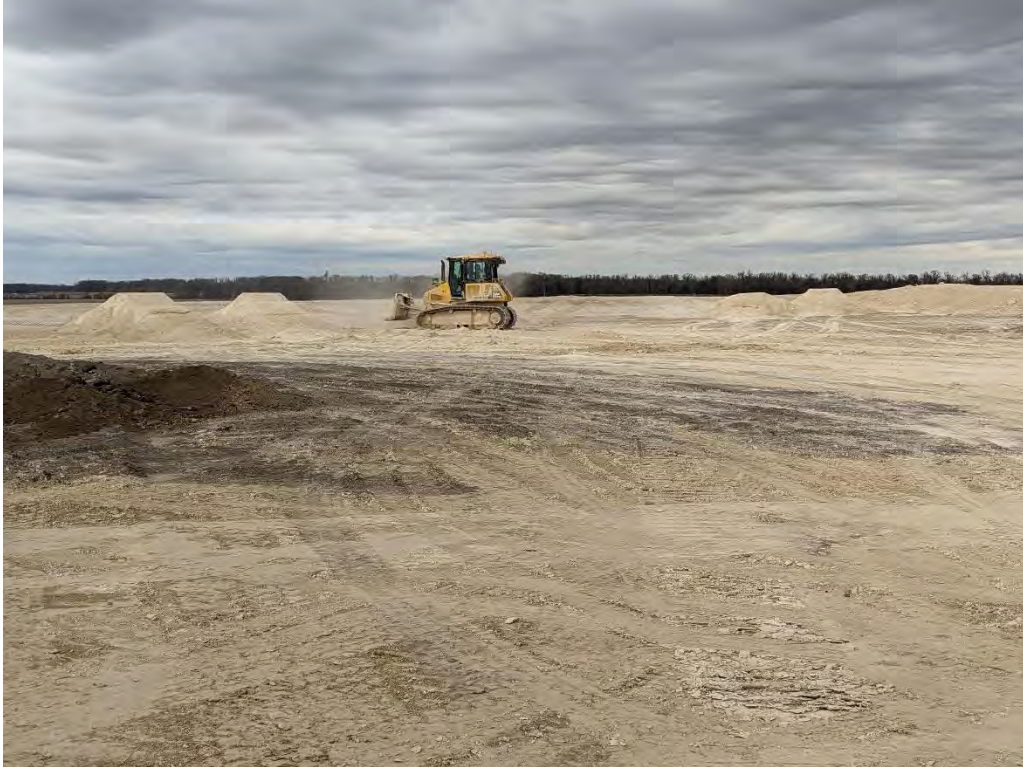
Photo 2. Active working face (Cell 3)

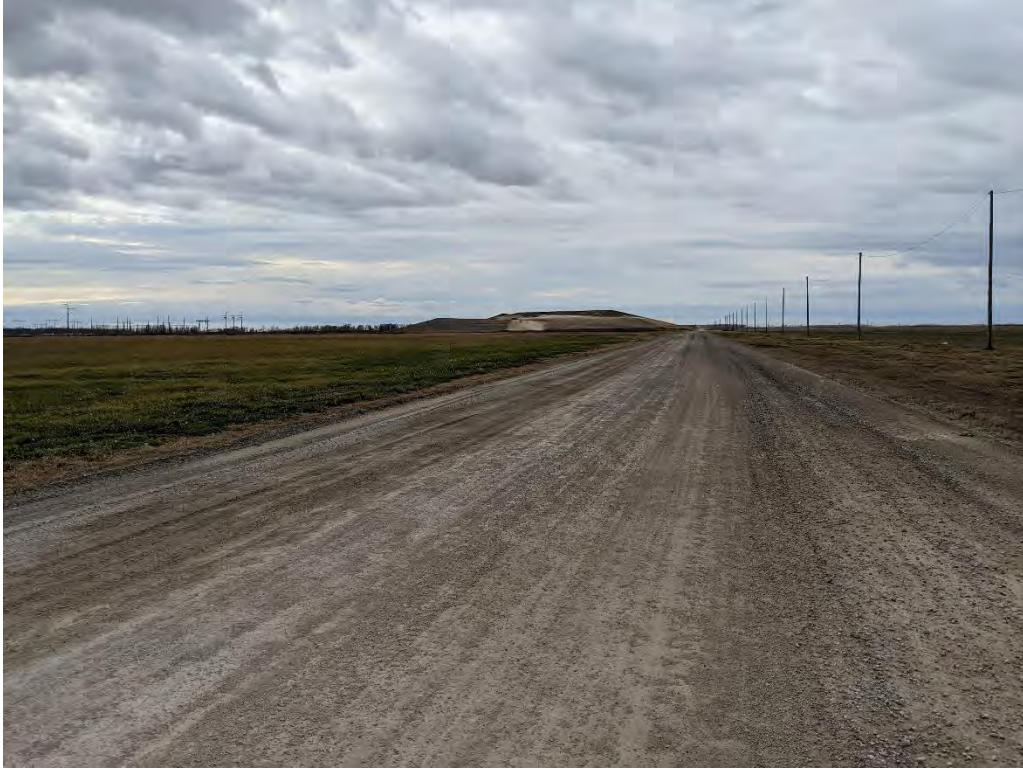
Photo 3. Haul road looking towards Landfill

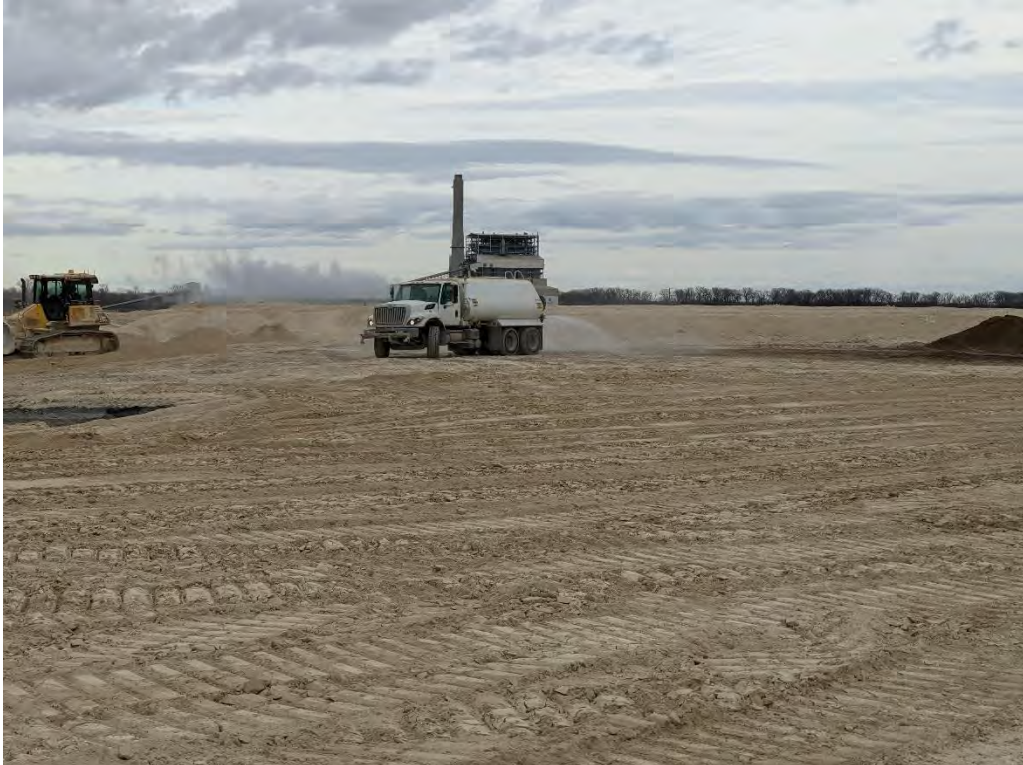
Fly ash is transported to the landfill using end-dump trucks with tarps. The ash is mixed with water in the pug mill at an appropriate rate to minimize fugitive dust problems during truck loading and dumping, but not create excess free liquids. Water is applied, when necessary, for dust suppression on roads and the landfill using a water truck. Disposal activities observed during the December 2020 annual inspection resulted in little dust, which appeared to be confined to the active area.

Photo 4. Water truck activities in active disposal area

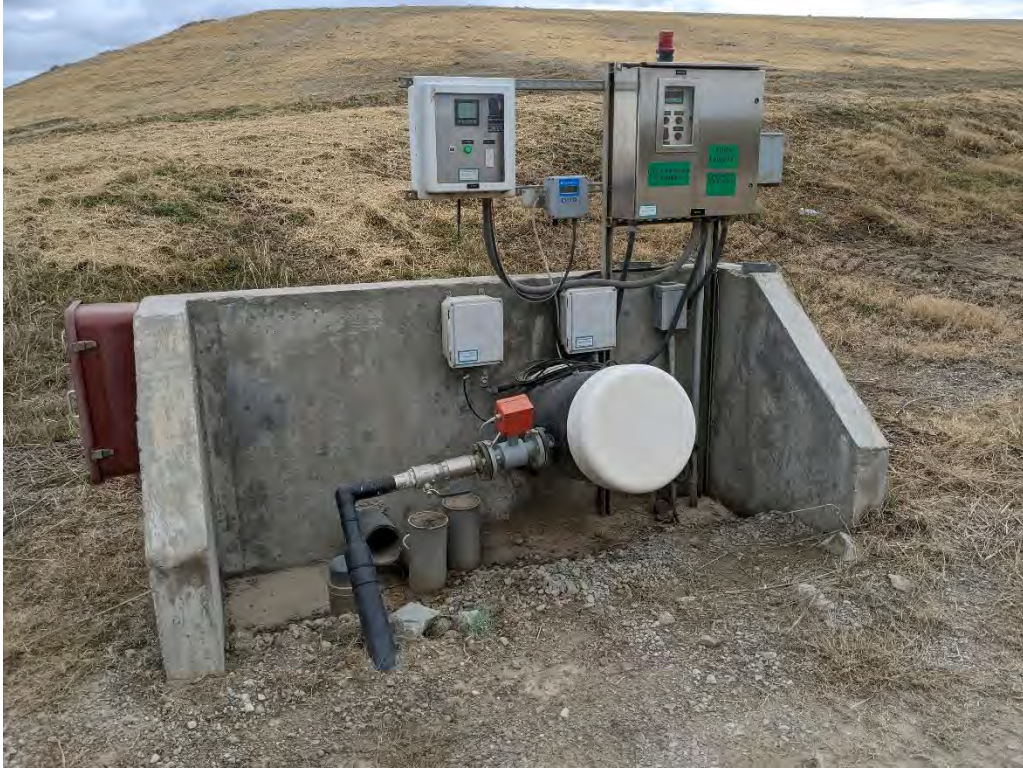
Photo 5. Typical Leachate Collection System monitoring and pumping system

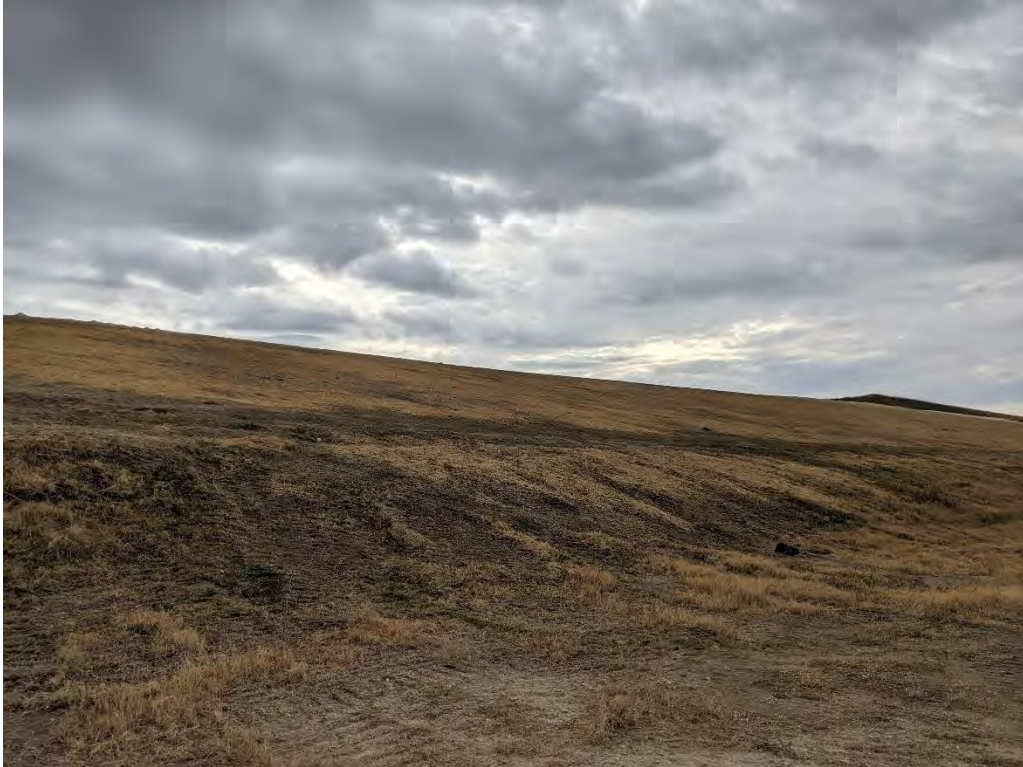
Photo 6. North slope Cell 3 with intermediate cover, seeding and mulch

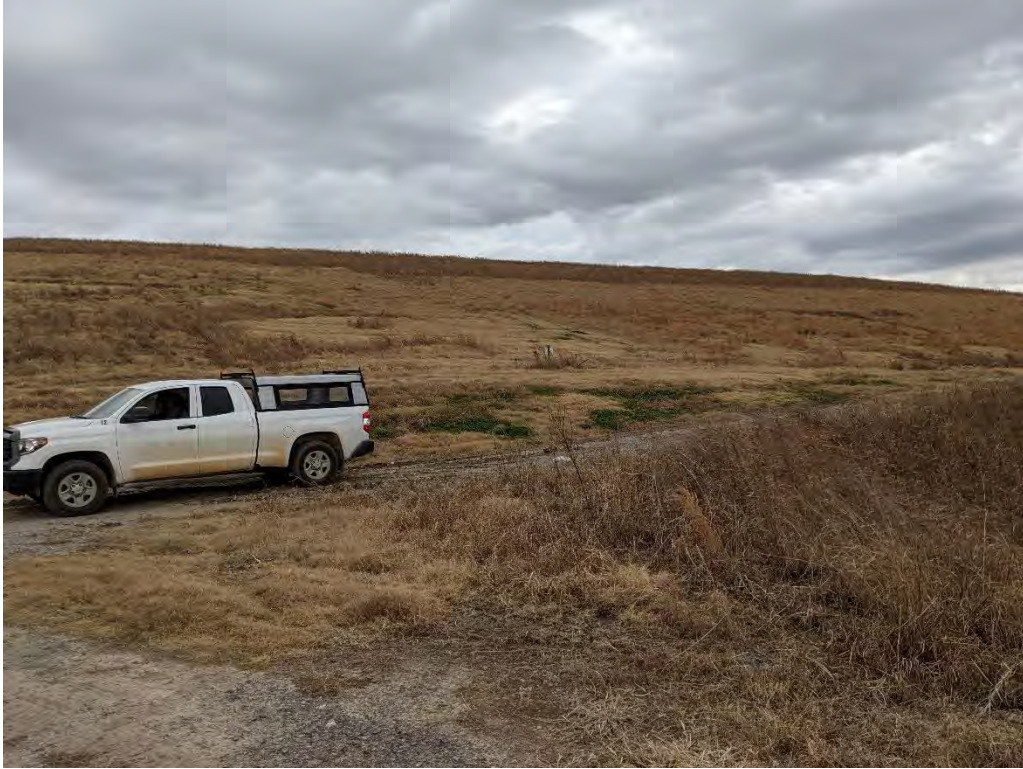
Both active cells remain open. Interim cover soil has been placed, as noted, on all of Cell 1 except for the east slope into Cell 3 and on Cell 3 as noted above.

Photo 7. Typical Cell 1 interim cover slope, from northwest.

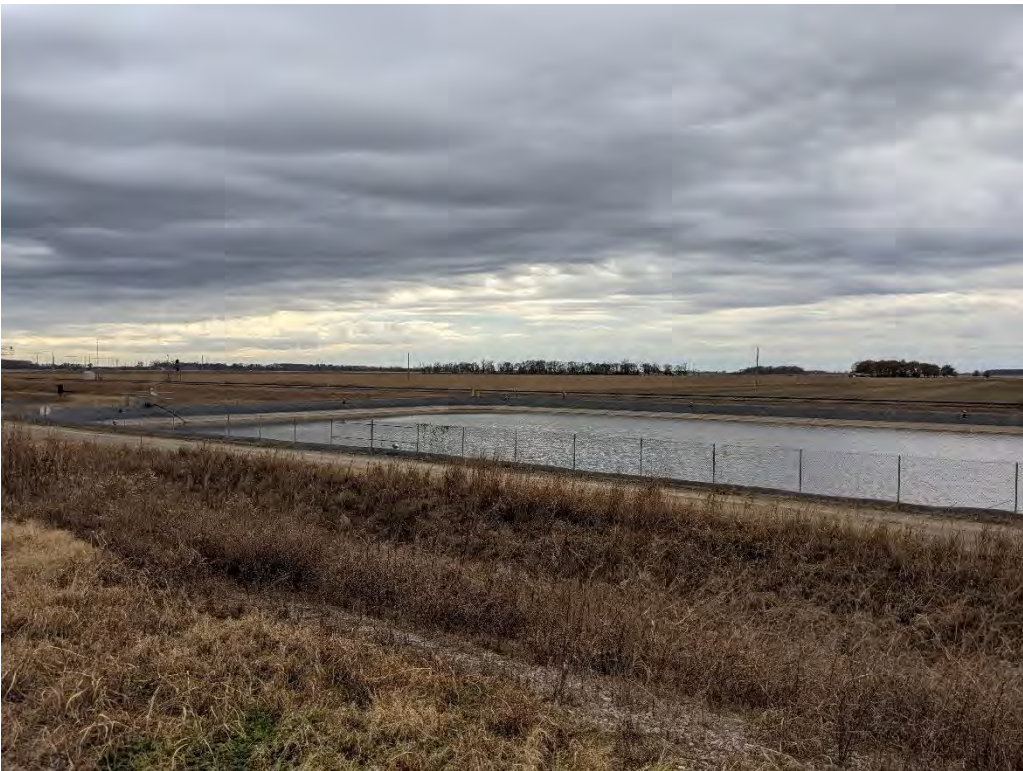
Photo 8. Leachate Pond from east.
