2022 ANNUAL ENGINEERING INSPECTION REPORT

PLUM POINT ENERGY STATION CLASS 3N LANDFILL

**PERMIT NO. 0303-S3N-R1
AFIN: 47-00461**

JANUARY 26, 2023

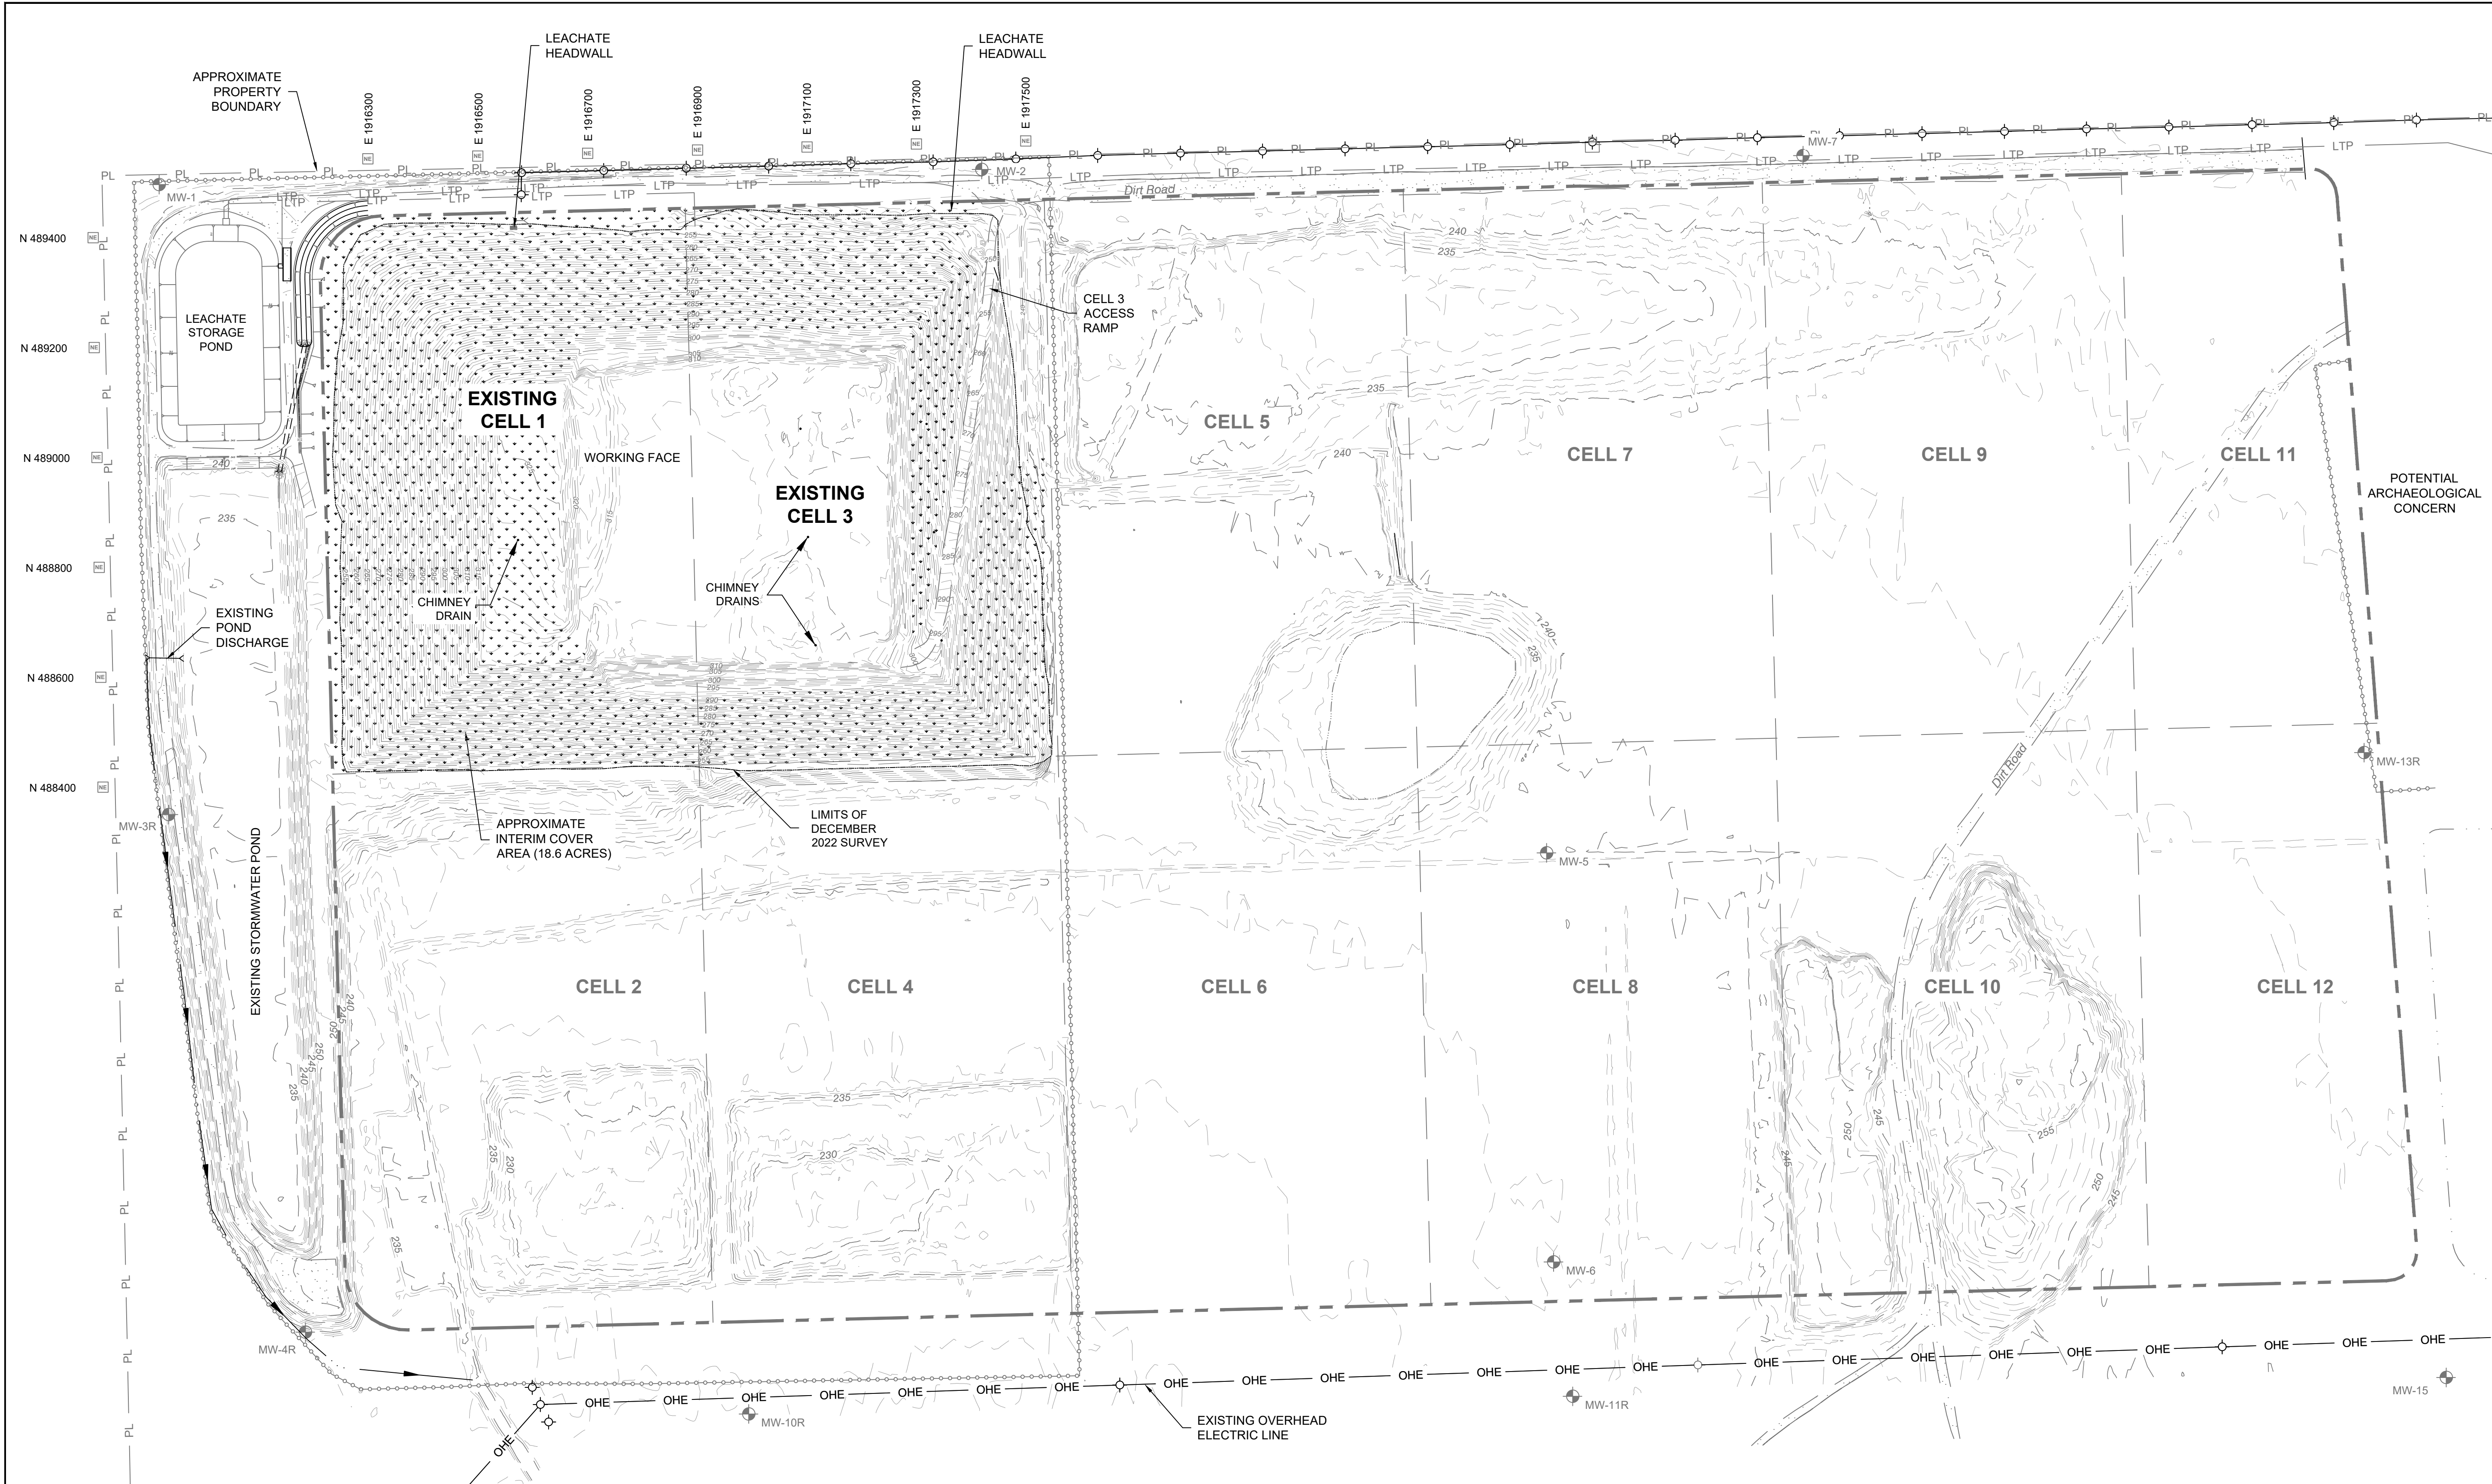
FIGURE 2
EXISTING CONDITIONS

No tension cracks or other features that indicate a potential slope failure were observed during the site inspection. In addition, no active seeps were noted on the exterior slopes.

Both active cells remain open. Interim cover soil has been placed on the western, northern and southern side slopes of Cell 1 and on the north, east, and south side slopes of Cell 3, as noted above.

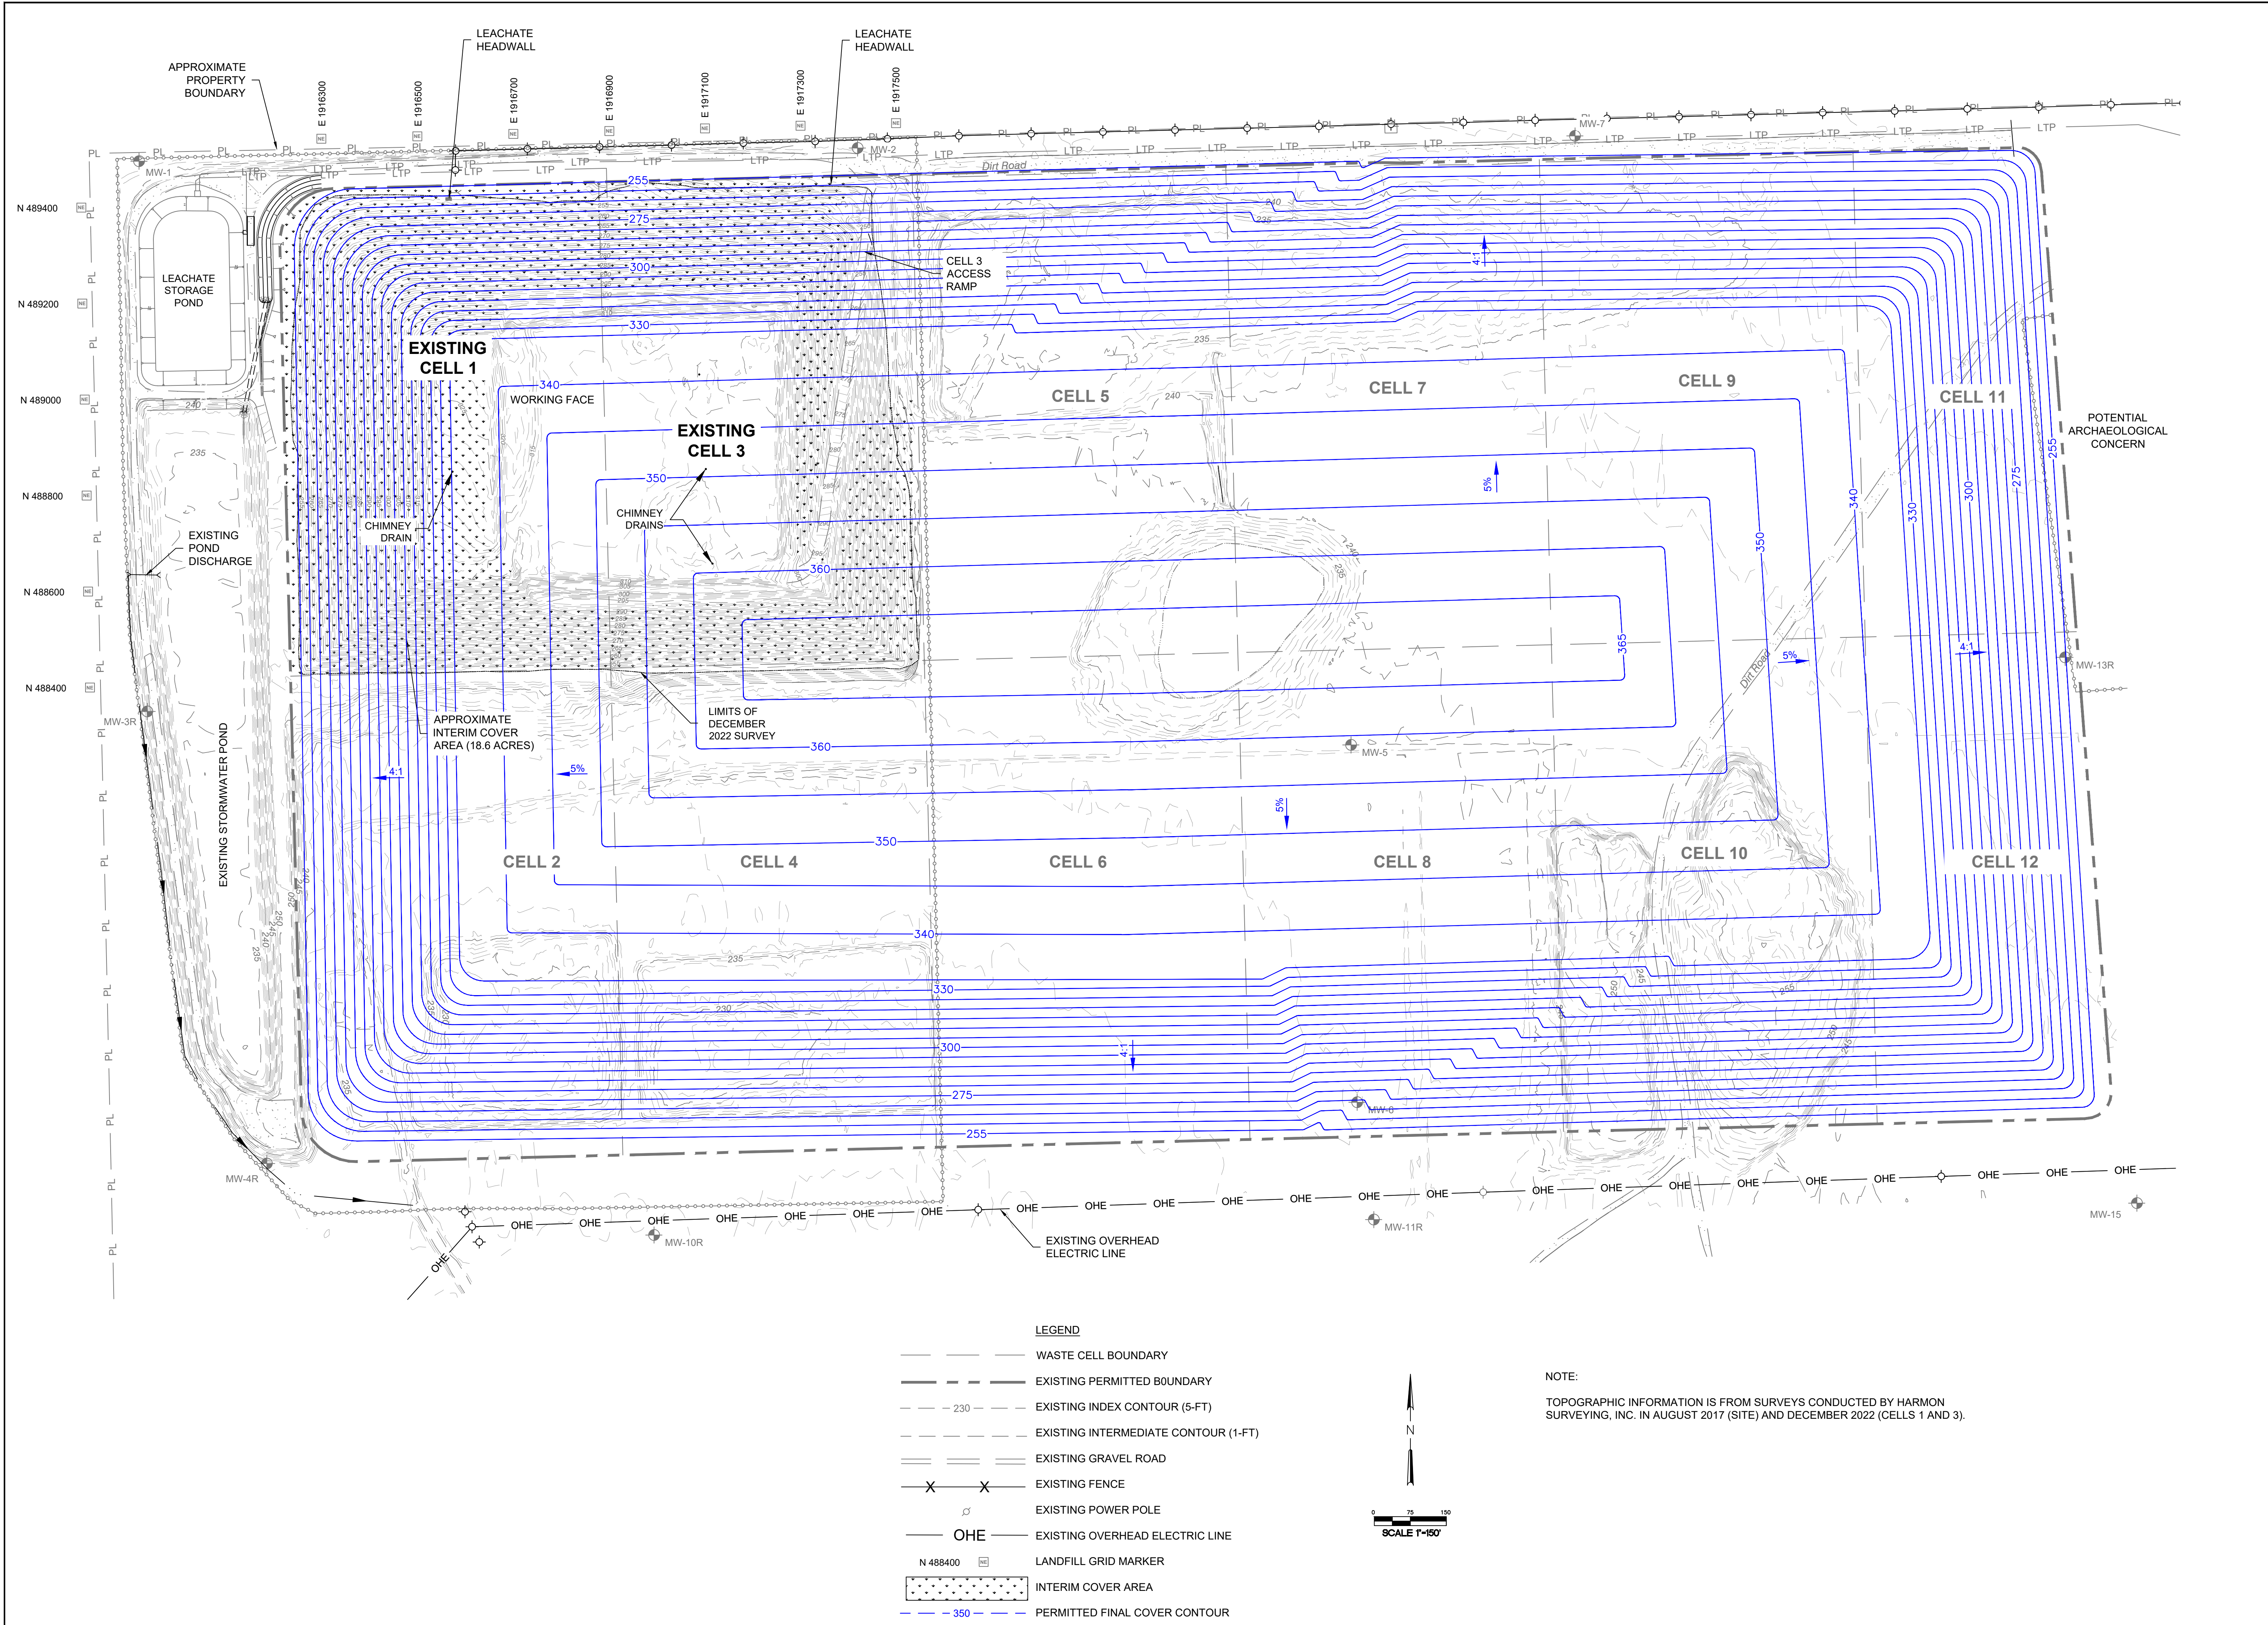
As noted, no final cover system has been installed on Waste Cells 1 or 3. Figure 3 presents contours for the currently permitted final cover system.

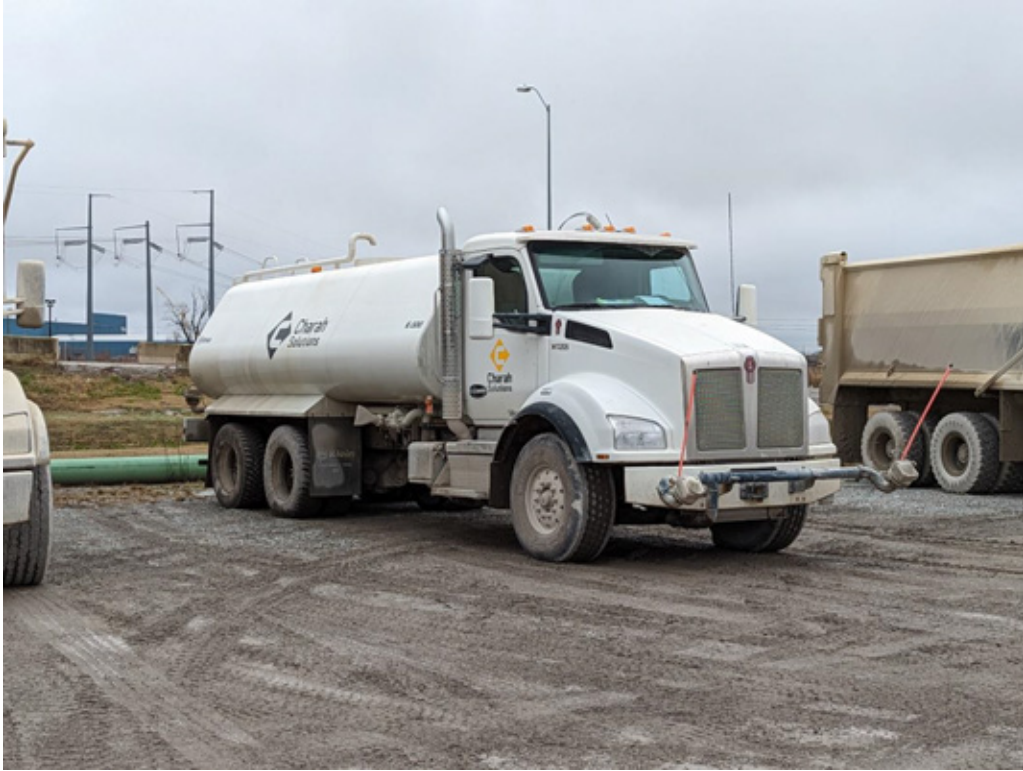
Photo 1. Water Truck staged in parking lot next to shop.

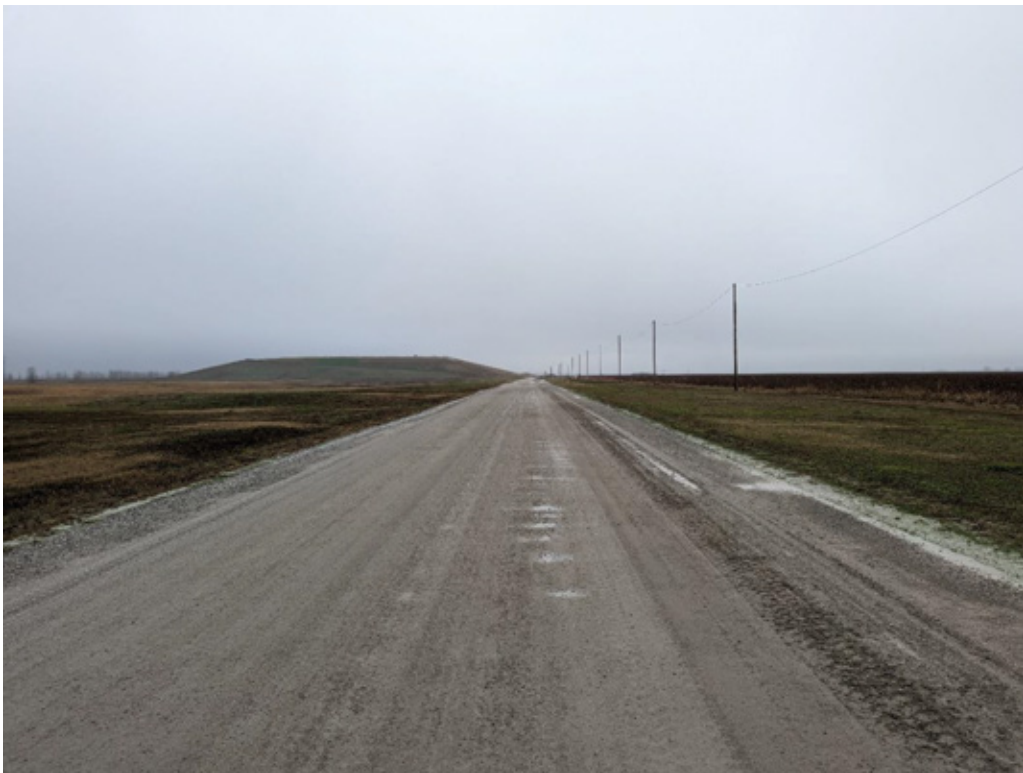
Photo 2. Haul road to landfill from east.

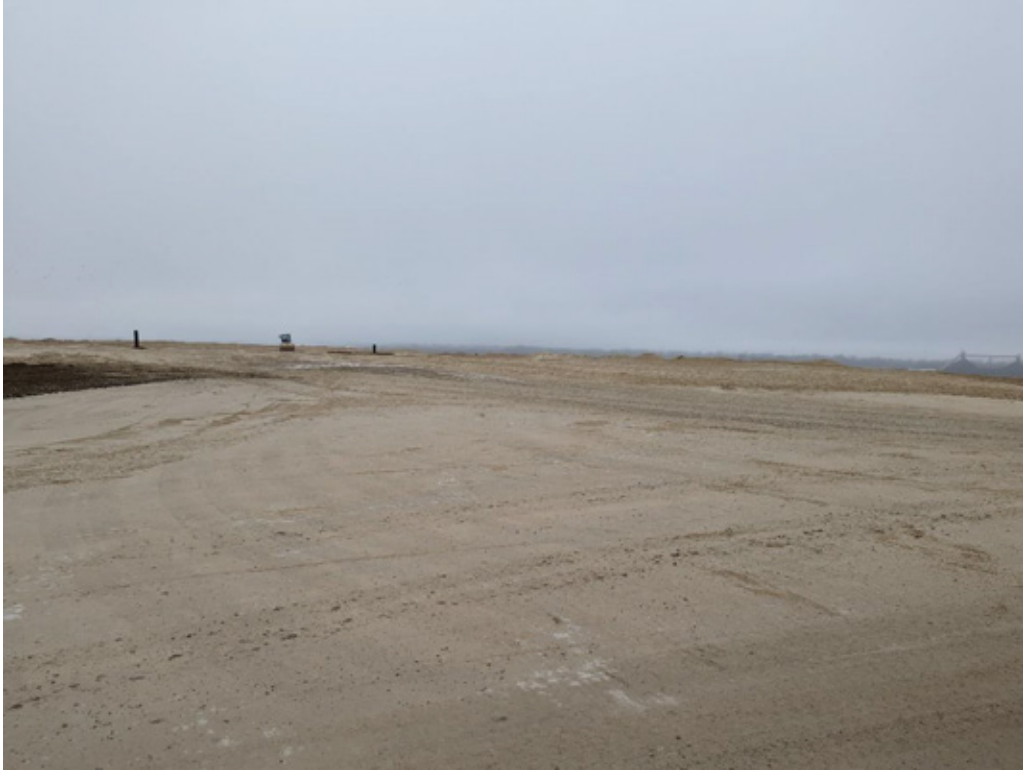
Photo 3. Active disposal area, fly ash (Cell 3).

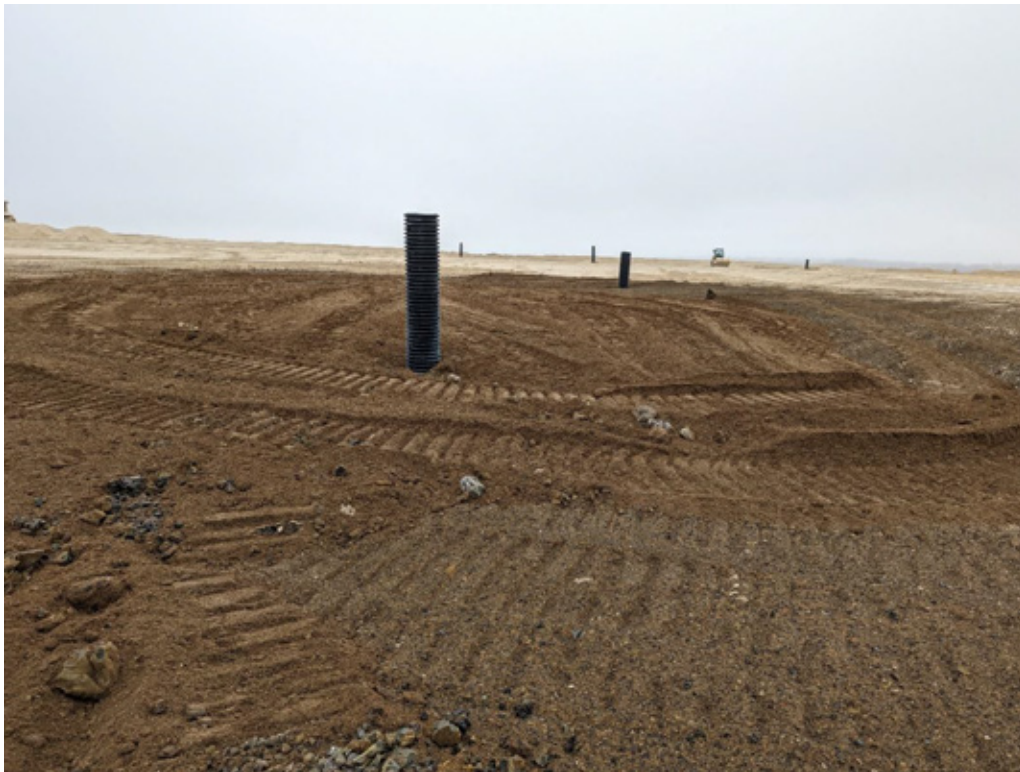
Photo 4. Active disposal area, bottom ash with chimney drains (Cell 3).

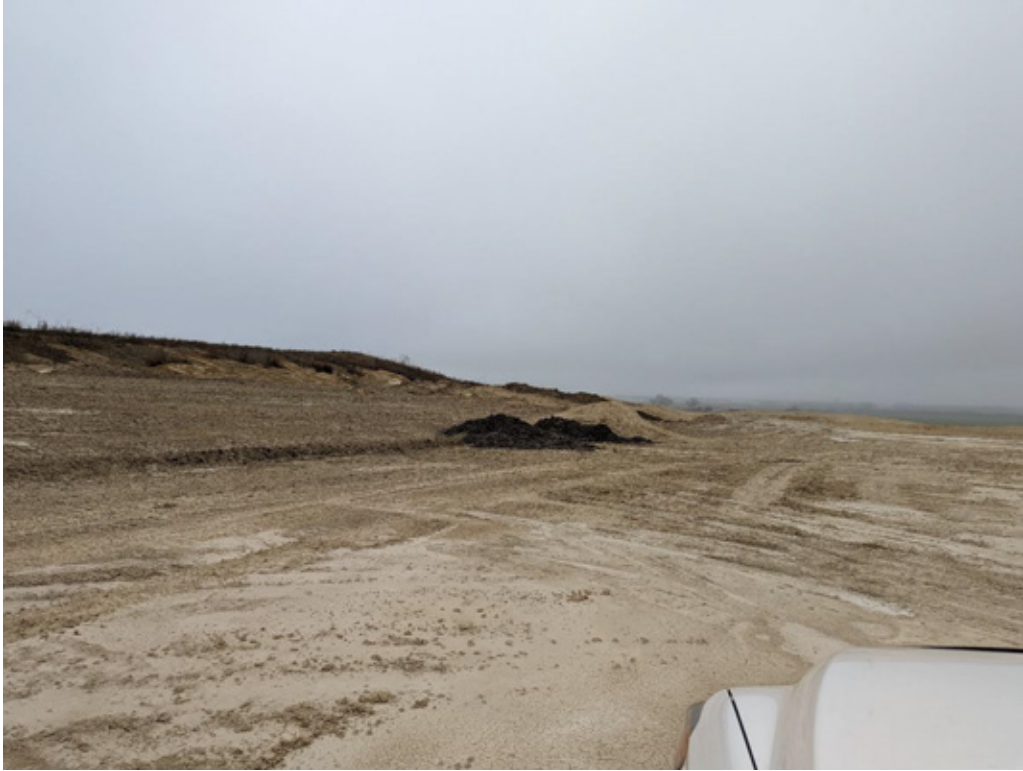
Photo 5. Working face looking northwest at Cell 1 top elevation.

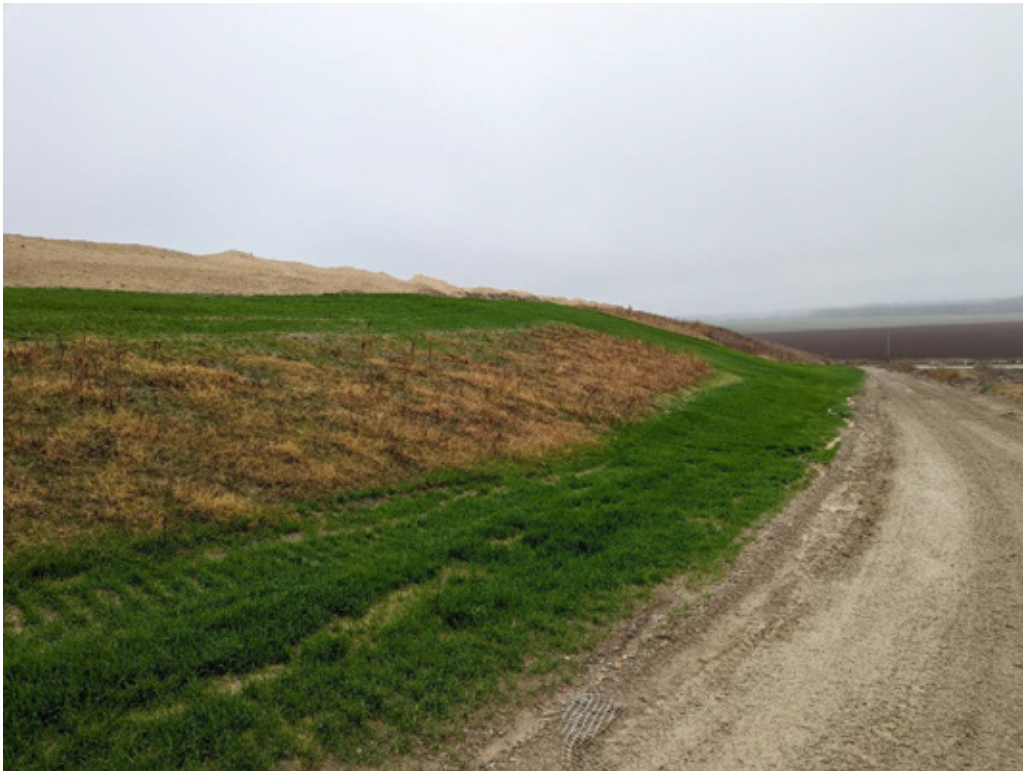
Photo 6. Cell 3 east slope intermediate cover and haul road.

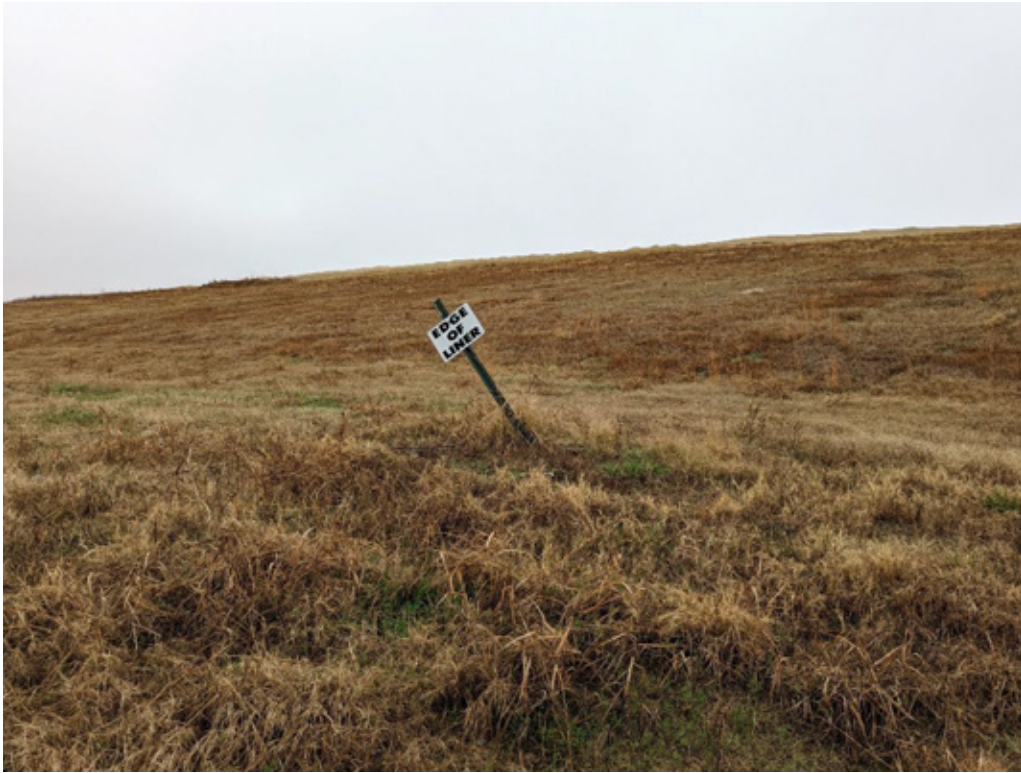
Photo 7. North slope intermediate cover with “Edge of Liner” sign.

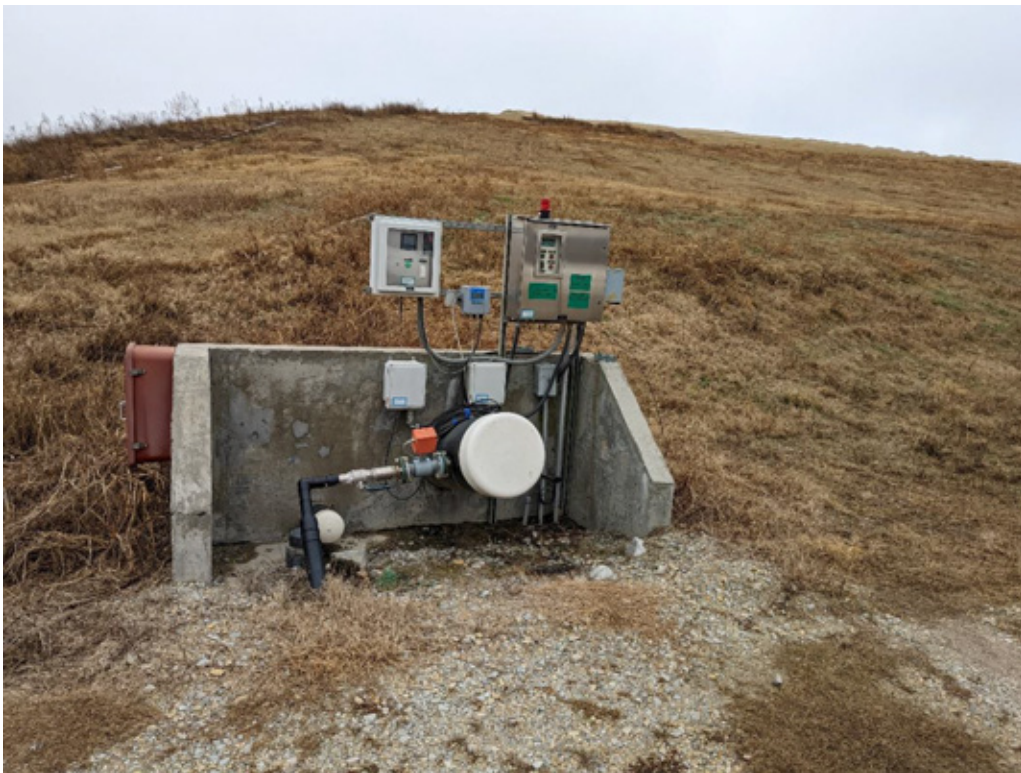
Photo 8. Typical leachate collection and monitoring system (Cell 3).

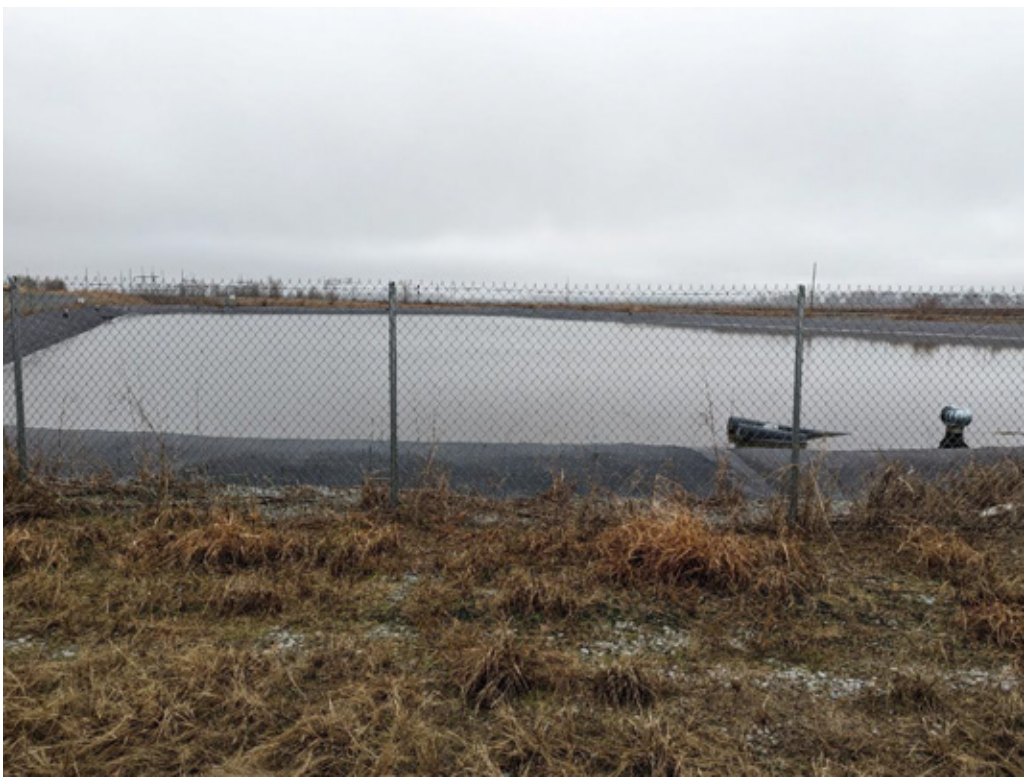
Photo 9. Leachate pond from north.

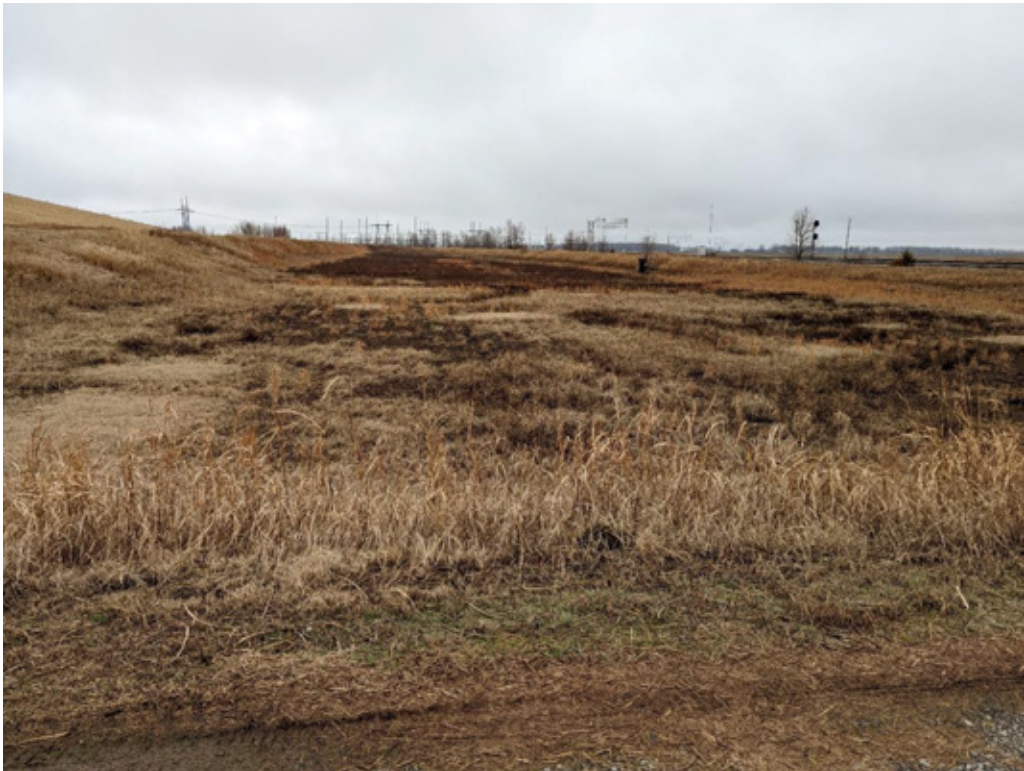
Photo 10. Stormwater pond from north.
